## HERO RESIDENTIAL INSPECTION

1234 Main St.  
Boulder Colorado 80305

Buyer Name  
12/13/2018 9:00AM

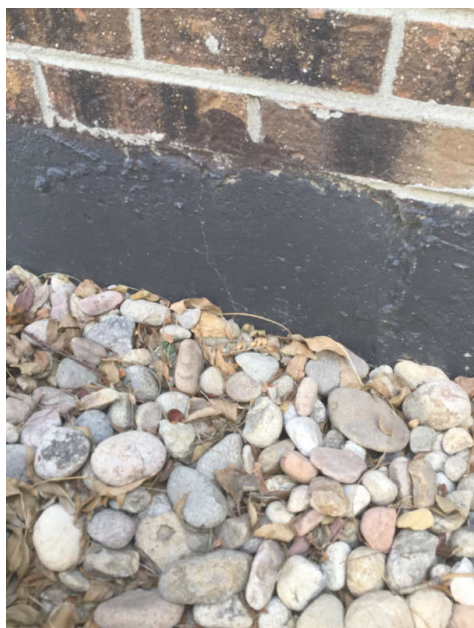
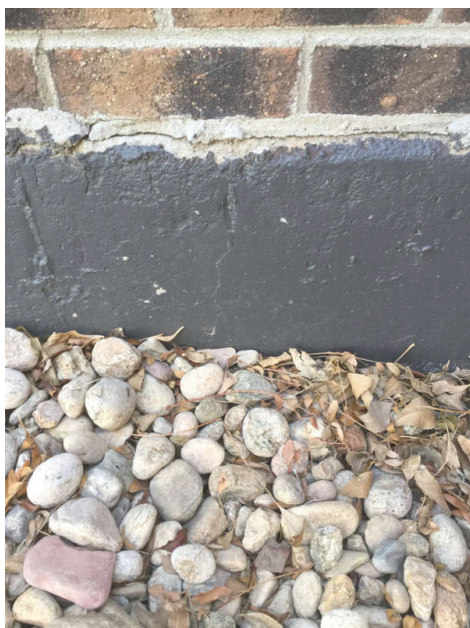
North Elevation

#### FOUNDATION - CRACKS - MINOR

There were minor cracks and/or cosmetic blemishes found in the foundation. These don't appear to be a structural concern, but recommend sealing them to prevent water infiltration and monitoring them in the future. Numerous products exist to seal such cracks including:

- Hydraulic cement. Requires chiseling a channel in the crack to apply.
- Resilient caulks (easy to apply).
- Epoxy sealants (both a waterproof and structural repair).

Contact a handyman or DIY project

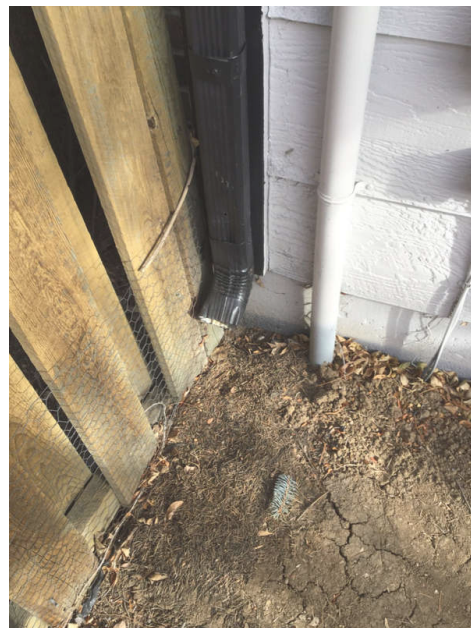
West Elevation

**DRAINAGE - DOWNSPOUTS EXTENSIONS MISSING OR INEFFECTIVE**

The downspouts have no extensions, or have extensions that are ineffective. This can result in water accumulating around the structure's foundation, or in basements and crawl spaces if they exist. Accumulated water is a conducive condition to wood destroying insects and organisms, and may also cause the foundation to settle and possibly fail over time. Repairs should be made as necessary, such as installing or repositioning splash blocks, or installing and/or repairing tie-ins to underground drain lines, so rain water is carried at least several feet away from the structure to soil that slopes down and away from the structure.

Contact a handyman or DIY project

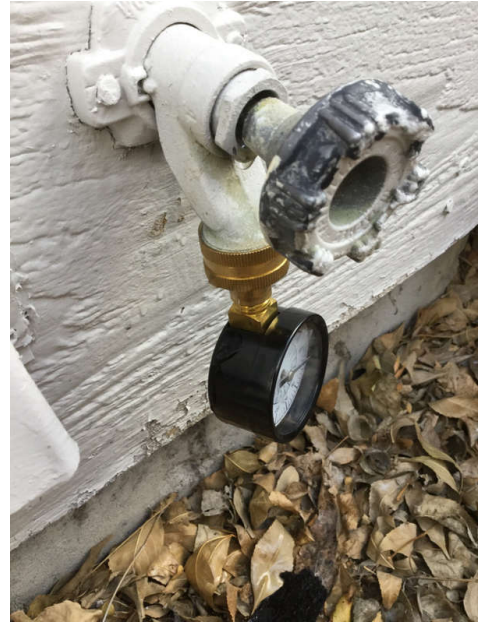
South Elevation

**FAUCET/ HOSE BIB - LEAKS**

The outside faucets leak. For example, from the valve stem when turned on or from the spigot when turned off. A qualified plumber should evaluate and repair as necessary.

Contact a qualified plumbing contractor.

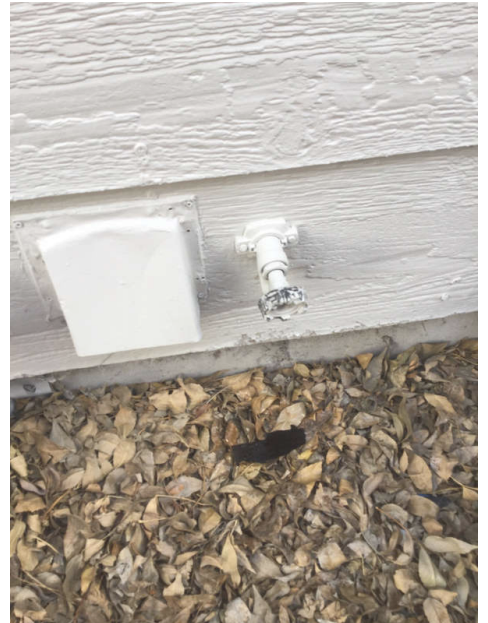
South Elevation

Outside faucets are missing backflow prevention devices. These devices reduce the likelihood of polluted or contaminated water entering the potable water supply. This condition can occur when an outside faucet is left in the "on" position with a hose connected and the sprayer head turned off. When pressure in the system fluctuates, water can be drawn back into the water supply pipes from the house. If a chemical sprayer is being used with the hose, those chemicals can enter the water supply pipes.

Recommend installing backflow prevention devices on all exterior hose bibs where missing. They are available at most home improvement stores and are easily installed. For more information, visit:

Contact a qualified plumbing contractor.

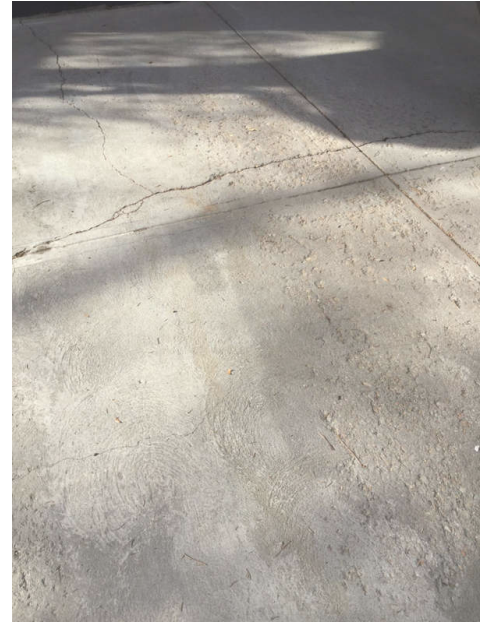
East Elevation

**DRIVEWAY - CRACKS MINOR**

There were minor cracks and/or cosmetic blemishes found in the driveway. These don't appear to be a structural concern, but recommend sealing them to prevent water infiltration and monitoring them in the future. Numerous products exist to seal such cracks including:

- Hydraulic cement. Requires chiseling a channel in the crack to apply.
- Resilient caulks (easy to apply).
- Epoxy sealants (both a waterproof and structural repair).

Contact a qualified driveway contractor.

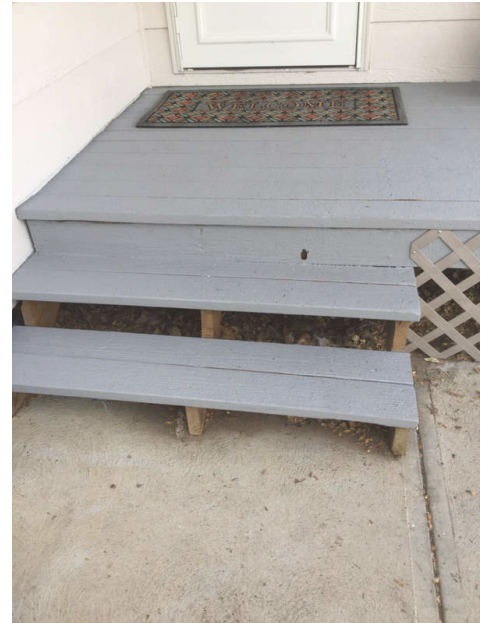
East Elevation

### HANDRAILS - MISSING

Flights of stairs with more than two risers have no handrail installed. This is a safety hazard. A qualified contractor should install graspable handrails that your hand can completely encircle at stairs where missing, and as per standard building practices.

Contact a handyman or DIY project

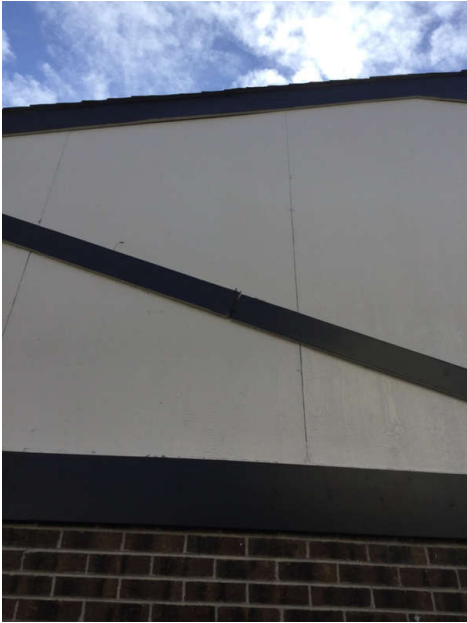
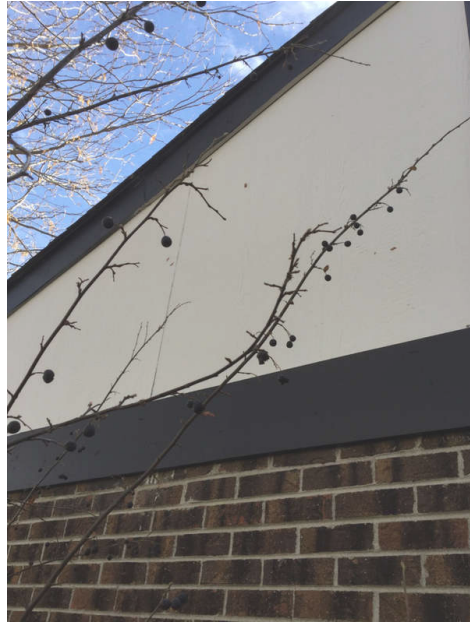
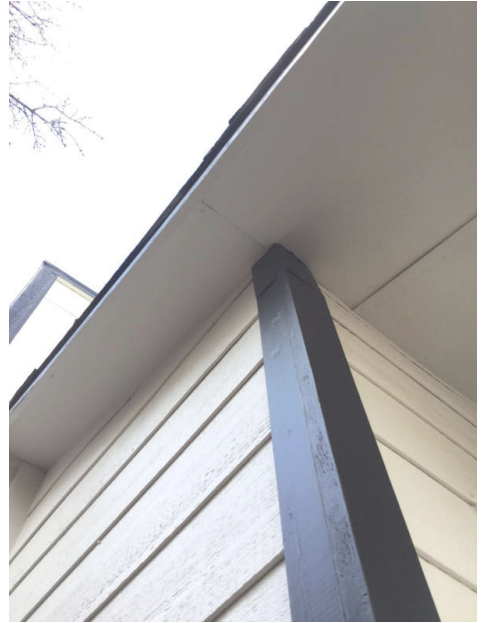
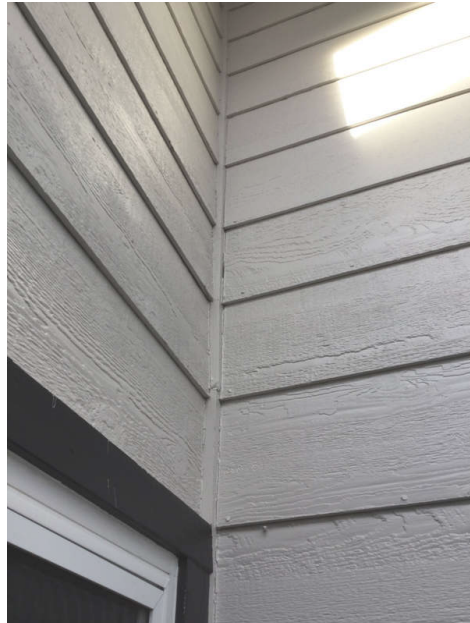
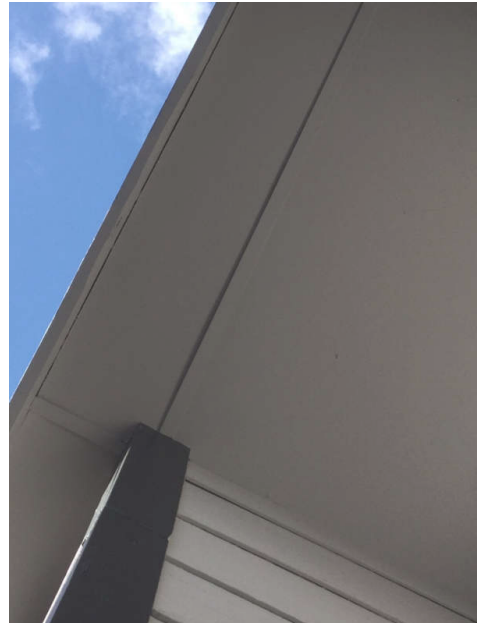
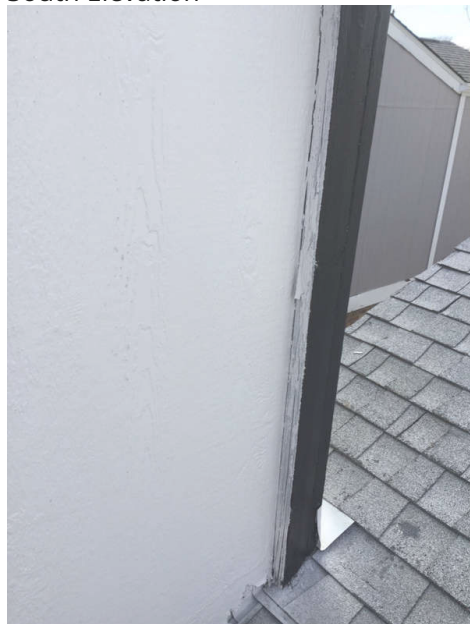
Caulking/sealant is missing and/or deteriorated around the entire exterior where similar and dissimilar materials meet. This is a general maintenance situation which typically requires regular attention. A qualified contractor should evaluate and make repairs as necessary.

Contact a handyman or DIY project

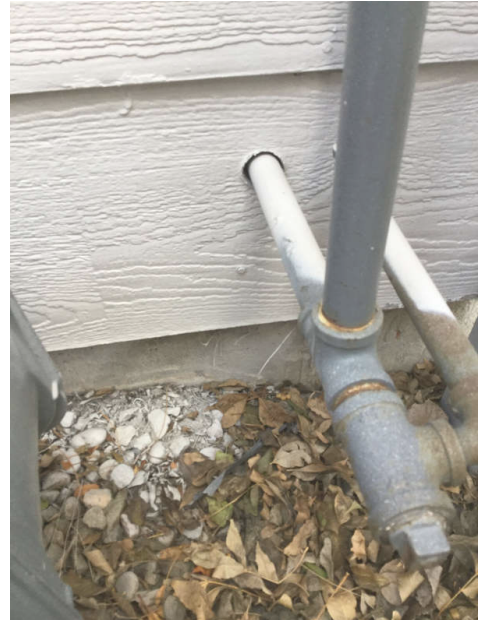
South Elevation

Gaps exist at openings around the exterior, such as those where outside faucets, refrigerant lines, and/or gas supply pipes penetrate the exterior. Gaps should be sealed as necessary to prevent moisture intrusion and entry by vermin.

Contact a handyman or DIY project

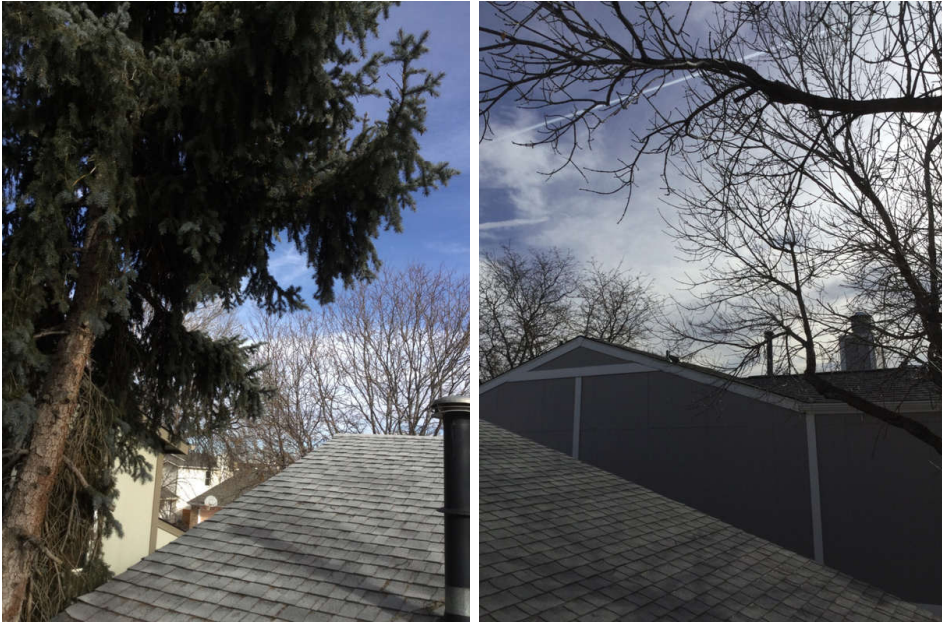
Trees are overhanging roof and are within 10 feet of roof vertically. This is a conducive condition for wood destroying insects and organisms since organic debris such as leaves or needles are more likely to accumulate on the roof surface. Accumulated debris may cause water to enter gaps in the roof surface and leak into attic and/or interior spaces. Trees should be pruned so they are at least 10 feet above roof, or don't overhang the roof.

Contact a qualified tree service company.

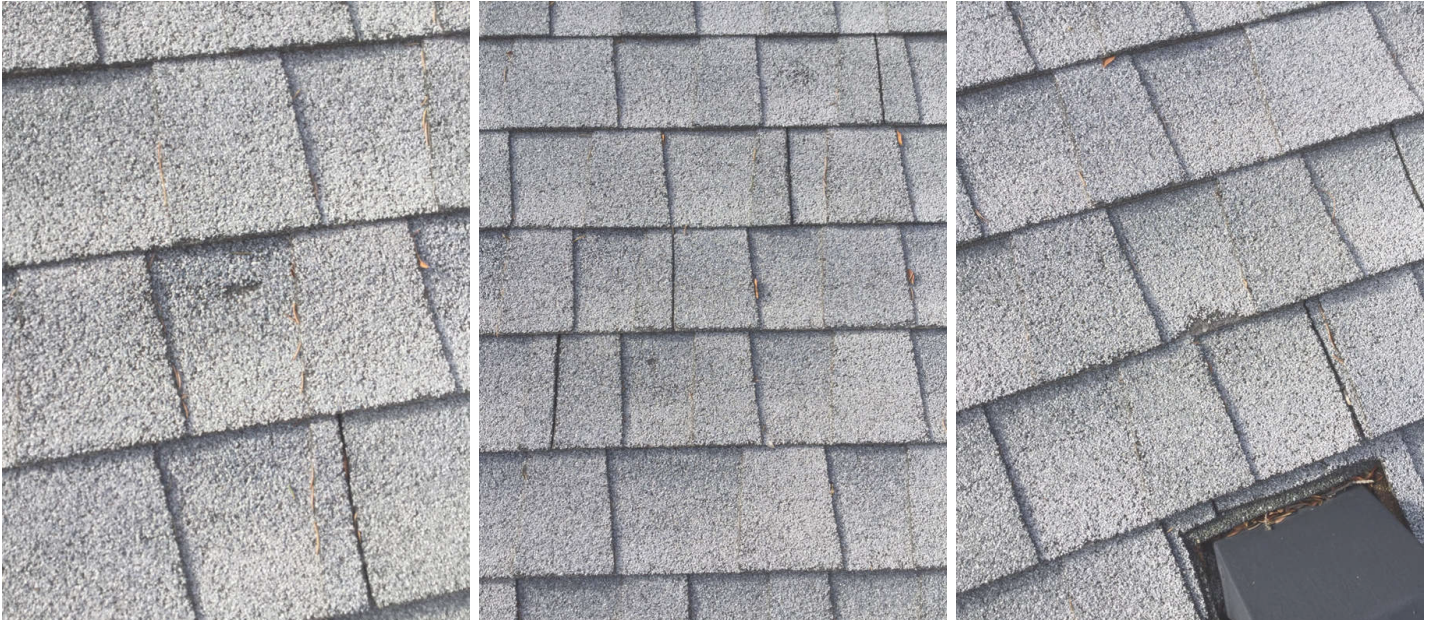
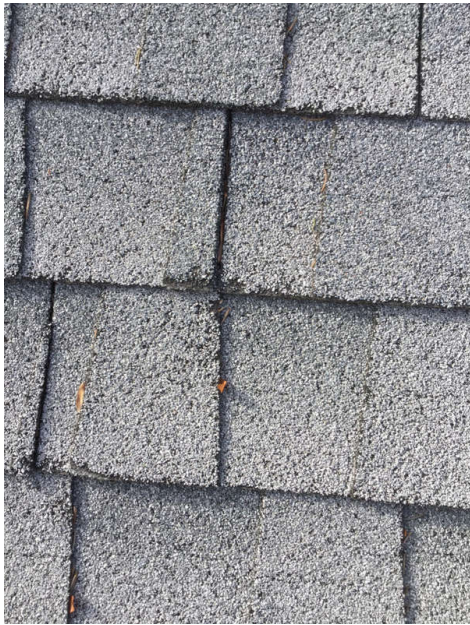
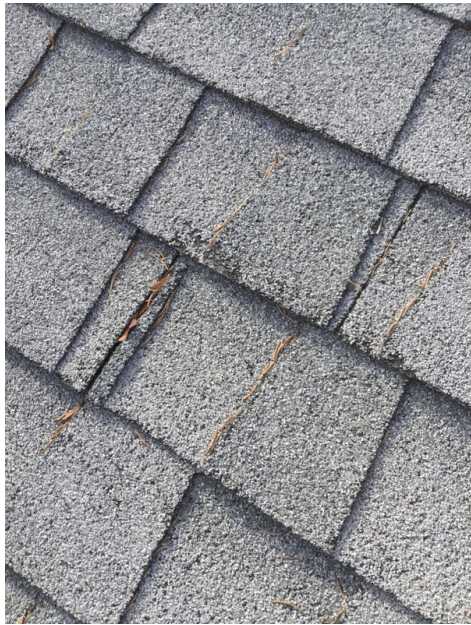
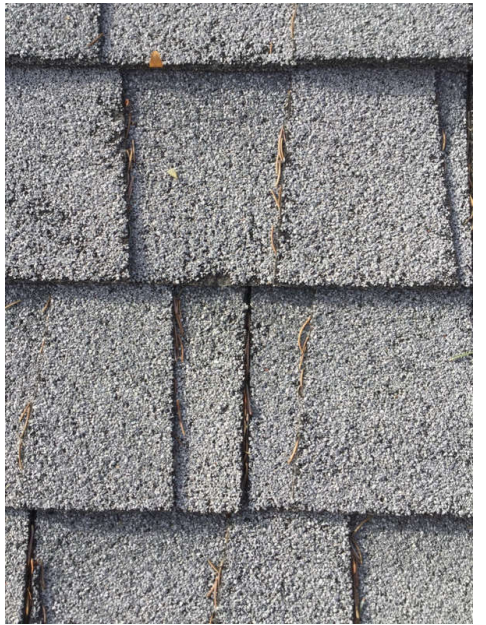
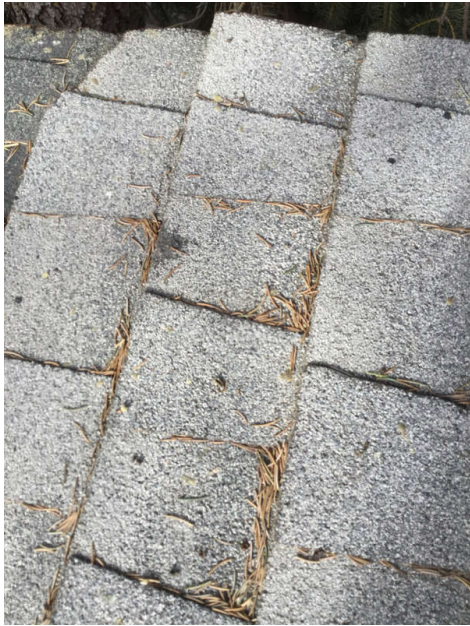
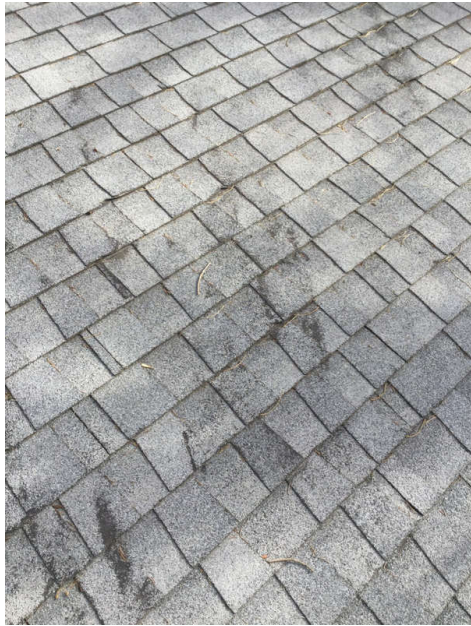
**DAMAGE - DETERIORATION - MINOR**

The roof has minor damage or deterioration. It is recommended to monitor the roofing system, however, the buyer may consider having it evaluated by a licensed roofer.

Recommend monitoring.

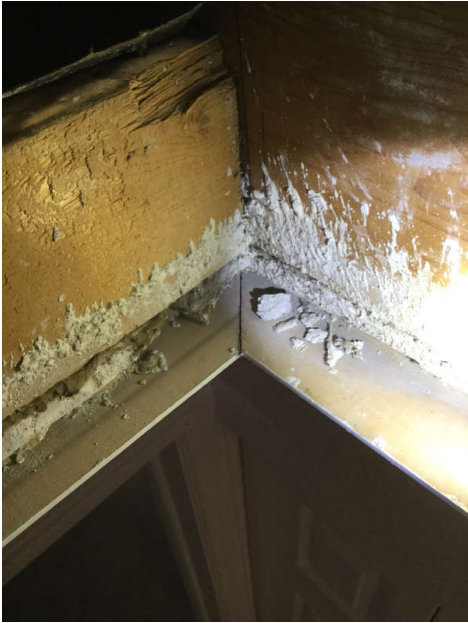
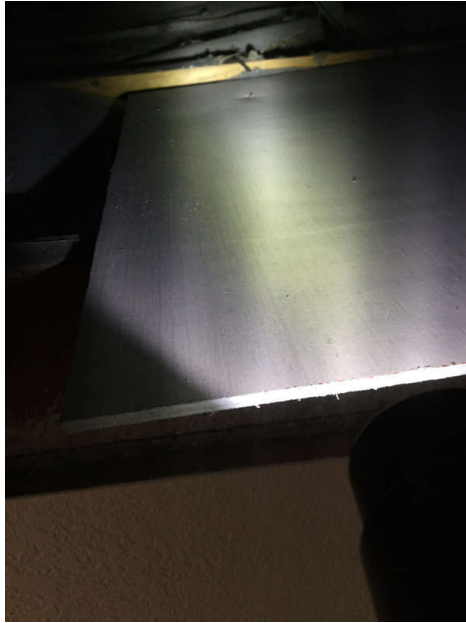
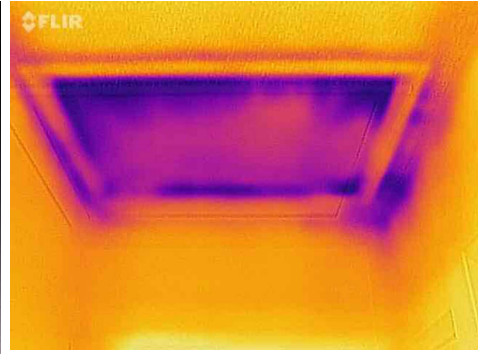
#### **INSULATION - ACCESS HATCH - MISSING AT COVER AND WEATHER STRIPPING**

No insulation is installed over the access hatch and there is no weatherstrip installed around the access hatch. Recommend installing insulation above hatch for better energy efficiency along with weatherstrip installed around the hatch to prevent conditioned interior air from entering.

Contact a handyman or DIY project

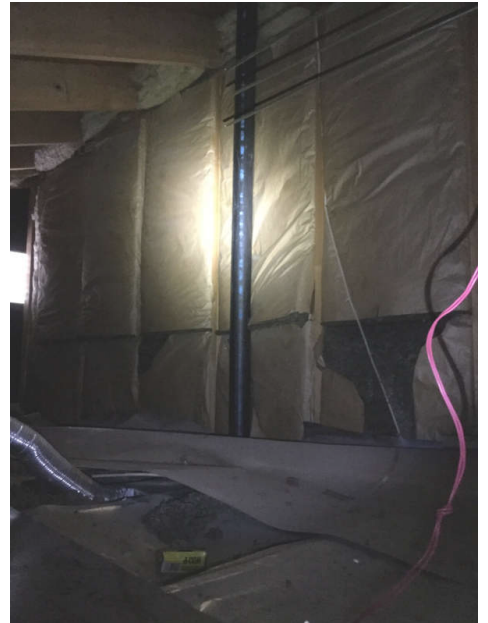
#### INSULATION - PAPER FACING ON BATTS EXPOSED

For newer batt insulation with paper facing on one side only, the paper facing should be oriented towards interior spaces rather than exposed, open spaces. The existing insulation should be reinstalled or replaced.

Also, the paper facing also acts as a vapor barrier, and if located away from the interior surfaces, can trap moisture from condensation in the cavity between the paper facing and the interior spaces. This is a conducive condition for wood destroying insects. The inspector was unable to evaluate the structure obscured by the insulation. When repairs are made, the exposed structure should be evaluated for damage by wood destroying insects and/or organisms, and repairs should be made if necessary.

For older batt insulation with paper facing on both sides, recommend that repairs be made as necessary to eliminate the exposed paper facing.

A qualified contractor should evaluate and make repairs as necessary, and as per standard building practices and the insulation manufacturer's recommendations to eliminate the fire hazard.

Contact a qualified insulation contractor.

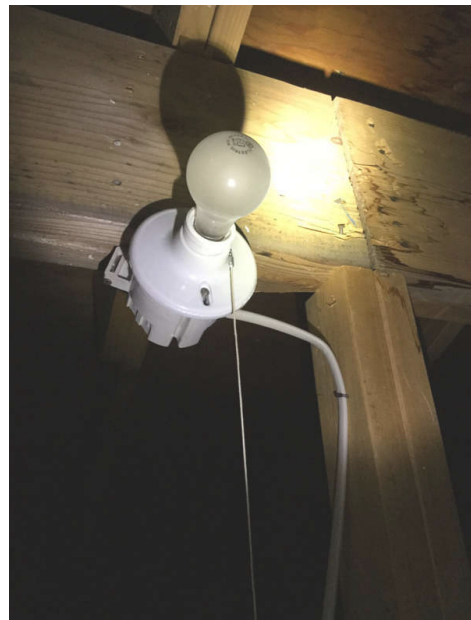
Minor - Safety | Deficiencies**LIGHT FIXTURE -  
INOPERABLE**

The light fixtures appear to be fully or partially inoperable. Recommend further evaluation by replacing bulb(s) and/or consulting with the property owner(s). Repairs or replacement of the light fixture by a qualified electrician may be necessary.

Contact a handyman or DIY project

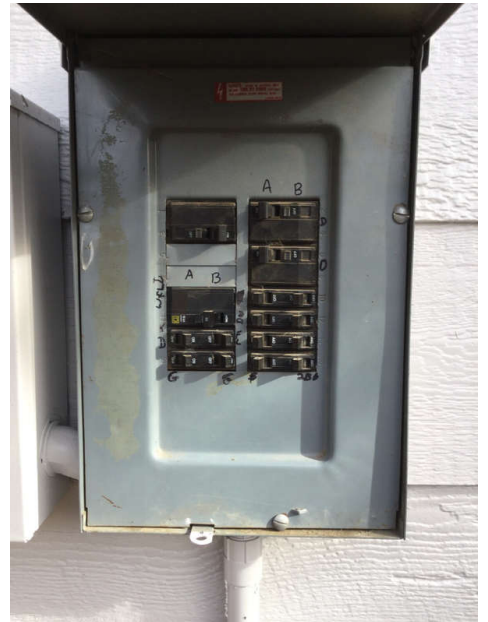
**SAFETY - MINOR - MISSING OR INADEQUATE LEGEND**

The legend for overcurrent protection devices (breakers or fuses) in the main service panel is missing, unreadable or incomplete. Recommend installing, updating or correcting the legend as necessary so it's accurate. Evaluation by a qualified electrician may be necessary.

Contact a qualified electrical contractor.

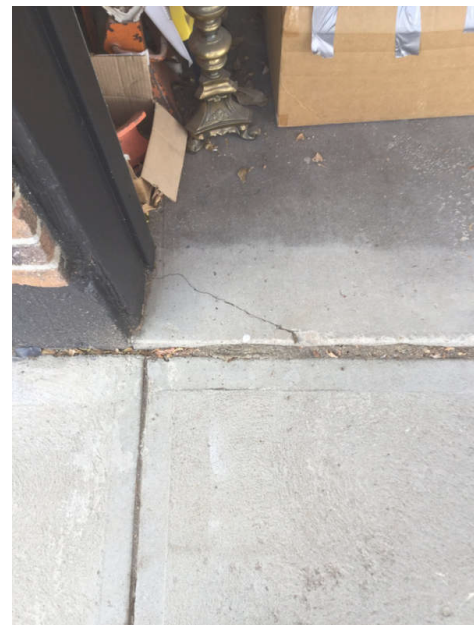
**FLOORS - CRACKS - MINOR**

There were minor cracks and/or cosmetic blemishes found in the garage floor. These don't appear to be a structural concern, but recommend sealing them to prevent water infiltration and monitoring them in the future. Numerous products exist to seal such cracks including:  
Hydraulic cement. Requires chiseling a channel in the crack to apply.  
Resilient caulks (easy to apply).  
Epoxy sealants (both a waterproof and structural repair).

Recommend monitoring.

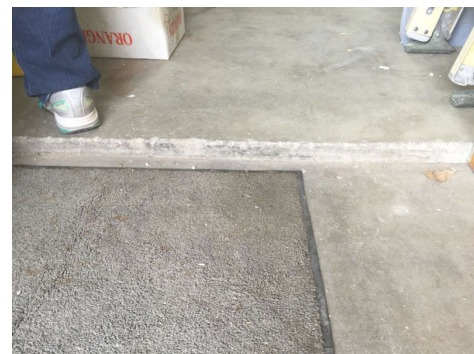
**FLOORS - CRACKS - TRIP HAZARD**

Trip hazards were found in the garage floor due to cracks, settlement and/or heaving. Recommend having a qualified contractor evaluate and repair or replace sections as necessary to eliminate trip hazards.

Contact a qualified concrete contractor.

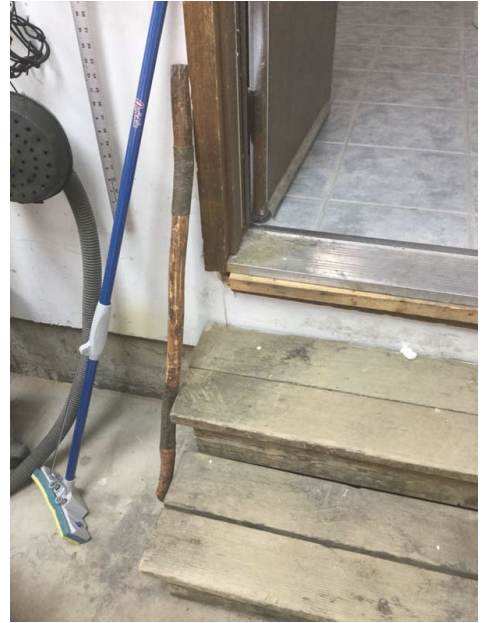
**HANDRAILS - MISSING**

Flights of stairs with more than two risers have no handrail installed. This is a safety hazard. A qualified contractor should install graspable handrails that your hand can completely encircle at stairs where missing, and as per standard building practices.

Contact a handyman or DIY project

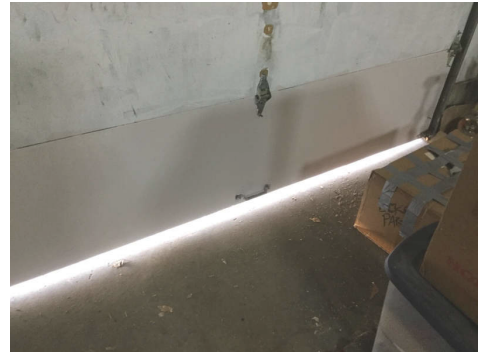
### VEHICLE DOOR - WEATHERSTRIP MISSING

Weatherstrip at the sides and/or bottom of the vehicle door is missing. It should be installed where missing to prevent water and vermin intrusion.

Contact a handyman or DIY project

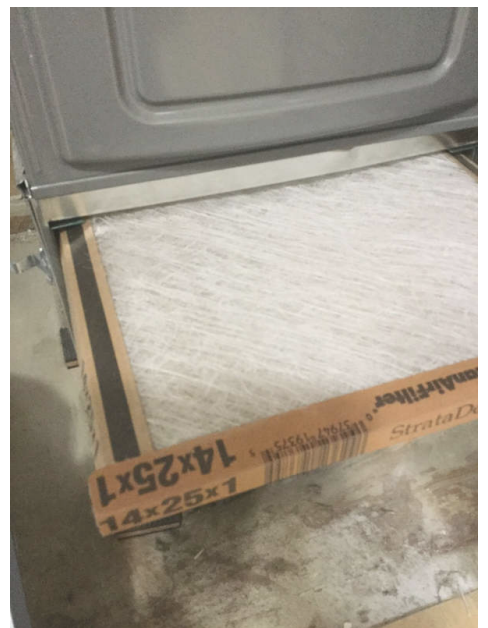
Air handler filter(s) should be checked monthly in the future and replaced or washed as necessary.

Recommended DIY Project

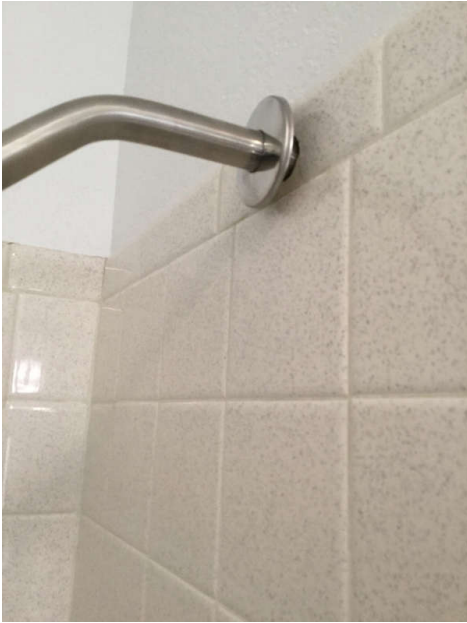
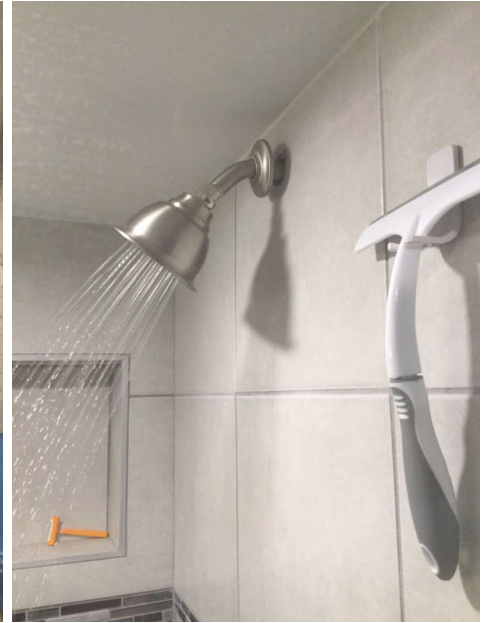
### CAULK - MISSING AT FIXTURES

Caulk is missing or deteriorated around fixtures such as the base of shower/bathtub spouts and/or at the base of the control valves and/or at the base of the shower head back plate. Caulk should be replaced where deteriorated and/or applied where missing to prevent water intrusion and damage to wall structures.

Contact a handyman or DIY project

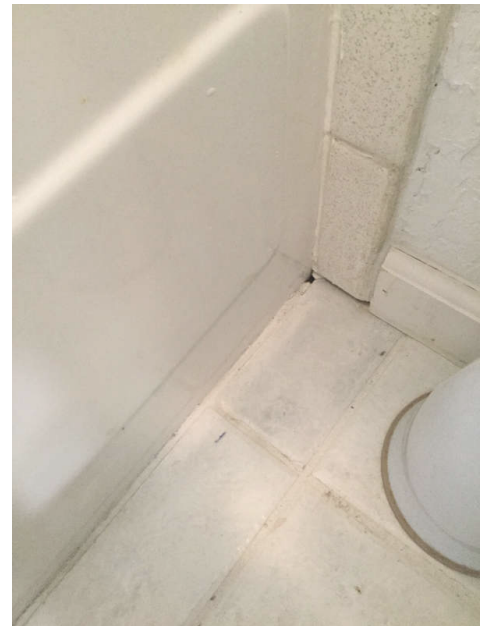
1st Floor Bathroom

**CAULK - MISSING AT FLOOR**

Caulk is missing or deteriorated along the base of the shower/bathtub, where flooring meets the shower/bathtub. It should be replaced where deteriorated and/or applied where missing to prevent water intrusion and damage to the floor structure.

Contact a handyman or DIY project

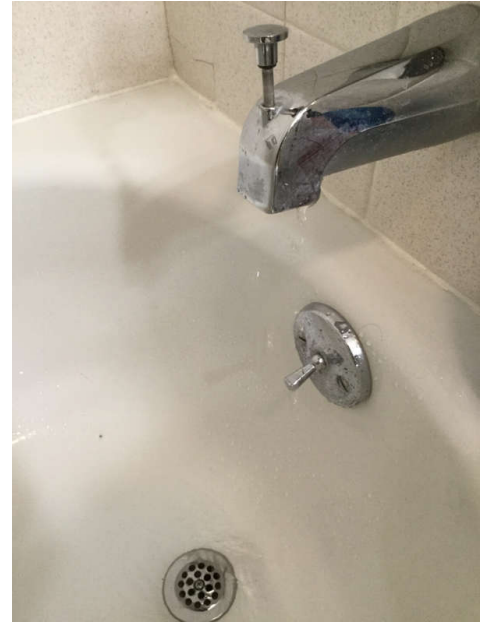
**SHOWER/TUB - DIVERTER VALVE DEFECTIVE - MINOR**

The shower diverter valve for the bathtub faucet is defective. Water comes out of the bathtub spout when the shower is turned on. Water will be wasted as a result. A qualified plumber should evaluate and replace components or make repairs as necessary.

Contact a qualified plumbing contractor.

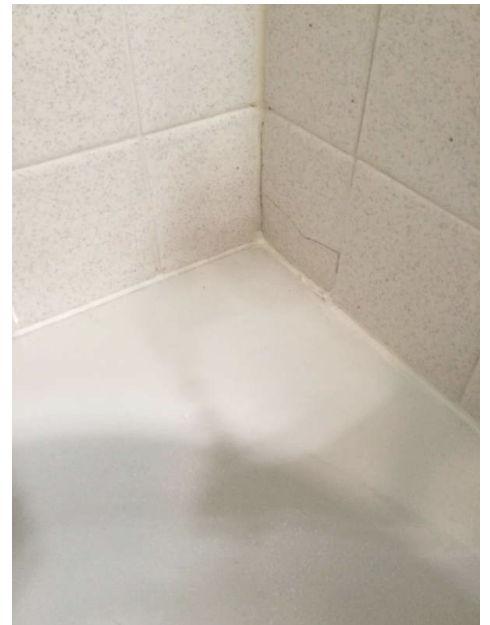
1st Floor Bathroom

**SHOWER/TUB - TILE OR GROUT DETERIORATED**

Tile and/or grout around the bathtub/shower is damaged or deteriorated. For example, deteriorated/missing grout, and/or cracked, missing or loose tiles, etc. A qualified contractor should evaluate and repair tile and/or grout as necessary.

Contact a qualified tile contractor

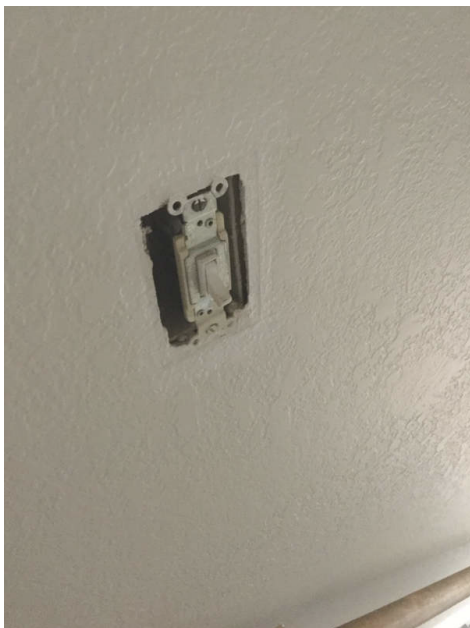
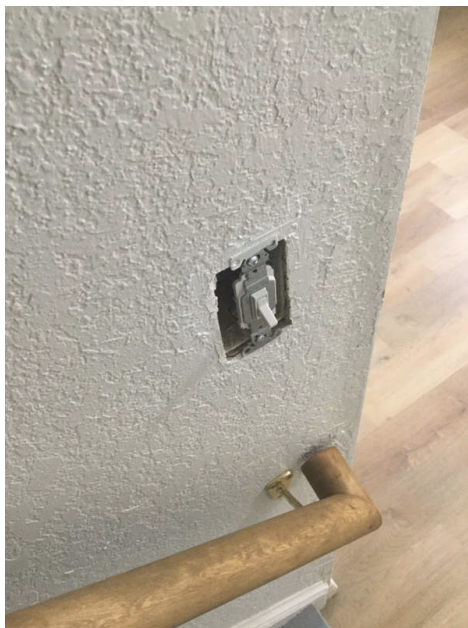
16.3.1 ELECTRICAL  
**COVER PLATES - MISSING**

Cover plate(s) are missing from electric boxes, such as for receptacles, switches and/or junction boxes. They are intended to contain fire and prevent electric shock from exposed wires. This is a safety hazard due to the risk of fire and shock. Cover plates should be installed where missing.

Contact a handyman or DIY project

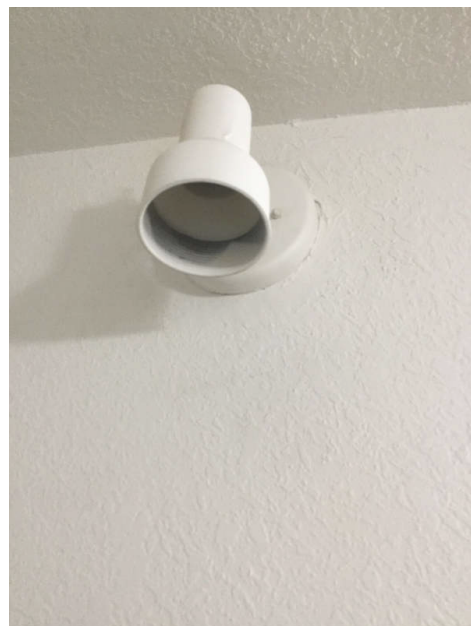
Basement

The light fixtures have missing bulbs and could not be fully evaluated. Bulbs may simply need to be installed, or repairs or replacement may be necessary.

Recommended DIY Project

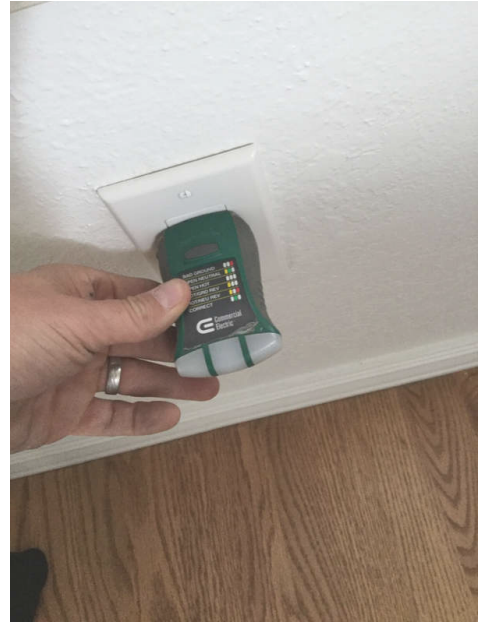
Family Room East Wall

**RECEPTACLES - LOOSE**

Electric receptacles and/or the boxes they are installed in are loose and/or not securely anchored. Wire conductors may be damaged due to repeated movement and/or tension on wires, or insulation may be damaged. This is a safety hazard due to the risk of shock and fire. A qualified electrician should evaluate and repair as necessary.

Contact a qualified electrical contractor.

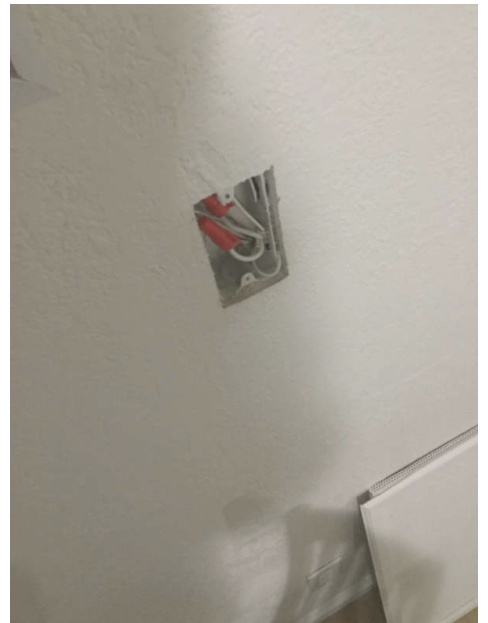
Basement East

Wire splices are exposed due to not being contained in a covered junction box. This is a safety hazard due to the risk of shock and fire. A qualified electrician should evaluate and make repairs as necessary. For example, install securely mounted junction boxes with cover plates where needed to contain wiring splices.

Contact a qualified electrical contractor.

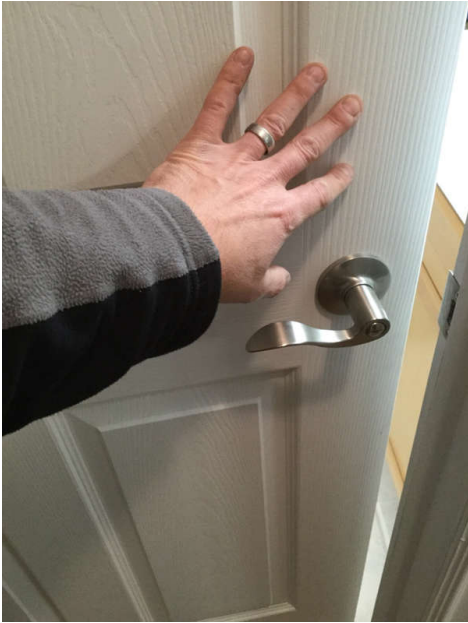
1st Floor Bathroom

Interior doors do not latch properly. Recommend handyman repair latch and/or strike plate.

Contact a qualified handyman.

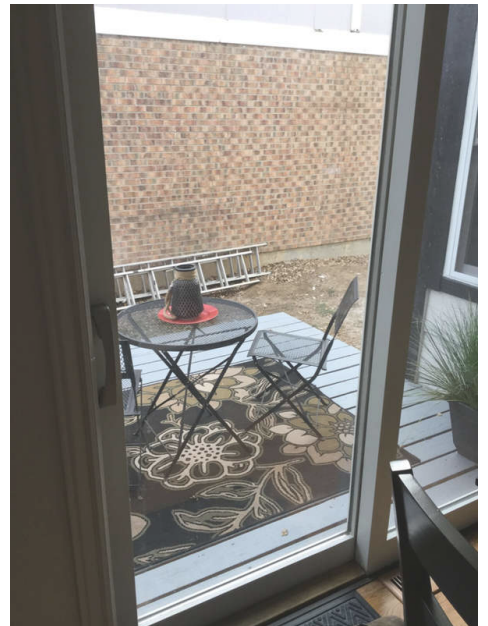
Side door

There are sliding glass doors that are the only source of ventilation for outside air, and no sliding screen door is installed. Recommend installing sliding screen doors for adequate ventilation when insects are active.

Contact a handyman or DIY project

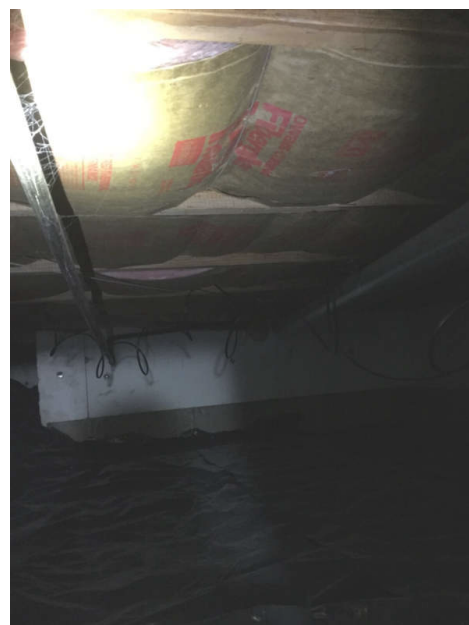
Paper facing on batt insulation is oriented towards open spaces, rather than against interior space surfaces. This occurs when newer, fiberglass batt insulation with paper facing on one side is installed backwards or upside down, or when older batt insulation wrapped on both sides with paper is installed. The paper facing is flammable. Newer insulation usually has a warning label indicating this on the facing.

For newer batt insulation with paper facing on one side only, the paper facing should be oriented towards interior spaces rather than exposed, open spaces. The existing insulation should be reinstalled or replaced.

For older batt insulation with paper facing on both sides, recommend that repairs be made as necessary to eliminate the exposed paper facing.

A qualified contractor should evaluate and make repairs as necessary, and as per standard building practices and the insulation manufacturer's recommendations to eliminate the fire hazard.
