CERTIFIED INSPECTORS OF NORTH CAROLINA LLC

RESIDENTIAL REPORT

1234 Main St.
Raeford NC 28376

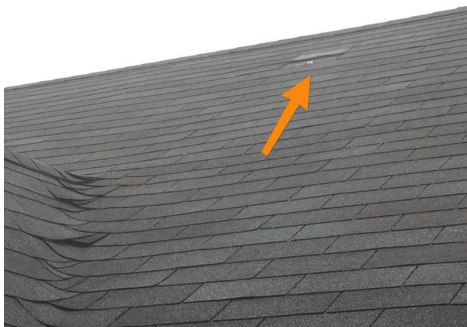
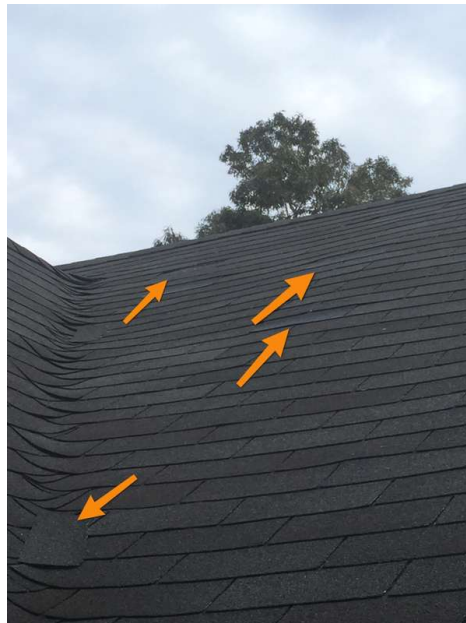
SHINGLES MISSING

Observed areas that appeared to be missing sufficient coverings. These areas are subject to water penetration to the wood roof sheathing as the roof covering material should overlap the previous course. Recommend qualified roofing contractor evaluate & repair.

Contact a qualified roofing professional.

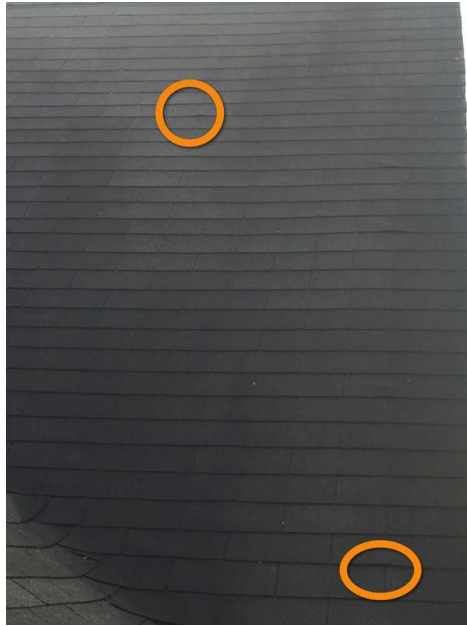
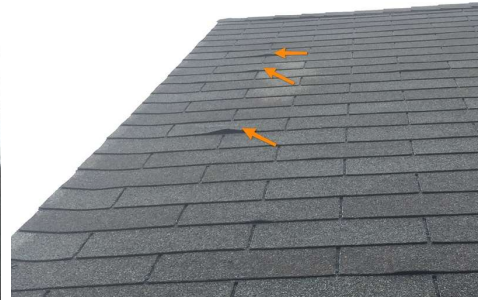
2.1.2 Coverings

Roof surface shows evidence of nail pops in several areas around the roof plane. Nails that are lifting and eventually popping through the shingle roof covering can cause small leaks in several different areas and lead to rotted roof sheathing and even damaged roof framing overtime if they are not repaired. Recommend a licensed roofing contractor do a full evaluation of the roof system and covering and make repair recommendations.

Contact a qualified roofing professional.

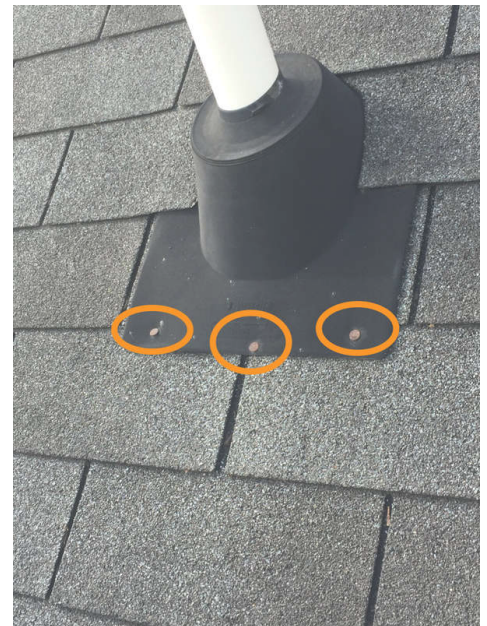
2.3.1 Flashings

BOOT FLASHING / NAIL SEALANT

The nails at the bottom of the plumbing boot flashing and vents are not sealed. Nail/screw heads should be sealed to prevent water intrusion to the roof structure from around the nail head. Recommend a qualified contractor seal the nail heads with silicone roof sealant.

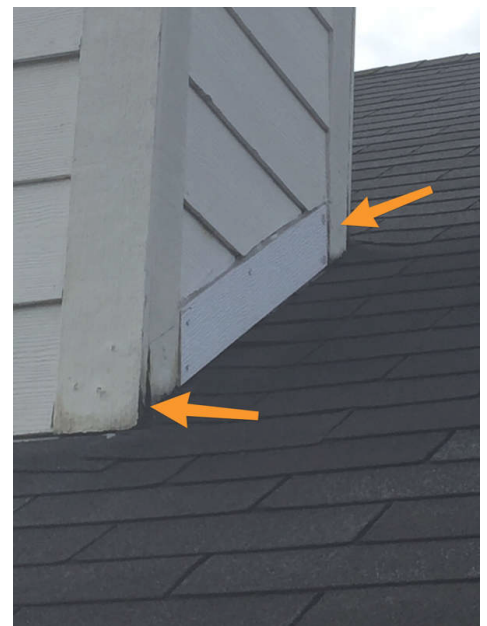
CHIMNEY SIDING/TRIM-WATER DAMAGE

Siding and trim In several areas have observed indications of water damage around the chimney. Recommend replacement by a licensed contractor.

Contact a qualified siding specialist.

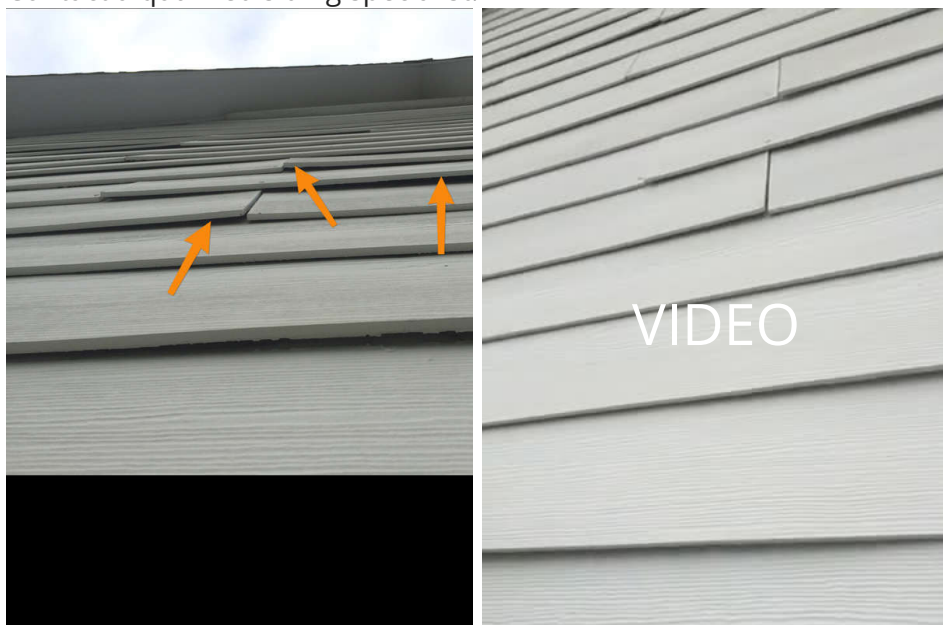
3.1.3 Siding, Flashing & Trim

SIDING LOOSE

The siding is loose on areas of the structure. This condition may allow a blow off of the siding from strong winds and subjects the exterior wall to the elements. Recommend further evaluation for damage and verify proper installation per manufacturer instructions and correct as needed by a licensed contractor.

Contact a qualified siding specialist.

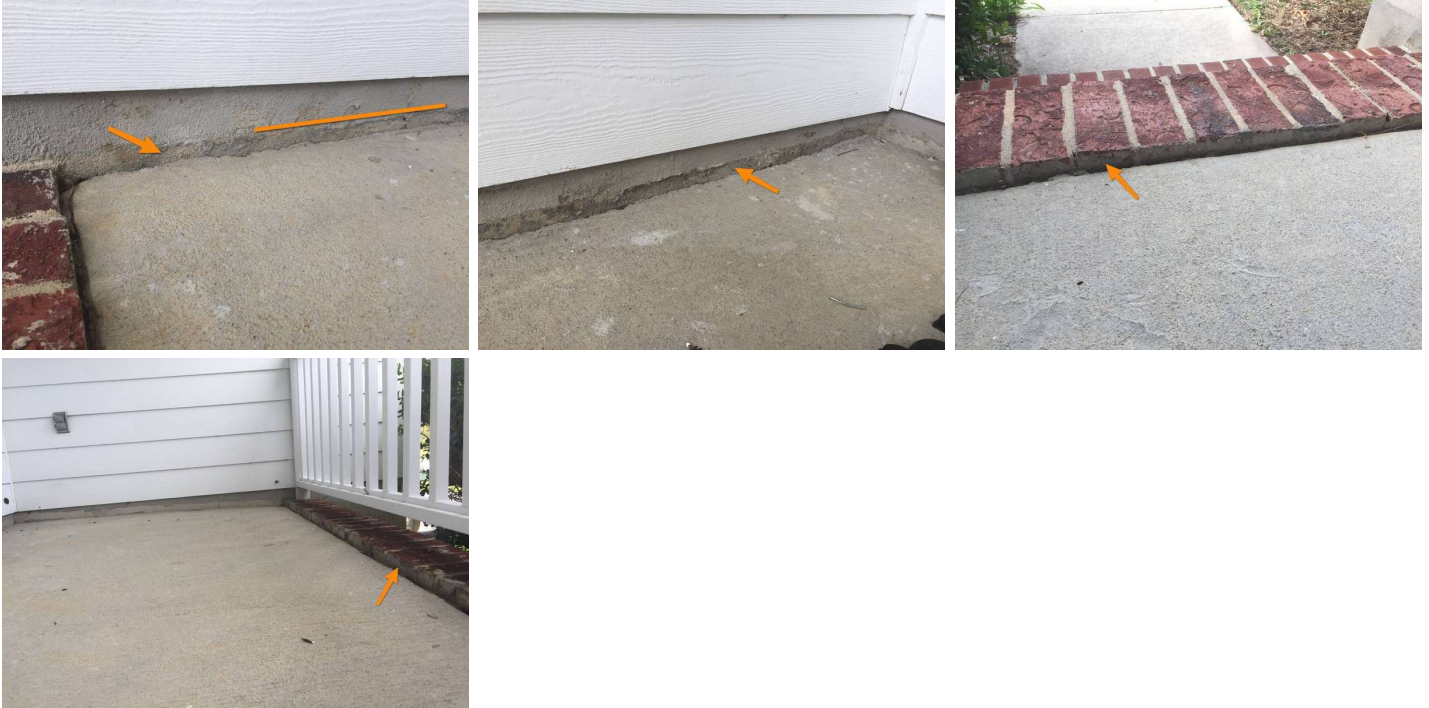
3.4.1 Decks, Balconies, Porches & Steps

FRONT PORCH SLAB MOVEMENT

The front porch slab has sunken several inches from the surrounding brick. In the majority of cases this is due to poor water drainage, but it can also be the result of ground movement, subsidence or poor construction. These problems can be repaired. Recommend a full evaluation by a licensed contractor to determine the cause and make recommendations for correction.

Contact a qualified general contractor.

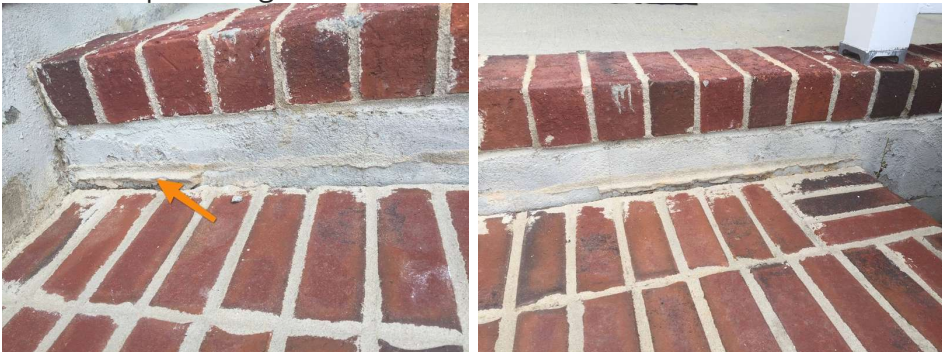
3.4.2 Decks, Balconies, Porches & Steps

The stairs had observed indications of movement. This could be caused by excessive water intrusion, soil instability or un-compacted soils, or other external factors. This condition may worsen if not corrected. A licensed general contractor should be consulted to determine the cause and take necessary corrective action.

Contact a qualified general contractor.

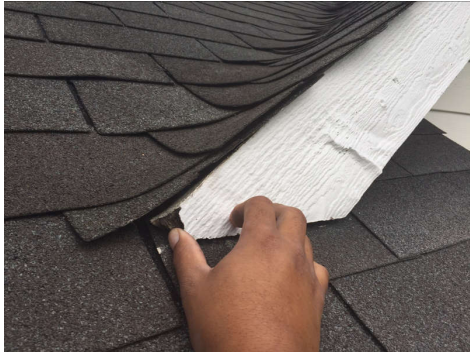
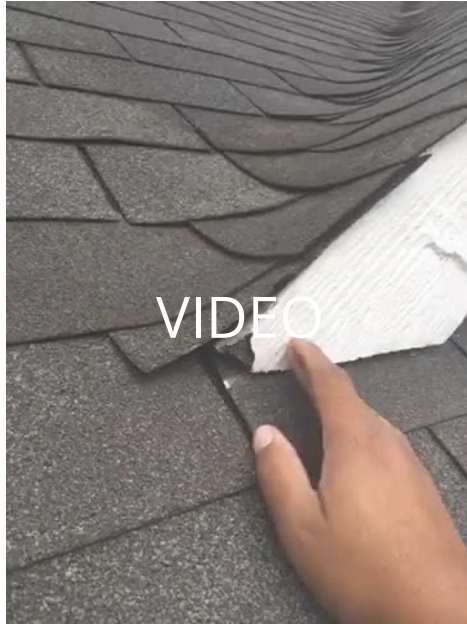
3.5.1 Eaves, Soffits & Fascia

The wood rake board is rotted and touching the roof surface. Wood will wick moisture from roof run off and rot, exposing adjacent materials to moisture damage. Recommend replacement of the roof rake trim board allowing a minimum of 1/2inch from roof surface. Repairs should be made by a qualified contractor.

Contact a qualified general contractor.

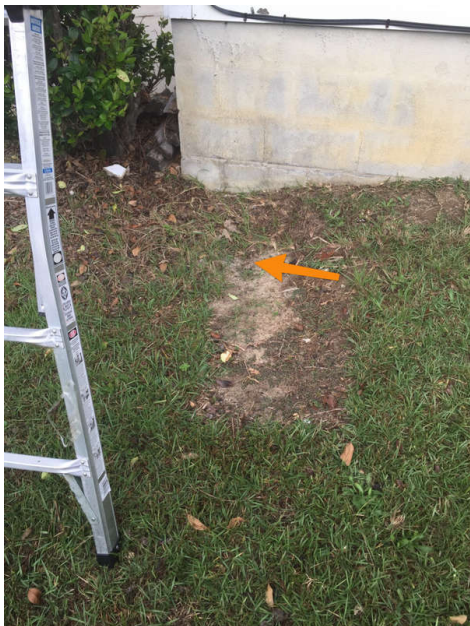
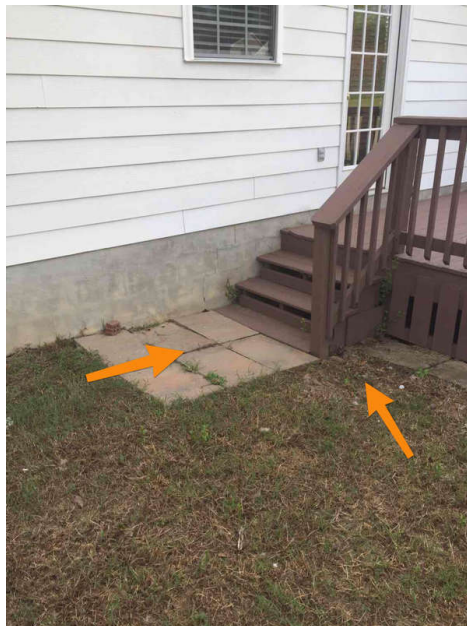
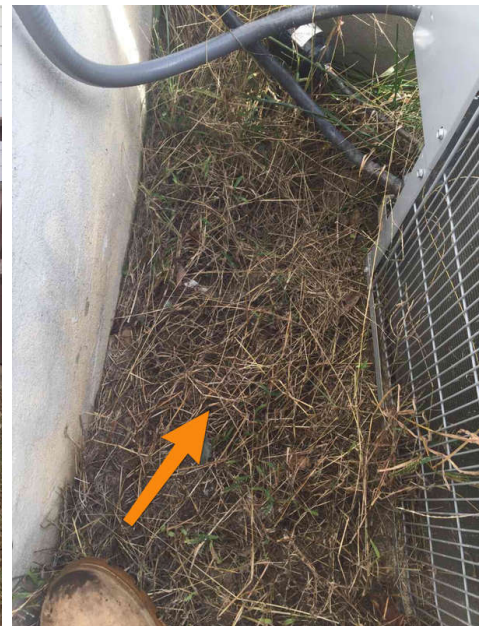
3.6.1 Vegetation, Grading, Drainage & Retaining Walls

Grading is sloping towards the home in some areas. This could lead to water intrusion and foundation issues. Recommend qualified landscaper or grading company regrade so water flows away from home. Some areas may easily be filled with fill dirt and sloped.

Rear of a/c unit

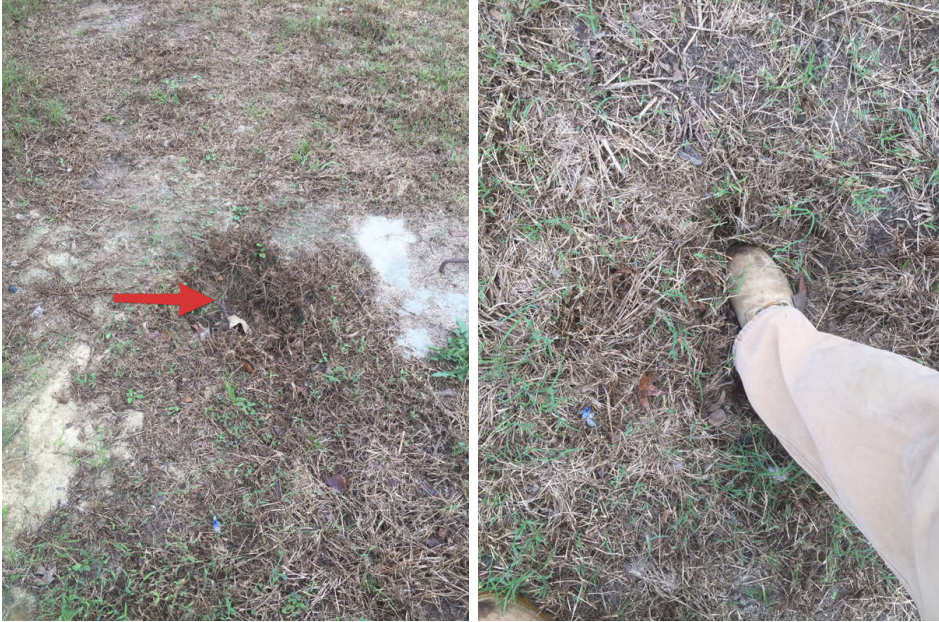
3.6.2 Vegetation, Grading, Drainage & Retaining Walls

There is a large hole in the walking surface of the yard. This condition may allow someone to step into the hole and cause personal injury and/or fall. This condition may be remedied by filling the hole with fill dirt, then compacting.

Contact a handyman or DIY project

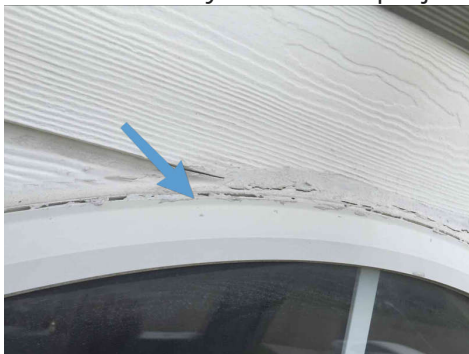
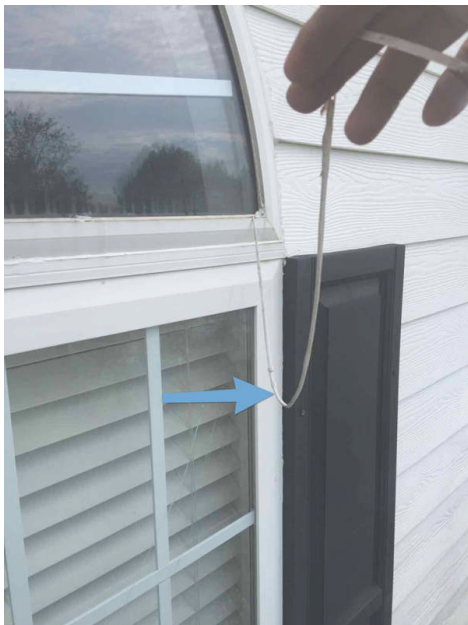
4.2.1 Windows

WINDOWS-EXTERIOR FAILED CAULKING

The caulking on the sides of the window frame is deteriorated. This condition will allow for water intrusion between the siding and window frame. Recommend that these areas be cleaned by removing the old caulk and re-caulking. Work may be performed by the homeowner or home maintenance company.

This area is excessively caulked. May be an indication of past water intrusion.

Contact a handyman or DIY project

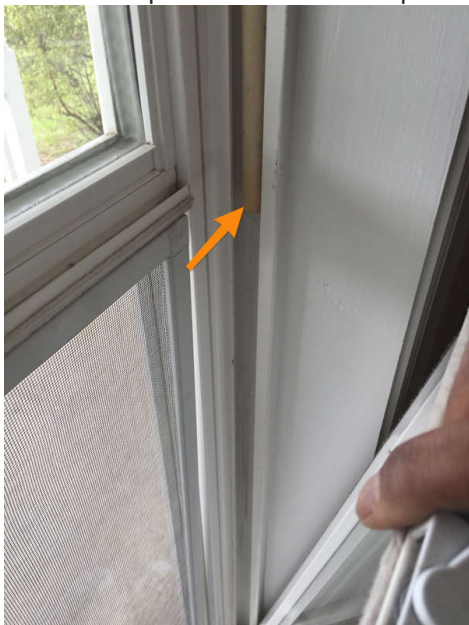
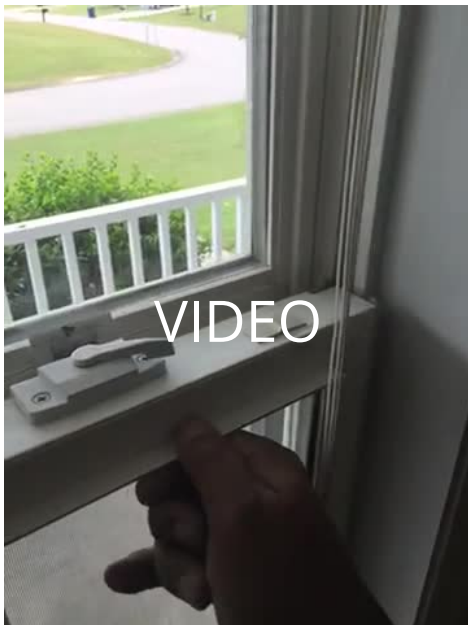
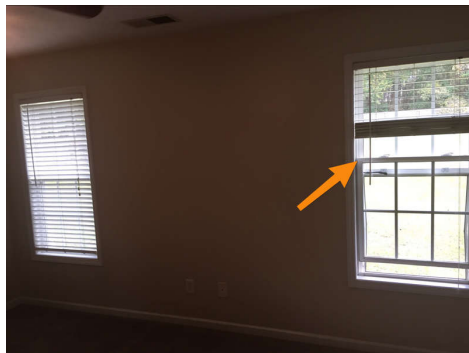
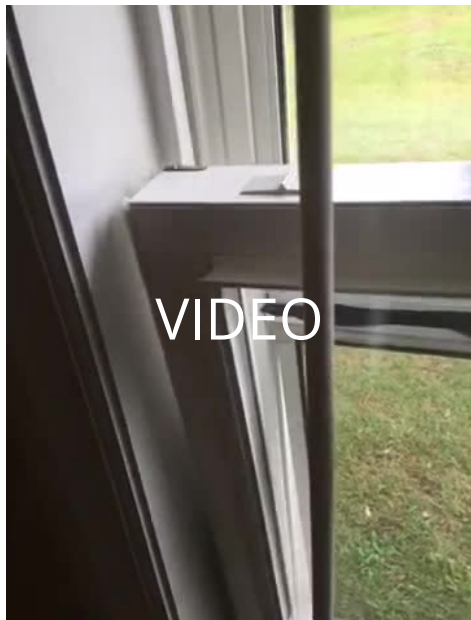
4.2.2 Windows

WINDOW-BROKEN BALAST

The window ballast was not properly adjusted or broken. A window ballast helps to support the weight of the sash. Windows may fall in their tracks if not working properly. Recommend a window installation company for repair.

Contact a qualified window repair/installation contractor.

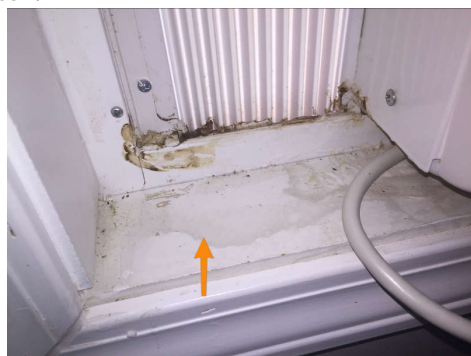
4.2.3 Windows

WINDOW SILL MOISTURE DAMAGE

The window seal on the interior of the window has indications of moisture damage. This is an indication of water intrusion and should be corrected by a licensed general contractor soon as possible. If correction is not made water may enter the wall assembly.

Contact a qualified general contractor.

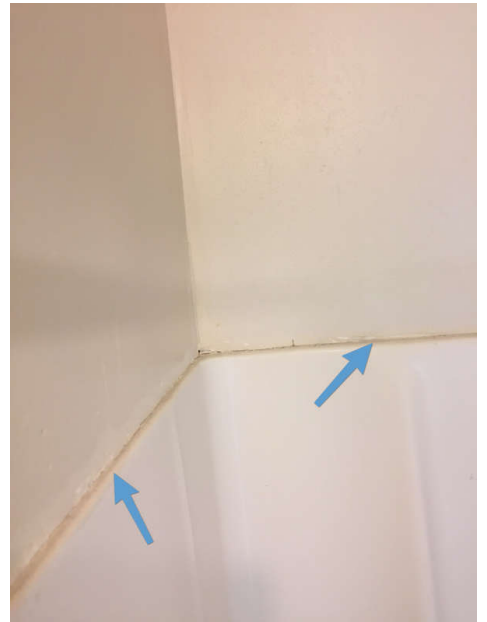
4.4.1 Walls

The wall adjacent to the shower surround is missing caulking between the wall and the top of the surround. Inspector recommends caulking this area and perform continued maintenance to keep water out of the wall assembly or from entering the separation. Correction can be made by home maintenance company or the homeowner.

Contact a handyman or DIY project

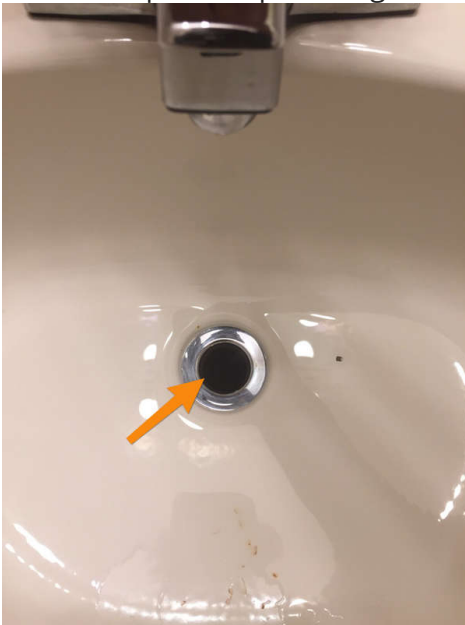
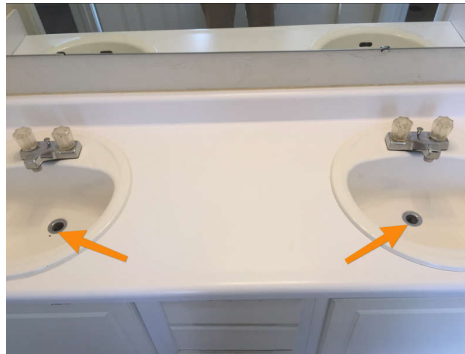
DRAIN STOP-MISSING

Drain stop is missing from the drain. A drain stop is a method to restrict or protect the waste outlet from an object or objects from entering and stopping up the drainage system (fixture arm, branch, drain, etc.) Recommend a licensed plumber repair or replace per standard building practices.

Contact a qualified plumbing contractor.

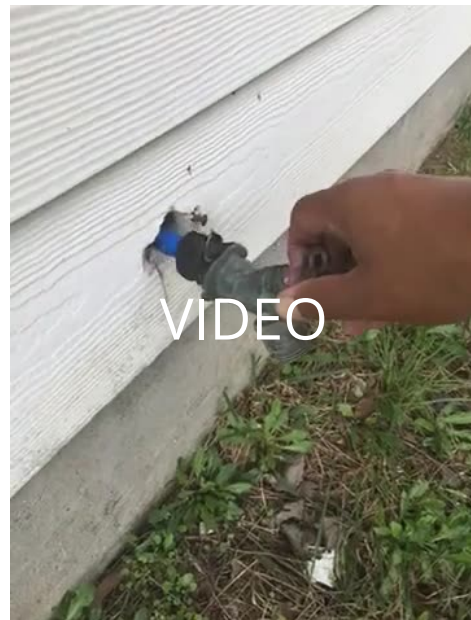
5.3.2 Water Supply, Distribution Systems & Fixtures

HOSE BIBB- LOOSE ATTACHMENT

The hose bib is not securely attached to the home. This condition may cause undue stress on the piping material and brackets. Recommend a licensed plumbing contractor secure the exterior Fossett to the building using standard building practices.

Contact a qualified plumbing contractor.

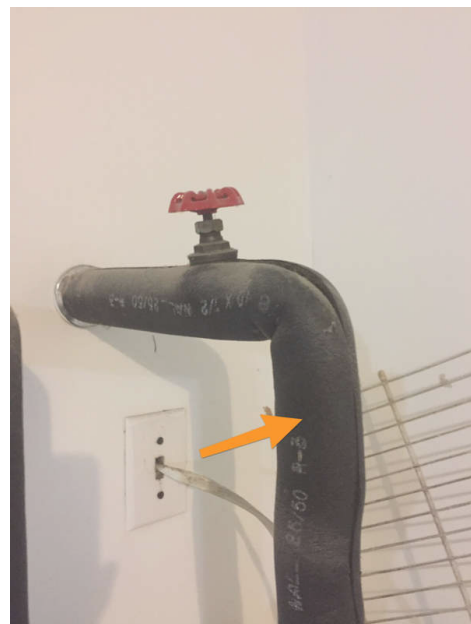
No expansion tank was present. Expansion tanks allow for the thermal expansion of water in the pipes. These are required in certain areas for new installs. Recommend a qualified plumber evaluate and install.

Contact a qualified plumbing contractor.

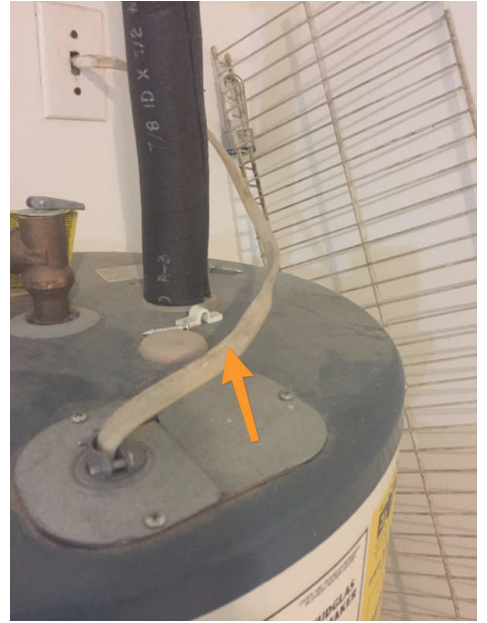
5.4.3 Hot Water Systems, Controls, Flues & Vents

The power cable to the water heater is not protected. Water heater power cables are not required to be in conduit, however, it is important that the power cable be protected primarily when in an area of the home where the cable may be subject to damage. Recommend a licensed plumber or electrical contractor make repairs as recommended.

Contact a qualified plumbing contractor.

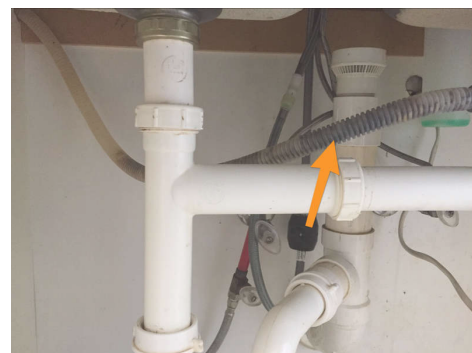
6.1.1 Dishwasher

There are observed indications of excessive debris or build up in the dishwasher drain hose. This may stop or slow down the flow of drain water to the waste pipe. It is recommended that the dishwasher drain be cleaned or replaced as needed by a licensed plumbing contractor

Contact a qualified plumbing contractor.

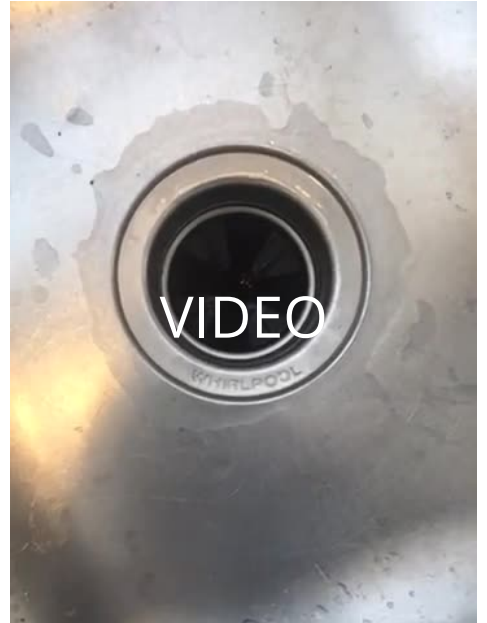
6.4.1 Garbage Disposal

The garbage disposal in the kitchen does not turn on when operated by the wall switch. This may be an inconvenience for the homeowner as it cannot be used when needed. If this is of concern to the client, the inspector recommends further evaluation and repair or replacement of the garbage disposal.

Contact a qualified plumbing contractor.

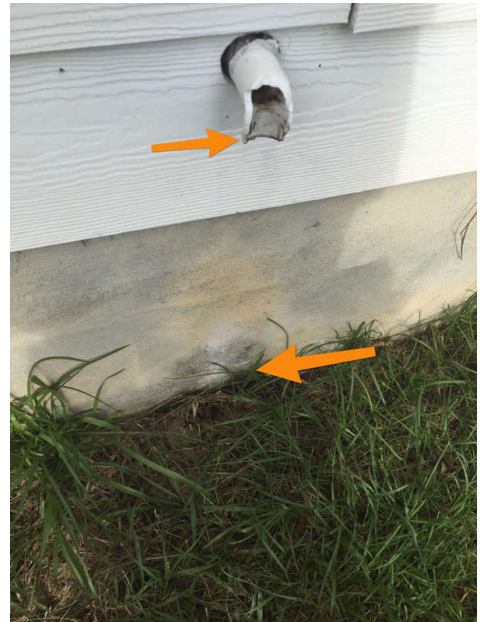
7.1.2 Cooling Equipment

CONDENSATE DRAIN-TOO CLOSE

A/C condensate drain line is too close to the foundation. The A/C drain water is usually routed just an inch or two from the edge of your foundation. Water pools there and seeps under your foundation. The hotter the weather, the harder the A/C unit works, the more condensation is created. An A/C unit can generate between 5 and 20 gallons of water per day. It is recommended that the condensate drain line be no less than 12 inches away from the foundation. Recommend that a Licensed HVAC Contractor make any necessary repairs.

Contact a qualified heating and cooling contractor

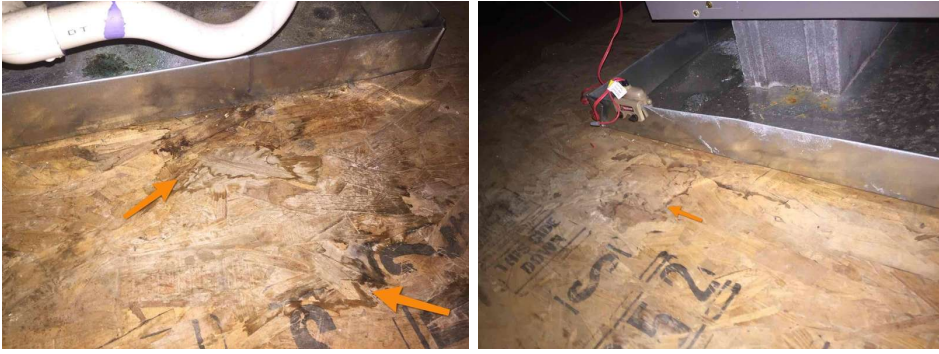
7.1.4 Cooling Equipment

CONDENSATE DRAIN LEAKING AT AIR HANDLER ATTIC

The condensate drain at the trap of the air handler was leaking water onto the attic flooring. This will cause water damage and rotting of the attic floor space over time. Water may also damage adjacent components. Recommend further evaluation by a licensed hvac contractor and correct the condition as necessary.

Contact a qualified heating and cooling contractor

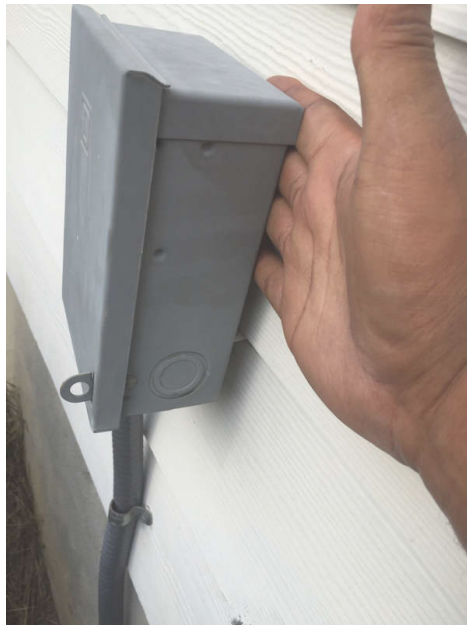
HVAC DISCONNECT-LOOSE

Contact a qualified heating and cooling contractor

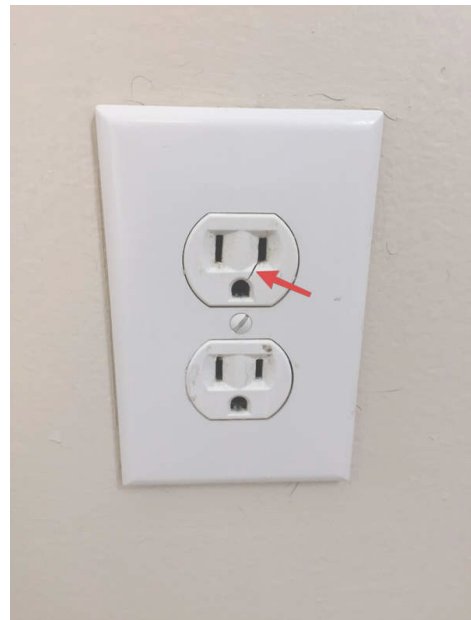
9.4.1 Lighting Fixtures, Switches & Receptacles

OUTLET-DAMAGED

Body of the electrical outlet is damaged. A damaged outlet may not be safe to use by the occupant risking electrical shock or arcing. Inspector recommends replacement of the outlet by a licensed electrical contractor.

Crack may get worse with use

Contact a qualified electrical contractor.
