RESIDENTIAL TEMPLATE

1234 Main St.
Truckee, CA 96161

Buyer Name
05/29/2019 9:00AM

Inspector
Stephen Saturno
Certified Master Inspector
5304143815
inspectorsaturno@gmail.com

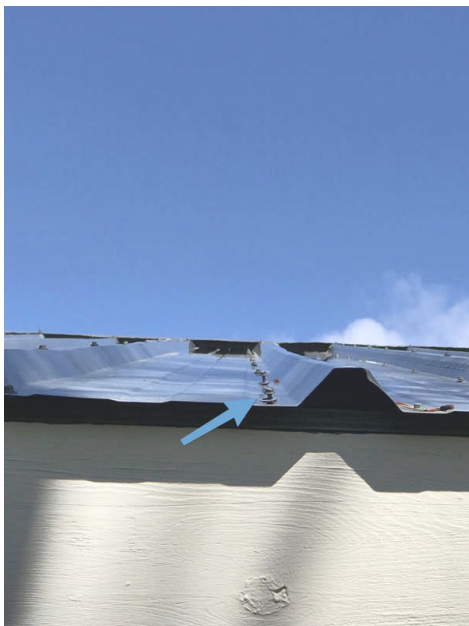
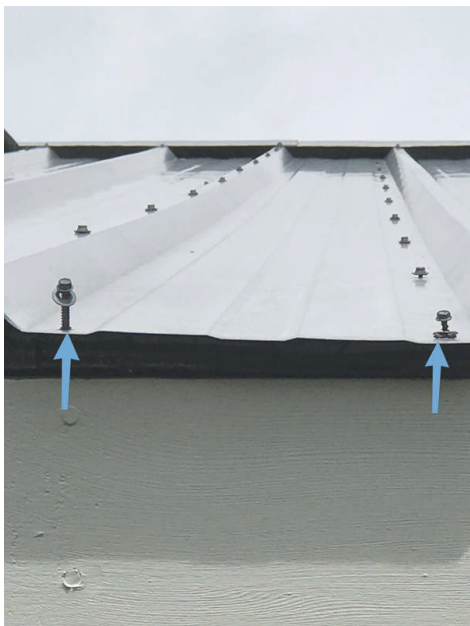
The screws securing the metal roof to the framing are withdrawing. This occurs because of the different expansion and contraction rates between the metal roof and the wood that it's screwed into. It is a maintenance issue. Recommend securing any loose screws to prevent leaks.

Contact a qualified roofing professional.

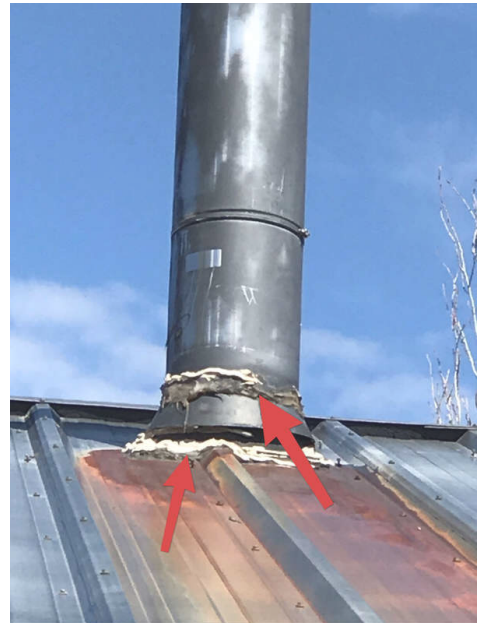
2.3.1 Chimney & Roof Penetrations

CHIMNEY IN POOR CONDITION

Sealant used to seal flashing around chimney vent. Bent vent stack above roof. Contact roofing contractor to repair flashing

Contact a qualified roofing professional.

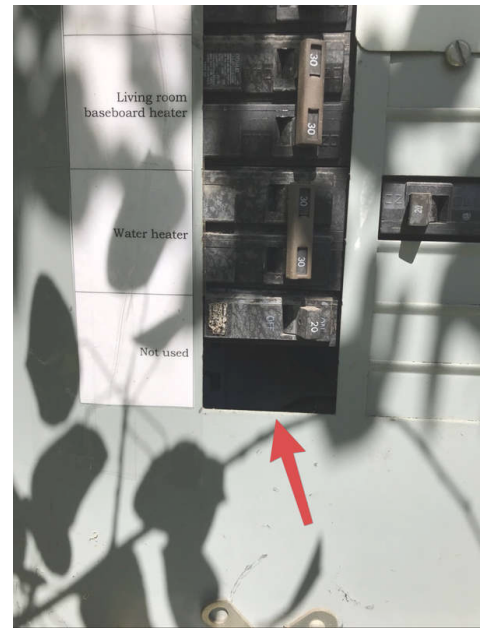
MISSING KNOCKOUTS

Hot conductors exposed. Recommend installing filler plates

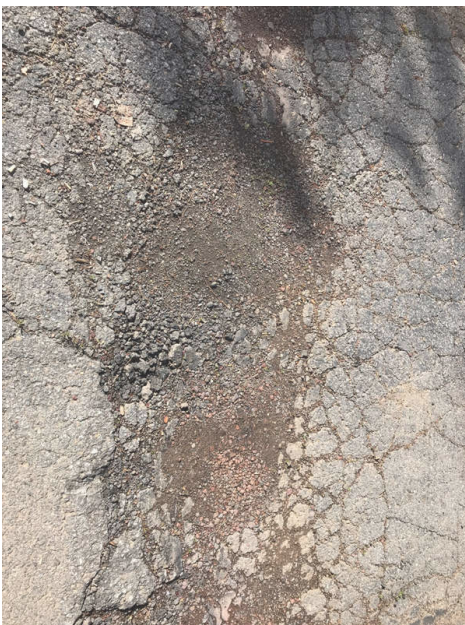
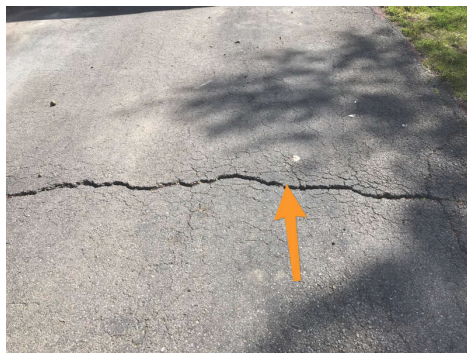
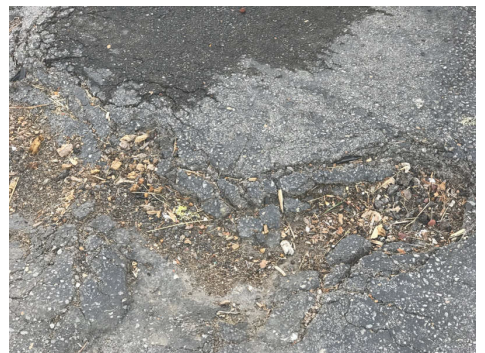
ASPHALT DETERIORATION - DEFICIENT

Repair and/or monitor for expansion of cracks and further deterioration. Recommend sealing annually to extend life.

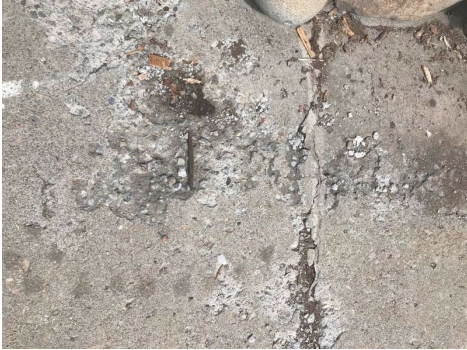
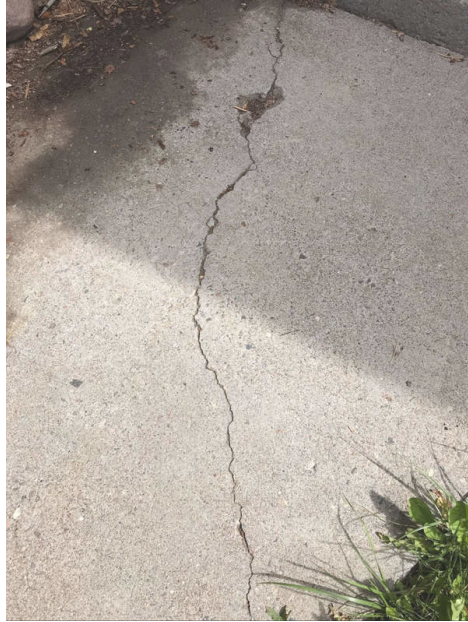
4.1.2 Driveway & Walkway

DAMAGED CONCRETE

Concrete at walkway is damaged and deteriorated. Recommend repair to prevent a tripping hazard

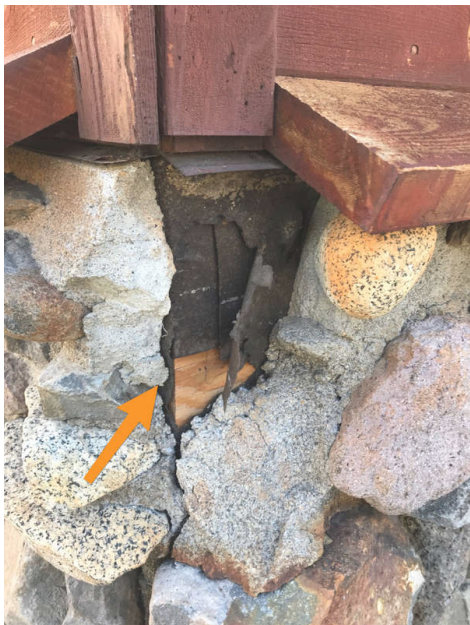
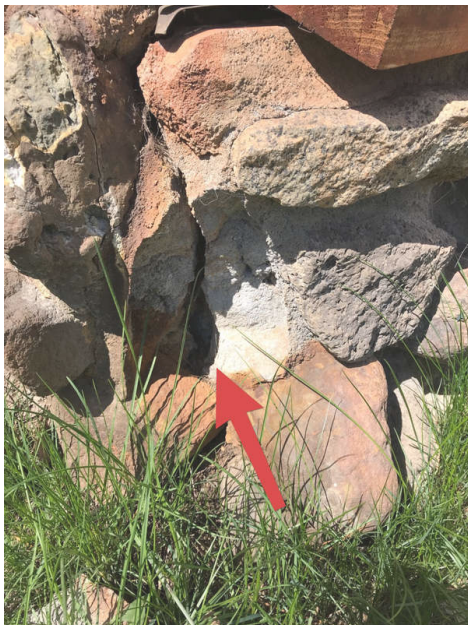
4.4.2 Exterior Finishes

STONE VENEER DAMAGE

Damage to stone veneer observed, some missing rocks and cracked grout. Recommend replacing missing rocks and maintaining grout to extend the life of the veneer.

Contact a qualified masonry professional.

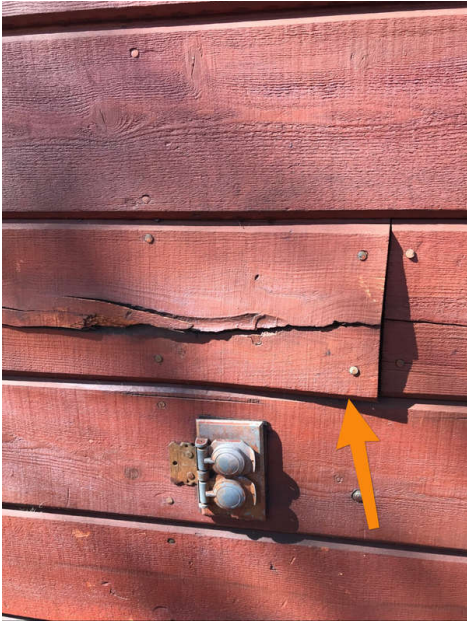
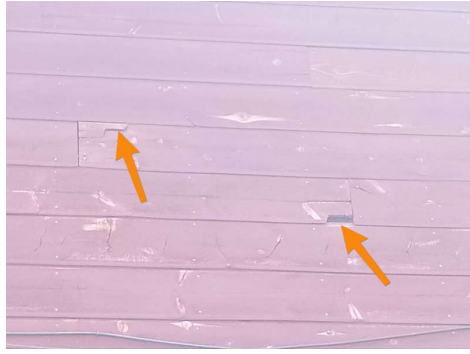
4.4.3 Exterior Finishes

DAMAGED SIDING

Recommend replacing or patching cracks in damaged siding.

Above entry

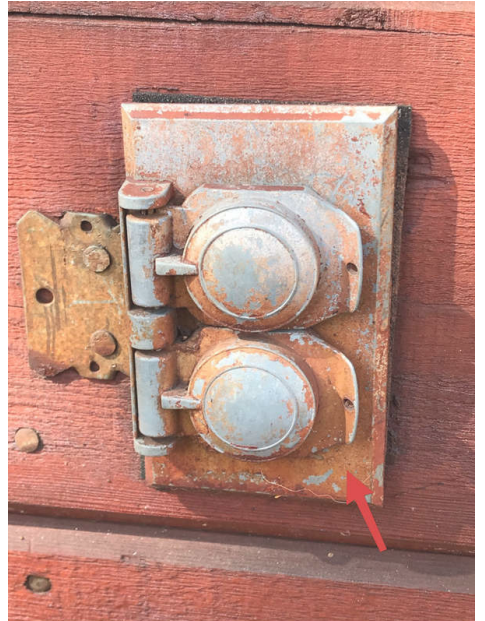
4.5.1 Electrical

All exterior outlets should be GFCI protected. Recommend updating for safety

Contact a qualified electrical contractor.

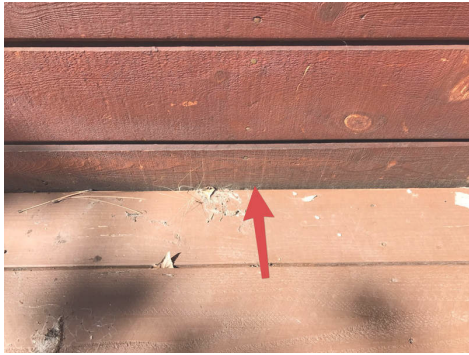
4.8.2 Decks & Porches

MISSING FLASHING

No flashing between deck ledger and siding. Flashing at this location helps prevent moisture from getting behind ledger and siding that can cause damage. This can typically be retrofitted without many issues.

Ledger Flashing

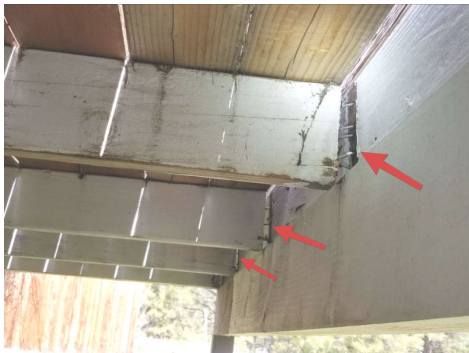
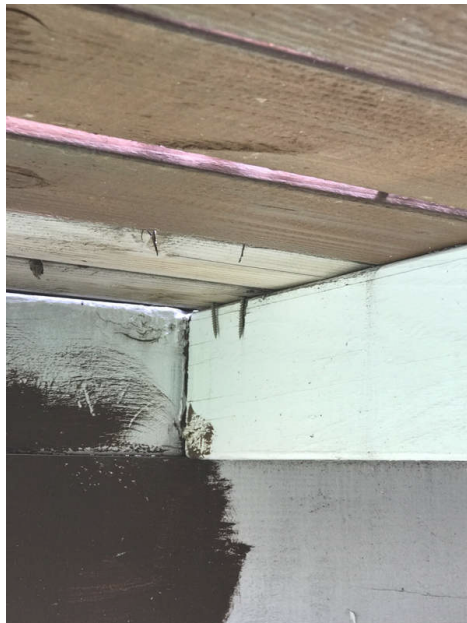
STRUCTURAL FAILURE

REAR DECK

Deck structure was of older construction and is a safety hazard. Missing hangers in several locations, settled footings, and inadequate framing. Recommend installing hangers on all deck joists to support beams.

Missing hangers

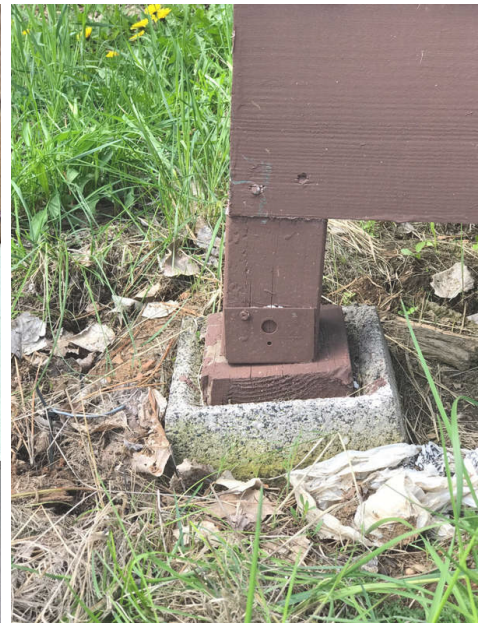
Settled footing

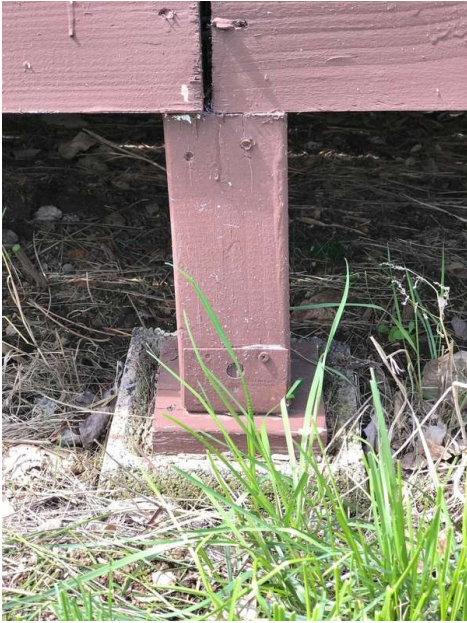
Settled footing

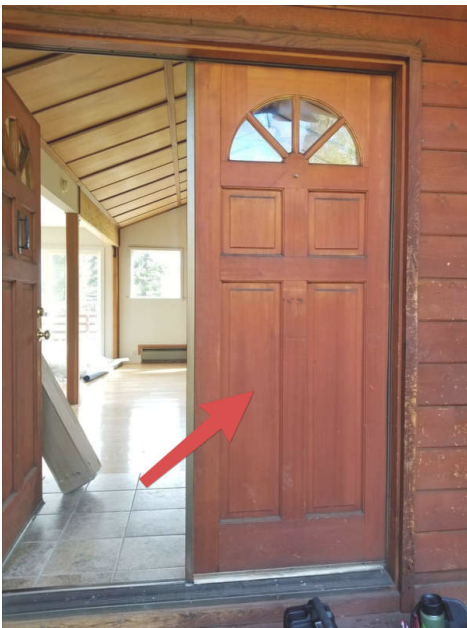
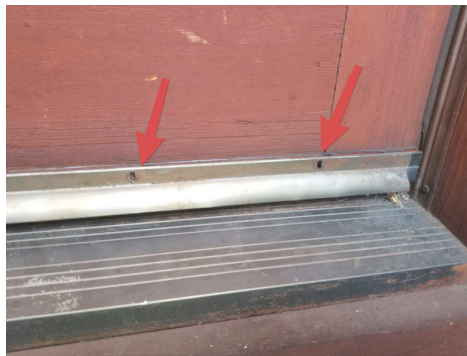
FRONT DOOR

Right side of front door without hardware does not open. Door sweep may be interfering. Screws missing at metal piece at bottom of door.

Missing screws

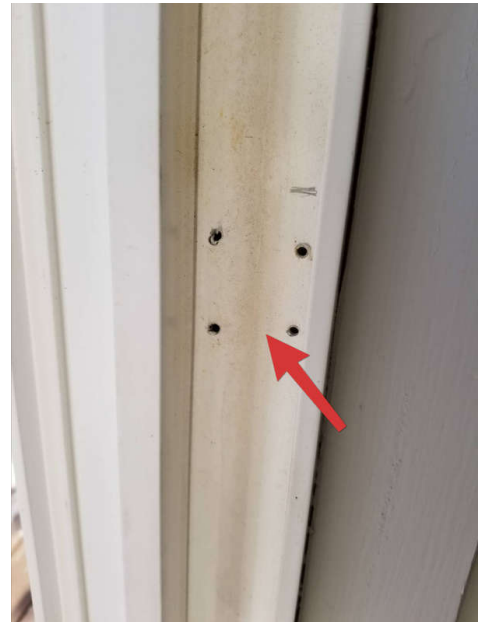
5.5.1 Patio Door

MISSING LOCK

Sliding patio door does not lock. Latch is missing on frame side.

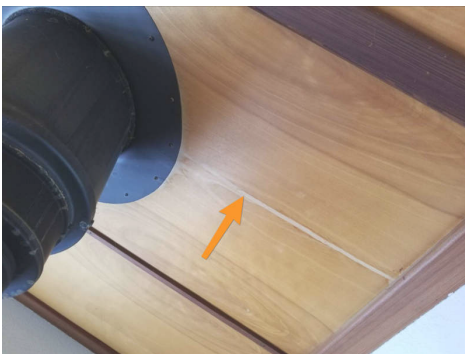
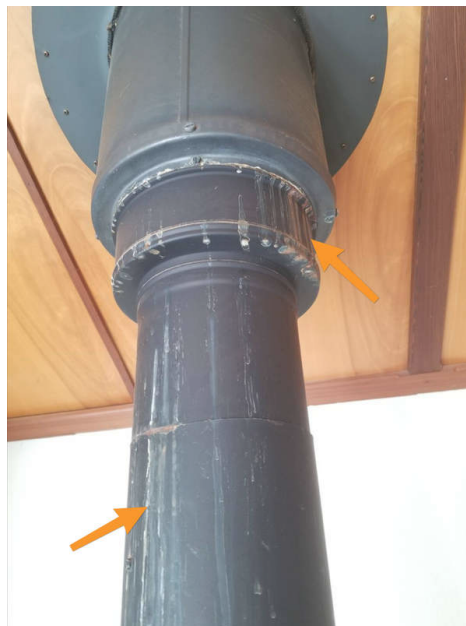
5.7.1 Ceilings

WATER STAINS

Water stains on wood panel above the living room and down vent pipe. Unable to determine when these occurred or if the issue has been resolved. Contact seller for more information. Flashing at roof may be inadequate or poorly installed

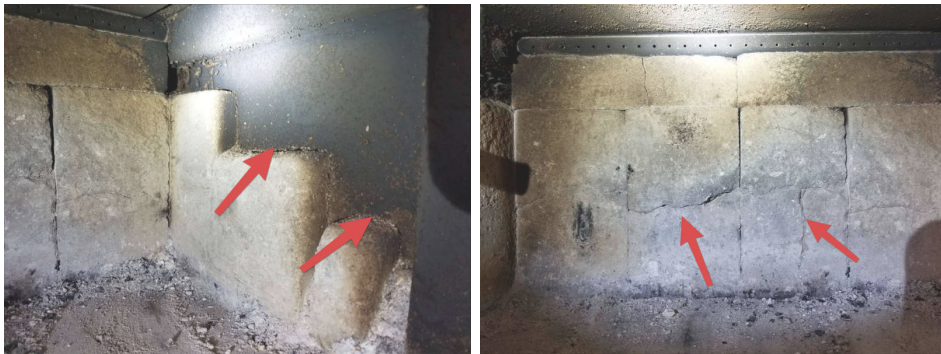
MISSING FIRE BRICKS

Damaged bricks

Recommend replacing fire bricks prior to use.

Contact a qualified fireplace contractor.

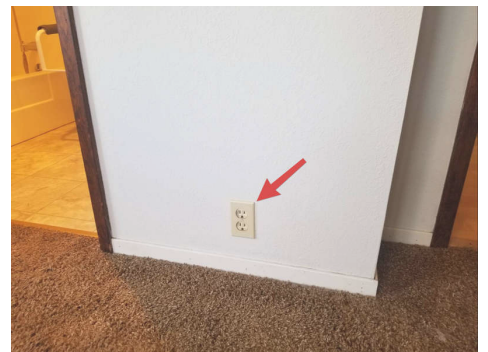
Receptacle was tested with a plug tester and did not have power at the time of inspection. Contact licensed electrical contractor for repair.

Top outlet only

Contact a qualified electrical contractor.

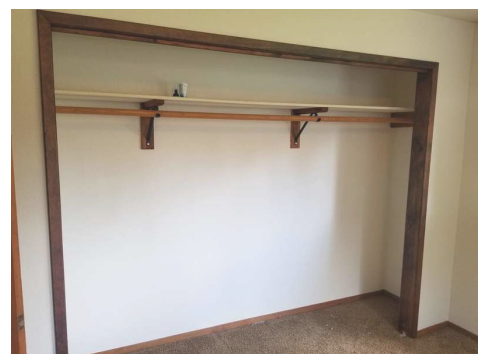
6.2.1 Closets

MISSING DOORS

MASTER BEDROOM

Missing closet doors. Hardware is installed. Doors observed in garage

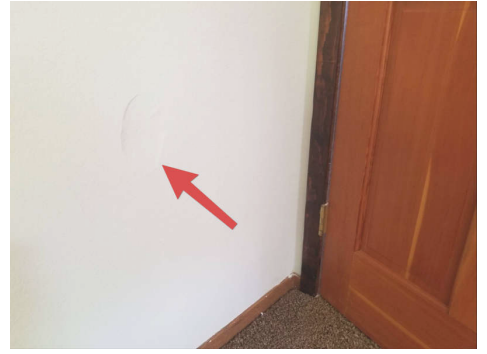
6.5.1 Walls

POOR REPAIR

Wall behind guest bedroom door was repaired with poor craftsmanship. This area is soft and likely to be damaged again. Recommend replacing drywall section and screwing into studs.

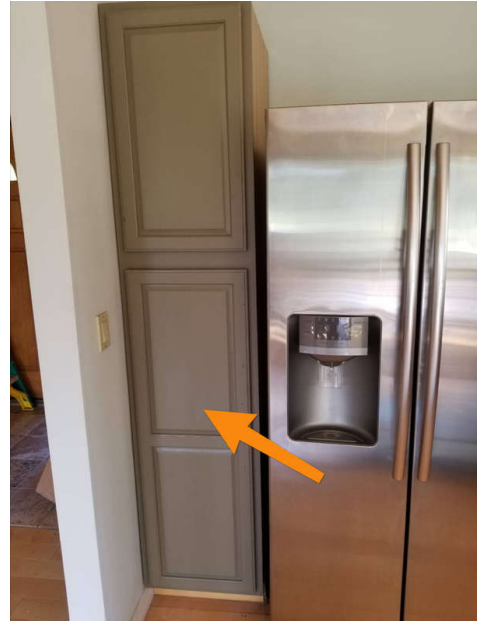
Cabinet left of refrigerator is not adequately screwed to wall.

Recommend repair for safety and to prevent damage to cabinet.

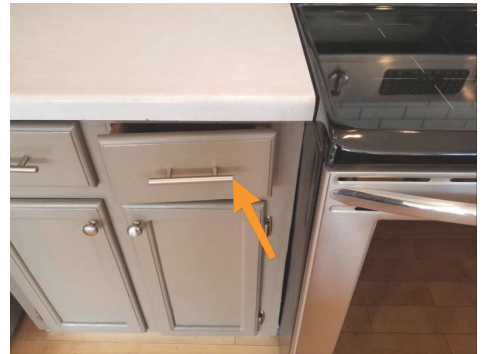
8.4.2 Cabinets

CABINET OFF TRACKS

Cabinet drawer left of oven was off its track at time of inspection.

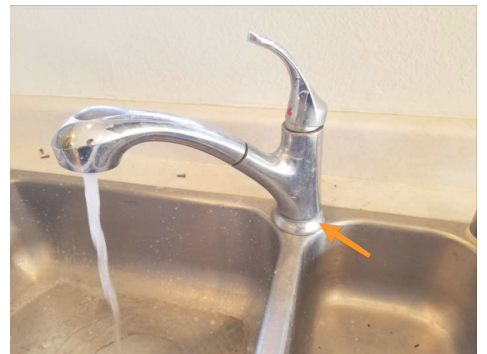
8.5.1 Sinks

FIXTURE IS LOOSE

Fixture is loose on sink basin or counter. Recommend tightening.

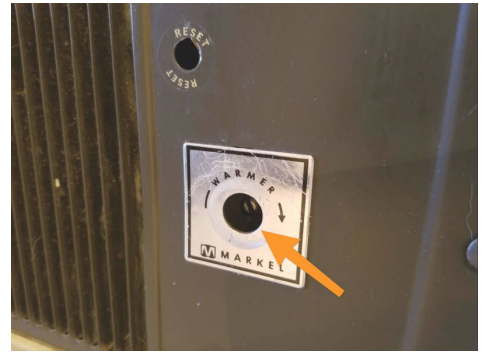
Unable to test wall heater in guest bathroom. Control knob was missing

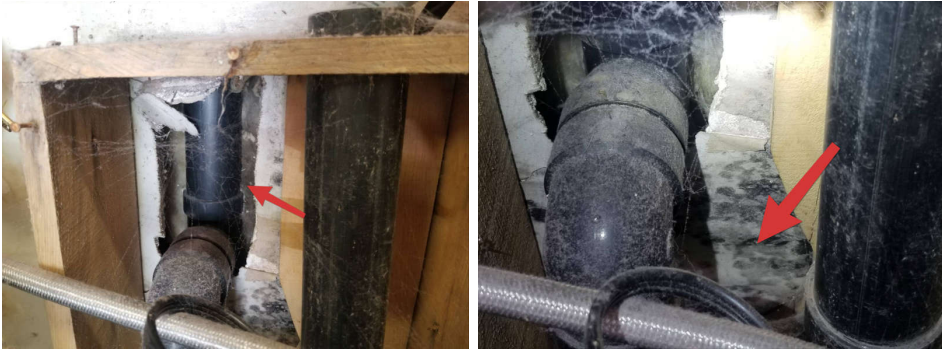
12.3.1 Walls/ Firewall

HOLE IN FIREWALL, ORGANIC GROWTH

Organic growth and hole at rear wall with laundry drain. Replace drywall with organic growth. Repair hole for fire safety. The garage should be separated from the house and its attic area by at least 1/2 inch continuous gypsum board (drywall) applied to the garage side. Garages beneath habitable rooms should be separated by at least 5/8-inch Type X gypsum board or equivalent.

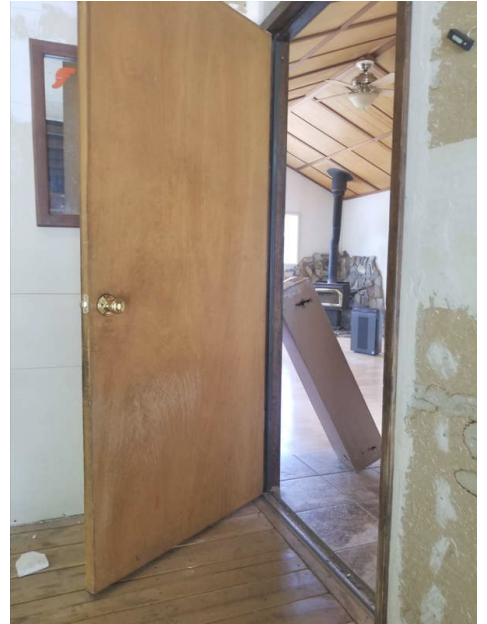
12.7.1 Fire Door

THE SELF-CLOSING DEVICE ON FIRE DOOR ISN'T SET

The self-closing device on the door from the house leading to the garage does not function properly. This is a fire hazard. Recommend adjusting or replacing the hinges to allow for proper closure of the door.

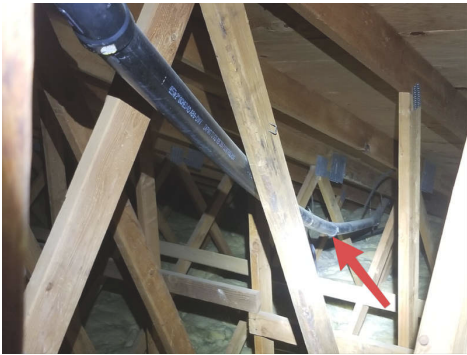
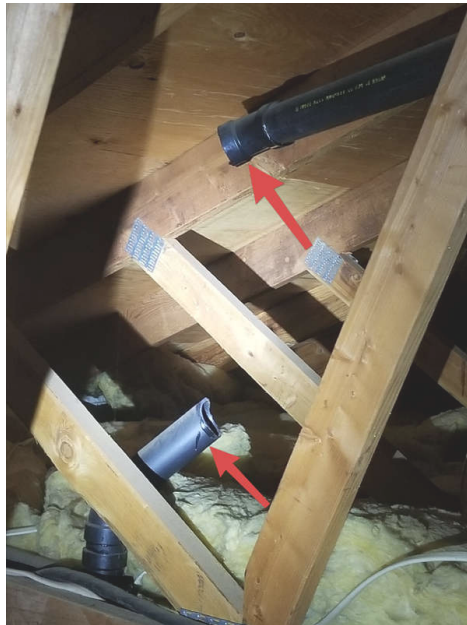
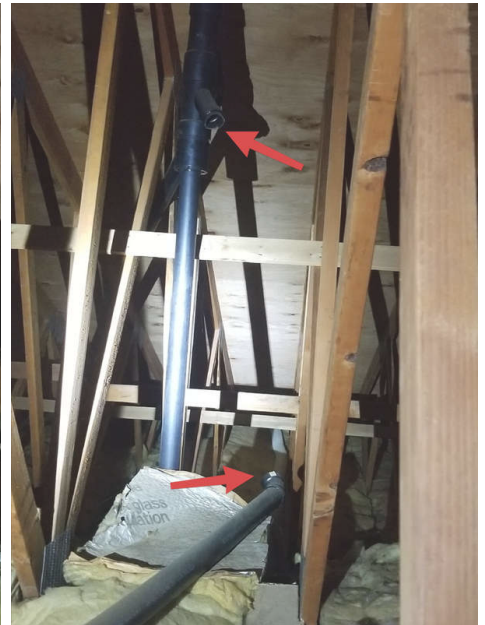
DAMAGED VENT PIPES

Two damaged plumbing vents observed in attic. Another vent is inadequately supported. Repair damaged vents and secure all existing vents to framing

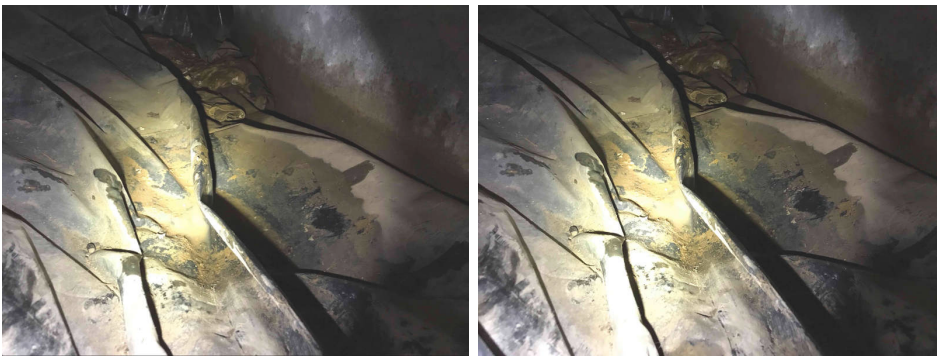
MOIST DIRT

Moisture in the crawlspace is normal this time of year. Recommend opening all vents to dry out the crawlspace area. Monitor space to ensure that soil dries before fungus begins to grow on surface.

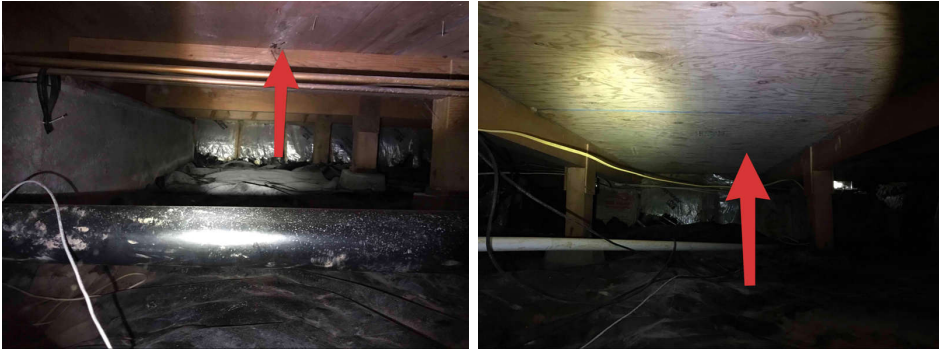
14.2.2 Crawlspace

NO INSULATION

No insulation was found in the crawlspace in between the floor framing members. Recommend installation of insulation between all framing members to increase the comfort and the efficiency of the home.

Contact a qualified insulation contractor.

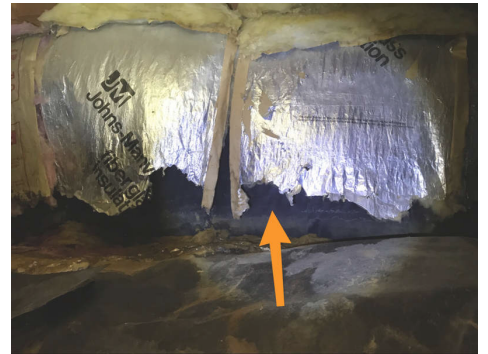
14.2.3 Crawlspace

POORLY INSTALLED INSULATION

Insulation installed on the walls of crawlspace are deteriorated and missing the bottom third of insulation do you to moisture and rodent intrusion. Recommend replacing with rigid insulation.

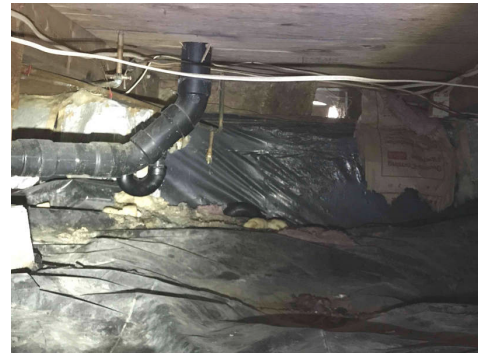
14.3.1 Venting

INSULATION COVERING VENTS

Recommend removing insulation from all vents to maintaining proper air flow and prevent moisture issues.

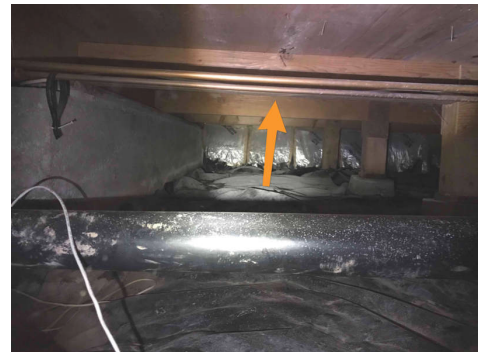
14.5.1 Plumbing

UNINSULATED WATER PIPES OBSERVED IN UNHEATED CRAWLSPACE

Recommend insulating water pipes, installing heat tape, or both to prevent pipes from freezing
