REDBUD PROPERTY INSPECTIONS, LLC

RESIDENTIAL REPORT

1234 Main St.
Edmond OK 73012

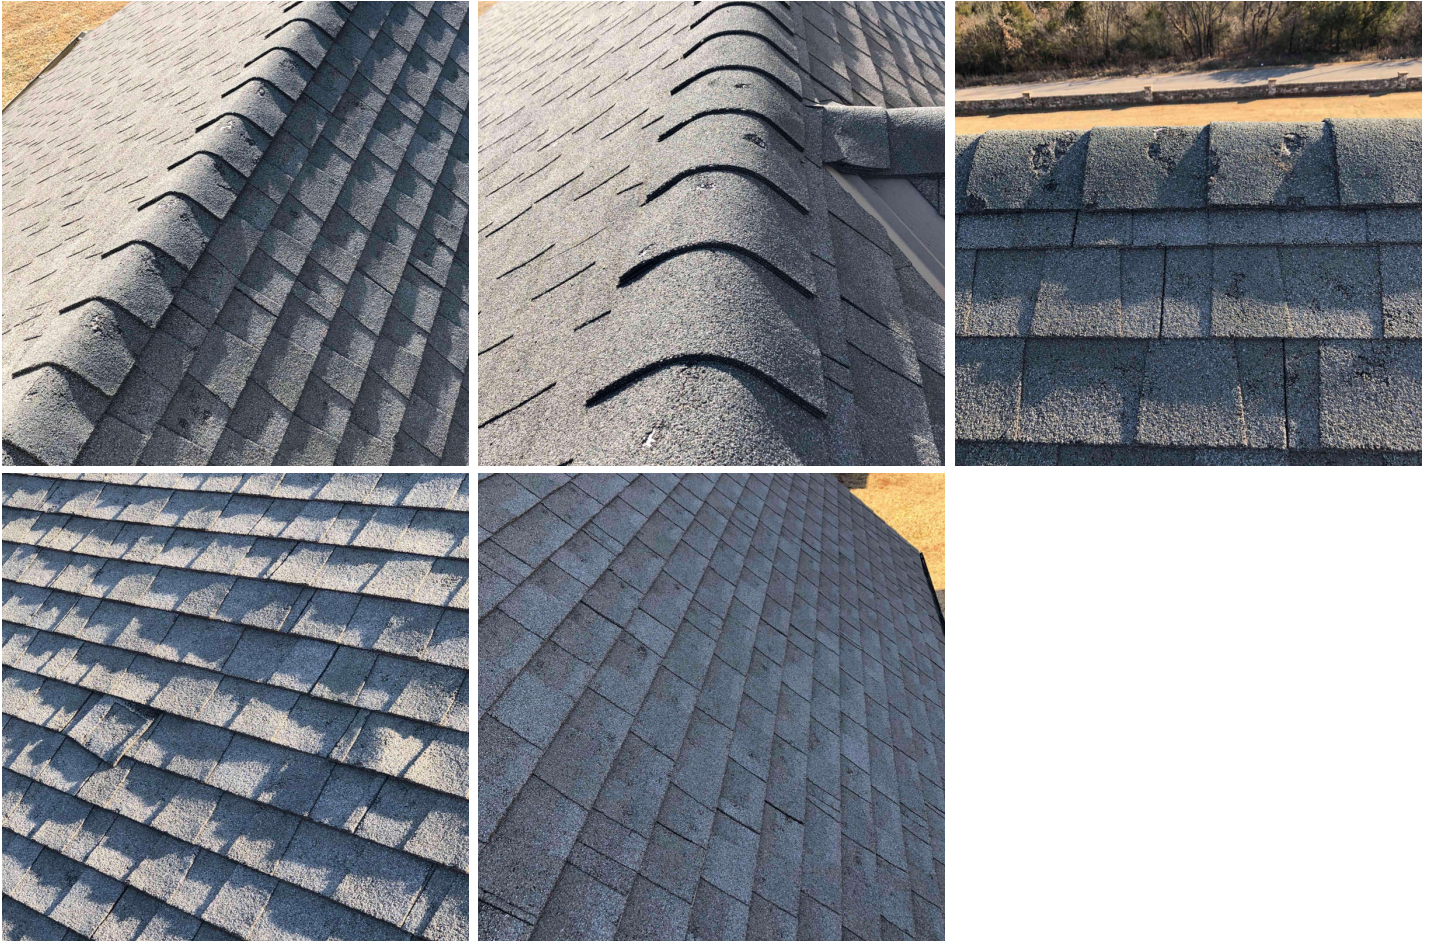
WIDESPREAD FUNCTIONAL HAIL DAMAGE

At the time of the inspection, the asphalt composition shingle roof had widespread damage visible that appeared to be the result of hail strikes. This damage appeared to meet the definition of what insurance companies call "functional damage." Functional damage is damage that;

The Inspector recommends replacement of all damaged shingles by a qualified contractor.

Contact a qualified roofing professional.

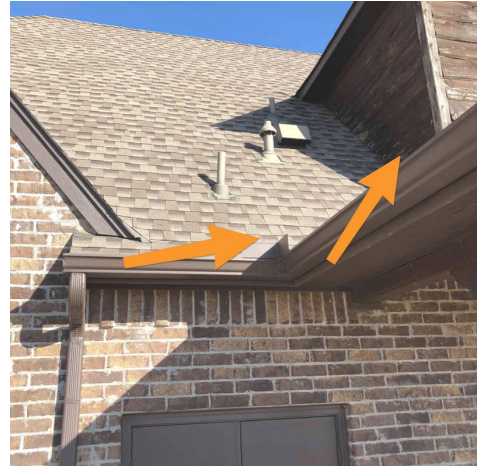
Southeast

GUTTER IMPROPERLY SLOPED

Gutters in certain areas sloped incorrectly. This condition can result in water pooling in the gutters, which will encourage corrosion and shorten gutter lifespan. It can also result in spillage and runoff draining to the foundation. Gutter spillage can result in excessively high moisture levels in soil at the foundation. Excessive moisture levels in soil near the foundation can affect the ability of the soil to support the weight of the structure above. The Inspector recommends repair of the roof drainage system to help protect the home structure and occupants. All work should be performed by a qualified contractor.

Contact a qualified roofing professional.

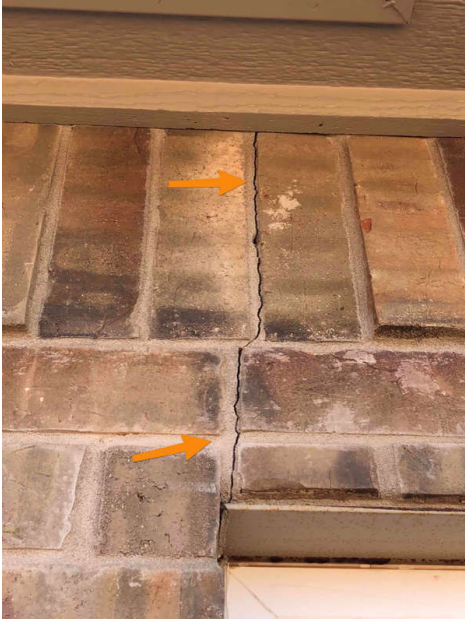
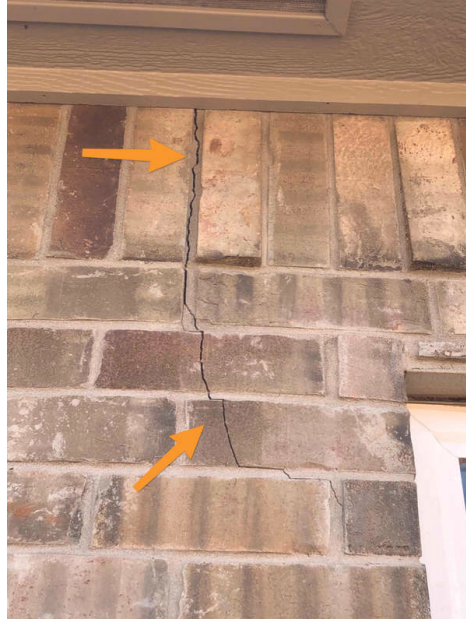
BRICK- EXPANSION CRACKING

What appears to be differential brick expansion cracking was observed near several exterior windows. Clay brick masonry undergoes irreversible expansion during its lifetime. This creates stress concentrations around door and window openings or at offsets in walls. These are common and do not reflect a structural problem or foundation issue. Recommend discussing repair options with a qualified masonry contractor.

Contact a qualified masonry professional.

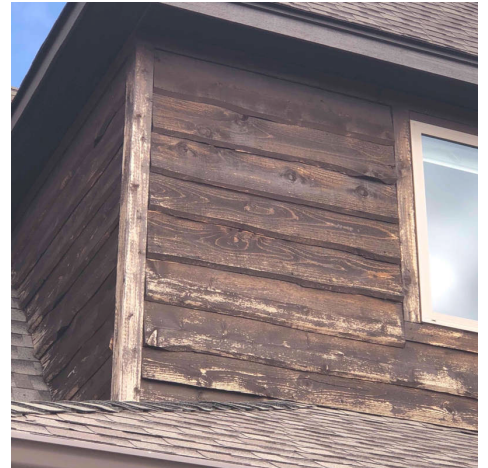
STAIN FADING

The wood siding could use a fresh stain. Over time, exposure to Mother Nature can take its toll on wood siding, allowing decay to begin. At present this is more of a cosmetic issue but it should be addressed sooner rather than later. Expect to re-stain every few years for best protection.

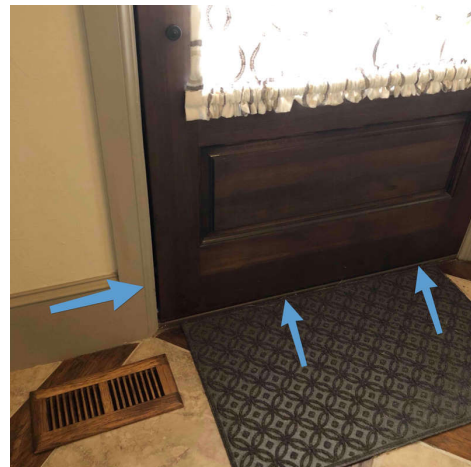
Front Entry

WEATHER-STRIPPING NOT PRESENT OR INADEQUATE

Door is missing standard weather-stripping or existing is damaged or inadequate. This can result in significant energy loss and moisture intrusion. Recommend installation or repair of standard weatherstripping.

Recommended DIY Project

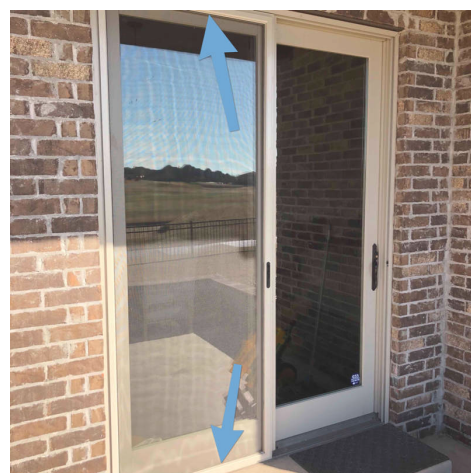
Southeast

The screen door does not open and/or close properly. It should be removed and adjusted/reinstalled. This is typically a DIY issue but fair warning- screen door repair can cause extreme frustration to those with limited patience!

Contact a handyman or DIY project

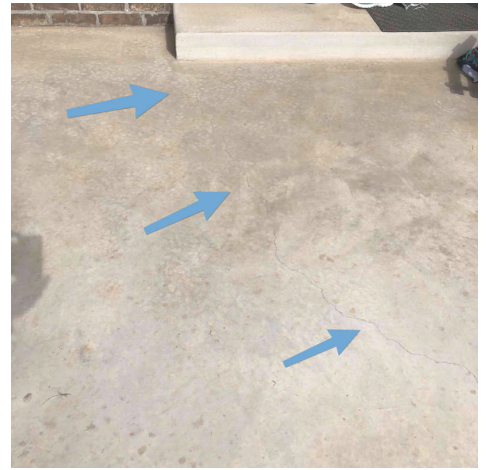
Southeast

PATIO CRACKING - MINOR

Normal settling & cracking observed. Recommend monitor and/or patch/seal.

Recommend monitoring.

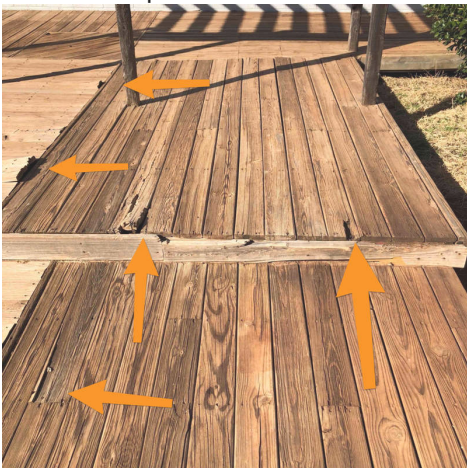
DECK - LOOSE/DAMAGED BOARDS

A number of deck boards were observed to be loose and/or damaged. Recommend they be replaced/refastened as necessary. This represents a significant area of the deck surface so a full replacement or removal may be necessary.

Contact a qualified deck contractor.

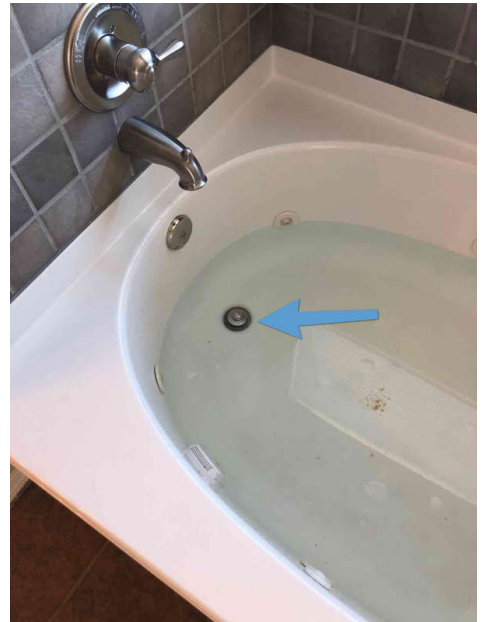
Master Bathroom

Shower/Bath had slow/poor drainage. Potential Handyman repair.

Contact a qualified handyman.

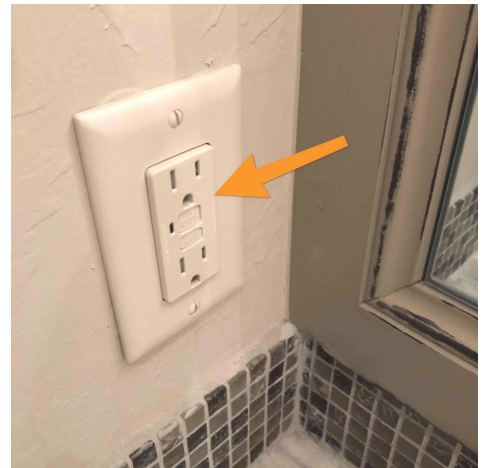
1st Floor 1/2 Bathroom

GFCI FAILURE

A ground fault circuit interrupter (GFCI) electrical receptacle did not respond to testing, did not re-set, was slow to re-set or made a buzzing sound when re-set. The Inspector recommends replacement of the receptacle to ensure that it works correctly when required. All work should be performed by a qualified contractor.

Contact a qualified electrical contractor.

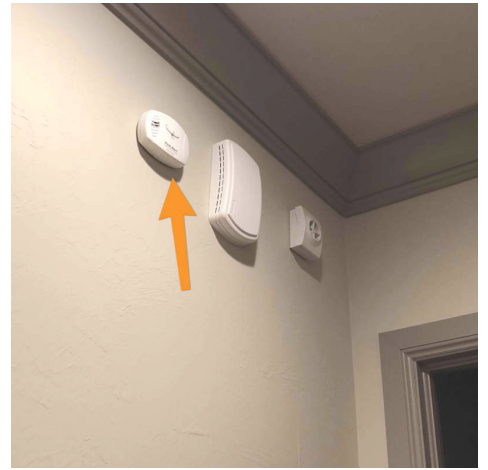
1st Floor Bedroom Hallway

Carbon monoxide detector failed to respond when tested. Recommend battery be changed or unit replaced if still no function.

Recommendation
Recommended DIY Project
