POTTS HOME INSPECTIONS, LLC

POTTS RESIDENTIAL REPORT

1234 Main St.
Chattanooga TN 37421

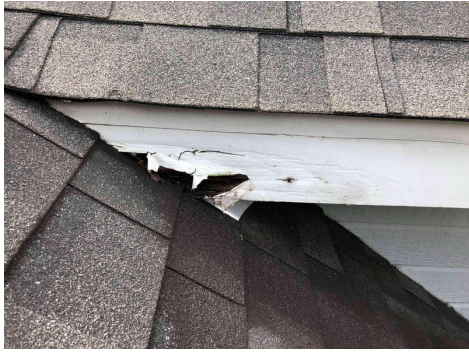
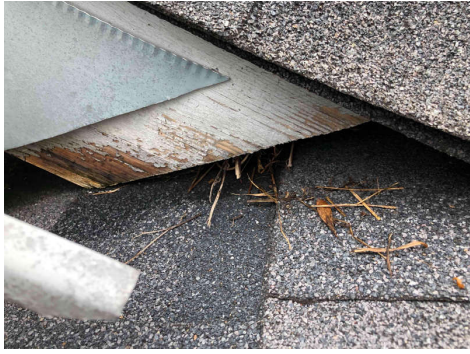
2.2.1 Flashings

WOOD DETERIORATION [TRIM/FLASHING]

Some evidence of wood deterioration noted. Repair flashing and trim to maintain optimal water removal and run-off.

Contact a qualified professional.

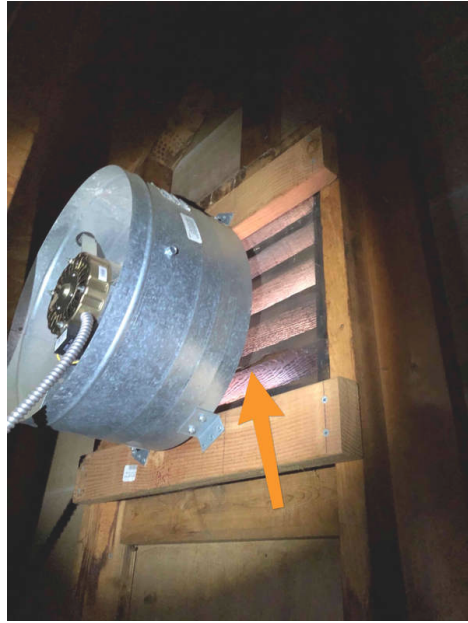
GABLE VENT DAMAGED

Gable vent was damaged, which could allow pests to enter. Recommend a qualified attic or ventilation contractor repair.

Contact a qualified professional.

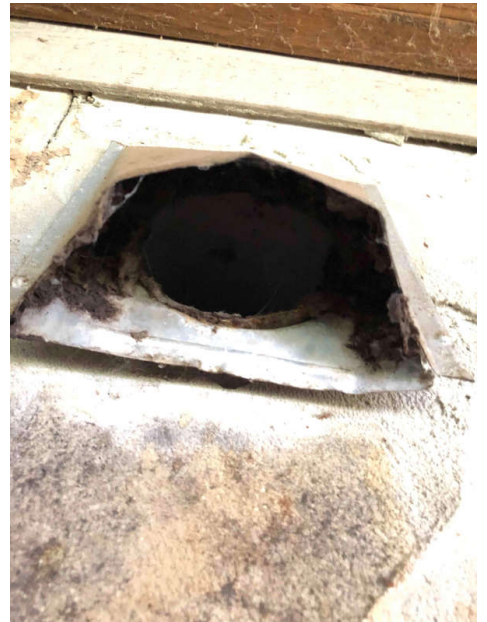
Back

Recommend replacing laundry done as the current damper is in the open position. Handyman/Contractor to replace.

Contact a qualified professional.

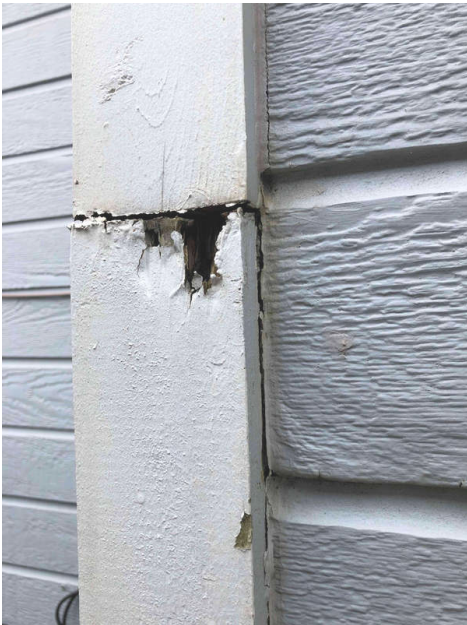
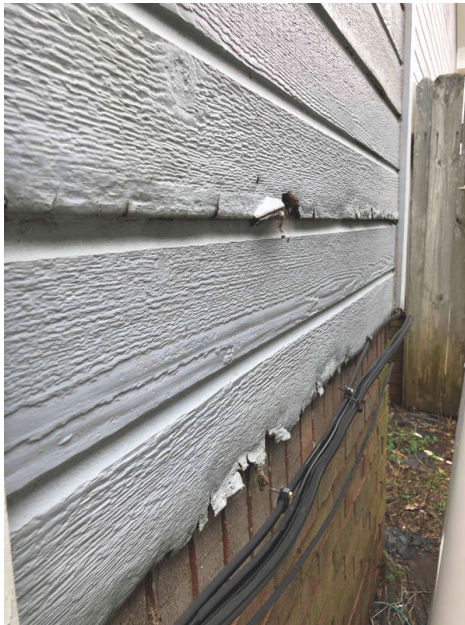
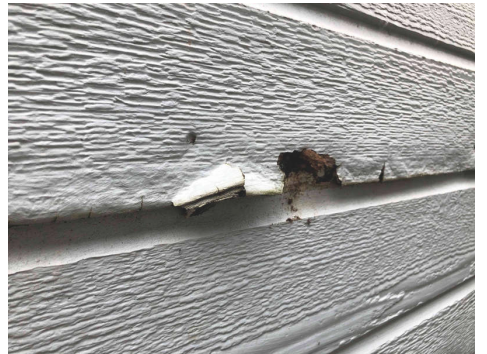
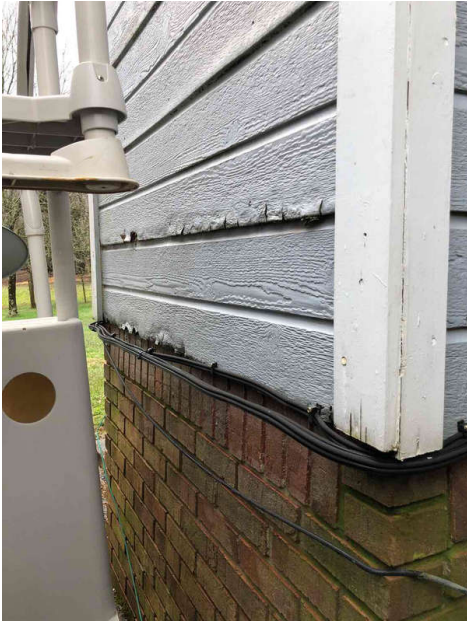
4.1.2 Siding, Flashing & Trim

WOOD DETERIORATION [SIDING]

Some evidence of wood deterioration noted. Repair siding and trim to maintain optimal water removal and run-off.

Contact a qualified professional.

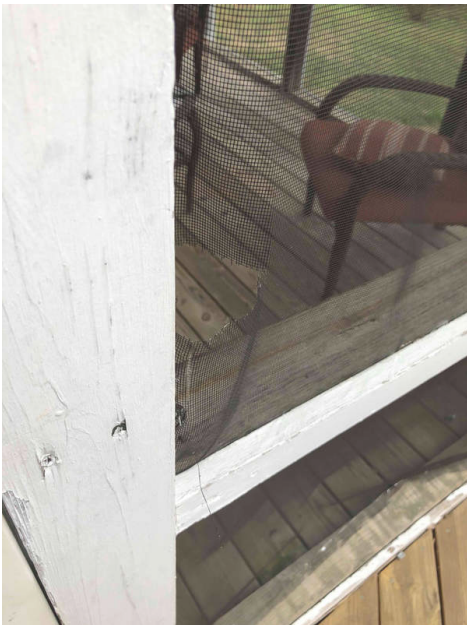
4.2.1 Exterior Doors

SCREEN PORCH RIPPED [EXTERIOR]

Screens around porch were ripped in multiple locations and can be an entry point for bugs, insects and other animals. Recommend repairing.

Contact a handyman or DIY project

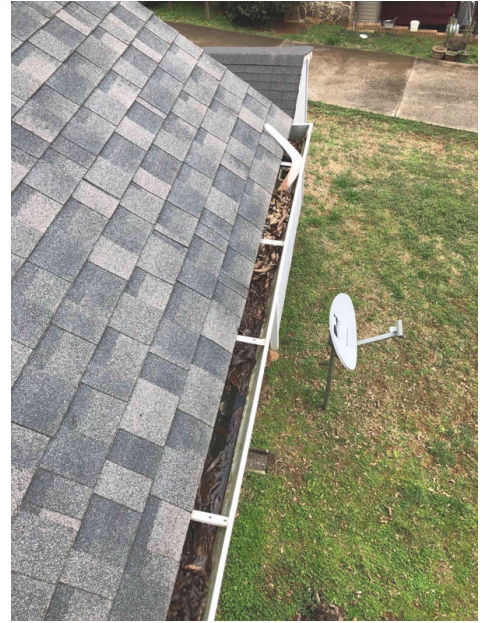
Back Left

DEBRIS

Debris has accumulated in the gutters. Recommend cleaning to help facilitate water flow.

[Here is a DIY resource](#) for cleaning your gutters.

Recommendation
Recommended DIY Project

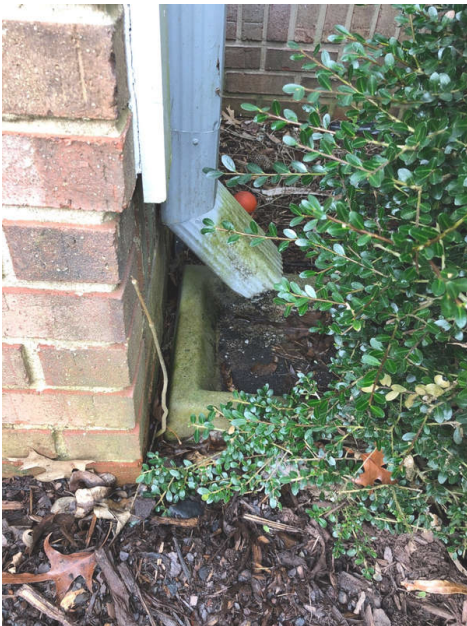
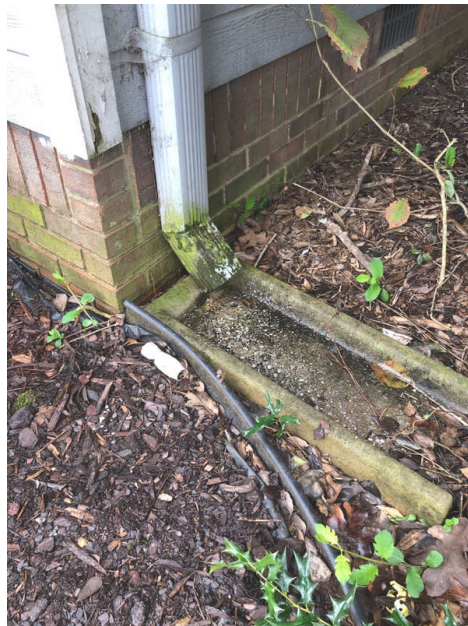
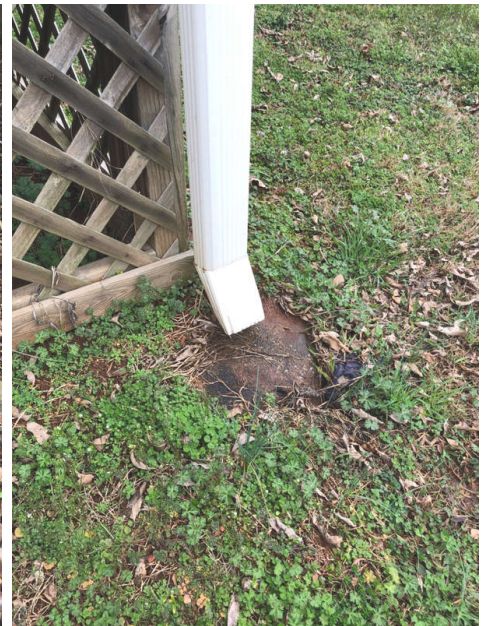
4.3.2 Roof Drainage Systems

One or more downspouts drain too close to the home's foundation. This can result in excessive moisture in the soil at the foundation, which can lead to foundation/structural movement.

Recommend a qualified contractor adjust downspout extensions to drain at least 6 feet from the foundation.

Contact a qualified roofing professional.

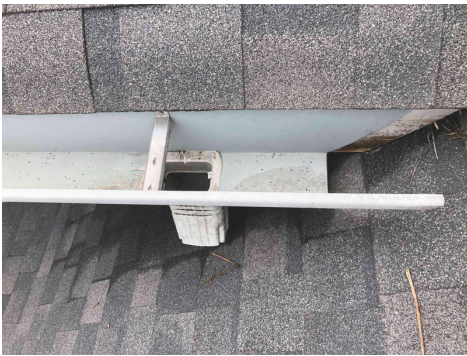
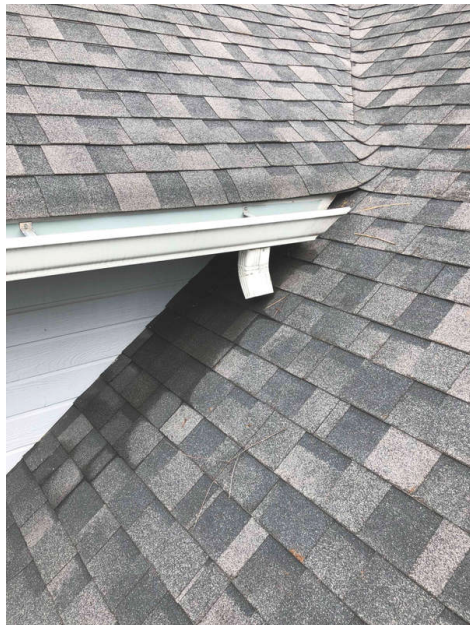
Downspout should run into another gutter and not terminate onto the roof. In its current condition it will shorten the lifespan of the shingles. Recommend roofing professional to update.

Contact a qualified gutter contractor

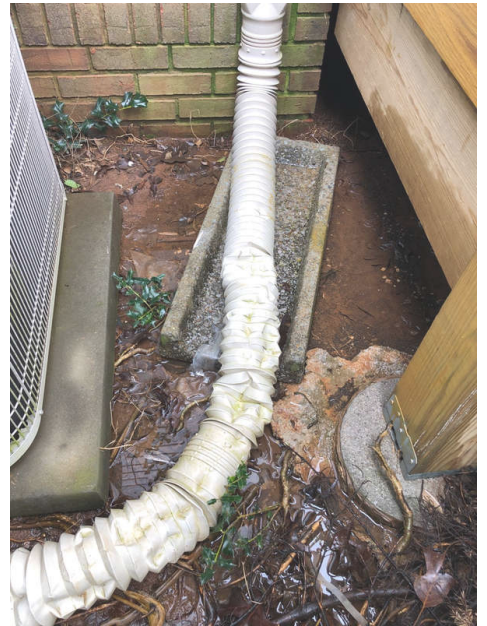
Back Right

Standing water observed, which indicates poor drainage and/or grading. Recommend following standing grading protocols via 6:10 rule and ensuring water adequately disperses away from the house.

Contact a qualified landscaping contractor

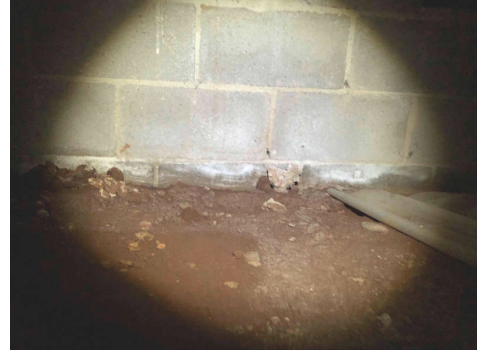
5.1.1 Foundation

Efflorescence alone does not pose a major problem, but it can be an indication of moisture intrusion, which can lead to a compromise in the structural material.

Correctly placing gutters/downspouts with a positive landscape grading away from your foundation can help to mitigate this issue.

Contact a qualified professional.

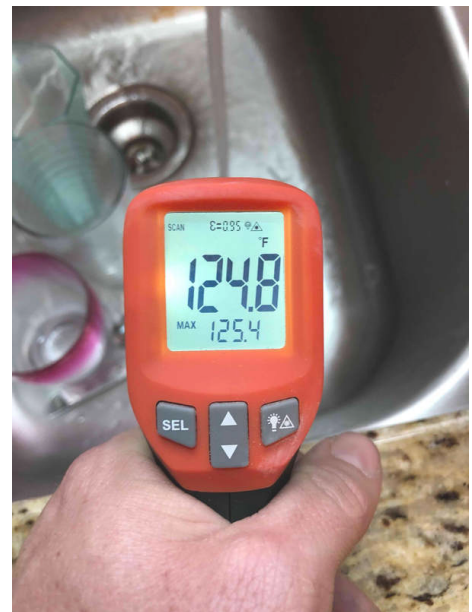
Hot Water Systems: Hot Water Temperature

125 °F

Water temperature typically taken at the Kitchen Sink.

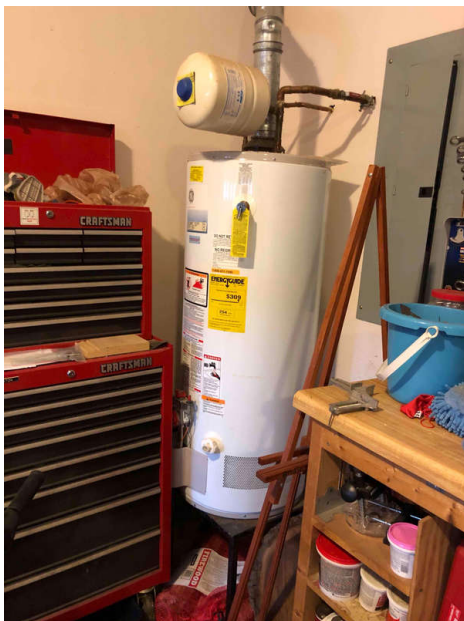
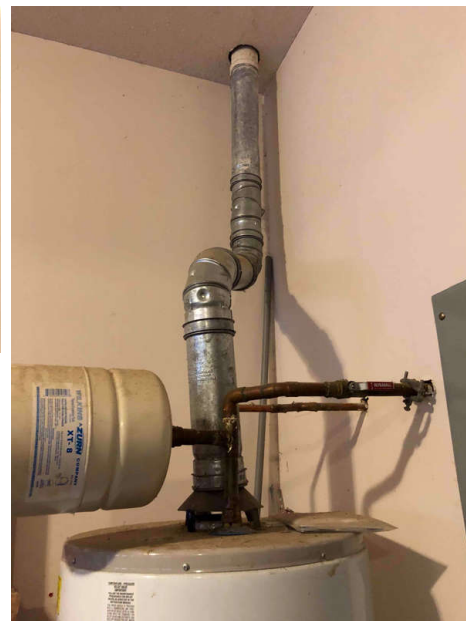
Hot Water Systems: Hot Water Heater Photos

I recommend flushing & servicing your water heater tank annually for optimal performance. Water temperature should be set to at least 120 degrees F to kill microbes and no higher than 130 degrees F to prevent scalding.

Water heaters should be flushed annually to prevent sediment buildup and maintain efficiency. Recommend a qualified plumber service and flush.

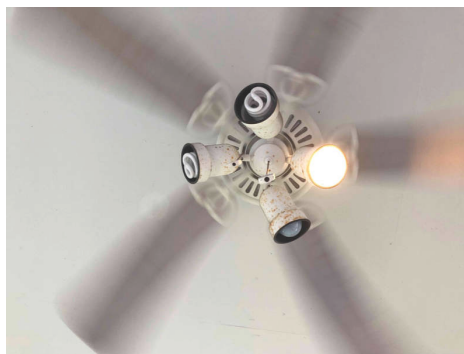
One or more exterior light fixtures were inoperable at the time of the inspection due to lack of light bulbs/blown bulbs. Most likely new light bulbs are needed, though it is impossible to test if electric works until they're replaced. Recommend Handyman/DIY to fix.

Recommend Electrician evaluation if light bulb doesn't turn on after bulb is in place.

Contact a handyman or DIY project

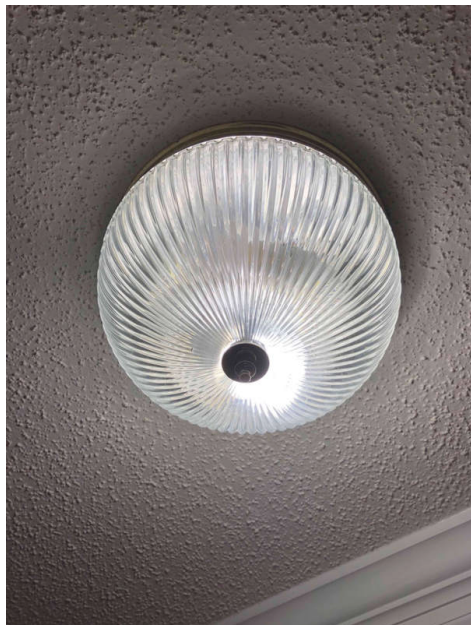
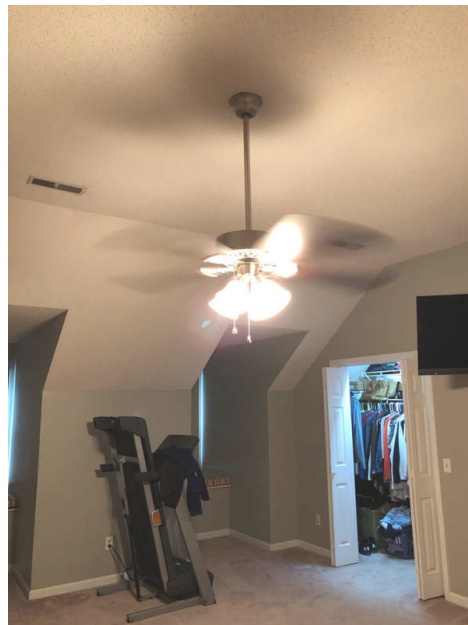
7.5.2 Lighting & Receptacles

LIGHT/S INOPERABLE [INTERIOR]

Multiple light fixtures were inoperable at the time of the inspection due to lack of light bulbs/blown bulbs. Most likely new light bulbs are needed, though it is impossible to test if electric works until they're replaced. Recommend Handyman/DIY to fix.

Recommend Electrician evaluation if light bulb doesn't turn on after bulb is in place.

Contact a handyman or DIY project

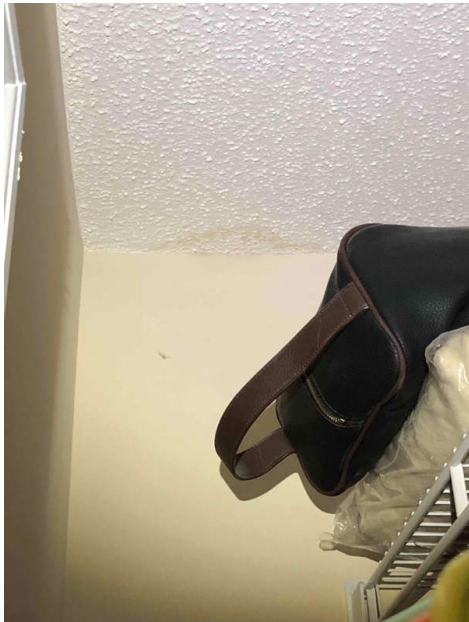
Closet

STAIN/S [CEILING]

There is a stain on ceiling/wall that requires repair and paint. Source of staining should be determined. The Spots were tested with moisture meter and tested fine. Continue to evaluate and monitor around the areas to ensure stains don't increase.

Recommend monitoring.

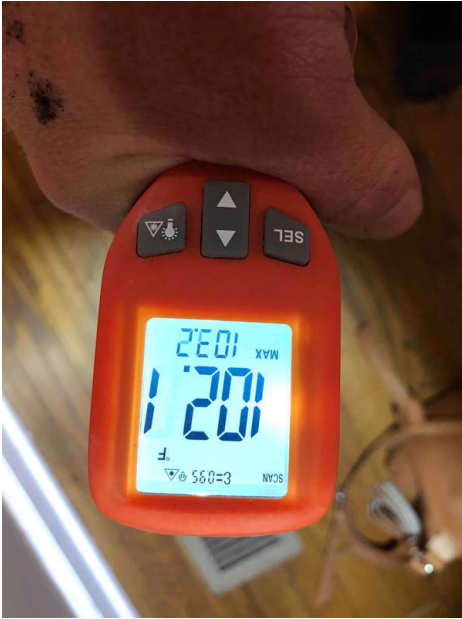
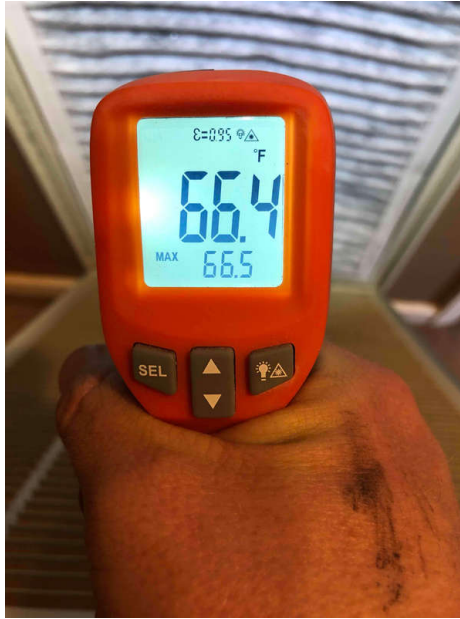
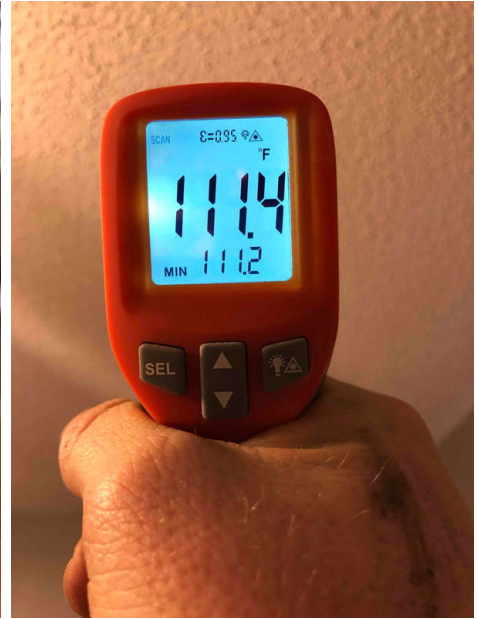
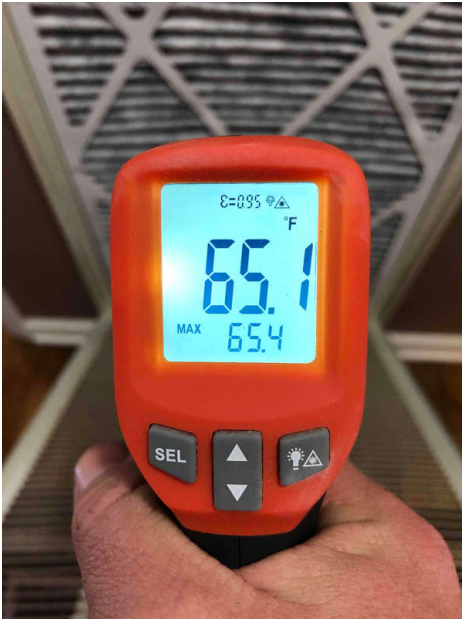
40 Degrees

This is the number of degrees the system is cooling (or heating) the house air. Normal range for this number is 16-24 degrees when operating the system during hot weather, lower when ambient temperatures are lower. The system functioned as expected when tested and appeared to be serviceable at the time of the inspection. As with all mechanical equipment, the unit may fail at any time without warning. The inspector cannot determine future failures.

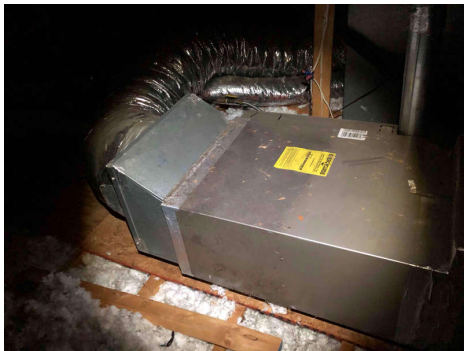
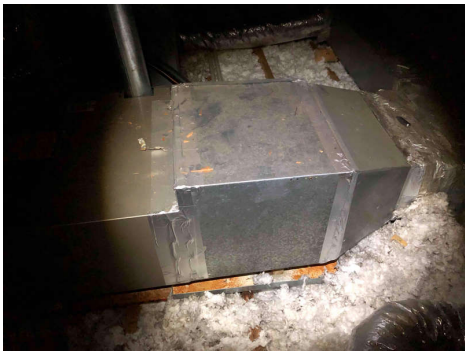
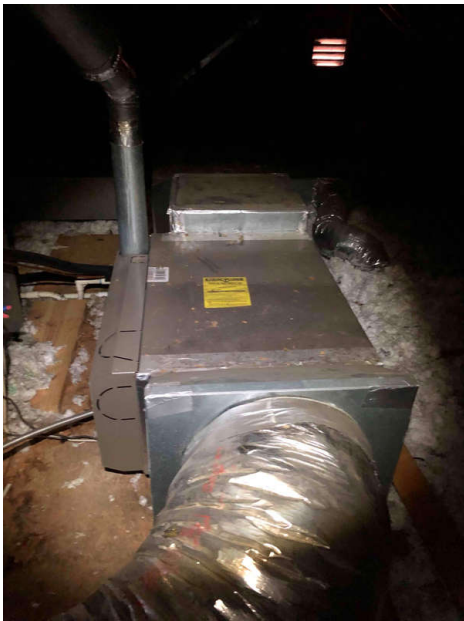
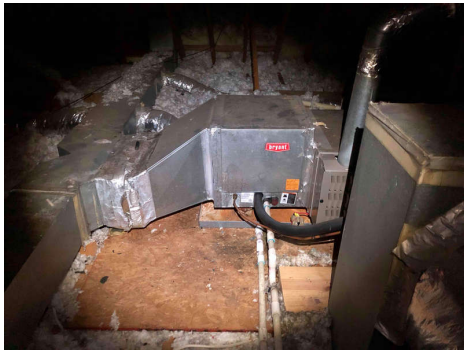
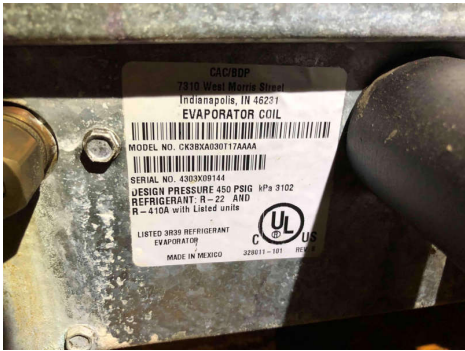
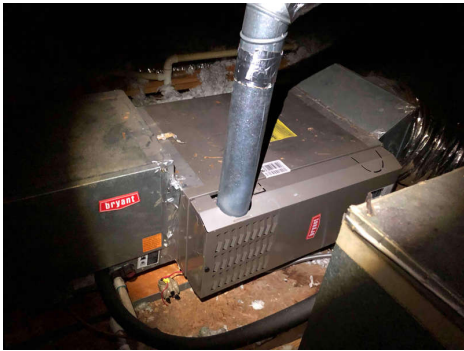
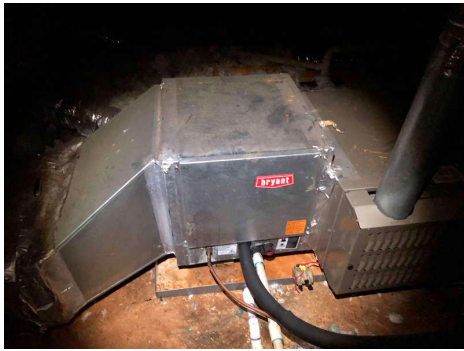
Air Handler: Pictures of unit

Be advised that there is air handler equipment installed in the non-air conditioned attic.

This unit is installed in the non-air conditioned Attic.(this is a very poor practice).

Recommendation

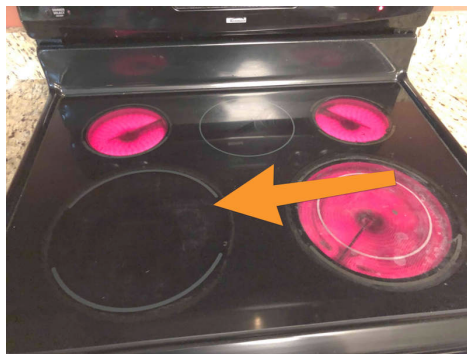
DAMAGED BURNERS

One or more of the burners at the stove are damaged. Recommend contacting an appliance repair specialist to evaluate cost of repair vs replacement.

Contact a qualified professional.

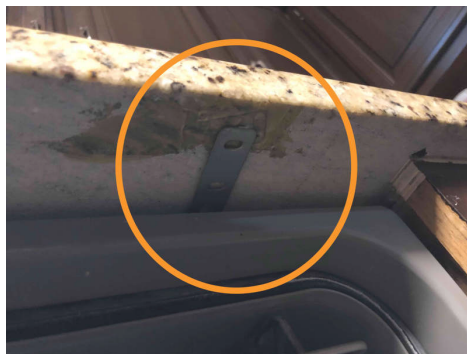
10.3.1 Dishwasher

The bracket that attaches the dishwasher to the underside of the countertop is loose, missing or installed in a substandard way. Repairs should be made as necessary, such as installing or reinstalling the bracket, and by a qualified contractor if necessary.

Contact a qualified appliance repair professional.
