GOLDEN STAR RESIDENTIAL REPORT

1234 Main St.
Spokane wa 99205

Buyer Name
10/15/2018 9:00AM

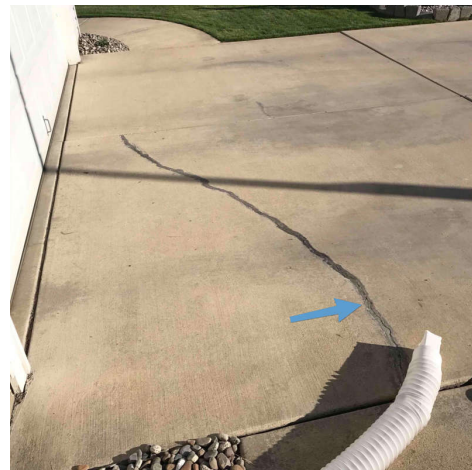
2.1.1 Walkways & Driveways

DRIVEWAY CRACKING

Some typical cracking observed. Previously repaired. Recommend monitoring, if cracks increase then we recommend cleaning out cracks and having a concrete contractor patch/seal to help prevent further deterioration.

Contact a qualified concrete contractor.

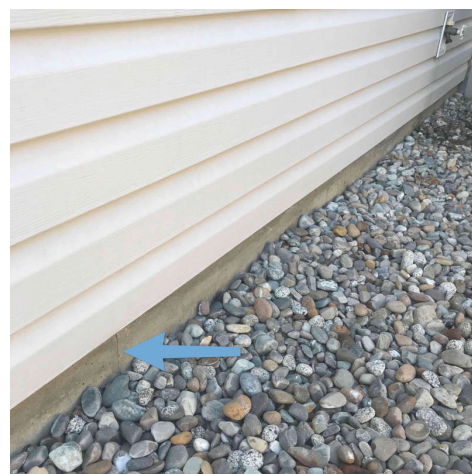
2.3.1 Exterior Foundation (Stem Wall)

FOUNDATION (STEM WALL) - MINOR CRACKING

Some cracking in the foundation stem wall observed. Shrinkage cracks appear over time. Recommend monitoring for any offset movement in the future and patching/sealing by a licensed foundation contractor

Contact a foundation contractor.

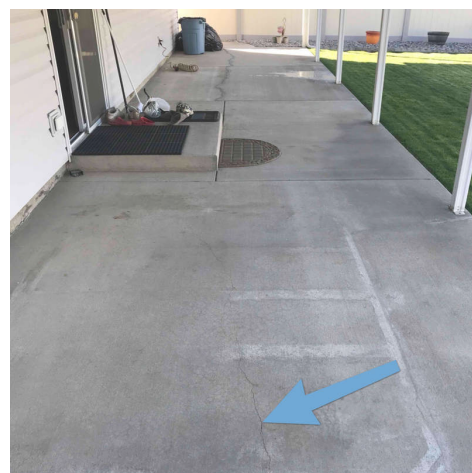
2.5.1 Patios

MINOR CRACKING

The patio had some typical cracking. Recommend sealing to prevent further deterioration and monitor for any movement.

Contact a handyman or DIY project

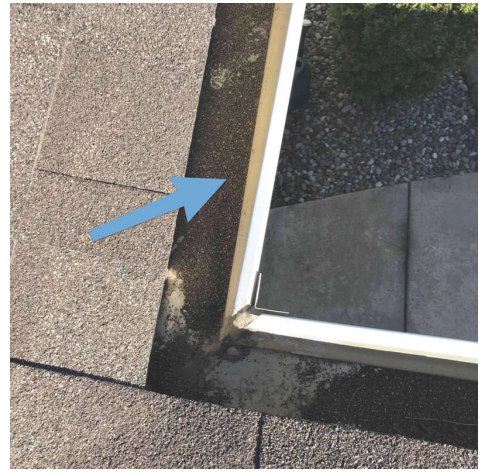
3.2.1 Roof Drainage Systems

GUTTER - DEBRIS

Debris has accumulated in the gutters. Recommend cleaning to facilitate water flow.

Contact a handyman or DIY project

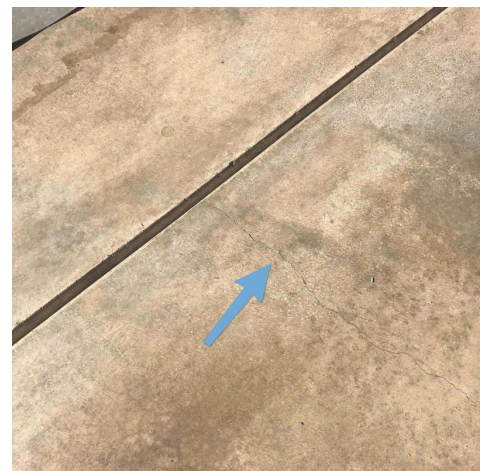
4.4.1 Floor

FLOOR - SHRINKAGE CRACKS

Some typical shrinkage cracks observed in the garage flooring. Recommend sealing and monitoring for any further offset movement in the future.

Recommend monitoring.

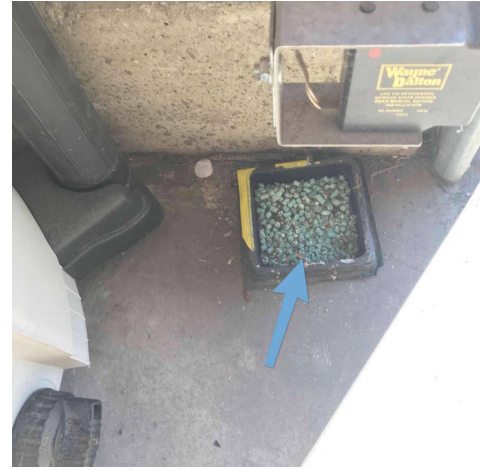
4.4.2 Floor

PESTS

There appeared to be some pest/rodent bait/traps observed in the garage and other areas. No activity was observed at the time of inspection. Recommend monitoring

Contact a qualified pest control specialist.

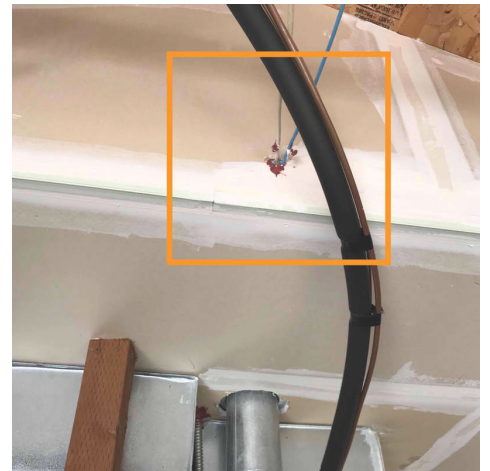
4.5.1 Ceilings, Walls & Fire Separation

FIRE BLOCK CAULKING

Some loose/missing fire block caulking observed in the garage ceiling. Recommend recaulking to preserve fire separation by a qualified drywall contractor

Contact a qualified drywall contractor.

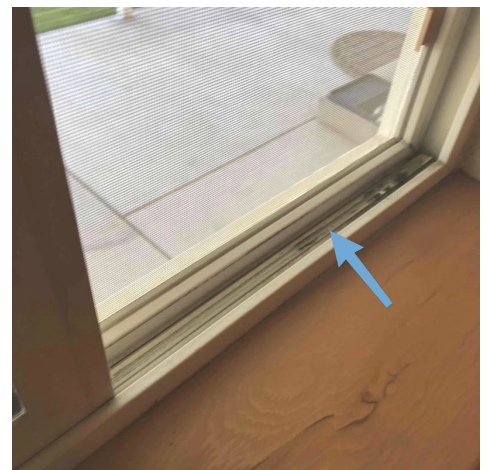
7.3.1 Windows

DIRTY TRACKS

One or more windows appeared to have excessive dirt in their tracks but, are operational. Recommend a window professional clean, lubricate & adjust as necessary.

Contact a qualified window repair/installation contractor.

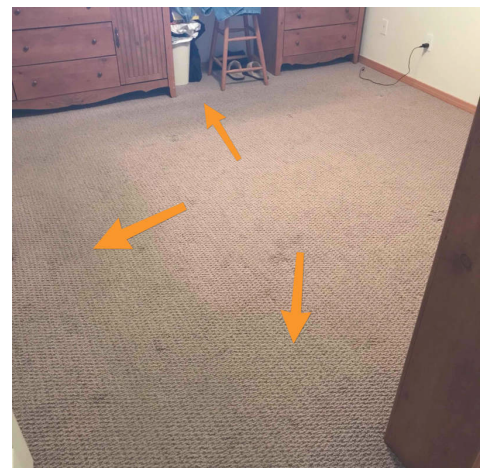
7.4.1 Floors

MODERATE WEAR

MASTER BEDROOM

Some floors in the home exhibited wear along major paths of travel. Recommend a qualified flooring contractor evaluate for a replacement carpet/pad

Contact a qualified flooring contractor

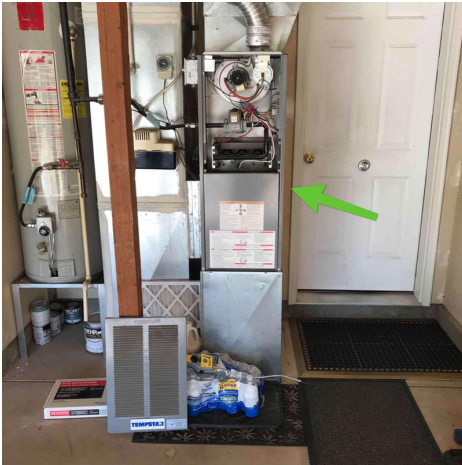
Heating Equipment: Furnace

The furnace appeared to be satisfactory and functioning properly at the time of inspection. Recommend servicing annually and changing the filter every 3-6 months. Appropriate filter size appeared to be 20x16x1.

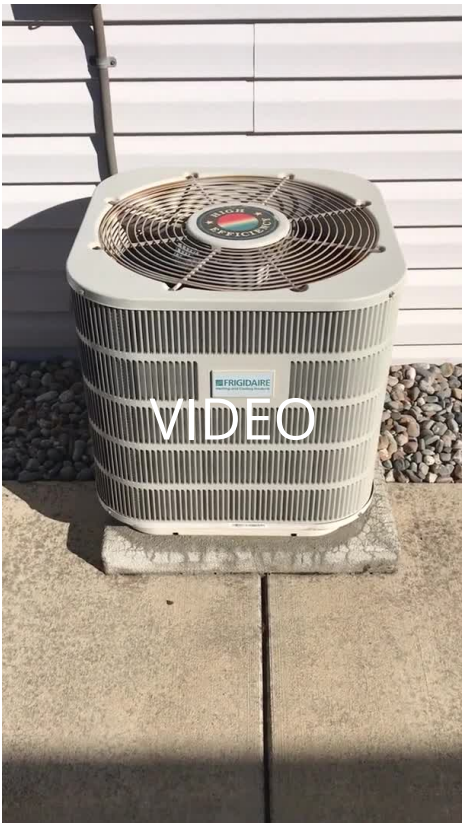
Cooling Equipment: A/C Condenser

The air conditioning condensing unit appeared to be operating properly at the time of inspection.

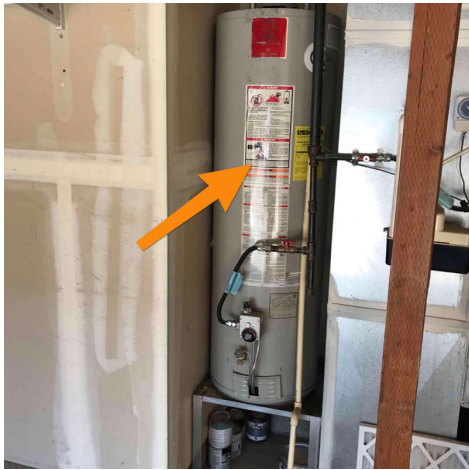
9.5.1 Hot Water Systems, Controls, Flues & Vents

SEISMIC STRAPPING

The seismic strapping was missing around the water heater. Recommend proper strapping be installed by a licensed plumber.

Contact a qualified plumbing contractor.

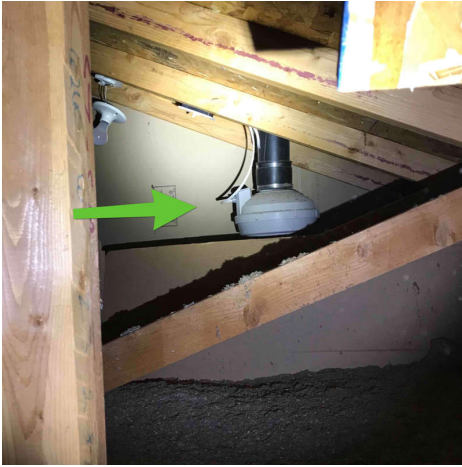
Garage Attic

Radon Mitigation: Radon Mitigation Installed

A radon mitigation system was observed at the time of inspection. It appeared to be in satisfactory condition. The Northwest areas of America are known to have elevated levels of radon. We and the EPA recommend having your home tested every couple of years during the winter months and action should be taken if levels are found to be in excess of 4 pCi/L of air.

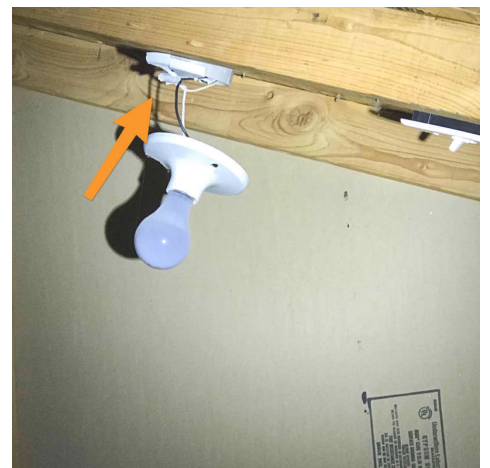
12.6.1 Attic Electrical

EXPOSED WIRING

ATTIC

Some exposed wiring observed at a loose/damaged light fixture. Recommend repair by a licensed electrician.

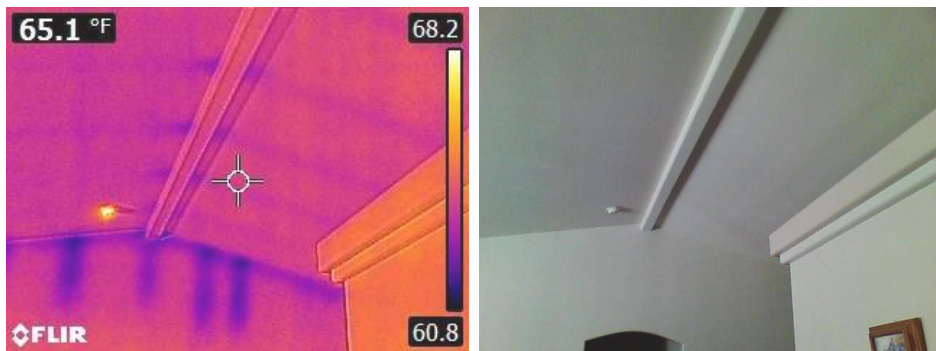
Air Infiltration Scan: Air Infiltration Satisfactory

Air infiltration of the home was minimal.

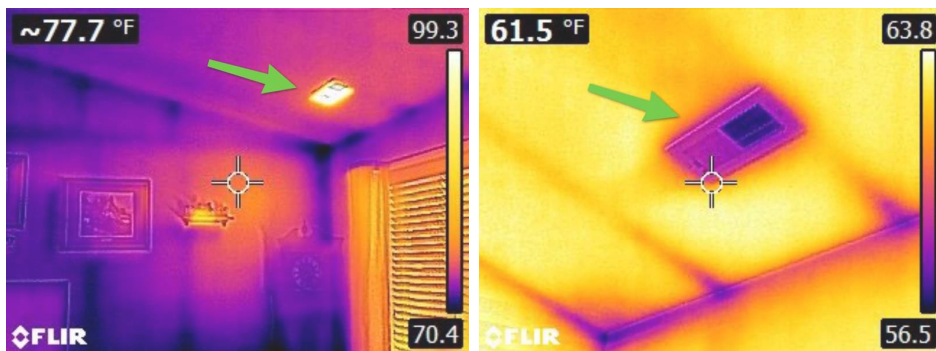
Heating System Scan: Heating & Cooling

The thermal scan of the registers and ducting indicate the ducting system was in satisfactory condition.
