DETAILS HOME INSPECTIONS

HOME INSPECTION

1234 Main St.
Washougal, Wa 98671

06/19/2019 9:00AM

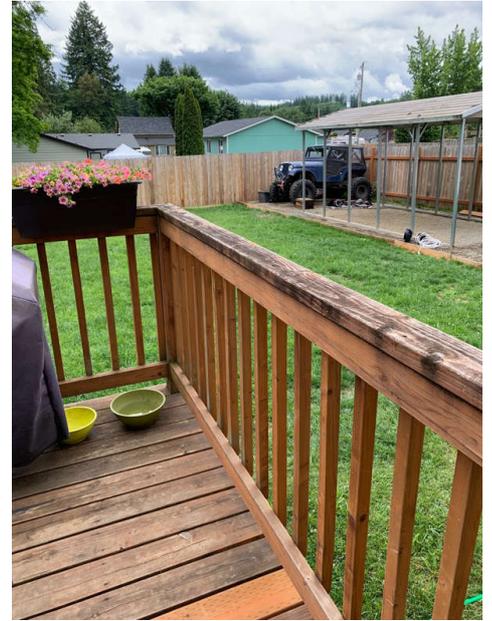
3.2.1 Decks, Balconies, Porches & Steps

RAILING LOOSE

Railing is loose, recommend securing railing properly, possible safety hazard, recommend repair.

Contact a qualified professional.

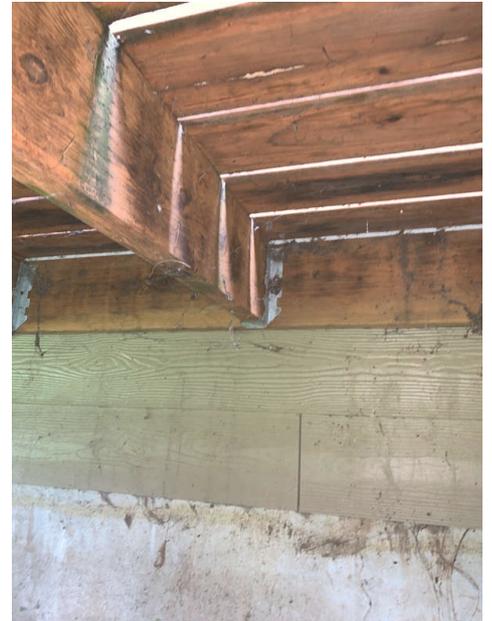
3.2.2 Decks, Balconies, Porches & Steps

RECOMMEND LAG BOLTS FOR ATTACHMENT TO LEDGER BOARD, RECOMMEND REPAIR

Recommend Lag bolts for attachment to ledger board, recommend repair

Contact a qualified professional.

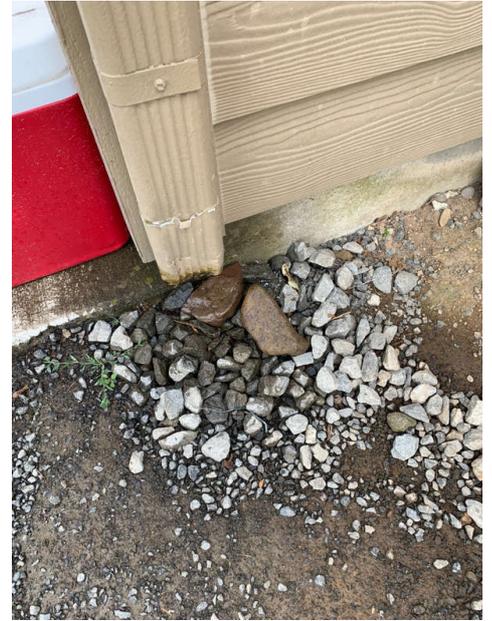
3.3.1 Gutters/Downspouts

DOWNSPOUTS DRAIN NEAR HOUSE

One or more downspouts drain too close to the home's foundation. This can result in excessive moisture in the soil at the foundation, which can lead to foundation/structural movement. Recommend a qualified contractor adjust downspout extensions to drain at least 6 feet from the foundation.

Contact a qualified roofing professional.

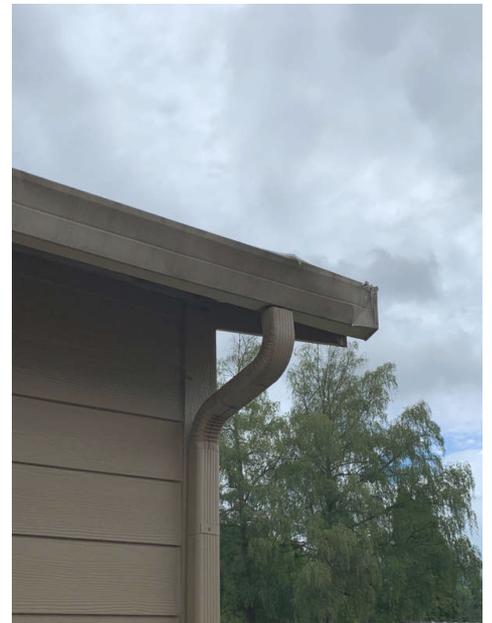
3.3.2 Gutters/Downspouts

GUTTER DAMAGED

Gutters were damaged. This can result in excessive moisture in the soil at the foundation, which can lead to foundation/structural movement. Recommend a qualified contractor evaluate and repair.

Contact a qualified roofing professional.

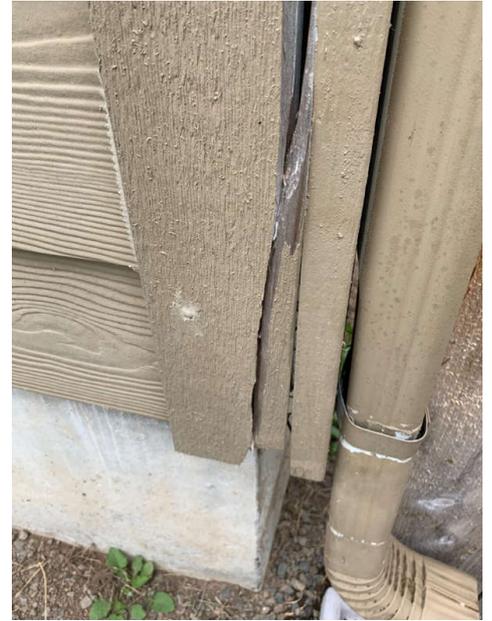
3.4.1 Siding, Flashing & Trim

TRIM DAMAGED

Trim had some deterioration, recommend repair and painting

Contact a qualified professional.

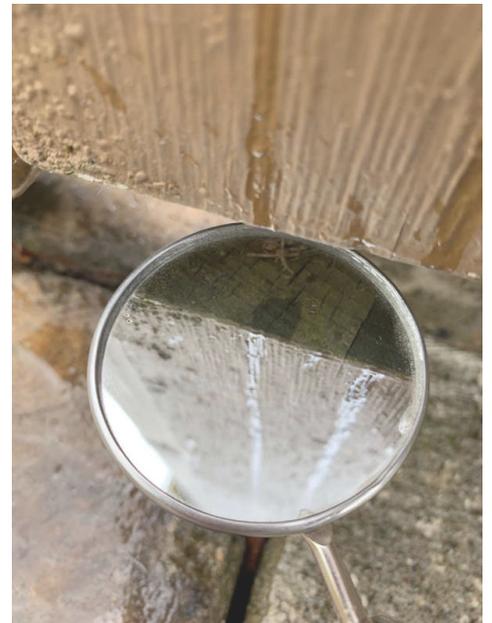
3.4.2 Siding, Flashing & Trim

PAINTING UNDERSIDE OF TRIM

Recommend painting underside of trim to prevent moisture intrusion.

Contact a qualified professional.

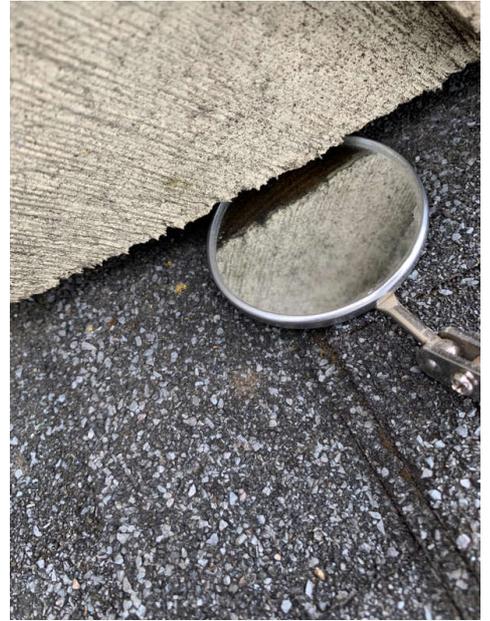
3.5.1 Eaves, Soffits & Fascia

PAINTING UNDERSIDE OF FASCIA

Recommend painting underside of fascia to prevent moisture intrusion.

Contact a qualified professional.

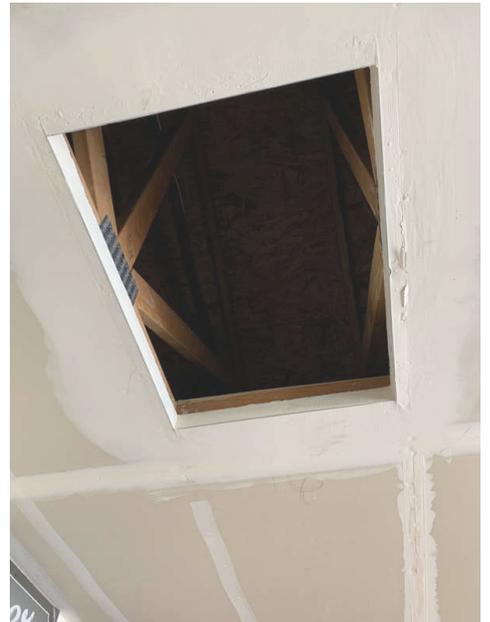
5.2.1 Walls, Firewalls and Ceiling

FIREWALL DAMAGED/MISSING

Firewall separating the home and garage is not compliant with modern building standards. Firewalls should be built with materials to prevent the spreading of a fire into the home living space. Recommend a qualified contractor evaluate and bring firewall up to standards.

Contact a qualified professional.

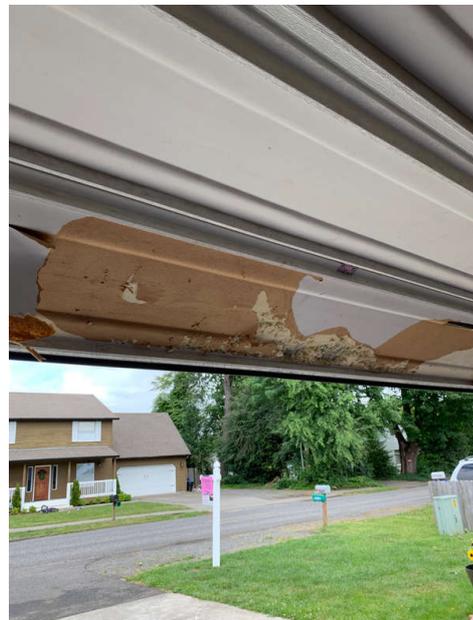
5.3.1 Garage Door

PANEL DAMAGE

Garage door panel is damaged and may need repair/replacement. Recommend a qualified garage door contractor evaluate.

Contact a qualified garage door contractor.

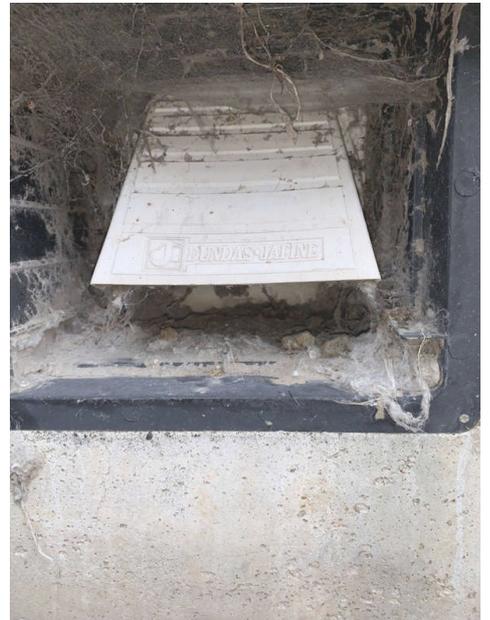
9.4.1 Dryer Vented

DUCT DIRTY/CLOGGED

Dryer duct, appears dirty/clogged, recommend cleaning.

Contact a qualified professional.

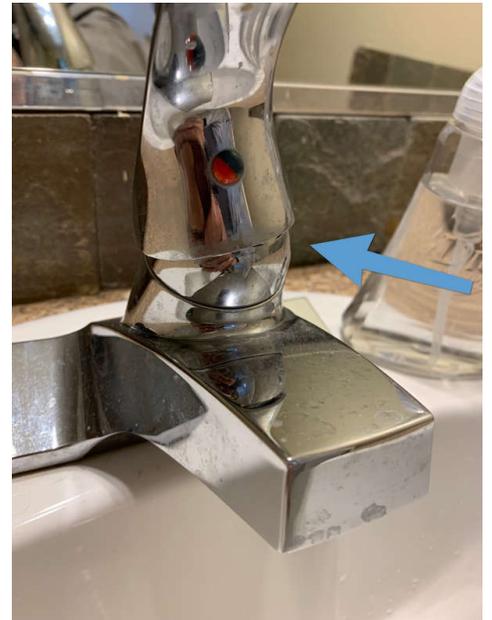
FACET LEAKS

Sink facet leaks, recommend repair.

Contact a qualified professional.

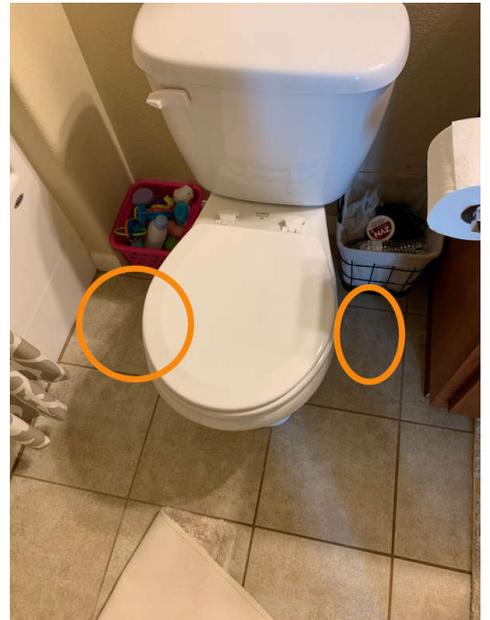
10.7.1 Shower/Tub area

MOISTURE

Floor appears to have moisture, possible leaks, recommend licensed contractor re-evaluate/repair as needed.

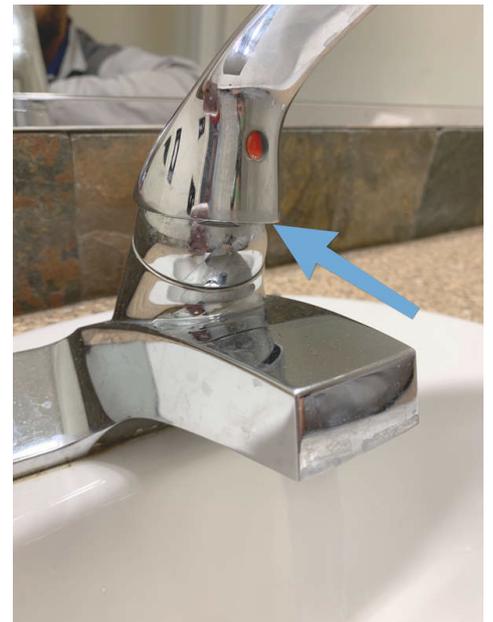
FACET LEAKS

Sink facet leaks, recommend repair.

Contact a qualified professional.

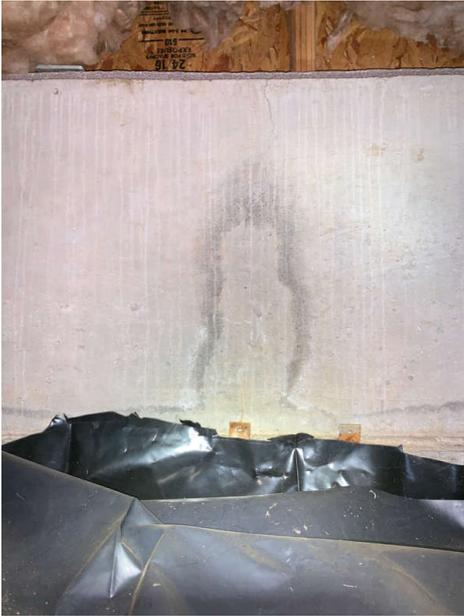
Moisture stains, monitor

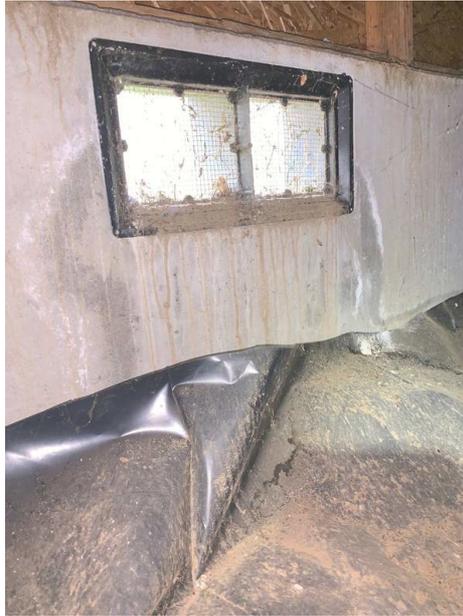
Moisture stains, monitor

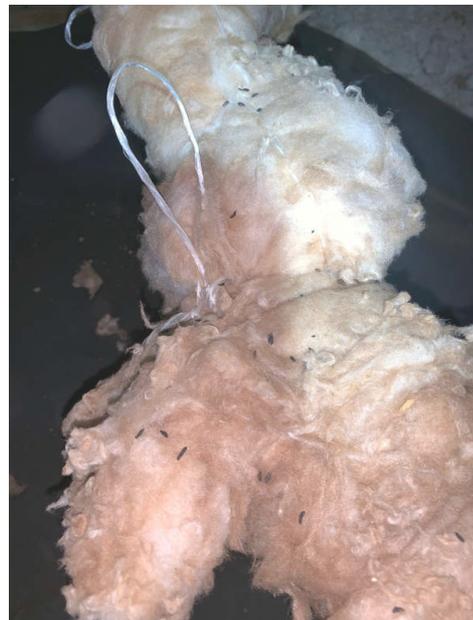
There is visible evidence of past rodent/pest activity in crawspace. The activity may or may not be currently active, however no current activity was visible at the time of inspection. Recommend licensed rodent/pest contractor re-evaluate.

Contact a qualified professional.

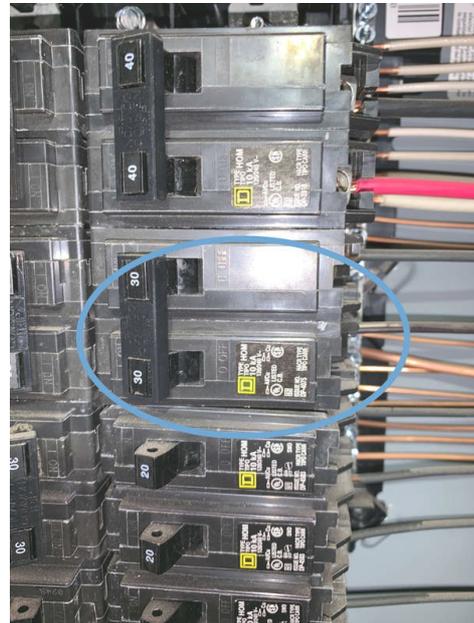
IMPROPERLY SIZED BREAKERS

A/C unit, Improperly sized breakers, recommend repair.

Contact a qualified professional.

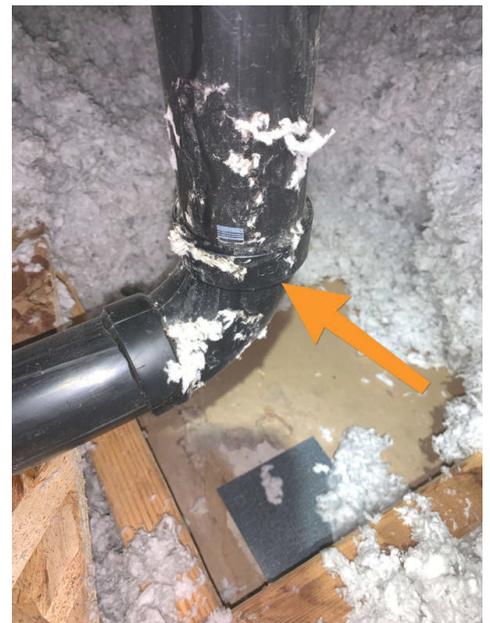
ATTIC, PLUMBING VENT LEAKING, RECOMMEND REPAIR

Attic, plumbing vent leaking, recommend repair
