INSPECT MONTANA | T&B HOUSE AND PROPERTY,
LLC

STANDARD RESIDENTIAL INSPECTION

1234 Main St.
LOLO MT 59847

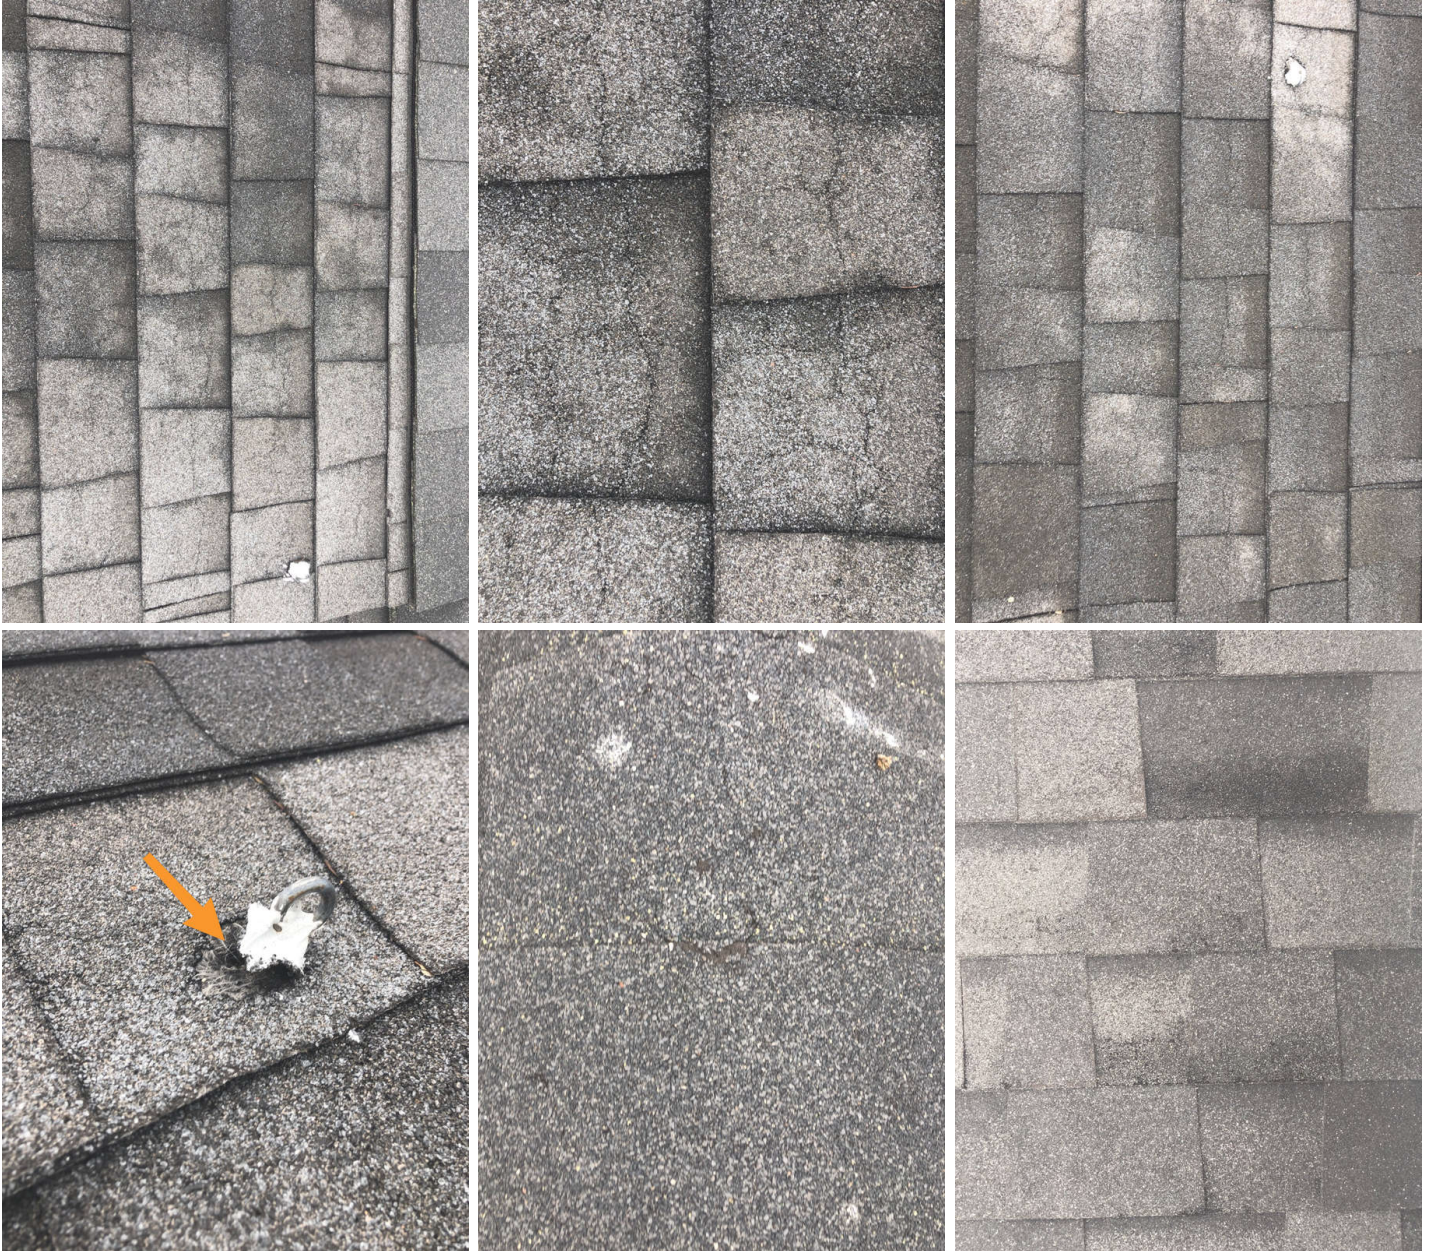
DAMAGED (GENERAL)

Roof coverings showed damage. Recommend a qualified roofing professional evaluate and repair.

Contact a qualified roofing professional.

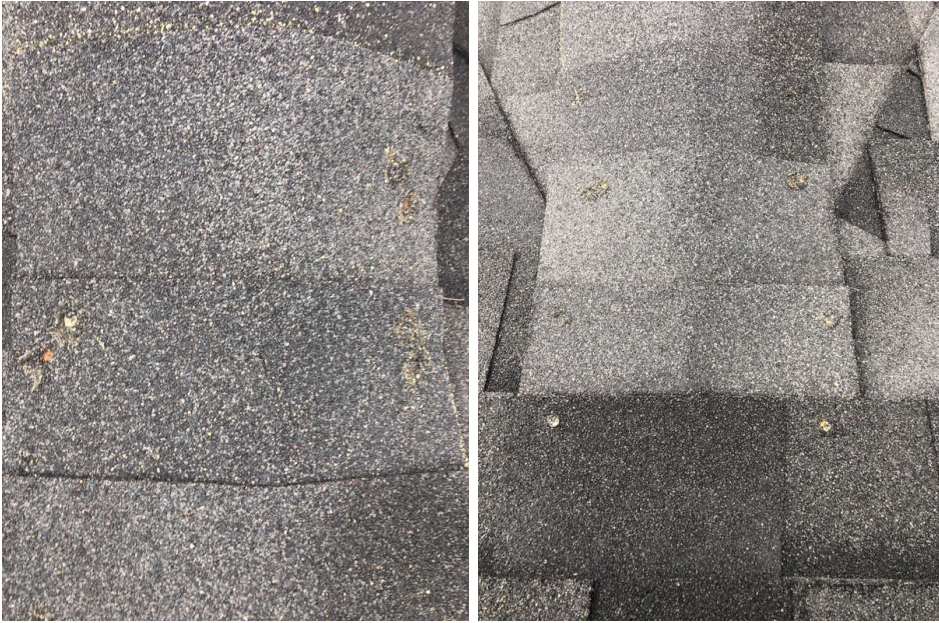
2.3.2 Coverings

EXPOSED FASTENERS

Several exposed fasteners without proper sealing were found.

Contact a qualified roofing professional.

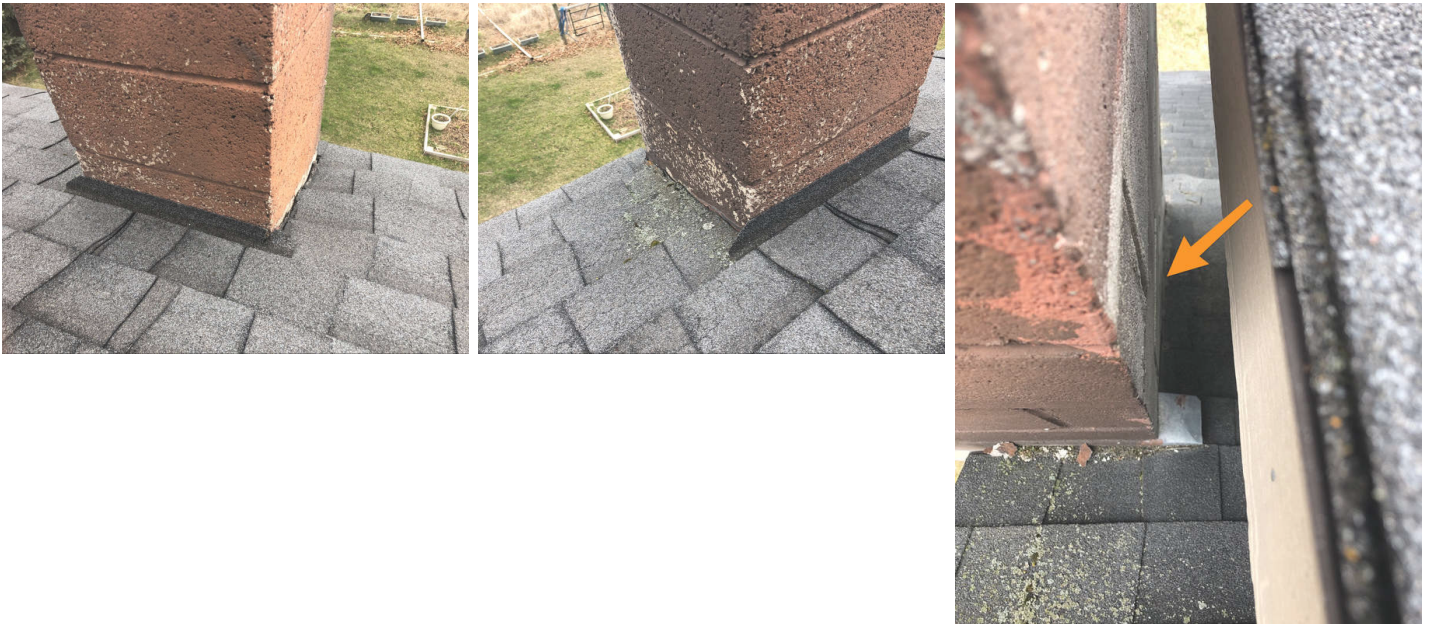
2.5.1 Flashings

MISSING

Proper flashings at chimneys were missing at time of inspection. Flashings provide protection against moisture intrusion. Recommend a qualified roofing contractor evaluate and remedy.

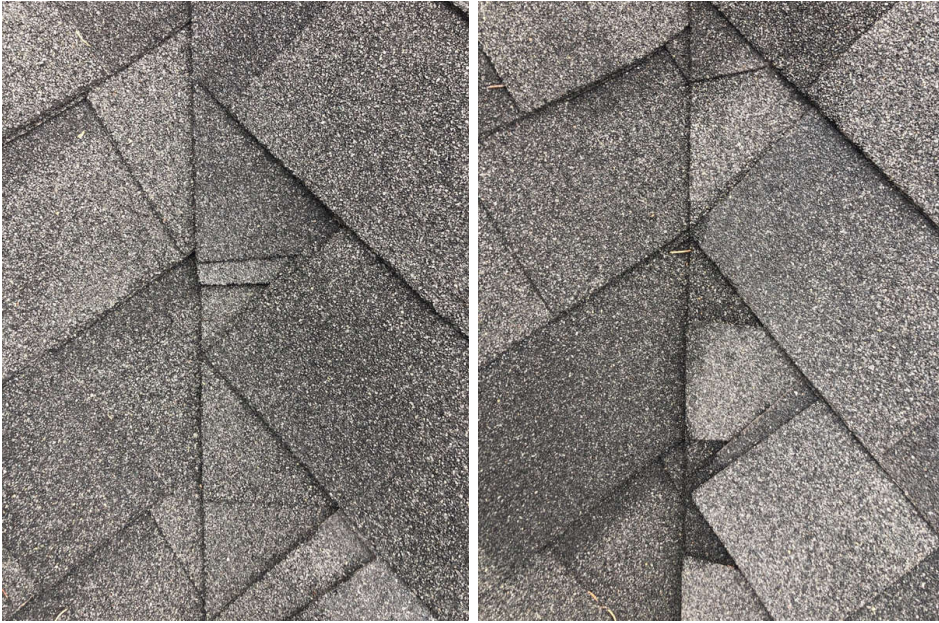
2.6.1 Valleys

IMPROPERLY CUT

Valley is improperly cut and may lead to moisture problems. See video explaining proper valley installation [here](#). Refer to a qualified contractor for evaluation.

Contact a qualified roofing professional.

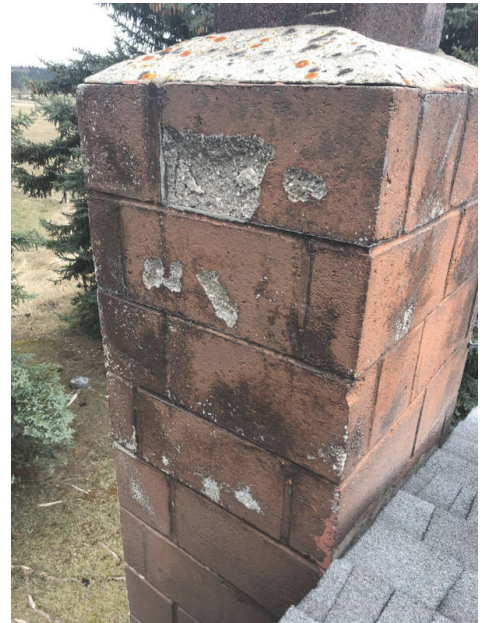
2.8.1 Chimneys

DETERIORATION

Portions of block were damaged and/or deteriorated. The crown was also deteriorated. Refer to qualified mason for correction.

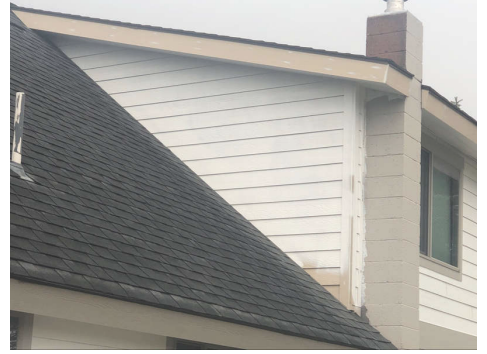
Eaves, Soffits & Fascia

UNDER CONSTRUCTION

Exterior portions of the fascia, siding, and eaves were under construction at time of inspection.

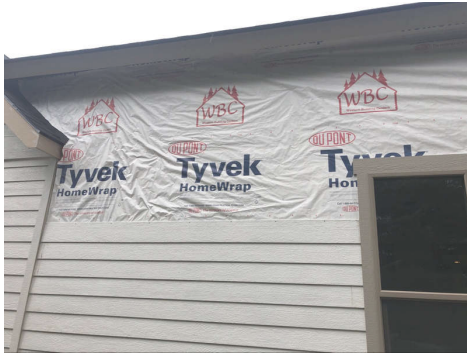
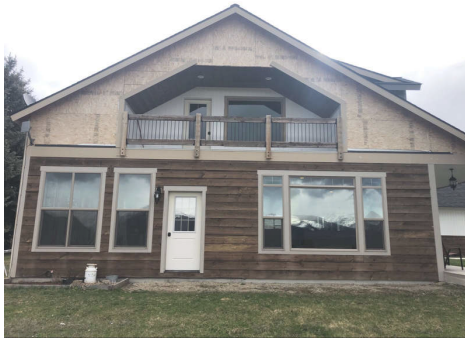
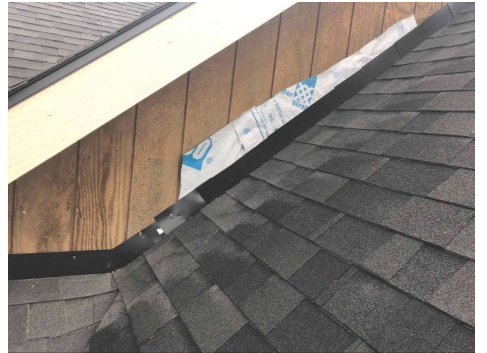
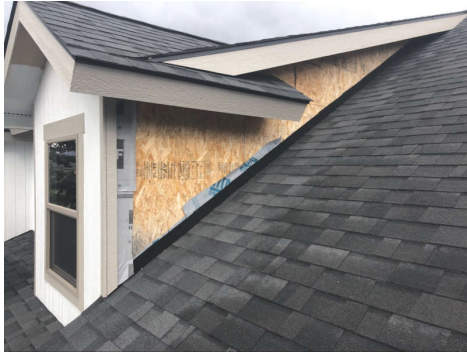
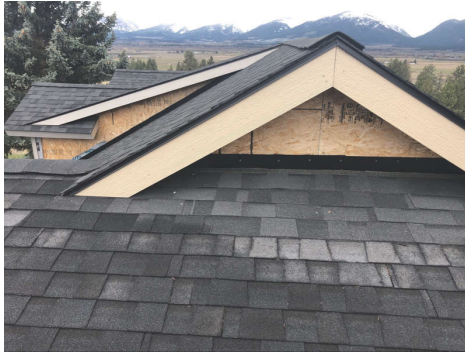
Siding

UNDER CONSTRUCTION

Exterior portions of the fascia, siding, and eaves were under construction at time of inspection.

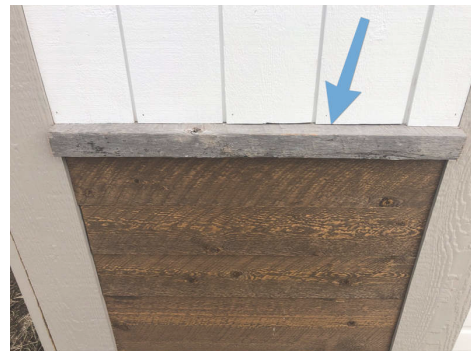
FLASHING/TRIM IMPROPERLY INSTALLED

Flashing was missing at transition points, which could result in moisture intrusion and damaging leaks if sealing and caulking are not installed and maintained regularly thereafter.

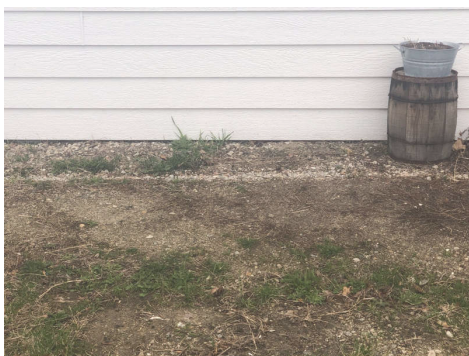
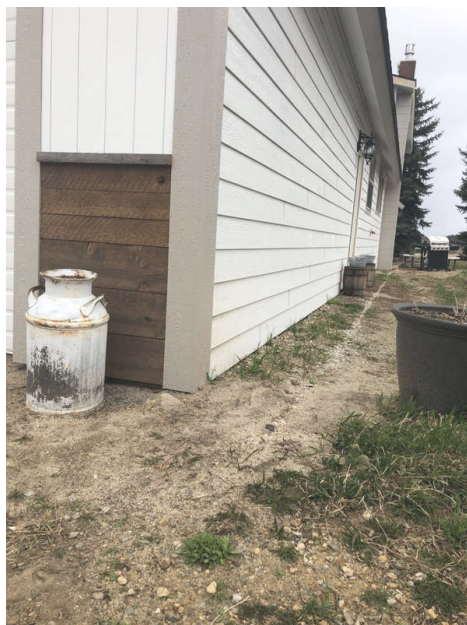
3.3.2 Siding

GROUND CLEARANCE

Inadequate clearance between the siding and ground. Recommend a minimum ground clearance between bottom of siding and ground of 6". Siding in contact with the ground or soil is a serious concern because that condition can provide direct access for water to susceptible materials.

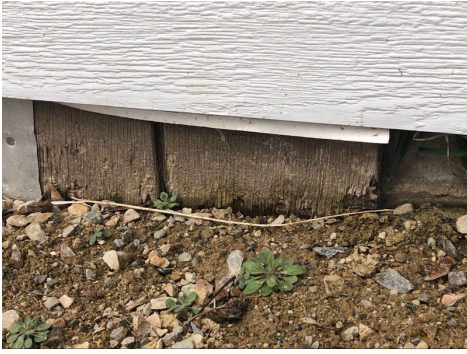
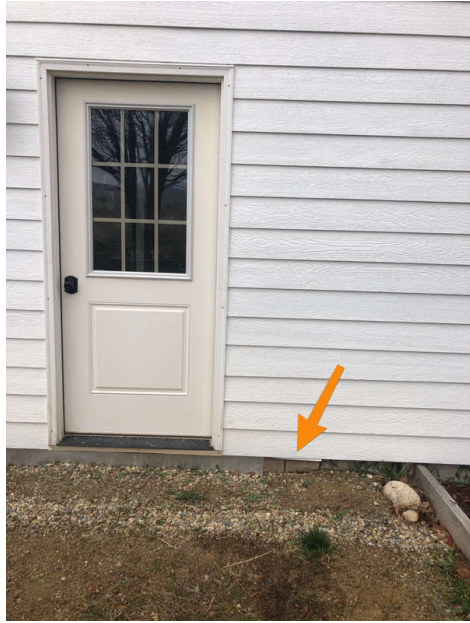
3.3.3 Siding

Wood was found to be in contact with soil. I would will run out as well as potential he create a van for moisture intrusion. We recommend reparations be done.

Contact a qualified professional.

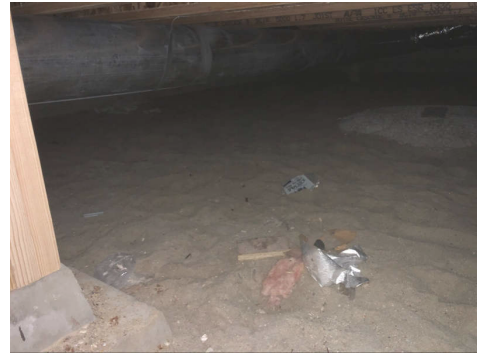
No Vapor Barrier observed. A minimum of 6mil. Plastic covering should be installed on floor surface to minimize moisture intrusion and potential mold growth. Refer to a qualified contractor for correction.

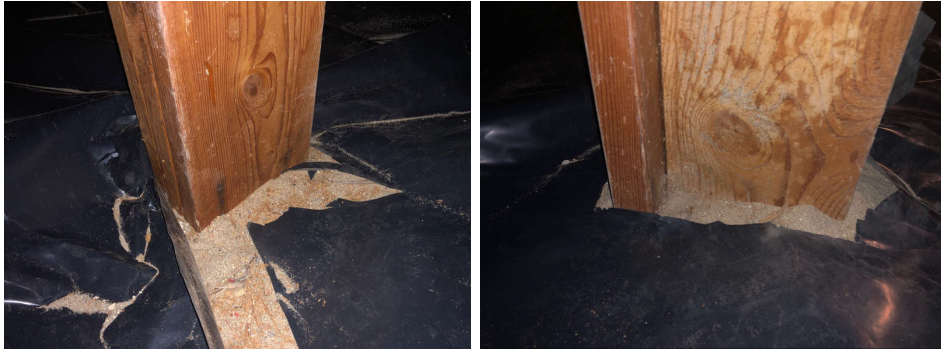
We recommend review by a structural specialist.

Contact a qualified structural engineer.

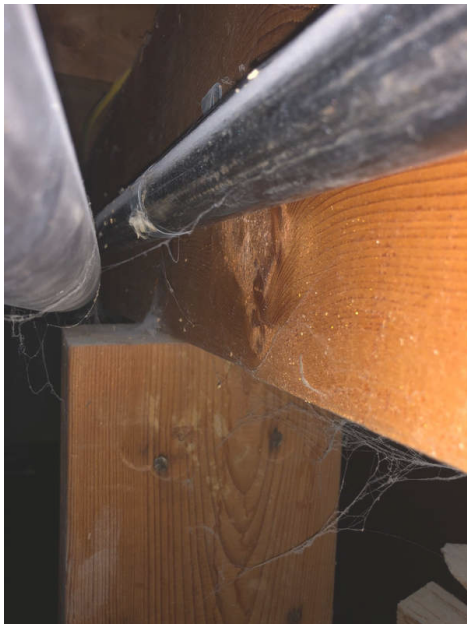
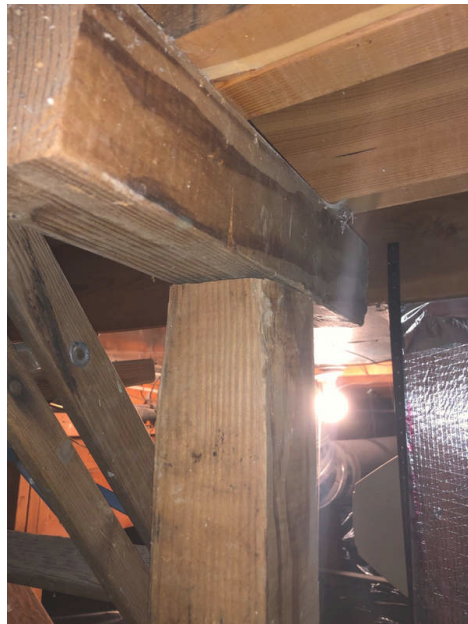
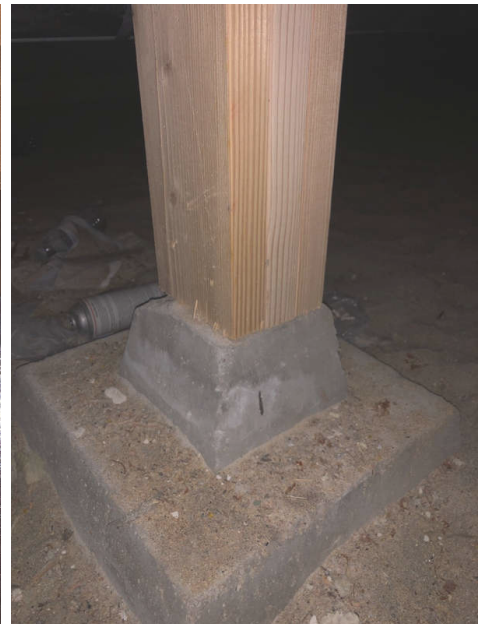
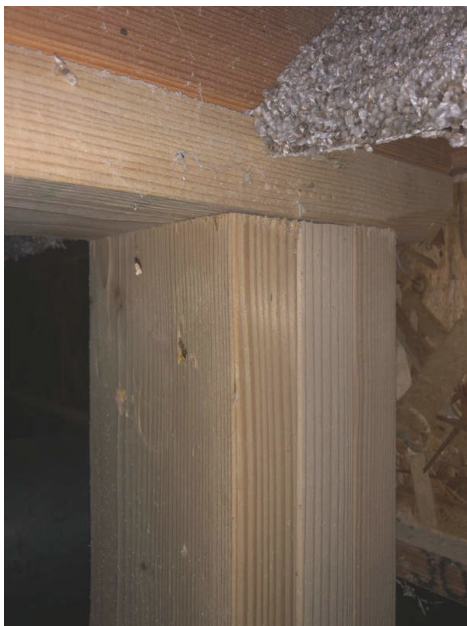
5.4.2 Piers

MISSING OR IMPROPER ANCHORING

Missing or improper anchoring was observed at several places throughout the crawlspace.

Contact a qualified professional.

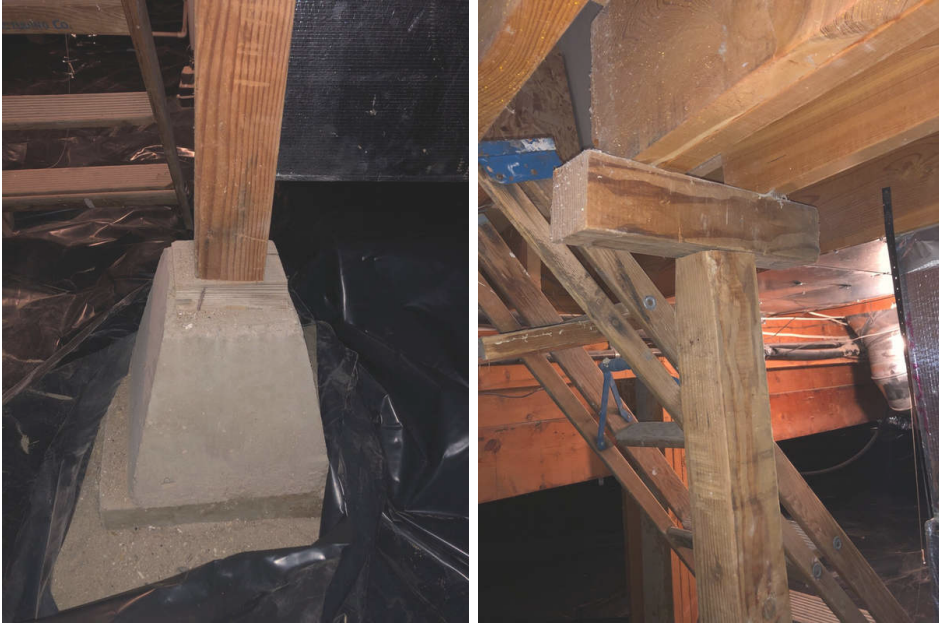
5.4.3 Piers

IMPROPER INSTALLATION

Improper installation of a pier holding up floor joists for the cut in crawlspace access hatch was noted.

Contact a qualified professional.

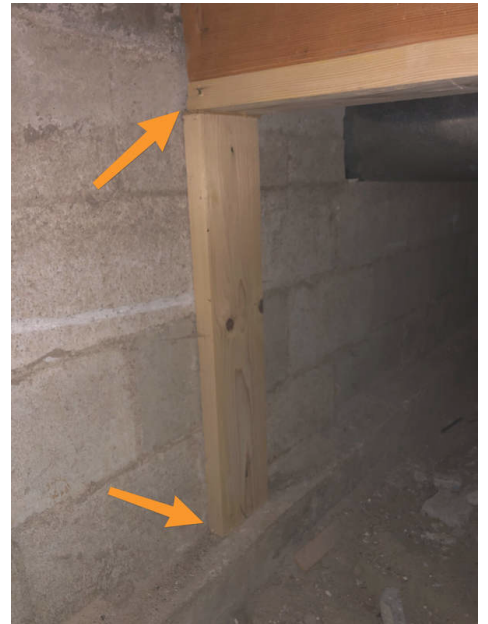
5.5.1 Beams

IMPROPER SUPPORT

A support under a short beam in the addition was inadequately supported and anchored according to standards.

Contact a qualified structural engineer.

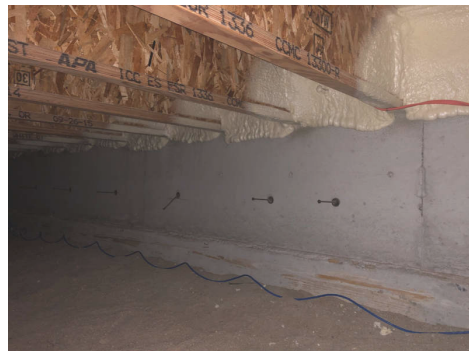
5.8.1 Insulation

INSULATION MISSING

Insulation was missing or inadequate.

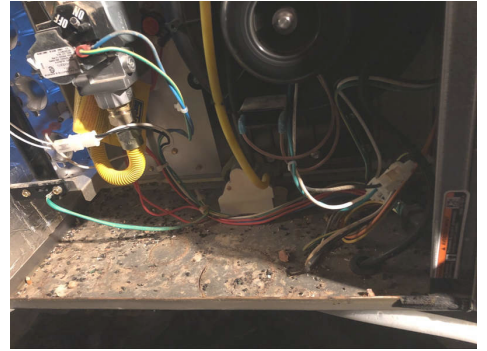
Furnace should be cleaned and serviced annually. We recommend a qualified HVAC contractor clean, service, and certify furnace.

Contact a qualified HVAC professional.

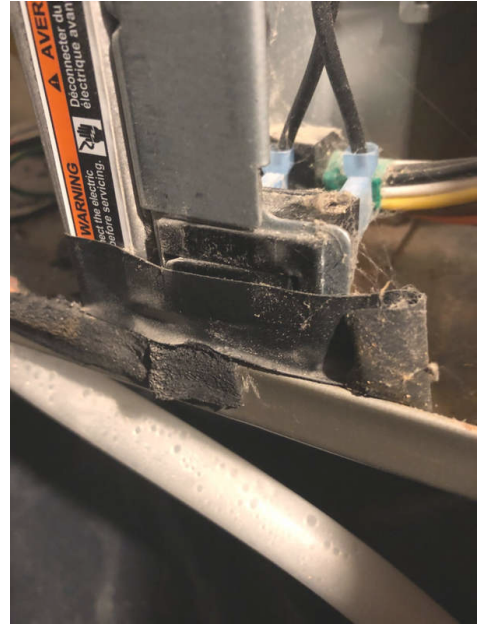
7.6.1 Blower Door Switch

MADE INOPERABLE

The safety switch was made inoperable by tape.

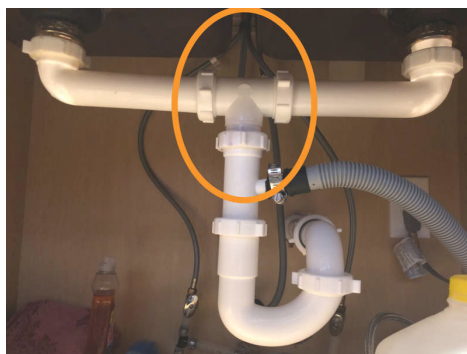
While this tee style drain set up under a two or more basin sink fixture is fairly commonly available in hardware stores, there is the potential for drain water and debris to back up from one basin to the next due to the proper installation of a proper Santee missing.

Contact a qualified professional.

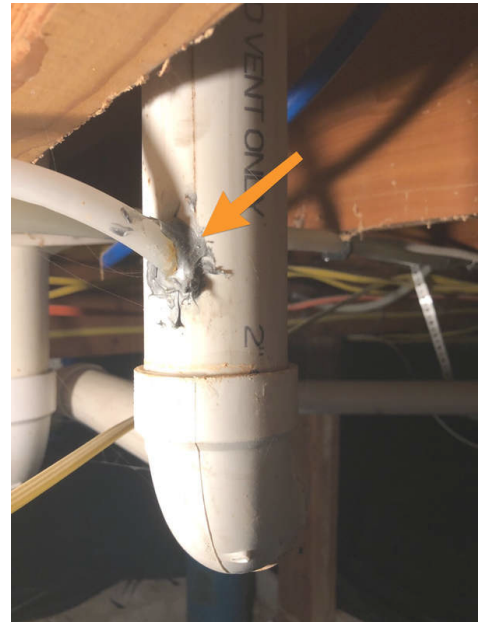
9.2.2 Drain, Waste, & Vent Systems

DAMAGE FROM IMPROPER PRACTICES

A vent pipe was cut into to accommodate the condensate drain line from the furnace. We recommend reparations and proper disposal of condensate.

Contact a qualified plumbing contractor.

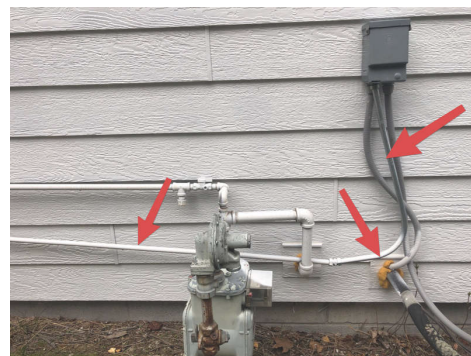
DAMAGED CONDUIT

The conduit to the AC unit wiring was damaged and unsupported. We recommend reparations to prevent damages to wiring within, creating potential hazards.

Contact a qualified professional.

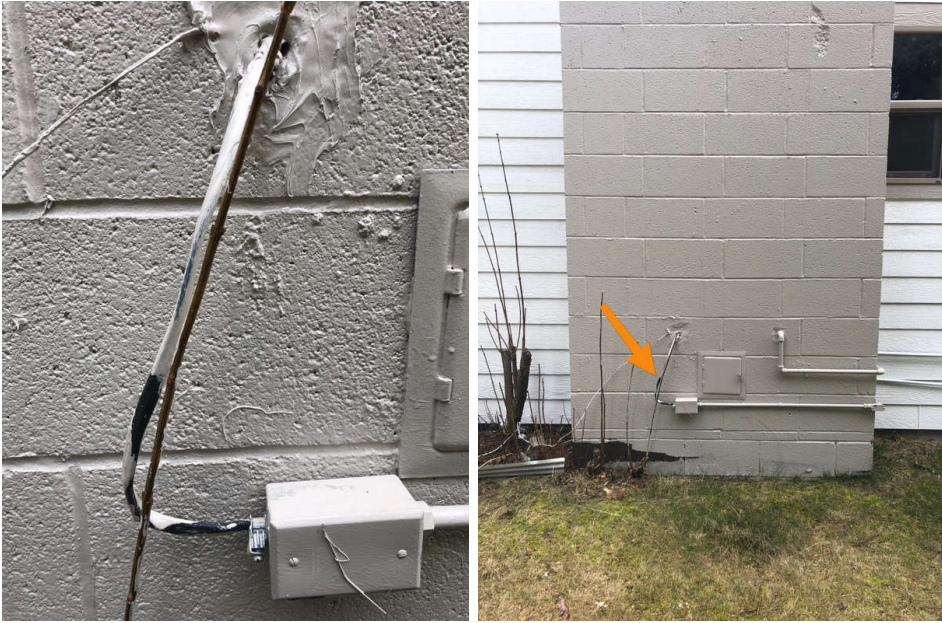
Cabling that appeared not to be designed for sunlight or moisture exposure was exposed outside.

Contact a qualified electrical contractor.

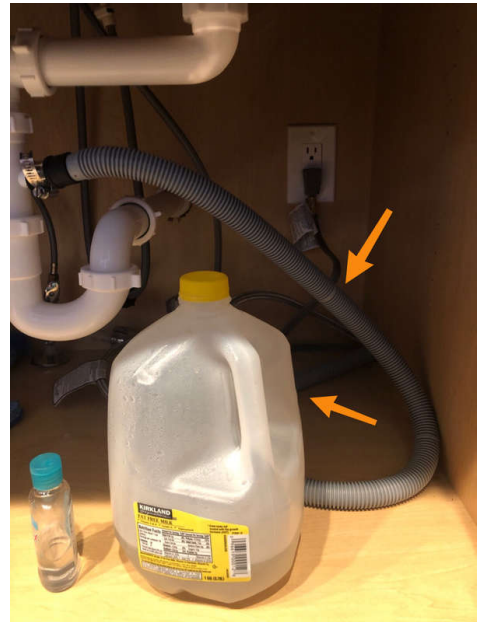
IMPROPERLY INSTALLED DRAIN PIPE

The dishwasher drain hose did not terminate through an air gap, or run in a high loop above the unit, either of which is typically required by manufacturers for proper operation.

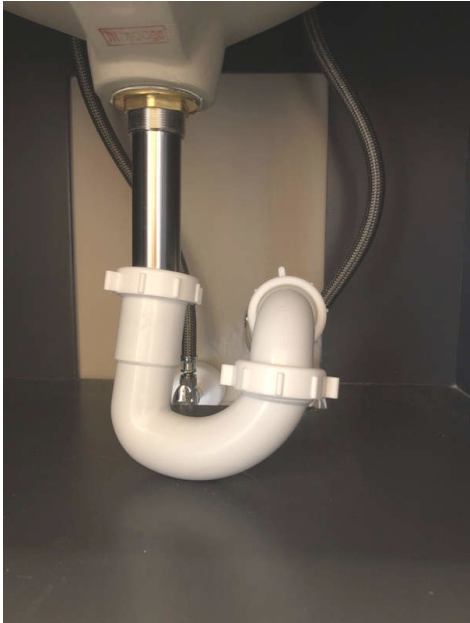
15.8.1 Bathroom 3 - Drains & Fixtures: Improper connection
-

IMPROPER CONNECTION

Recommendations

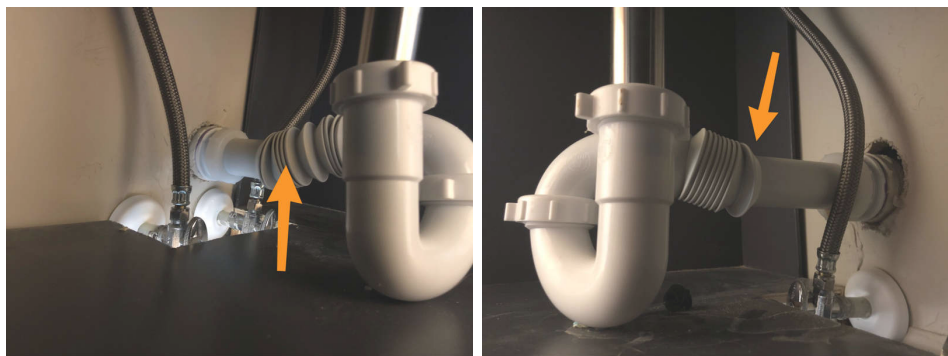
15.8.2 Drains & Fixtures

CORRUGATED DRAIN LINES

Though sold regularly at hardware stores these corrugated drain lines are never recommended by professionals due to the high probability of blockages from accumulated debris.

Contact a qualified plumbing contractor.

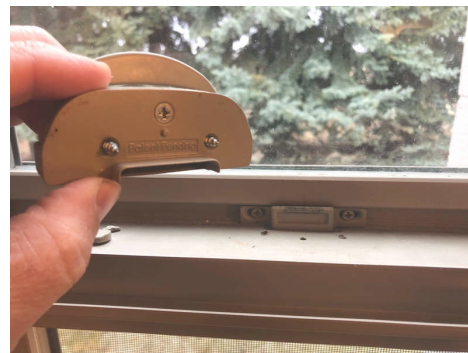
MISSING / DAMAGED HARDWARE

The hardware for one or more windows to properly lock / open / close is missing or damaged. We recommend that all windows in the home be properly tested and in proper working function prior to closing.

Contact a handyman or DIY project

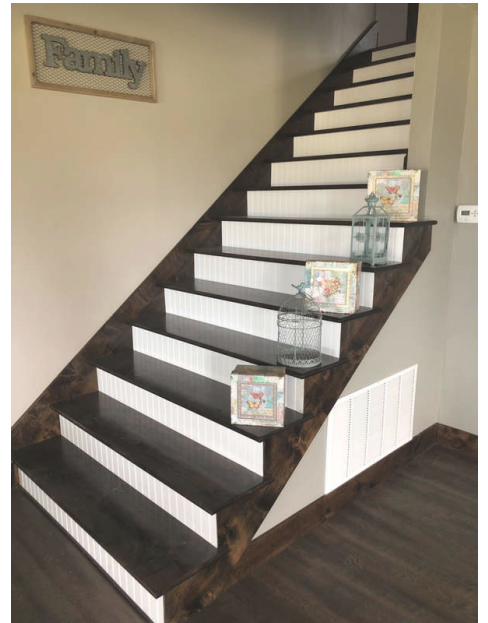
17.6.1 Steps

OPEN SIDE

For added safety add a handrail to open side of stairs.
