RESIDENTIAL REPORT

1234 Main St.
Calgary, Alberta T3L3A3

Buyer Name
05/28/2019 9:00AM

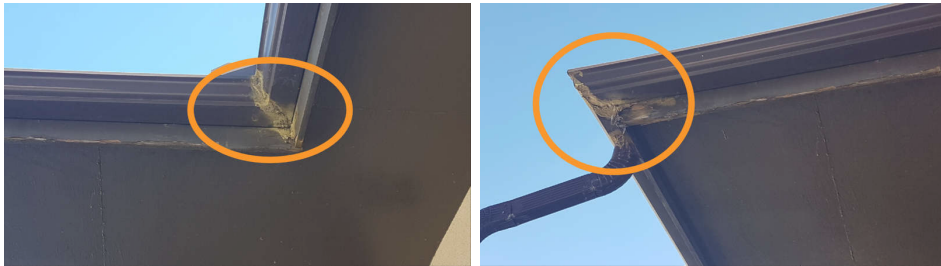
Gutter corners appear to have been patched from what I assume is water leaks. Because of the cold weather I cannot say if they are currently leaking however, I do recommend that a roofing professional assess the gutter system for repair and/or replacement.

Contact a qualified roofing professional.

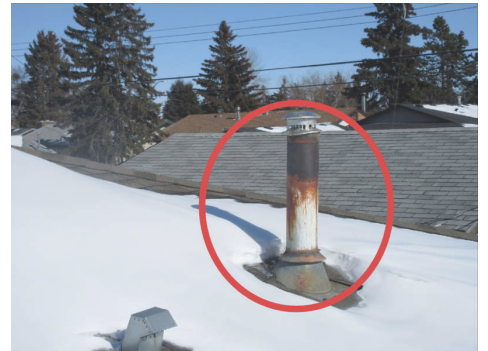
2.4.1 Skylights, Chimneys & Other Roof Penetrations

METAL CHIMNEY RUST

The metal chimney shows evidence of rust and/or rusting. Recommend monitoring the chimney which may have to be replaced at some point.

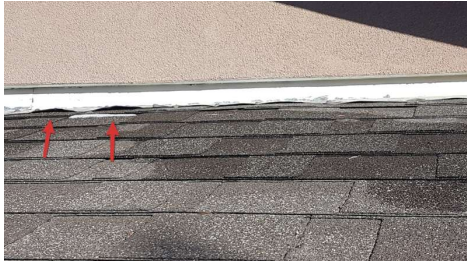
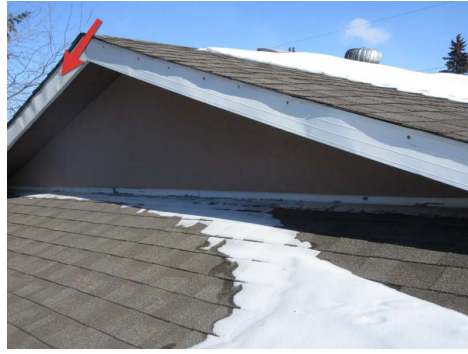
FRONT OF HOUSE

FLASHING/TRIM IMPROPERLY INSTALLED

Flashing & trim pieces were improperly installed, which could result in moisture intrusion and damaging leaks. Recommend a qualified siding contractor evaluate and repair.

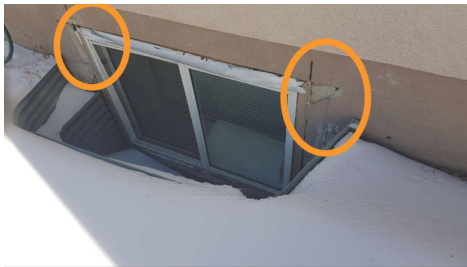
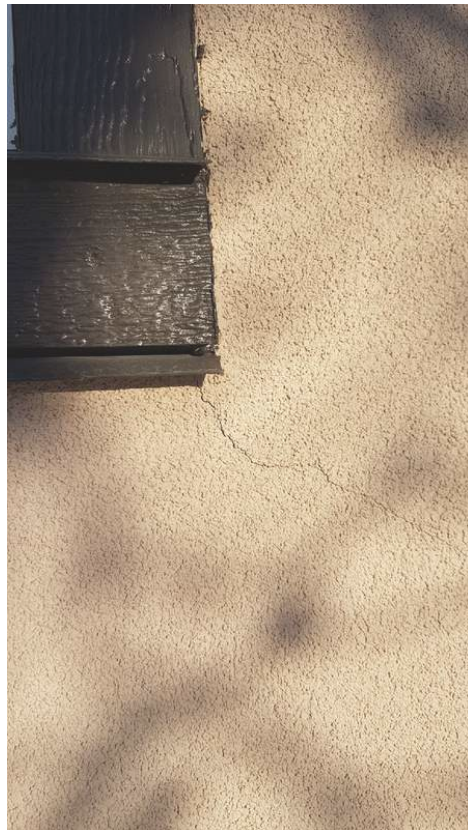
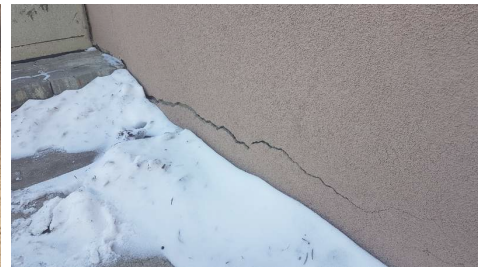
3.1.2 Siding, Flashing & Trim

STUCCO NEEDS REPAIR

Stucco at several points of the exterior shows that it is in need of repair. Recommend stucco professional to remedy in order to prevent possible water intrusion

Contact a stucco repair contractor

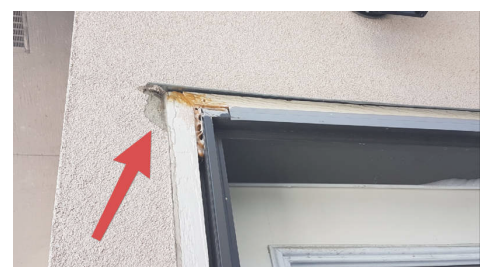
3.2.1 Exterior Doors

DOOR SILL/TRIM

Door sill and/or trim is loose, deteriorated or worn and repair or replacement should be considered.

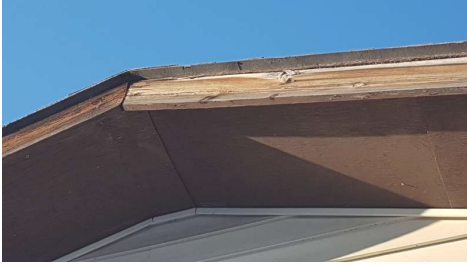
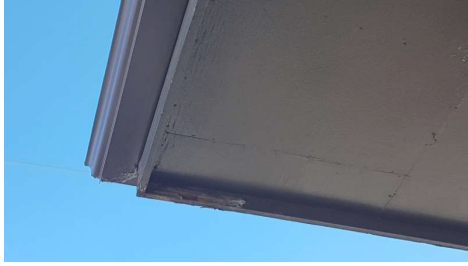
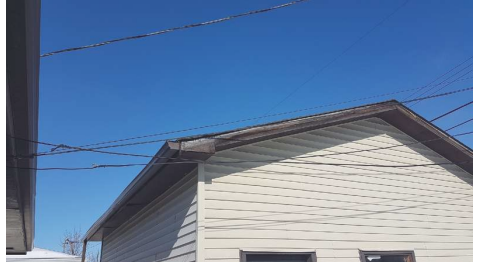
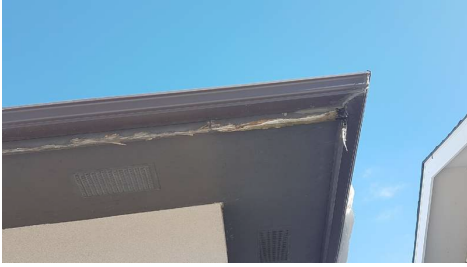
3.4.1 Eaves, Soffits & Fascia

FASCIA - ROTTED

One or more sections of the fascia are rotted, decayed and/or require paint. Recommend qualified roofer evaluate & repair.

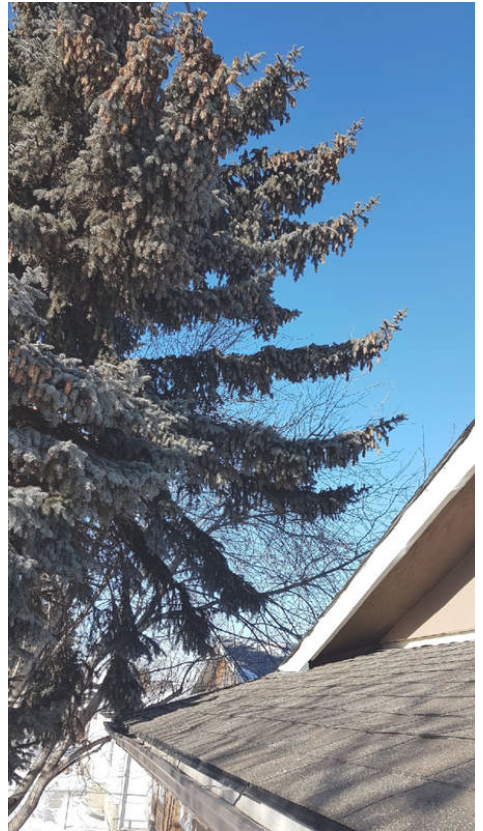
3.5.1 Vegetation, Grading, Drainage & Retaining Walls

TREE OVERHANG

Trees observed overhanging the roof. This can cause damage to the roof and prevent proper drainage. Recommend a qualified tree service trim to allow for proper drainage.

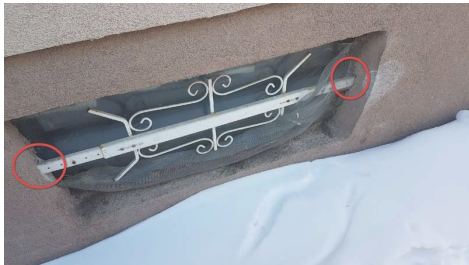
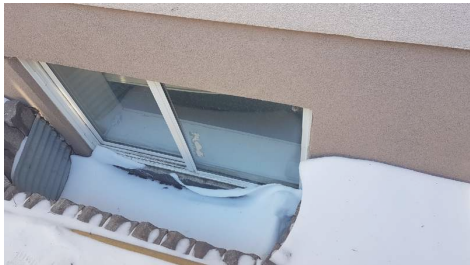
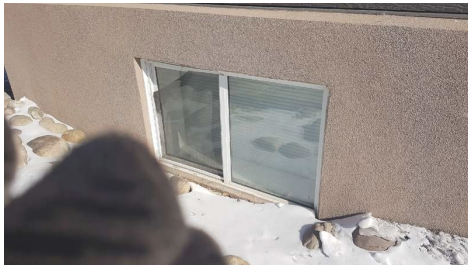
3.6.1 Windows

INADEQUATE FLASHING

Recommend professional to replace with appropriate flashings.

Contact a qualified window repair/installation contractor.

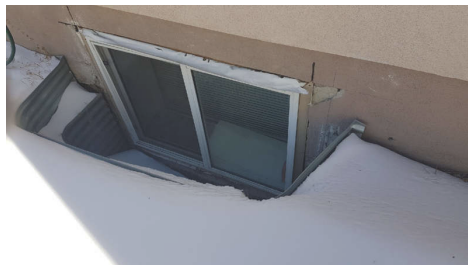
3.6.2 Windows

UNFINISHED WINDOW TRIM/FLASHING

Basement window appears to be in an unfinished state, leaving untreated wood exposed to the elements which will lead to wood decay/rot. This may also allow water intrusion. I recommend contacting a qualified window installer to evaluate and remedy.

Contact a qualified window repair/installation contractor.

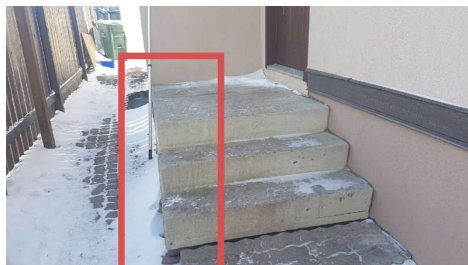
3.8.1 Guard Rails & Hand Rails

MISSING

Guard rails were missing during time of inspection. Steps with 4 or more risers require a handrail.

Recommend installation of handrail and guard at front steps to prevent falls.

Contact a qualified professional.

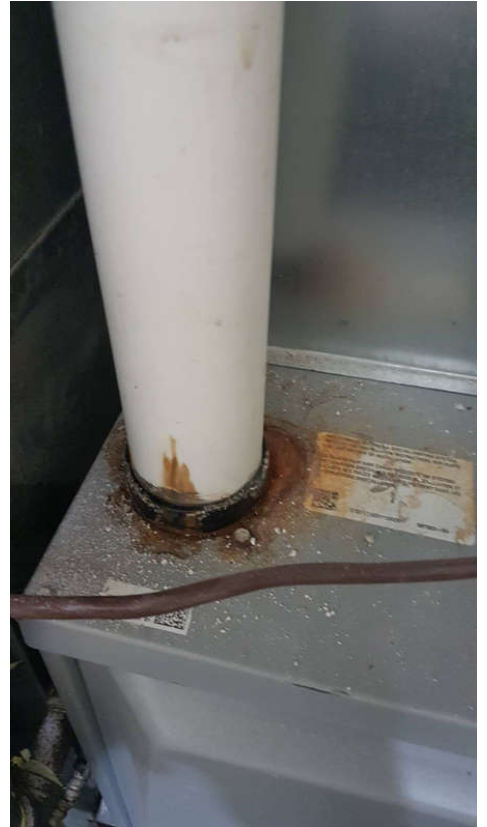
CORROSION

Furnace was corroded in one or more areas. This could be the result of improper venting, which the source would need to be identified. Recommend a HVAC contractor evaluate and repair.

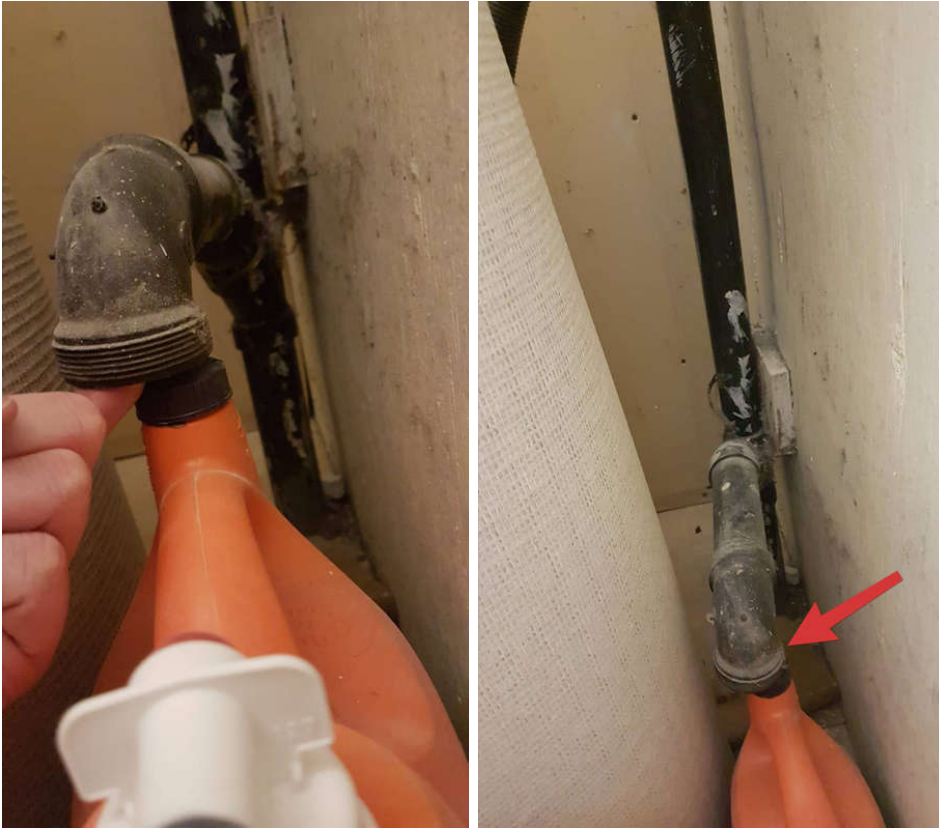
CAP MISSING OR IMPROPER INSTALLATION

Basement waste pipe was missing cap which may allow sewer gases in to the house. Recommend sealing off this pipe to prevent this.

Contact a qualified plumbing contractor.

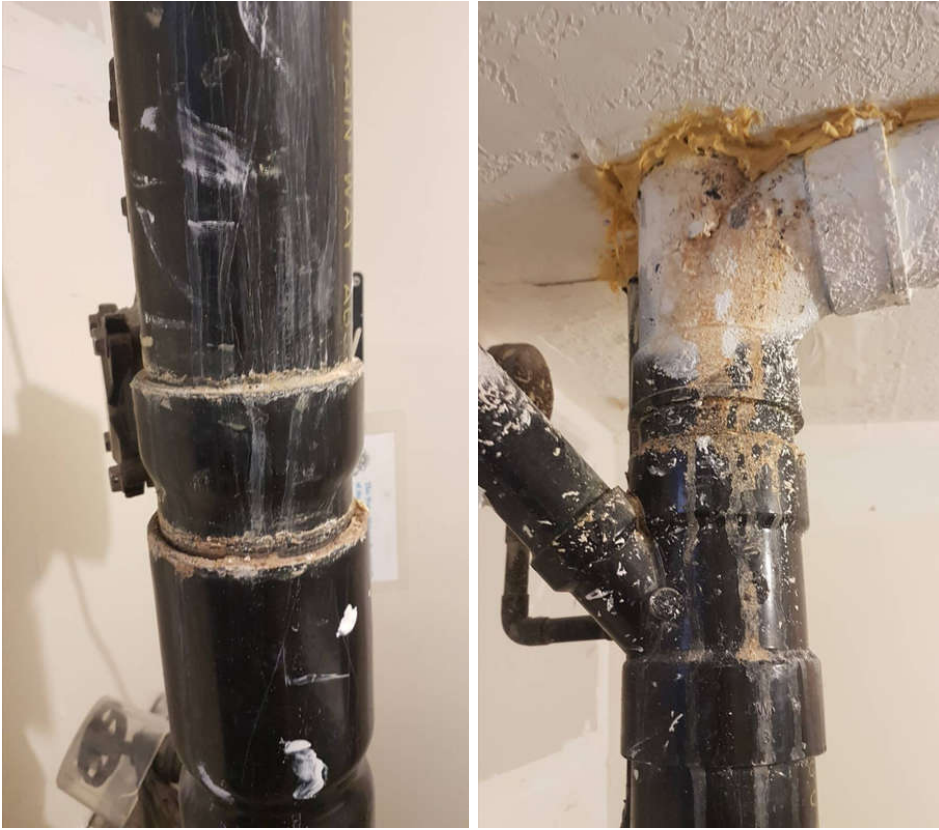
8.2.2 Drain, Waste, & Vent Systems

EVIDENCE OF PRIOR LEAKS

Although there appeared to be signs of previous waste pipe leaks, none were observed on the day of the inspection.

Recommend monitoring for signs of future leaks.

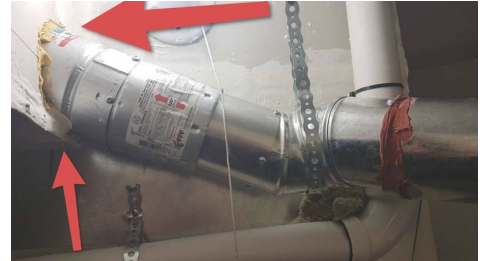
8.4.1 Hot Water Heater, Controls, Flues & Vents

Safety Hazard
IMPROPER INSTALLATION

Water heater is improperly installed or in a dangerous location. "Type B" gas vent is running through drywall which is not allowed. Type B gas vents require a **MINIMUM 1" CLEARANCE** from combustibles as these vents heat up which can pose a fire hazard. Recommend qualified plumber evaluate & repair/relocate.

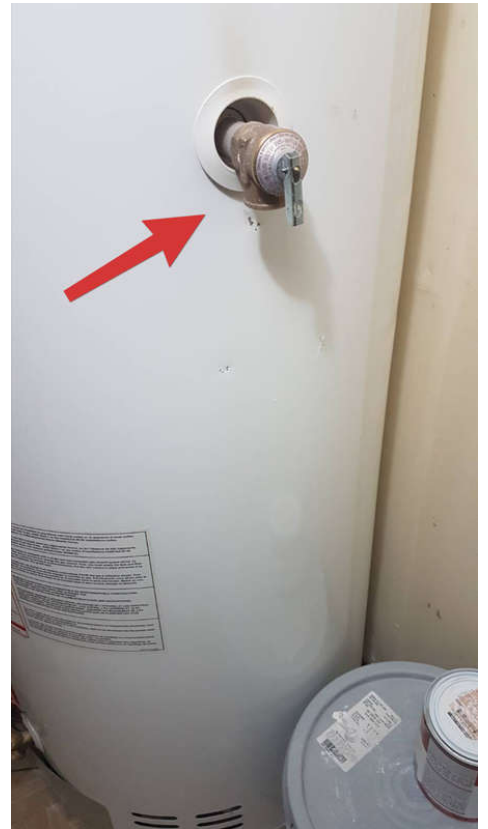
8.4.2 Hot Water Heater, Controls, Flues & Vents

Safety Hazard
TPR VALVE MISSING/NEED REPAIR

Contact a qualified professional.

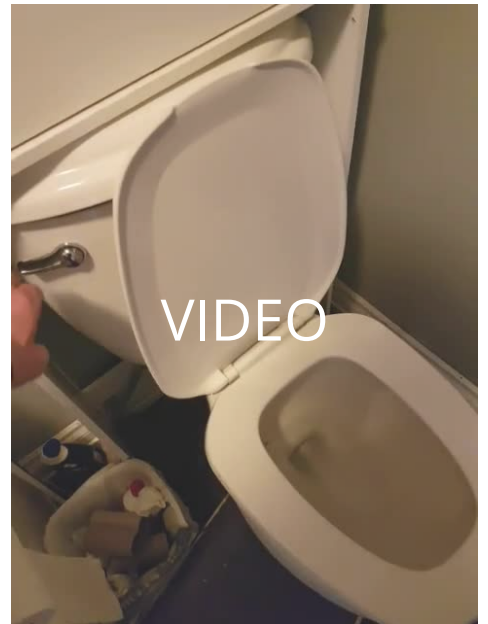
8.7.1 Toilets

TOILET NOT FLUSHING PROPERLY

Contact a qualified professional.

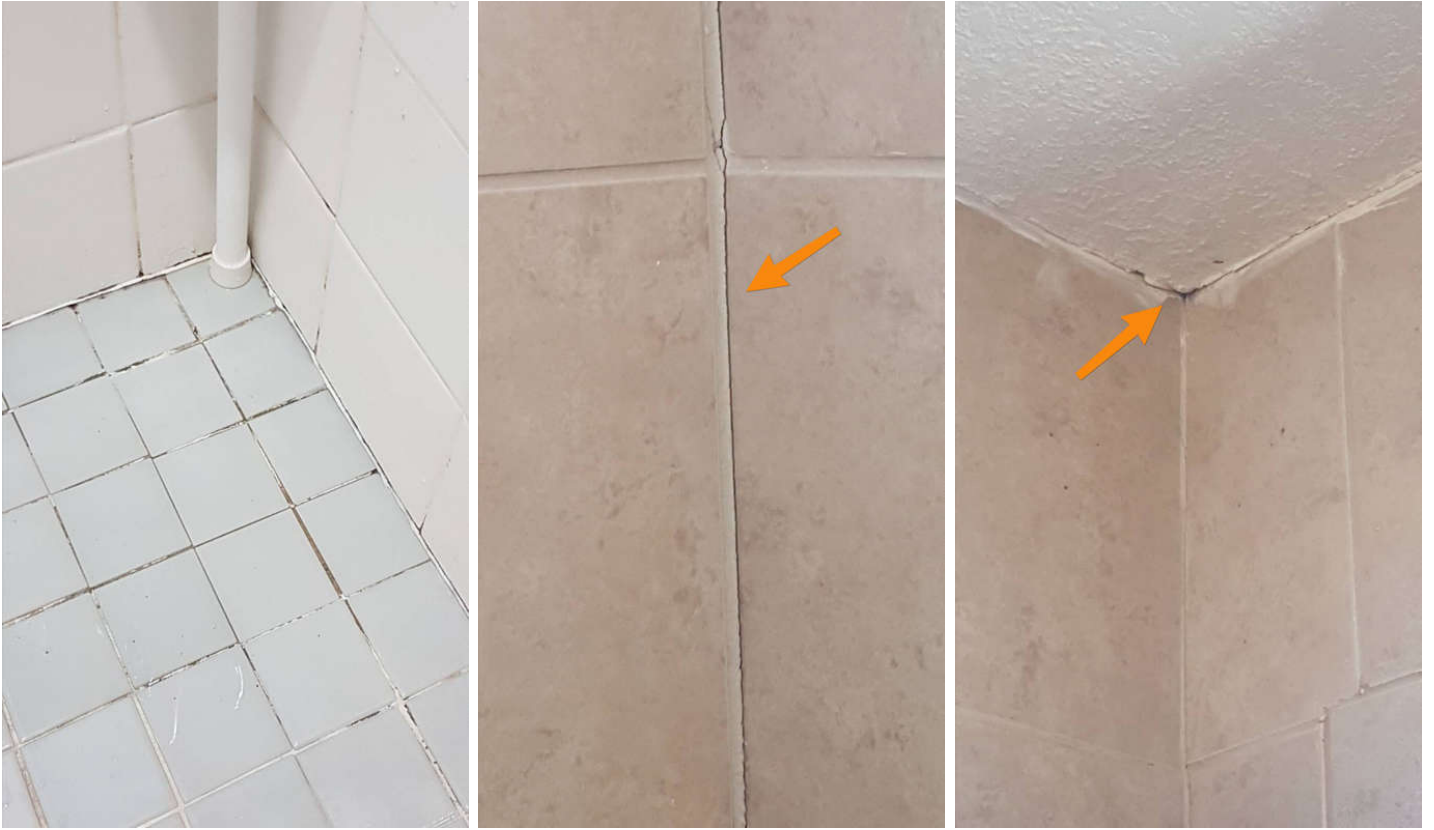
8.8.1 Bathtubs(s) and shower enclosures

CAULKING/SEALANT

Caulking/sealant in need of repair to prevent water from penetrating floor/wall areas surrounding tub/shower enclosure.

Contact a qualified professional.

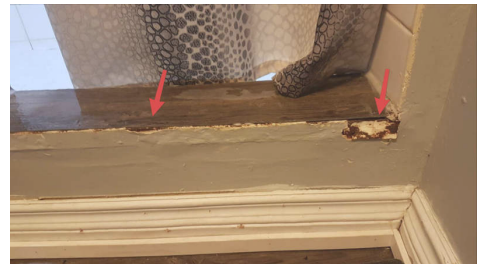
8.8.4 Bathtubs(s) and shower enclosures

WOOD ROT

Contact a qualified professional.

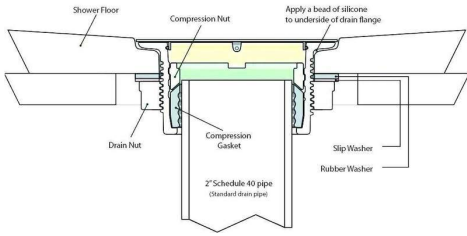
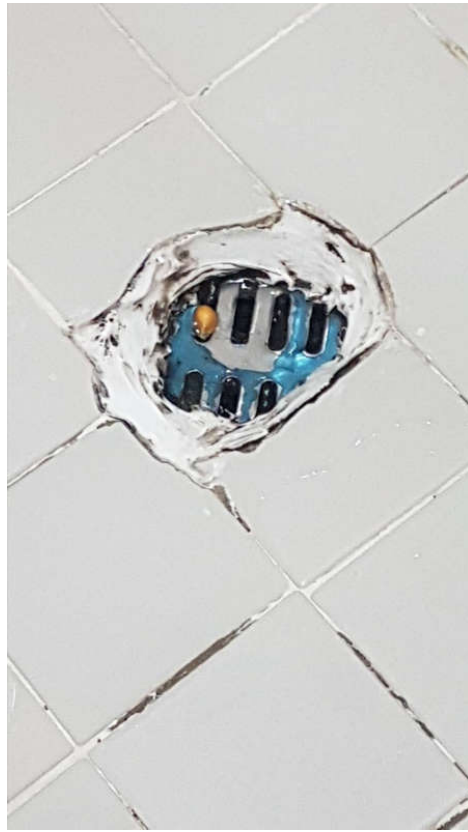
8.8.5 Bathtubs(s) and shower enclosures

IMPROPER DRAIN ASSEMBLY

Contact a qualified professional.

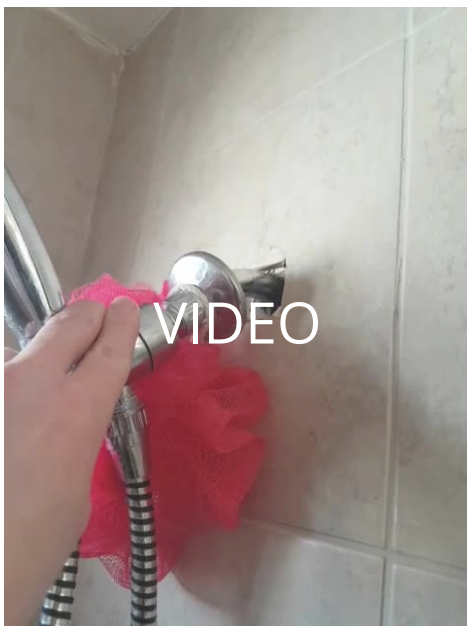
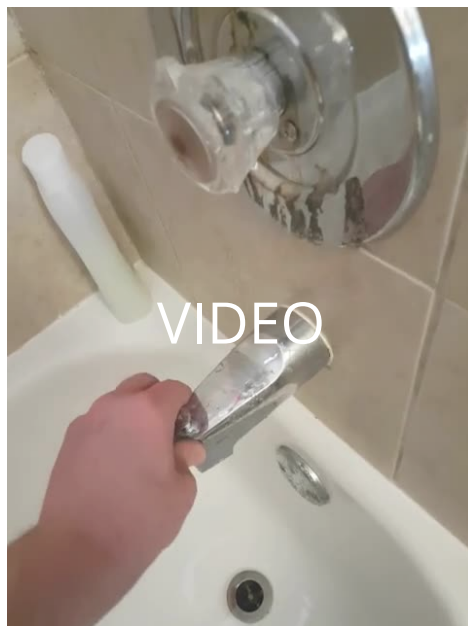
8.8.6 Bathtubs(s) and shower enclosures

LOOSE CONNECTIONS

Contact a qualified professional.

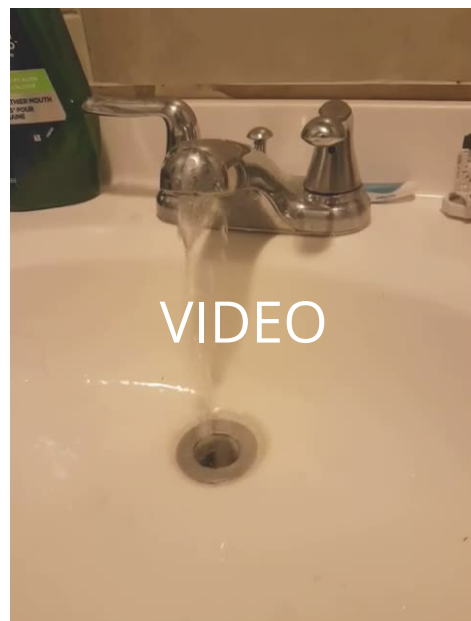
8.9.1 Faucets

VERY LOW COLD WATER FLOW

Contact a qualified plumbing contractor.

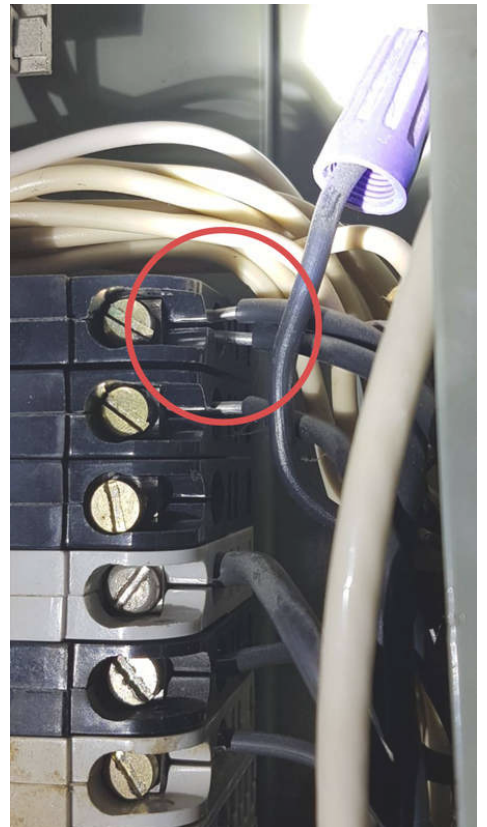
9.2.1 Main & Subpanels, Service & Grounding, Main Overcurrent Device

DOUBLE TAPPED BREAKER

Contact a qualified electrical contractor.

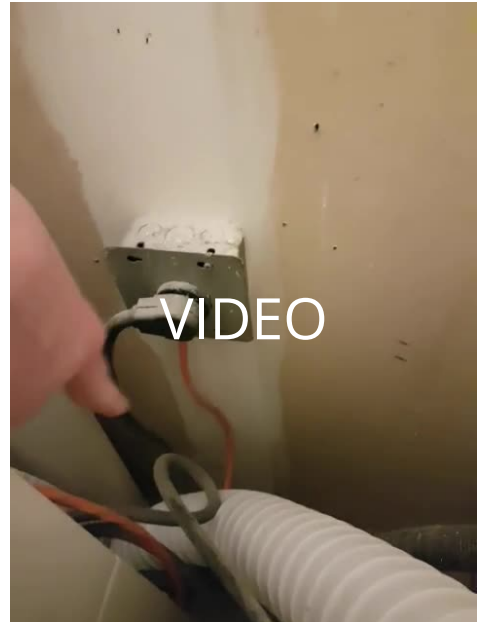
9.3.1 Branch Wiring Circuits, Breakers & Fuses

ALUMINUM BRANCH CIRCUITS

Contact a qualified electrical contractor.

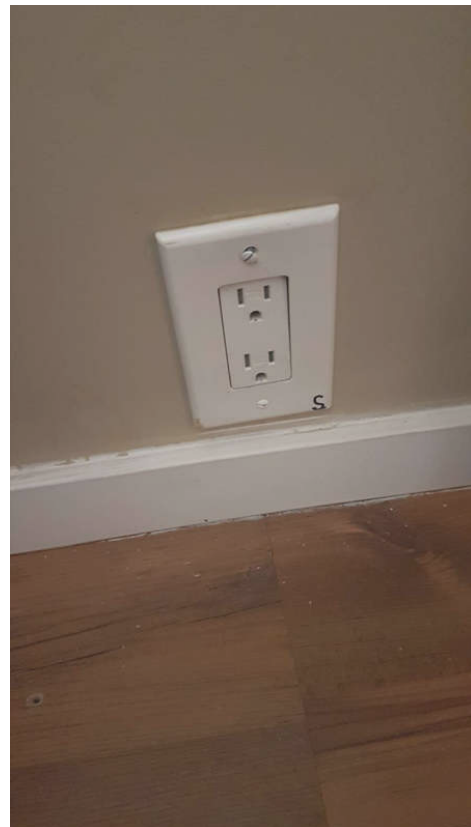
9.4.2 Lighting Fixtures, Switches & Receptacles

LOOSE RECEPTACLE

Contact a qualified professional.

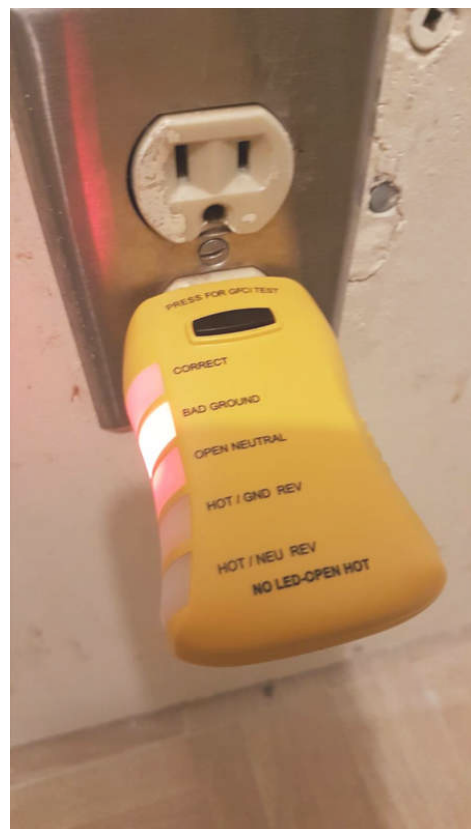
9.4.3 Lighting Fixtures, Switches & Receptacles

BAD GROUND OBSERVED

Contact a qualified electrical contractor.

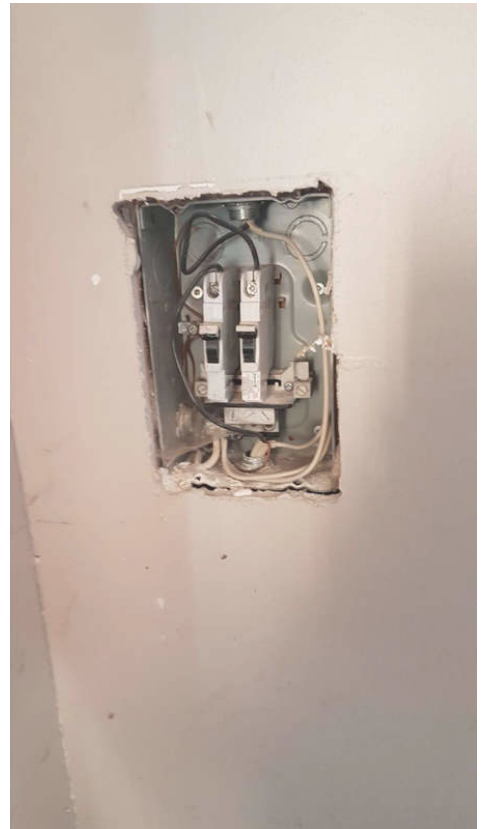
9.4.4 Lighting Fixtures, Switches & Receptacles

UNSAFE ELECTRICAL IN GARAGE

Contact a qualified electrical contractor.

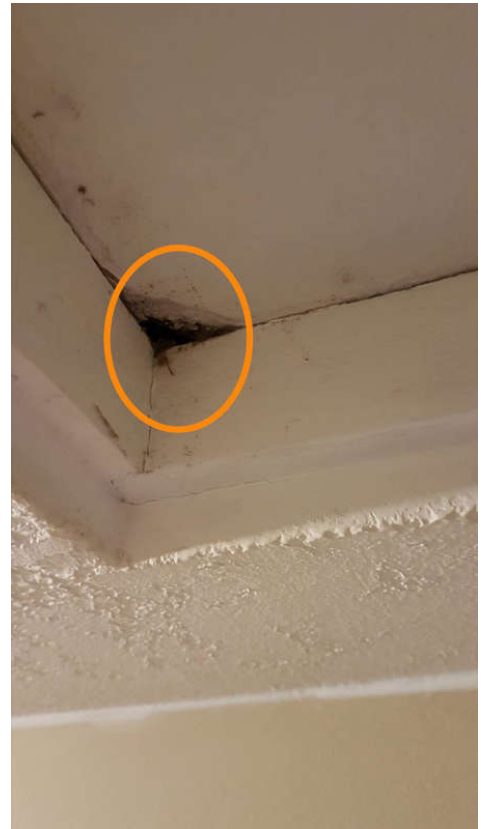
10.1.5 Attic Insulation, Venting & Vapour Barriers

HOLE IN ATTIC HATCH

Contact a qualified professional.

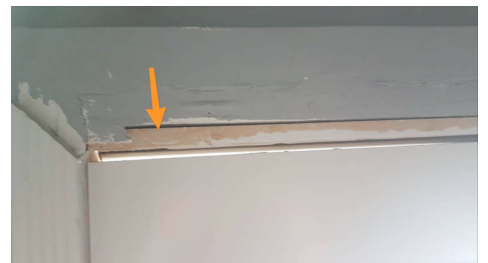
SOUTH ENTRY DOOR

One or more gaps could result in energy loss. Recommend handyman or door contractor evaluate.

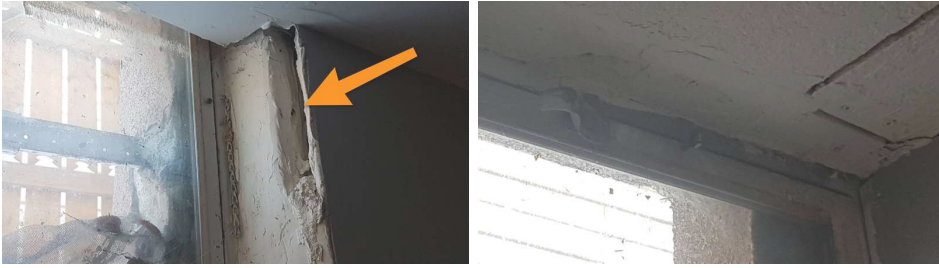
11.2.1 Windows

BASEMENT WINDOWS NOT FINISHED

Contact a qualified professional.

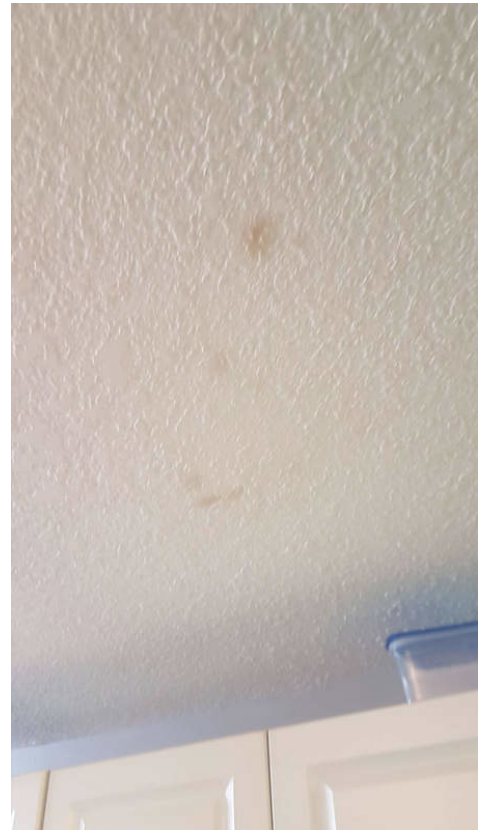
11.5.1 Ceilings

STAIN(S) ON CEILING

There is a stain on ceiling/wall that requires repair and paint. Source of staining should be determined.

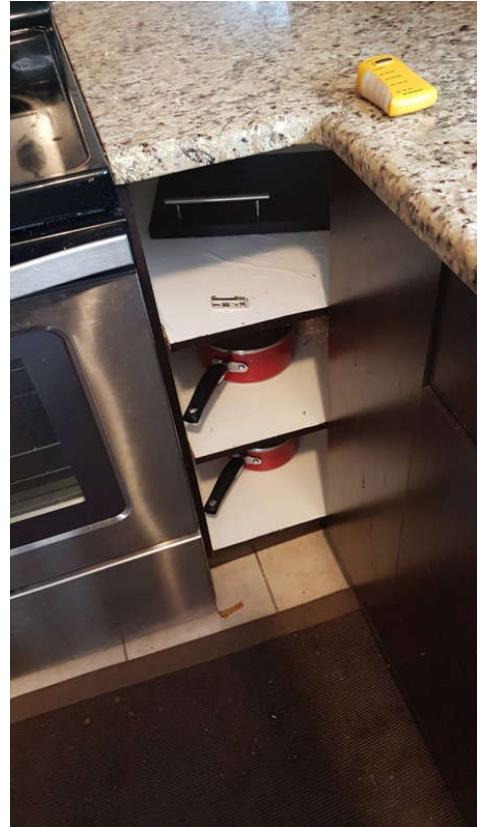
11.7.1 Countertops & Cabinets

CABINET DOOR MISSING

One or more cabinet doors were missing.

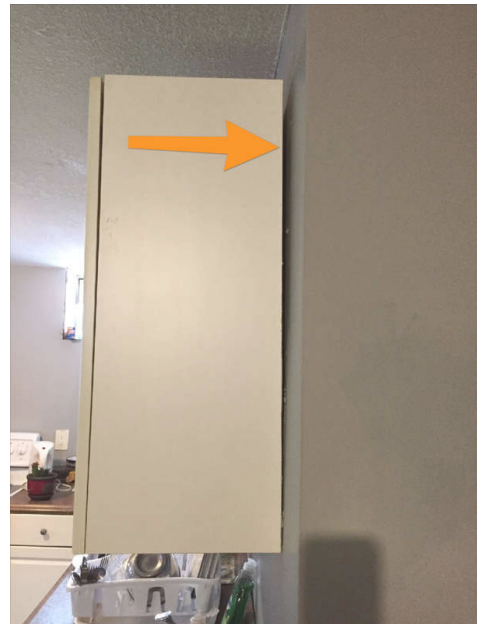
11.7.2 Countertops & Cabinets

CABINET SEPARATING FROM WALL

Cabinets are separating from wall. Recommend a qualified cabinet contractor re-fasten cabinets securely.

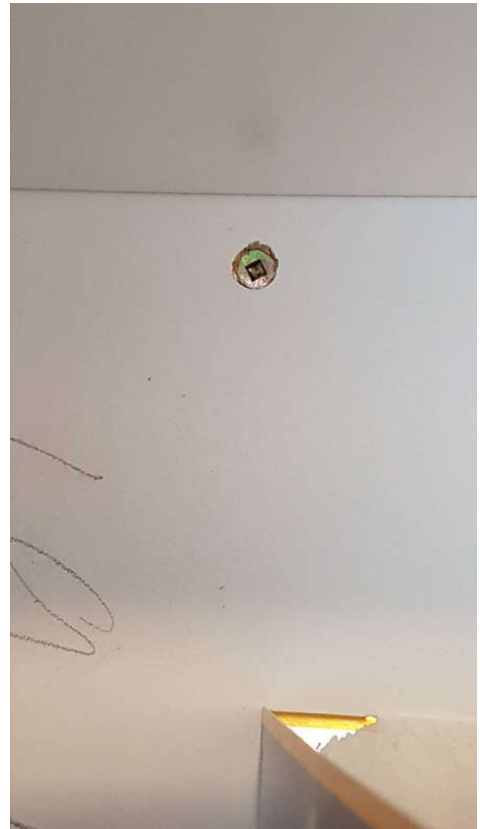
11.7.3 Countertops & Cabinets

IMPROPER FASTENERS

Contact a qualified professional.
