HIGHLANDER INSPECTIONS

RESIDENTIAL INSPECTION

1234 Main St.
Big Bear Lake, California 92315

05/29/2019 9:00AM

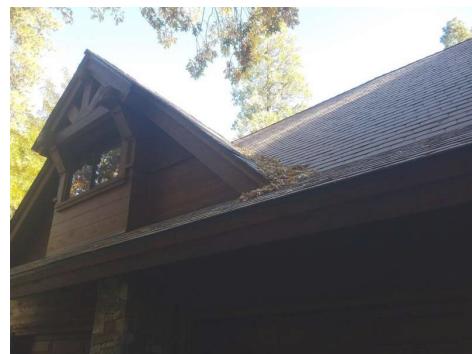
Debris was observed on roof surface. Tree droppings will trap water and moisture long enough for it to eventually find a path beneath the roofing and into the structure. I recommend removal of the debris.

Contact a qualified roofing professional.

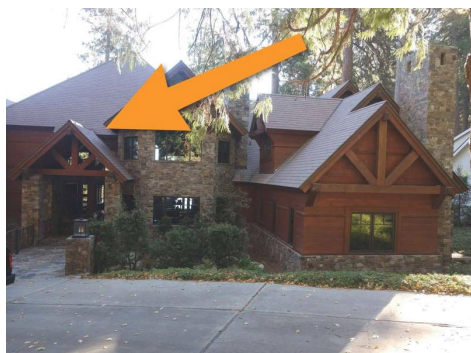
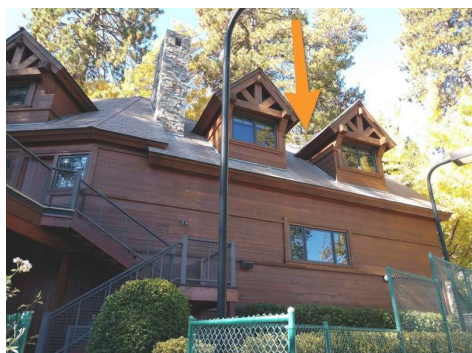
Roof had cracked/broken tiles. I recommend consulting a qualified professional to replace to prevent moisture intrusion and damage.

Contact a qualified roofing professional.

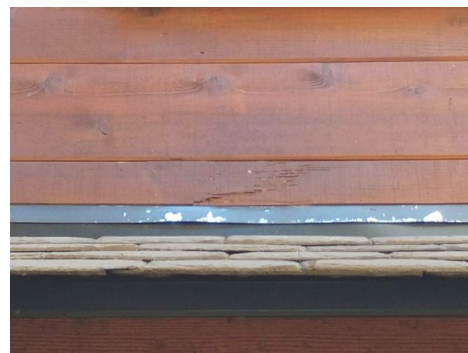
Observed damaged siding in one or more location.

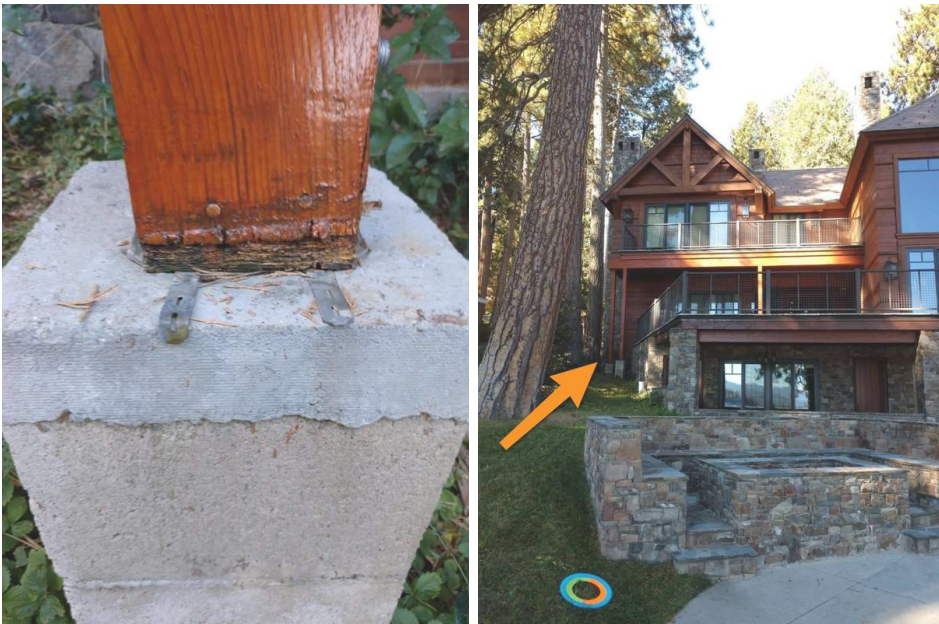
Observed use of improper material application. Use of OSB as a shim below an exposed exterior framing member will retain moisture and degrade at an accelerated rate. I recommend replacement by a qualified professional.

Contact a qualified deck contractor.

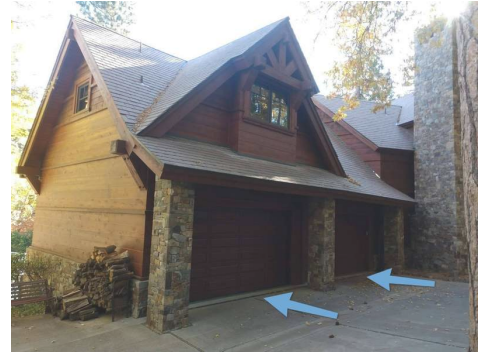
I observed drain lines nearly filled with material preventing the collection of water. I recommend clearing away material to allow the flow of water away from the building.

Contact a qualified professional.

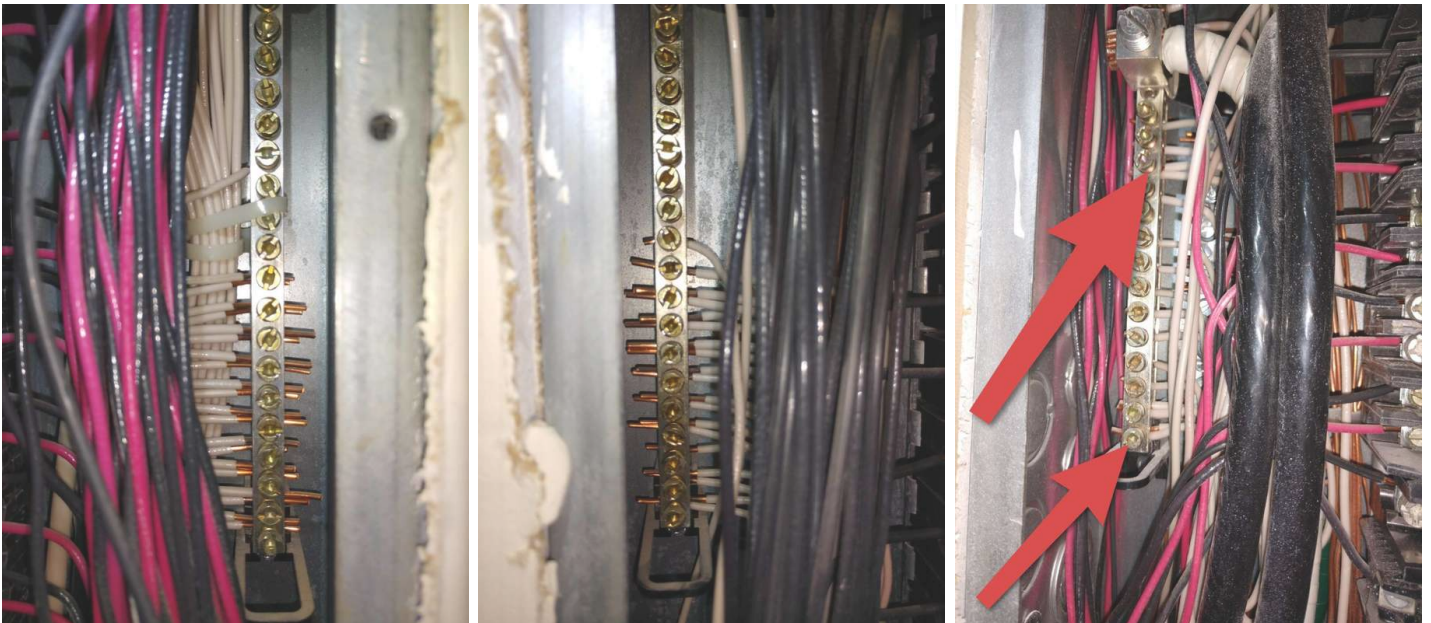
Observed one or more lugs on neutral bus bar with more than one wire. This prevents isolation of the circuit if it needs to be worked on, and wires may slip out of lugs that are not designed for multiple conductors, creating a fire hazard. I recommend consulting a qualified professional to evaluate and correct.

Contact a qualified electrical contractor.

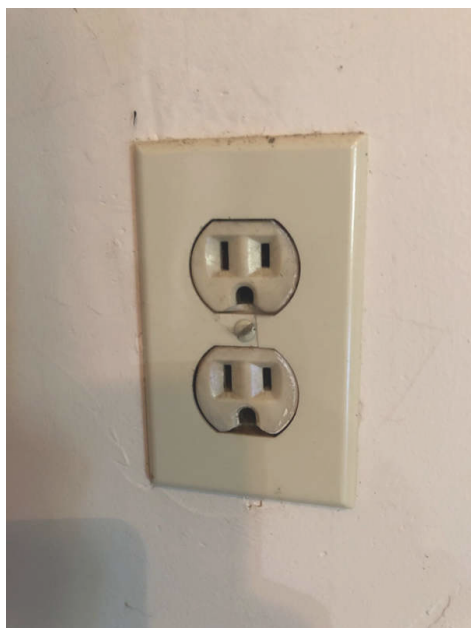
Garage

One or more switch or receptacle have a damaged cover plate. I recommend replacement.

Recommended DIY Project

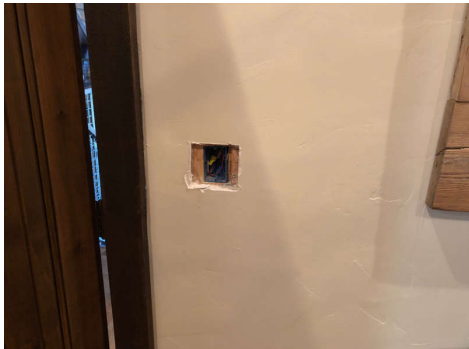
2nd Floor South Bedroom

Observed one or more outlets (junction box, receptacle, switch) were missing a cover plate. This creates a short and shock risk. I recommend installation.

Recommended DIY Project

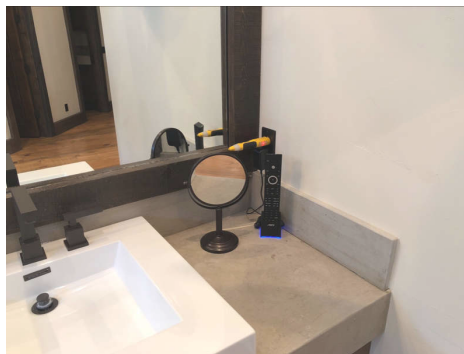
2nd Floor South Bathroom

Observed one or more receptacles have been wired in reverse polarity (hot and neutral reversed). This can create a shock hazard. I recommend correction by a qualified professional.

Contact a qualified electrical contractor.

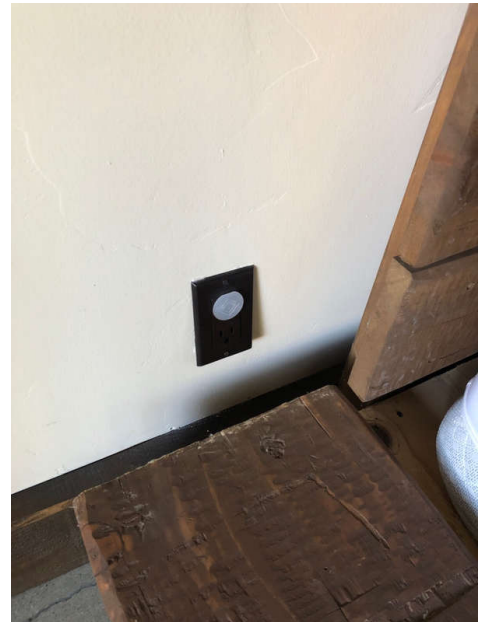
Basement Southeast Bedroom

I observed one or more damaged / loose receptacle(s). Receptacles having damage (cracks, missing insulation, etc.) or that are loose (moves around when inserting or removing plug) cause a potential electrical short or electrocution hazard. I recommend having a qualified professional evaluate and correct.

Contact a qualified electrical contractor.

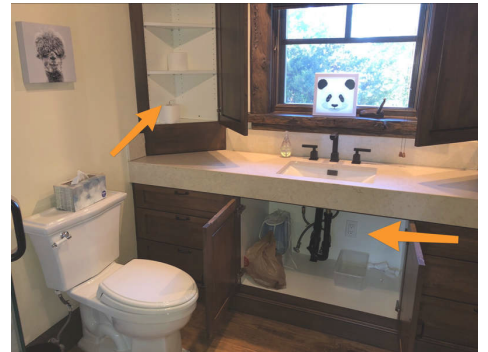
2nd Floor Northeast Bathroom

I observed no power to one or more electrical outlet. I recommend consulting a qualified professional for evaluation and correction.

Contact a qualified electrical contractor.

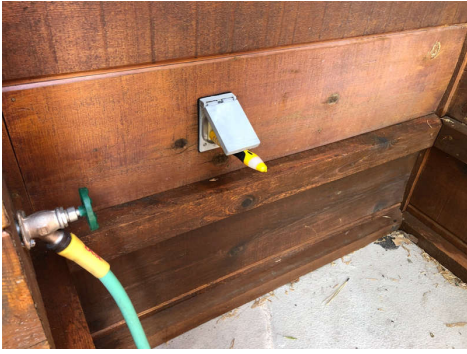
2nd Floor Master Patio

Observed no power to outlet outside

Contact a qualified professional.

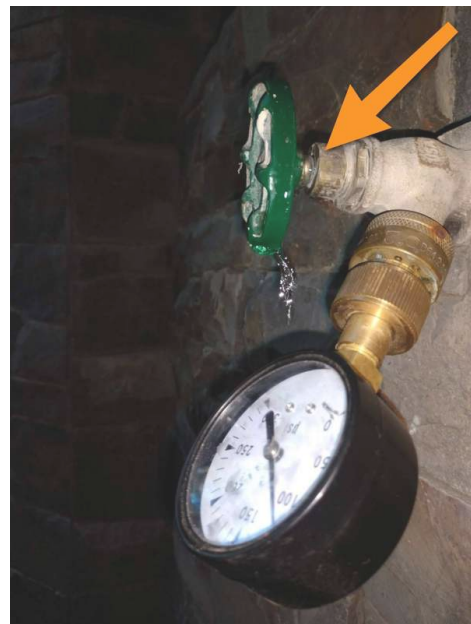
Observed leaking water supply valve. Recommend correction by a qualified professional.

Contact a qualified plumbing contractor.

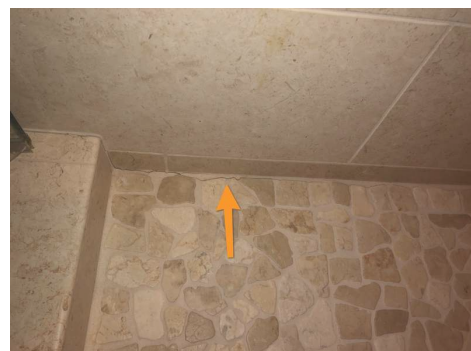
2nd Floor Northwest Bathroom, floor
to wall intersection.

Damaged grout line in shower enclosure.

Contact a qualified professional.

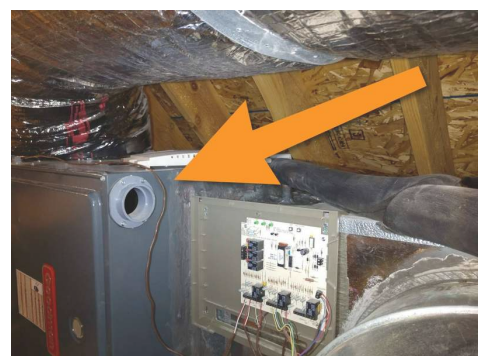
Observed missing intake / exhaust vent connector. I recommend consulting a qualified professional for evaluation and correction.

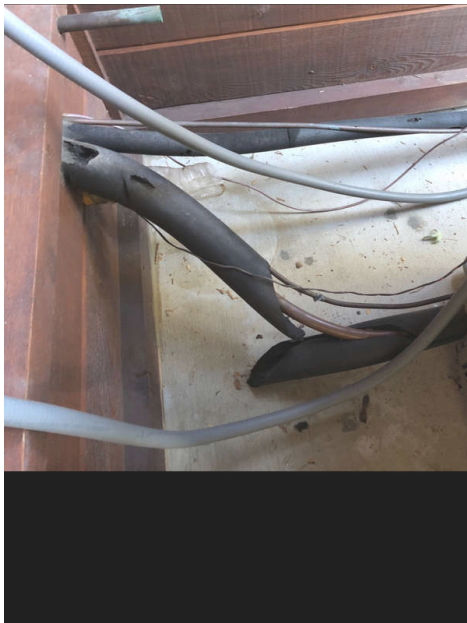
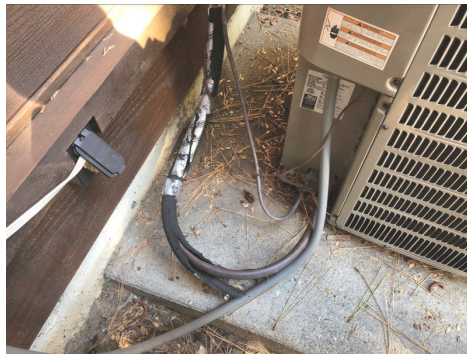
Missing or damaged insulation on refrigerant line can cause energy loss and condensation.

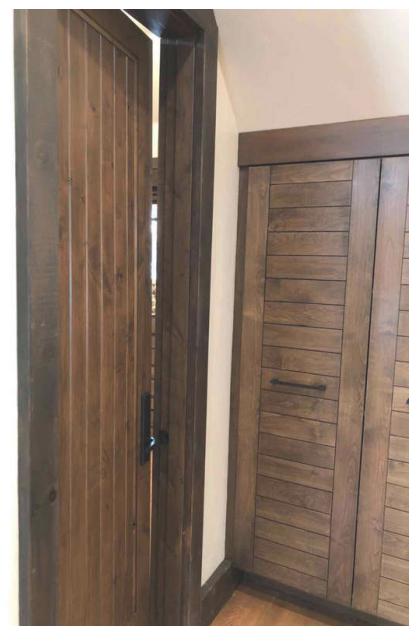
2nd Floor South Master Closet

I observed one or more door that doesn't latch properly due to being warped. I recommend evaluation and correction by a qualified professional

Contact a qualified door repair/installation contractor.

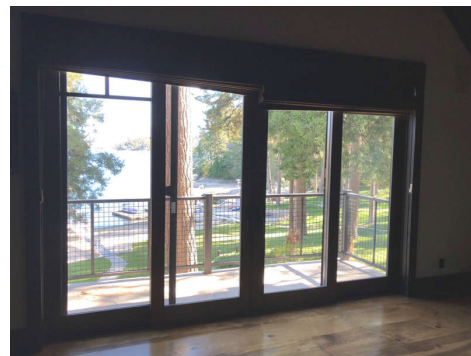
2nd Floor Southeast Master Bedroom

Door latch and/or strike plate is out of alignment. I recommend correction by a qualified professional.

Contact a qualified door repair/installation contractor.

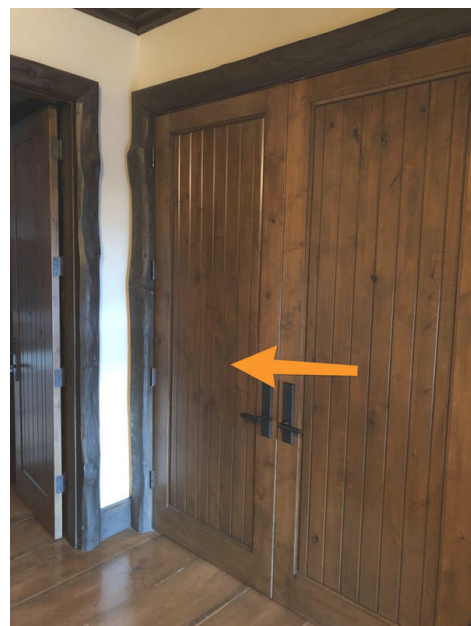
1st Floor Southeast Bedroom Closet

Door sticks and won't open. Recommend evaluation and correction by licensed contractor

Contact a qualified door repair/installation contractor.

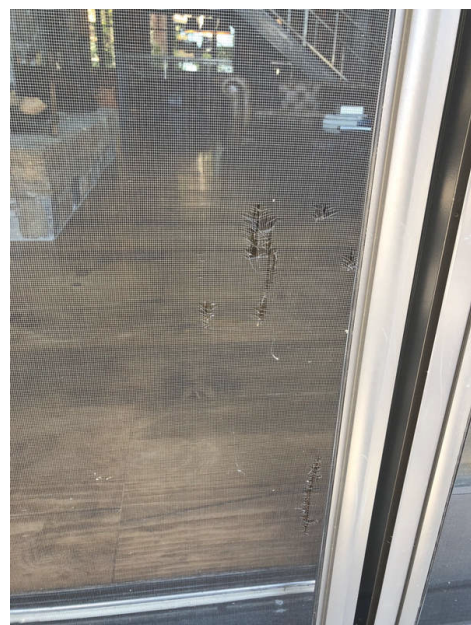
1st Floor

Observed one or more damaged window or door screen. Recommend repair/replacement by qualified professional.

Contact a qualified professional.

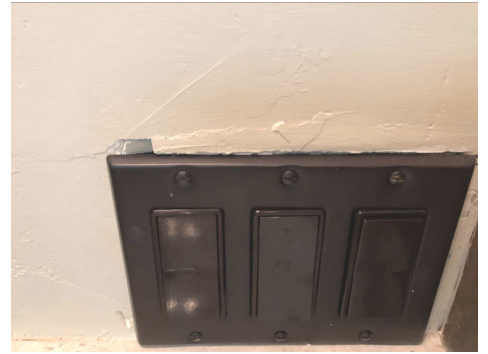
1st Floor Southwest Bathroom

Observed cracks at the intersections and surfaces of walls in one or more location. I recommend monitoring for change, consult a qualified professional as needed for correction.

Recommend monitoring.

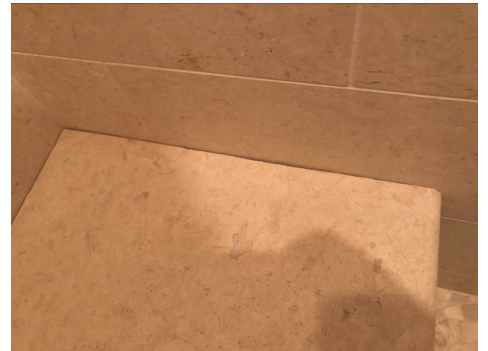
1st Floor Southeast Bathroom

Observed sealant in tub/shower enclosure degrading and becoming ineffective in one or more location. I recommend removing, cleaning and replacing as a DIY project, or consult a qualified professional for correction.

Contact a qualified painting contractor.

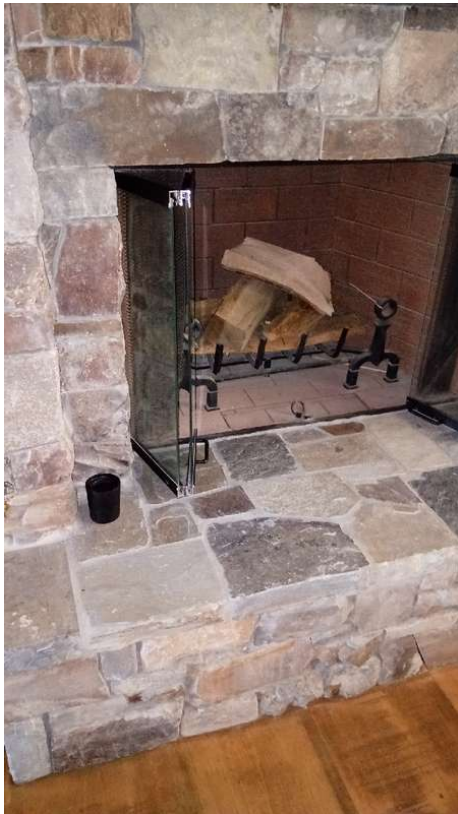
Fireplace: Loft Sitting Room Fireplace

Natural gas control valve inset behind Masonry is non-operational

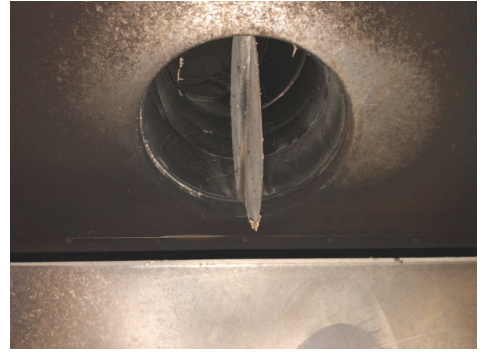
2nd floor left fire place missing damper clamp.

Contact a qualified professional.

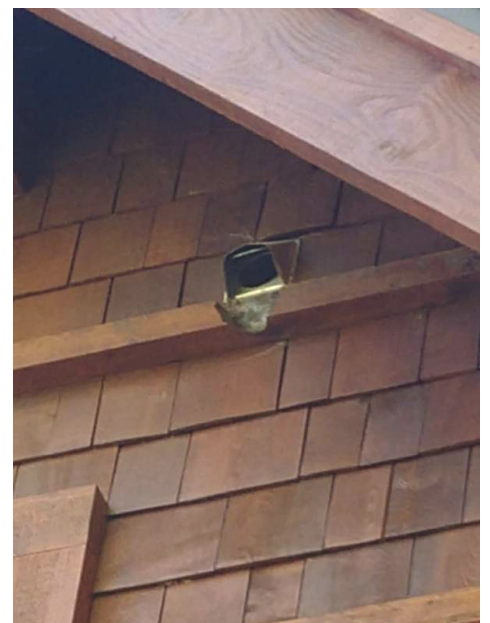
Observed missing damper in exhaust duct. I recommend replacement (wildlife may find it an inviting nesting place).

Contact a qualified professional.

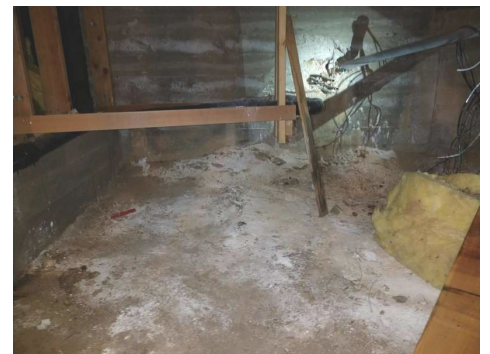
Efflorescence is present on the crawlspace surface (bare earth). This a white, powdery deposit that is consistent with moisture intrusion. This can compromise the soil's ability to support the home structure and/or lead to mold growth. I recommend a qualified professional identify the source of moisture and correct.

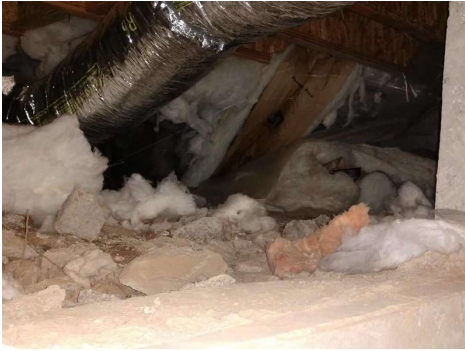
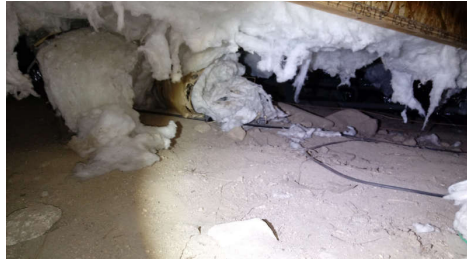
I observed in one or more location missing, damaged or fallen insulation from the floor or wall structure. I recommend reinstalling the insulation to improve climate control in the conditioned space above as a DIY project or by a qualified professional.

Contact a qualified insulation contractor.

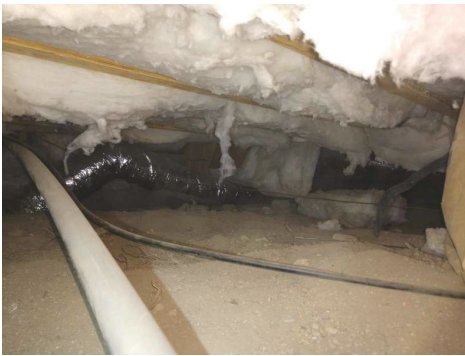
I observed the absence of a moisture barrier on the floor (exposed dirt) of the crawlspace. This is not a requirement of any kind, but it will reduce the amount of ground moisture introduced into the area below the conditioned space (living area). I recommend considering installation of a moisture barrier.

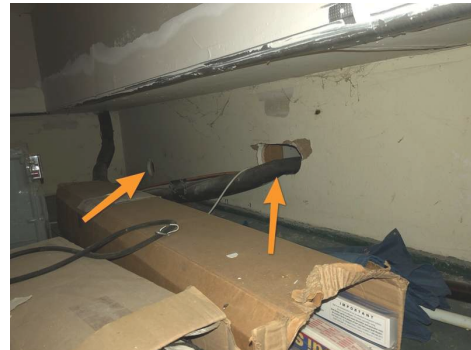
Observed damaged drywall or unsealed penetration or transition. I recommend correction by a qualified professional.

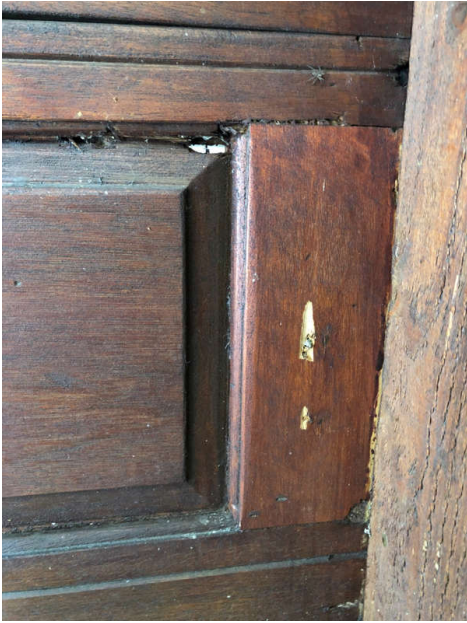
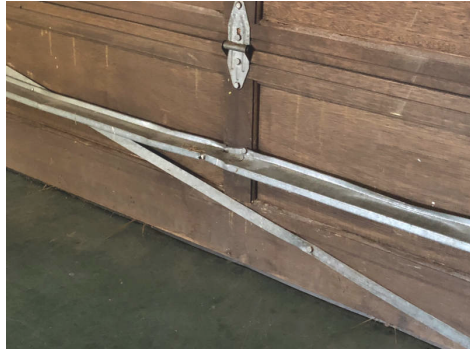
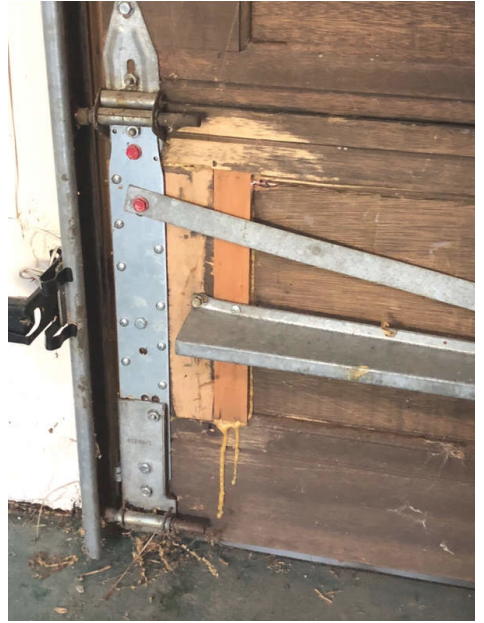
Left door

Garage door panel is damaged and may need repair/replacement. Recommend a qualified garage door contractor evaluate.

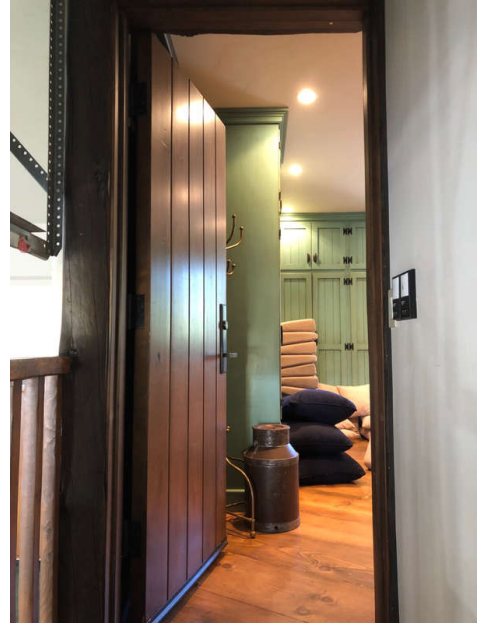
Door separating garage from home should have self-closing hinges or a door closer to help prevent spread of a fire to living space. I recommend installation self-closing hinges or a door closer.
