SYSCHECK INSPECTIONS

INSPECTION REPORT

1234 Main St.
Villa Rica GA 30180

Buyer Name
03/11/2019 9:00AM

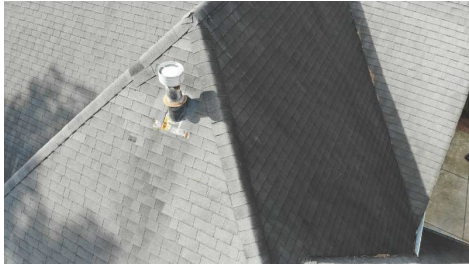
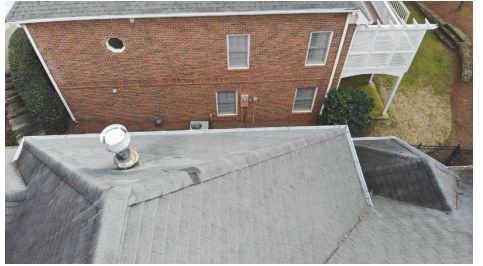
DAMAGE - ARCHITECTURAL SHINGLE

The roof covering showed some damage and signs of aging. Granular loss and frayed edges were observed. Areas of possible storm damage were noted including loose or missing shingles. The average life expectancy for an architectural shingle is 25 to 30 years.

I recommend a qualified roofing professional evaluate all roof covering and flashings.

Contact a qualified roofing professional.

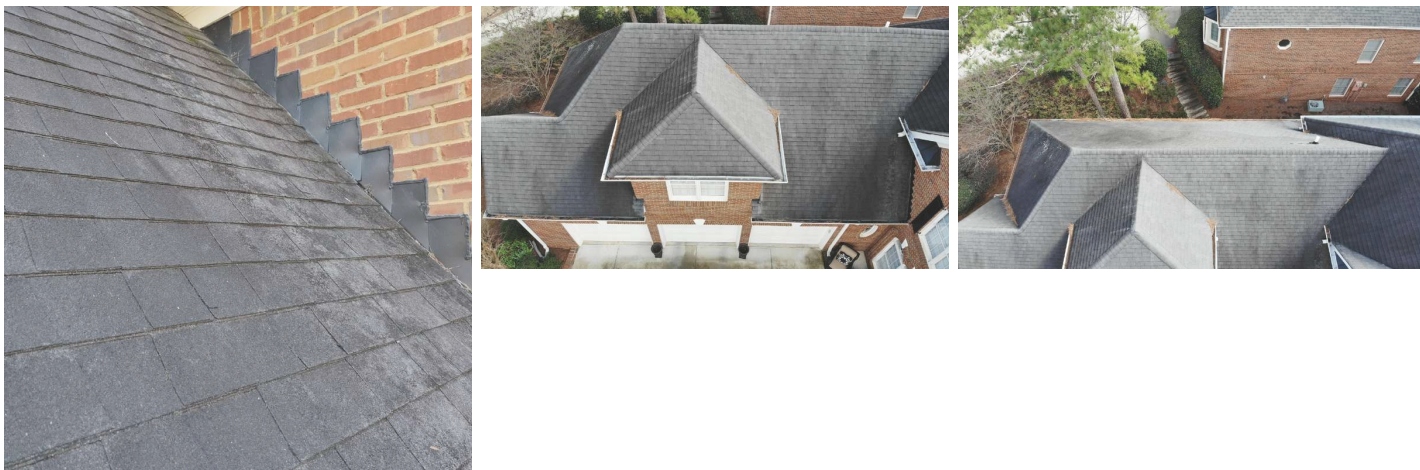
2.2.3 Roof Covering

DISCOLORATION / ALGAE STAINS

I observed discoloration consistent with algae stains. This is common in high-humidity areas. Recommend a qualified Roofing professional evaluate further and correct to prolong the life of shingles.

Contact a qualified roofing professional.

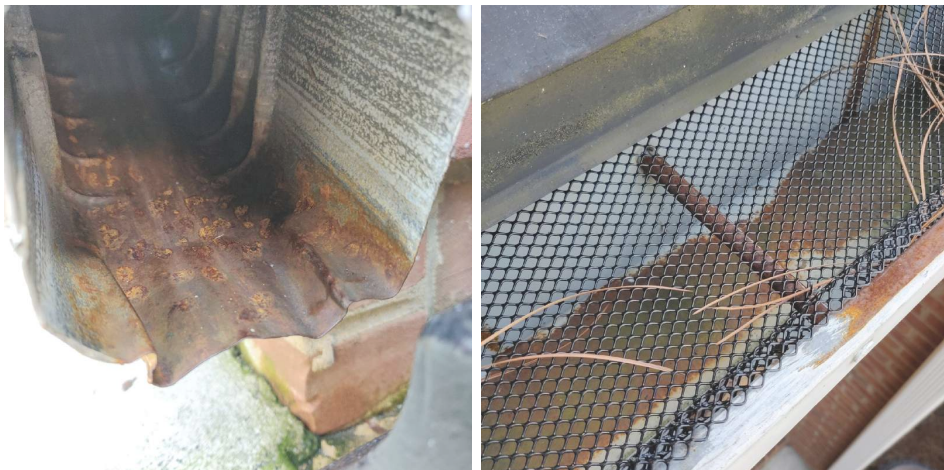
2.3.1 Roof Drainage Systems

GUTTER/DOWNSPOUT RUST

Observed rust on the gutter system. I recommend a qualified gutter contractor evaluate further and repair as needed.

Contact a qualified professional.

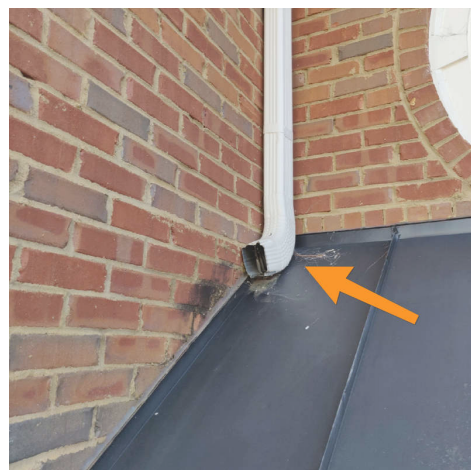
2.3.2 Roof Drainage Systems

DOWNSPOUT - POOR DISCHARGE LOCATION

I observed a gutter that discharges in a poor location. I recommend improving to allow for proper drainage.

Contact a qualified professional.

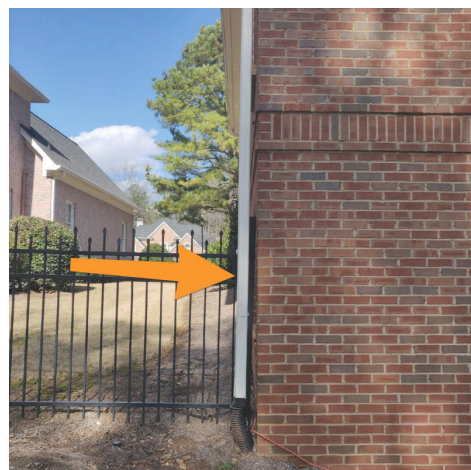
2.3.3 Roof Drainage Systems

DOWNSPOUT LOOSE

I observed a downspout that was loose or lacking proper support. I recommend a qualified gutter contractor secure as needed.

Contact a qualified professional.

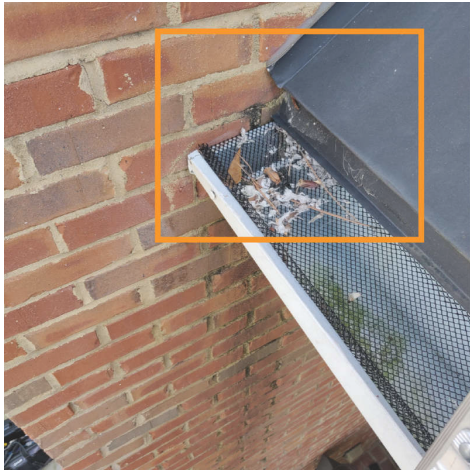
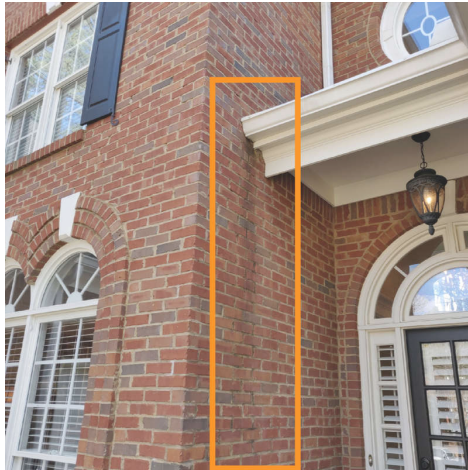
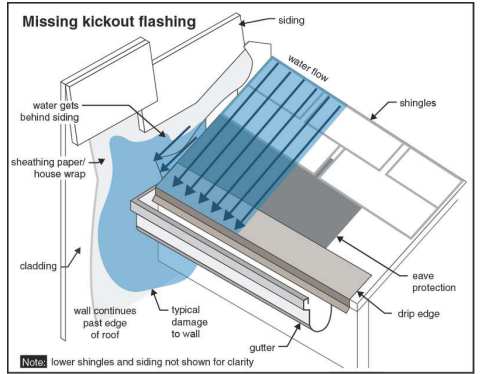
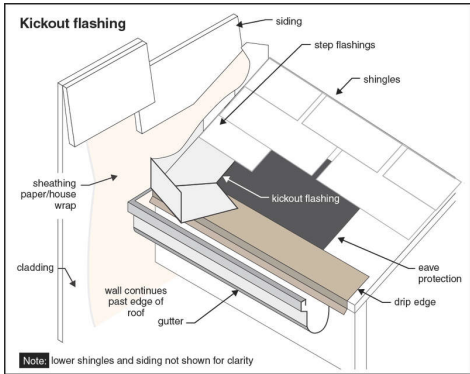
2.4.1 Flashings and Penetrations

KICKOUT FLASHING MISSING

I recommend adding kickout flashing at this area to prevent water from running down the wall.

Contact a qualified roofing professional.

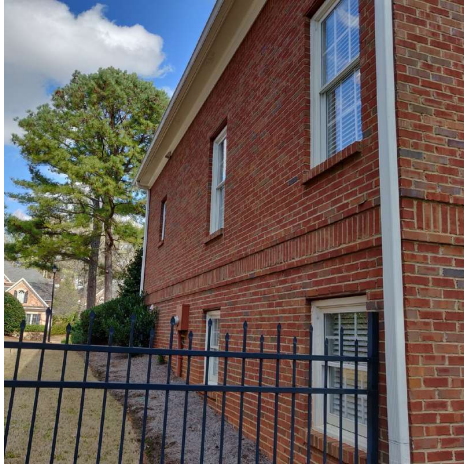
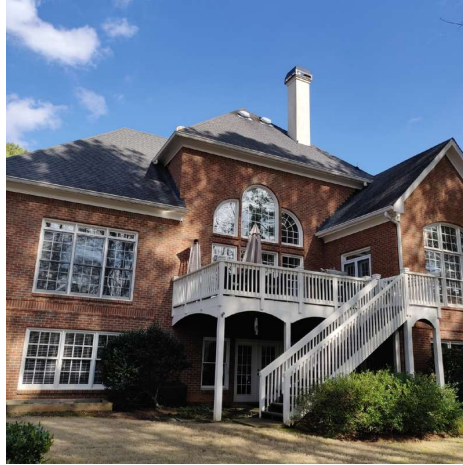
The exterior finishings will be observed for general condition and signs of obvious defects. Siding materials are described in this section. Window and door exterior condition are observed as well as any deck or porch structures. Penetrations through the wall surface will be visually observed for signs of defects.

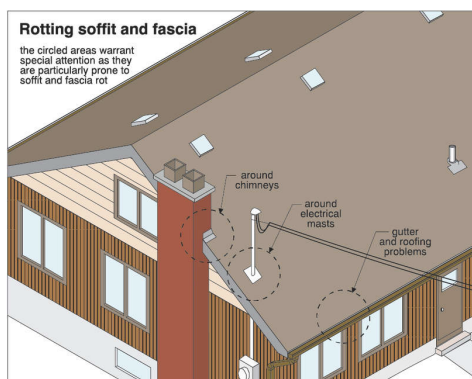
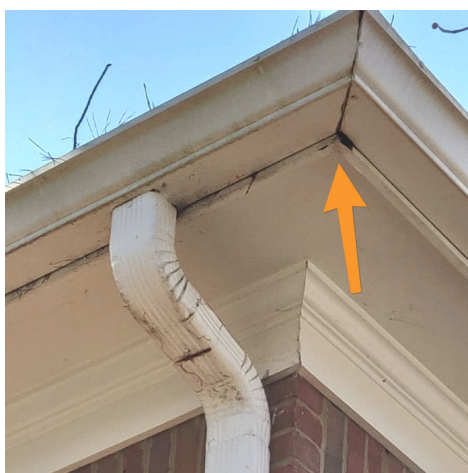
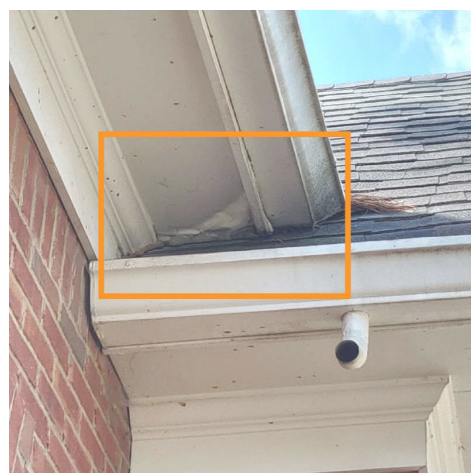
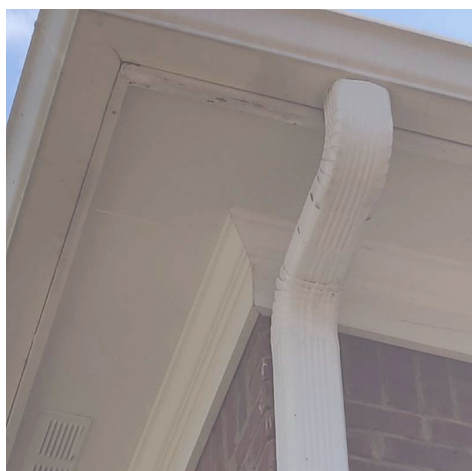
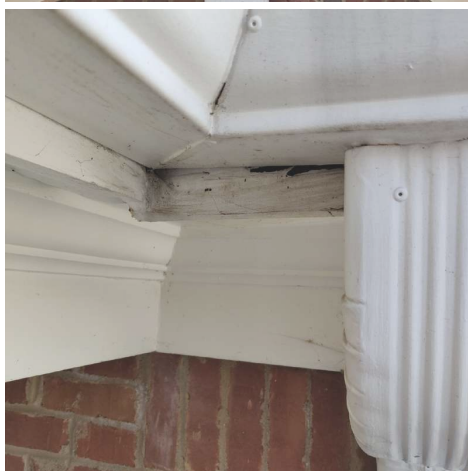
EAVES - DAMAGED

Sections of the eaves/soffit were damaged. I recommend qualified contractor evaluate & repair.

Contact a qualified roofing professional.

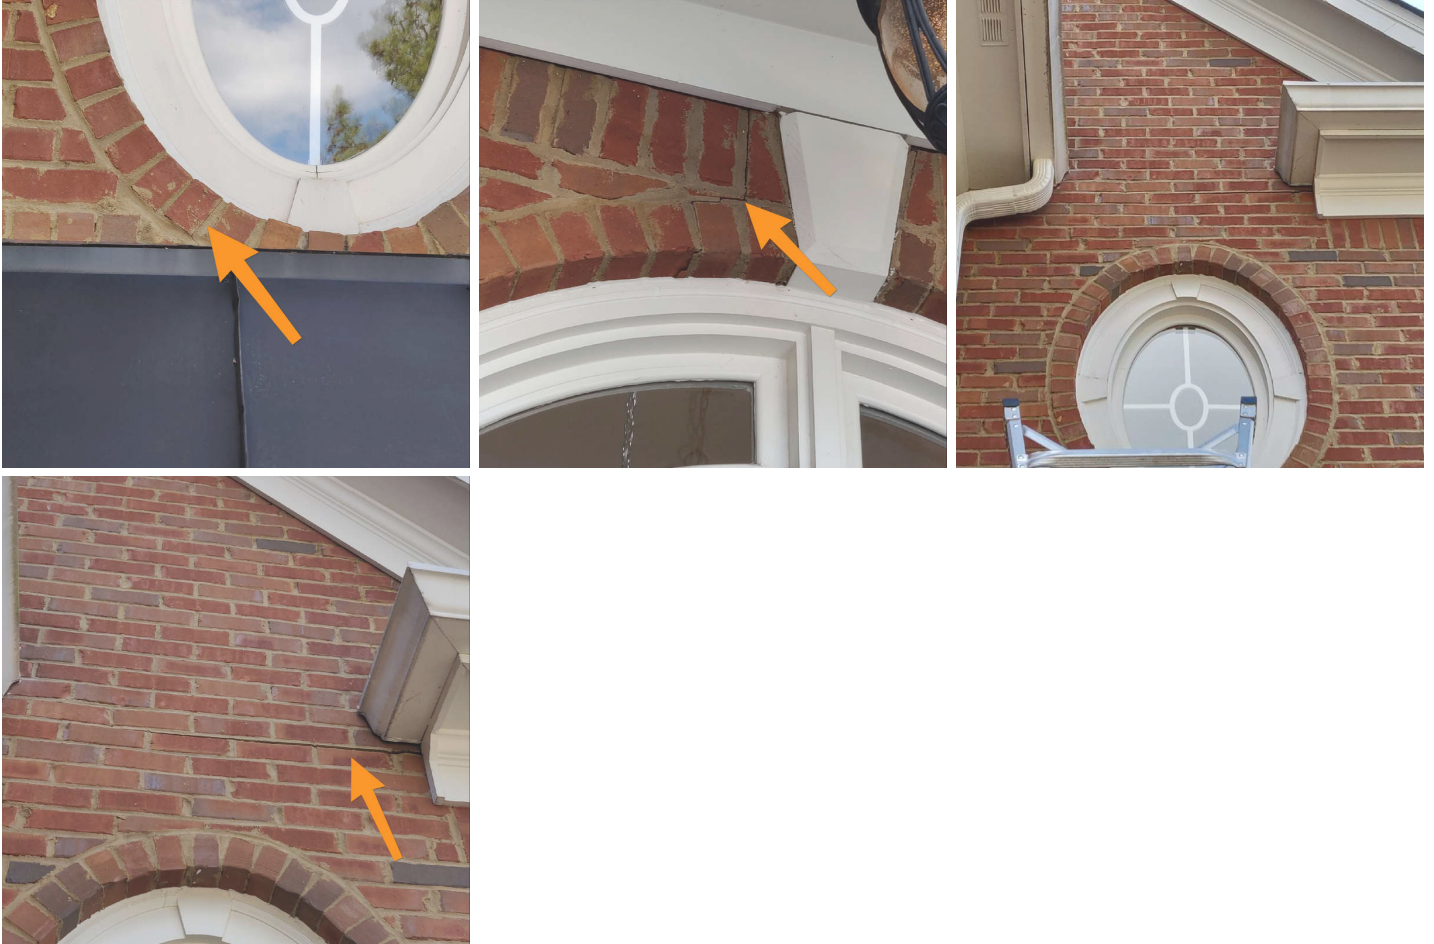
3.3.1 Siding & Trim

Signs of movement in the brick was observed. I recommend a qualified professional evaluate further and repair as needed

Contact a qualified masonry professional.

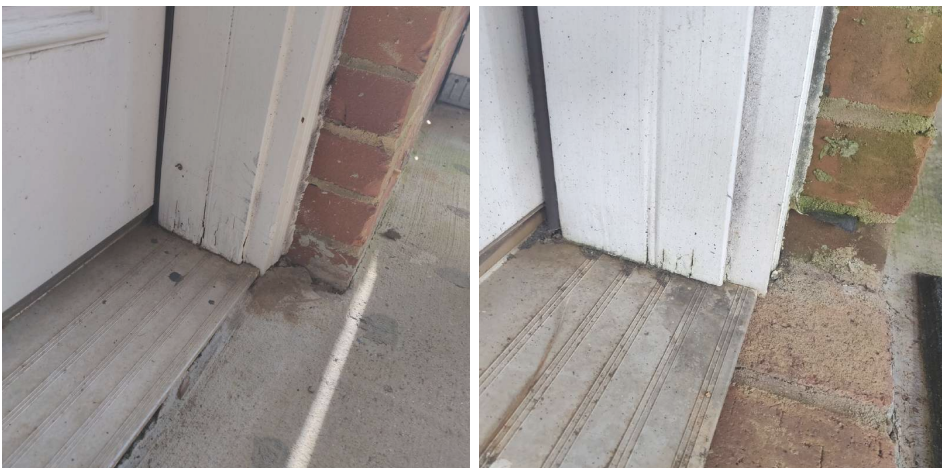
3.4.1 Exterior Doors & Windows

DOOR TRIM - ROT

Observed water damage to the lower sections of door trim/frame. Recommend a qualified professional evaluate further and repair these areas to prevent further damage.

Contact a qualified professional.

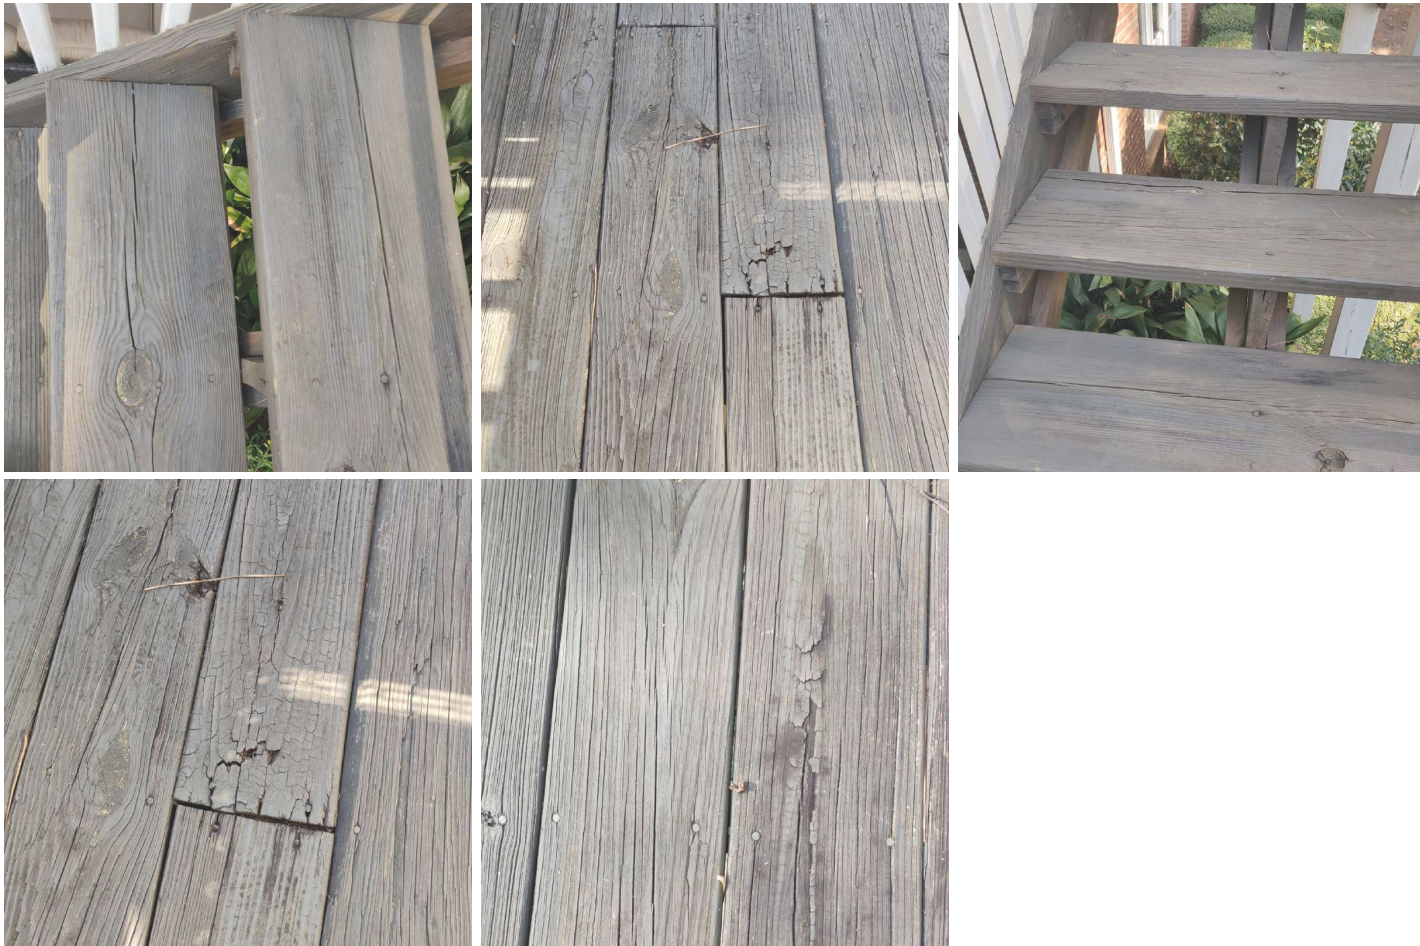
3.6.1 Decks, Balconies, Porches & Steps

Deck and/or components are showing signs of aging. Recommend a qualified deck contractor evaluate further and as part of regular maintenance seal to prolong life of boards.

Contact a qualified deck contractor.

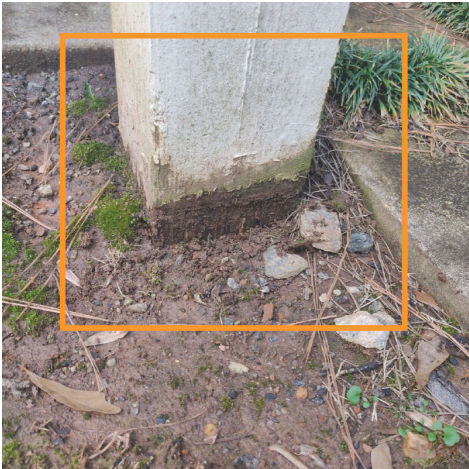
3.6.2 Decks, Balconies, Porches & Steps

Observed decking components touching ground. While components may be rated for ground contact, ground contact allows the boards to hold moisture and will eventually rot the wood. Upon probing areas just below the ground surface no immediate signs of being rotted through were observed.

Recommend a qualified decking contractor evaluate and correct.

Contact a qualified deck contractor.

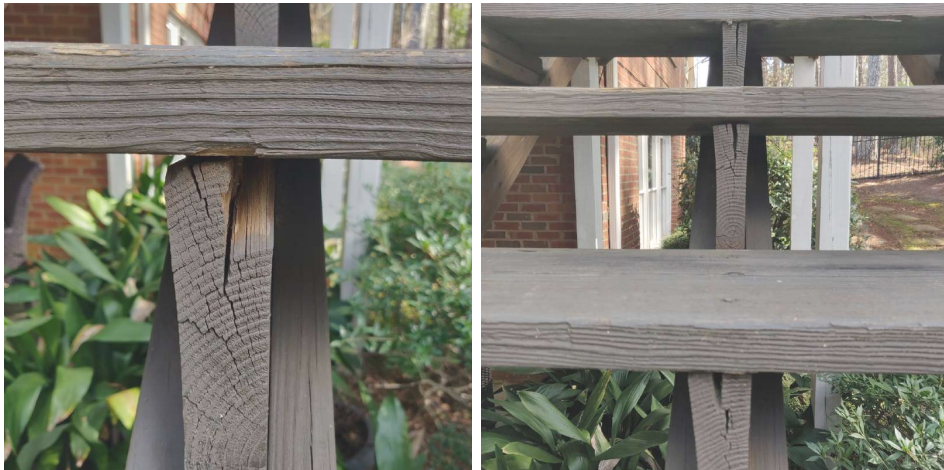
3.6.3 Decks, Balconies, Porches & Steps

STAIR STRINGERS - DAMAGE

I observed damage to one or more stair stringers. I recommend a qualified decking contractor evaluate further and correct.

Contact a qualified deck contractor.

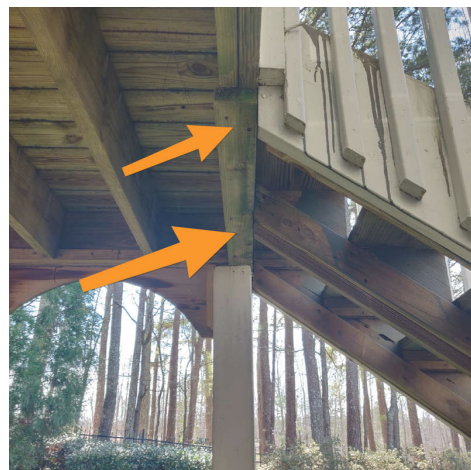
3.6.4 Decks, Balconies, Porches & Steps

The deck stair stringers were poorly attached (raises potential for detachment). Consult with a reputable contractor for repair.

Contact a qualified deck contractor.

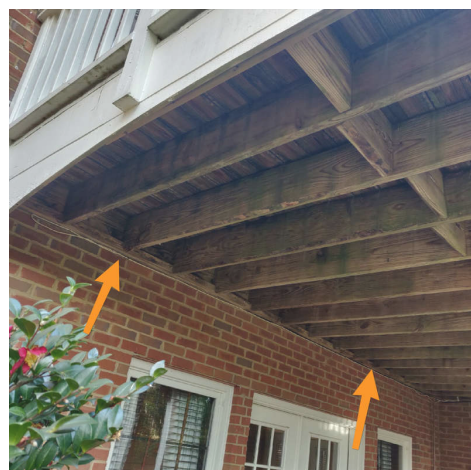
3.6.5 Decks, Balconies, Porches & Steps

It is not recommended for decks to be installed over brick veneer. This raises concerns for lateral movement. I recommend a qualified decking contractor evaluate and correct as needed.

Contact a qualified deck contractor.

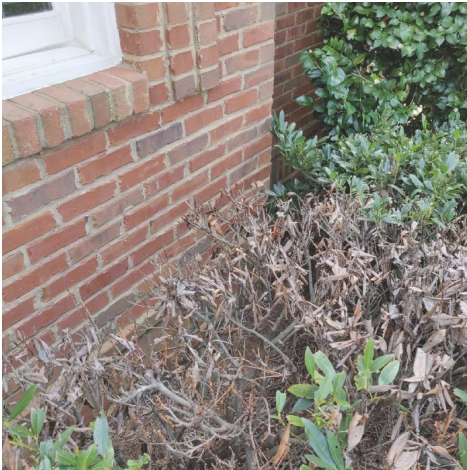
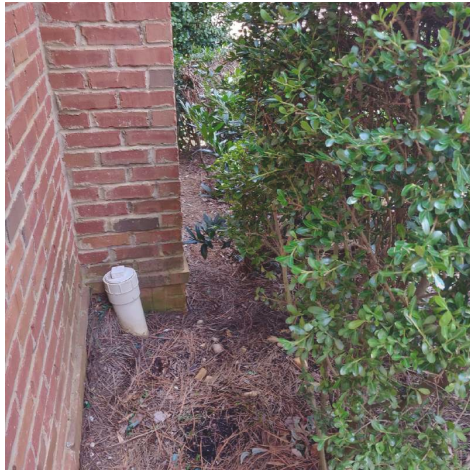
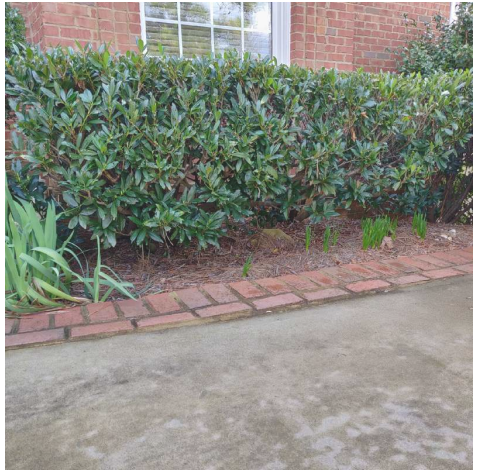
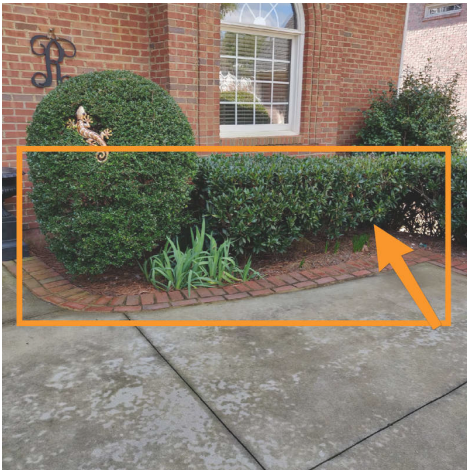
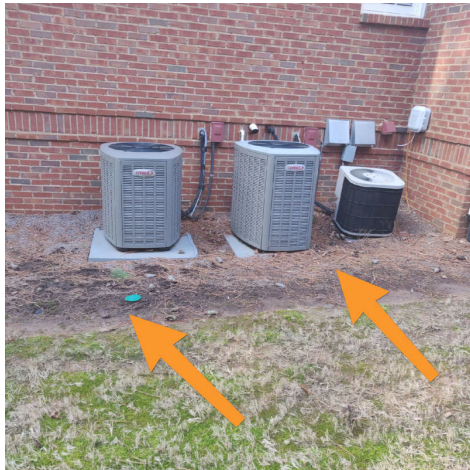
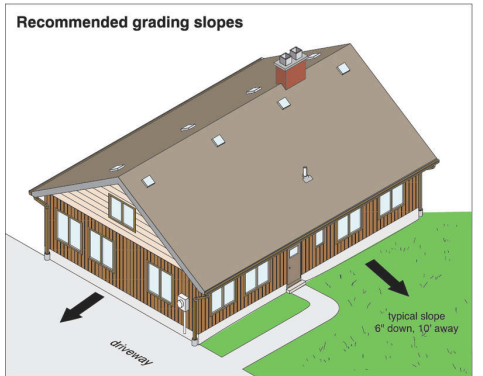
3.7.1 Vegetation, Grading, Drainage & Retaining Walls

There was an area of negative grading and poor drainage at the front of the home. there was also an area around the air conditioner units that appeared to hold water. I recommend qualified grader or contractor regrade so water flows away from home. it may be beneficial to add drains from this area to prevent ground erosion under the driveway.

Contact a qualified professional.

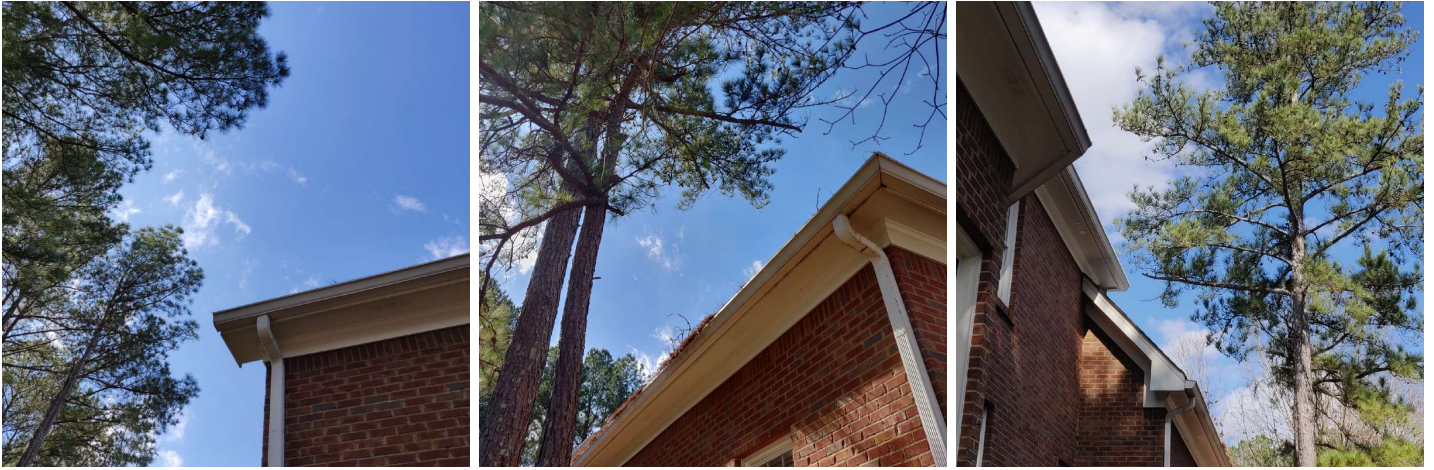
3.7.2 Vegetation, Grading, Drainage & Retaining Walls

Trees observed overhanging the roof. This can cause damage to the roof and prevent proper drainage. Recommend a qualified tree service trim to allow for proper drainage.

Contact a qualified tree service company.

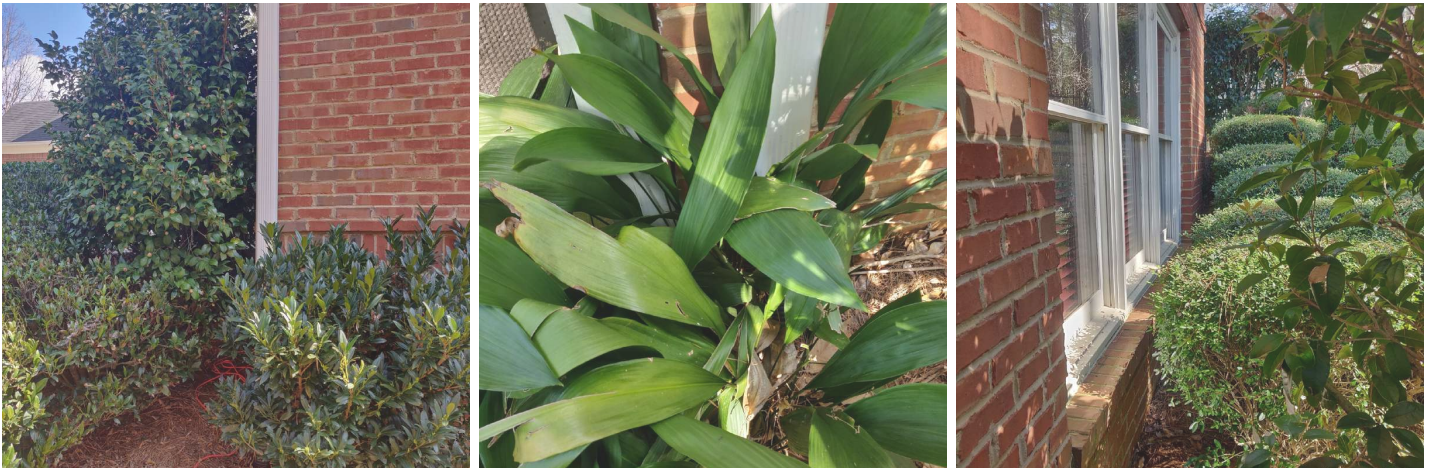
3.7.3 Vegetation, Grading, Drainage & Retaining Walls

When vegetation touches the home it is an entry point for pests, possible water intrusion and could damage exterior components.

I recommend any vegetation be trimmed back to have a 6-inch clearance.

Contact a qualified professional.

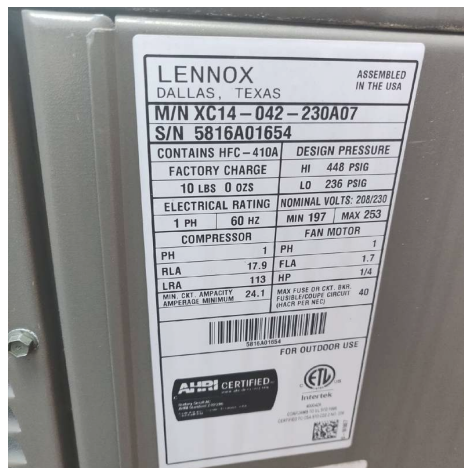
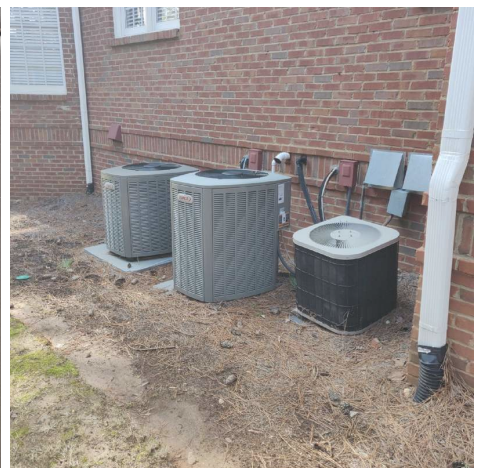
Cooling Equipment: Brand

Lennox

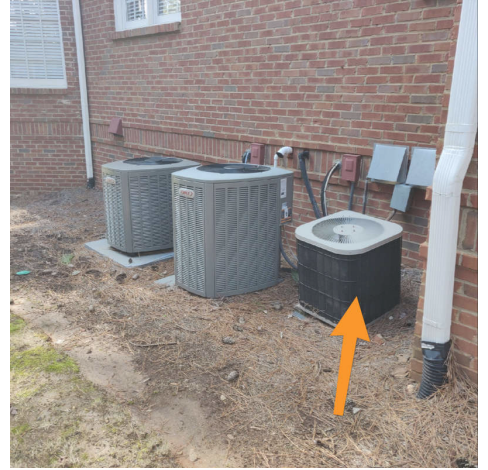
The average lifespan is 13 to 17 years. The air conditioner unit(s) showed signs of wear and tear. Recommend monitoring effectiveness.

During the aging process, other HVAC components such as lineset insulation can deteriorate. It is a good idea to have all components evaluated by qualified HVAC professional.

As part of regular maintenance I recommend a qualified HVAC professional cleaning service and certify the HVAC system.

Contact a qualified HVAC professional.

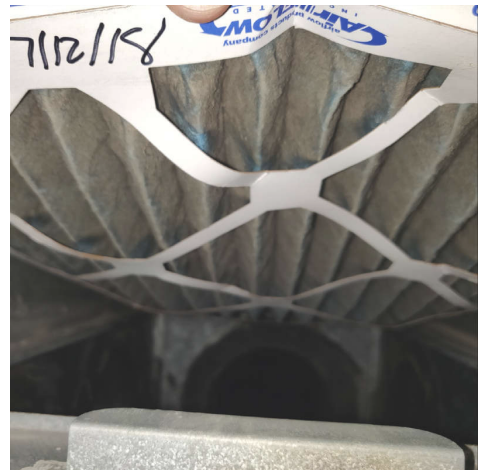
4.3.1 Heating Equipment

FILTER DIRTY

The furnace filter is dirty. It is important to replace the filter every 1 to 2 months keep the system clean and running smoothly.

Contact a qualified HVAC professional.

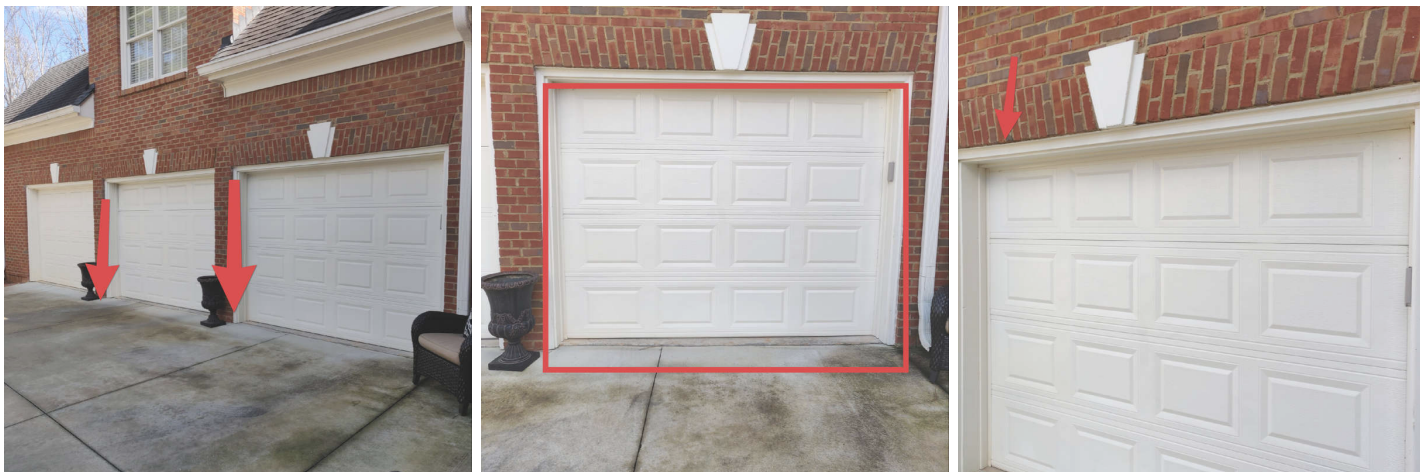
Wall structure showed signs of settlement in between garage doors. Garage doors were out of square and breaking and cracks in bricks were noted above.

I recommend a qualified contractor evaluate and make corrections or repairs as needed.

Contact a qualified professional.

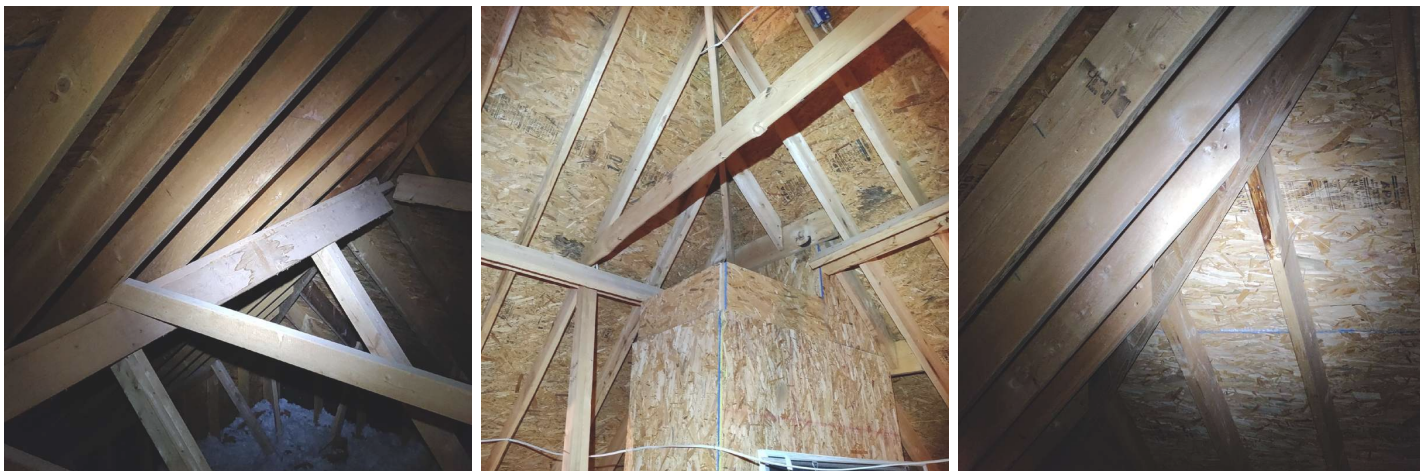
5.6.1 Roof & Ceiling Framing

WATER STAINS

I observed water stains in the attic at various areas. It appears one location of the roof covering and sheathing was drilled through to allow TV cables. Cables should be moved to another location and this area repaired by qualified roofer I recommend a qualified roofer evaluate further and repair as needed.

Contact a qualified roofing professional.

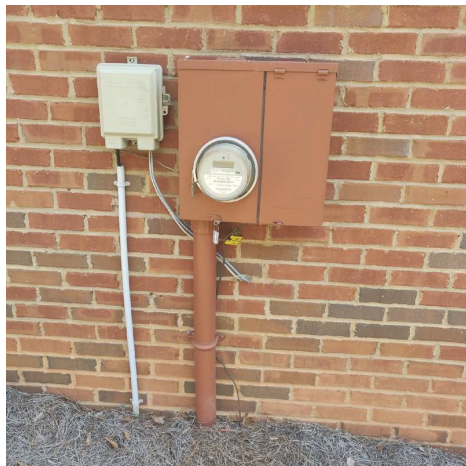
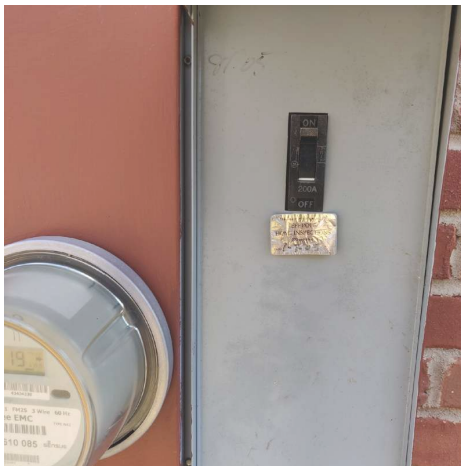
Service Entrance Conductors: Meter

Right Side

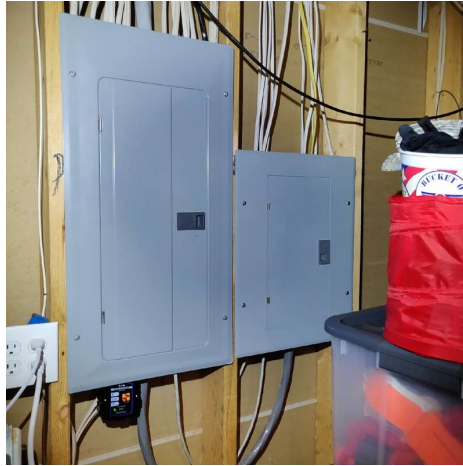
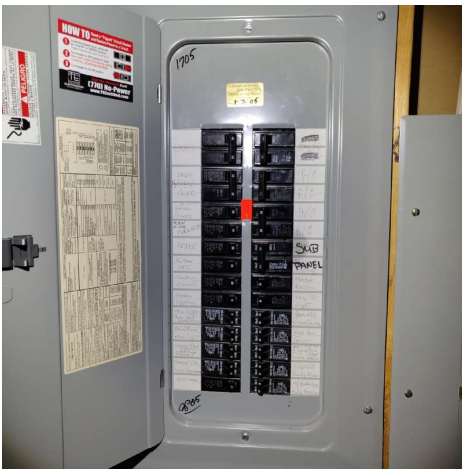
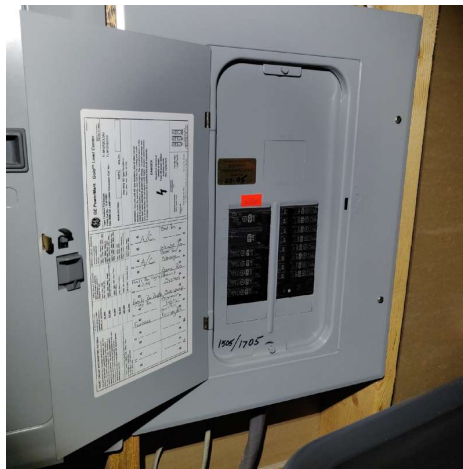
Main & Subpanels, Service & Grounding, Main Overcurrent Device: Main Panel Location Basement

Main & Subpanels, Service & Grounding, Main Overcurrent Device: Panel Capacity
200 AMP

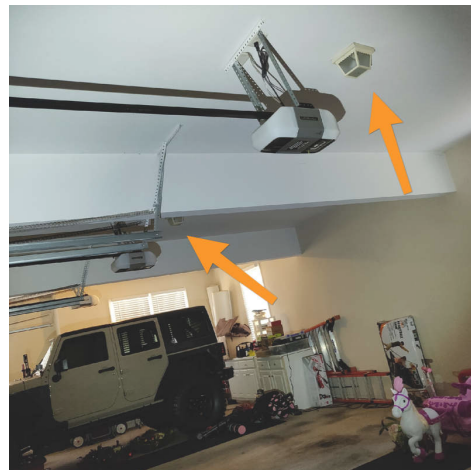
Light(s) not operating. New light bulbs possibly needed or there could be a disconnect in the wiring/light fixtures. I recommend a qualified electrician evaluate further.

Contact a qualified electrical contractor.

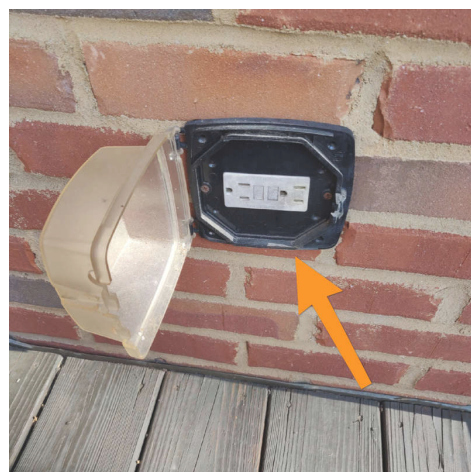
6.6.1 GFCI & AFCI

GFCI protected outlet tested faulty. There is power to this outlet but it may no longer function as a GFCI protected Outlet. Recommend a qualified electrician evaluate and correct.

Contact a qualified professional.

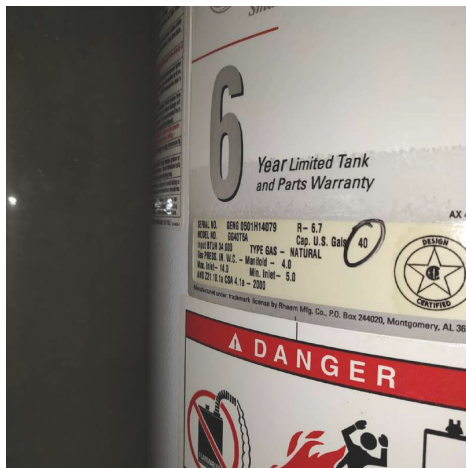
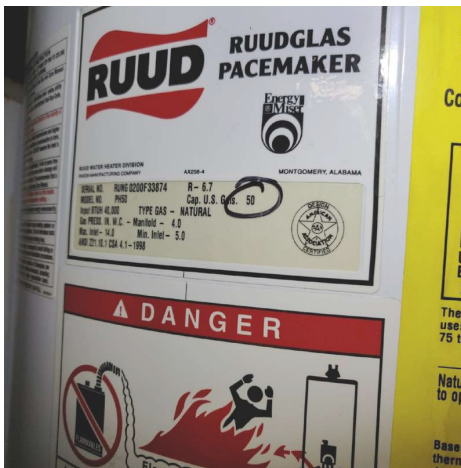
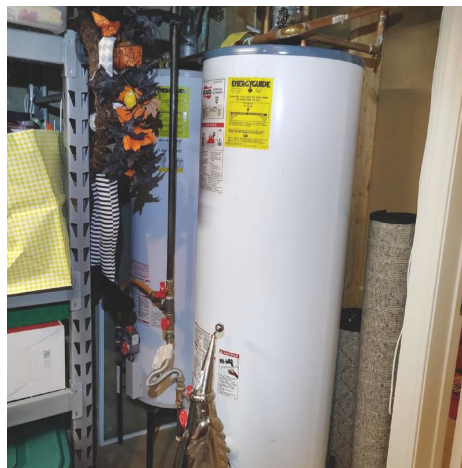
I recommend flushing & servicing your water heater tank annually for optimal performance. Water temperature should be set to at least 120 degrees F to kill microbes and no higher than 130 degrees F to prevent scalding.

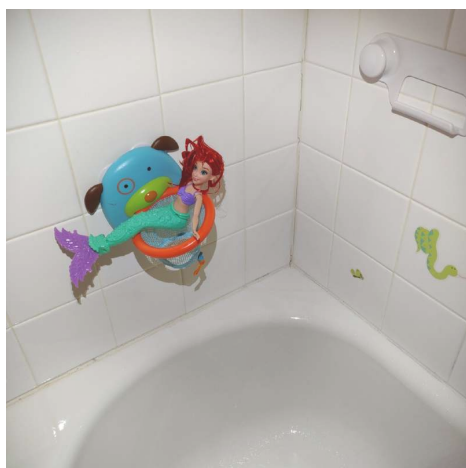
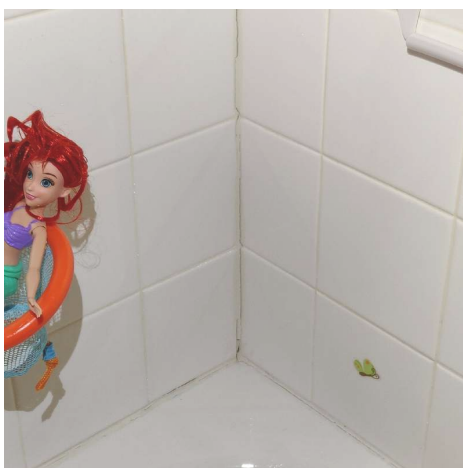
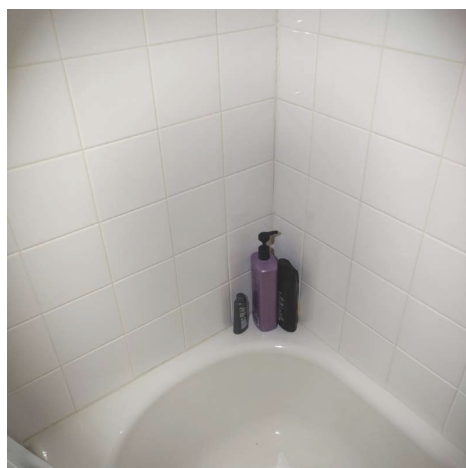
Sinks, Bathtubs & Shower Enclosures : Grout/Sealant Needed

I observed areas in the shower and around the bathtub that have cracks in the grout. Recommend sealing these areas to prevent water intrusion.

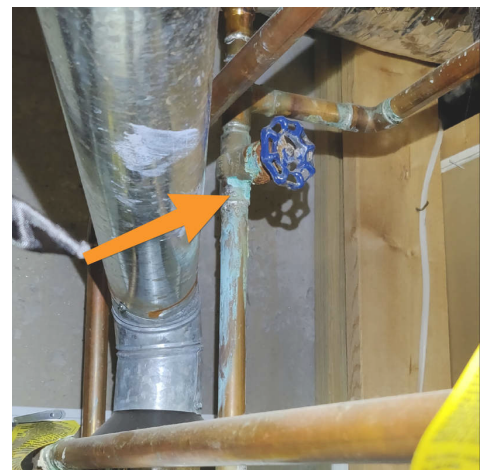
RUST/CORROSION

I observed rust and corrosion on plumbing components. Signs of leaking were observed. I recommend a qualified plumber evaluate further and repair as needed.

Contact a qualified plumbing contractor.

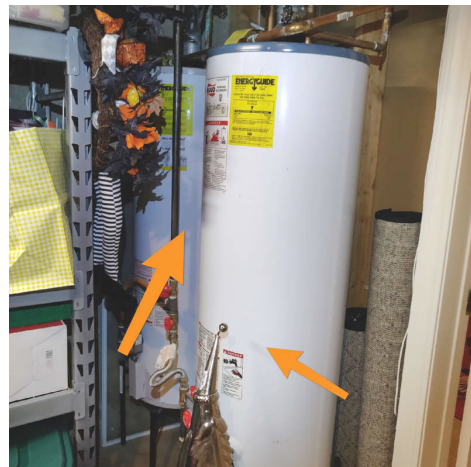
7.4.1 Hot Water Systems, Controls, Flues & Vents

The average life expectancy for a water heater is 10 to 12 years. Recommend monitoring it's effectiveness and consider replacing in the near future.

Contact a qualified plumbing contractor.

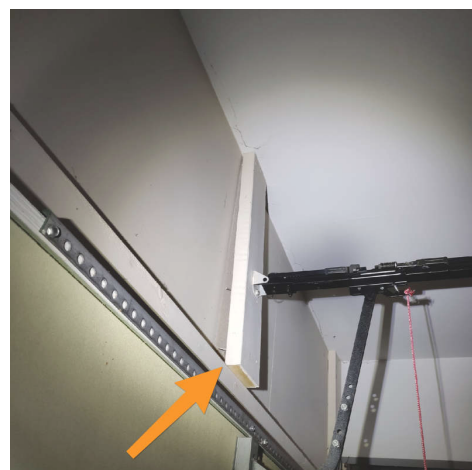
LOOSE COMPONENT

Bracing for the overhead garage door component was loose. I recommend a qualified professional correct to prevent damage or injury.

Contact a qualified professional.

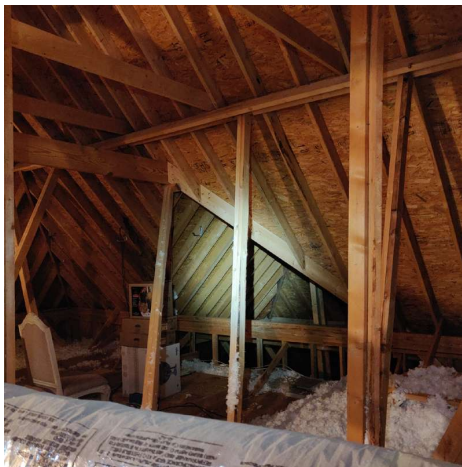
General: Description of Inspection of the Attic

Inspection of the attic spaces includes observation of the following components: the presence and general condition of the insulation, methods of ventilation, and visual condition of the framing. As noted in the standards of practice, the roof framing system is not inspected for design or load calculations - ventilation and insulation value are not calculated for adequacy or performance. Obvious and visible signs of water intrusion will be noted in this report and effort will be made to try to determine water entry is ongoing - however, it is not possible in all situations to verify. All items in this section should be reviewed and corrected by the appropriate trades professionals.

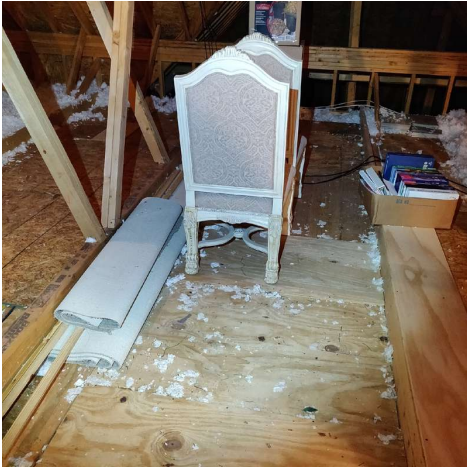
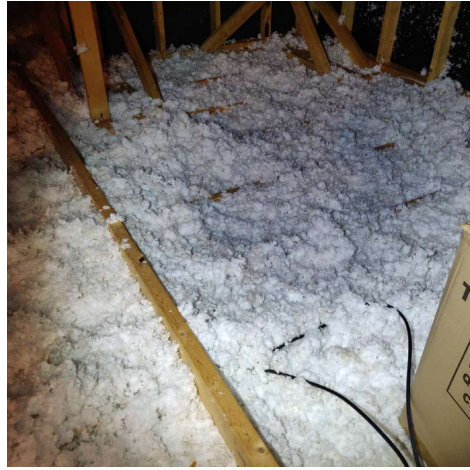
Insulation depth was low in areas. Some settlement/compression of insulation is normal. The insulation had been compressed from sheathing placed on top. I recommend a qualified attic insulation contractor add additional insulation as needed.

Contact a qualified insulation contractor.

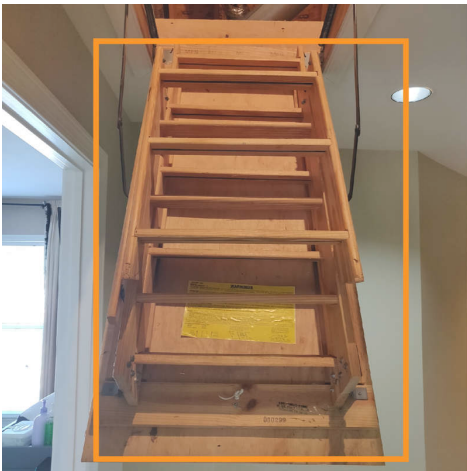
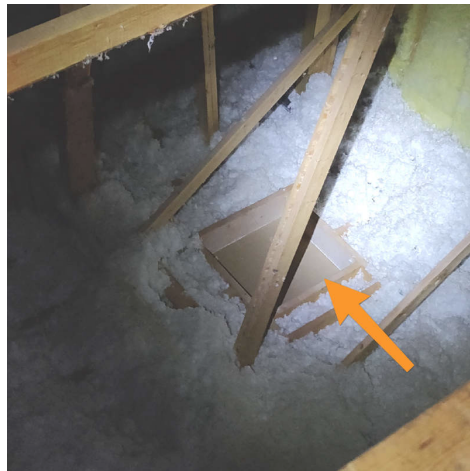
9.3.2 Attic Insulation

ATTIC ACCESS - NOT INSULATED

I recommend adding insulation to the attic access door to prevent energy loss.

Contact a qualified professional.

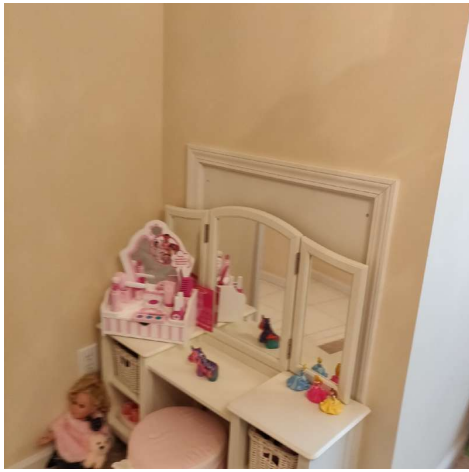
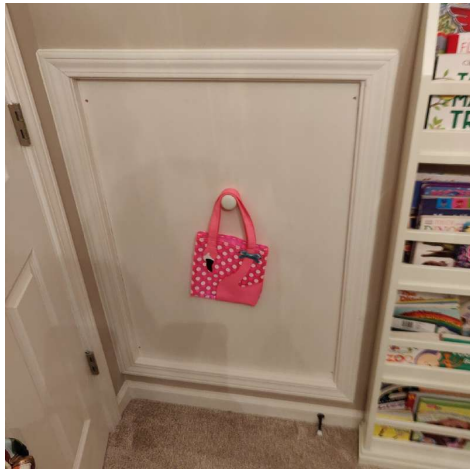
9.3.3 Attic Insulation

ACCESS BLOCKED

Access panels to the knee wall attic areas above the garage are sealed off. Recommend making these accessible as needed.

Contact a qualified professional.

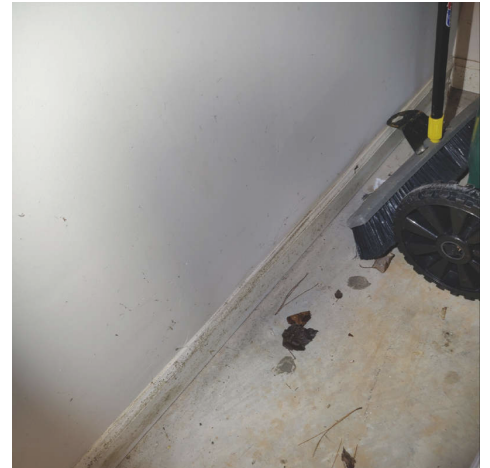
I observed signs of microbial growth on the trim in garage. This area was dry at the time of inspection. This is most likely due to excess humidity in the garage in the summer months corrected. I recommend a qualified contractor clean as needed..

Contact a qualified mold inspection professional.

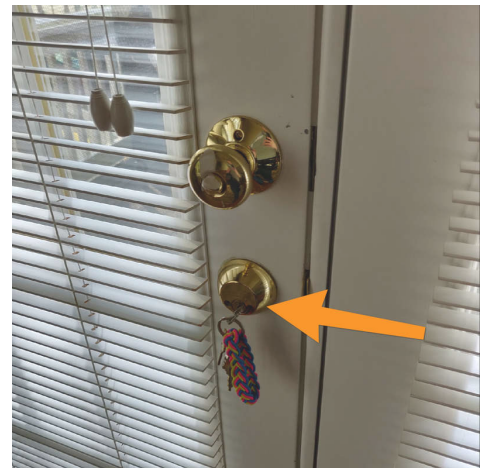
10.3.1 Doors

One or more door locks require a key to unlock from the inside. This is a fire escape hazard. I recommend all deadbolts be unlockable from the inside without a key.

Recommended DIY Project

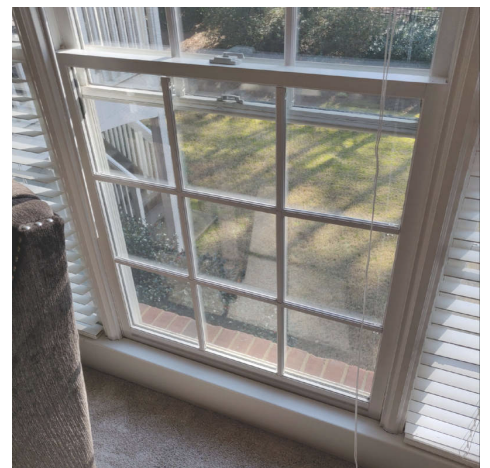
10.4.1 Windows

I observed a number of the windows to be difficult to open and close. I was unable some windows at the time of inspection especially the top sashes. I recommend a window professional clean, lubricate & adjust as necessary.

Contact a qualified window repair/installation contractor.

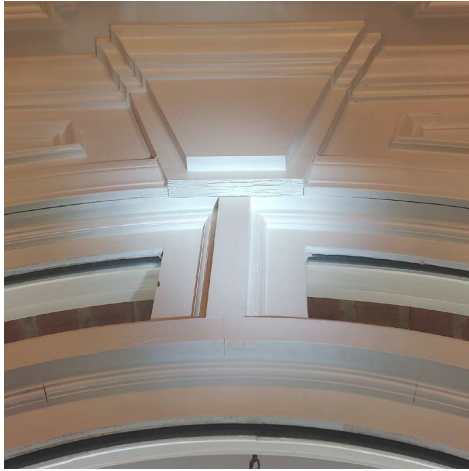
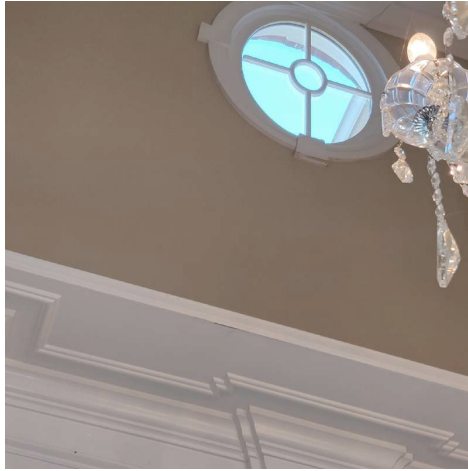
10.4.2 Windows

Water stains were underneath the window in the foyer. I recommend a qualified siding contractor evaluate siding further and correct.

Contact a qualified siding specialist.
