RESIDENTIAL REPORT

1234 Main St.
Spokane Washington 99224

03/02/2019 9:00AM

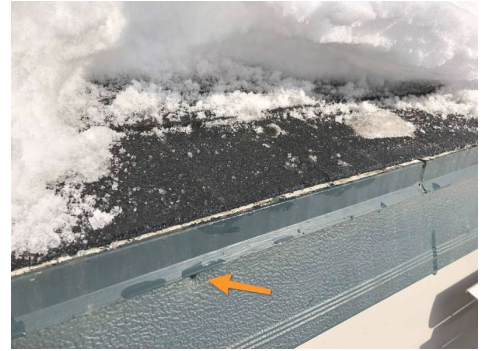
GUTTERS MISSING

There are no gutters present on the structure. Given the observed hole pattern throughout the aluminum fascia covering, there may have been gutters present on the house in the past. Gutters are recommended because they collect rain water from the roof and direct it away from the building.

There is a series of holes just at and/or beneath the drip edge that suggests there may have been gutters on the house previously.

Contact a qualified gutter contractor

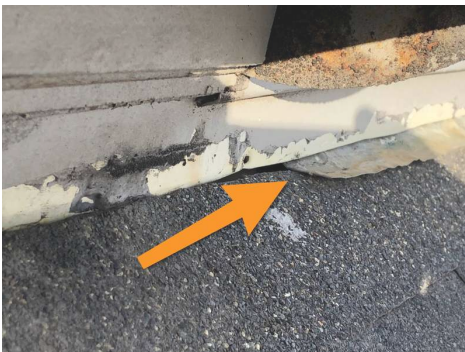
MISSING FLASHING

Although I could not observe all roof locations, flashings were missing at one or more locations at the time of inspection. Flashings provide protection against moisture intrusion. Recommend continued monitoring and definitely get a closer look when the snow melts. Should there be flashing missing in multiple locations, contact a qualified roofing contractor evaluate and remedy. Most good roofing contractors can come out and assess the situation free of cost. I use Roman at [Performance Roofing](#), he has always treated my clients well and does exceptional work.

Flashing from sidewall over side entry roof stops short, it should be continuous across roof.

Contact a qualified roofing professional.

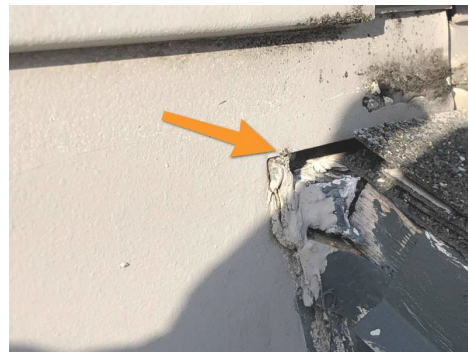
Kickout flashing missing here, with evidence of previous moisture exposure.

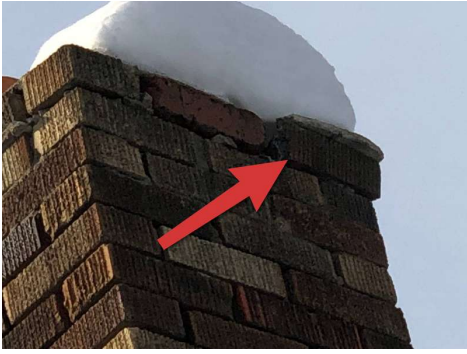
Joints in the masonry have deteriorated and should be repointed. (Repointing is the restoration of the mortar joints in the masonry). I counted 13 courses of brick down from the top that had deteriorated mortar. It is likely that the masonry chimney cap is deteriorated as well. At least one loose brick was observed, so I have highlighted this as a safety concern. I recommend contacting a licensed chimney repair contractor. I have had success with [Dobson Chimney](#), they are affordable and trustworthy folks.

This brick is loose and will fall eventually unless repairs are made.

Contact a qualified chimney contractor.

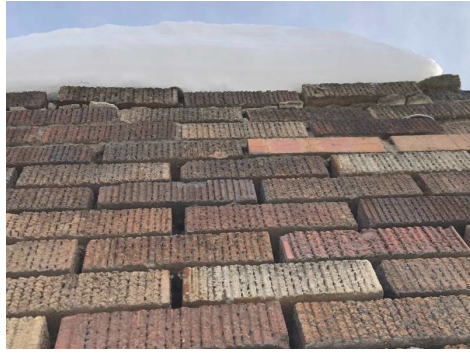
From the top down there are at least 13 courses of brick that need mortar repointed.

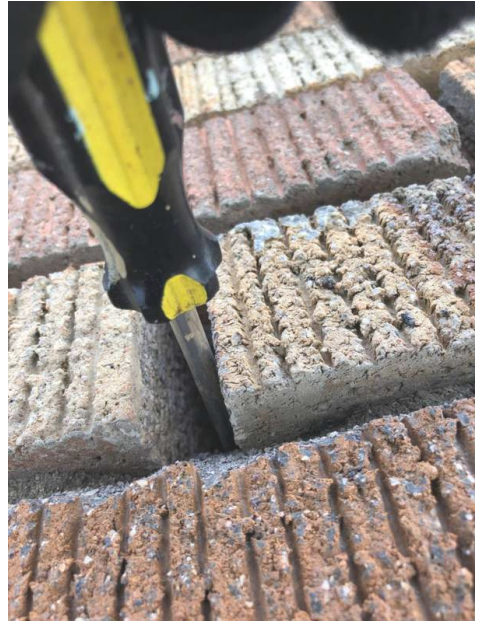
This screwdriver is 6 inches long, you should not be able to do this.

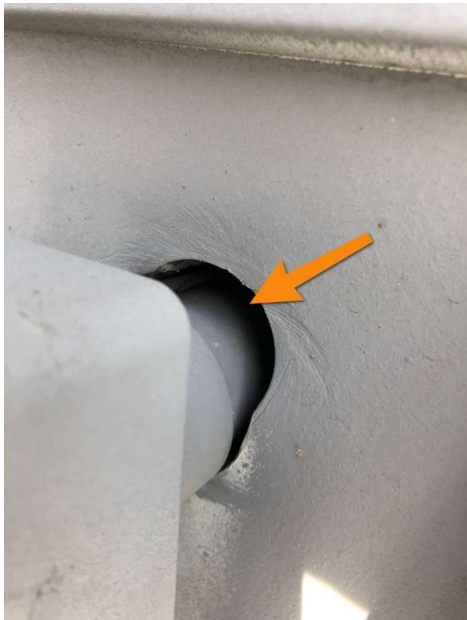
All penetrations like this one need to be sealed.

Recommended DIY Project

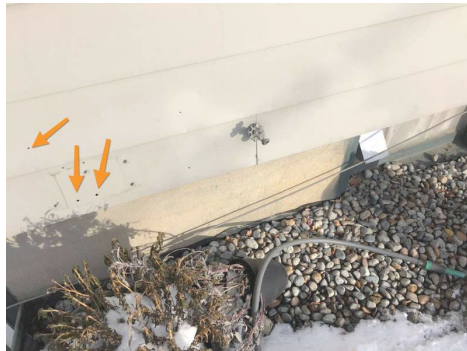
Various siding penetrations need sealed.

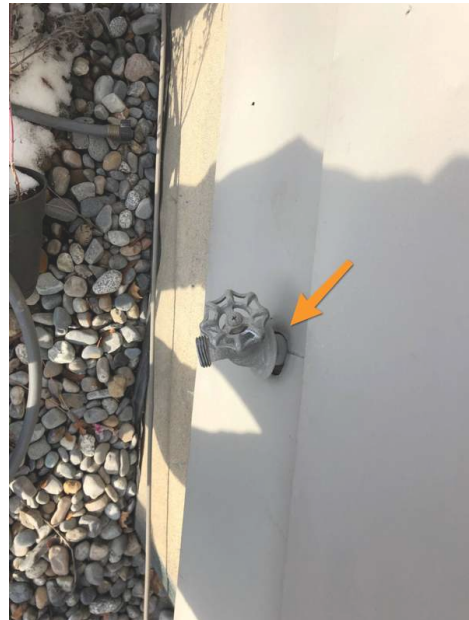
Seal here. Also this is not a frost free hose bib, so good idea to protect in winter, and/or replace in future.

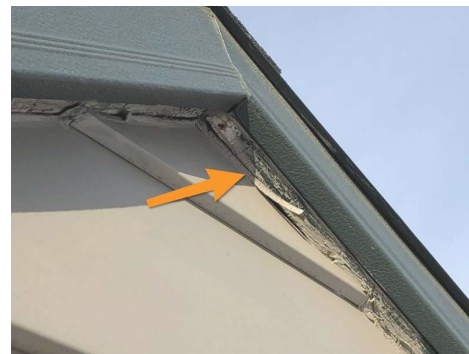
FAILING CAULK

One or more areas of siding had failing caulk. Recommend re-caulking to prevent moisture intrusion.

Failing caulk.

Contact a handyman or DIY project

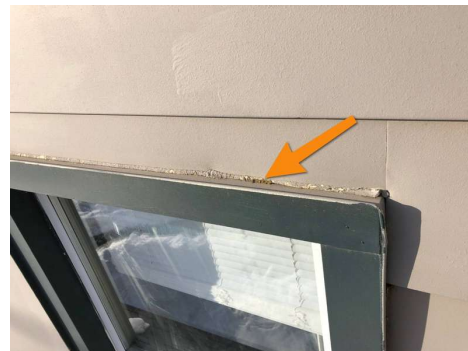
CAULK FAILING

Areas above doors or windows had failing caulk. Recommend re-caulking to prevent moisture intrusion.

Caulk deterioration.

Contact a handyman or DIY project

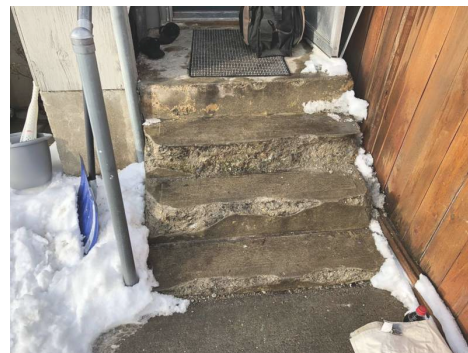
STAIRS - DETERIORATED

One or more sections of the exterior stairs are deteriorated. Also the rise and run ratio of the steps is not correct, which can pose a tripping hazard. Recommend qualified concrete contractor evaluate & repair. I have used [Allwright Concrete](#) in the past.

These concrete steps are shot.

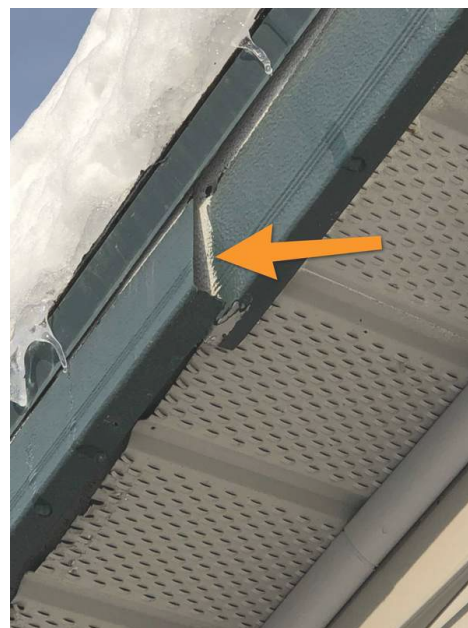
FASCIA - LOOSE

One or more sections of the fascia are loose. Recommend qualified individual evaluate & repair.

Loose fascia.

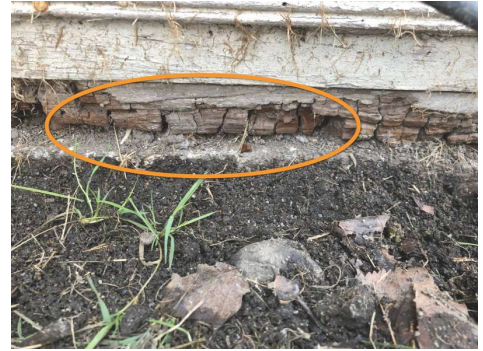
Grading is sloping towards the home in some areas, specifically on the north side of house near chimney. This could lead to water intrusion and left unchecked, eventually foundation issues. At least one window showed evidence of prior moisture exposure and wood rot due to close proximity to earth and negative grading. There were numerous sprinkler heads located in close proximity to the exterior foundation, so vigilant monitoring is recommended to keep the spray pattern away from the house. Recommend replacement of rotted wood and addition of window wells as needed. More importantly, recommend DIY project, or a qualified landscaper regrade so water flows away from home.

This is classic wood rot that needs replacement with pressure treated wood and the underlying moisture needs to be resolved with better grading and or addition of a window well.

Contact a handyman or DIY project

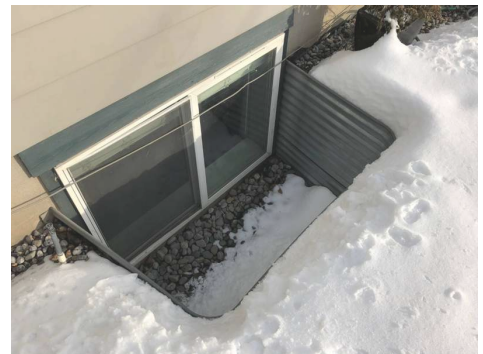
OPEN EGRESS WELL

Egress window well observed to be open (no cover). In areas that are easily accessible, such as this one, it is recommended that a cover be provided to eliminate a fall hazard, and this also helps keep moisture out.

Open egress well

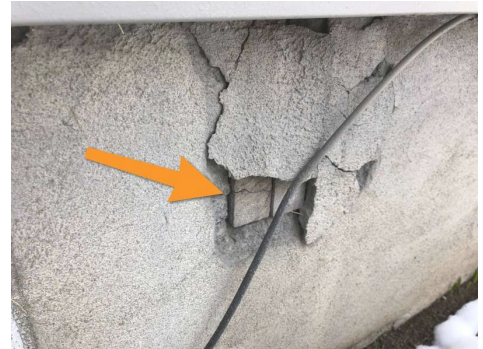
EXTERIOR FOUNDATION VENEER ISSUES

One or more areas of the foundation veneer (cosmetic covering) showed evidence of disrepair. In this case the parge coat of the exterior foundation was deteriorated. Recommend repair as necessary to prevent moisture intrusion. Here is a link to learn more about this kind of [repair products](#), as well as a useful [video](#).

Foundation parge coat is failing. Structural members can be seen. this needs to be sealed up to prevent moisture intrusion.

Contact a qualified professional.

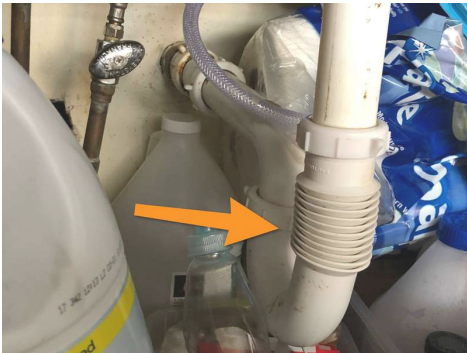
IMPROPER CONNECTION

Improper connections were observed. There are flexible drain trap/discharge tube extensions installed for trap assemblies under the kitchen sink and main floor bathroom vanity. The kitchen sink drain was clogged/slowly draining, and the bathroom vanity drain leaked upon filling the basin and allowing to drain. Although the flexible, accordion-shaped pipe shown in the photo and video is sold in home improvement stores, it is not approved for installation by plumbing codes, which require that any waste pipe fitting have a smooth interior surface that allows the free flow of drain water and prevents waste buildup clogs. A professional plumber can adjust the tailpipe and trap assembly to use all rigid pipe. Recommend a qualified plumber evaluate and repair as necessary. As highlighted in other areas, there is evidence of unprofessional plumbing work done throughout the house, so a more thorough inspection by a plumber for all plumbing is warranted. Justin at [Vertical](#) is my go to plumber.

Flexible trap.

Contact a qualified plumbing contractor.

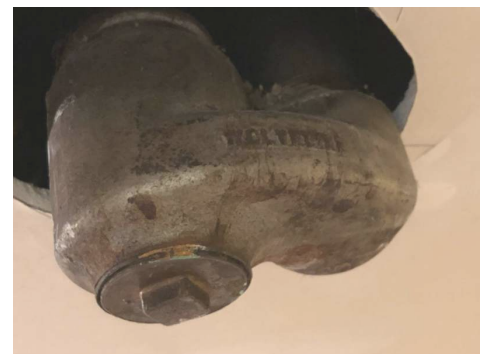
Drum traps are common in older buildings and homes. Generally they are not allowed in modern plumbing. Had a professional plumbing contractor done the plumbing work, this trap would have been replaced. Drum traps usually work just fine, but they're more prone to getting clogged, and can be difficult to service. Recommend wait until a plumber is out doing other work to have your drum trap replaced.

Drum trap below main bath. These are old school.

Contact a qualified plumbing contractor.

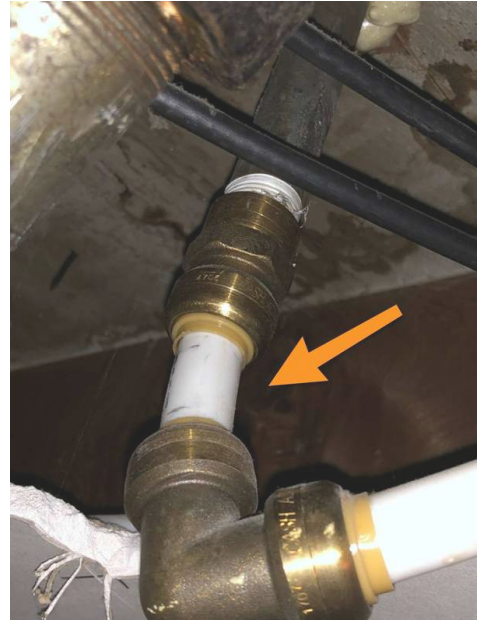
IMPROPER INSTALLATION

Distribution pipes were installed in a sub-standard way. at least one connection appeared to be under strain. Recommend a qualified plumber evaluate and properly fit and install pipes.

This connection should be made more in-line so that the connection is not under stress.

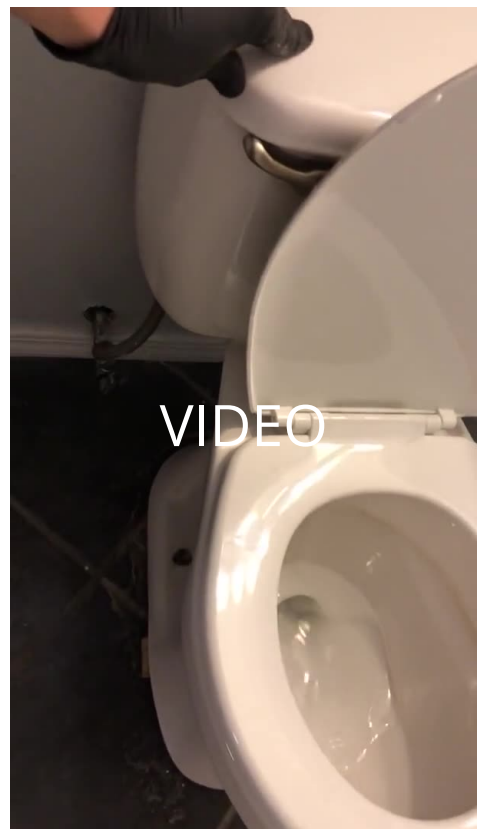
TOILET LOOSE

Toilet is loose at the base. Recommend a qualified plumber evaluate and repair as necessary. Although not leaking currently, it is only a matter of time that the wax seal would be compromised, potentially allowing sewer gas entry into the home as well as leaks.

Contact a qualified plumbing contractor.

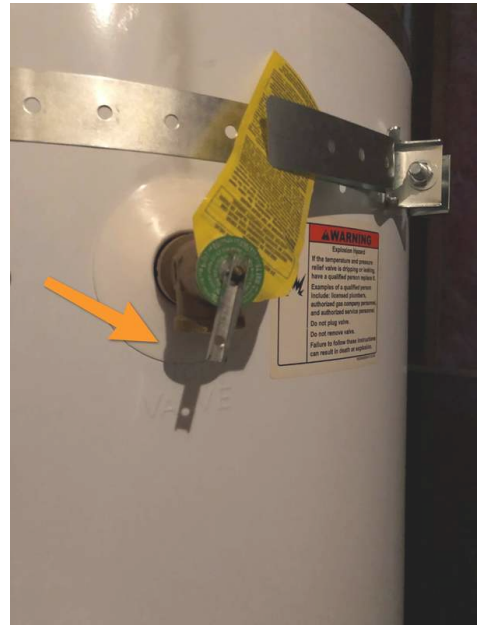
MISSING TPR VALVE DISCHARGE PIPE

At the time of inspection, the hot water heater Temperature Pressure Relief (TPR) valve discharge pipe was observed to be missing. Discharge pipes are required to be installed at a length to within 6 inches from the floor (when an available floor drain is nearby). This is an easy repair. Recommend addition of discharge pipe (DIY/and or have a plumber install it when doing other repairs). The hot water heater appeared to be newer and in good condition otherwise.

Missing discharge pipe here.

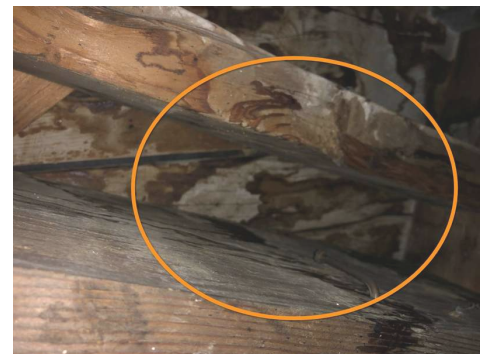
EVIDENCE OF MOISTURE EXPOSURE

In the limited unfinished areas that could be observed, there were signs of previous water staining in the underlying subfloor structure, likely caused by previous plumbing leaks. At the time of inspection, these areas were observed to be dry and were in tact upon probing. Recommend monitoring for any new moisture issues.

Water stains.

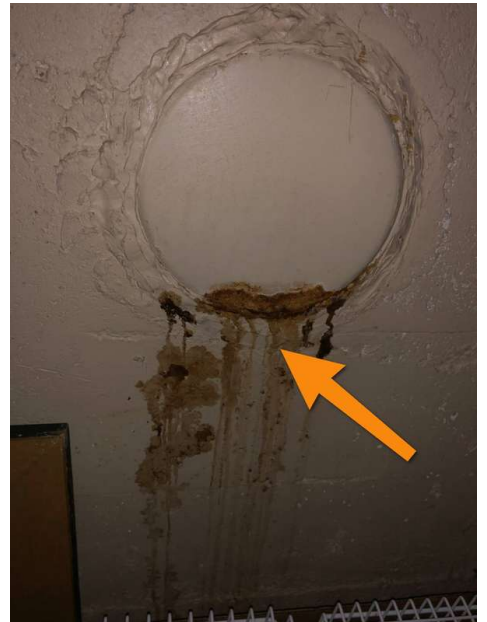
EVIDENCE OF WATER INTRUSION

Wall structure showed signs of water intrusion at an old flue pipe penetration. The structure is currently in tact, however continued and prolonged leaking could lead to structural damage over time. This may be tied to the chimney cap/mortar deterioration. Recommend monitoring for any active leaking and/or a hire qualified individual to identify source of moisture and remedy.

Previous moisture intrusion.

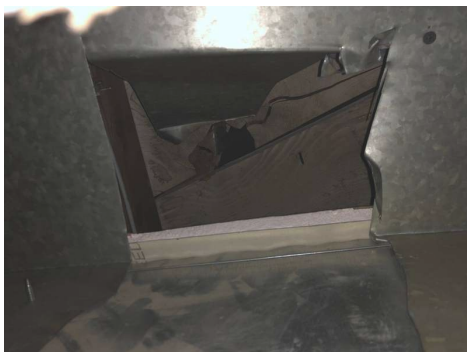
DUCT LEAKING

Supply duct was observed to be leaking air through a cut open flange in the duct. This may have been done to heat the floor space above, or to allow conditioned air to enter a floor joist bay in order to reach a register. In either case this is an inefficiency. Recommend a qualified HVAC technician evaluate and repair as necessary.

This HVAC trunk line has been cut open.

Contact a qualified HVAC professional.

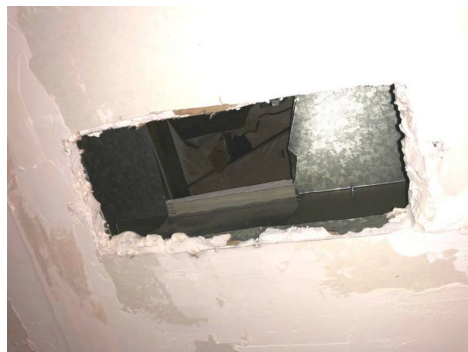
Open ducting above ceiling register.

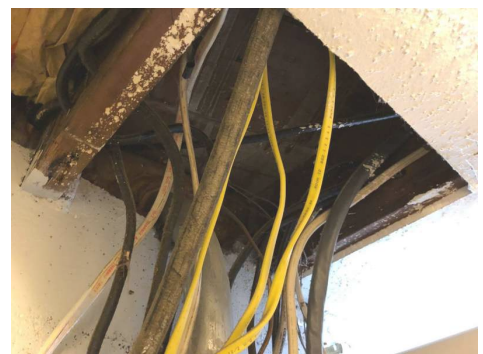
UNPROTECTED OR INADEQUATELY SECURED WIRE

Electrical cables below 8-feet above the floor (in other words, within reach) are required to be protected either inside a wall, floor/ceiling bay, or running in conduit. Recommend electrician evaluate and repair as necessary.

Unprotected wires.

Contact a qualified electrical contractor.

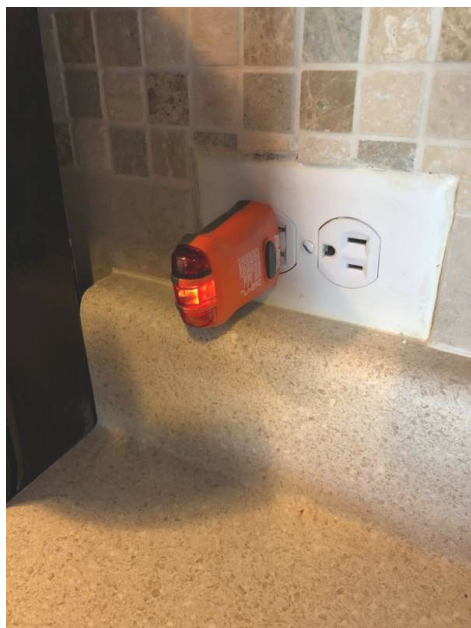
Open grounds were observed in several locations. Ground Fault Circuit Interruptors (GFCI) protection was not present in all required locations. Open grounds in three prong receptacles are a common issue found in older homes. This is an unsafe condition and should be corrected. The repair is fairly simple and does not require rewiring the home as some mistakenly believe. Only those circuits with the ungrounded receptacles are required to be addressed. Recommend licensed electrician upgrade by installing ground fault receptacles in all required locations.

Open Ground/No GFCI.

Contact a qualified electrical contractor.

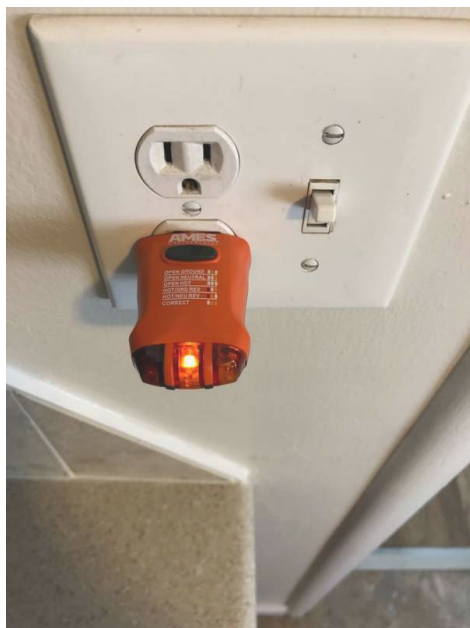
Open Ground.

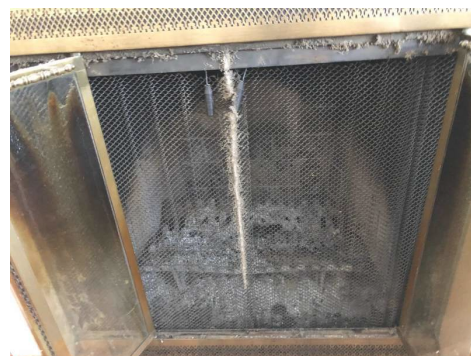
Chimney box and liner had layer of creosote and dust, so underlying structure couldn't be inspected for cracks. Recommend qualified chimney sweep company inspect and/or clean annually. I personally use [Oakenshield Chimney Service](#) for my own home.

Contact a qualified chimney sweep.

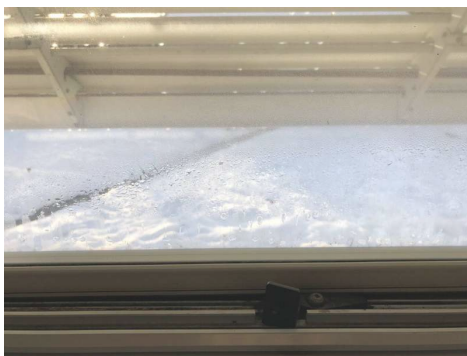
FAILED SEAL

Observed condensation between the window panes of some windows, which indicates a failed seal. Recommend qualified window contractor evaluate & replace as necessary.

Condensation between window panes.

Contact a qualified window repair/installation contractor.

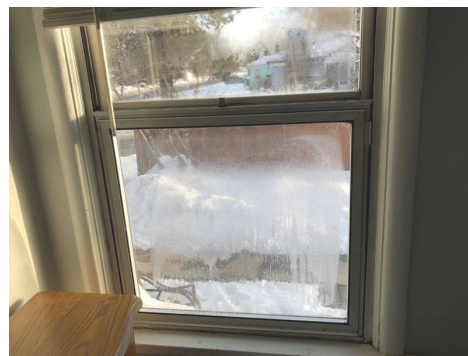
Seals blown between panes.

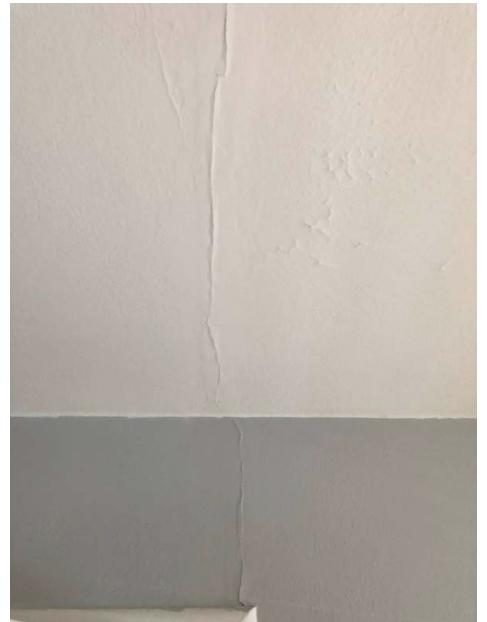
MINOR CORNER CRACKS

Minor cracks at the corners of doors and windows in walls. Appeared to be the result of long-term settling. Some settling is not unusual in a home of this age and these cracks are not a structural concern.

Minor plaster cracking.

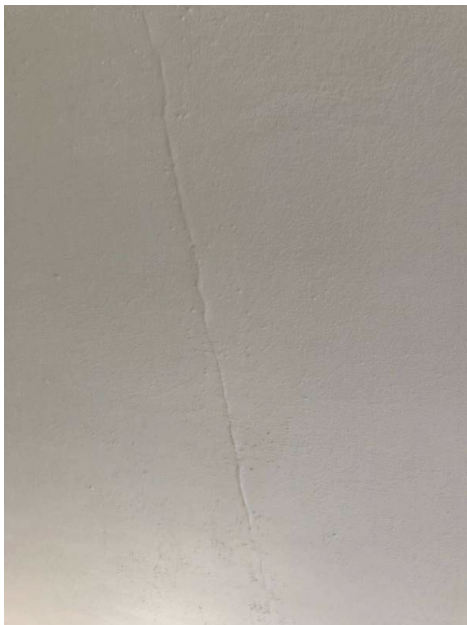
MINOR DAMAGE

Minor damage or deterioration to the ceiling was visible at the time of the inspection. Recommend DIY/handyman patch or paint as necessary.

Minor surface crack.

Contact a handyman or DIY project

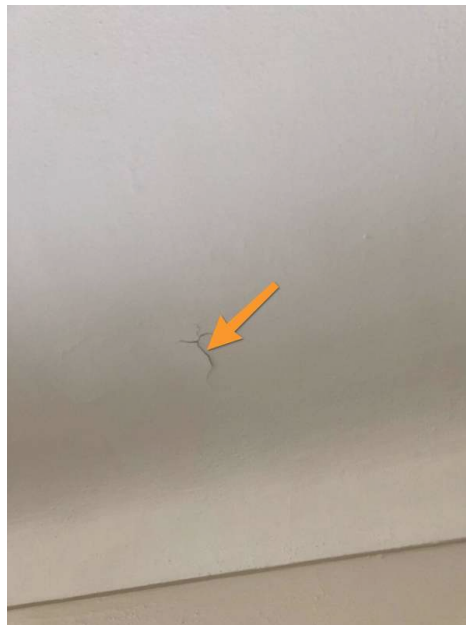
Cracks.

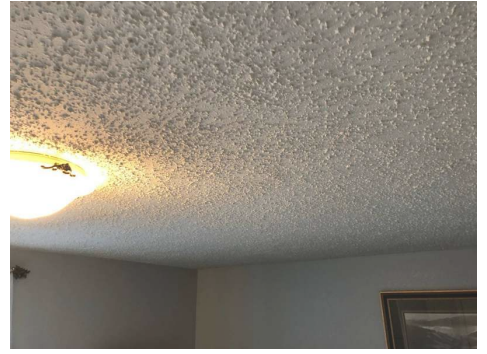
POPCORN TEXTURE

The general condition of most ceilings appeared to be in serviceable condition at the time of inspection. NOTE- some forms of the ceiling coating and materials installed prior to 1978 have been known to contain asbestos. Typically this is only an issue during remodeling when the materials may be disturbed. Testing for this hazardous material is beyond the scope of this inspection. Please refer to the [Washington State Department of Health](#) recommendations regarding this issue.

Textured ceilings.

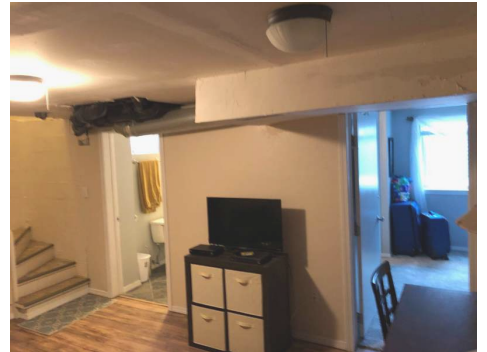
SUB-STANDARD DRYWALL REPAIR

Sub-standard drywall finishing observed at time of inspection in basement ceilings. Recommend re-patching/finishing as needed.

Basement ceiling drywall.

Contact a qualified drywall contractor.

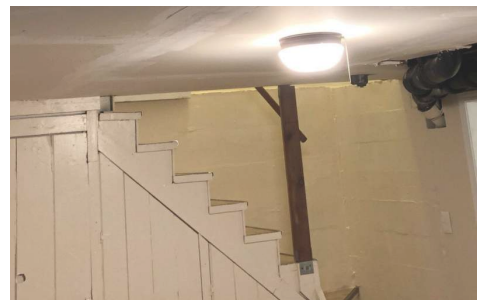
HANDRAIL/BALUSTER CONSTRUCTION UNSAFE

The overall construction of handrail and/or baluster spacing is not up to modern safety standards. The space between balusters should not allow passage of a 4 inch sphere for child safety. Recommend a qualified handyman or contractor repair and bring up to code.

Stairs have no balusters.

Contact a qualified professional.

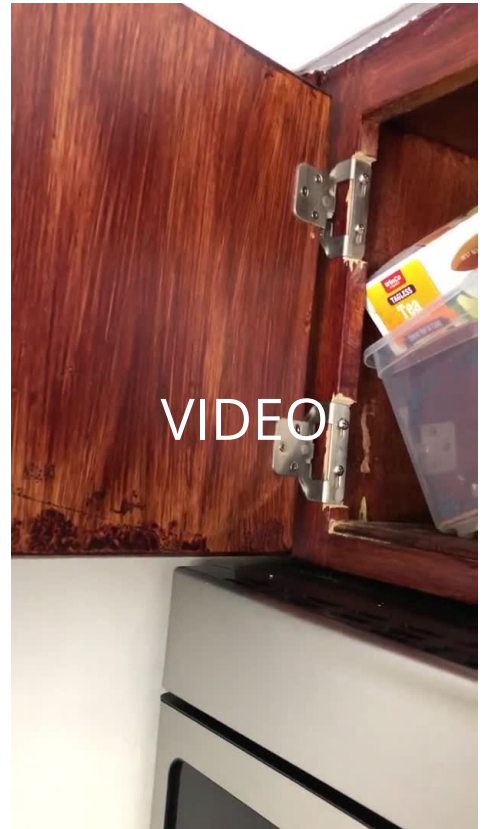
CABINET HINGE LOOSE

One or more cabinet hinges were loose. Recommend a qualified handyman or DIY repair.

[Here is a helpful DIY article on cabinet repairs.](#)

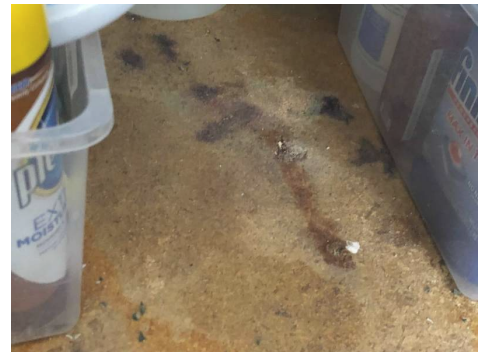
CABINETS DAMAGED

Cabinets had visible damage at time of inspection. Specifically under the sink there was evidence of previous moisture exposure from prior plumbing leaks.

Moisture damaged cabinet floor.

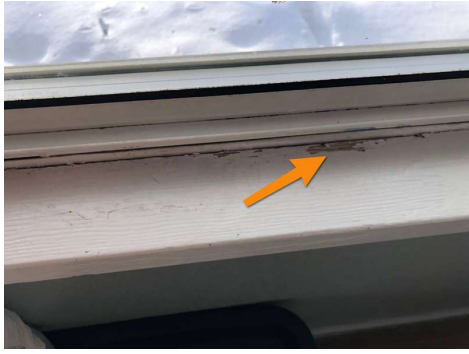
FAILING PAINT/FINISH

One or more areas of trim showed excessive wear or failing paint/finish. This is a cosmetic issue only. Also there was trim missing in some locations. Recommend maintenance with appropriate paint/finish.

Paint failing.

Contact a handyman or DIY project

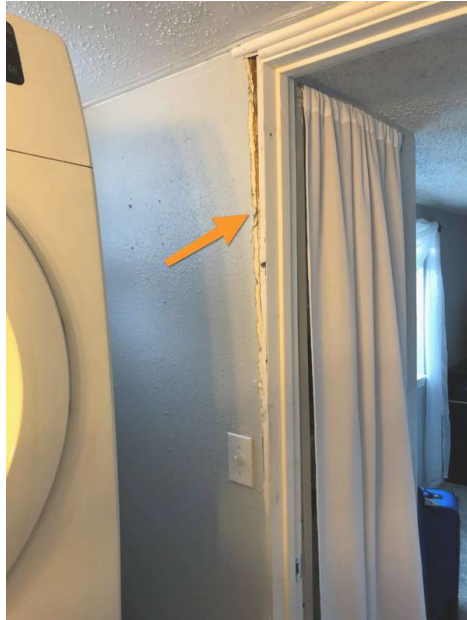
Missing door trim.

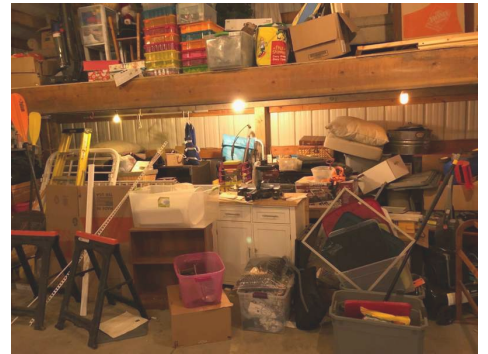
PERSONAL ITEMS OBSTRUCTING VIEW

The garage appeared to be in excellent condition, however it is worth noting that at the time of inspection personal items obstructed complete view of garage walls and floor

Personal items present.
