NEXT CHAPTER HOME INSPECTIONS PLLC

PROPERTY INSPECTION REPORT

Concerning: 1234 Main St. Richardson TX 75080
(Address or Other Identification of Inspected Property)

By: Eric Lundquist - TREC# 23575 04/28/2019 9:00AM
(Name and License Number of Inspector) (Date)

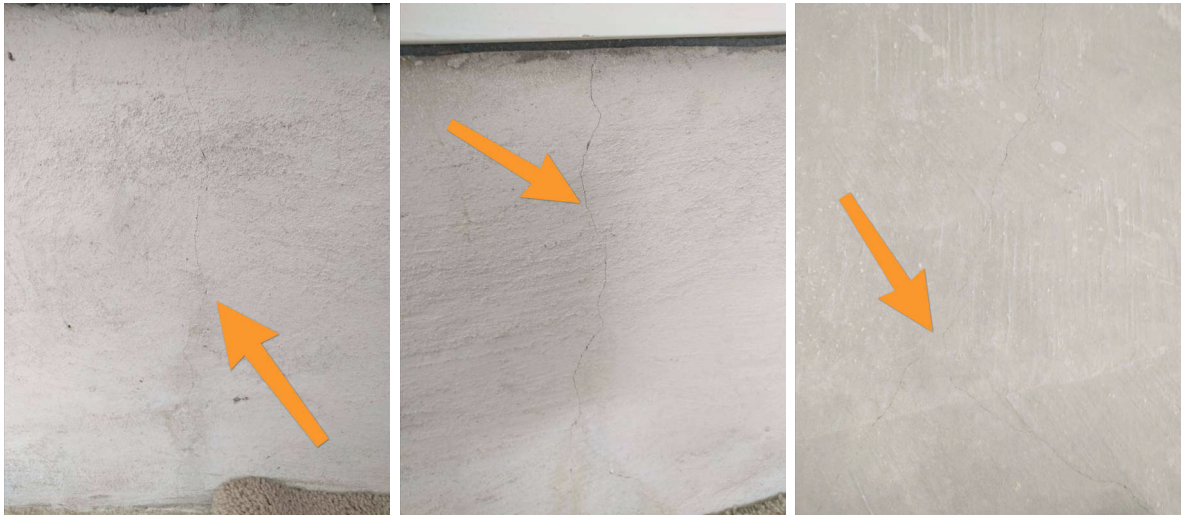
1: Foundation Cracks - Minor

Minor cracking was noted at the foundation. This is common as concrete ages and shrinkage surface cracks are normal. Recommend monitoring for more serious shifting/displacement.

Recommendation: Contact a qualified structural engineer.

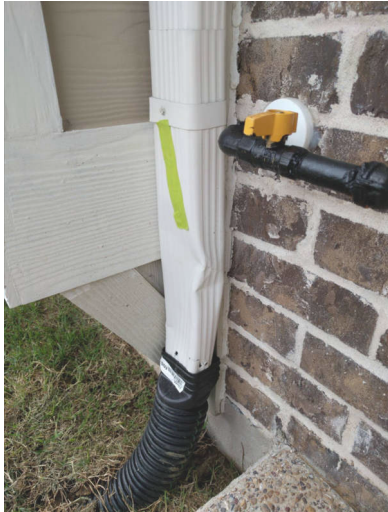
1: Damaged Gutter or Downspout

Gutters or downspouts appear to be damaged. This could obstruct the flow of shedding water. Recommend having landscape experts evaluate and repair.

Recommendation: Contact a qualified landscaping contractor

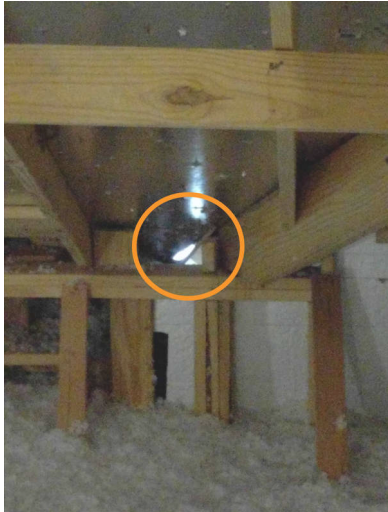
1: Possible Rodent Entry

Gaps in attic structure big enough to allow possible rodent entry.

Recommendation: Contact a qualified handyman.

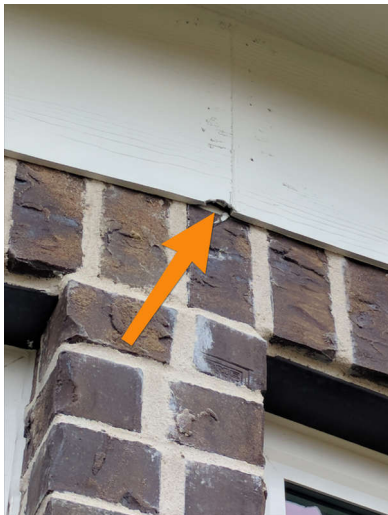
1: Broken/Craked Siding

there was a few areas on the exterior walls that were not properly caulked or sealed upon installation. Including the window lintils on the second story by the back porch.

All damage / cracked siding should be repaired or replaced in any crack seal to keep the integrity of the weather envelope provided by exterior wall coverings.

Recommendation: Contact a qualified siding specialist.

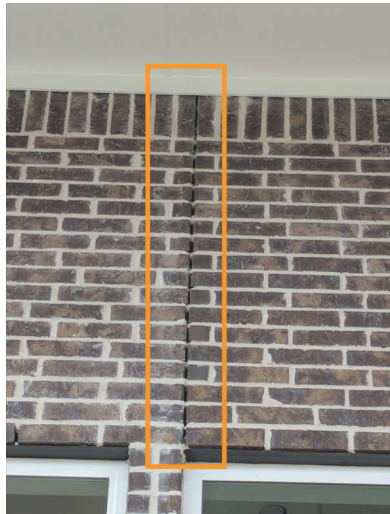
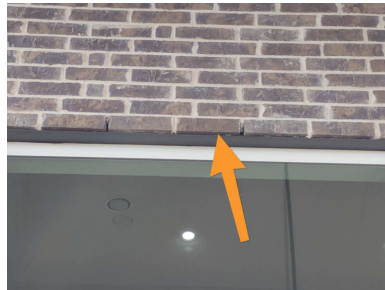
2: Gaps at Exterior Wall

Seal all gaps at joints and utility penetrations to prevent moisture and pest intrusion.

Recommendation: Contact a qualified professional.

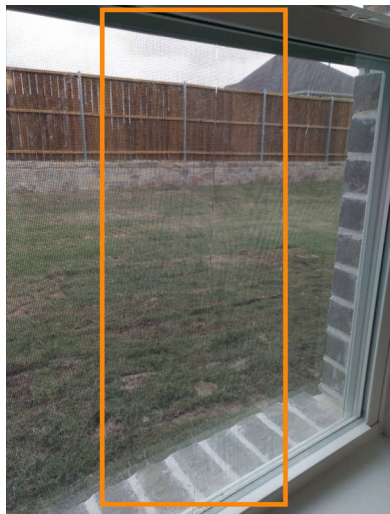
1: Damaged

Master Bedroom

One or more windows appears to have general damage, but are operational. Recommend a window professional clean, lubricate & adjust as necessary.

Recommendation: Contact a qualified window repair/installation contractor.

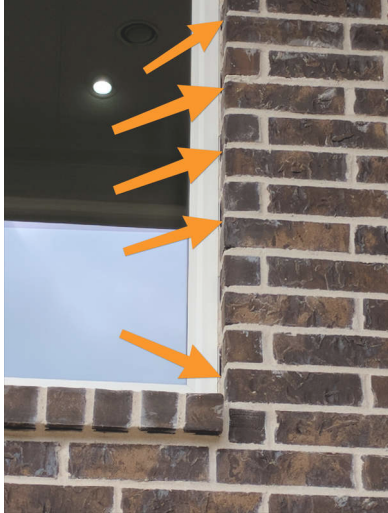
2: Improper Installation

2nd Floor Porch Windows

Windows appear to not be operating properly due to substandard installation. Recommend window specialist evaluate.

Recommendation: Contact a qualified window repair/installation contractor.

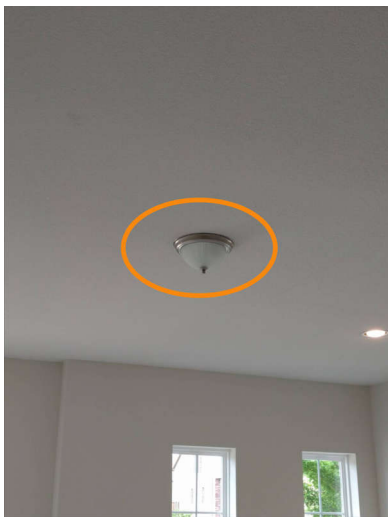
1: Light Inoperable

Game room

One or more lights are not operating. New light bulb possibly needed.

Recommendation: Contact a qualified electrical contractor.

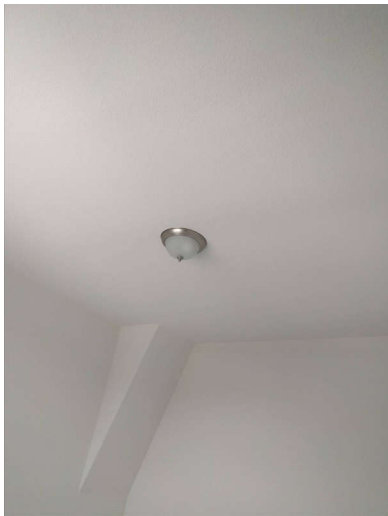
1: Improper Venting

2nd Floor

One or more areas had improper or substandard venting, which can lead to inefficient heating/cooling. If room is intended for only storage please disregard.

Recommendation: Contact a qualified professional.

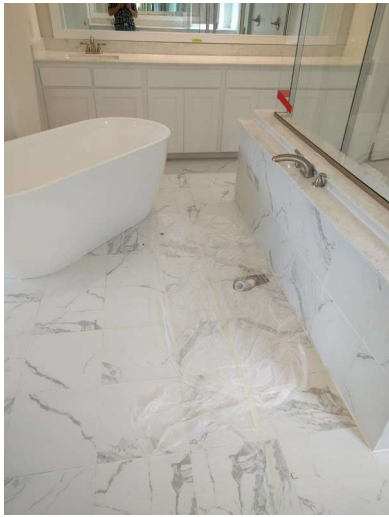
Master Bathroom

Comments:
Unable to test bathtub plumbing not yet installed.

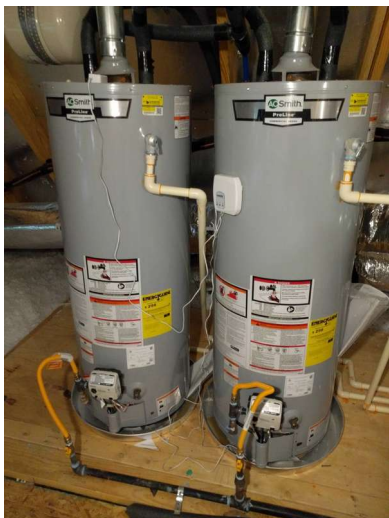
Attic

C. Water Heating Equipment
Energy Sources: Gas
Capacity: 50 Gallons
Comments:
Two 50-gallon units located in attic.

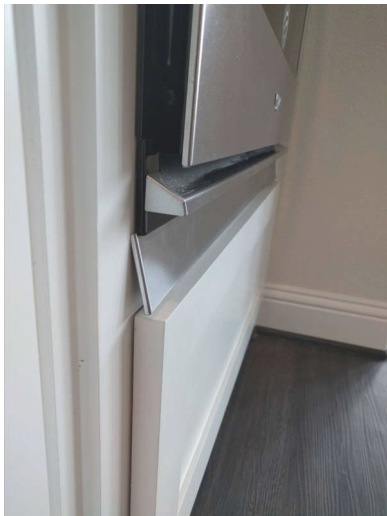
1: Improper Installation

Oven or microwave trim not flush. This is a brand new install. There is no reason at this time for trim not to be properly installed.

Recommendation: Contact a qualified cabinet contractor.
