SMART INSPECTIONS LLC

RESIDENTIAL COPY

1234 Main St.
Waterford Works New Jersey 08089

01/13/2019 9:00AM

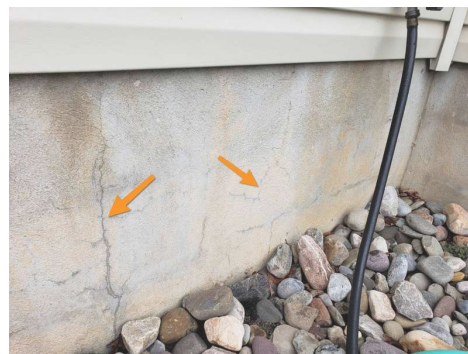
2.1.1 Foundation Walls

EXTERIOR FOUNDATION - SHRINKAGE CRACKS

The foundation wall exhibited signs of shrinkage cracking. Shrinkage cracks appear as part of the natural concrete curing process and are not a structural concern. The inspector recommends monitoring the cracks for future displacement or shifting by a qualified professional.

Contact a foundation contractor.

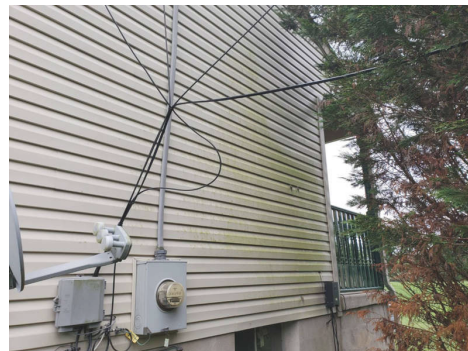
2.2.1 Exterior Cladding

The vinyl siding exhibited signs of organic growth at one or more locations. This condition may discolor and shorten the life expectancy of the siding. The inspector recommends cleaning of the affected areas by a qualified professional.

Contact a qualified cleaning service.

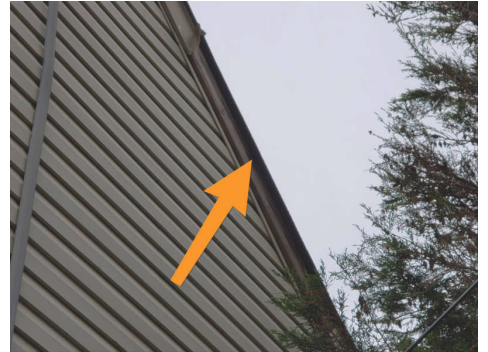
2.4.1 Trim and Flashing

TRIM - MISSING

A section of the rack board trim is missing. This condition may allow moisture intrusion to damage surrounding components. The inspector recommends further evaluation and repair of the trim by a qualified professional.

Contact a qualified siding specialist.

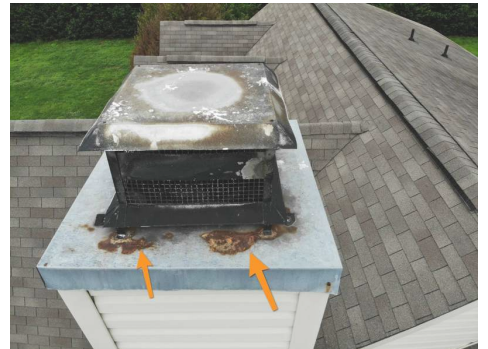
2.8.1 Chimney Exterior

CHIMNEY CROWN - MINOR CORROSION

The chimney crown exhibited signs of corrosion. This condition may allow moisture intrusion, which may cause damage to surrounding components. The inspector recommends further evaluation and repair of the chimney crown by a qualified professional.

Contact a qualified chimney contractor.

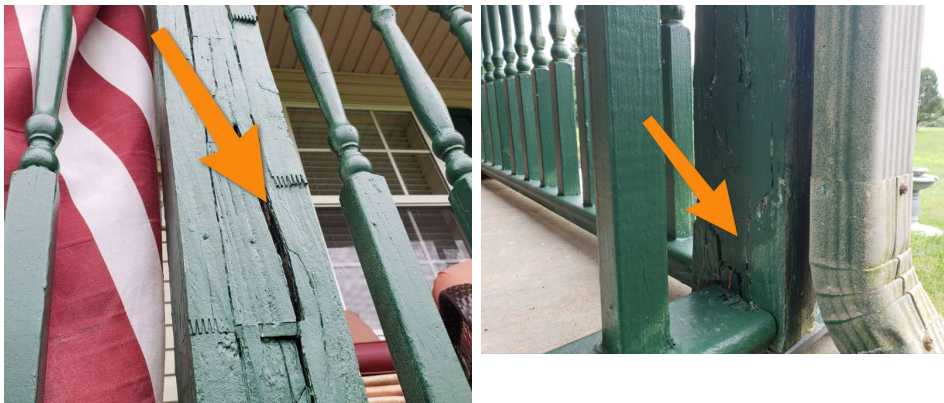
2.9.1 Decks, Patios and Porches

One or more porch roof support posts exhibited signs of wood rot. This condition is likely caused by moisture intrusion and will only worsen over time. The inspector recommends further evaluation and repair of the damaged posts by a qualified professional.

Contact a qualified carpenter.

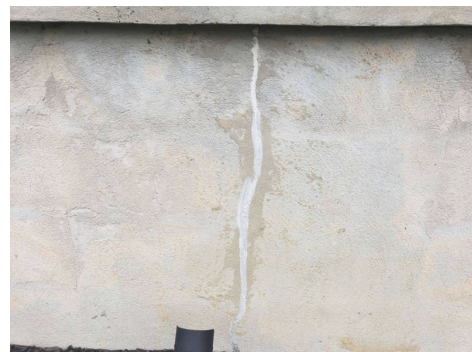
2.9.2 Decks, Patios and Porches

PORCH - EVIDENCE OF PAST REPAIR

The front porch exhibited signs of past repair, likely from settlement. Additional settlement may cause the mortar joints to deteriorate. The inspector recommends the affected areas be monitored for further settlement or separation of mortar joints by a qualified professional.

Contact a qualified concrete contractor.

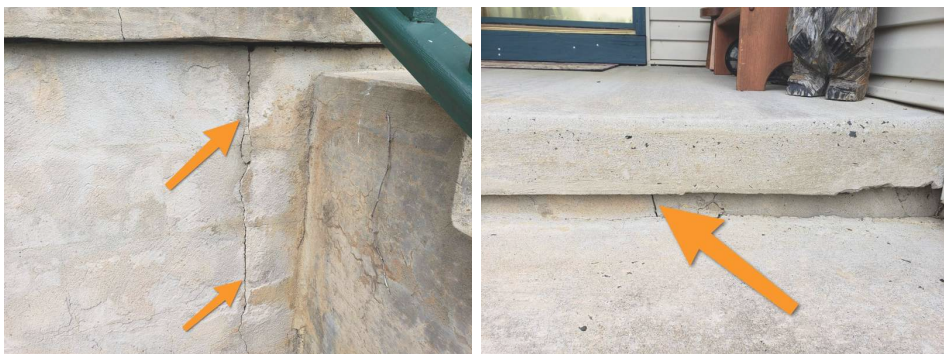
2.9.3 Decks, Patios and Porches

PORCH - MINOR CRACK

The porch had one or more minor cracks. This condition may allow moisture intrusion and cause additional damage to the concrete porch. The inspector recommends the cracks be further evaluated and repaired by a qualified professional.

Contact a qualified concrete contractor.

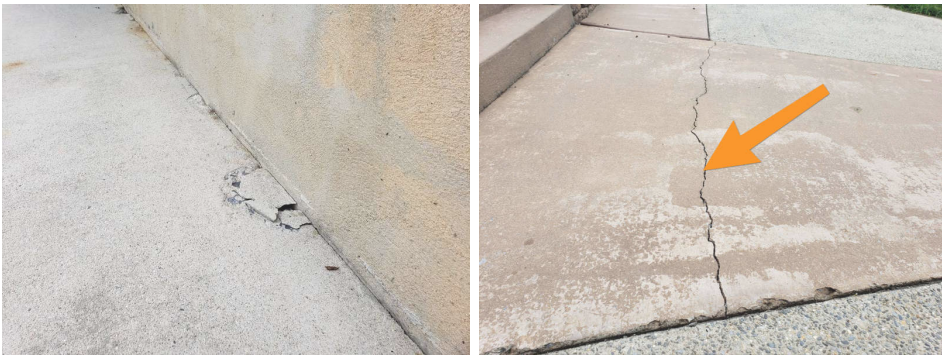
2.10.1 Walkways, Steps and Railings

WALKWAY - CRACKING

One or more sections of the concrete walkway were cracked. This condition may allow moisture intrusion, which could cause upheaval. The inspector recommends further evaluation and repair by a qualified professional.

Contact a qualified concrete contractor.

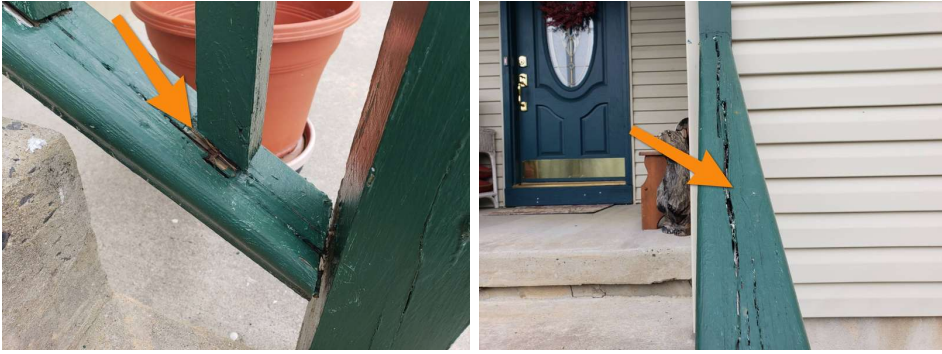
2.10.3 Walkways, Steps and Railings

RAILING - WOOD ROT

The front railing exhibited signs of wood rot in one or more locations. This condition may cause structural failure of the railings. The inspector recommends further evaluation and repair by a qualified professional.

Contact a qualified carpenter.

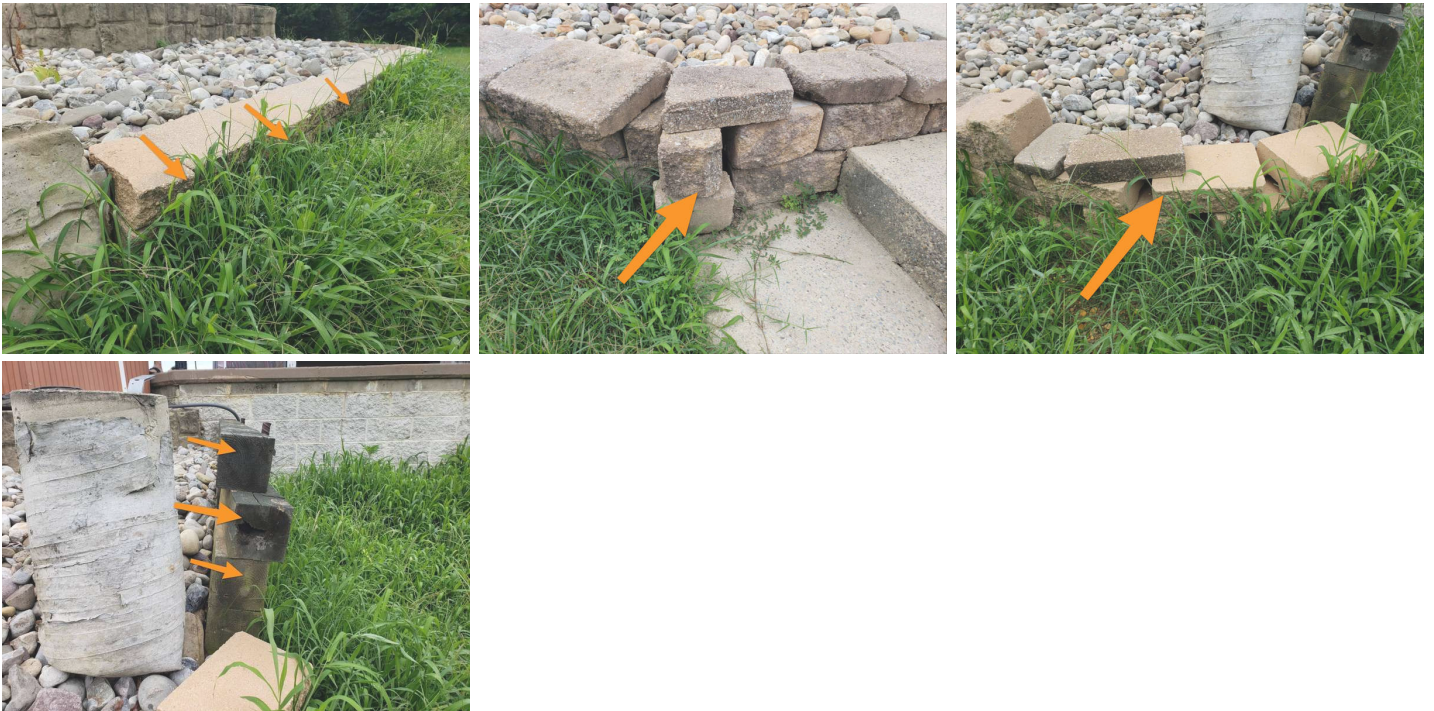
2.12.1 Landscaping and Retaining Walls

RETAINING WALL - DETERIORATION

One or more retaining walls are exhibiting signs of deterioration. This condition may cause the retaining walls to fail when under additional loads. The inspector recommends further evaluation and repair of the retaining walls by a qualified professional.

Contact a qualified professional.

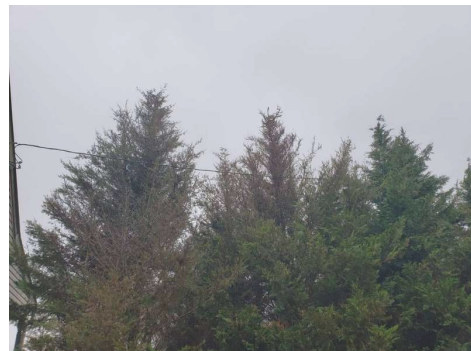
2.12.2 Landscaping and Retaining Walls

Decorative vegetation is either too close or touching the siding or foundation. Vegetation too close to the structure can lead to excess moisture around the soil and foundation. The inspector recommends that all vegetation be cut back or removed by a qualified handyman or contractor. There should be a minimum of a two foot buffer between the structure and vegetation.

Contact a qualified professional.

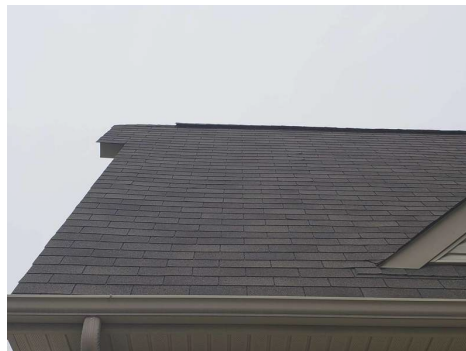
Although functional, standard three tab roof shingles had widening gaps between tabs and missing granules, which indicate they are near the end of their functional life expectancy. The shingles are likely original to the structure, approx. 17 years old. The life expectancy of three tab shingles is about 20 years. Continued use of the shingles without replacement may lead to moisture penetration into the interior space. The inspector recommends further evaluation of the asphalt shingles by a qualified professional.

Contact a qualified roofing professional.

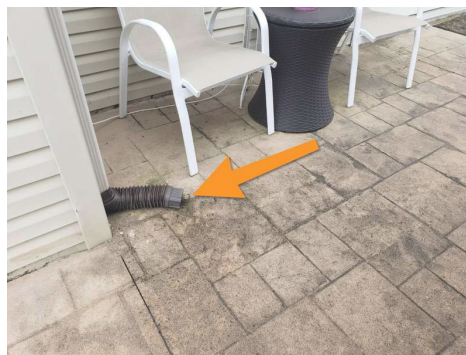
3.2.1 Roof Drainage Systems

One or more downspouts drain too close to the home's foundation. This can result in excessive moisture in the soil at the foundation, which can lead to foundation/structural movement. The inspector recommends a qualified contractor adjust downspout extensions to drain at least 6 feet from the foundation.

Contact a qualified gutter contractor

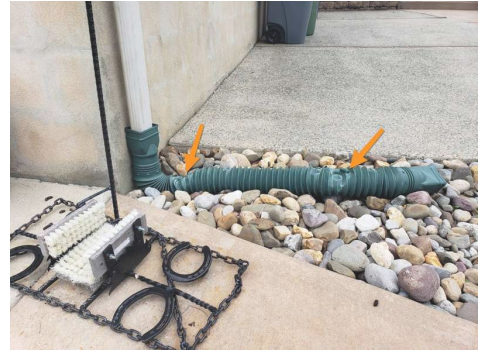
3.2.2 Roof Drainage Systems

One or more downspout extension pipes were crushed. This condition may cause water to back up, causing the roof drainage system to fail. The inspector recommends further evaluation and repair of the entire roof drainage system by a qualified professional.

Contact a qualified gutter contractor

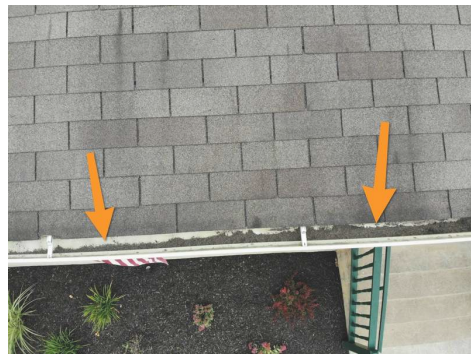
3.2.3 Roof Drainage Systems

GUTTER - LOOSE GRANULES

One or more gutters exhibited signs of containing loose shingle granules. This condition is characteristic of an aging roof. The granules should be cleaned from the gutters so they don't impede the flow of water runoff. The inspector recommends further evaluation and repair by a qualified professional.

Contact a qualified roofing professional.

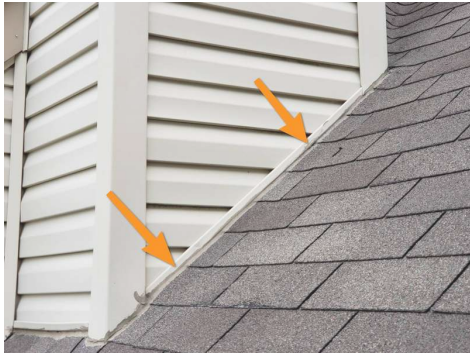
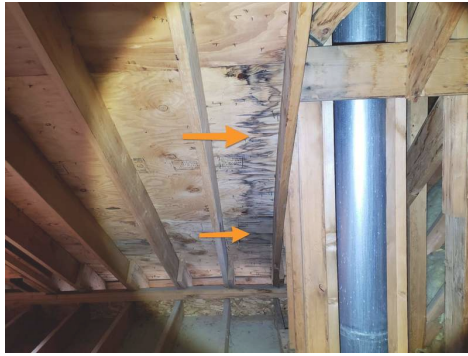
3.3.2 Roof Flashings

The joint around the chimney is sealed with silicon. Silicon is not the preferred method for sealing the connection between the siding and chimney. This condition is likely an attempt to stop moisture intrusion that has caused damage to the roof structure over the garage. The inspector recommends further evaluation and repair of the affected areas by a qualified professional.

Contact a qualified roofing professional.

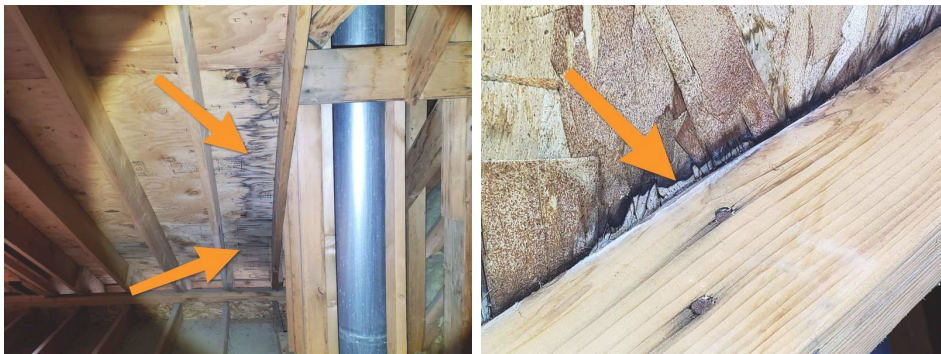
ROOF SHEATHING - MOISTURE INTRUSION

At the time of the inspection, one or more sections of the roof sheathing exhibited signs of moisture intrusion. This condition, if it has not already been repaired, may lead to the growth of mold and/or water damage to surrounding components. The inspector recommends further evaluation of the roof sheathing by a qualified professional.

Contact a qualified roofing professional.

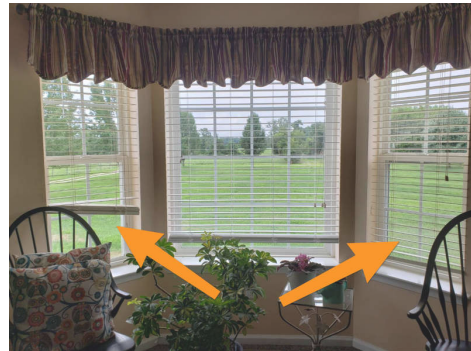
5.1.1 Windows

One or more of the windows at the time of the inspection were not operational. Inoperable windows may prevent egress during emergency situations. The inspector recommends that all of the windows be evaluated and repaired by a qualified professional.

Contact a qualified window repair/installation contractor.

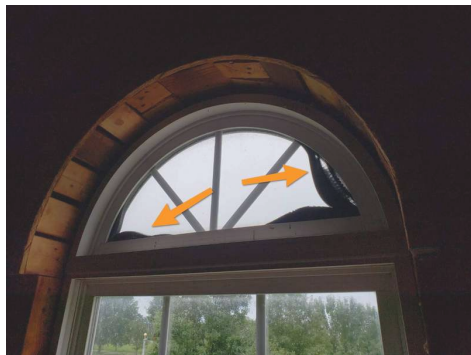
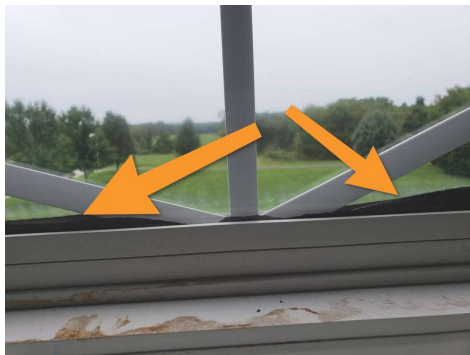
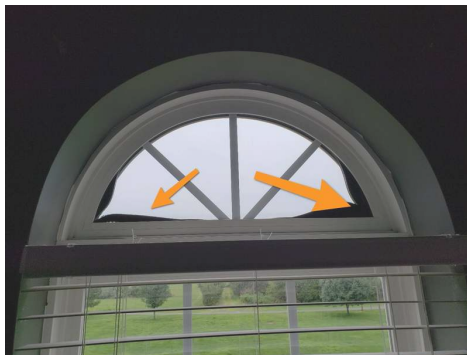
5.1.2 Windows

WINDOW - DAMAGED SEALANT

One or more windows exhibited signs of damaged sealant. This condition may compromise the thermal efficiency of the windows. The inspector recommends further evaluation and repair by a qualified professional.

Contact a qualified window repair/installation contractor.

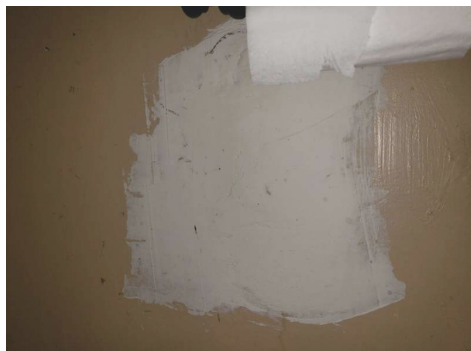
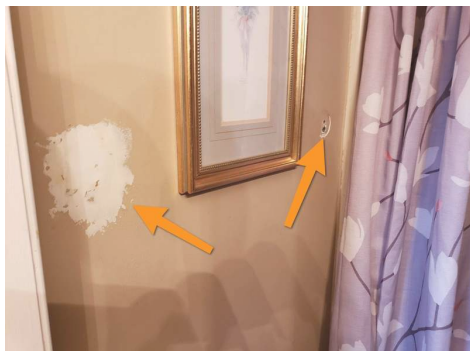
5.5.1 Walls

One or more sections of dry patching was sub-standard. This condition is an indication of poor workmanship, likely not done by a qualified professional. The inspector recommends the drywall be re-patched using proper techniques by a qualified professional.

Contact a qualified drywall contractor.

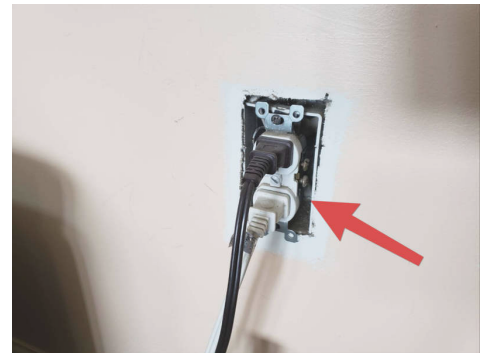
6.6.2 Lighting Fixtures, Switches & Receptacles

RECEPTACLE - MISSING COVER PLATE

One or more receptacle cover plates were missing. This condition may cause an electrical short or shock hazard. The inspector recommends evaluation and repair of all cover plates by a qualified professional.

Contact a qualified electrical contractor.

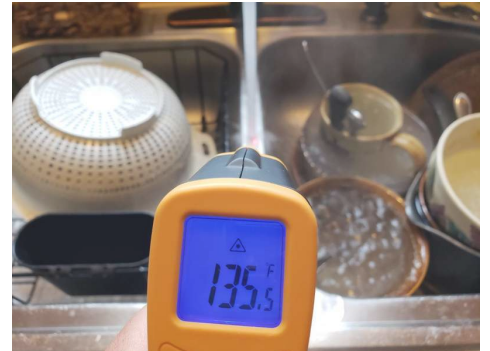
7.5.1 Water Heater

At the time of the inspection the temperature of the water in the kitchen was 135 Degrees F. This condition may be a scalding hazard. The inspector recommends further evaluation and repair by a qualified professional.

Contact a qualified plumbing contractor.

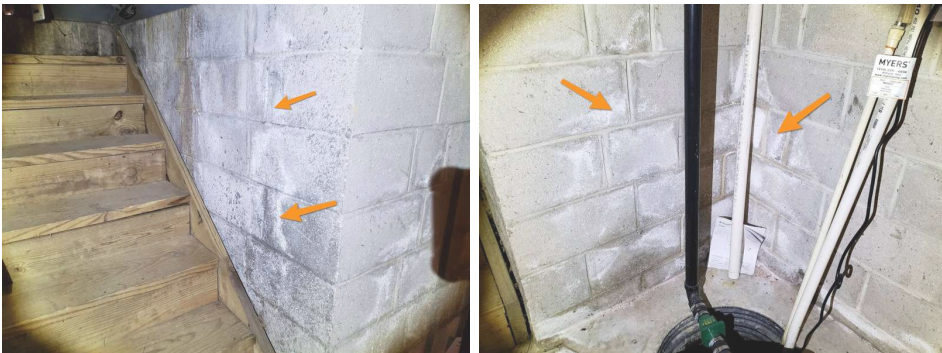
8.1.1 Foundation Walls

One or more foundation walls showed signs of efflorescence. Efflorescence is a white, powdery deposit that is consistent with moisture intrusion. This can compromise the soil's ability to support the home structure and/or lead to mold growth. The inspector recommends the affected walls be evaluated by a qualified contractor to identify the source of moisture and repair.

Contact a foundation contractor.

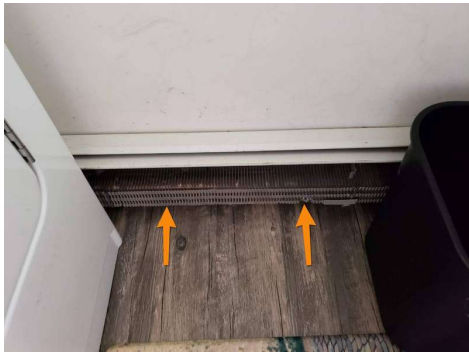
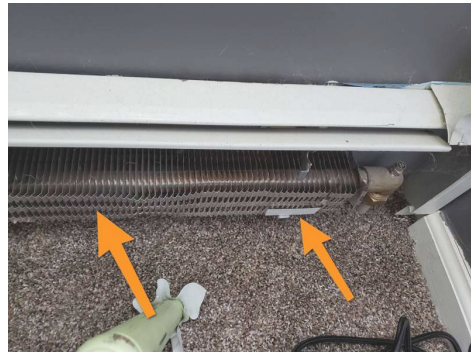
One or more sections of baseboard heating elements were not covered. This condition is a burn hazard especially to small children. The elements are also susceptible to damage if not covered. The inspector recommends further evaluation and repair of all of the baseboard heating elements by a qualified professional.

Contact a qualified heating and cooling contractor

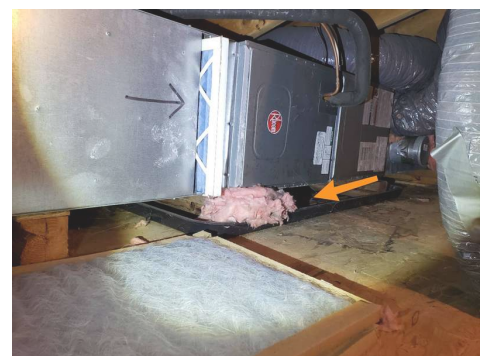
The air handler does not have an high water alarm on the condensation overflow pan. This condition may allow condensation to overflow the pan without being noticed until damage is done to surrounding components. The inspector recommends further evaluation and repair by a qualified professional.

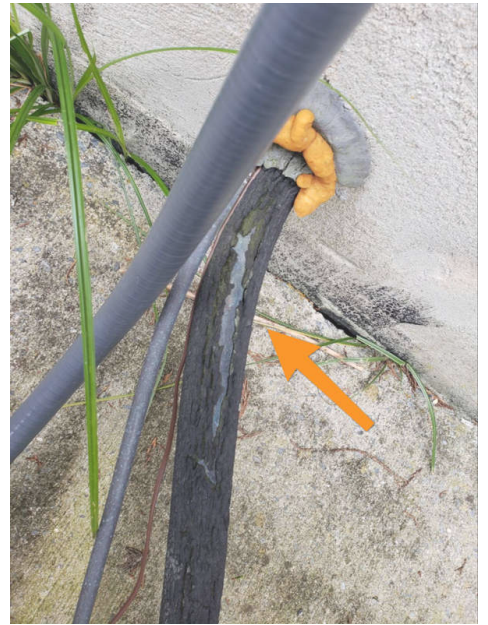
10.3.1 Refrigerant Lines

MISSING SUCTION LINE INSULATION

The suction line insulation is not adequate and is in poor condition. This condition may cause the condensing coil to operate less efficiently. The inspector recommends complete insulation of the refrigerant line by a qualified handyman or contractor.

Contact a handyman or DIY project

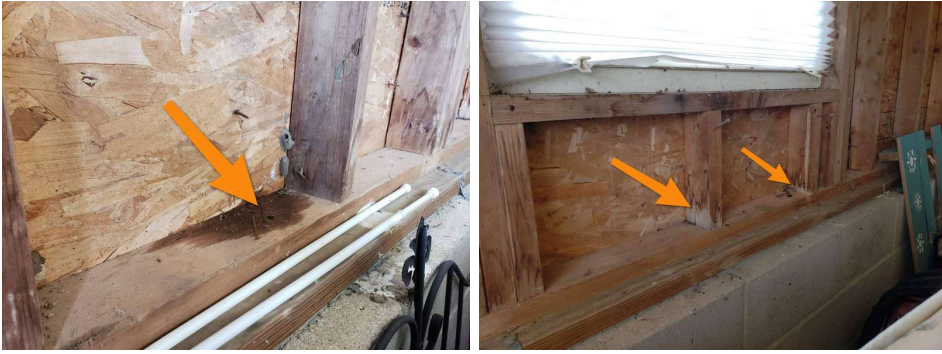
12.3.1 Walls & Firewalls

GARAGE WALL - MOISTURE INTRUSION

Contact a qualified carpenter.

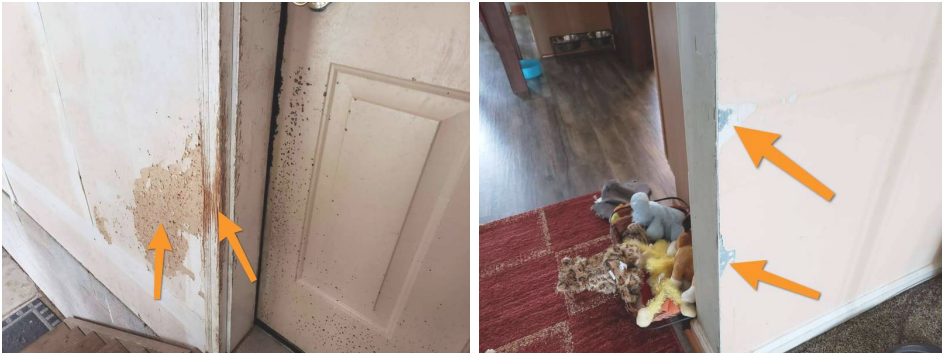
12.3.2 Walls & Firewalls

INTERIOR WALL - PET DAMAGE

Contact a qualified carpenter.

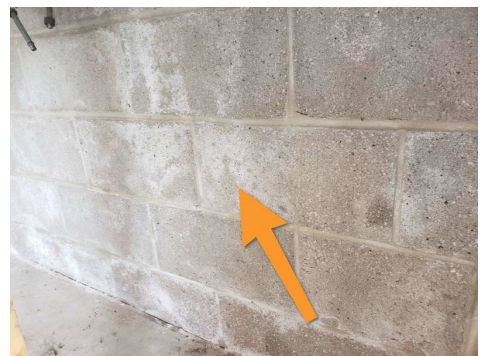
12.6.1 Foundation Wall

WALL - EFFLORESCENCE

Contact a foundation contractor.
