HOMESCAN HOME INSPECTION SERVICES, LLC

HOMESCAN RESIDENTIAL INSPECTION REPORT

1234 Main St.
Warrior AL 35180

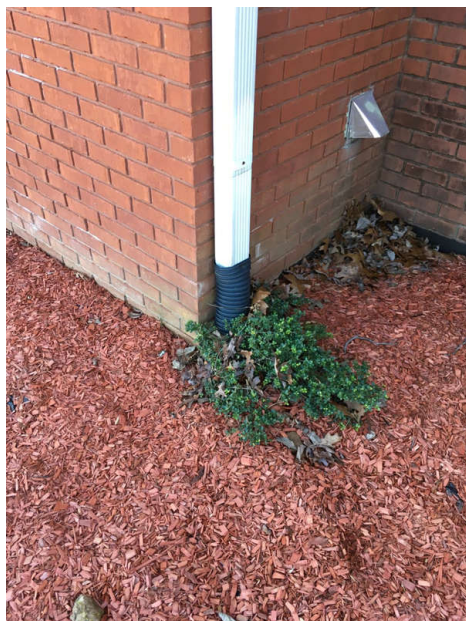
Front Left

Multiple gutters terminate into underground drainage tubes and I am unable to determine efficiency of the systems.

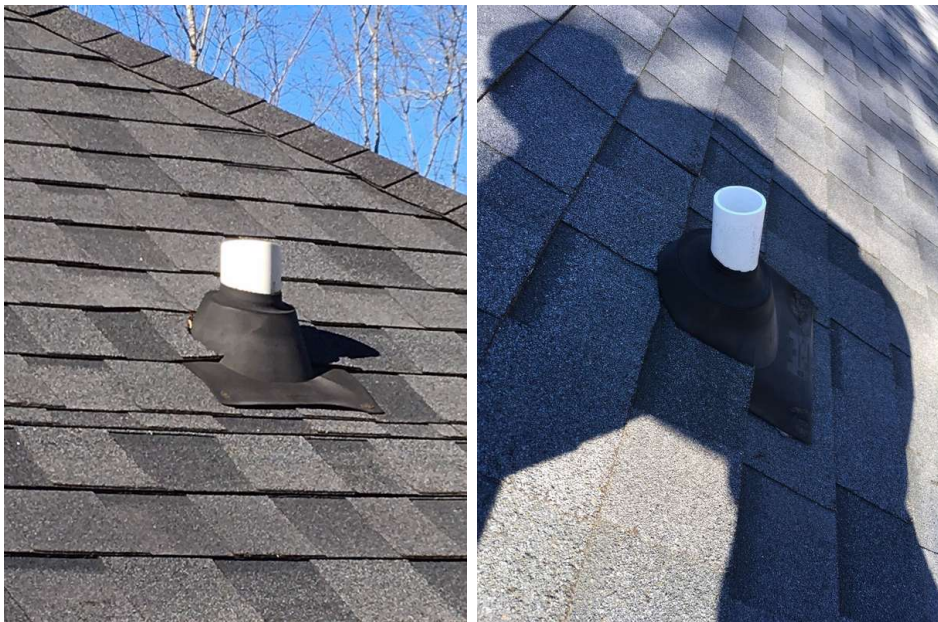
All vents and exhaust penetrations through the roof have no obvious defects.

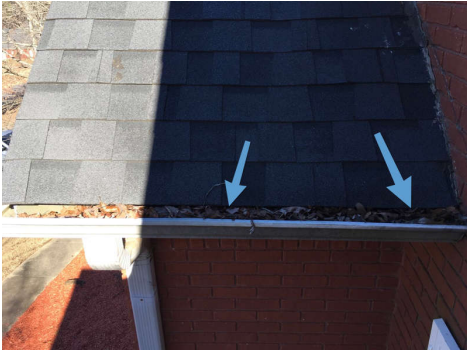
Front Left

2.2.1 Roof Drainage Systems

Contact a handyman or DIY project

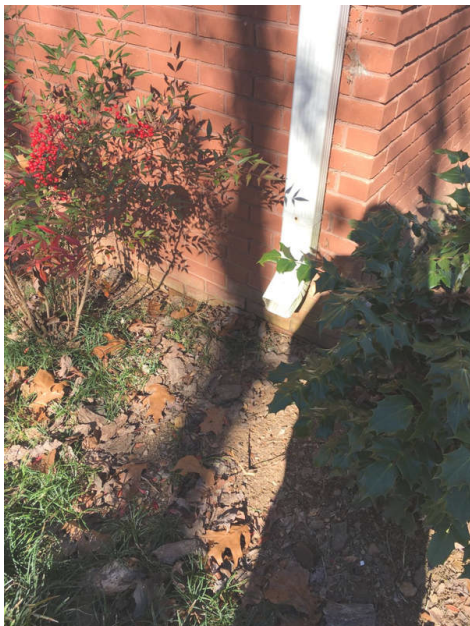
Right Rear

One or more downspouts drain too close to the home's foundation. This can result in excessive moisture in the soil at the foundation, which can lead to foundation/structural movement. The two gutters at the rear of the structure appear to be one of the causes for excess moisture in the basement. Recommend a qualified contractor adjust downspout extensions to drain at least 6 feet from the foundation.

Contact a handyman or DIY project

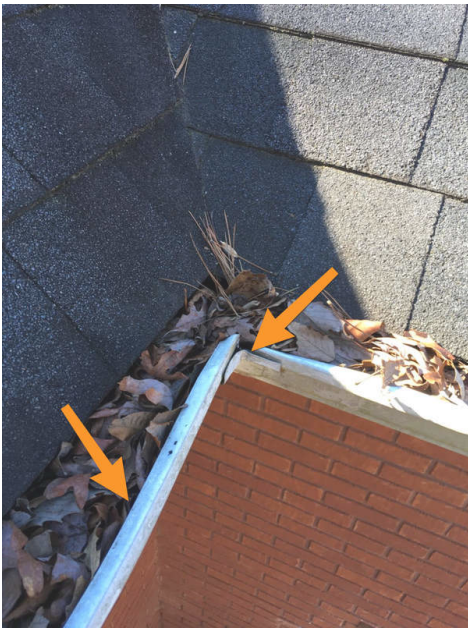
Rear

GUTTER DAMAGED

Multiple gutters had mechanical damage and also what appeared to be poor workmanship at the joints. This can result in excessive moisture in the soil at the foundation, which can lead to foundation/structural movement. Recommend a qualified contractor evaluate and repair.

Contact a qualified gutter contractor

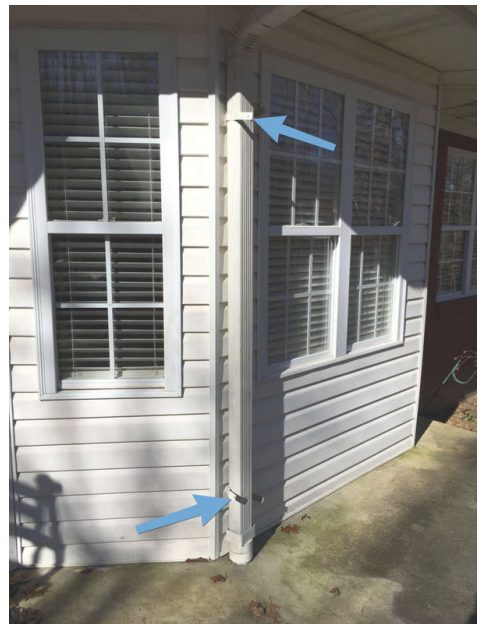
Rear

GUTTER/DOWNSPOUT LOOSE

The gutter/downspout is loose and needs to be re-fastened to fascia/siding and pitched properly (if required).

Contact a handyman or DIY project

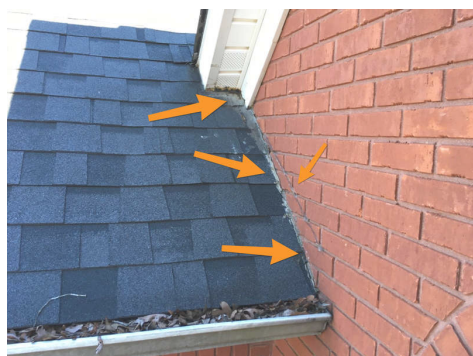
Front Left

MISSING

Flashings were not visible at time of inspection. Flashings provide protection against moisture intrusion. It appears as though certain flashings were left off when the most recent roofing job was performed.

Moisture intrusion was visualized in one of these areas during the attic inspection. Recommend a qualified roofing contractor evaluate and remedy.

Contact a qualified roofing professional.

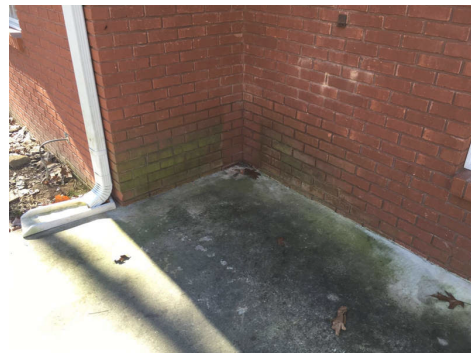
Rear

There are signs of algae and/or mildew on the siding. This is a cosmetic issue and is not uncommon especially on shaded portions of the home. Recommend that said areas be washed or cleaned on a regular basis.

Contact a handyman or DIY project

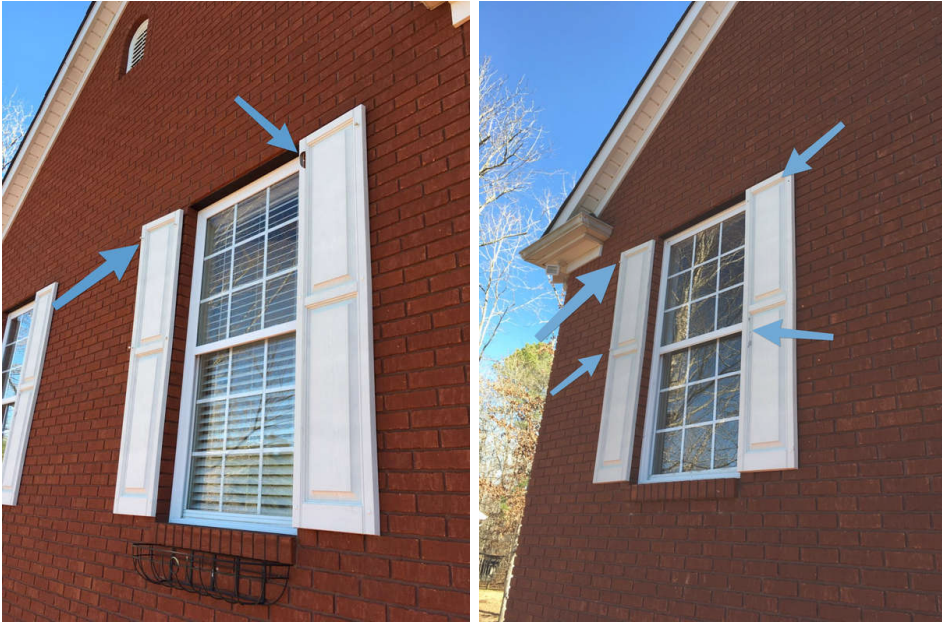
Front Left

DAMAGE TO SHUTTERS

The vinyl shutters on the front of the structure were poorly attached and had mechanical damage present.

Contact a qualified professional.

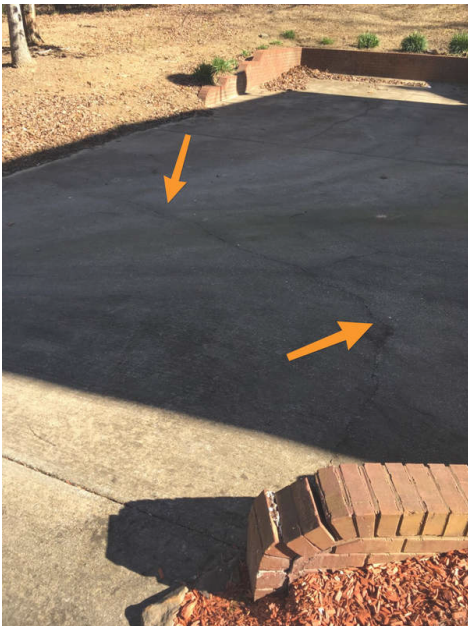
Left

DRIVEWAY CRACKING - MINOR

Minor cosmetic cracks observed, which may indicate movement in the soil. Recommend monitor and/or have concrete contractor patch/seal.

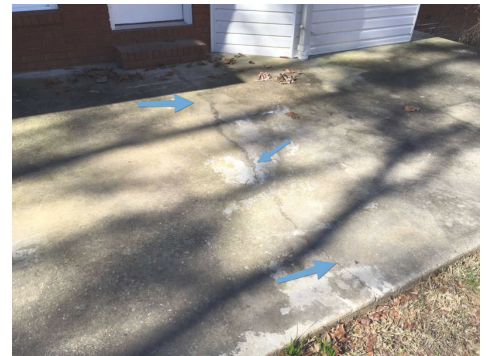
Rear

PATIO CRACKING - MINOR

Normal settling & cracking observed. Recommend monitor and/or patch/seal.

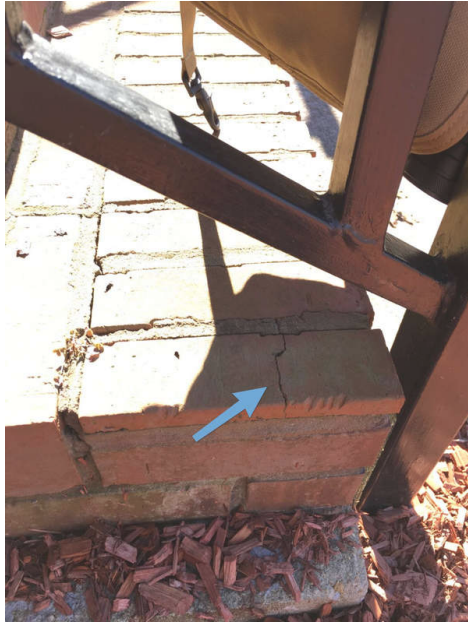
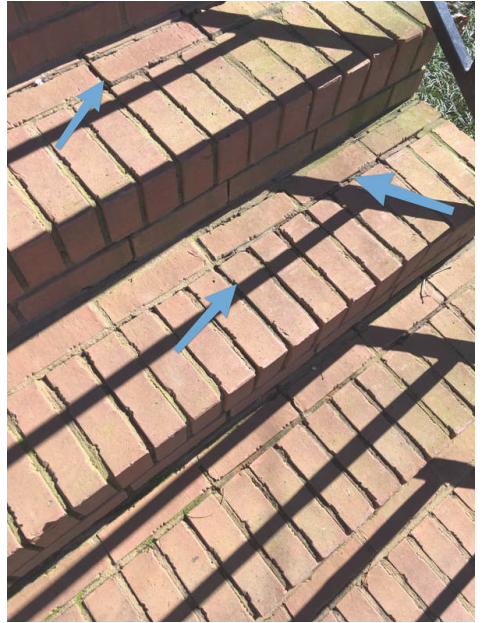
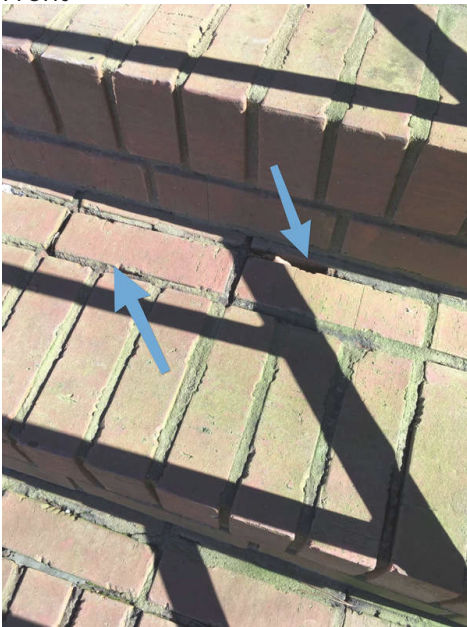
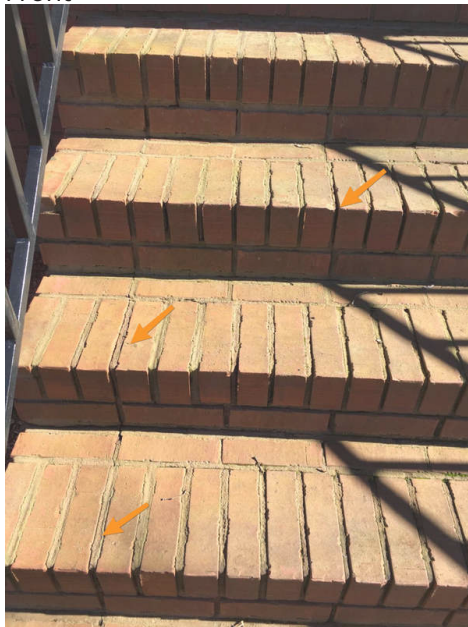
Front

STAIRS - DETERIORATED

One or more sections of the exterior stairs are deteriorated. Recommend qualified contractor evaluate & repair.

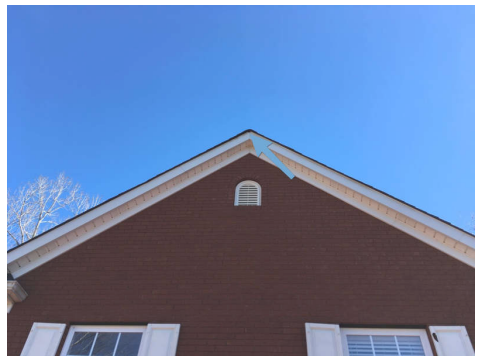
Front Left

FASCIA - DAMAGED

One or more sections of the fascia are damaged. Recommend qualified roofer evaluate & repair.

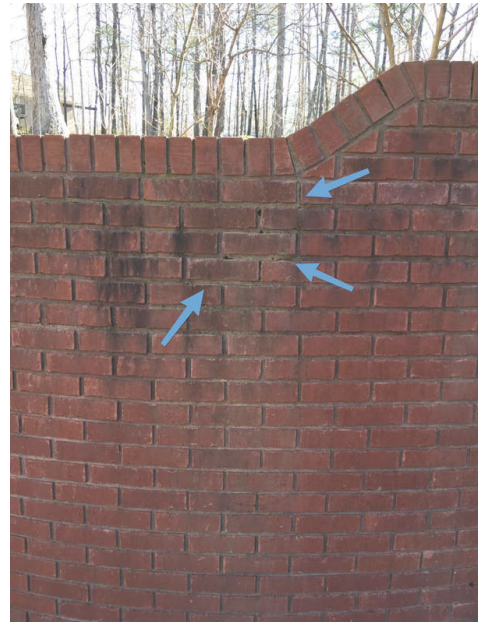
Left Rear

RETAINING WALL CRACKS

Retaining wall showed signs of minor cracking and appeared to be cosmetic.

Contact a qualified professional.

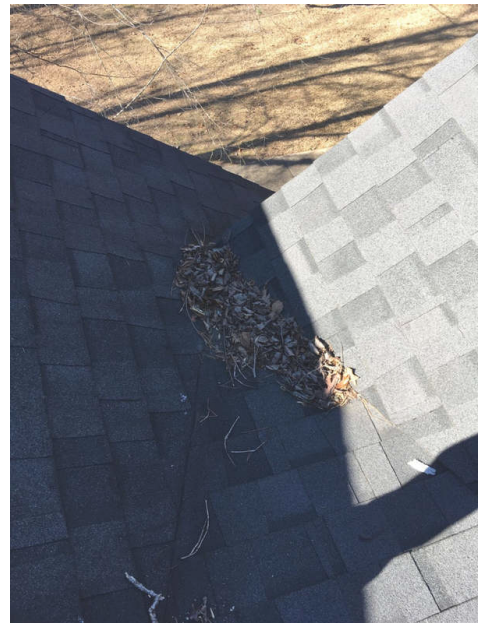
Front Right

Tree debris observed on roof. This can cause decreased and/or improper drainage to gutters and deterioration to roofing material. Recommend clearing debris.

Contact a handyman or DIY project

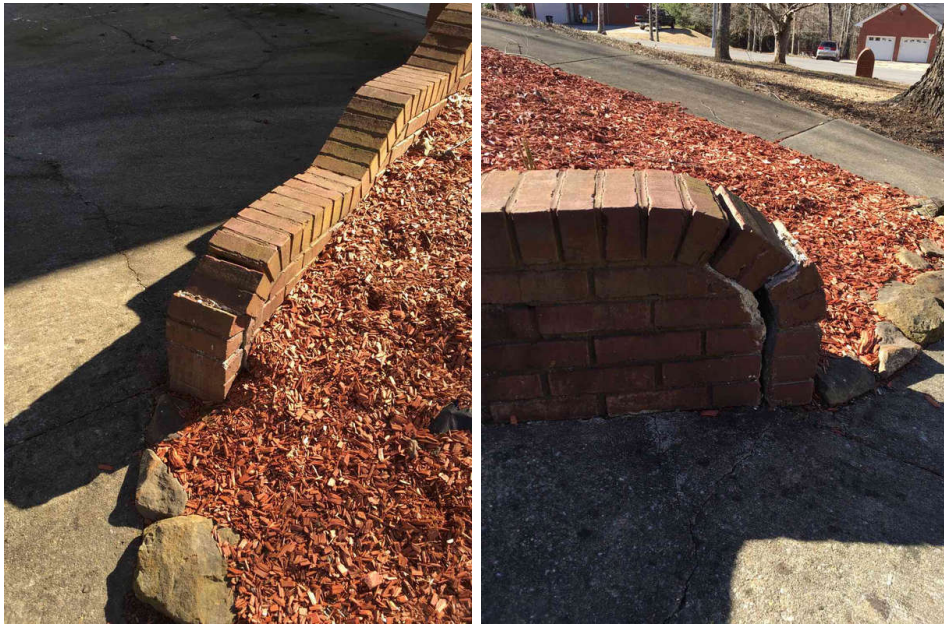
RETAINING WALL - DAMAGE

The retaining wall showed signs of mechanical damage, possibly from a vehicle. Recommend contacting a concrete contractor to make repairs.

Contact a qualified professional.

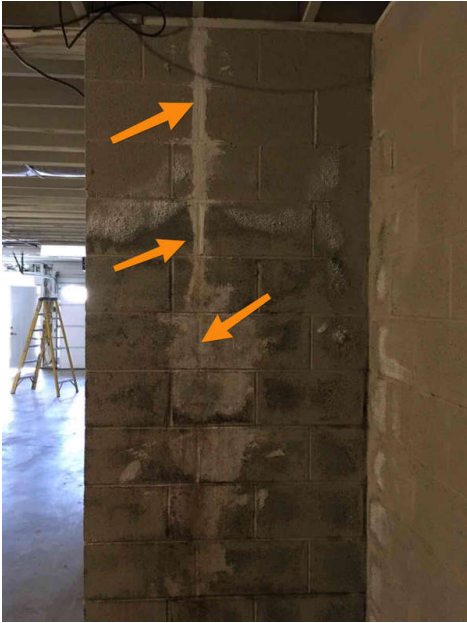
Rear Basement

FOUNDATION CRACKS

Contact a qualified structural engineer.

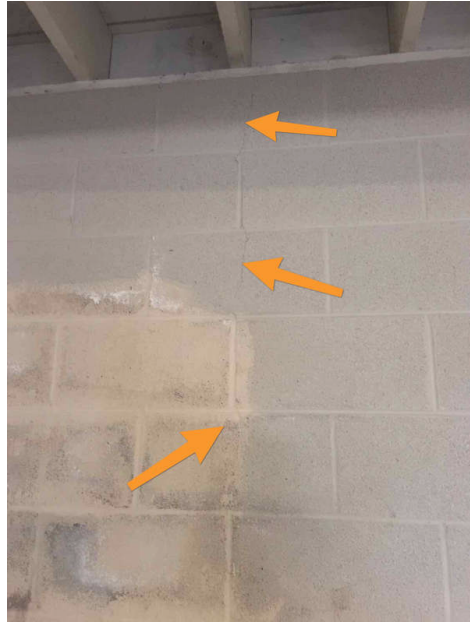
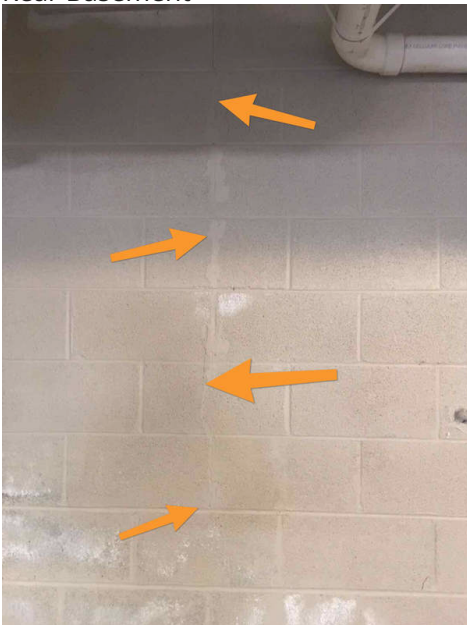
Right Rear Basement

Cracking noted at the foundation. This is typically consistent with soil movement and could lead to serious damage to structural components, foundation and/or slabs. Recommend a structural engineer evaluate and provide a report on course of action and remedy.

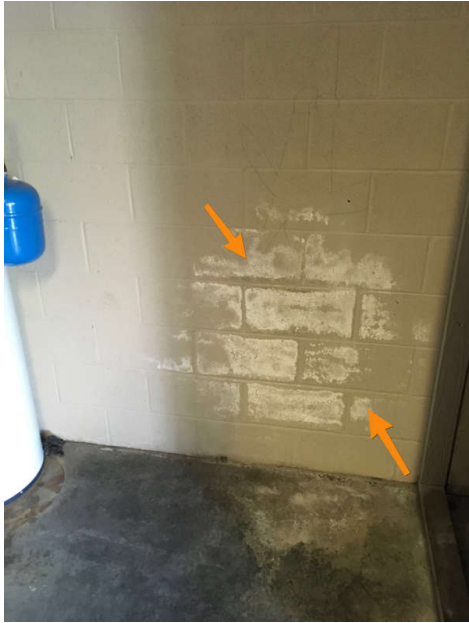
Front Basement

Efflorescence noted on the block surface. This a white, powdery deposit that is consistent with moisture intrusion. This can compromise the soil's ability to support the home structure and/or lead to mold growth. Recommend a qualified contractor identify source or moisture and correct.

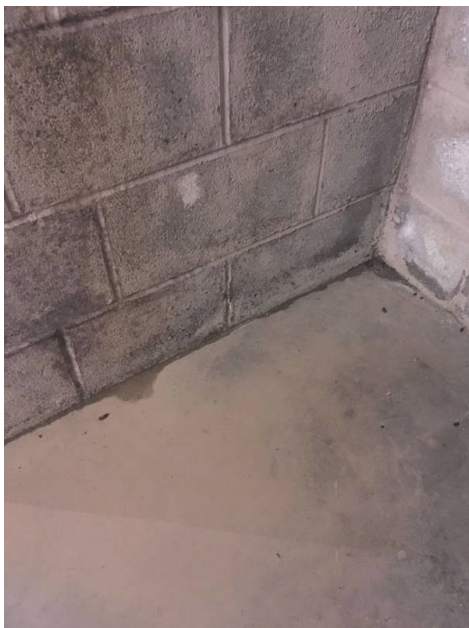
Rear Basement

HIGH MOISTURE LEVELS

High levels of moisture were noted in areas of the basement. Recommend monitoring and finding source of moisture intrusion to prevent damage to structure.

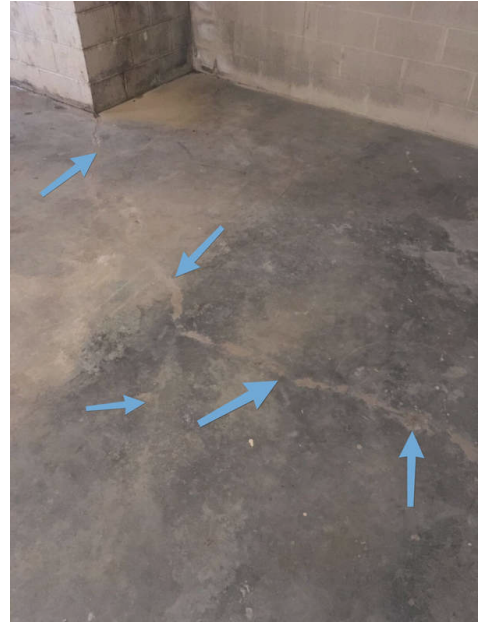
Right Rear Basement

MINOR CRACKING

Minor cracks found in the basement floor near the right rear corner. These cracks appeared cosmetic in nature. Recommend monitoring.

Contact a qualified professional.

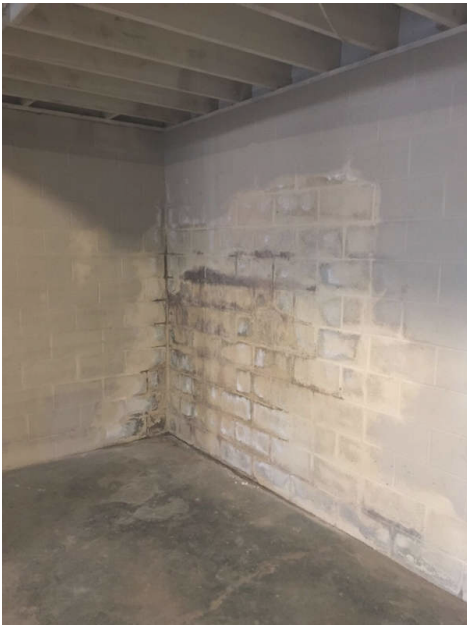
Right Rear Basement

Wall structure showed signs of water intrusion, which could lead to more serious structural damage and mold issues. These areas are directly below where two gutter downspouts empty next to the structure. Recommend a qualified contractor identify source of moisture and remedy.

Contact a qualified professional.

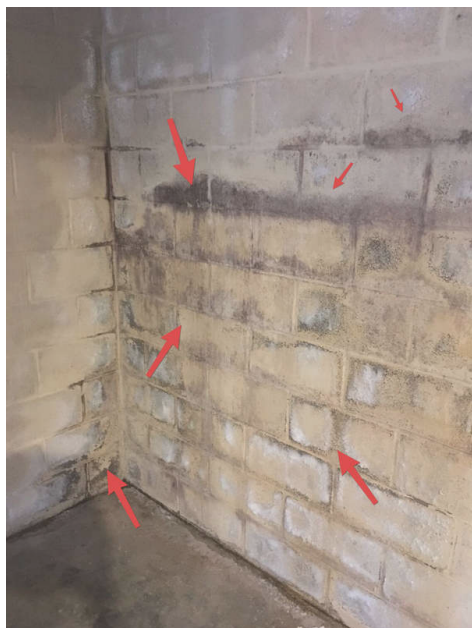
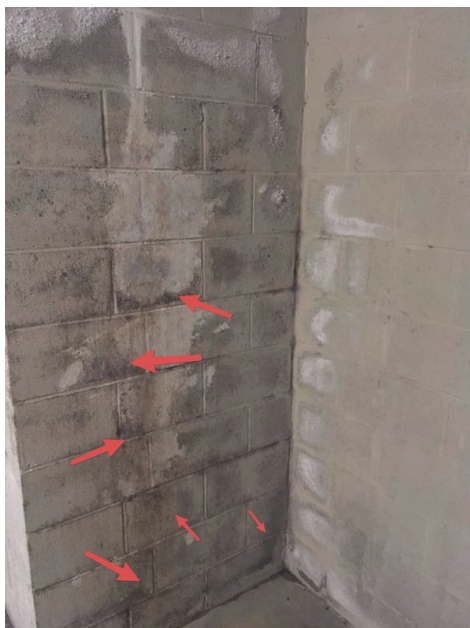
Right Rear Basement

Observed signs of microbial growth in one or more areas in the wall structure. Recommend identifying source or moisture intrusion and sending samples to a lab for testing.

Contact a qualified professional.

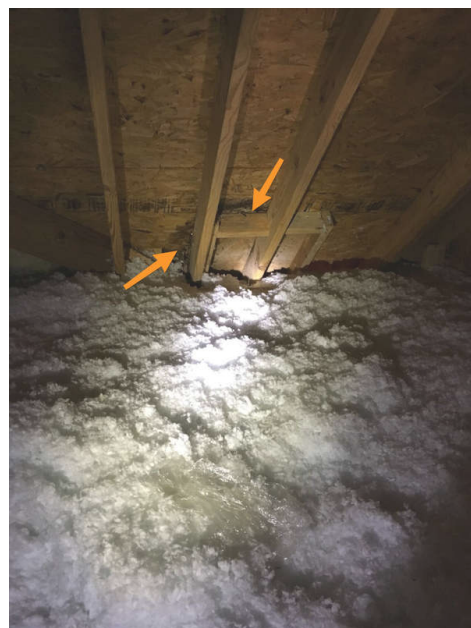
Left Attic

Ceiling structure (roof decking) in attic space showed signs of water intrusion, which could lead to more serious structural damage. Recommend a qualified contractor identify source or moisture and remedy.

Contact a qualified professional.

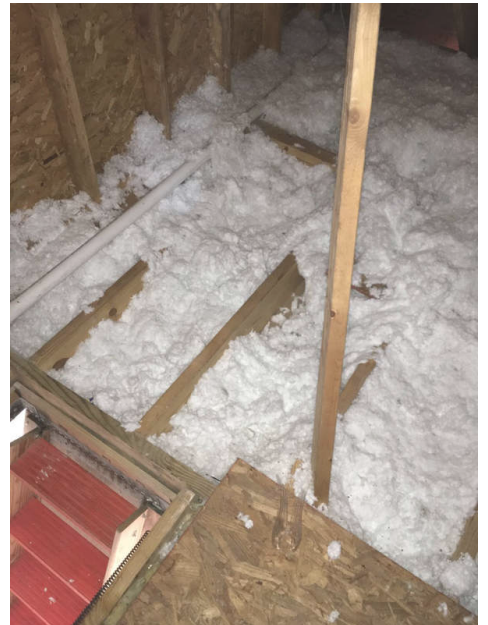
Attic

Insulation depth was inadequate around the attic access. Recommend a qualified attic insulation contractor install additional insulation.

Contact a qualified insulation contractor.

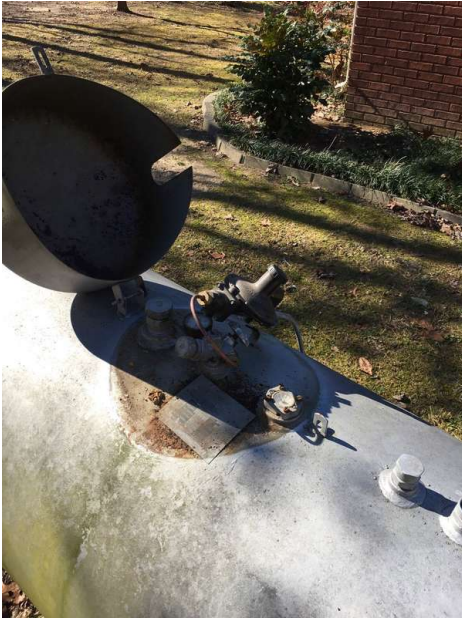
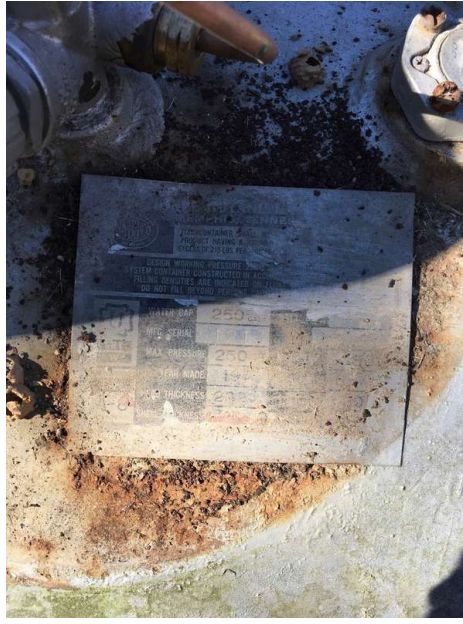
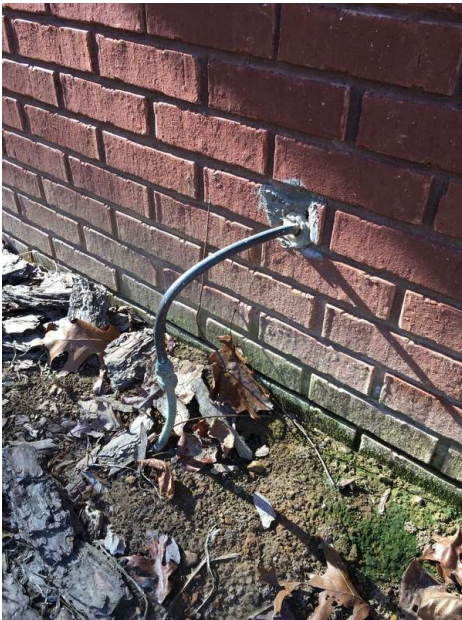
Fuel Storage & Distribution Systems: Fireplace Only

The propane tank in the backyard only supplied the fireplace in the living room. The tank is currently empty.

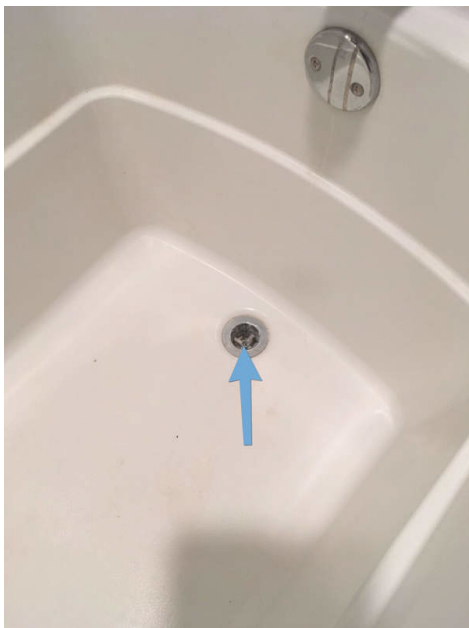
Right Hallway Bathroom

MISSING STOPPER

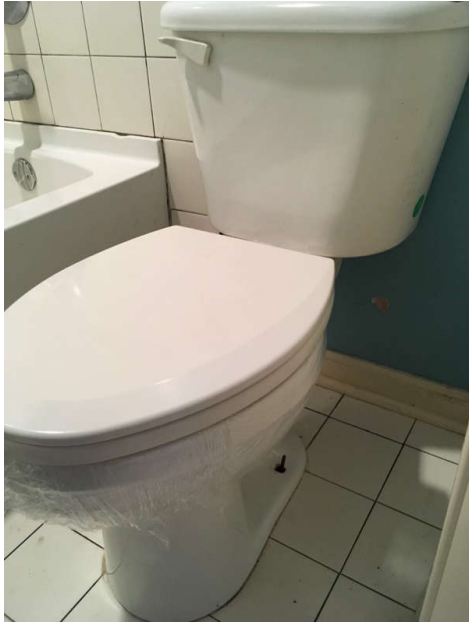
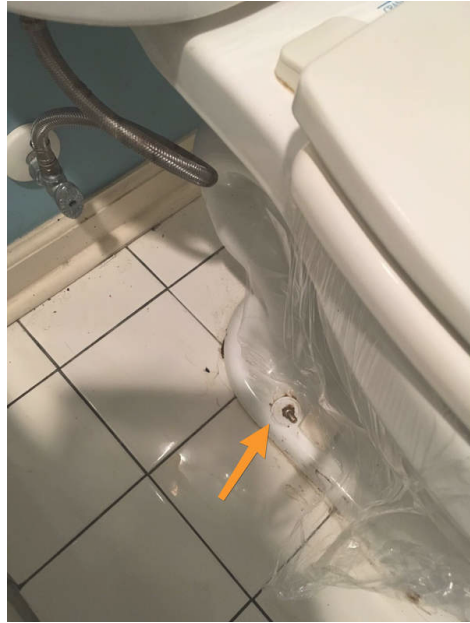
Right Hallway Bathroom

TOILET LOOSE

The toilet bolts were loose which allowed excessive movement. Recommend a plumber to reset the toilet to prevent moisture damage to surrounding area.

Contact a qualified professional.

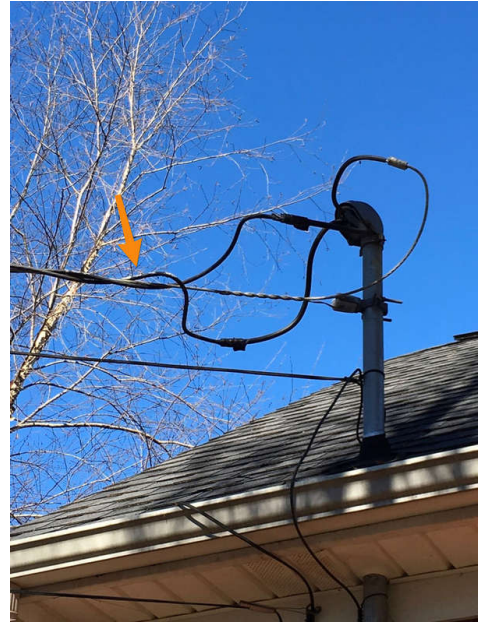
Right

Wires on service entrance appear damaged or frayed. Recommend contacting your electric utility company or a qualified electrician to evaluate and repair.

Contact your local utility company

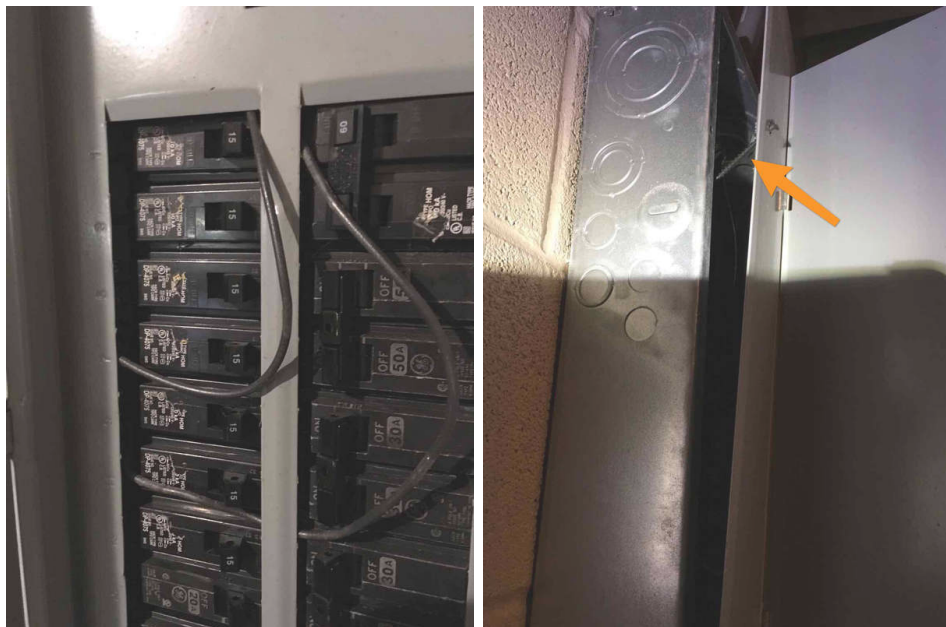
PANEL COVER LOOSE

The dead panel cover was loose and inappropriately attached with sheet rock screws. Wires were also visible around the breakers through the knockouts. Recommendation is for an evaluation by a licensed electrician.

Contact a qualified electrical contractor.

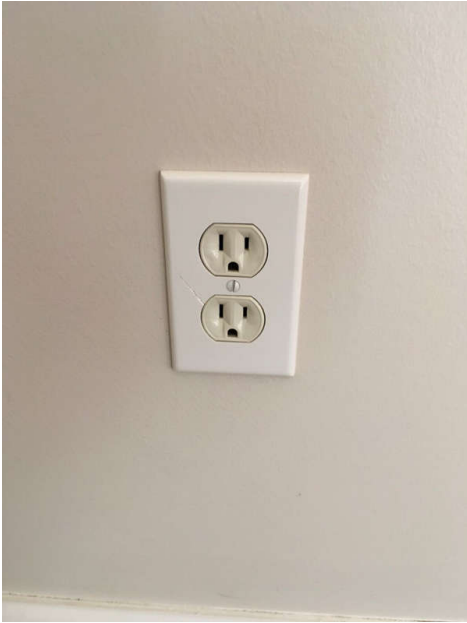
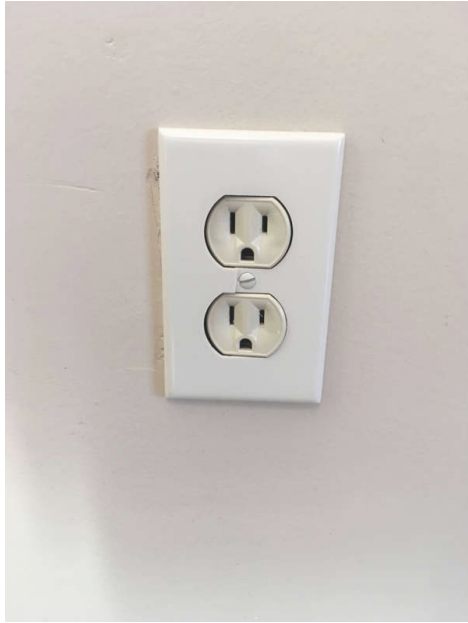
Right Front Bedroom

COVER PLATES DAMAGED

One or more receptacles have a damaged cover plate. Recommend replacement.

Contact a handyman or DIY project

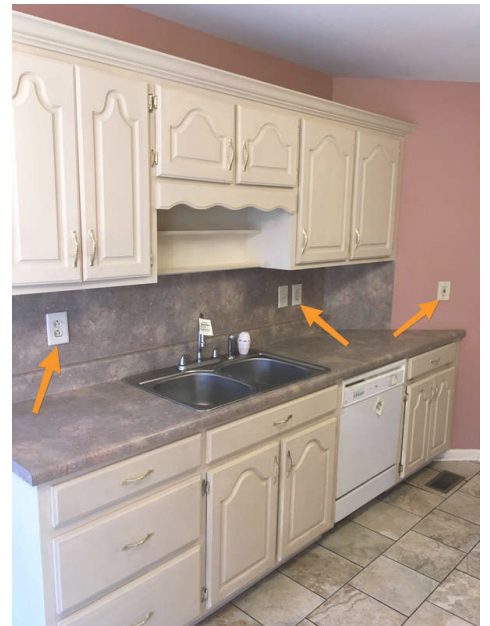
Kitchen

The circuit in the kitchen on the sink wall had no power. The GFCI receptacle was not operational either. Recommend evaluation by a licensed electrician.

Contact a qualified professional.

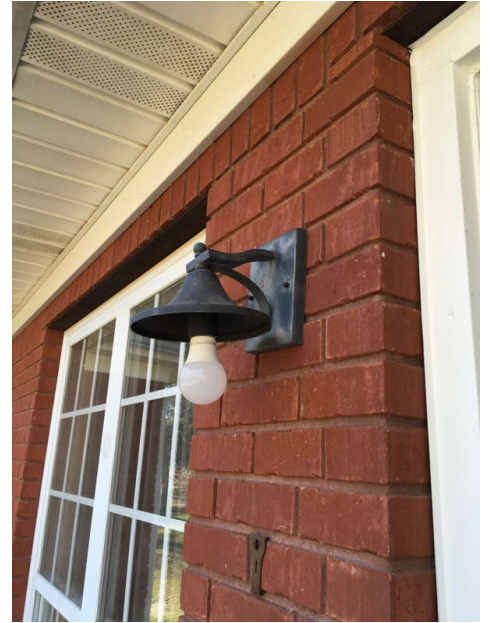
Rear Patio

FIXTURE DAMAGED

The light fixture at the rear door is missing a globe. Recommend replacement.

Recommended DIY Project

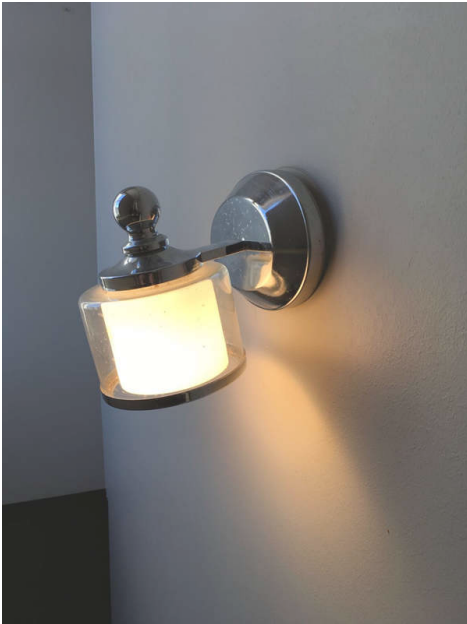
Basement Stairwell

FIXTURE LOOSE

The light fixture in the stairwell and at the Garage door entrance are loose and should be tightened or replaced.

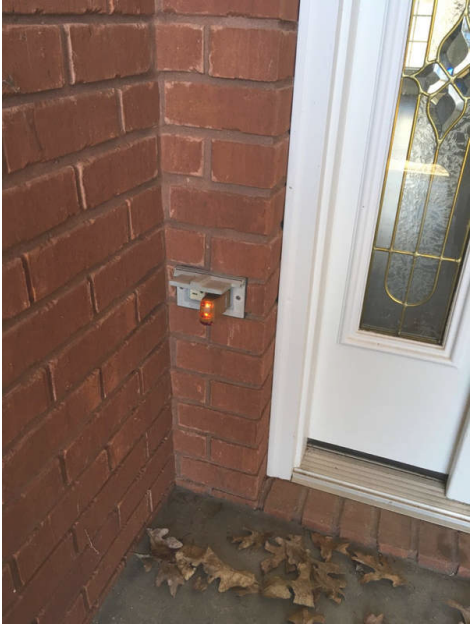
Front Porch

GFCI FAILED TEST

Receptacle failed test and/or would not reset. Recommend evaluation by a licensed and qualified professional.

Contact a qualified electrical contractor.

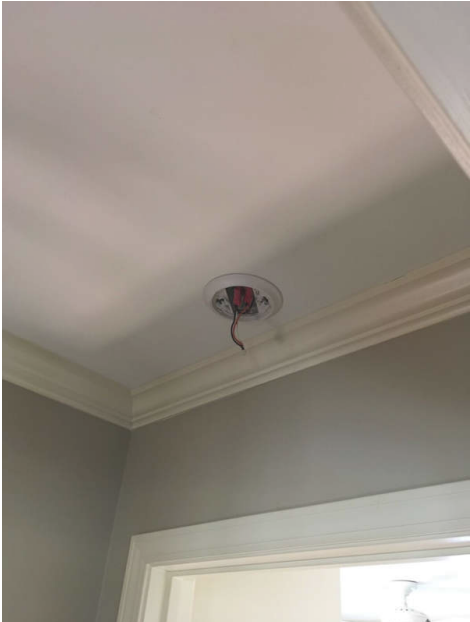
Right Bedroom Hallway

Smoke detectors have been removed from multiple locations. Recommend re-installation.

Contact a qualified professional.

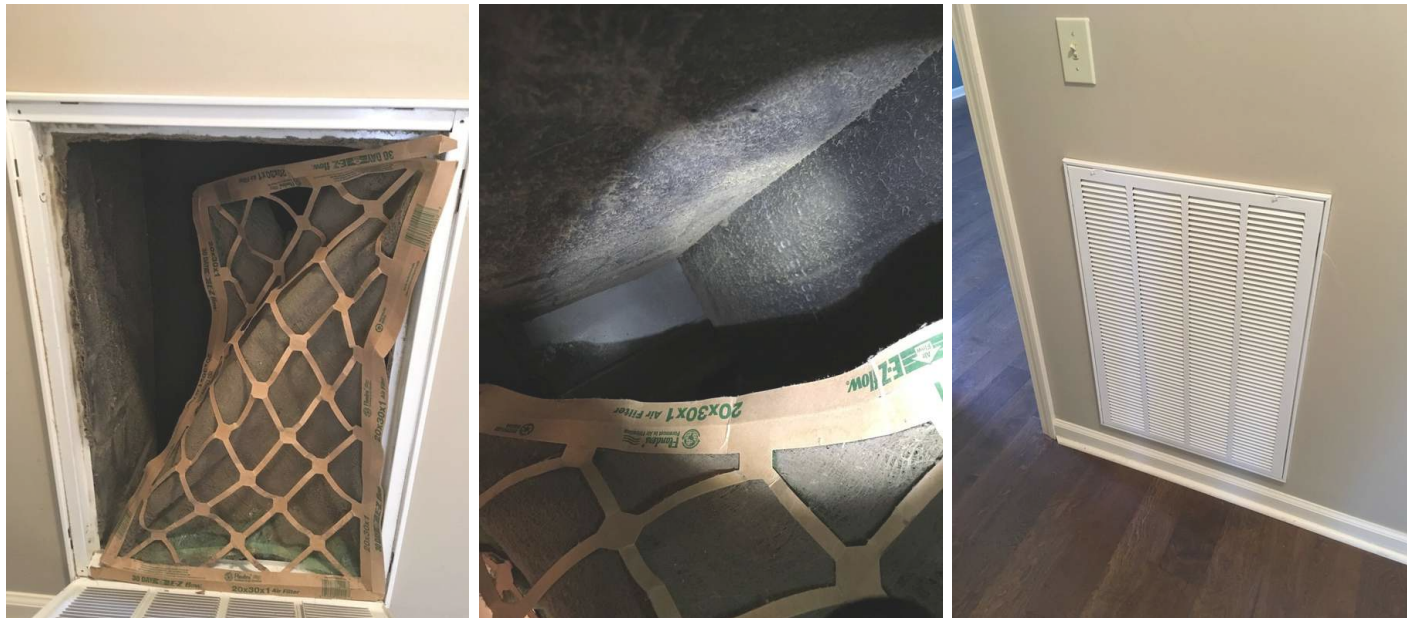
General: Filter Dirty

The HVAC filter is dirty and in need of replacement. Depending on conditions the filter should be checked and/or replaced monthly. Dirty filters can put extra strain on the system and cause premature wear and tear.

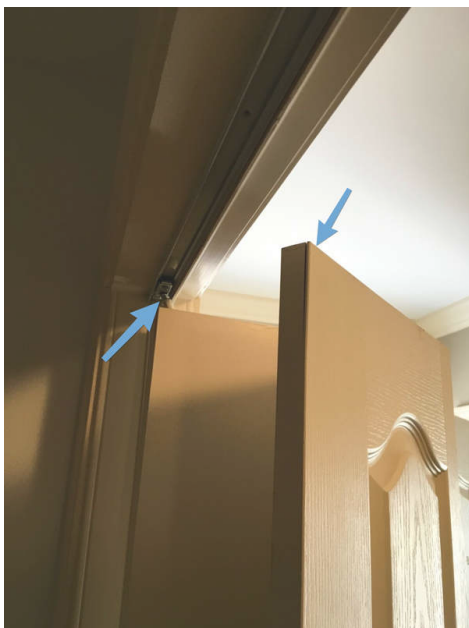
Laundry Closet

The bifold doors for the laundry area will not remain inside the track. Part of the hardware is missing that assists in this. The door going from the living area to the basement has damage to the handles on both sides. Recommend replacement.

Contact a qualified professional.

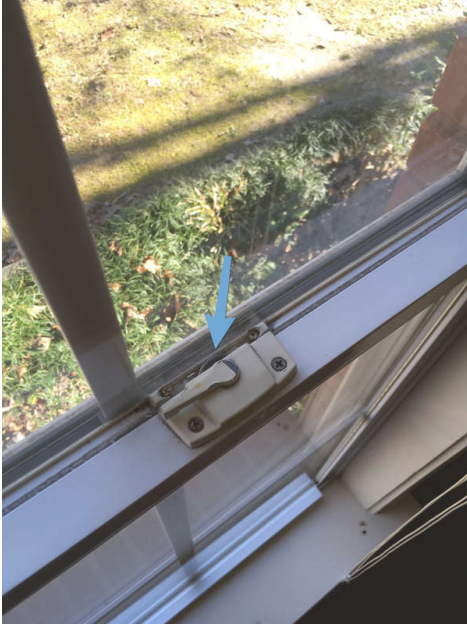
Right Rear Bedroom

One or more windows appears to have general damage, but are operational. Recommend a window professional clean, lubricate, adjust, or repair as necessary.

Contact a qualified professional.

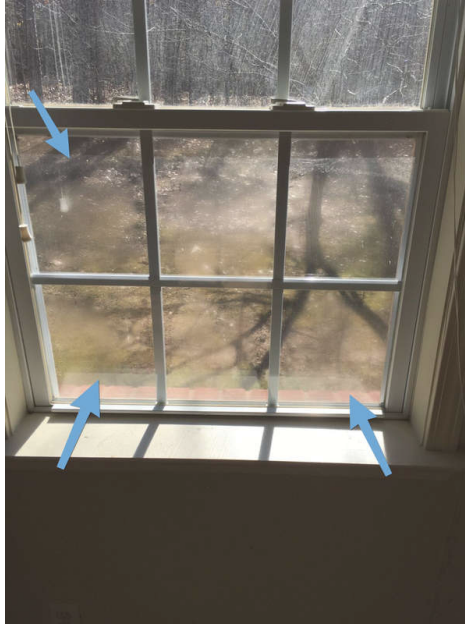
Right Rear Bedroom

Observed condensation between the window panes, which indicates a failed seal. Recommend qualified window contractor evaluate & replace.

Contact a qualified window repair/installation contractor.

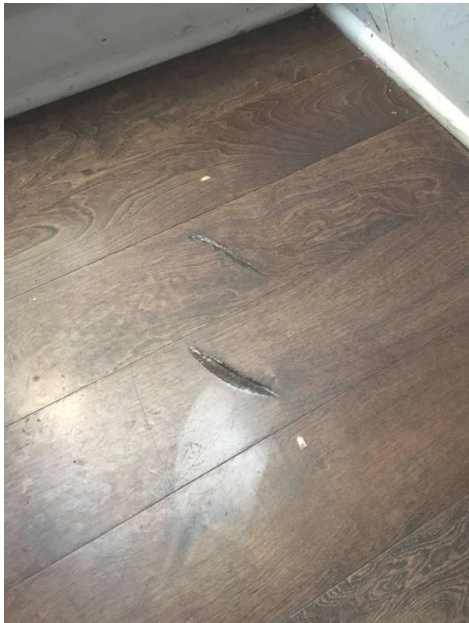
Basement Stairwell

DAMAGED (GENERAL)

The home had generalized moderate damage visible at the time of the inspection. Recommend service by a qualified contractor.

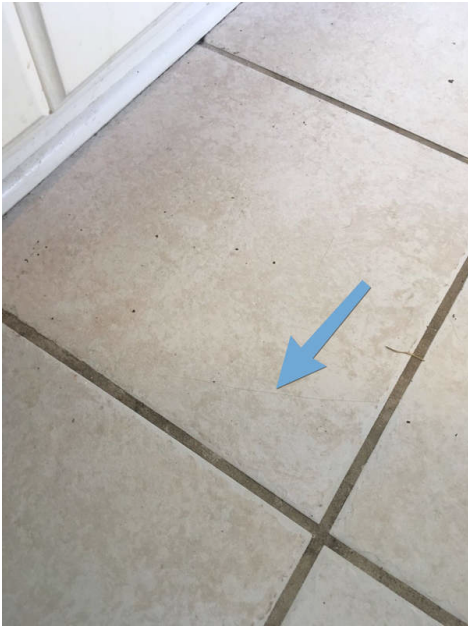
Master Bathroom

The tile in the master bathroom is cracked in multiple places. Recommend replacement of damaged tiles by a qualified professional .

Contact a qualified professional.

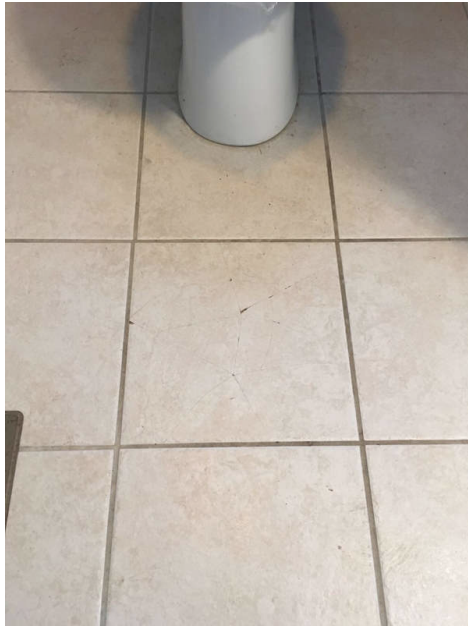
Master Bathroom

TILE CRACKED

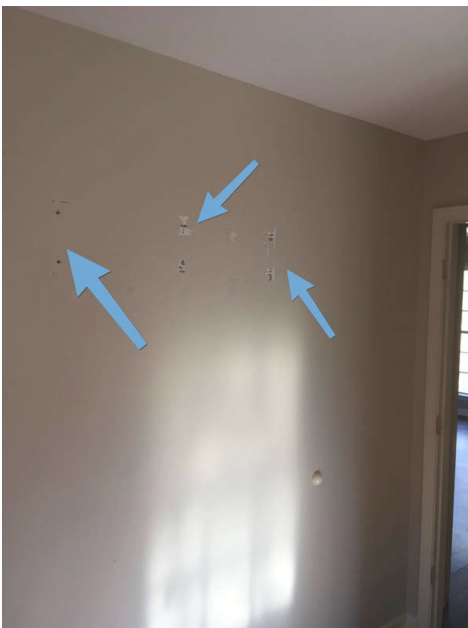
Front Right Bedroom

GENERAL DAMAGE

General areas of damage were noticed in one or more areas during the inspection. This appeared to be cosmetic.

Contact a handyman or DIY project

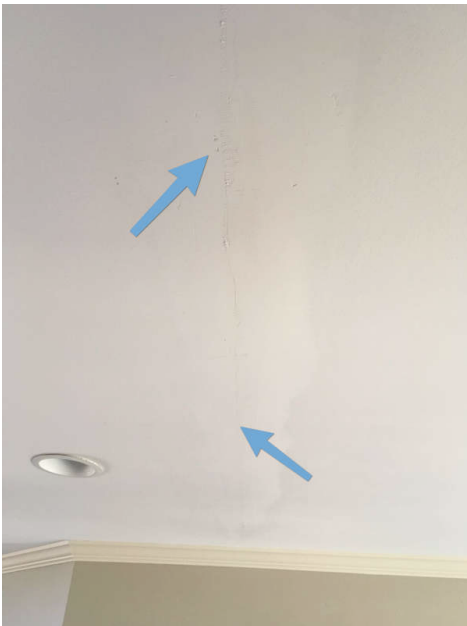
Living Room

MINOR DAMAGE

Minor damage or deterioration to the ceiling was visible at the time of the inspection. This appeared to be an attempted patch of a previous crack. Recommend proper patching by qualified professional.

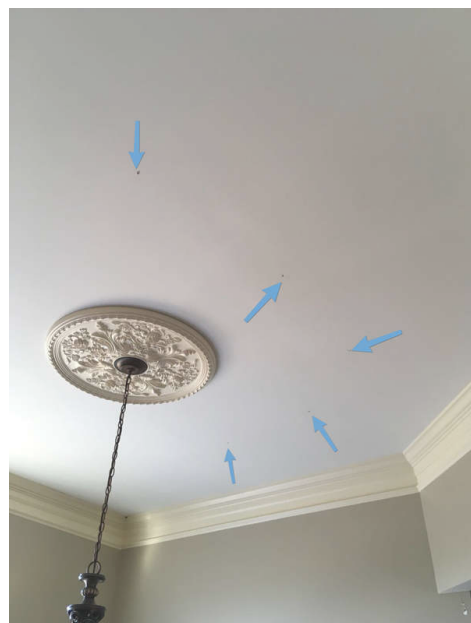
Dining Room

Nail pops were present in the dining room ceiling. Recommend patching and painting by a qualified professional.

Contact a qualified professional.

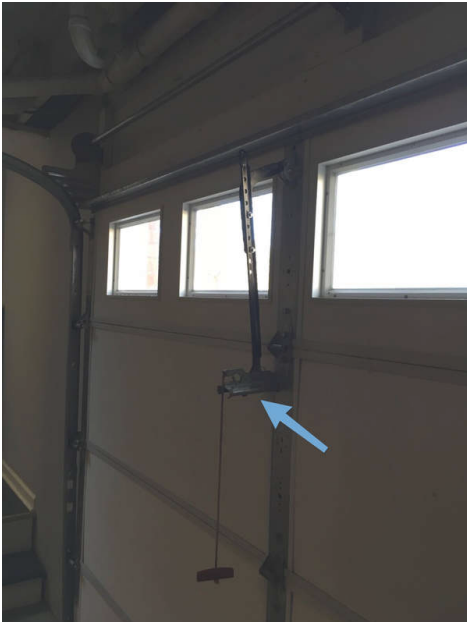
Garage

DAMAGE

One of the two garage doors had an arm that attaches the door to the track was damaged. Also damaged was the photo electric eye on the same door.

Contact a qualified professional.
