ALPINE BUILDING PERFORMANCE, LLC

HOME INSPECTION REPORT

1234 Main St.
Denver Colorado 80216

04/05/2019 9:00AM

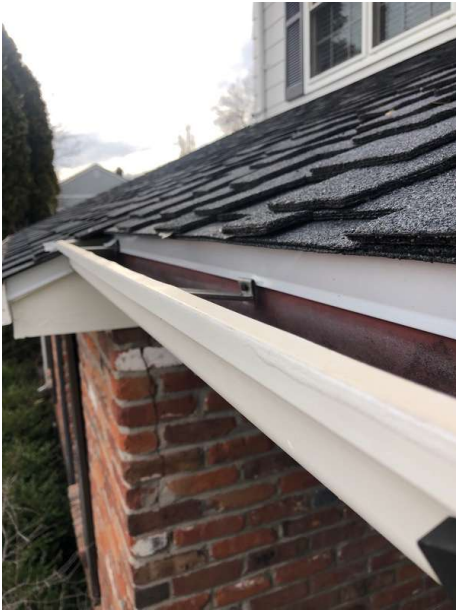
Roof Drainage Systems: Gutter Material

Galvanized steel

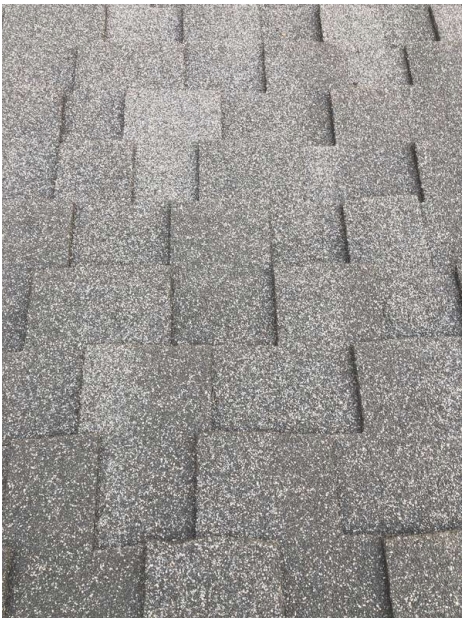
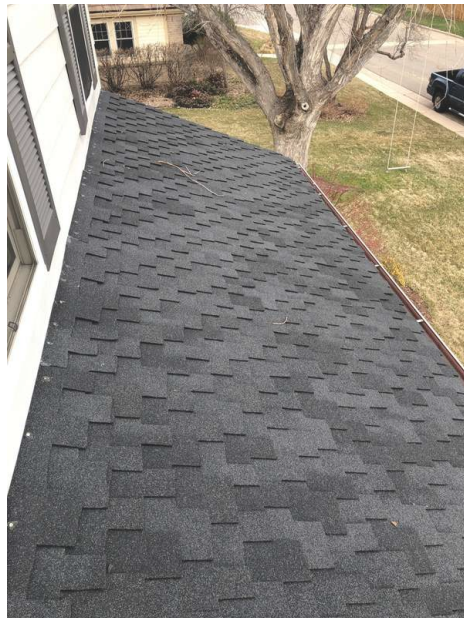
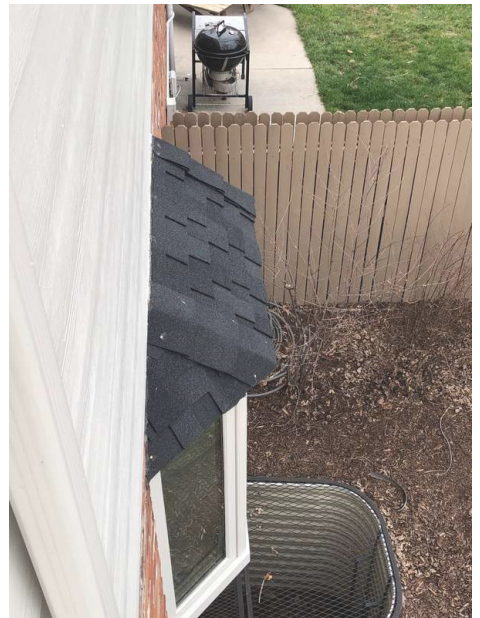
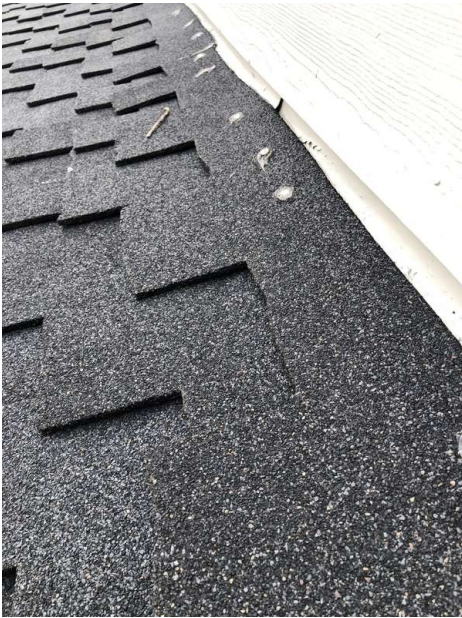
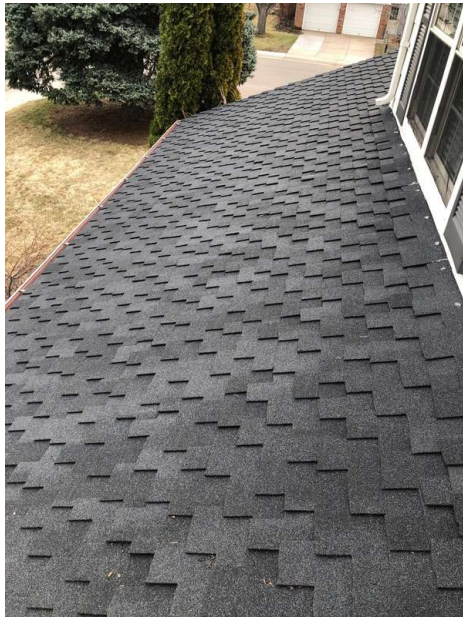
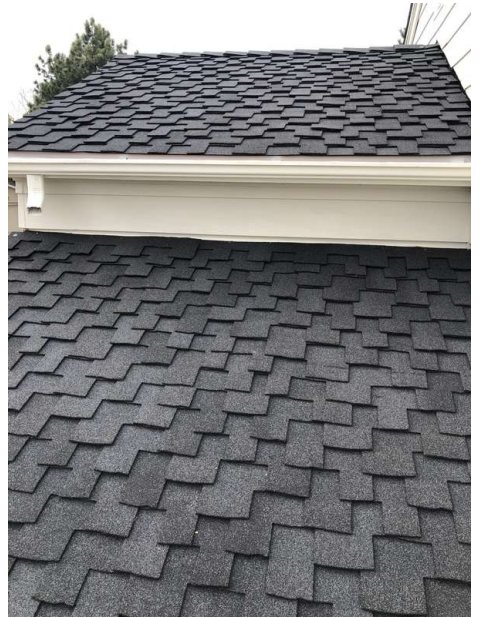
Coverings: Material

Asphalt - Shingle

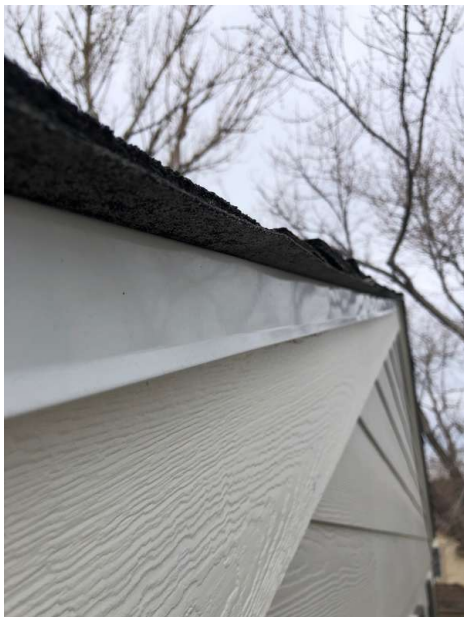
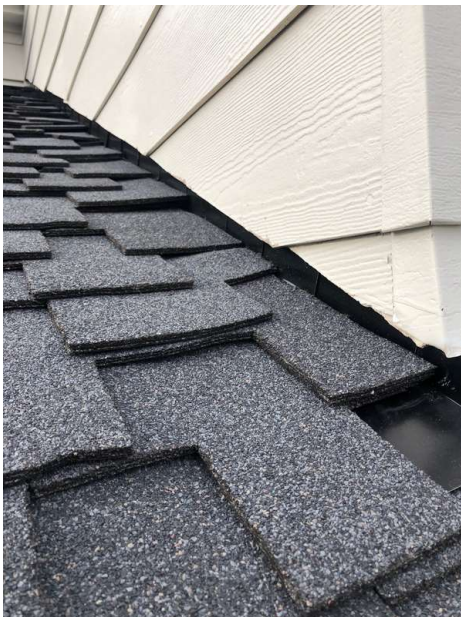
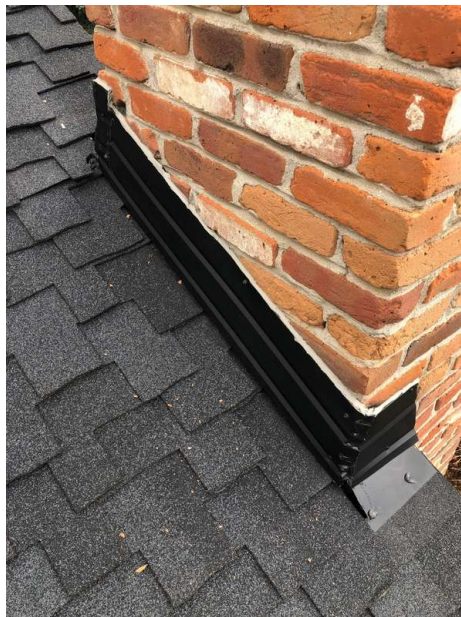
Flashings: Material

Galvanized Steel

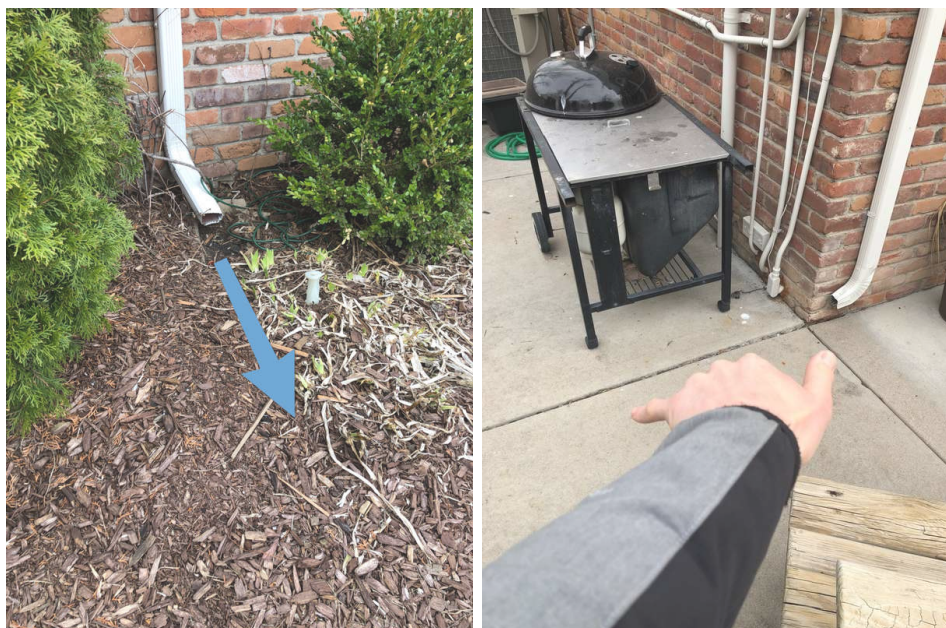
2.5.1 Roof Drainage Systems

Downspout extensions are recommended to discharge roof drainage a minimum of 6 feet from the foundation. Downspout extensions are a simple improvement that have a great impact on preventing water accumulation and intrusion around the foundation.

Contact a qualified handyman.

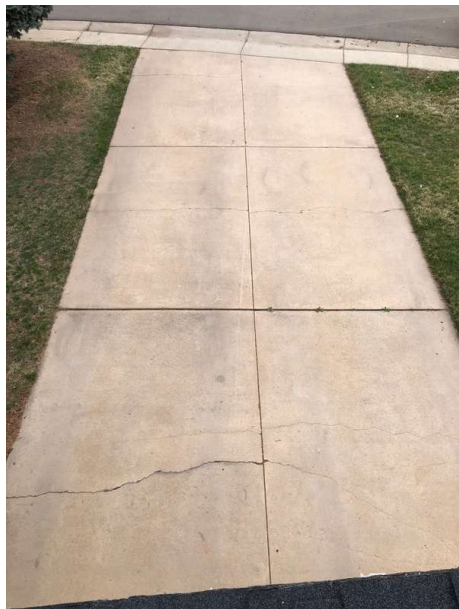
Walkways, Patios & Driveways:
Walkway, Patio & Driveway Material

Concrete, Tile on Concrete

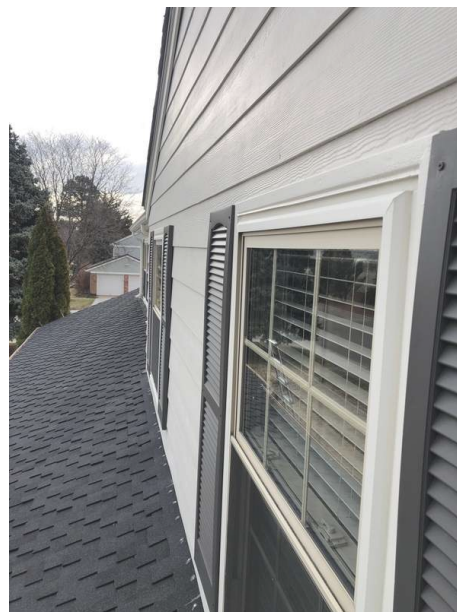
Siding, Flashing & Trim: Siding Material

Brick Veneer, Fiber Cement

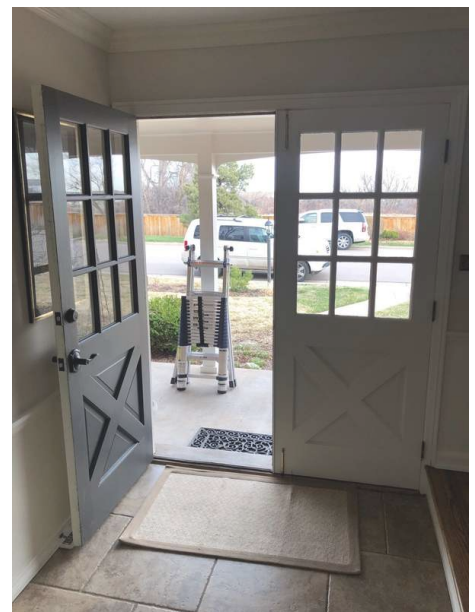
Exterior Doors: Exterior Entry Door

1/2 - Lite Wood

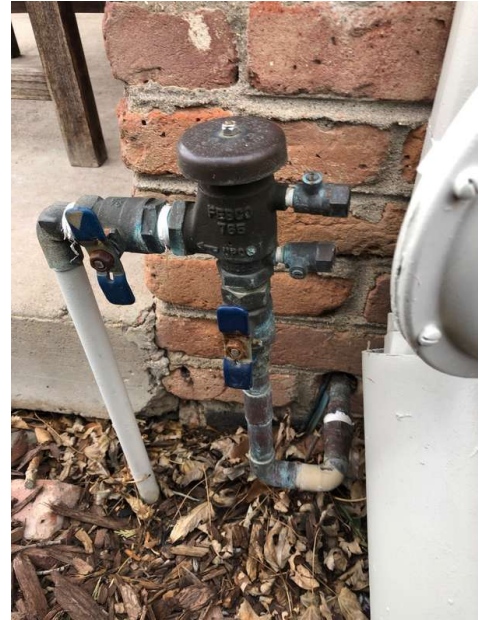
Landscape Irrigation

IRRIGATION SYSTEM MAIN VALVE LOCATION

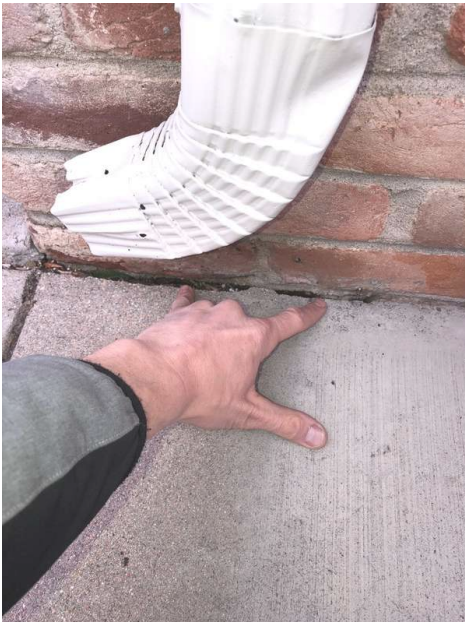
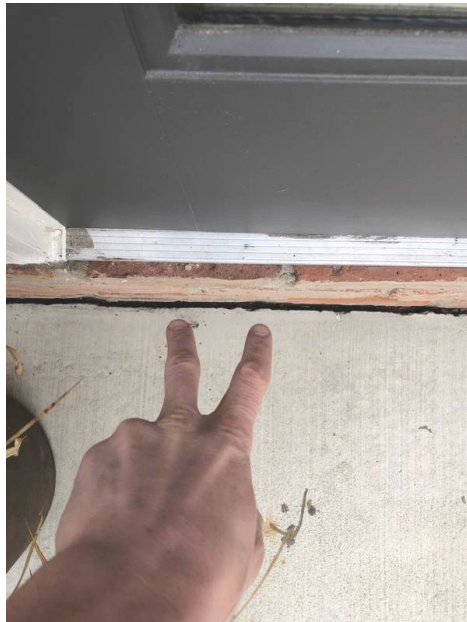
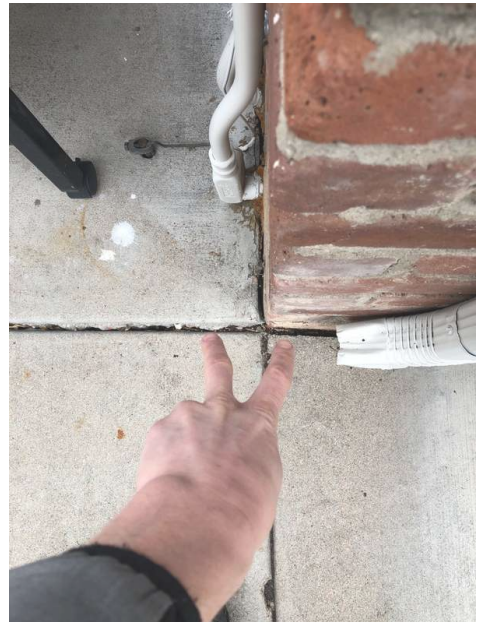
3.1.2 Walkways, Patios & Driveways

PATIO - NO SEAL AT EXTERIOR WALL

The joint at which the patio met the exterior walls was not sealed. Saturation of soil near the foundation can create a variety of problems depending on soil type. The Inspector recommends that the joint at which the driveway met the exterior walls should be protected by a sealant that will need to be maintained.

Contact a handyman or DIY project

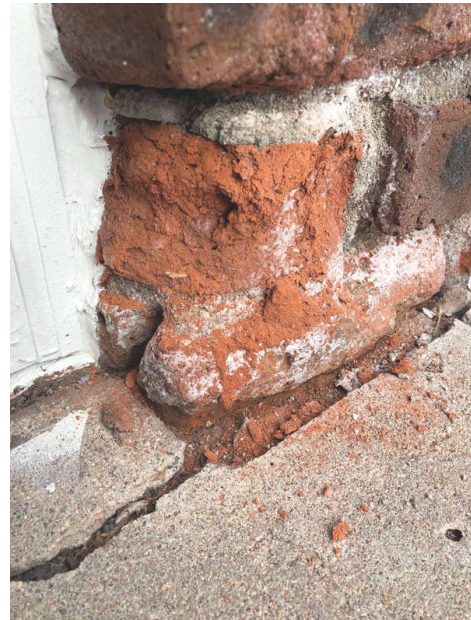
3.2.1 Siding, Flashing & Trim

BRICK DETERIORATION - NEEDS SEALING

A bottom course of brick is damaged and deteriorated from exposure to moisture over the years. Recommend sealing the brick to prevent further moisture uptake and deterioration.

Contact a qualified masonry professional.

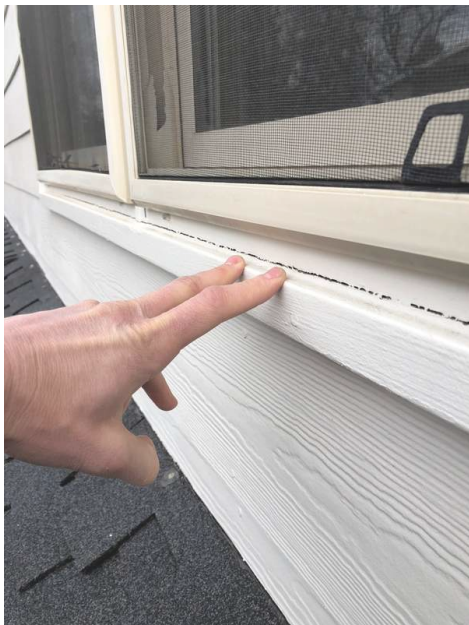
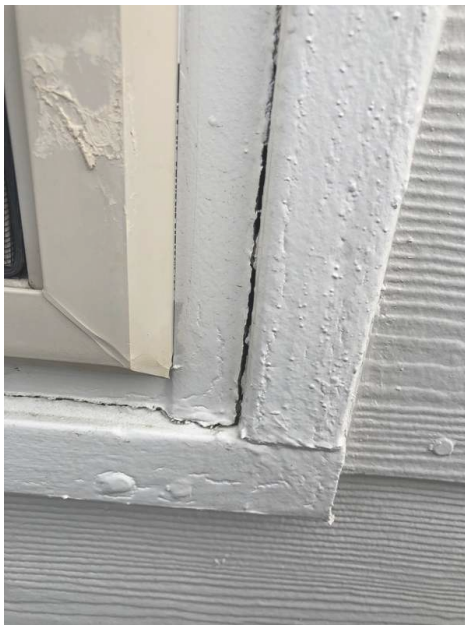
3.2.2 Siding, Flashing & Trim

Exterior caulking has dried, cracked and separated. The caulk is no longer functioning as intended and needs to be re-caulked to ensure proper protection of exterior siding elements.

Contact a qualified painting contractor.

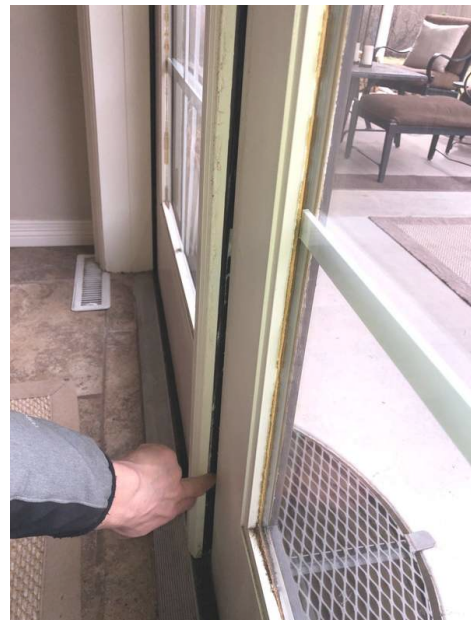
3.4.1 Exterior Doors

DOOR IS MISALIGNED AND HAS DAMAGED STRIKER PLATE

Door does not close or latch properly. Recommend qualified handyman adjust strike plate and/or lock.

Contact a qualified door repair/installation contractor.

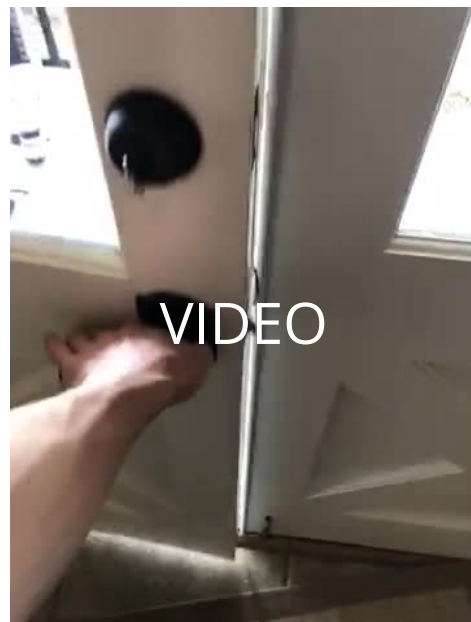
3.4.2 Exterior Doors

An exterior door was sticking and difficult to operate due to misalignment within the frame. Recommend adjustment.

Contact a qualified handyman.

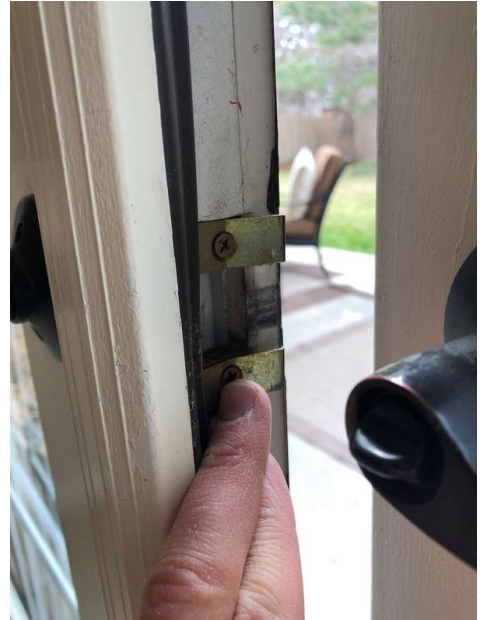
3.4.3 Exterior Doors

STRIKER PLATE - DAMAGED

An exterior door striker plate was damaged at the time of inspection. Recommend repair for proper door closing and locking.

Contact a qualified handyman.

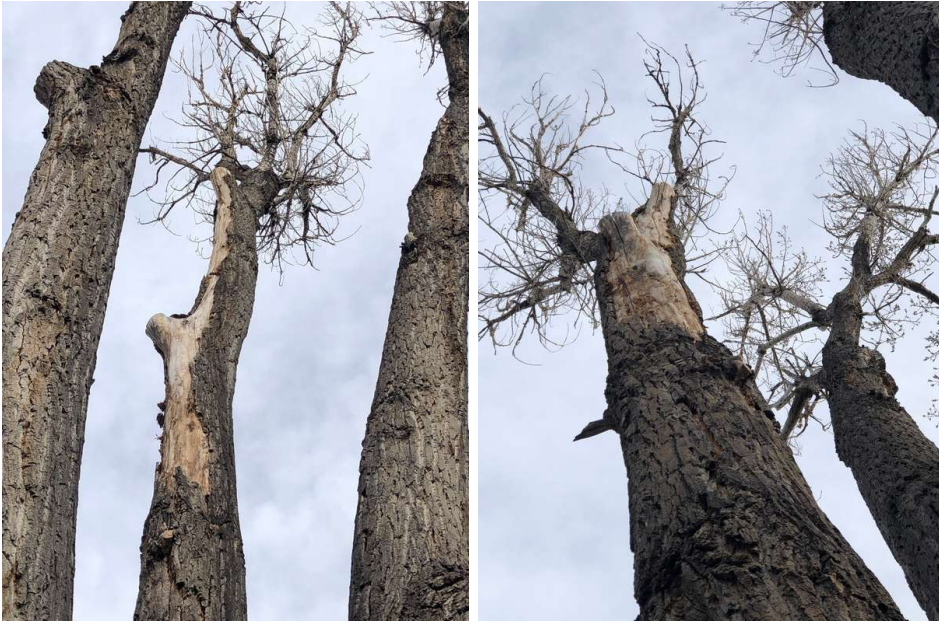
A dying tree on the property will eventually fall or be blown over by wind and may cause injury or damage. The Inspector recommends removal of the tree for safety reasons.

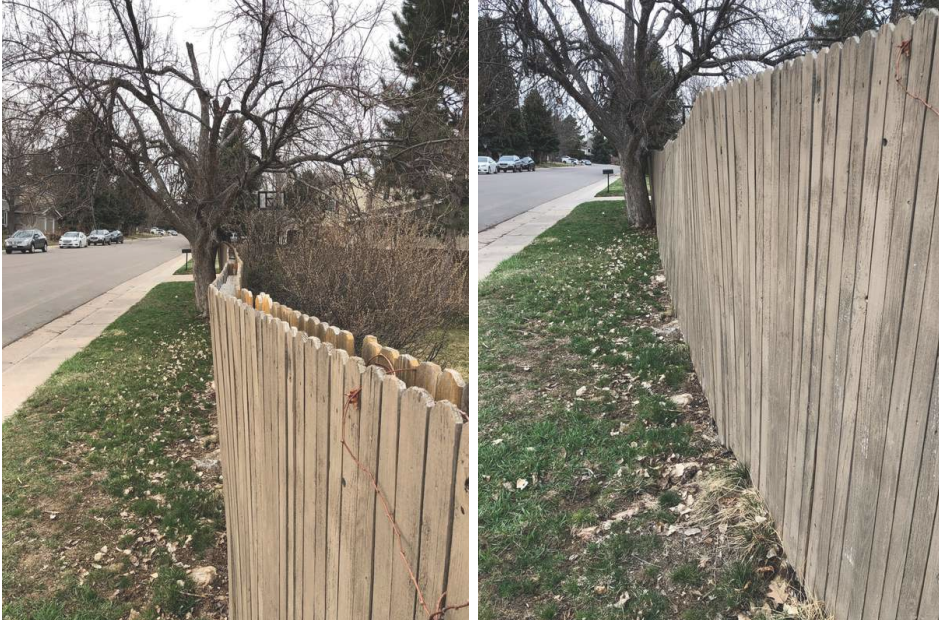
3.10.1 Fence/Gate

The fence structure was leaning significantly at the time of inspection. Recommend repair of the leaning areas to restore full functionality of the fence.

Contact a qualified carpenter.

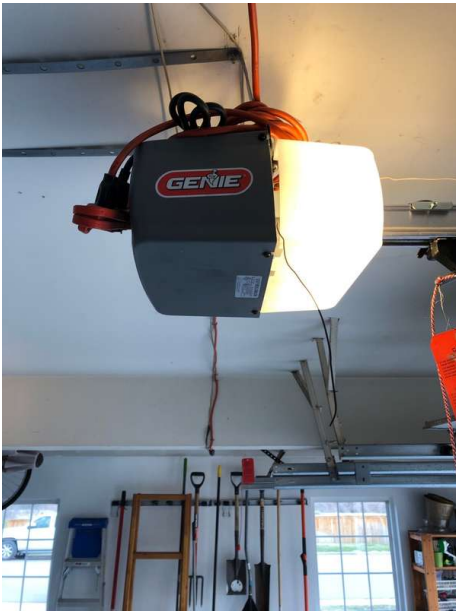
Garage Door: Type

Automatic

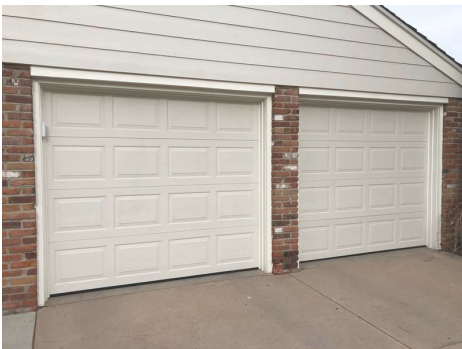
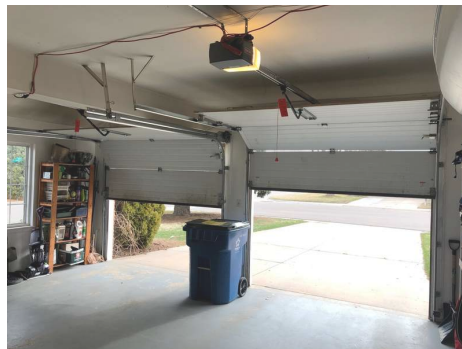
Garage Door: Material

Insulated, Steel

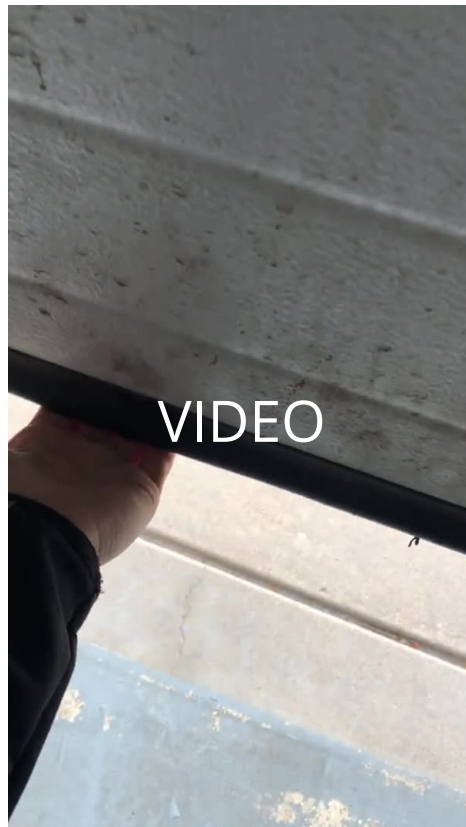
The auto reverse pressure sensor was not responding at time of inspection. This is a safety hazard to children and pets. Recommend a qualified garage door contractor evaluate and repair/replace.

Contact a qualified garage door contractor.

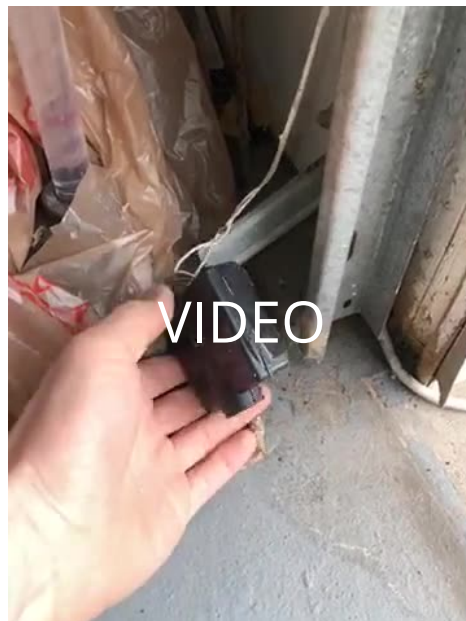
4.4.2 Garage Door

**OPTICAL SAFETY SENSOR LOOSE**

One of the optical safety sensors was loose, and may lead to improper function. This will present a safety danger if the sensor does not properly function. Recommend that a qualified professional repair safety devices.

Contact a qualified garage door contractor.

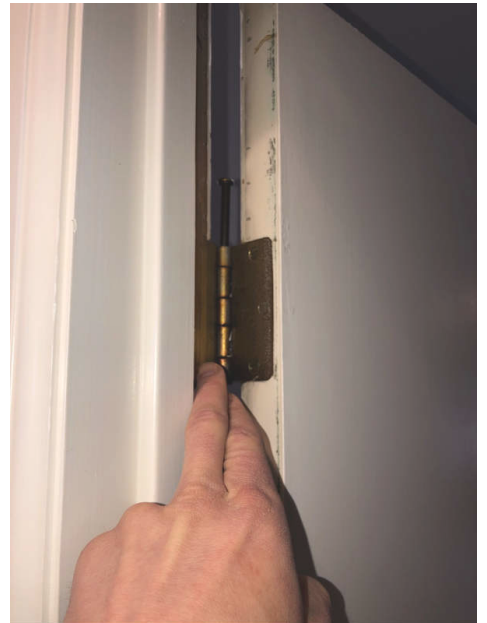
4.6.2 Occupant Door

Door from garage to home should have self-closing hinges to help prevent spread of a fire to living space. Recommend a qualified contractor install self-closing hinges, or adjust self closing hinges if they are present but not functioning properly.

Contact a qualified door repair/installation contractor.

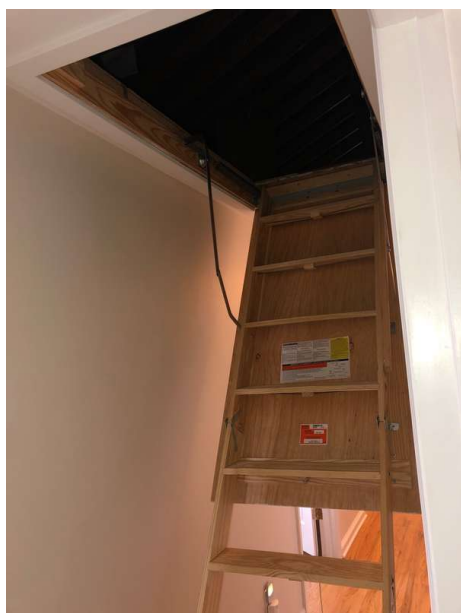
Wall Insulation: R-Value (Thermal Insulation Level)

Unknown - No Access, Infrared Imaging

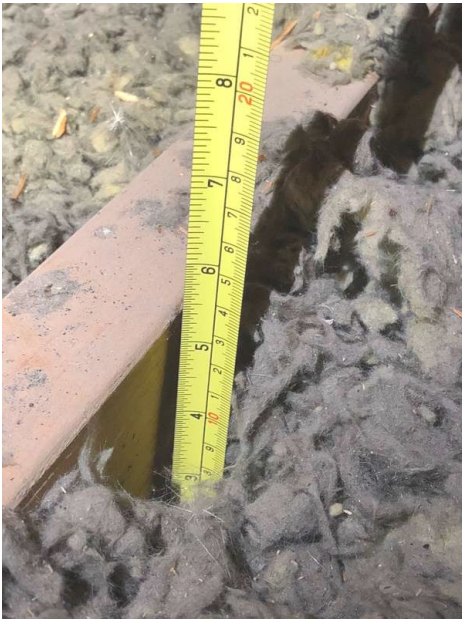
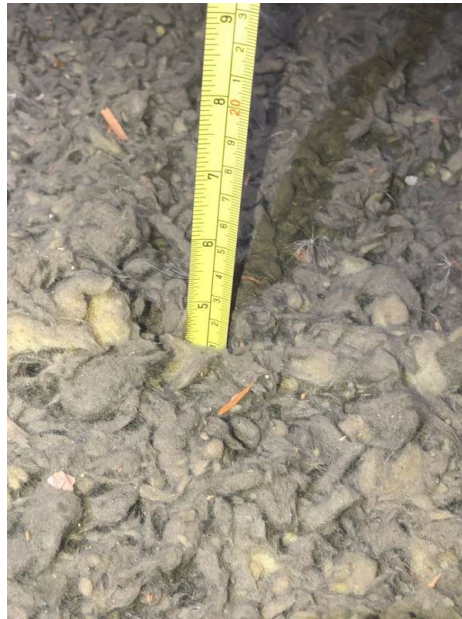
Attic Insulation: R-Value (Thermal Insulation Level)

R-15

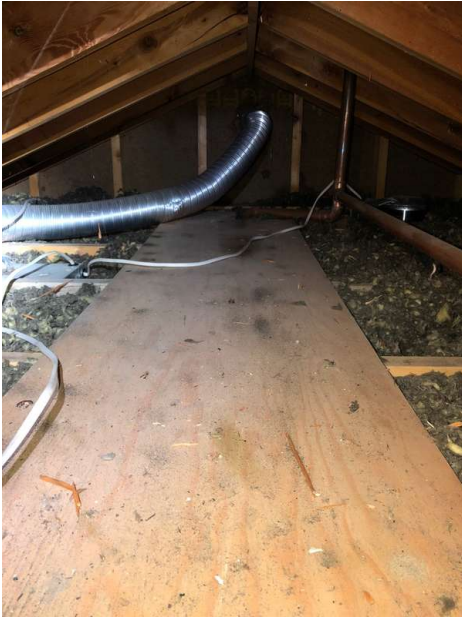
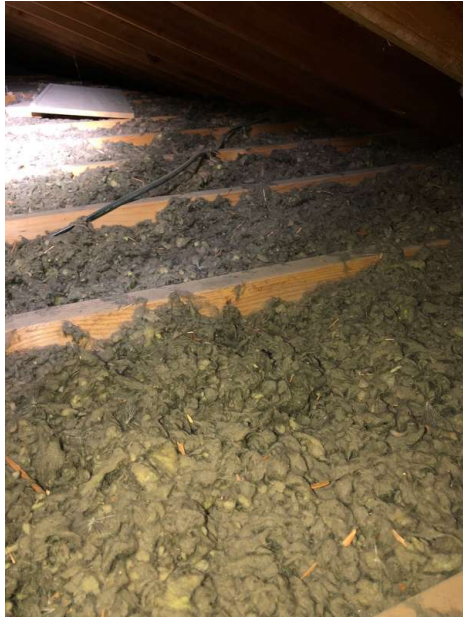
Attic Insulation: Insulation Type

Blown, Fiberglass

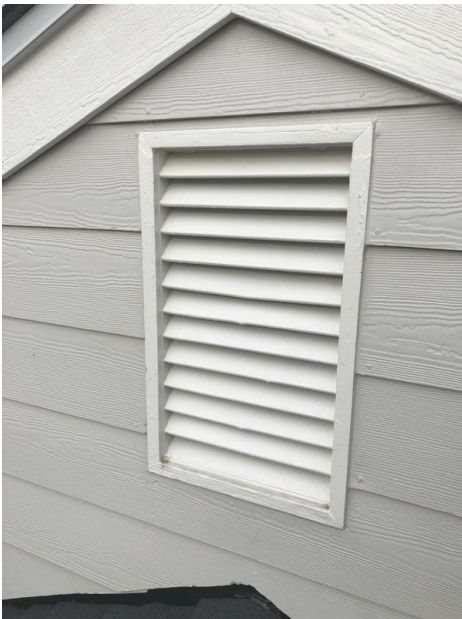
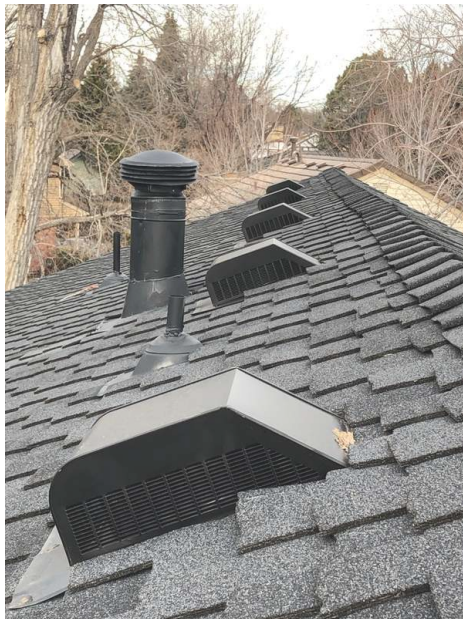
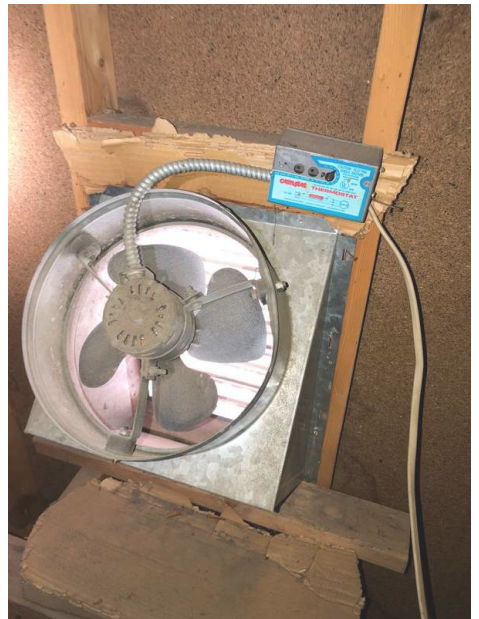
Attic Ventilation: Ventilation Type

Gable Vents, Passive, Soffit Vents, Thermostatically Controlled Fan

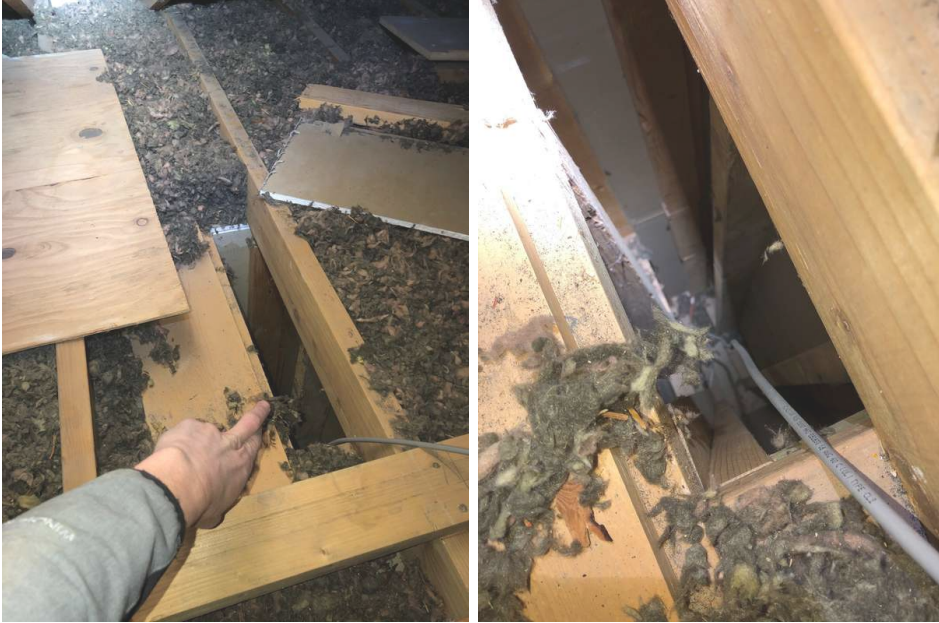
**COMFORT AND EFFICIENCY RECOMMENDATION - THERMAL BYPASS**

A thermal bypass was observed. A thermal bypass allows for unconditioned air to move into an area of conditioned space, or a space that should be sealed off from unconditioned areas. Recommend having this bypass sealed and insulated by a qualified home performance contractor.

Contact a qualified insulation contractor.

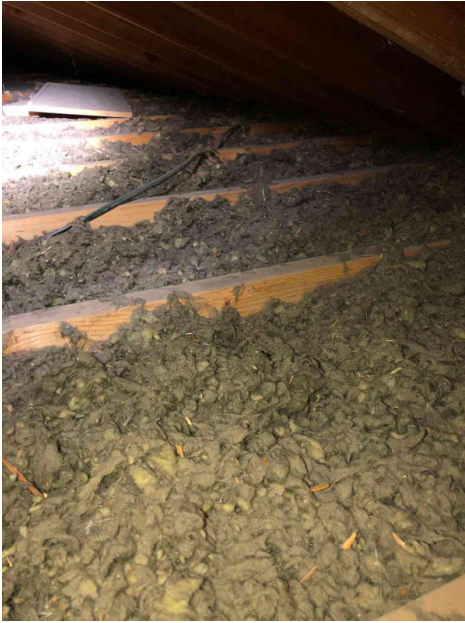
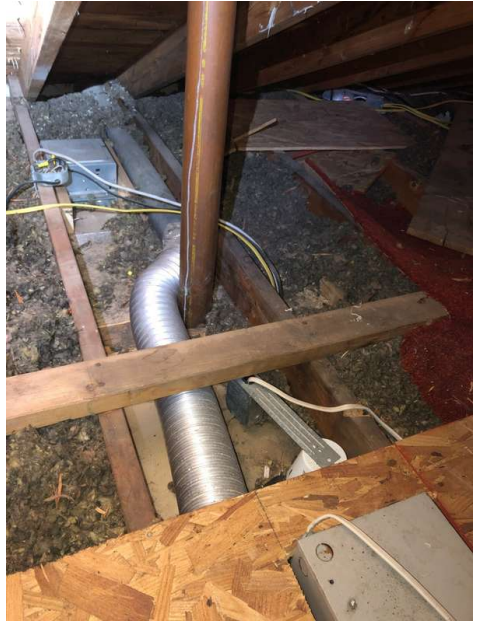
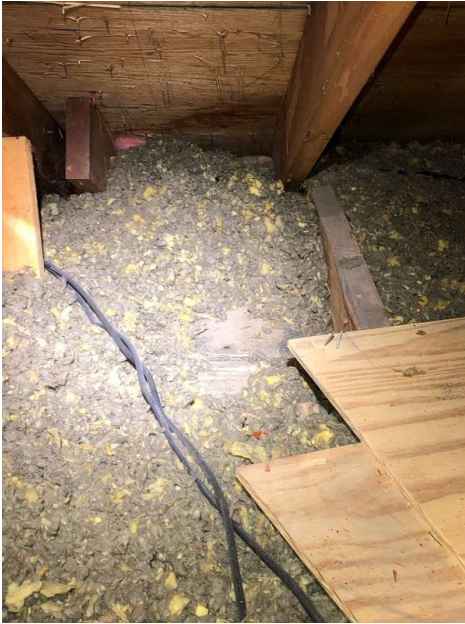
5.2.2 Attic Insulation

**COMFORT AND EFFICIENCY RECOMMENDATION-INSUFFICIENT INSULATION**

Insulation depth was inadequate. Modern energy efficiency standards suggest a minimum of R-38 insulation (around 12" of blown insulation) up to R-60 (about 18" of blown insulation). Sufficient attic insulation is one of the most impactful measures that can be taken to improve occupant comfort and reduce energy demands. Insulation is relatively inexpensive and can qualify for rebates from local utilities if eligibility is met. Recommend a qualified attic insulation contractor install additional insulation.

Contact a qualified insulation contractor.

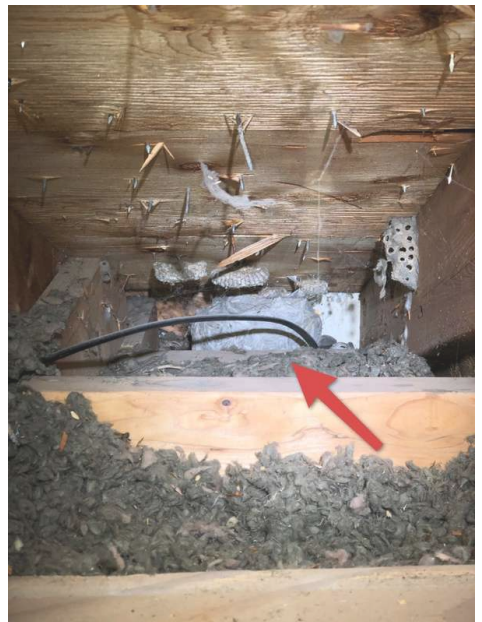
5.2.3 Attic Insulation

WASPS NEST

A wasps nest was visible in the attic at the time of inspection. The nest was not active at the time of inspection, but may be due to the season. The Inspector recommends nest removal by a qualified contractor.

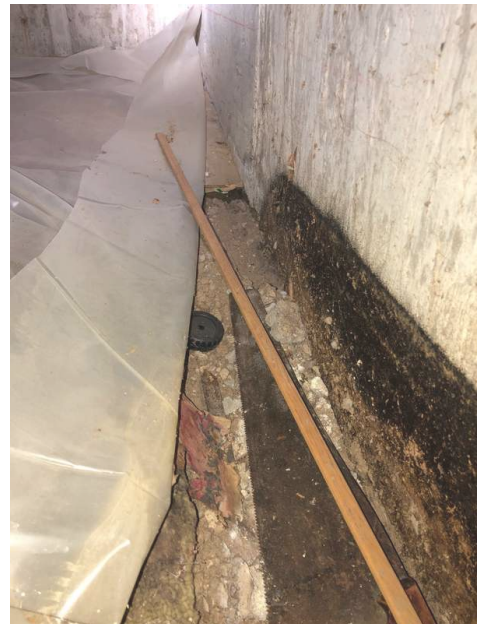
5.5.1 Vapor Retarders (Crawlspace or Basement)

Vapor barrier is not sealed at the seams and at the foundation wall. This can result in unwanted moisture and soil gasses such as radon infiltrating the crawlspace through and around gaps and unsealed seams in the plastic barrier. Recommend that an insulation or crawlspace contractor seal the vapor barrier to create a continuous seal.

Contact a qualified insulation contractor.

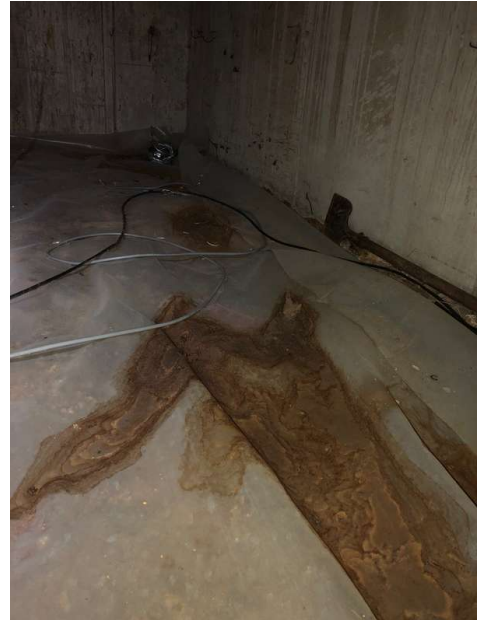
5.5.2 Vapor Retarders (Crawlspace or Basement)

Sediment deposit on the top of the crawlspace vapor barrier indicates past water infiltration and evaporation or removal. Recommend consulting with the previous owner to determine moisture intrusion history.

Contact a qualified professional.

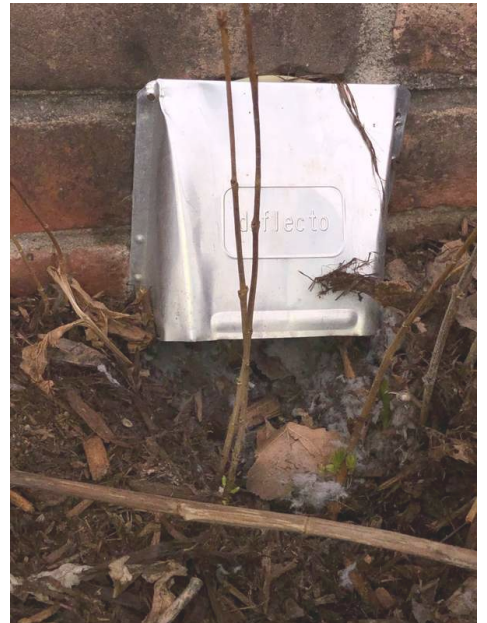
5.7.1 Exhaust Systems

Dryer vent was close to the exterior ground. If mulch is to accumulate, then exhaust air flow may be hindered. Recommend continued monitoring to ensure proper exhaust flow.

Contact a handyman or DIY project

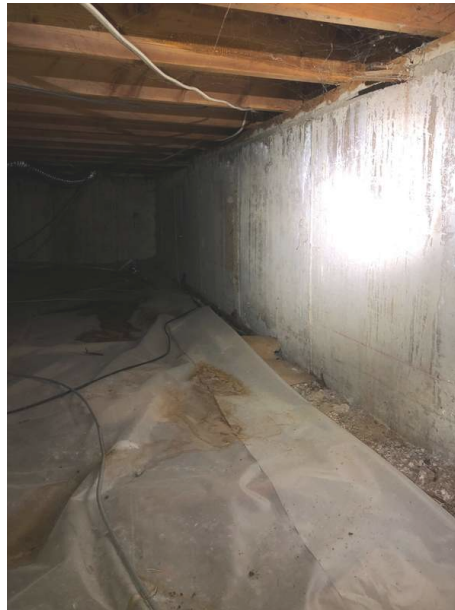
Foundation: Material

Concrete

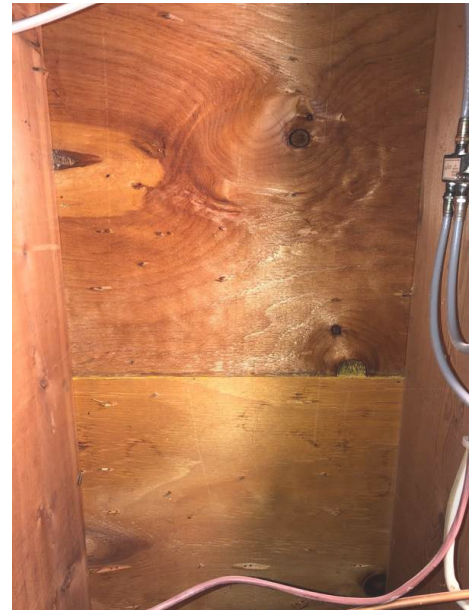
Floor Structure: Sub-floor

Plywood

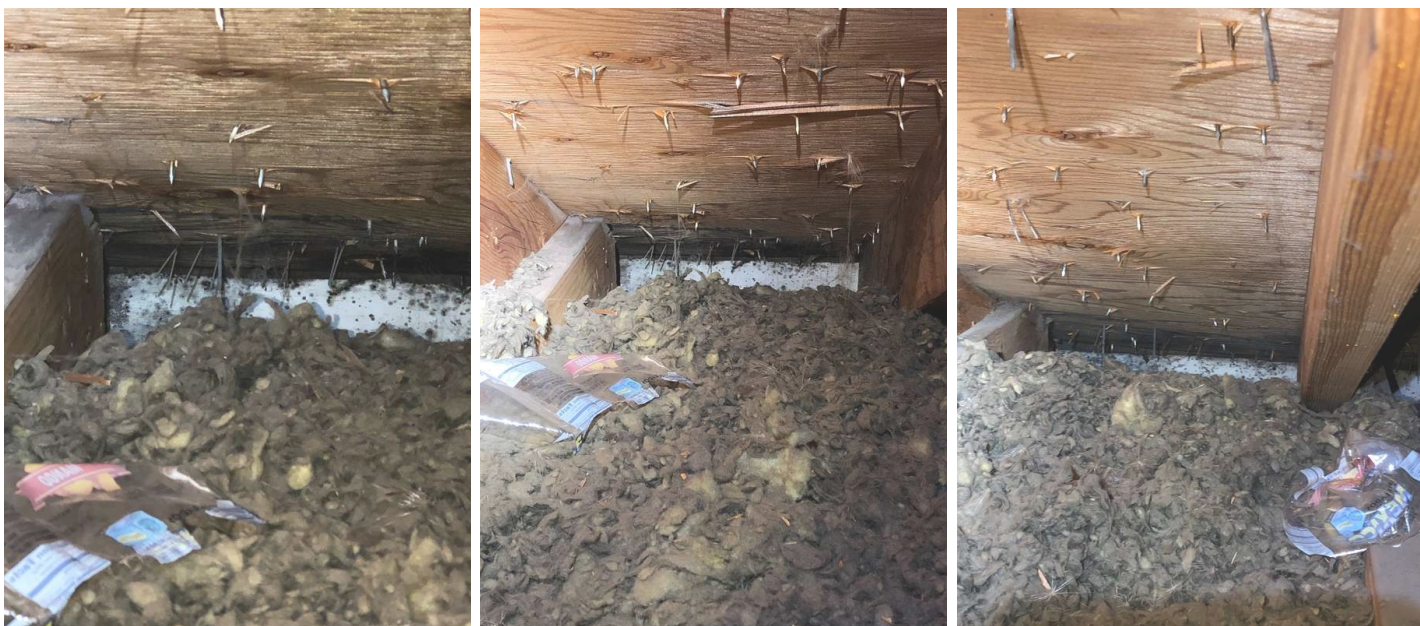
6.7.1 Roof Structure

MOISTURE DAMAGE AND POSSIBLE MICROBIAL GROWTH

Evidence of past water intrusion, associated moisture, and visible apparent microbial growth was noted in one localized area of the underside of the roof deck surface at the NE eve.. The moisture damage and staining appeared to be caused by roof leakage, potentially from ice damming, or the possibility of ventilation issues. It's most likely that the microbial growth is not currently active, and although present, dead. Recommend further evaluation of the area to determine the exact cause a need for remediation. Recommend mold testing of the affected areas to determine the status of the apparent microbial growth

Contact a qualified environmental contractor

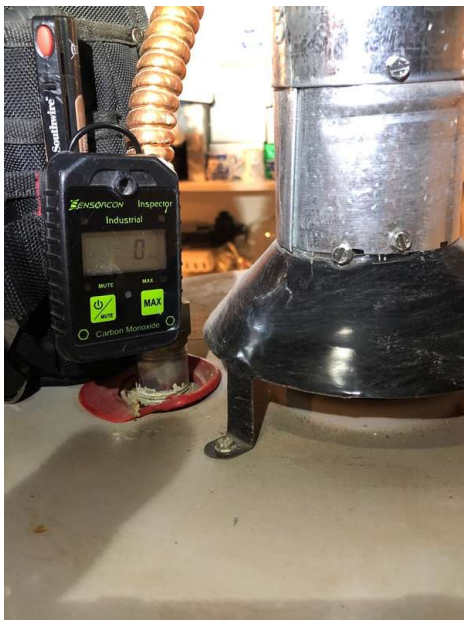
Hot Water Systems, Controls, Flues & Vents: Combustion safety test conducted

Combustion safety testing was performed on the water heater to ensure that the combustion gasses are drafting properly into the venting system, and not backdrafting into the home. At the time of inspection, the water heater passed spillage testing and was observed to be in safe operating condition.

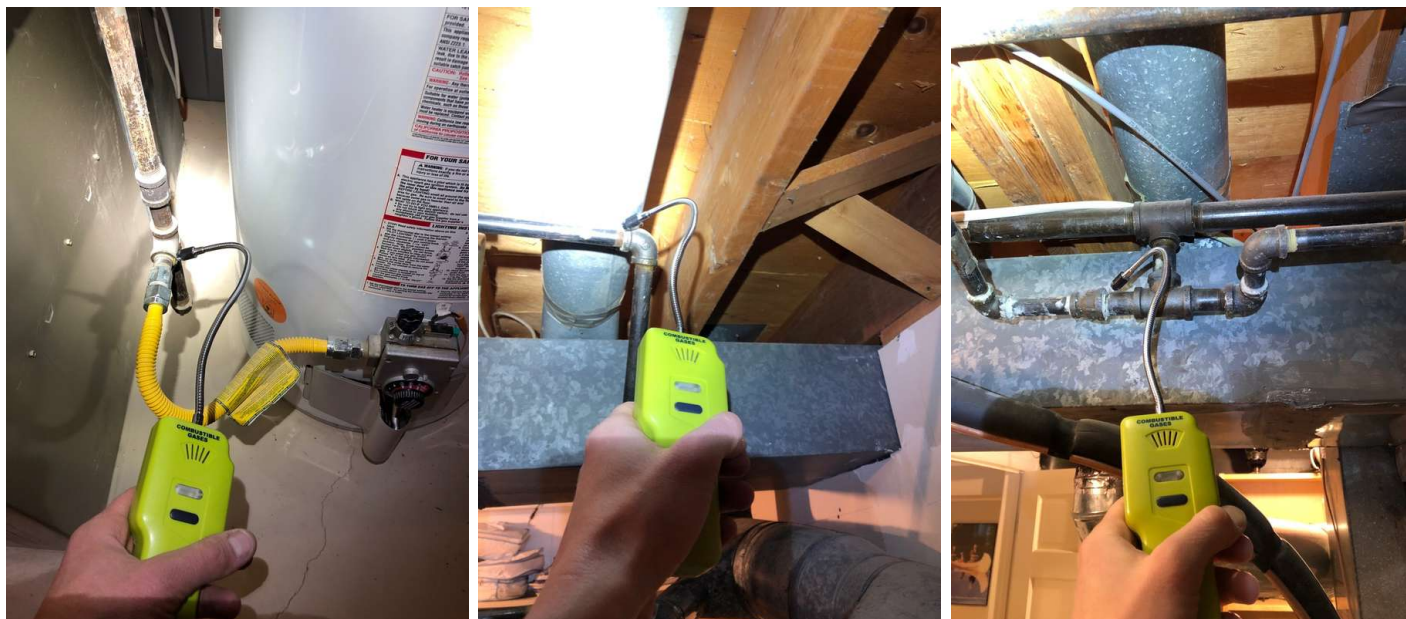
Fuel Storage & Distribution Systems: No Gas Leaks Detected

All accessible fuel lines were checked for leakage. No gas leaks were detected at the time of inspection.

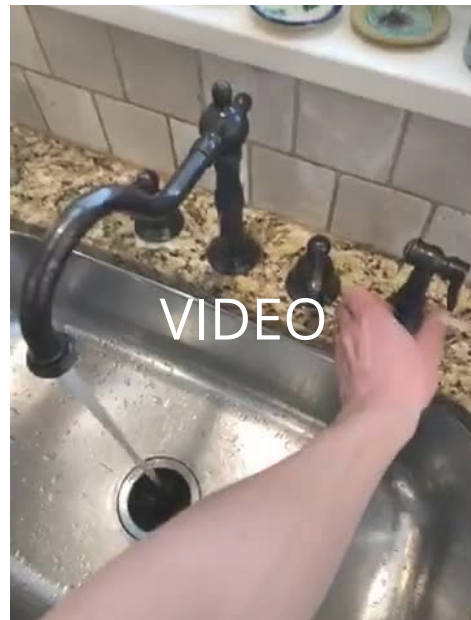
7.3.1 Plumbing Fixtures

KITCHEN SINK SPRAYER - IMPROPER FUNCTION

The kitchen sprayer, when engaged, turns the water flow off. It's speculated that this is due to an odd functional byproduct of higher water pressure, but further recommendation by a plumber would be recommended for accurate analysis.

Contact a qualified plumbing contractor.

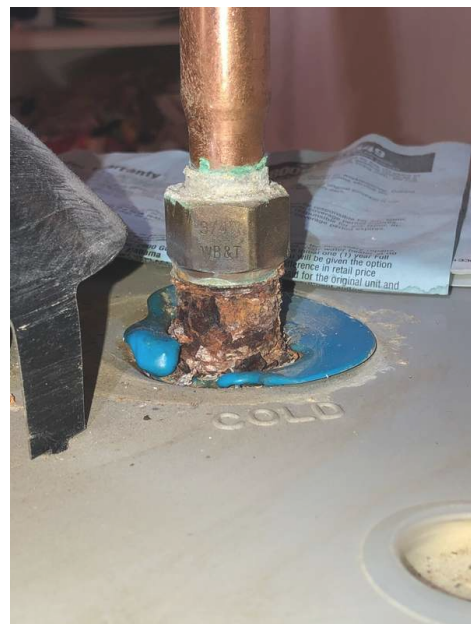
7.5.1 Hot Water Systems, Controls, Flues & Vents

PIPE CORROSION - DISSIMILAR METALS

Corrosion visible on water pipes connected to this water heater appeared to be the result of dissimilar metals in contact with each other. This condition can cause galvanic corrosion. The Inspector recommends installation of a dielectric union by a qualified plumbing contractor to help prevent further corrosion, deterioration and/or leakage made possible by this condition.

Contact a qualified plumbing contractor.

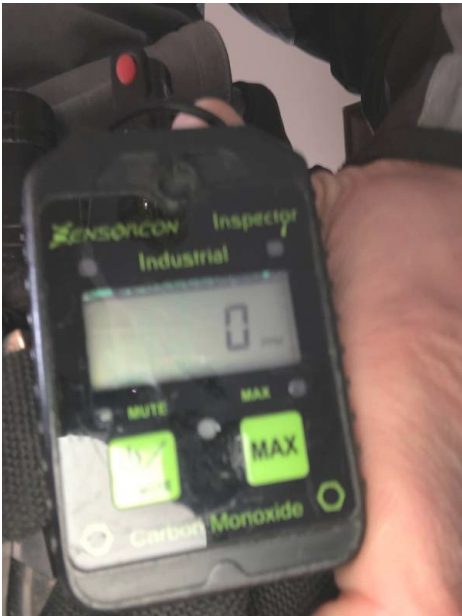
Carbon Monoxide Detectors: Health and Safety - Continuous CO Monitoring

Alpine Building Performance, LLC takes the potential presence of CO seriously. Carbon Monoxide (CO) levels were continuously monitored throughout the course of the inspection. CO monitoring is conducted during all Alpine Building Performance home inspections as a health and safety assurance to the current and future occupants of the building. No atmospheric CO was detected during the course of the inspection.

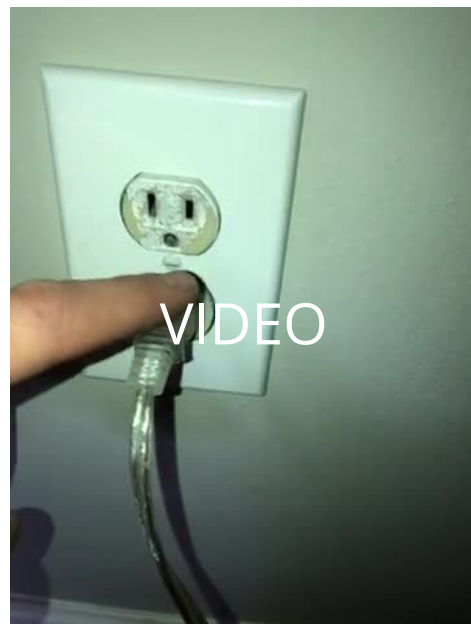
DAMAGED RECEPTACLE

A receptacle was physically damaged. The receptacle poses a potential shock hazard and should be replaced even if currently functional.

Contact a qualified electrical contractor.

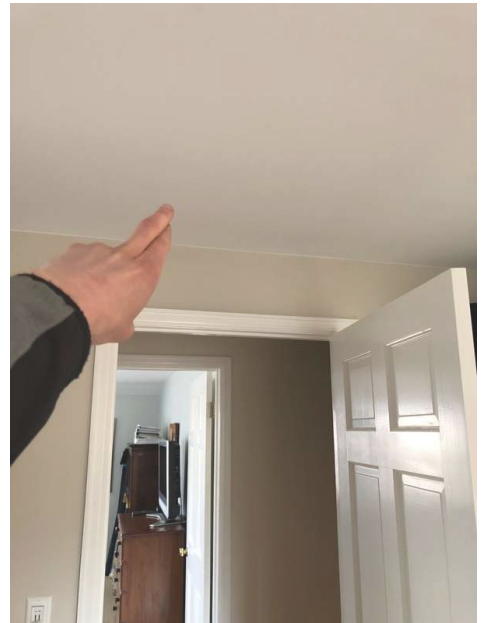
SAFETY RECOMMENDATION - INSTALL ADDITIONAL SMOKE ALARMS

The amount of smoke alarms observed in the home at the time of inspection is inadequate by accepted safety standards. The National Fire Alarm and Signaling Code requires as a minimum that smoke alarms be installed inside every sleep room (even for existing homes) in addition to requiring them outside each sleeping area and on every level of the home.

Contact a handyman or DIY project

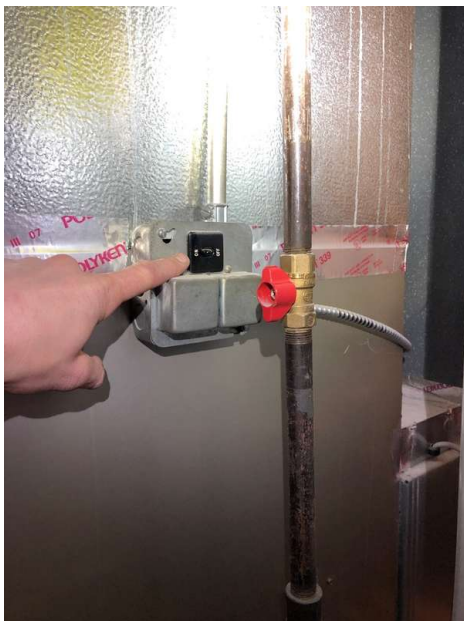
Furnace Disconnect: Disconnect OK

The electrical disconnect for the furnace was properly located and installed and in serviceable condition at the time of the inspection.

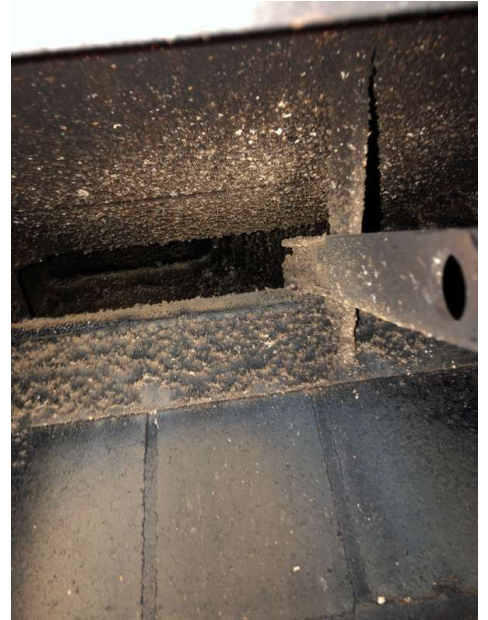
9.9.1 Solid Fuel Heating Device (Fireplace, Woodstove)

the flue for the wood-burning fireplace appeared to need cleaning. Dirty fireplaces are potential fire hazards. The flue should be cleaned by a qualified contractor.

Contact a qualified fireplace contractor.
