ALPINE BUILDING PERFORMANCE, LLC

HOME INSPECTION REPORT

1234 Main St.
Denver Colorado 80216

04/05/2019 9:00AM

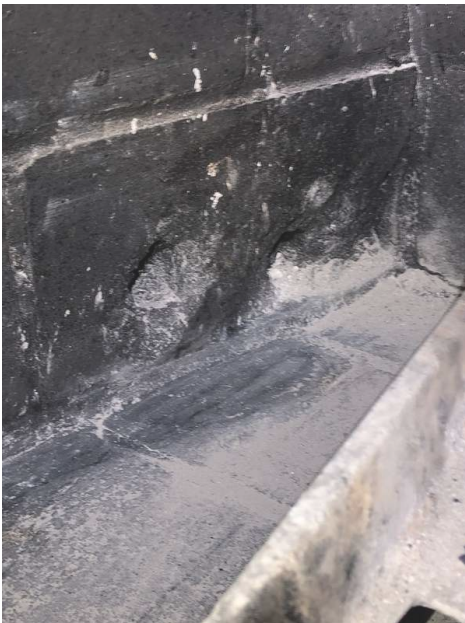
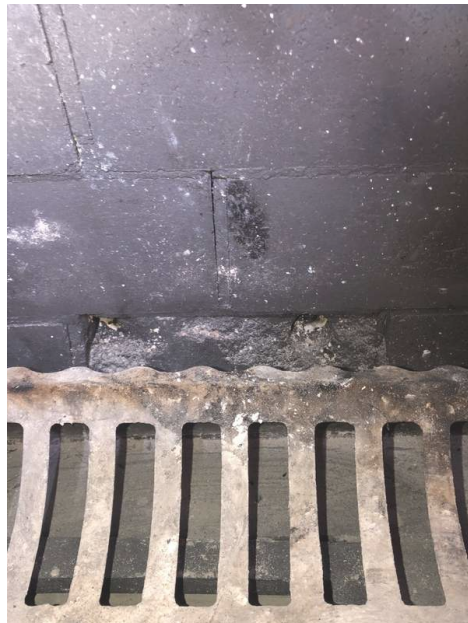
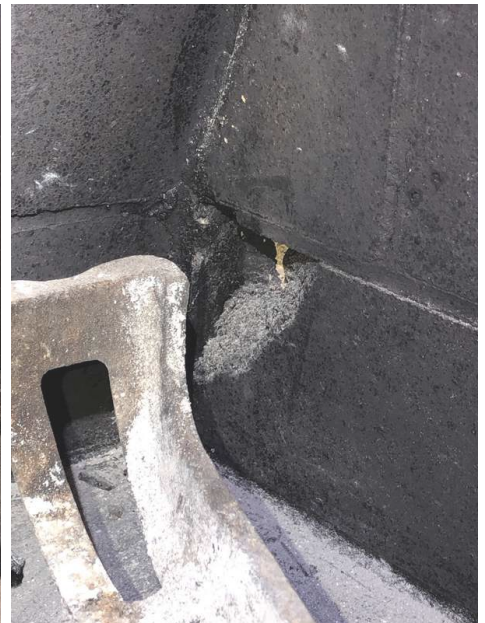
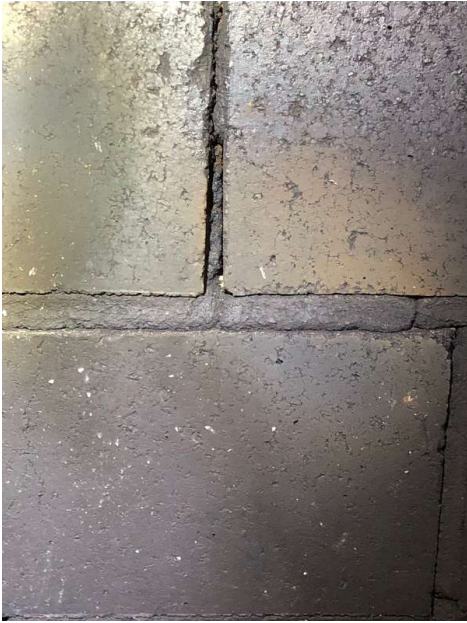
9.9.2 Solid Fuel Heating Device (Fireplace, Woodstove)

CRACKED FIREWALL

The fireplace firewall was cracked in one area, and a gap in mortar on the sides was noted. This could lead to further chimney damage or toxic fumes entering the home upon operation of the fireplace. Recommend a qualified fireplace contractor evaluate and repair.

Contact a qualified chimney contractor.

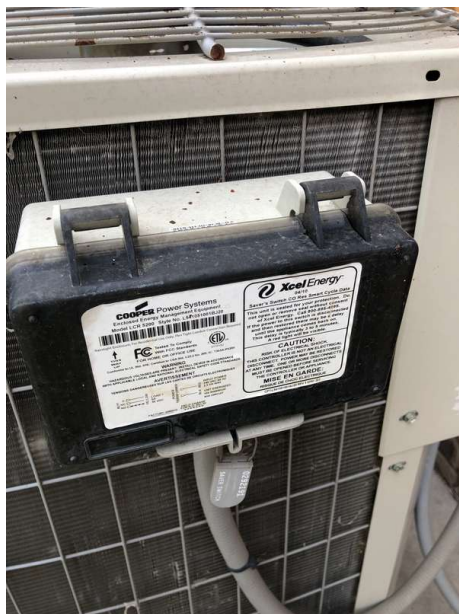
General: Xcel Energy savers switch installed

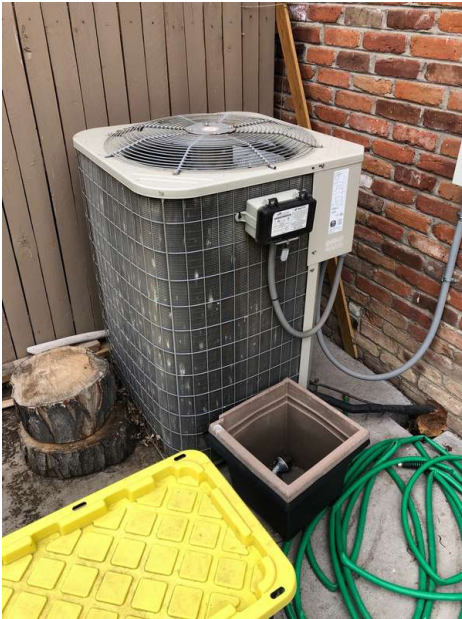
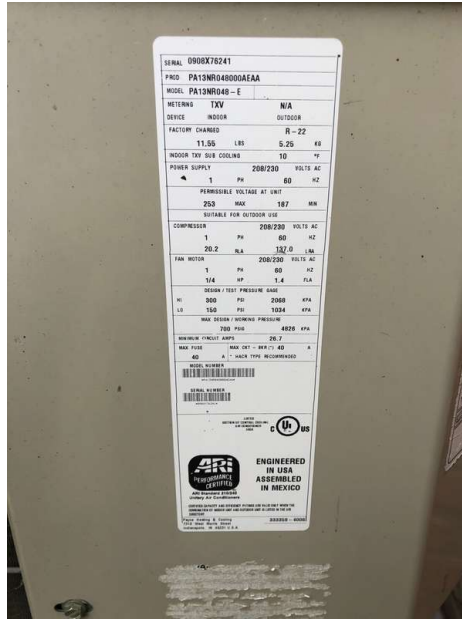
Cooling Equipment: Cooling System Data Plate and Photos

13 SEER

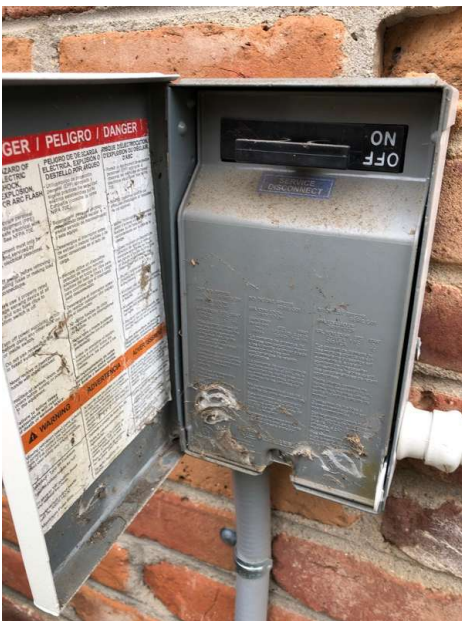
A/C Disconnect: Disconnect OK

Although it was not operated, the electrical disconnect for the condensing unit appeared to be properly located and installed and in serviceable condition at the time of the inspection.

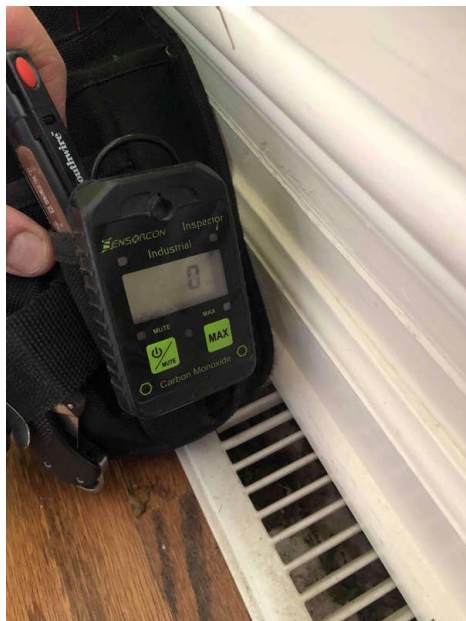
Distribution System/Ductwork: No Carbon Monoxide Detected at Registers - Safety Check

The HVAC distribution registers were tested for carbon monoxide-which could indicate a cracked heat exchanger in the furnace. No leaks were detected.

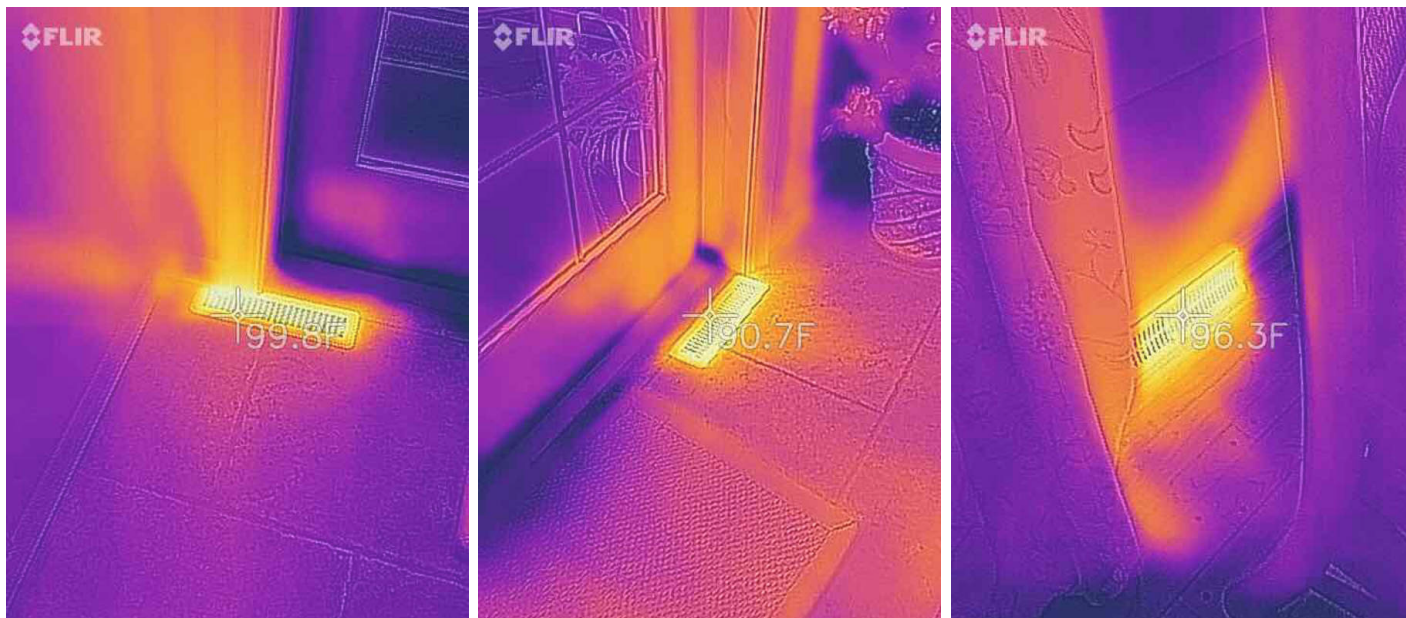
Presence of Installed Cooling Source in Each Room: Proper Temperature Split Observed

Temperature split between the supply and return registers was within the proper range of 14-22 degrees F. Thermal images of the cooling supply were taken to document the working condition of the cooling system at the time of inspection.

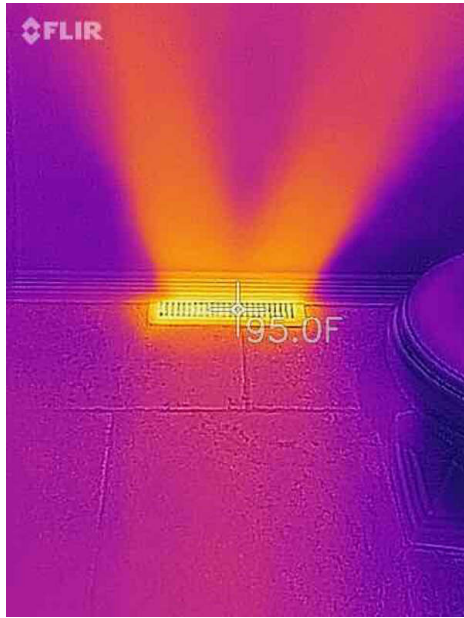
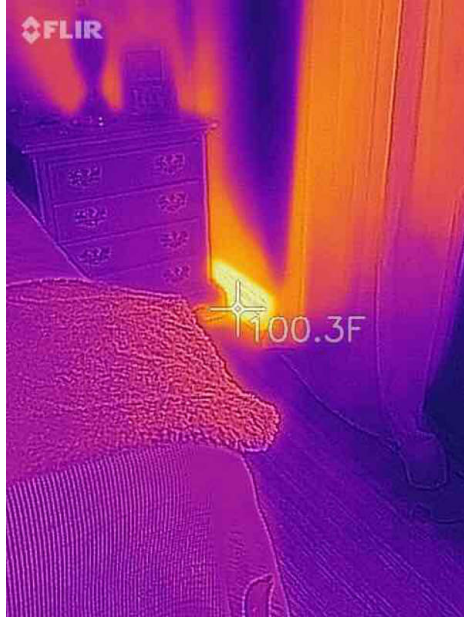
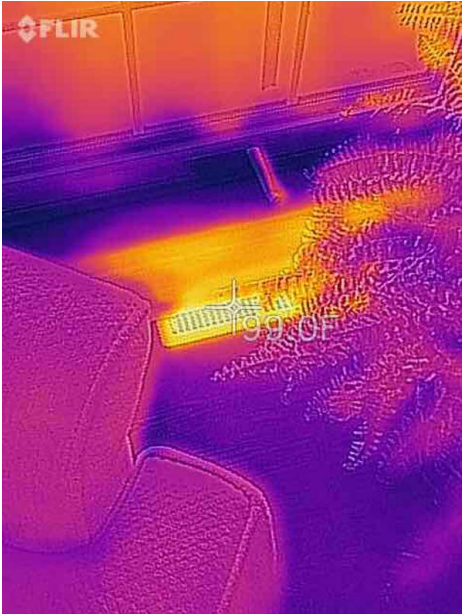
Presence of Installed Heat Source in Each Room: Heating Supply Thermal Images

Thermal images of the heat supply were taken to document the working condition of the heating system at the time of inspection.

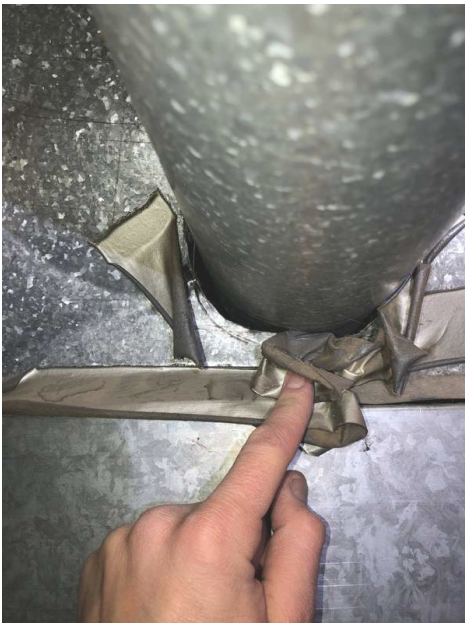
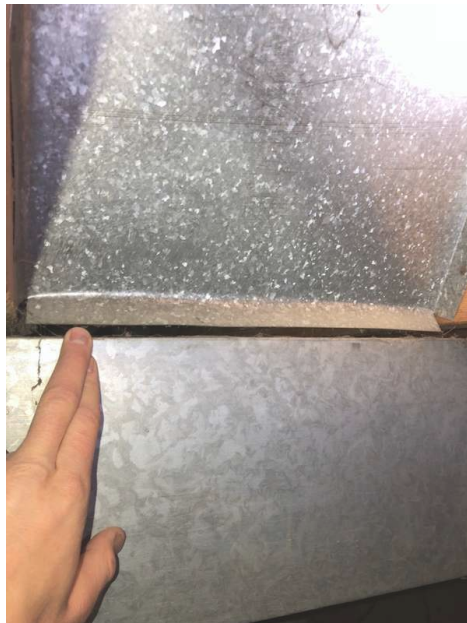
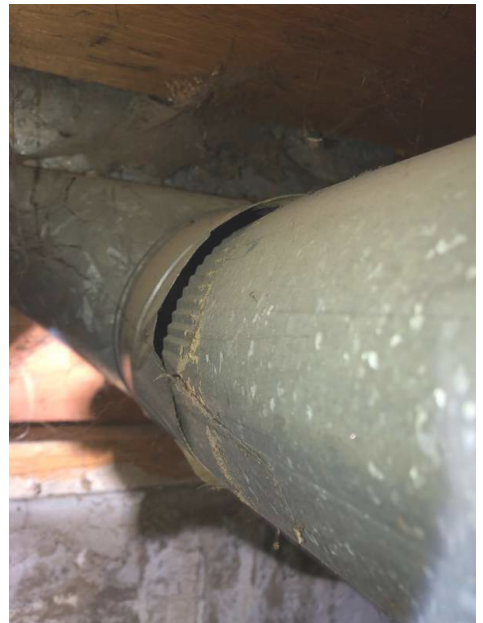
11.1.1 Distribution System/Ductwork

COMFORT AND EFFICIENCY RECOMMENDATION - DUCT SEAMS UNSEALED

Gaps were noted around supply air duct fittings in the crawlspace. These gaps can lead to unwanted air infiltration and conditioned air into the crawlspace. Recommend sealing the seams in the ductwork with liquid mastic.

Contact a qualified HVAC professional.

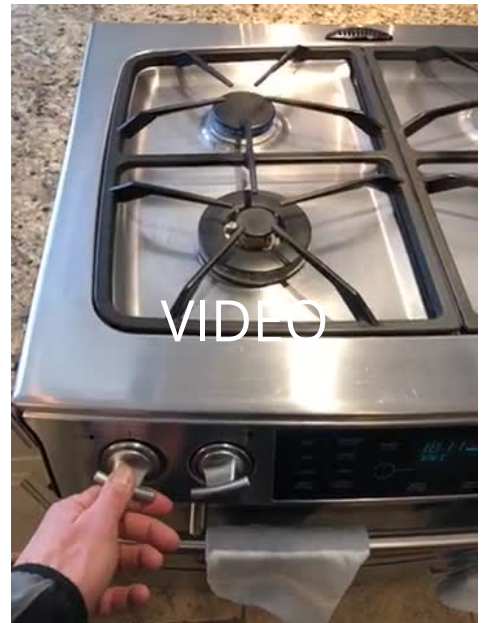
12.4.1 Range/Oven/Cooktop

BURNER NOT FUNCTIONING

One or more heating elements did not heat up/ignite when turned on. Recommend qualified professional evaluate & repair.

Contact a qualified appliance repair professional.

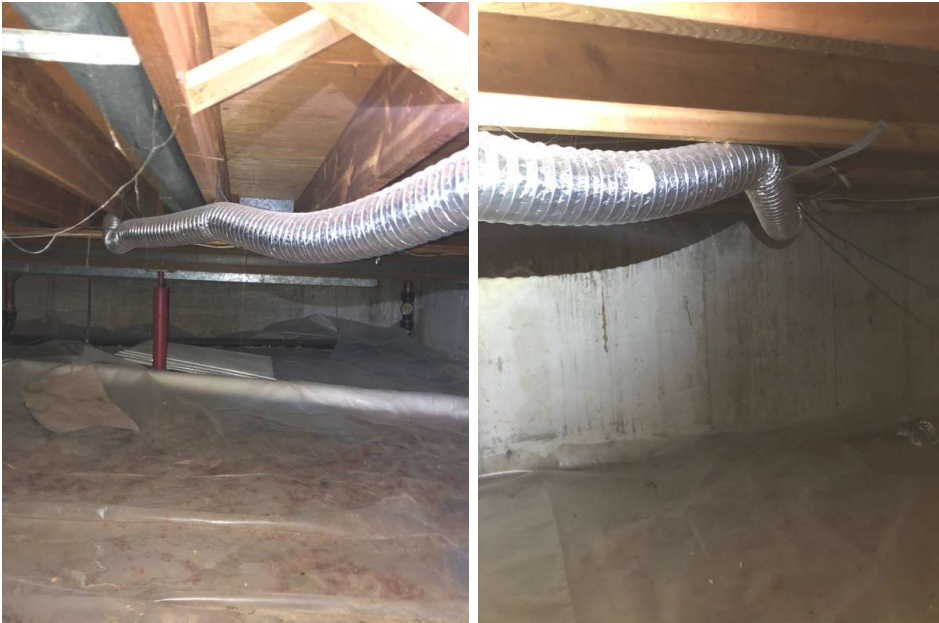
The dryer vent was observed to be too long. Dryer vents that are too long will not vent properly and are subject to faster clogging with lint. Recommend shortening or moving vent for proper air flow. A flex dryer vent should be no longer than 25' total run. Each 90 degree turn derates the total length by 5' and each 45 degree bend derates the total length by 2.5'.

Contact a qualified appliance repair professional.

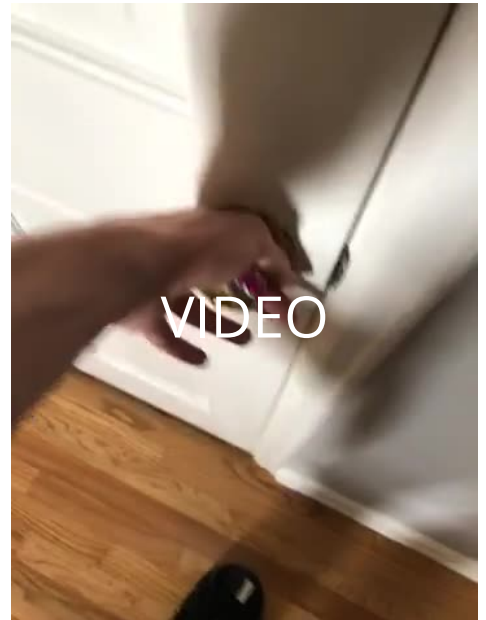
One or more doors doesn't latch properly. Door latch and/or strike plate is out of alignment. Recommend handyman repair latch and/or strike plate.

Contact a qualified handyman.

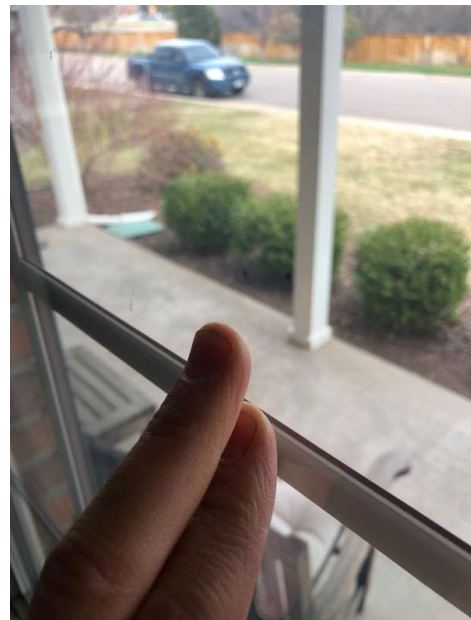
13.2.1 Windows

SUSPECTED EARLY STATE FAILED SEAL

Light fogging or moisture observed between the two panes of glass meaning that a window seal may be failing. Recommend further evaluation by qualified window contractor to determine options for repair or replacement.

Contact a qualified window repair/installation contractor.

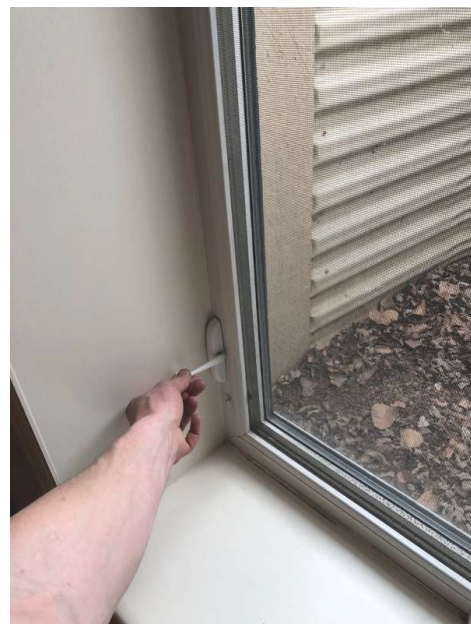
13.2.2 Windows

A window did not latch when operated. Recommend further evaluation and repair.

Contact a qualified window repair/installation contractor.

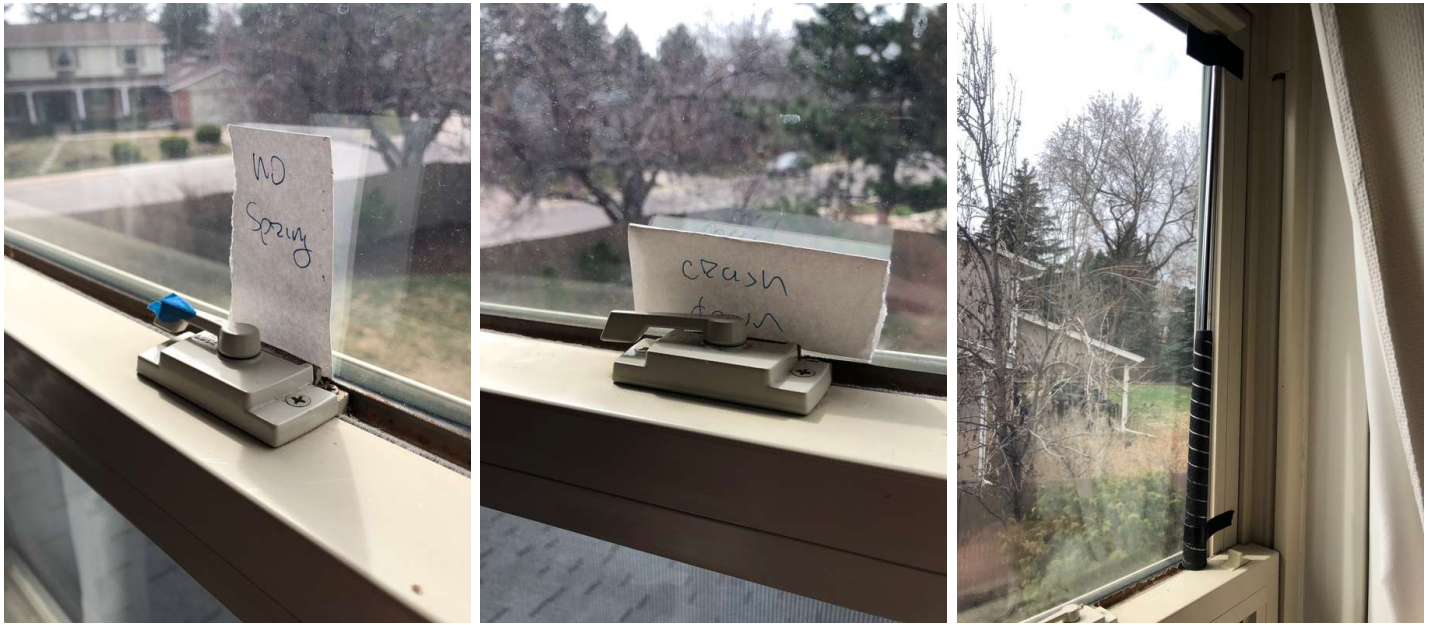
13.2.3 Windows

Safety Hazard

Multiple windows would not stay open on their own at the time of inspection, and would slam when unlatched. The inspector can speak to this after having an upper window sash close quickly on a fingernail while unlatching the window. Recommend repair or replacement by a qualified window specialist.

Contact a qualified window repair/installation contractor.

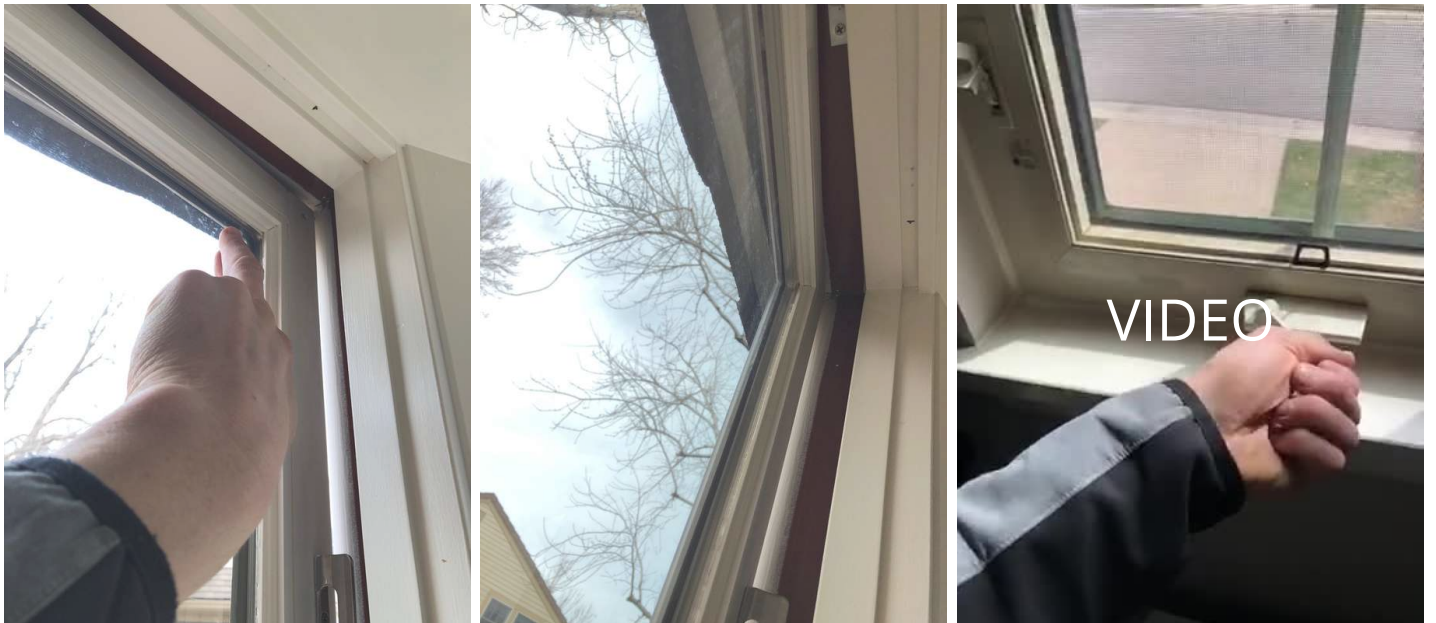
13.2.4 Windows

Four windows were not fully inoperable at time of inspection. The 2 bay windows in the dining room were caught on the drip flashing above, and the upstairs bathroom crank windows would not open. Recommend repair by a qualified professional.

Contact a qualified window repair/installation contractor.

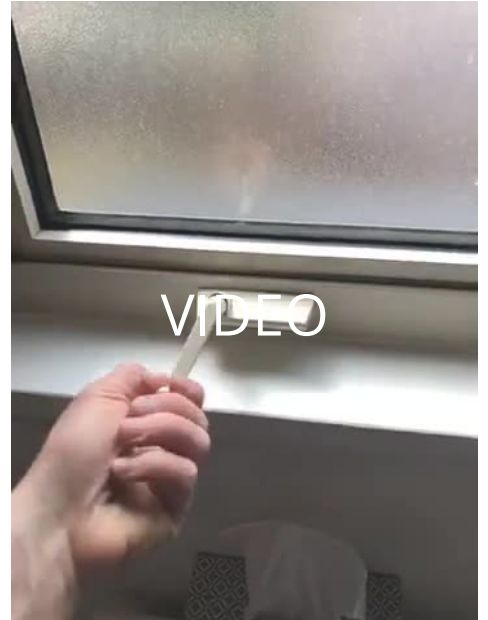
13.2.5 Windows

A window crank was inoperable at the time of inspection. Recommend repair in order to restore full functionality of the window.

Contact a qualified window repair/installation contractor.

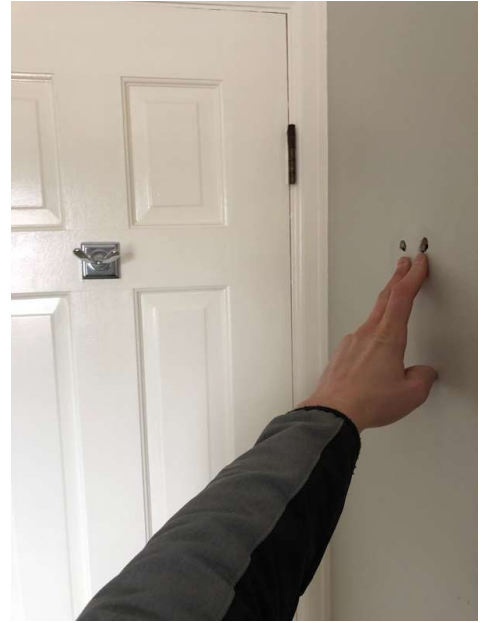
A hole was observed in wall. Recommend repair.

Recommendation

Contact a qualified drywall contractor.

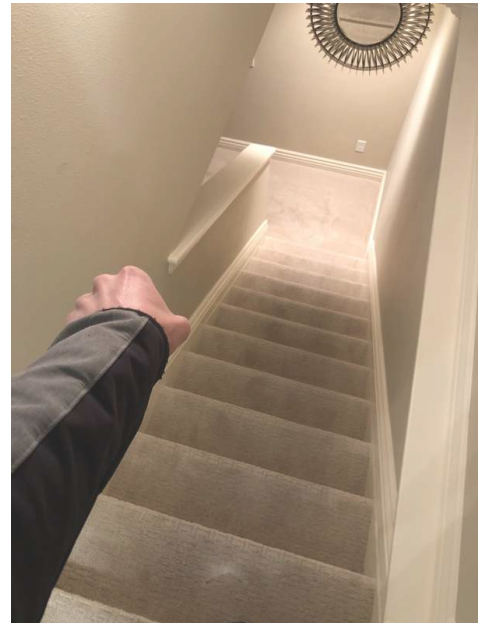
13.6.1 Steps, Stairways & Railings

Although it had 4 or more risers, this staircase had no handrail installed. This condition is a potential fall hazard. In order to comply with generally-accepted current standards which require a handrail at staircases with 4 or more risers, this staircase would need a handrail installed. The Inspector recommends that a handrail be installed that complies with modern safety standards. All work should be performed by a qualified contractor.

Recommendation

Contact a qualified carpenter.
