PLATINUM HOME INSPECTIONS

RESIDENTIAL HOME INSPECTION REPORT

1234 Main St.
Merrimack NH 03054

01/21/2019 9:00AM

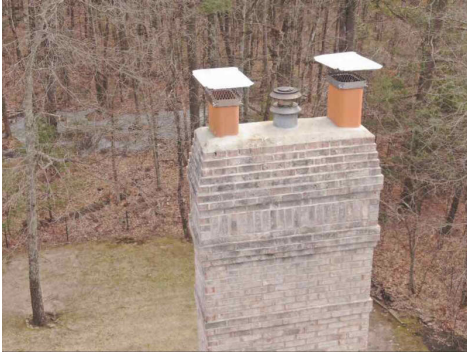
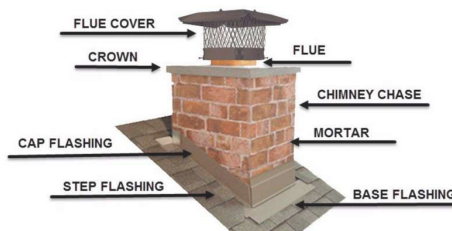
CHIMNEY CAP BLOCKED FLUE ACCESS

A chimney cap prevented viewing the interior of the chimney flue. Removal of the chimney cap lies beyond the scope of the General Home Inspection.

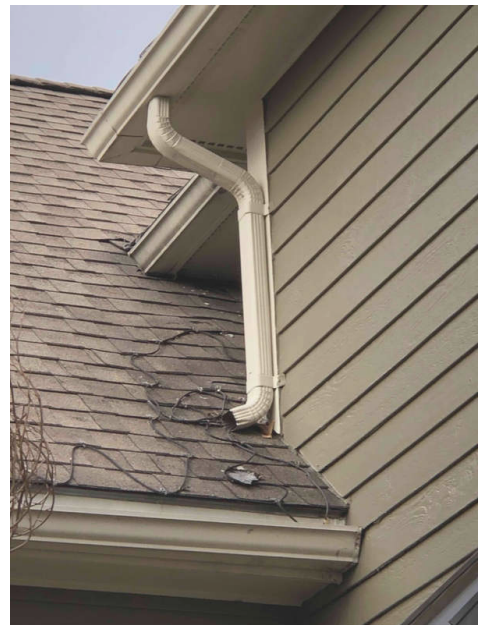
Roof de-icing / heat cable was observed at the home. These heat cables were not inspected or tested for operation. It is unknown if these cables are operable, powered by a switch or are wired properly. Recommend to inspect these cables to understand how they operate and to ensure they are in proper working condition prior to first snowfall. Monitor as part of preventative maintenance to ensure satisfactory operation. De-icing / heat cables may have been installed as a result of a known ice-dam issue. For more information regarding ice-dams, read here.

Contact a qualified professional.

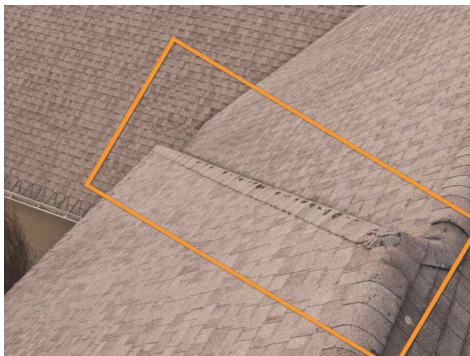
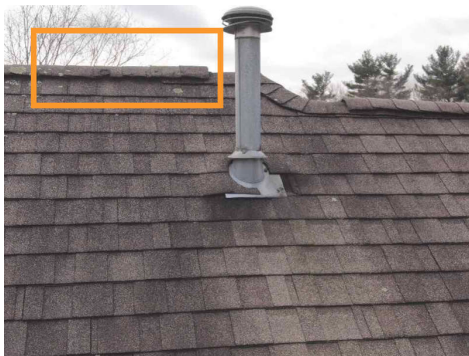
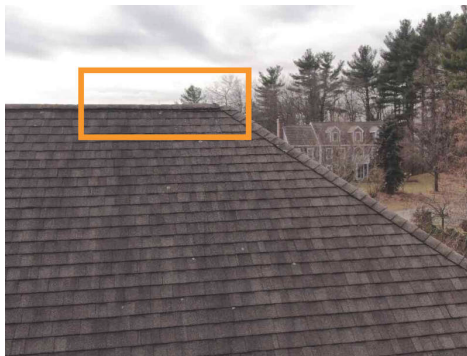
2.1.2 Coverings

DAMAGED RIDGE CAP SHINGLES

Cap shingles/ridge vent shingles are damaged/aging. Cap shingles are shingles that cover areas where the roof changes direction, like at roof peaks and hips. Recommend roofing professional evaluate and repair as needed.

Contact a qualified roofing professional.

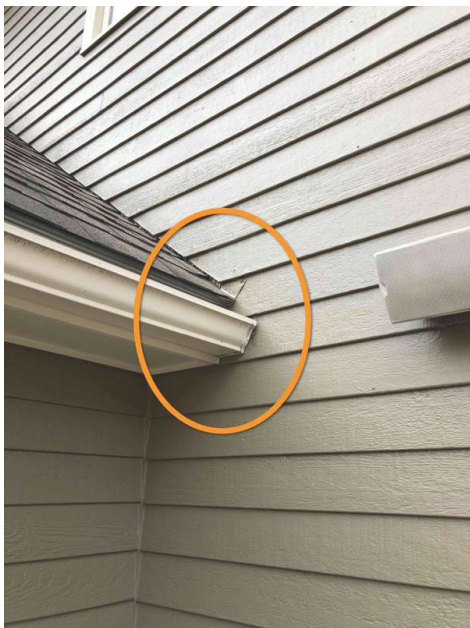
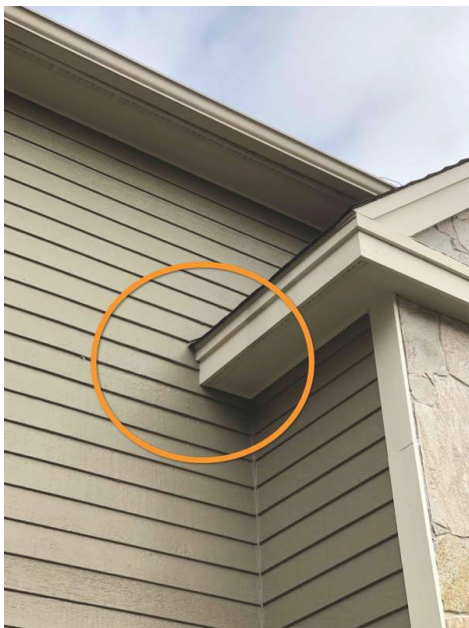
2.3.1 Flashings

MISSING KICK-OUT FLASHING

Kick-out flashing was missing where walls extended past roof edges.

Contact a qualified roofing professional.

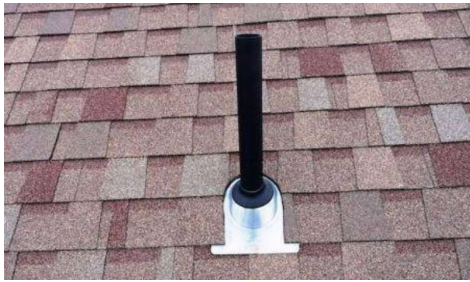
DWV PIPE FLASHING - MISSING COVER SHINGLE ON RIGHT SIDE

Drain, waste and vent pipe flashing should be covered on the back and sides by the shingles. Bottom edge/apron of the flashing should be the only exposed area. Recommend qualified roofing contractor rectify to prevent potential moisture intrusion.

Contact a qualified professional.

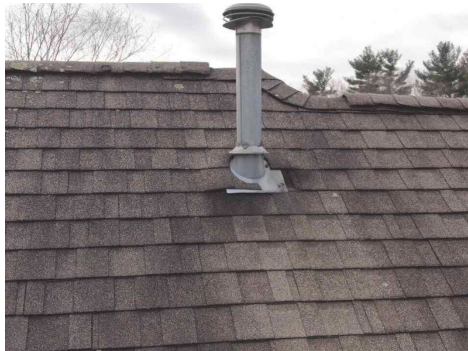
Example of properly flashed DWV Pipe.

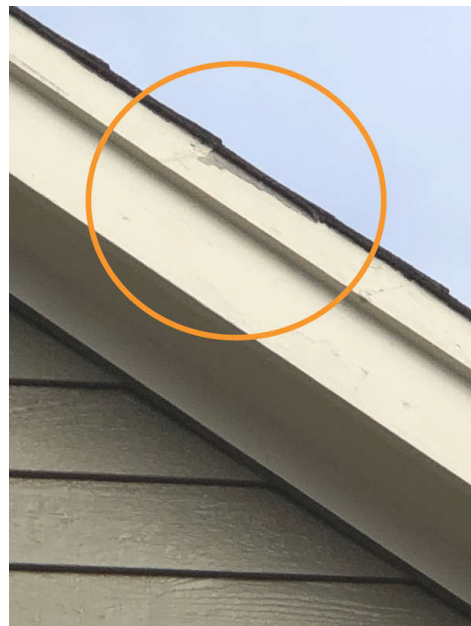
Front

Minor areas of peeling paint was observed on exterior surfaces, such as Siding, Trim, Fascia, Soffits, and Eave edges. Recommend qualified contractor to perform normal paint maintenance to prevent moisture damage to these areas.

Contact a qualified painter.

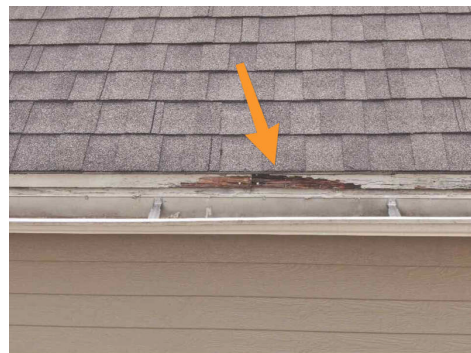
One or more sections of the fascia appear to be rotted. Listing agent explained that this damage is not rot, but caused by woodpeckers. Recommend qualified roofer evaluate & repair as needed.

Contact a qualified roofing professional.

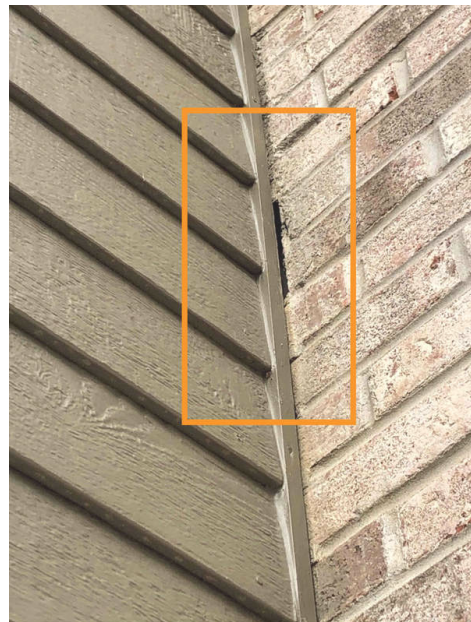
Observed a gap where the house siding meets the brick chimney. Recommend repointing/caulking to prevent moisture/insect intrusion.

Contact a qualified professional.

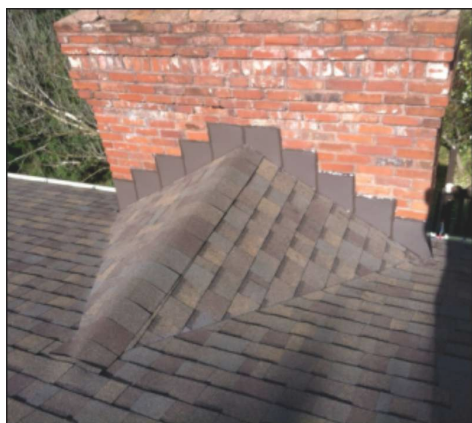
A cricket was installed to protect roofing near the chimney. A cricket is a small roof built on the uphill side of and abutting the chimney. Its purpose is to keep roof drainage from pooling on the uphill side of the chimney and eventually causing leakage. The Inspector observed few deficiencies in the condition of the cricket such as excessive caulking around the flashing as well as aging flashing. Recommend monitoring and have professional roofer repair as needed.

Example #1 of properly flashed cricket.

Contact a qualified roofing professional.

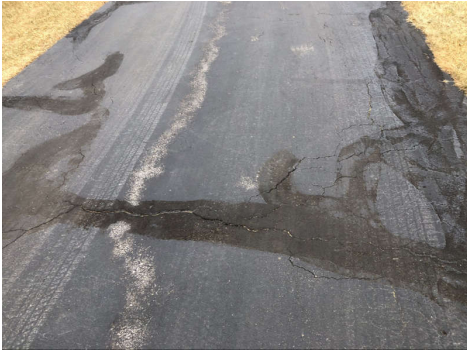
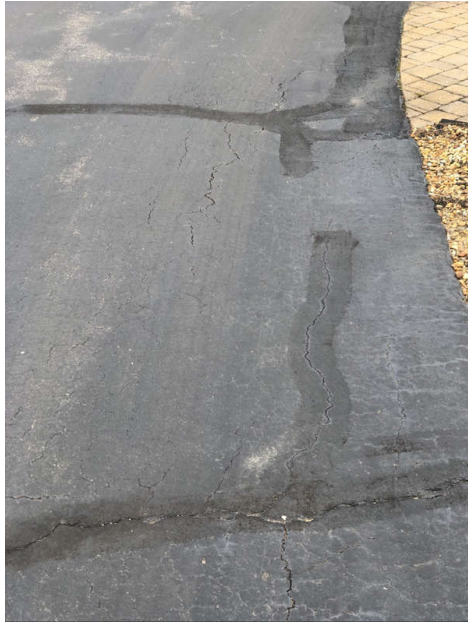
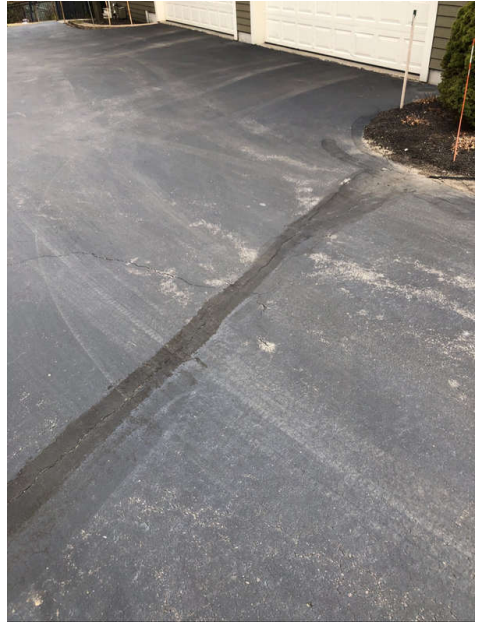
ASPHALT DRIVEWAY - TYPICAL CRACKING

Asphalt driveway... this material has typical cracking which is normal for its age recommend seal coating as needed to prolong life expectancy.

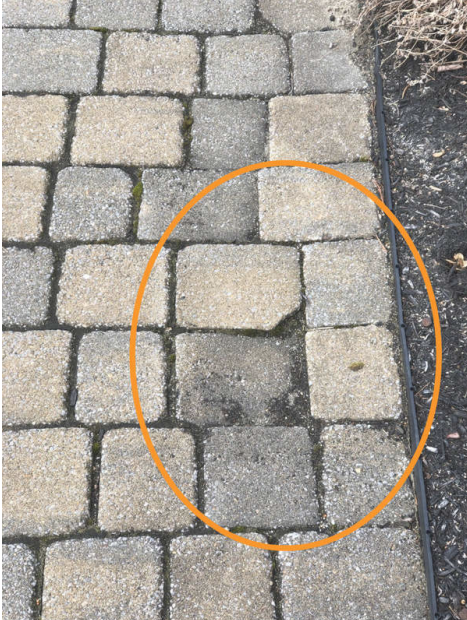
3.2.2 Walkways, Patios & Driveways

WALKWAY TRIP HAZARD

Trip hazards observed. Patch or repair recommended.

Pavers have sunk along stair tread

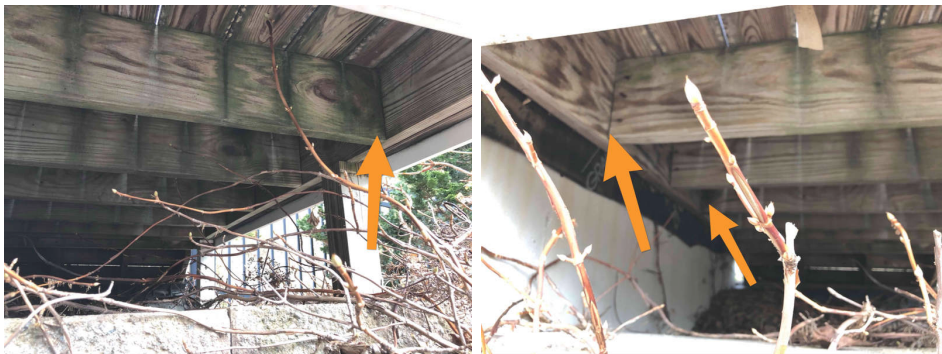
JOIST HANGERS - MISSING

Joist hanger(s) are missing or improperly installed. This could cause the deck structure to fail. Recommend that joist hangers be properly installed by qualified contractor.

Contact a qualified deck contractor.

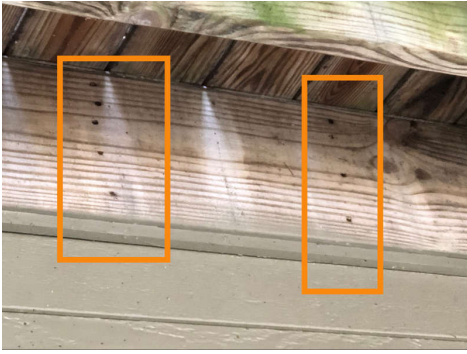
3.3.3 Decks, Balconies, Porches & Steps

Ledger boards for one or more decks, balconies or porches appeared to be attached with nails only. This method of attachment is substandard and may result in such structures separating from the main building. This is a potential safety hazard. Modern standards call for ledger boards to be installed with 1/2 inch lag screws or bolts into solid backing, and brackets such as [Simpson Strong Tie DTT2 brackets and threaded rod](#), connecting interior and exterior joists. Recommend that a qualified contractor repair per standard building practices. For more information, visit:

Contact a qualified deck contractor.

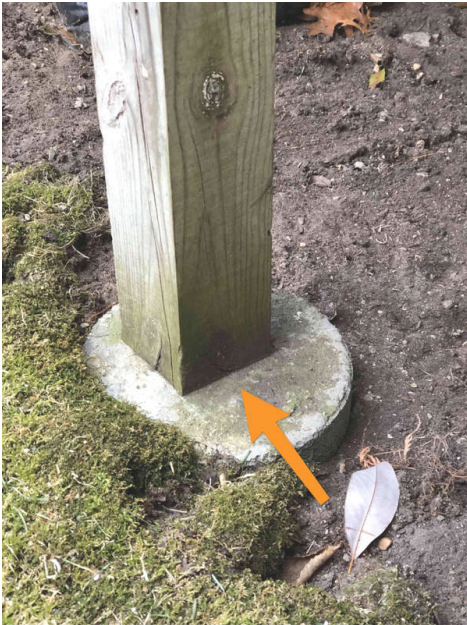
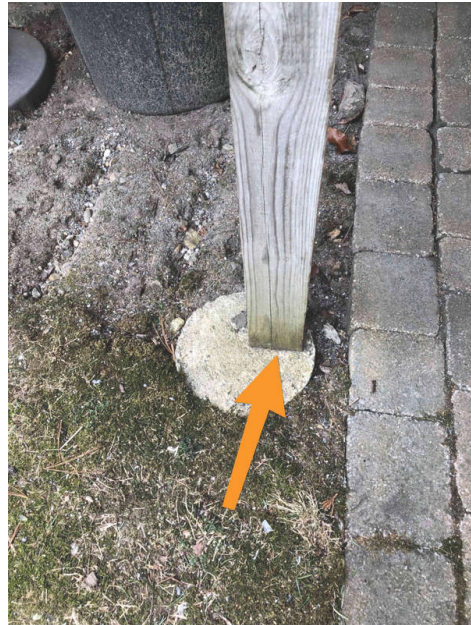
3.3.4 Decks, Balconies, Porches & Steps

SUPPORT POSTS - MISSING ANCHORS

While the deck structure seems solid at the time of inspection the support posts are missing anchors. Recommended installing metal base anchors with 1/2" through bolts for added stability.

Contact a qualified deck contractor.

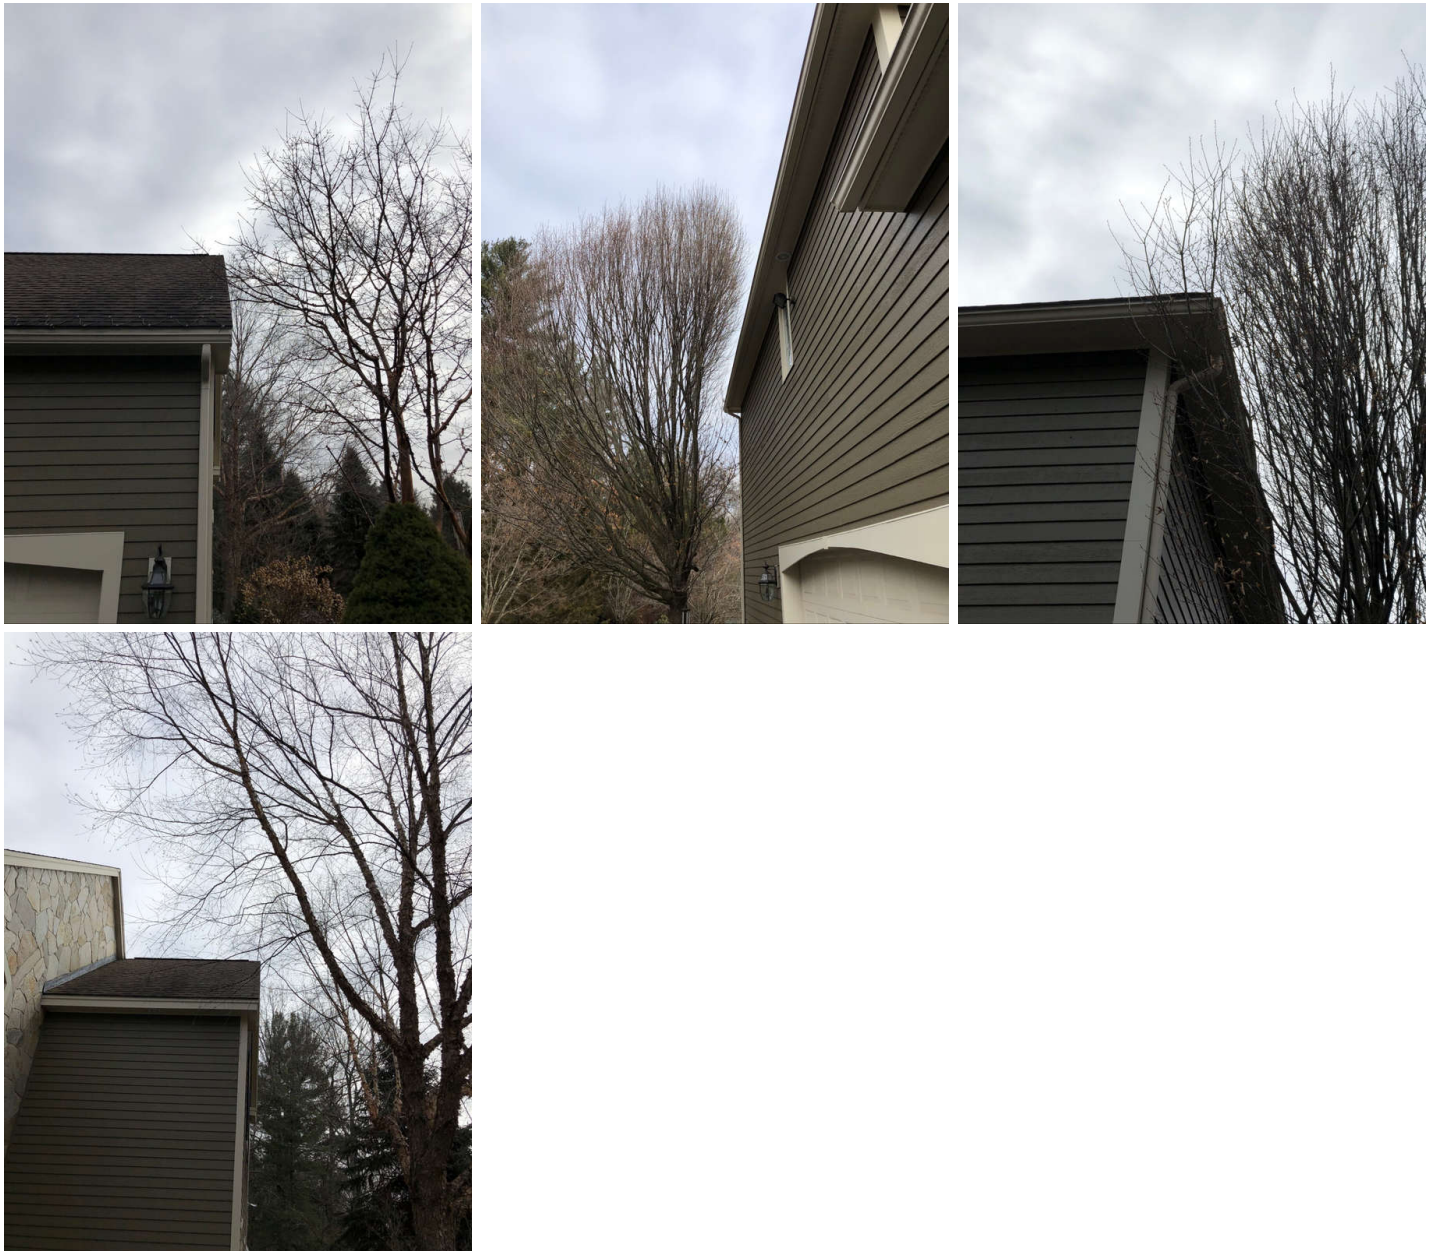
3.4.1 Vegetation, Grading, Drainage & Retaining Walls

TREE OVERHANG

Trees observed overhanging the roof. This can cause damage to the roof and prevent proper drainage. Recommend a qualified tree service trim to allow for proper drainage.

Contact a qualified tree service company.

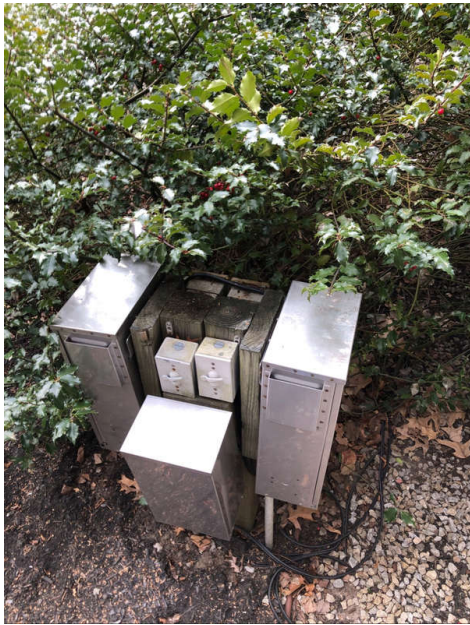
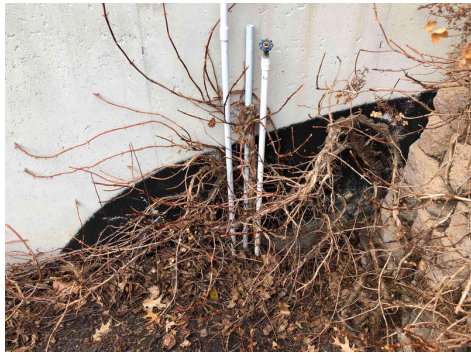
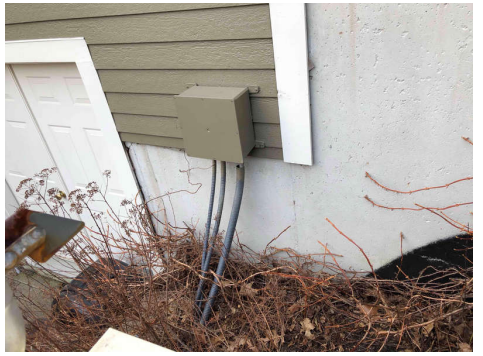
3.4.2 Vegetation, Grading, Drainage & Retaining Walls

VEGETATION ON HOME

Vegetation growing on home, recommend removal to prevent possible moisture damage.

Contact a qualified landscaping contractor

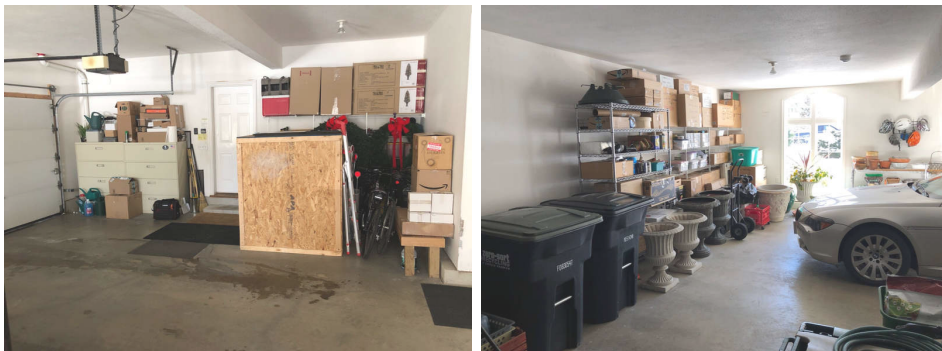
STORED ITEMS

Garage was filled with stored household items interior portions of garage are not fully visible recommend a re-evaluation once items have been removed.

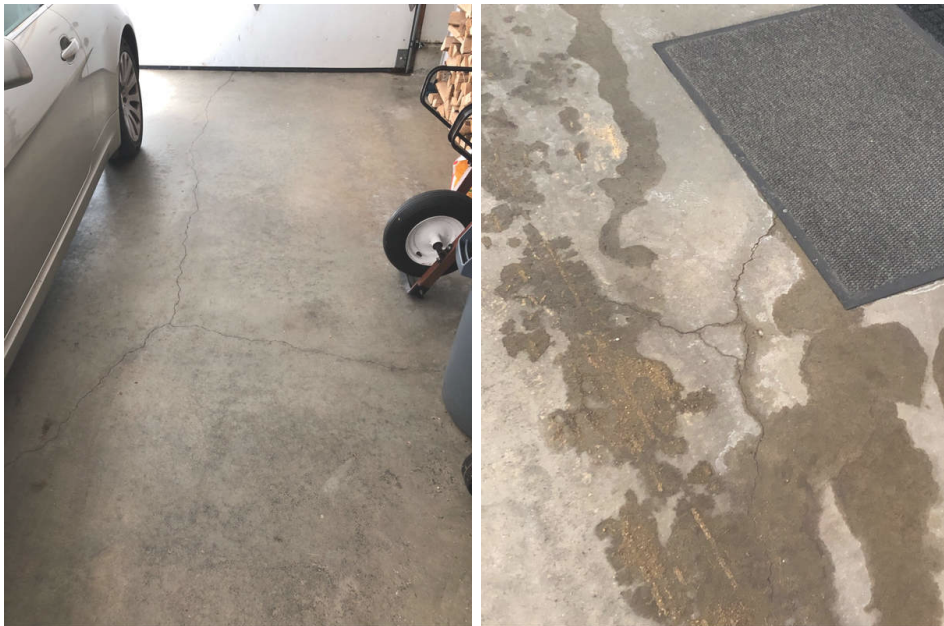
4.2.1 Floor

CRACKING

Typical cracking/settlement observed in concrete. If trip hazards become present, recommend licensed contractor to repair to prevent injuries.

Contact a qualified concrete contractor.

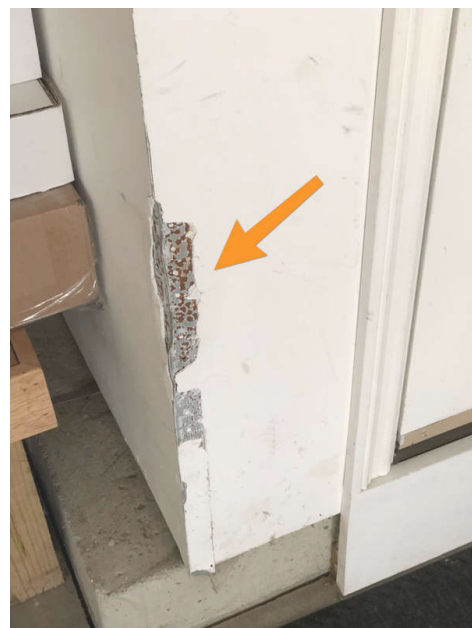
4.3.1 Walls & Firewalls

DAMAGED DRYWALL

Garage wall had damaged drywall. Recommend drywall contractor repair.

Contact a qualified drywall contractor.

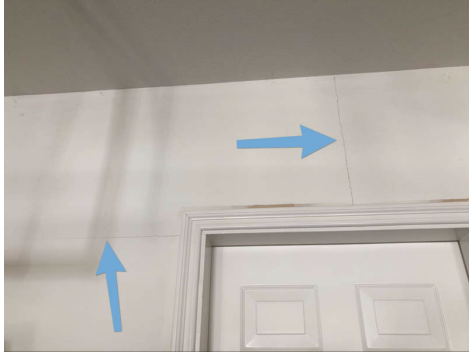
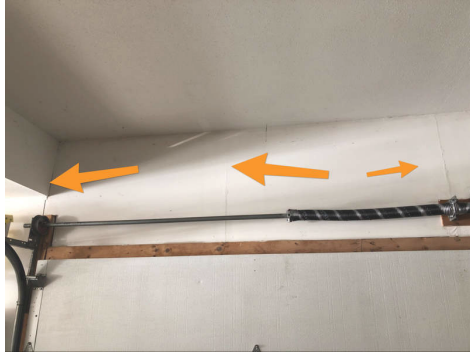
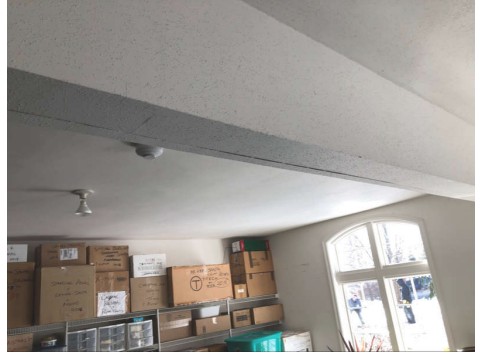
4.3.2 Walls & Firewalls

CRACKING-MINOR

Observed typical cracking in the drywall of the garage.

Corner bead pulling away

Contact a qualified professional.

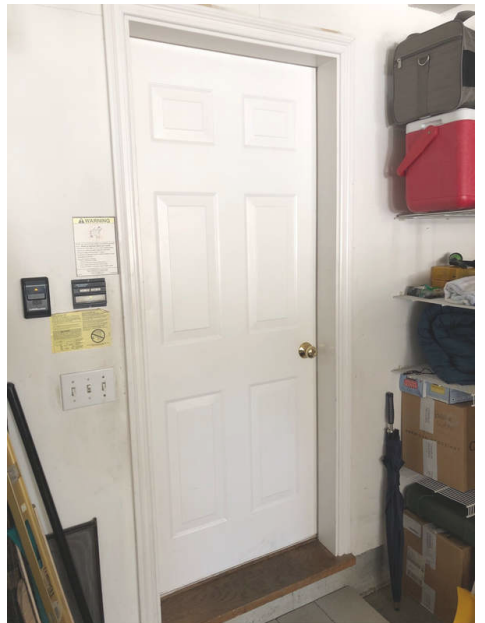
4.5.1 Occupant Door (From garage to inside of home)

Door from garage to home should have self-closing hinges to help prevent spread of a fire to living space. Recommend a qualified contractor install self-closing hinges.

Contact a qualified door repair/installation contractor.

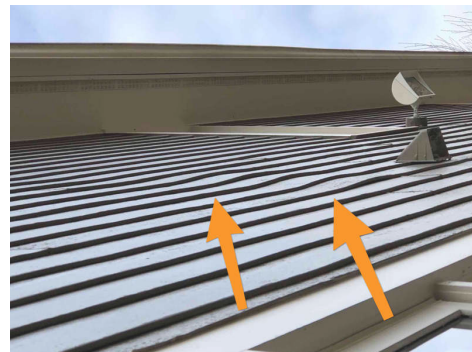
Clapboard siding had one area that is warping or buckling. As there is a vent directly to the right of the subject area this is most likely caused by excessive moisture venting to this area. There were no other signs of warping anywhere else on the exterior. Recommend a qualified siding contractor evaluate and repair.

Contact a qualified siding specialist.

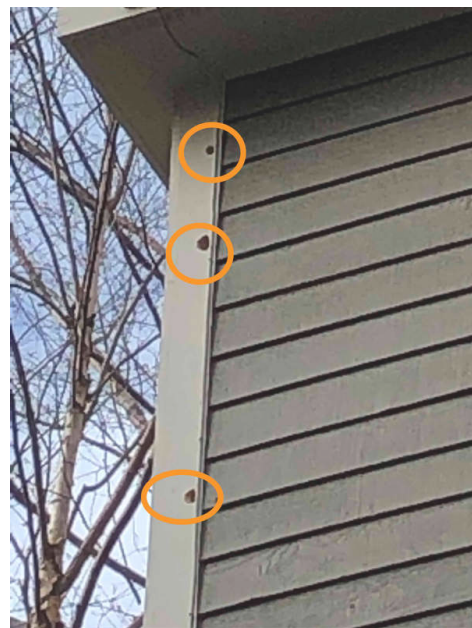
5.1.3 Siding, Flashing & Trim

DAMAGE TRIM BOARD

Observed a few holes in the right side trim. Recommend repairing to prevent moisture intrusion.

Contact a qualified professional.

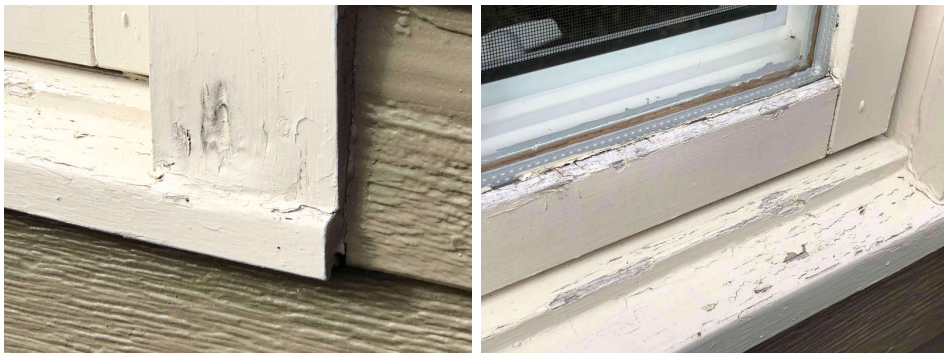
5.2.1 Exterior Windows

Exterior windows have painted components that are peeling, recommend qualified contractor to perform normal paint maintenance as needed to prevent potential damage.

Contact a qualified painter.

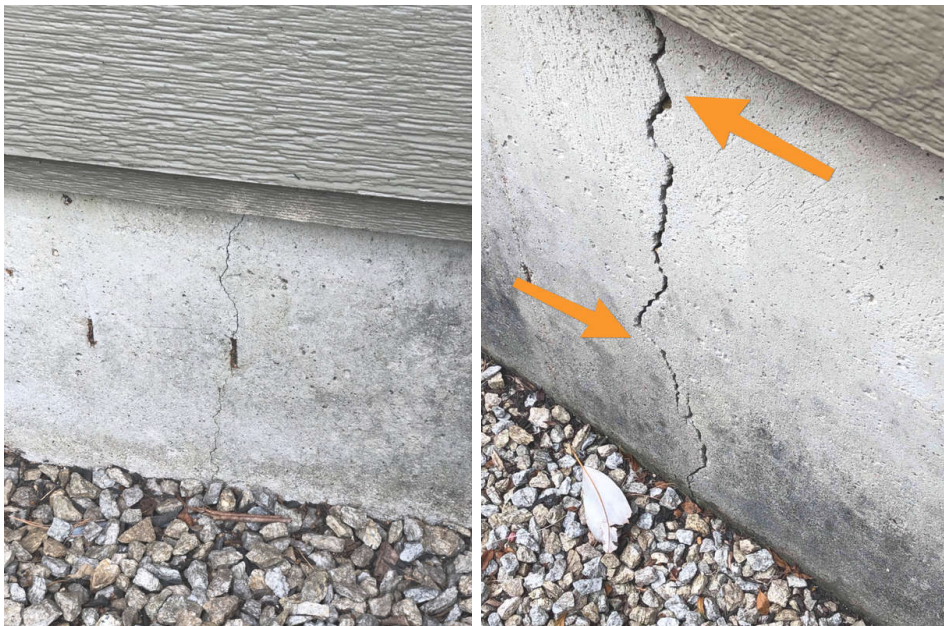
5.5.1 Exterior foundation

TYPICAL CRACKING

Exterior foundation contains typical cracks due to shrinkage and normal freeze thaw cycle. Recommend patching as needed to prevent moisture intrusion.

Left front, near elec meter

Contact a foundation contractor.

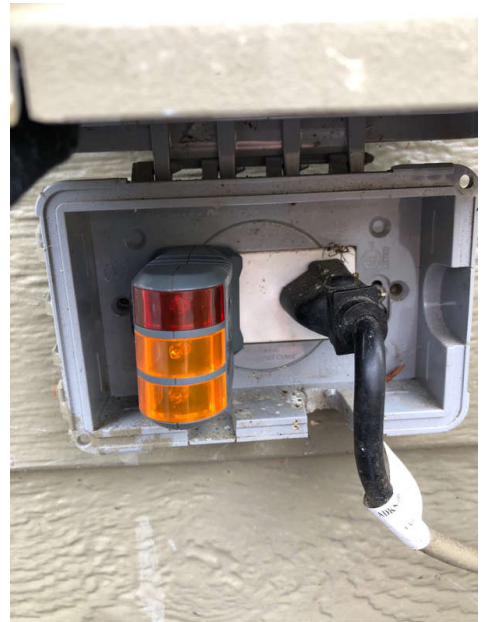
Garage

No GFCI protection present in all locations. Recommend licensed electrician upgrade by installing ground fault receptacles in all locations.

Contact a qualified electrical contractor.

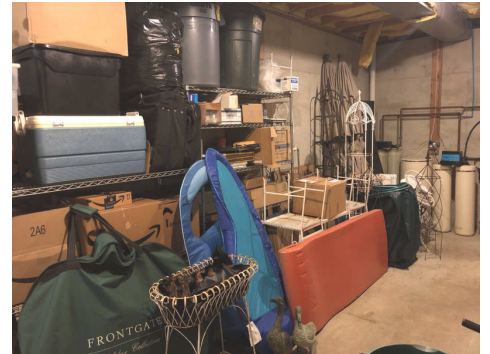
OBSTRUCTIONS OF VIEW

Full visibility of the foundation was not possible due to a partially or full finished basement, furniture, stored household items or drywall/paneling. Potential defects may be concealed, however none were observed at time of inspection.

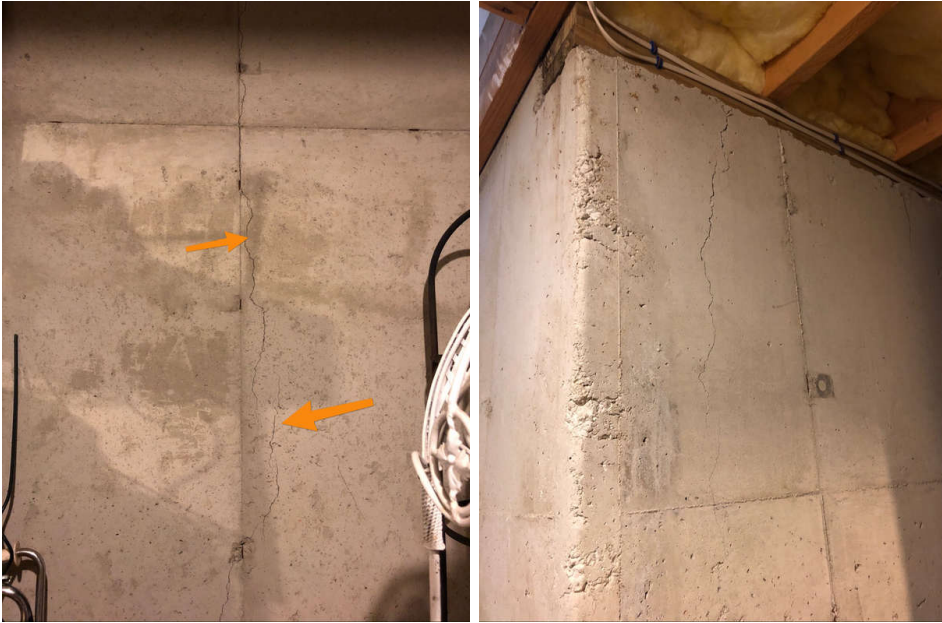
6.2.1 Foundation

FOUNDATION CRACKS - MINOR

Minor cracking was noted at the foundation. This is common as concrete ages and shrinkage surface cracks are normal. Recommend monitoring for more serious shifting/displacement.

Contact a foundation contractor.

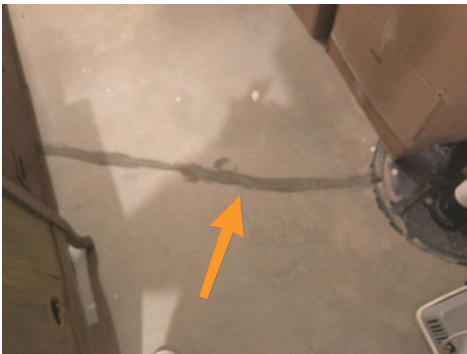
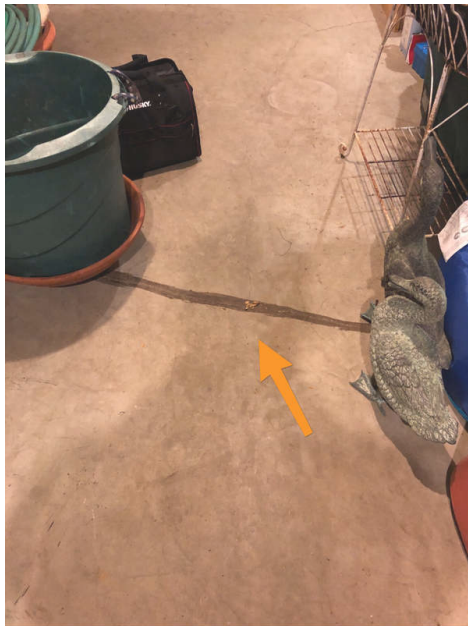
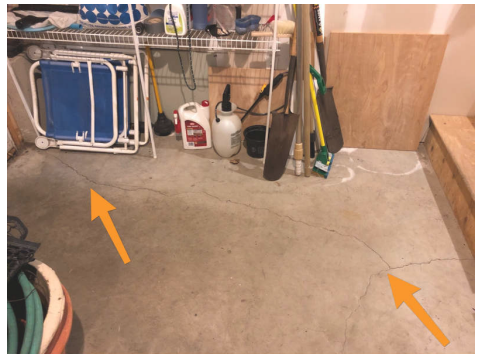
6.3.1 Floor & Ceiling Structure

TYPICAL CRACKING

Contact a qualified professional.

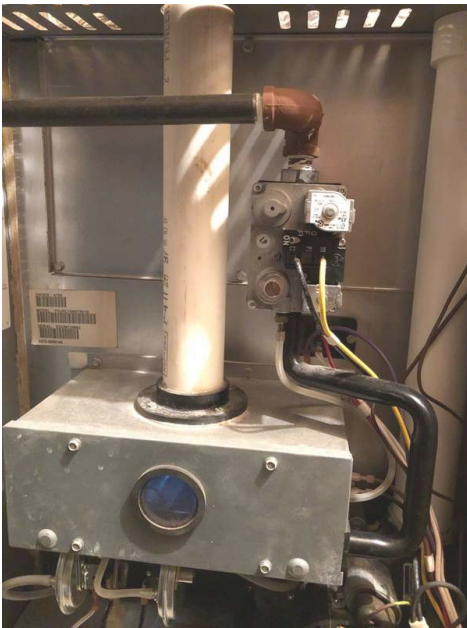
Unit B

The furnace was a high-efficiency system and had a sealed combustion chamber which would require invasive measures which lie beyond the scope of the General Home Inspection to inspect. The Inspector recommends that an evaluation be performed by a qualified heating, ventilation and air-conditioning (HVAC) contractor.

Contact a qualified HVAC professional.

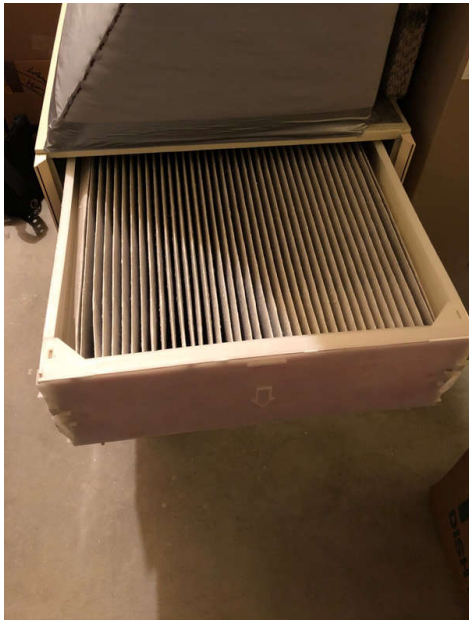
Unit B

The furnace filter is dirty and should to be replaced every 6 months.

Contact a qualified HVAC professional.

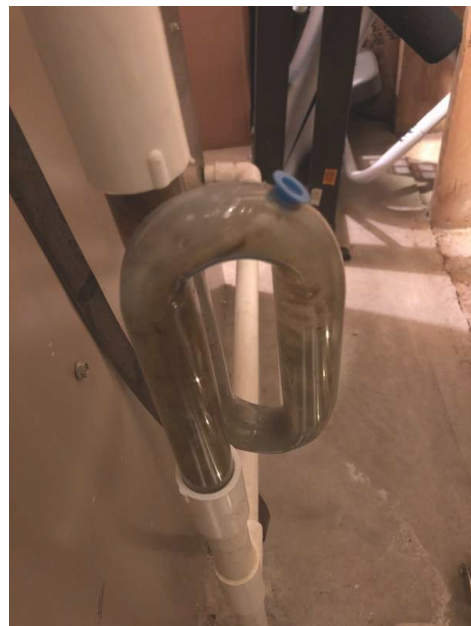
Unit B

The condensation tube from the appeared to contain microbial growth. Some types of microbes can cause health problems in sensitive people. The Inspector recommends tube replacement by a qualified heating, ventilation and air-conditioning (HVAC) contractor.

Contact a qualified HVAC professional.

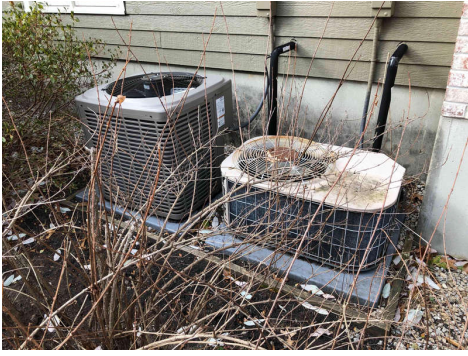
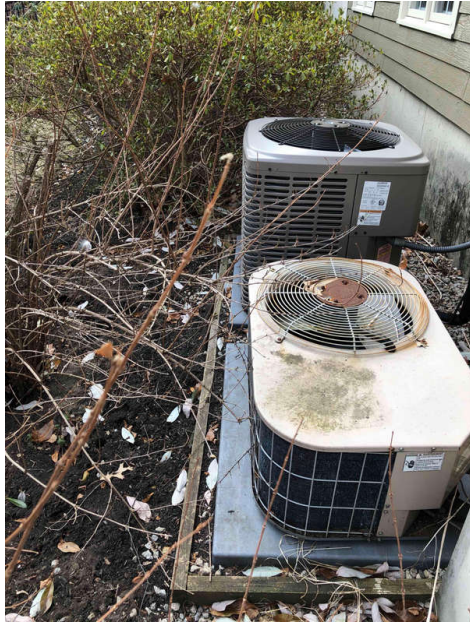
7.2.1 Cooling Equipment

Vegetation was too close to the compressor, which can limit heat dissipation and limit effectiveness. Recommend cutting back vegetation to avoid overheating compressor.

Contact a qualified landscaping contractor

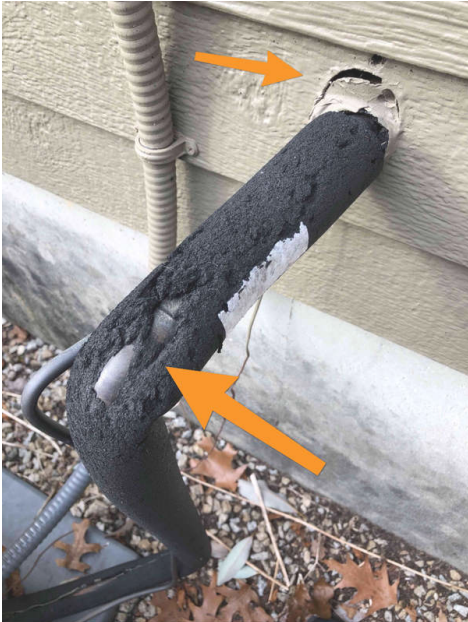
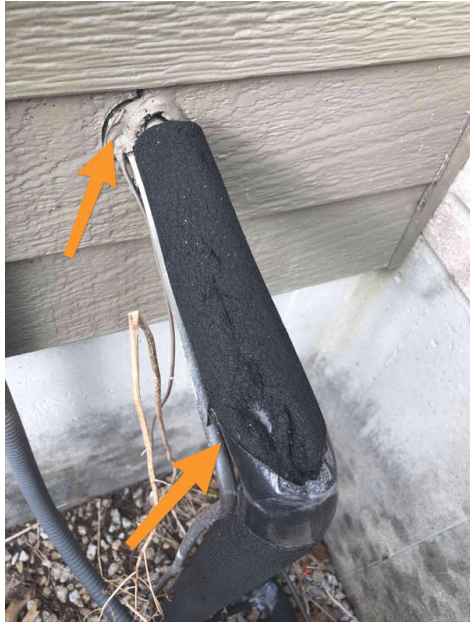
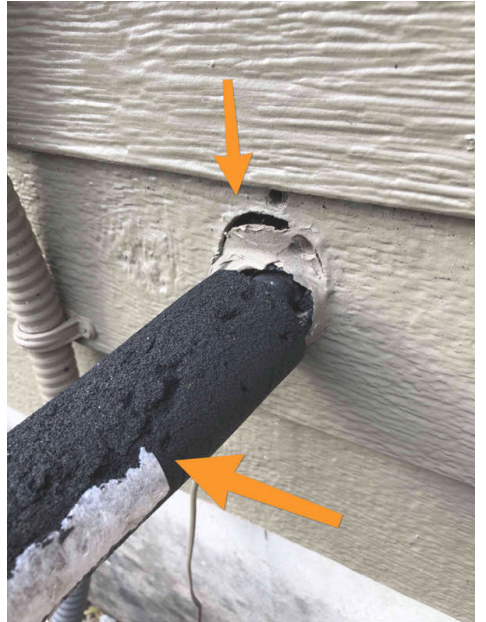
7.2.2 Cooling Equipment

DAMAGED / MISSING INSULATION

Insulation on the A/C suction (large, insulated) line was damaged or missing at areas and should be replaced by a qualified HVAC contractor. Deteriorated penetrations should also be resealed.

Contact a qualified HVAC professional.

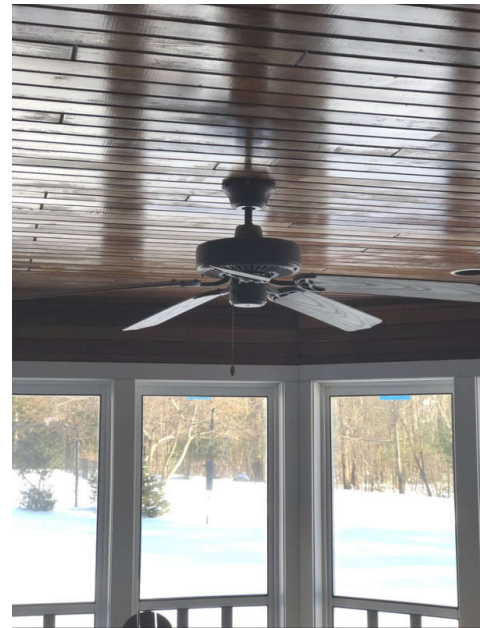
Sunroom ceiling fan not operational recommend licensed contractor to further evaluate and repair as needed

Contact a qualified professional.

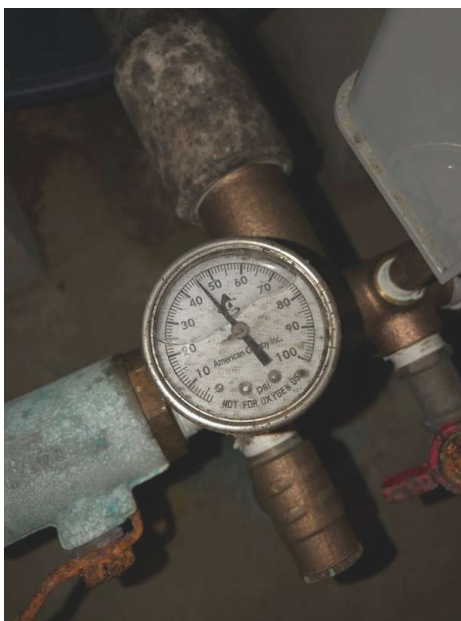
Main Water Pressure.

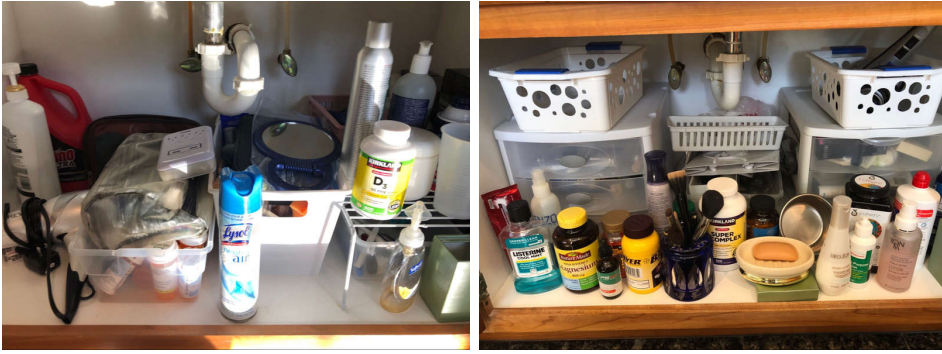
PERSONAL ITEMS

Could not see 100% under sink do to personal items.

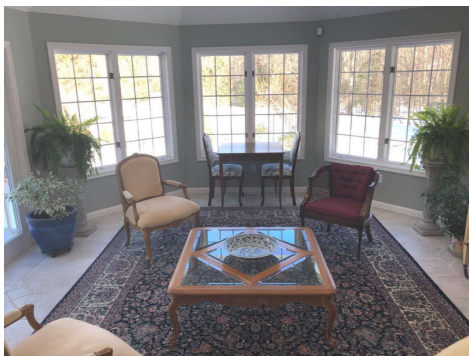
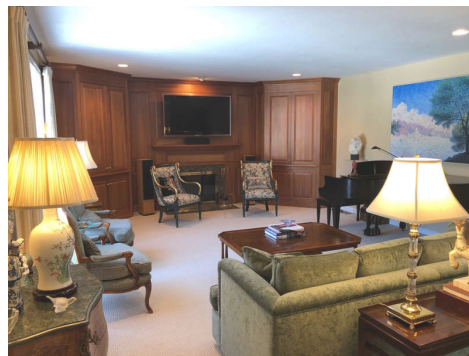
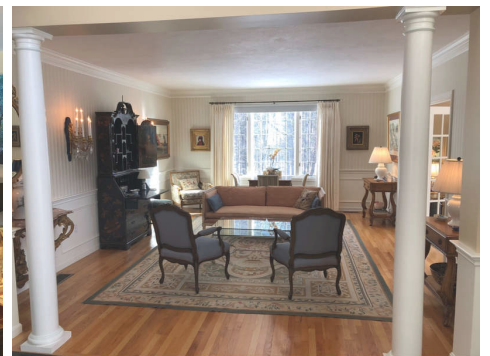
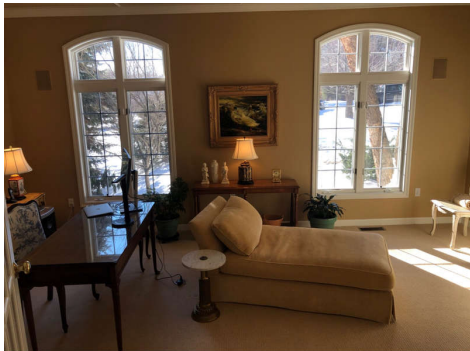
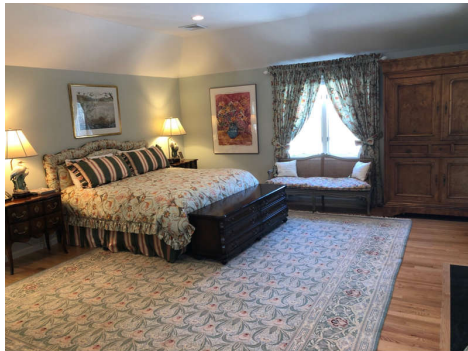
OBSTRUCTIONS OF VIEW

Full visibility of this room was not possible due to furniture, stored household items. Recommend checking for damage at final walk through.

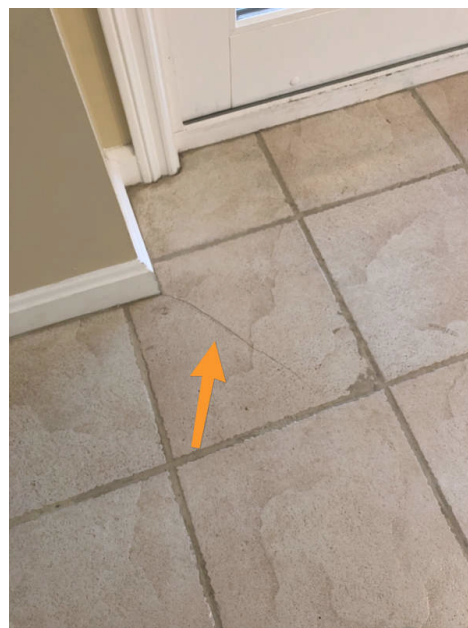
Basement

11.3.1 Interior Floors

CRACKED TILE

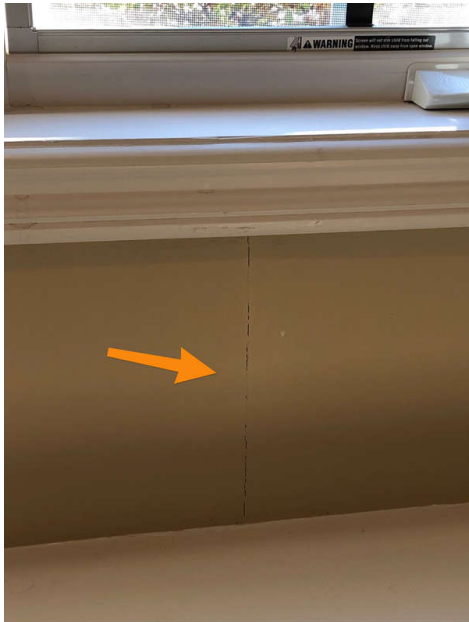
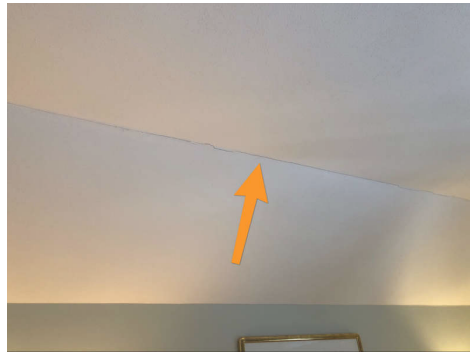
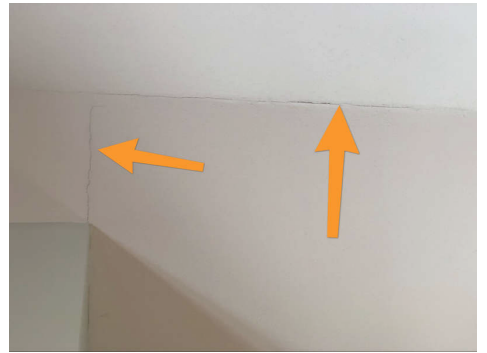
11.5.1 Walls and Ceilings

TYPICAL CRACKS OBSERVED

Typical cracks in drywall/plaster were observed. These cracks may develop due to normal aging of a home, minor settling, as well as moisture/temperature changes. Recommend repair as needed. No evidence of structural defect observed at time of inspection.

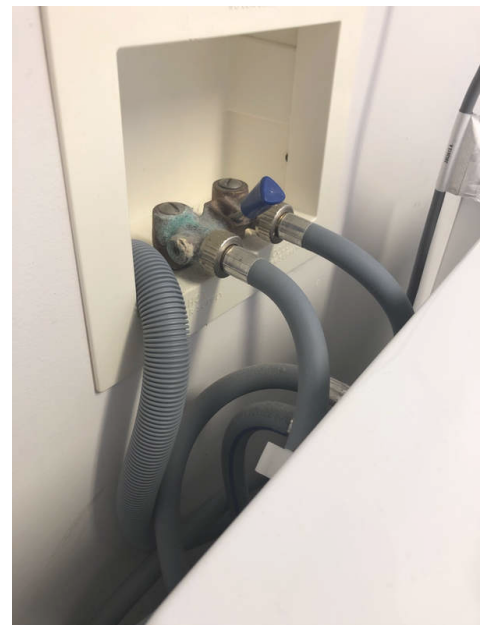
WASHER HOSES IMPROPER

Current hoses are rubber. Recommend replacing with Stainless Steel Braided hoses as rubber can crack and burst.

Contact a qualified professional.

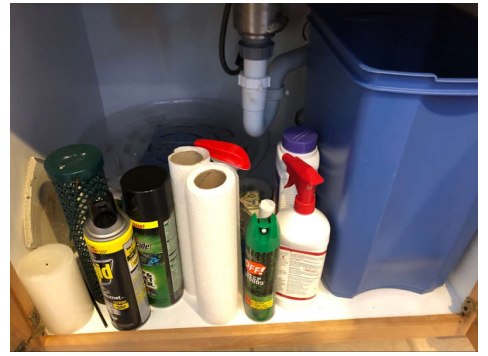
Basement

PERSONAL ITEMS

Could not see 100% under sink do to personal items.

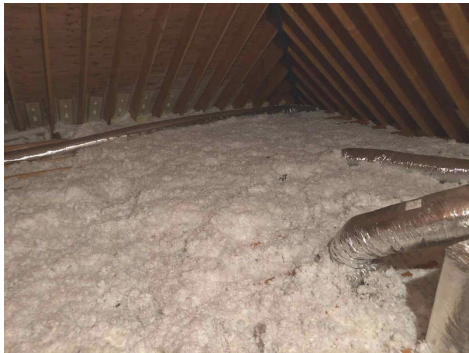
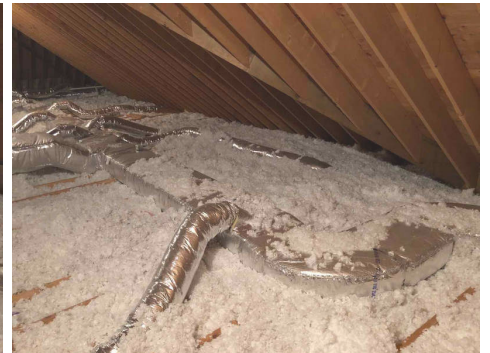
16.2.1 Attic Insulation

INSUFFICIENT INSULATION

Contact a qualified insulation contractor.

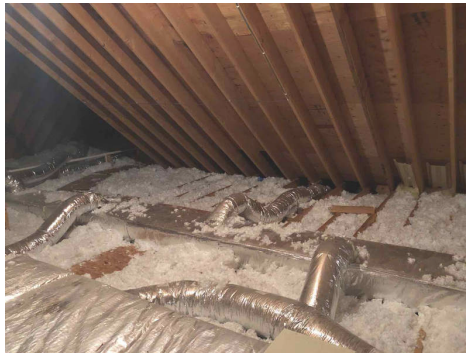
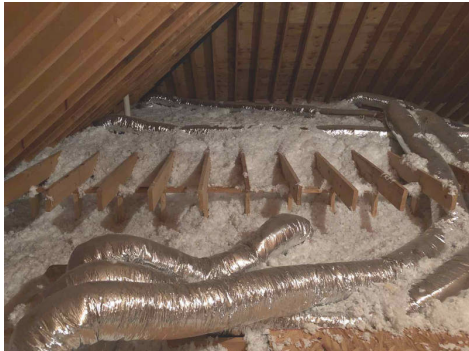
16.2.2 Attic Insulation

PEST

Evidence of pest and / or rodent feces was observed in attic area, recommend licensed pest control

contractor to evaluate and repair as needed.

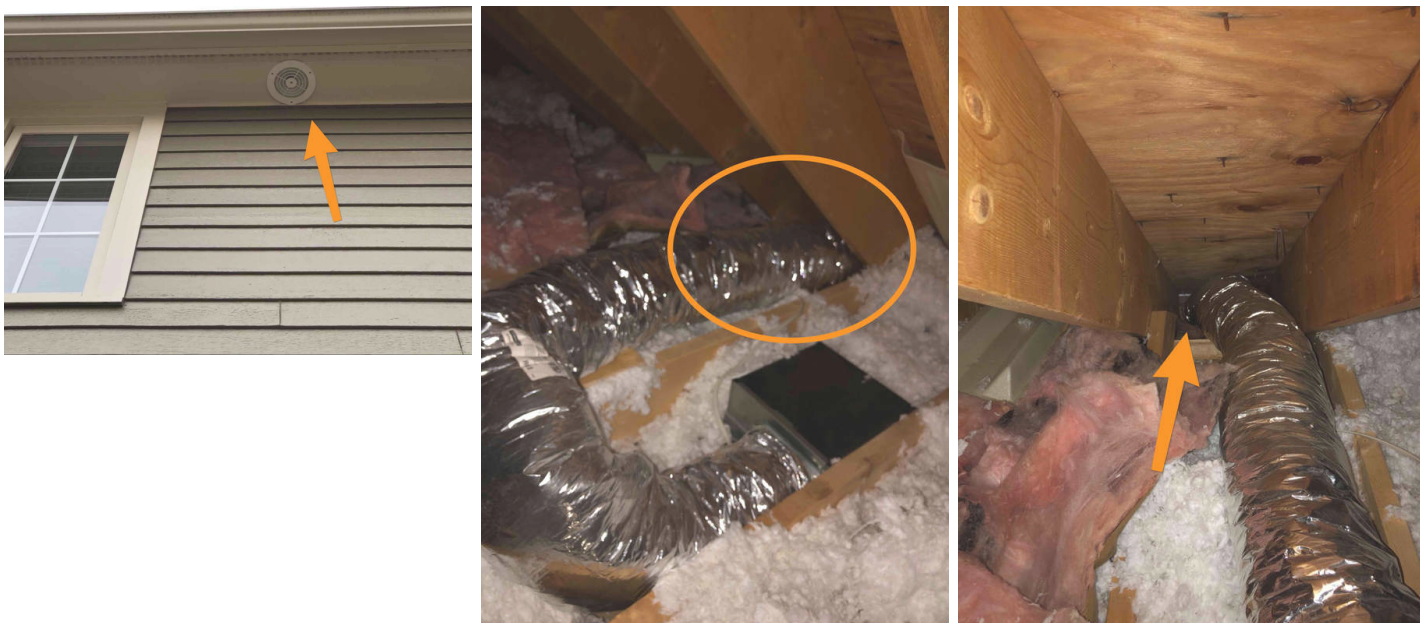
16.3.1 Ventilation

EXHAUST DUCTS TO SOFFIT

Contact a qualified professional.
