# PINNACLE HOME INSPECTION

## RESIDENTIAL REPORT

1234 Main St.  
Turlock California 95380

Buyer Name  
09/06/2018 9:00AM

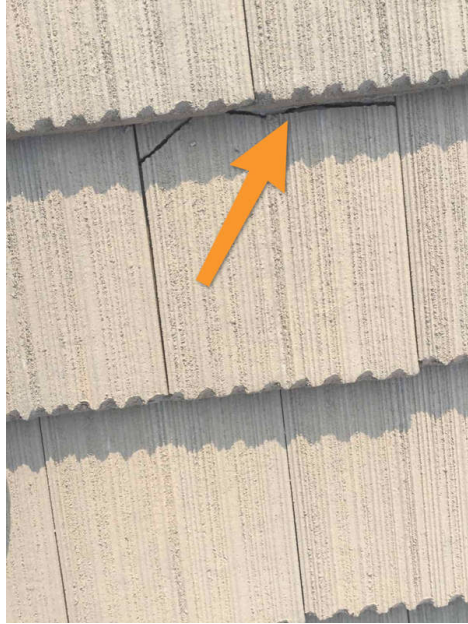
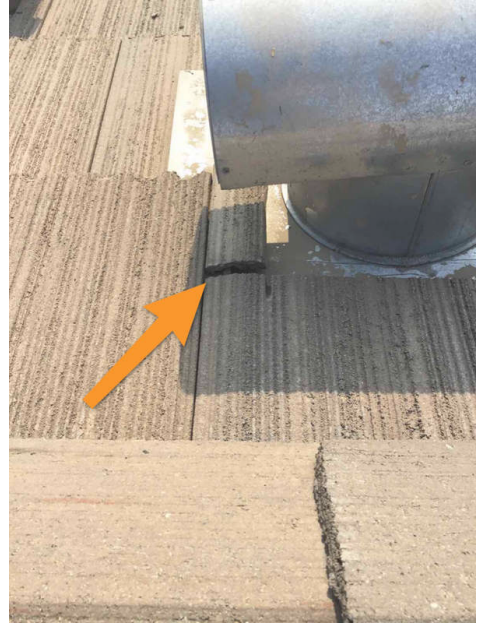
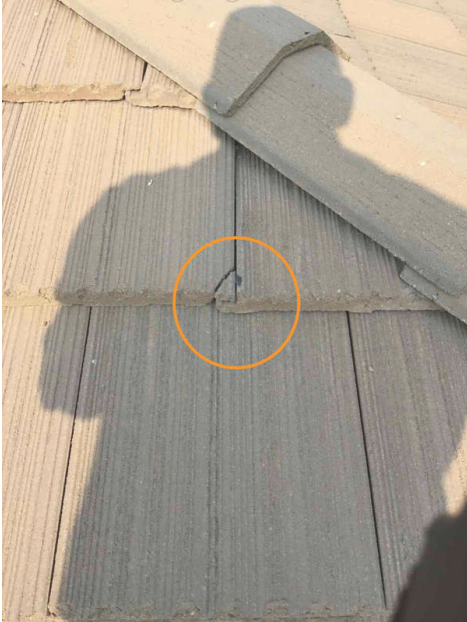
#### TILES CRACKED/BROKEN

Roof had cracked/broken tiles. This can cause potential water intrusion and lead to further damage. Recommend a qualified roof contractor repair or replace broken tiles.

North side of garage roof.

West side of garage roof.

East side of garage roof at ridge.

Condition observed at multiple locations.

Contact a qualified roofing professional.

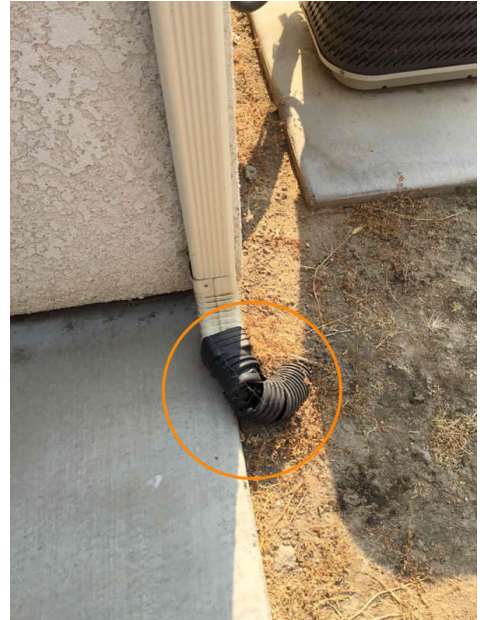
Southwest corner of building.

**DOWNSPOUT DAMAGED**

Downspout extension is damaged. This can lead to water in the soil at the foundation causing movement or damage. Recommend replacing downspout extension.

Contact a handyman or DIY project

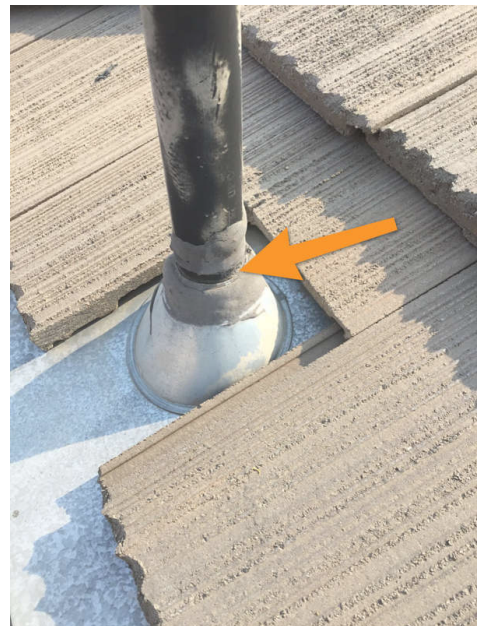
**PLUMBING JACK**

Mastic sealant at plumbing jack is worn away. This occurs as the mastic hardens and the plastic plumbing vent pipe expands and contracts with the changing weather. This can lead to potential water intrusion and further damage. Recommend resealing and maintaining these annually.

Condition observed at multiple locations.

Contact a handyman or DIY project

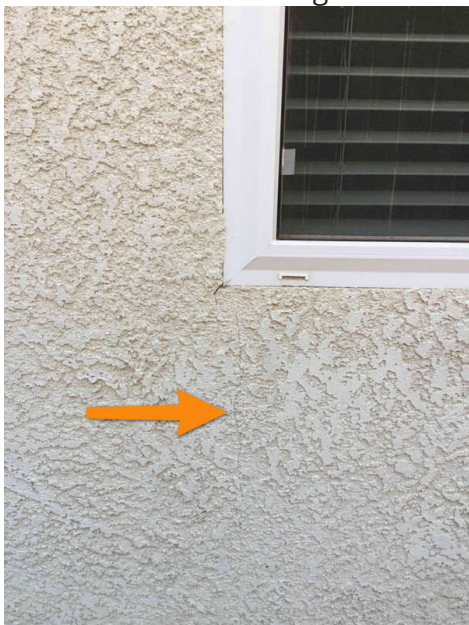
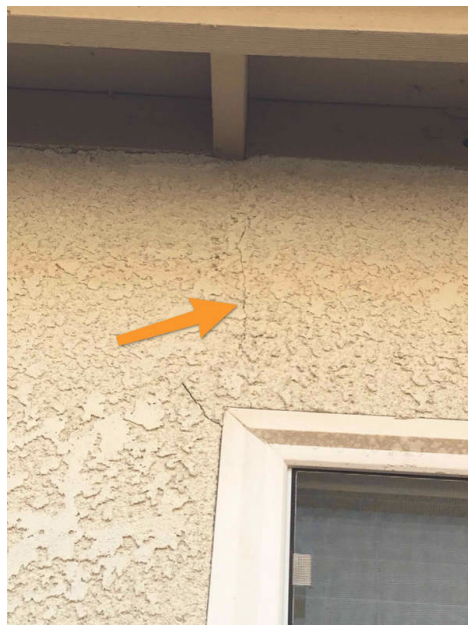
West side of building below window. West side of building above window.

#### CRACKING - MINOR

Stucco showed cracking in one or more places. This is a result of temperature changes and settling, and typical as homes with stucco age. Recommend monitoring.

Recommend monitoring.

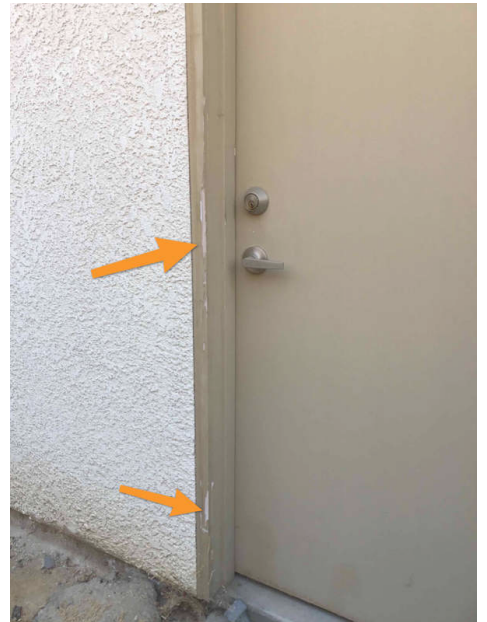
West side garage door trim.

**PAINT/FINISH FAILING**

Paint on wood trim is cracked and peeling. This can lead to deterioration of the underlying surface. Recommend repainting.

Contact a handyman or DIY project

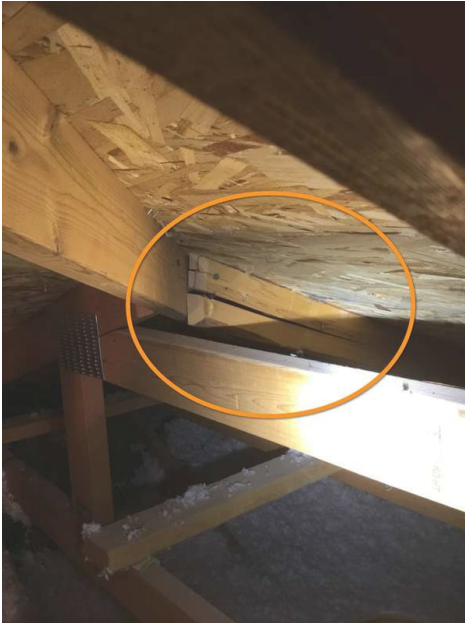
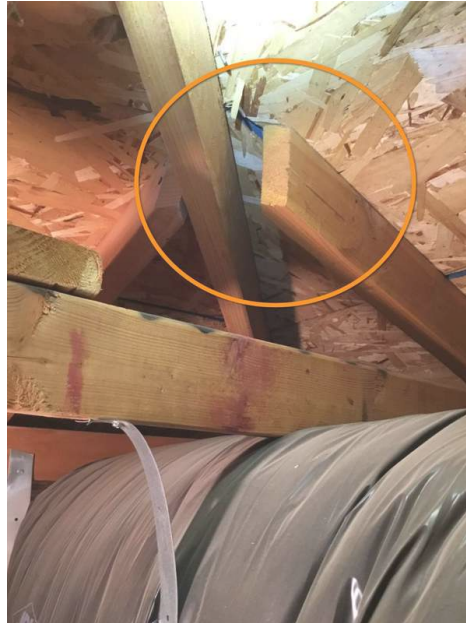
#### TRUSS DAMAGE

A crack was observed at the end of a jack rafter and another jack rafter appeared to be cut short. This could potentially cause additional damage. Recommend further evaluation and repair by a qualified professional.

Near end of equipment platform looking Southwest.

Near HVAC equipment looking North.

Contact a qualified general contractor.

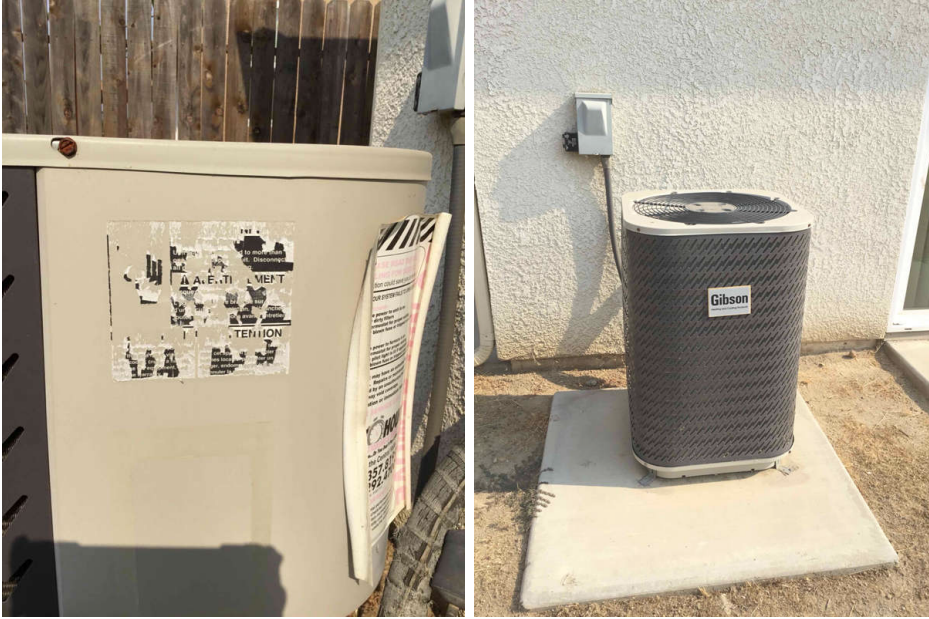
Missing manufacturer's info sticker.

Manufacturer's information sticker was missing. Unable to determine BTU size or seasonal energy efficiency rating (SEER) of unit. However, the minimum SEER for new HVAC equipment installation in 2007, the year this home was built, was 13 SEER.

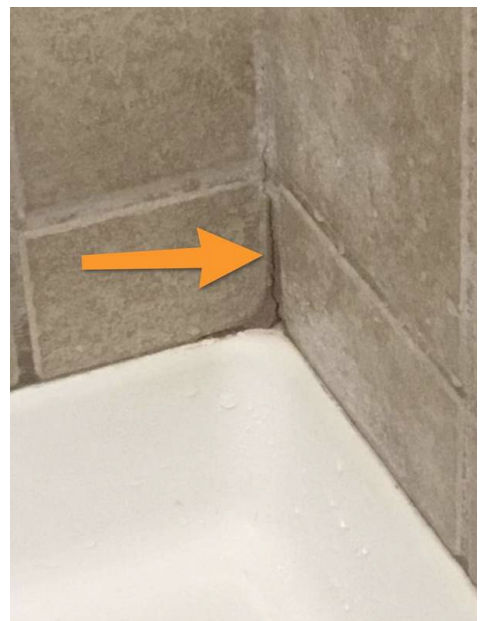
#### SHOWER WALL TILE

Cracked grout at bottom corner of tile shower wall in Master Bathroom. This can cause potential water leaks and damage. Recommend repairing the damaged grout.

Contact a handyman or DIY project

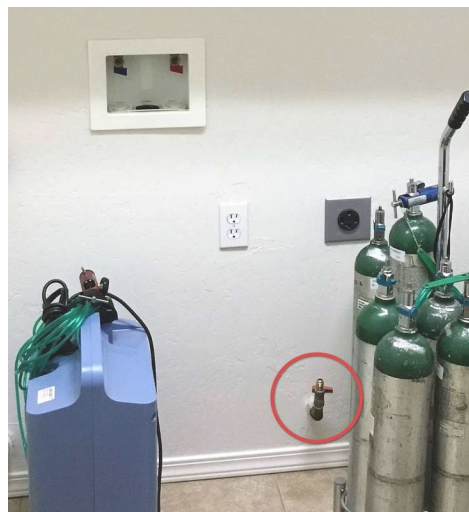
**GAS SHUT-OFF**

The shut-off valve is not connected to an appliance. It could be opened, causing a gas leak and explosion hazard. Gas outlets that do not connect to appliances should be capped gas-tight.

Gas shut-off valve for dryer.

Contact a qualified plumbing contractor.

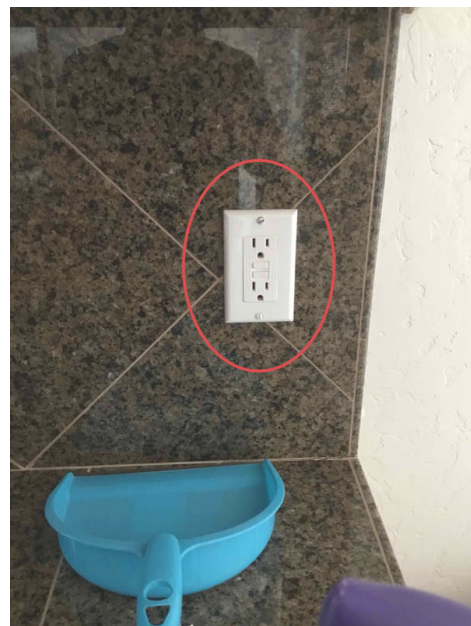
**INOPERATIVE GFCI**

IN THE KITCHEN ON THE RIGHT SIDE OF THE SINK.

GFCI outlet did not trip when tested. This is a potential shock hazard. Recommend repair or replacement by a qualified electrician.

Contact a qualified electrical contractor.

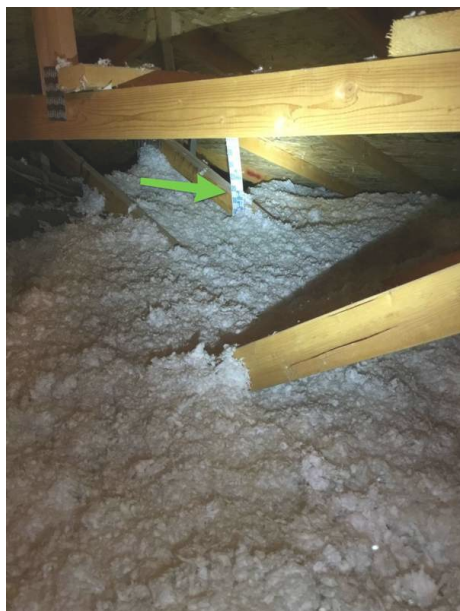
Picture shows insulation gauge in attic which indicates an R-value of 38.

Insulation in attic.
