THAT PLACE HOME INSPECTIONS, LLC

RESIDENTIAL REPORT

1234 Main St.
Pearisburg VA 24134

10/04/2018 9:00AM

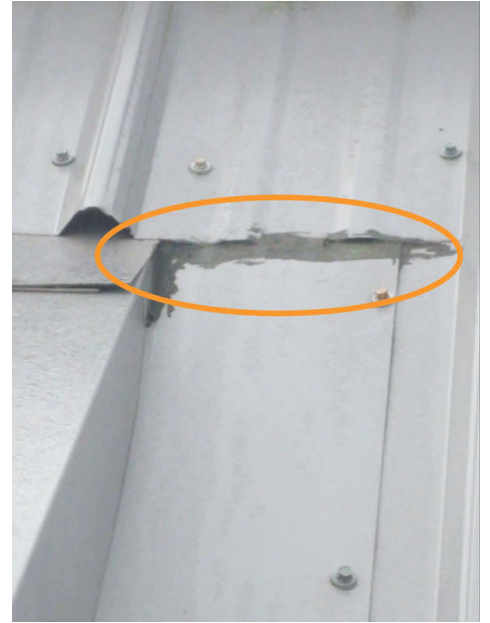
2.1.1 Coverings

Caulking/sealant was used on the roof at the corners where the gable portion of the roof meets the shed portion. Generally, caulking/sealant should not be needed in these areas and this may have been use to stop a previous leak. Recommend monitoring this area for signs of moisture intrusion and reseal as needed. Also recommend further evaluation by a qualified contractor to repair as needed.

Contact a qualified roofing professional.

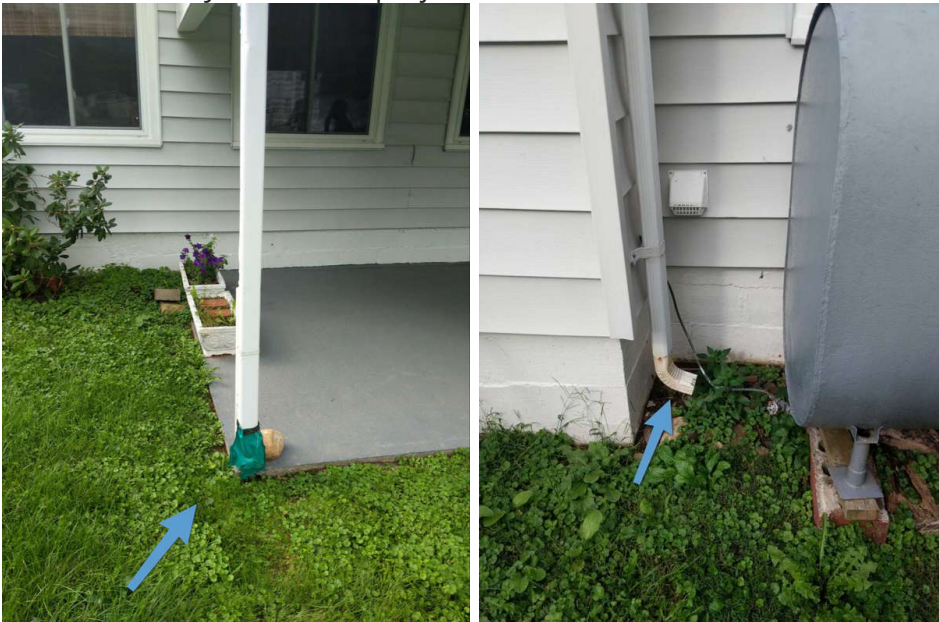
2.2.1 Roof Drainage Systems

DOWNSPOUTS DRAIN NEAR HOUSE

One or more downspouts drain too close to the home's foundation. This can result in excessive moisture in the soil at the foundation, which can lead to foundation/structural movement. Recommend adjusting downspout extensions to drain at least 6 feet from the foundation.

Contact a handyman or DIY project

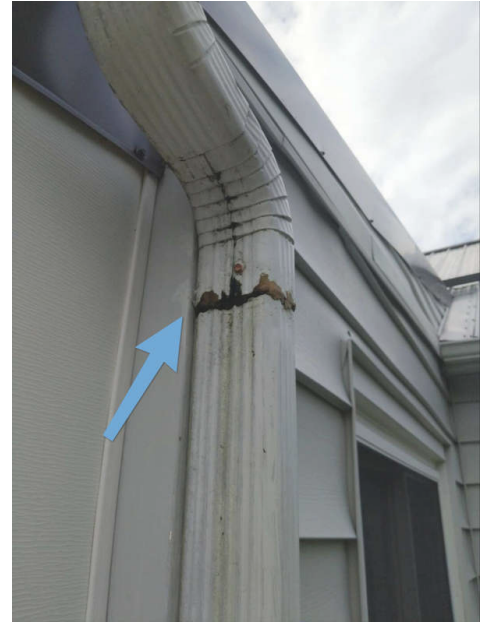
2.2.2 Roof Drainage Systems

GUTTER LEAKAGE

The elbows on this downspout were improperly installed and showed signs of previous leaking. This can result in excessive moisture in the soil at the foundation, which can lead to foundation/structural movement. Recommend a qualified contractor evaluate and repair to proper functionality.

Contact a handyman or DIY project

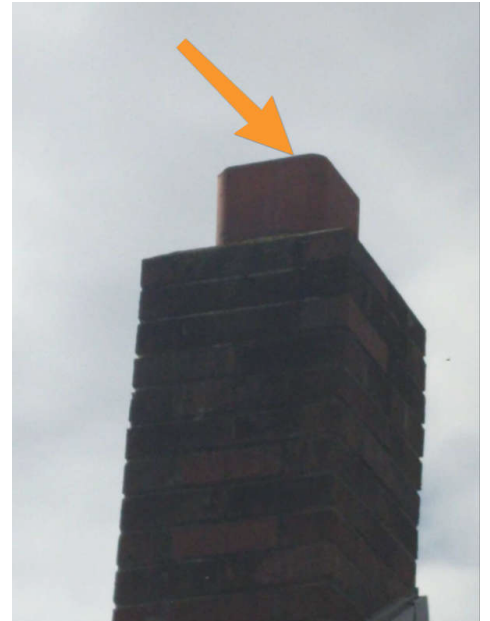
2.4.1 Skylights, Chimneys & Other
Roof Penetrations

CHIMNEY CAP MISSING

No chimney cap was observed. This is important to protect from moisture intrusion and protect the chimney. Recommend a qualified roofer or chimney expert install.

Contact a qualified roofing professional.

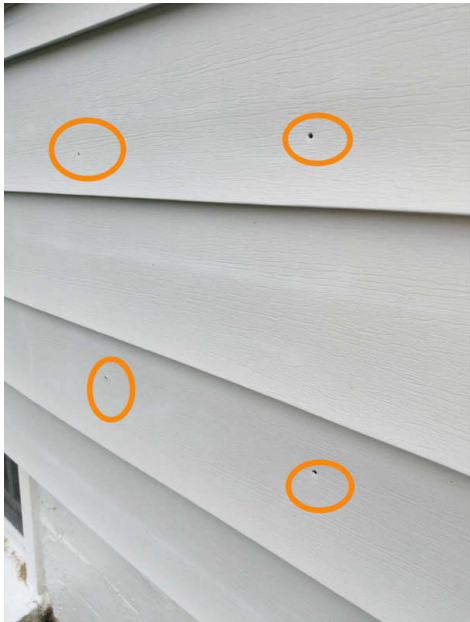
West

Holes were observed in the siding. This can lead to water intrusion, further siding deterioration and/or mold. A bird was observed flying out of the hole on the East side of the house. Recommend a qualified siding contractor evaluate and repair.

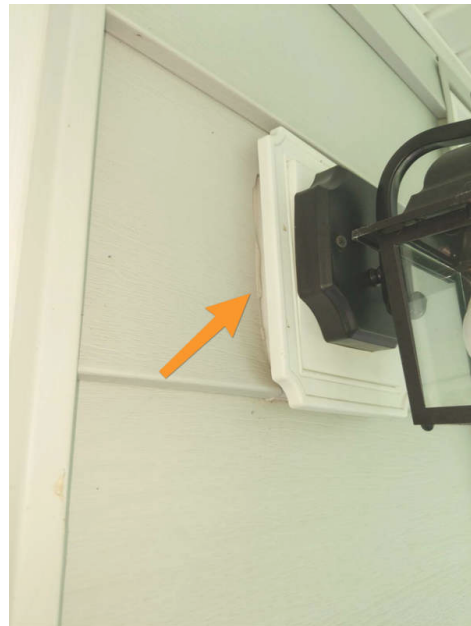
3.1.2 Siding, Flashing & Trim

MISSING CAULK AROUND J BLOCK

Recommend adding caulking around J-Block where it meets the siding to create a waterproof barrier around this light.

Contact a handyman or DIY project

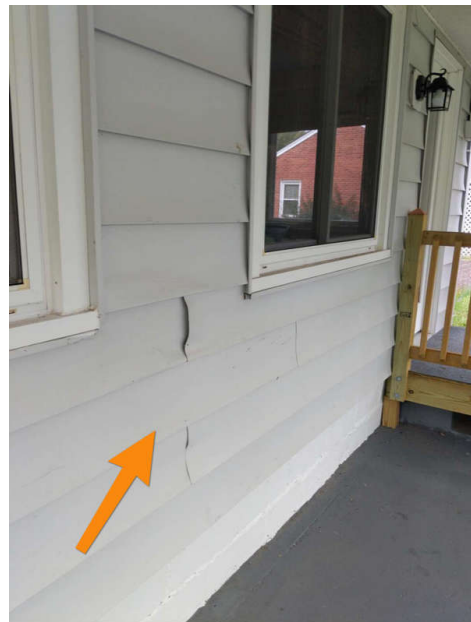
3.1.3 Siding, Flashing & Trim

Vinyl siding was warping or buckling in this area on the back porch. This is often as a result of a BBQ grill that was too close to the side of the house. This is mostly a cosmetic defect but should be monitored for further separation on the seams. Recommend a qualified siding contractor evaluate and repair.

Contact a qualified professional.

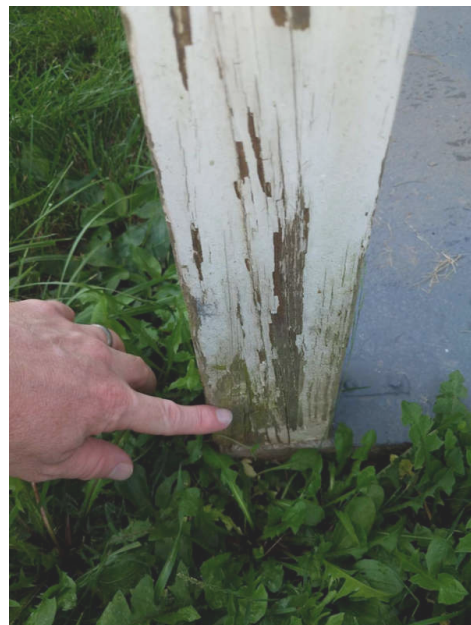
North Porch

PORCH SUPPORT - MOISTURE DAMAGE

This porch support showed signs of moisture damage at its base. This could become a safety hazard if further deterioration is allowed. Recommend qualified deck contractor evaluate and repair.

Contact a qualified deck contractor.

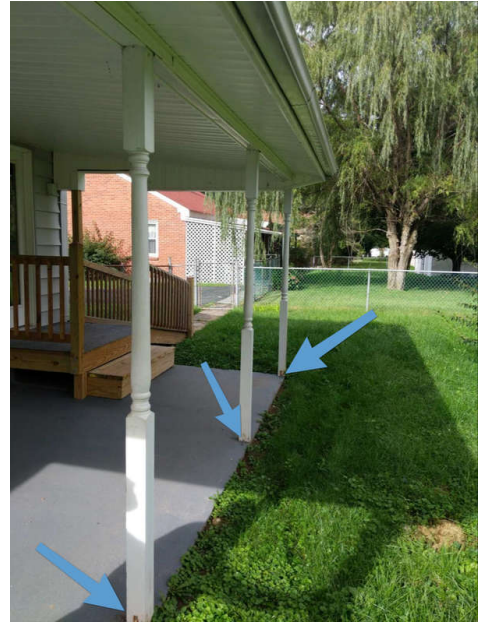
North Porch

Recommend adding a fresh coat of paint to the porch supports to save the wood from moisture intrusion and possible damage.

Contact a handyman or DIY project

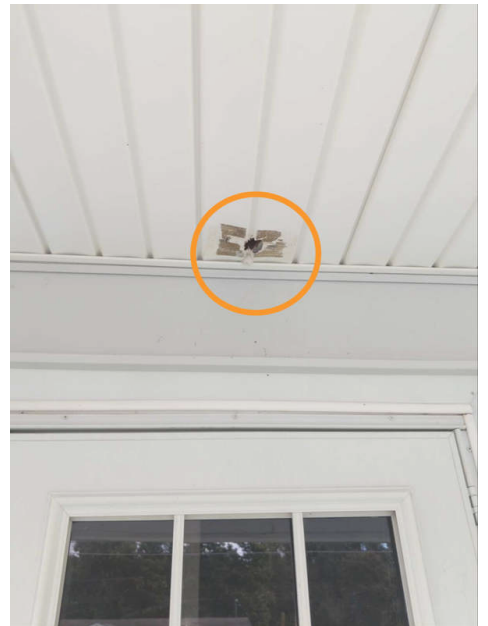
Front Porch

SOFFIT DAMAGED

There was a hole in the porch soffit above the front door. A wasp was seen flying out of this hole. Recommend replacing this section of the soffit.

Contact a qualified professional.

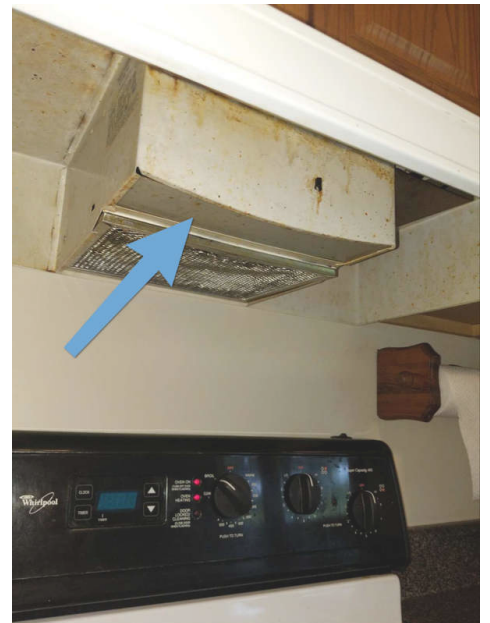
Range hood lights were inoperable at the time of the inspection. The bulb may be burned out, or there may be a problem with the switch, wiring or light fixture. If after replacing the bulb the light fixture still does not respond, the Inspector recommends service by a qualified contractor.

Contact a qualified professional.

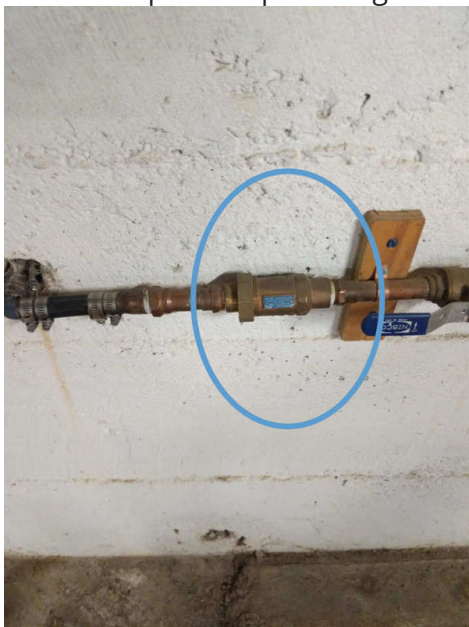
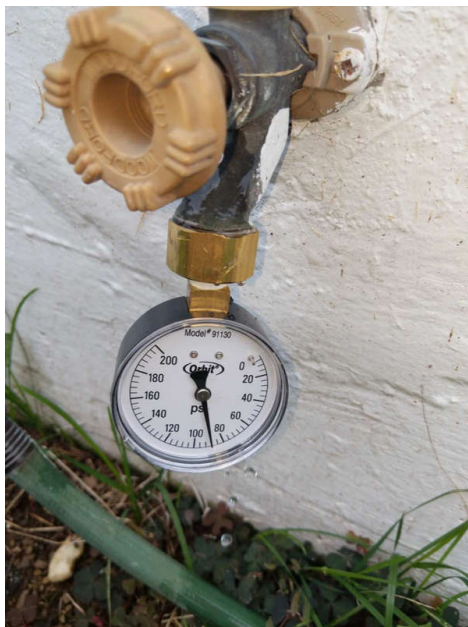
Home water pressure exceeded 90 pounds per square inch (psi) at the time of the inspection. This is considered excessively high. Excessively high water pressure can damage plumbing fixtures. Acceptable water pressure is between 40 and 90 psi. The house does have a regulator installed prior to the main shut off in the basement.

Contact a qualified plumbing contractor.

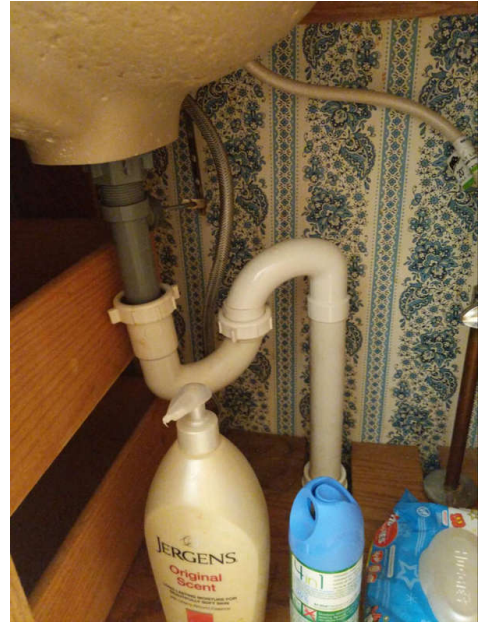
Bathroom

A trap beneath the sink was of a type that is no longer allowed to be installed in new construction for safety reasons. Although this type of trap may have been commonly considered safe at the time the home was originally constructed, as general knowledge of safe building practices has improved with the passage of time, building standards have changed to reflect current understanding. The Inspector recommends updating the existing traps to meet generally-accepted current standards. All work should be performed by a qualified plumbing contractor.

Contact a qualified plumbing contractor.

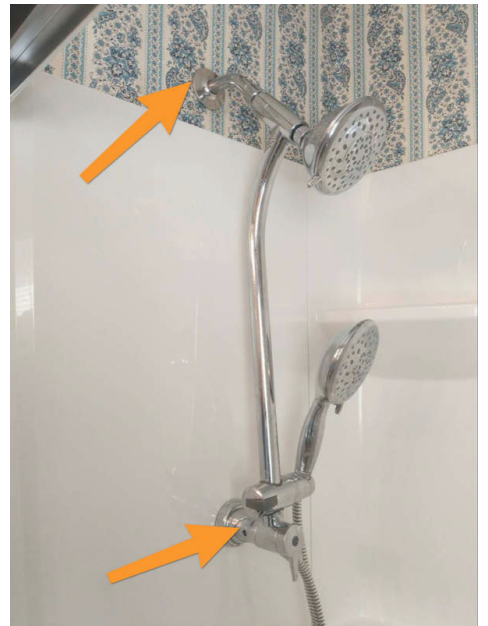
5.3.1 Water Supply, Distribution Systems & Fixtures

FIXTURE LOOSE

The fixture was loose and needed maintenance. All work should be performed by a qualified plumbing contractor.

Contact a qualified plumbing contractor.

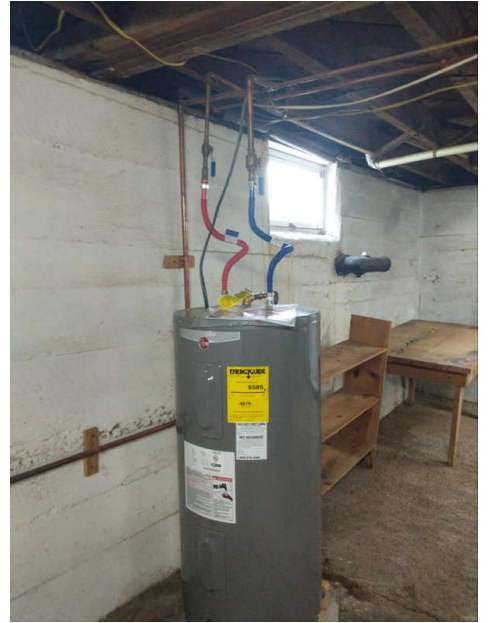
5.4.1 Hot Water Systems, Controls, Flues & Vents

No expansion tank was present. Expansion tanks allow for the thermal expansion of water in the pipes. These are required in certain areas for new installs. Recommend a qualified plumber evaluate and install.

Contact a qualified plumbing contractor.

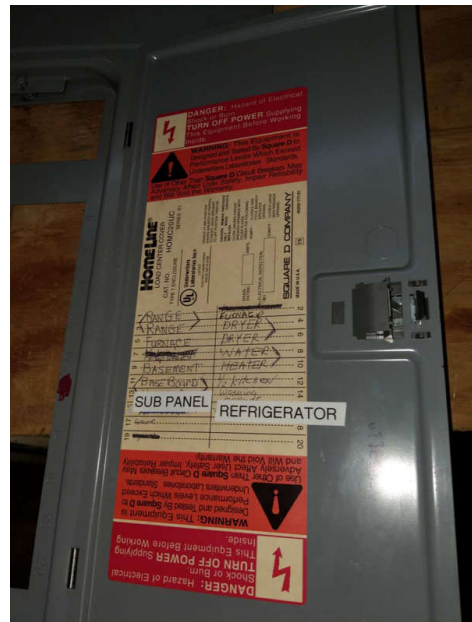
6.2.1 Main & Subpanels, Service & Grounding, Main Overcurrent Device

MISSING LABELS ON PANEL

The cabinet should contain a clearly-marked label identifying individual circuits so that in an emergency, individual circuits can be quickly shut off. The Inspector recommends that a properly-marked Circuit Directory label be installed by a qualified electrical contractor.

Contact a qualified electrical contractor.

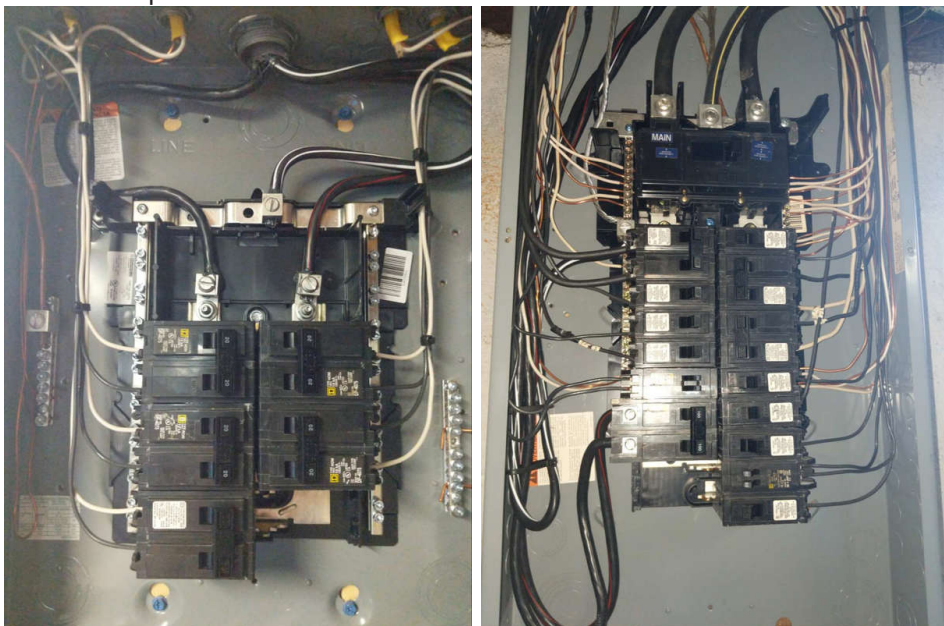
6.2.2 Main & Subpanels, Service & Grounding, Main Overcurrent Device

One or more white, neutral wires is being used as a hot wire. This is common practice in some instances such as a 240 connection. Inspector recommends that neutral wires being used as hot wires to be marked accordingly. All work should be completed by a qualified professional.

Contact a qualified electrical contractor.

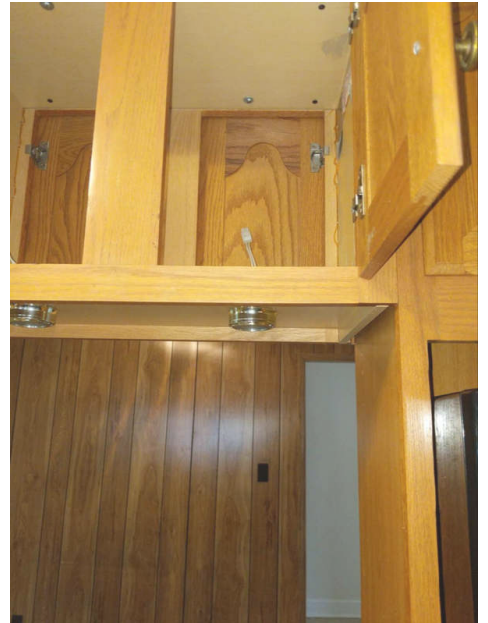
Kitchen

There was a low voltage lighting system installed under the kitchen cabinets that was not operable and seemed to be missing some components. Recommend removing, repairing or replacing this system. Inspector recommends that an evaluation and any necessary repairs be performed by a qualified electrical contractor.

Contact a qualified electrical contractor.

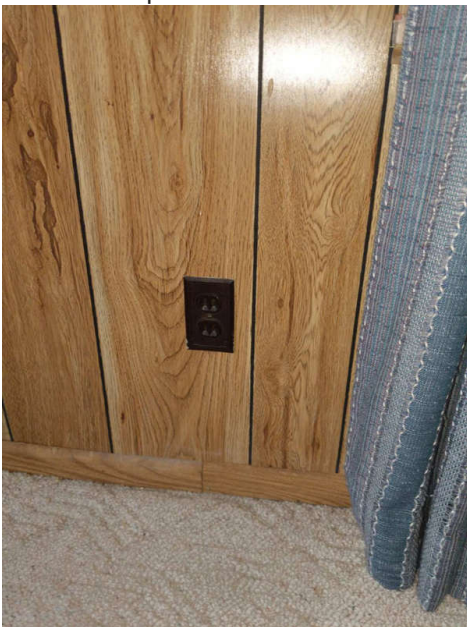
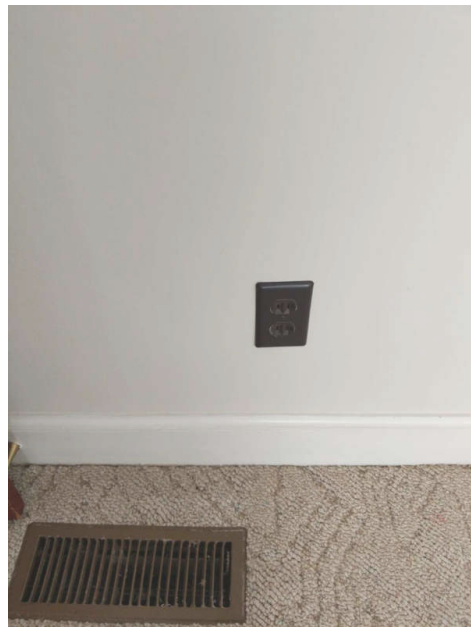
Several rooms in the home had two prong outlets. Two prong outlets are not grounded, which can leave you unprotected from stray currents and result in electrocution or a power surge through sensitive electronics or appliances. Recommend qualified electrician evaluate & repair.

Contact a qualified electrical contractor.

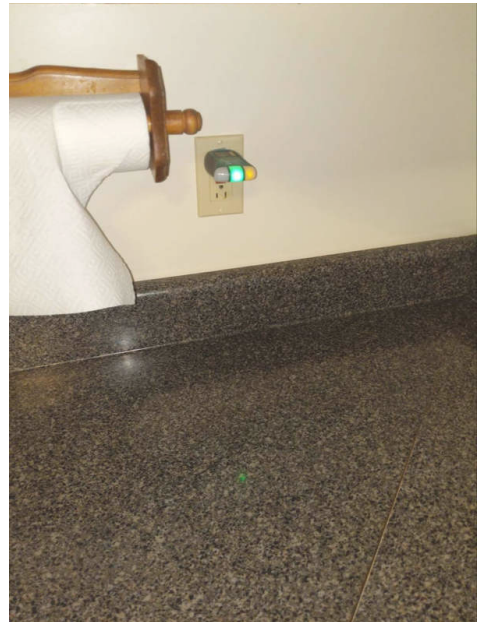
Kitchen

A Ground Fault Circuit Interrupter (GFCI) electrical receptacle had an open ground. The Inspector recommends correction by a qualified electrical contractor.

Contact a qualified electrical contractor.

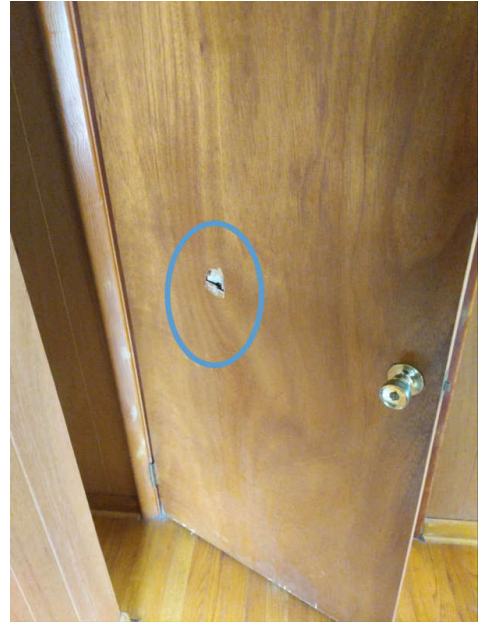
2nd Floor West Bedroom

COSMETIC DAMAGE / DEFECT

Observed damage or defect in door that did not impede functionality of the door.

Contact a handyman or DIY project

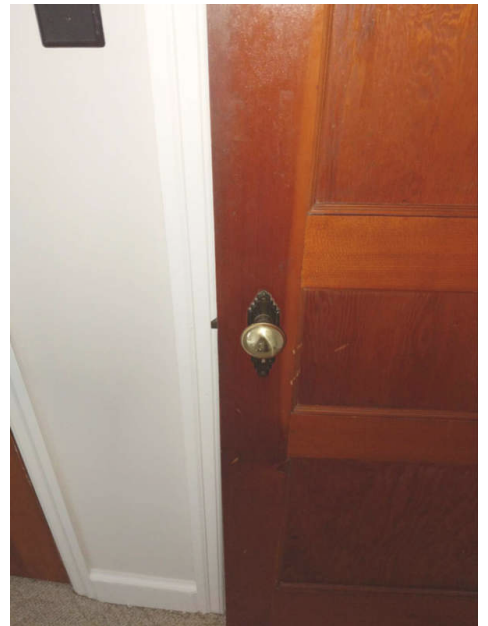
North Bedroom

Door latch and/or strike plate is out of alignment. Recommend a handyman repair.

Contact a handyman or DIY project

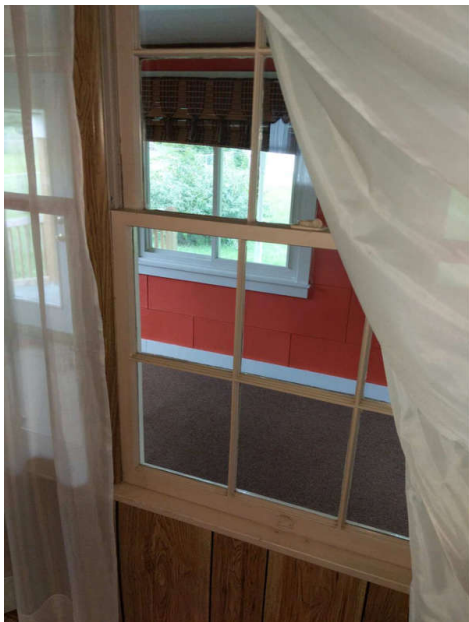
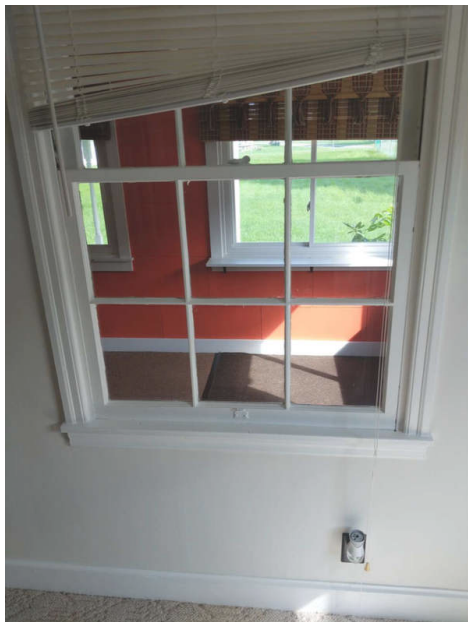
One or more windows are painted shut. Recommend windows be restored to functional use.

Contact a handyman or DIY project

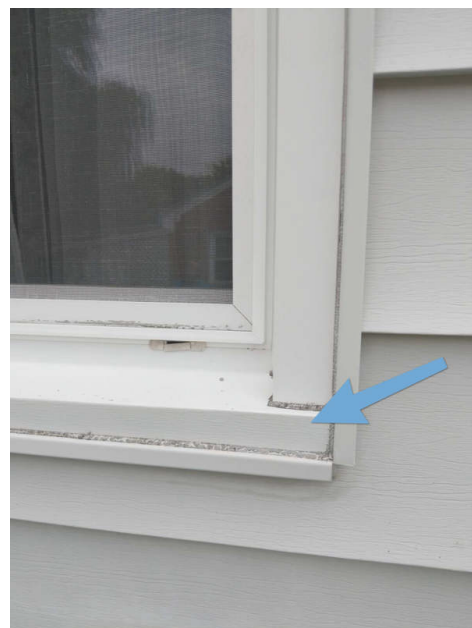
9.3.2 Windows

Window trim had gaps that should be filled with an appropriate sealant by a qualified contractor to help prevent moisture and insect entry.

Contact a handyman or DIY project

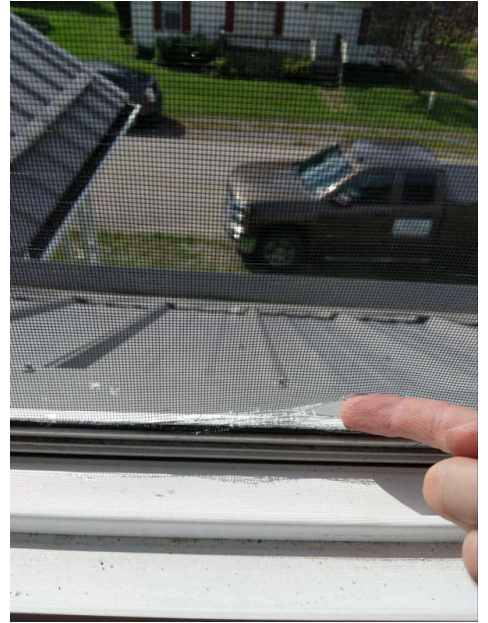
2nd Floor West Bedroom

SCREEN DAMAGED

Recommend replacing screen.

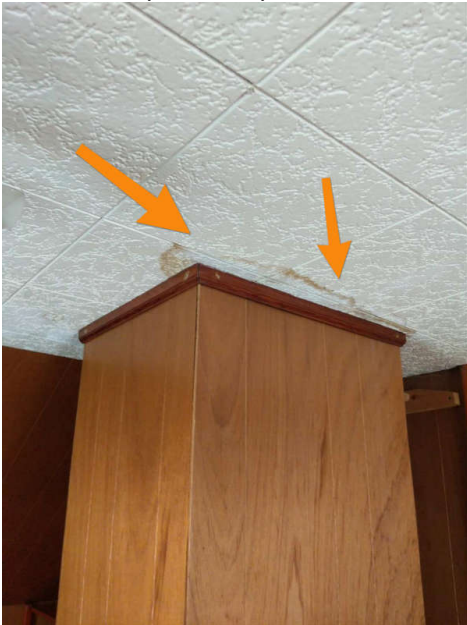
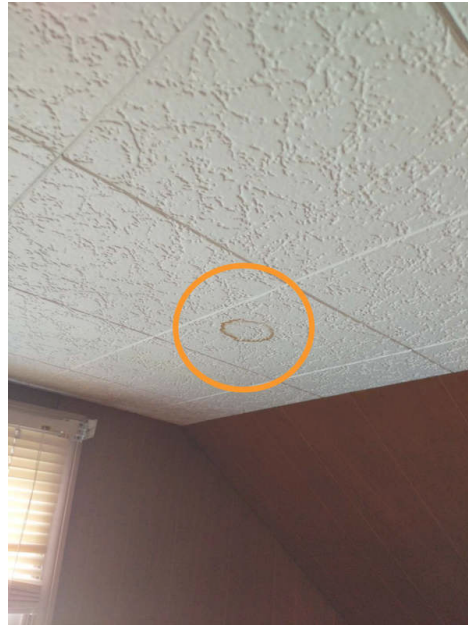
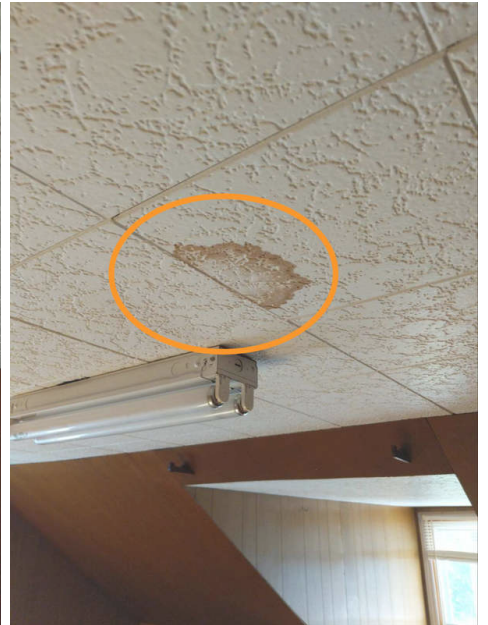
Ceiling structure showed signs of water intrusion, which could lead to more serious structural damage. Recommend a qualified contractor identify source or moisture and remedy.

Contact a qualified professional.

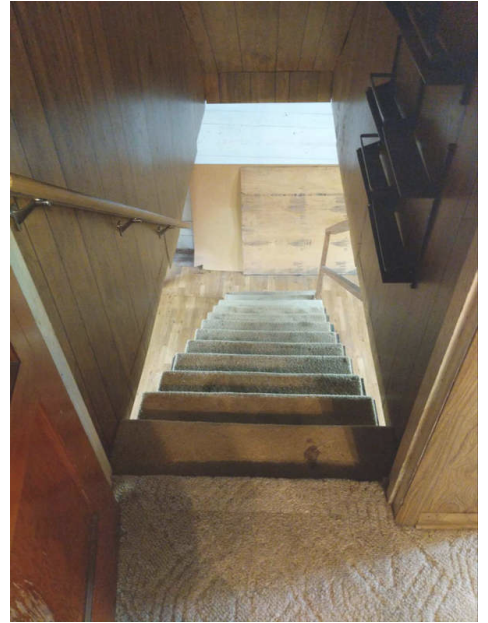
Basement

A handrail at this staircase did not comply with generally-accepted current standards which require that handrails be continuous over the full length of the flight of stairs from top riser to bottom riser. For safety reasons, the Inspector recommends that the handrail be altered or replaced to protect the entire staircase.

Contact a qualified professional.

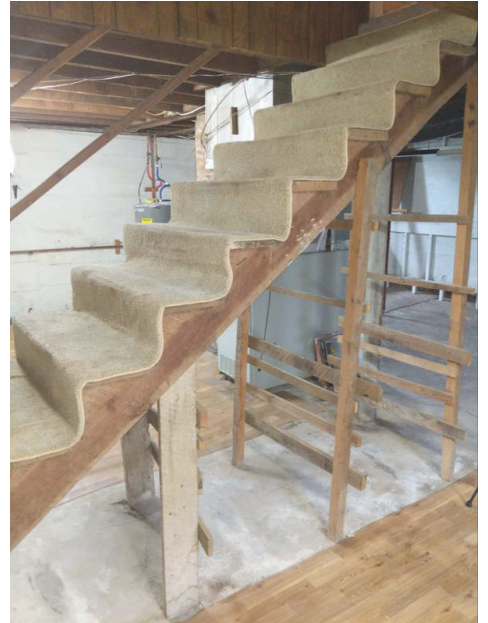
9.7.2 Steps, Stairways & Railings

At the time of the inspection, the staircase moved excessively when tested. The Inspector recommends additional support or fasteners be installed by a qualified contractor.

Contact a qualified professional.

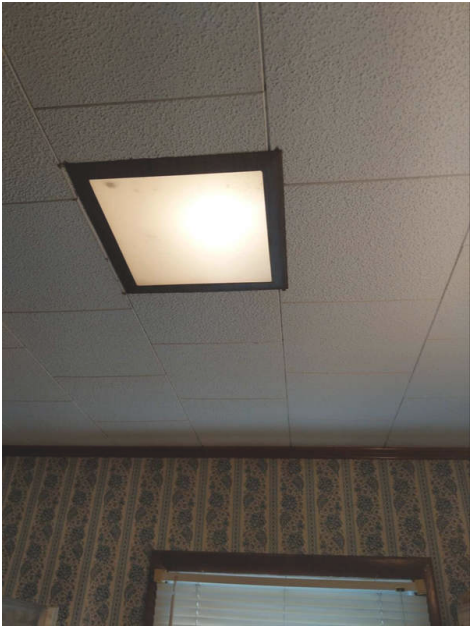
Bathroom

No room ventilation was provided for this bathroom at the time of the inspection. To avoid poor conditions resulting from excessively moist air, The Inspector recommends installation of an exhaust fan by a qualified contractor.

Contact a qualified professional.

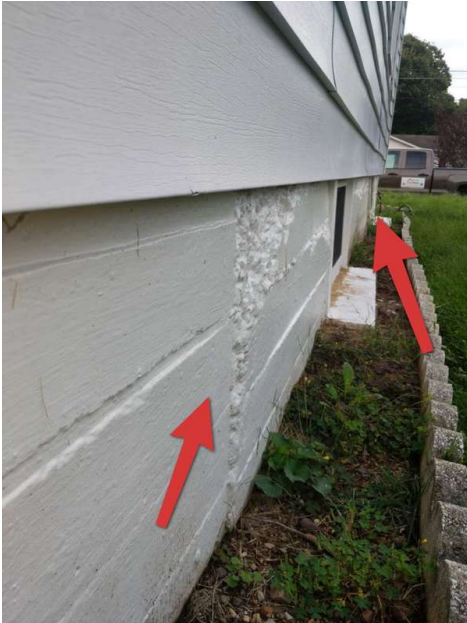
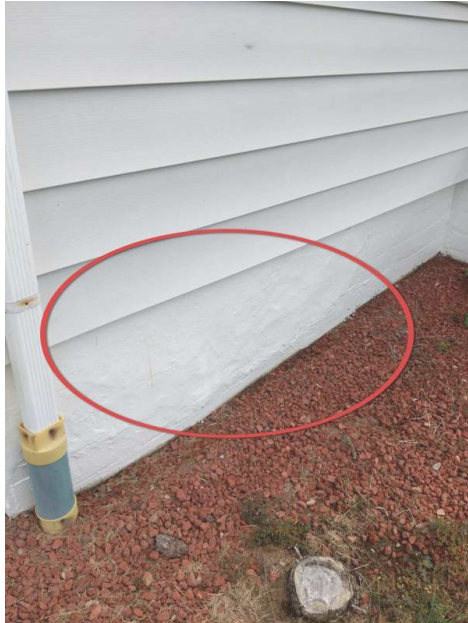
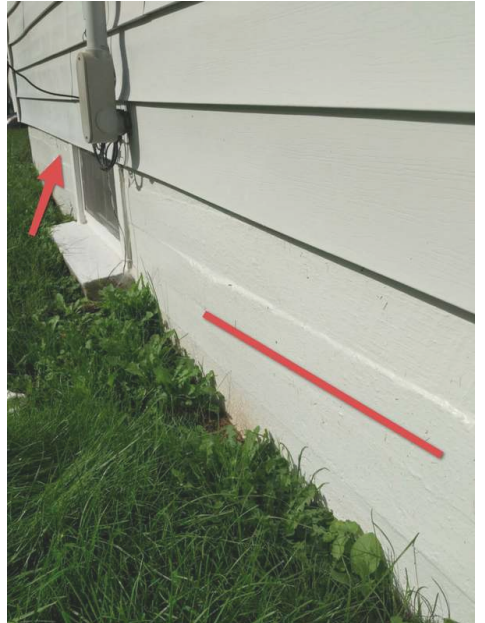
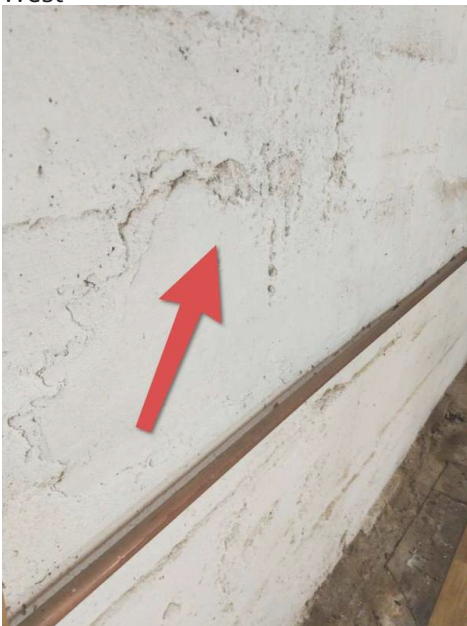
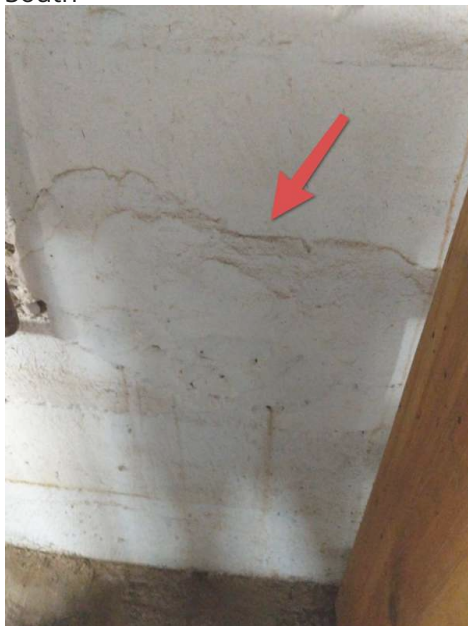
Foundation wall is bowing and/or leaning. It does appear that repairs have been made. These show signs of being older repairs with no signs of movement since the repairs. Accurate determination of the cause or future potential of this condition lies beyond the scope of the General Home Inspection. Consider evaluation by a structural engineer or qualified contractor to more accurately determine the cause, the likelihood of future damage and to discuss the need and options for repair.

Contact a qualified structural engineer.
