## RESIDENTIAL HOME INSPECTION REPORT

1234 Main St.  
Merrimack, NH 03054

Buyer Name  
07/12/2019 9:00AM

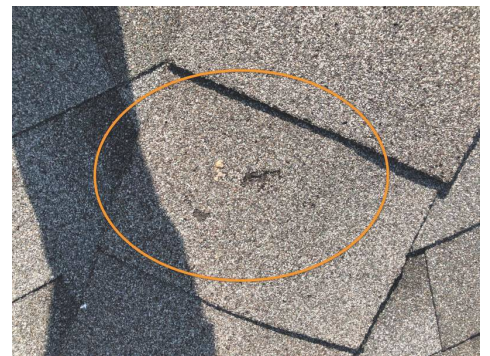
### DAMAGED RIDGE CAP SHINGLES

Cap shingles/ridge vent shingles are damaged/aging. Cap shingles are shingles that cover areas where the roof changes direction, like at roof peaks and hips. Recommend roofing professional evaluate and repair as needed.

Recommendation

Contact a qualified roofing professional.

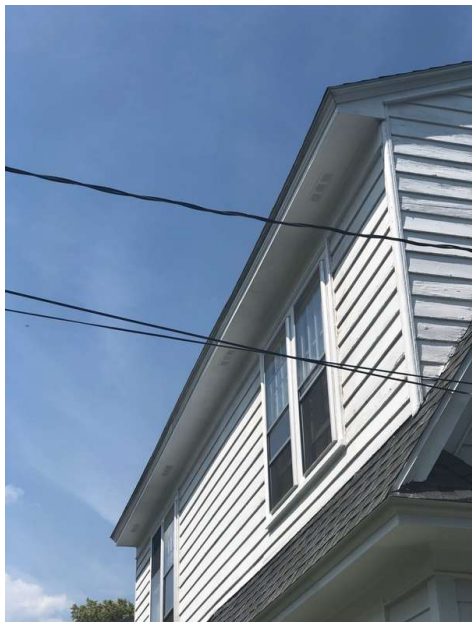
2.2.1 Roof Drainage  
Systems

### GUTTERS MISSING

There are no gutters present on the structure. Gutters are recommended because they collect rain water from the roof and direct it away from the building.

Recommendation

Contact a qualified gutter contractor

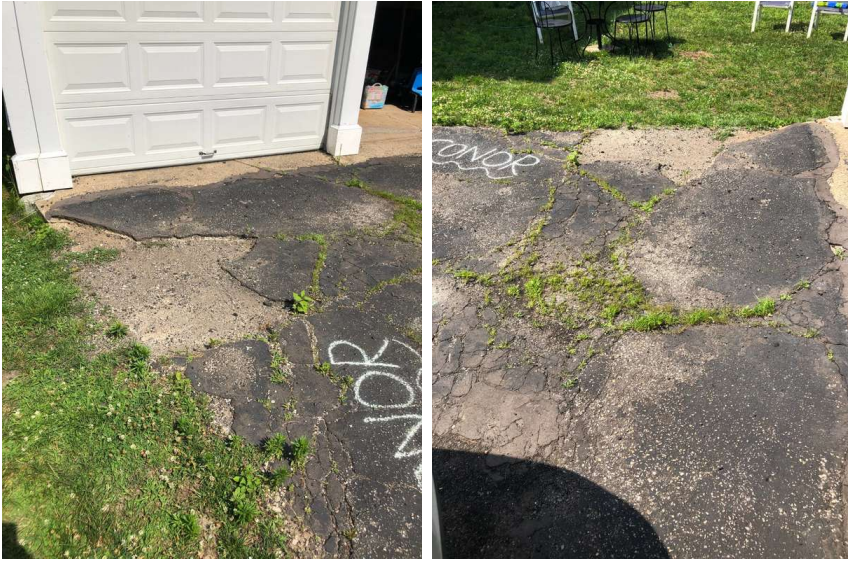
3.1.2 Walkways, Patios & Driveways

### DRIVEWAY CRACKING/SETTLEMENT - MAJOR

Major cracks and settling observed. Recommend qualified professional evaluate and repair as needed to prolong the life of the driveway.

Recommendation

Contact a qualified professional.

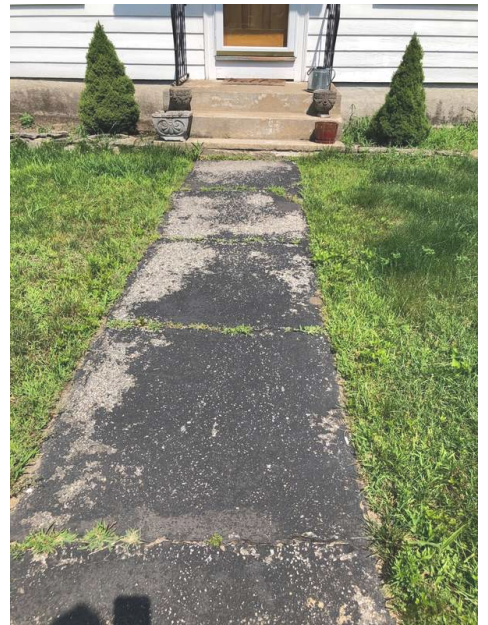
### 3.1.3 Walkways, Patios & Driveways

#### **WALKWAY CRACKING - MINOR**

Minor cosmetic cracks observed. Recommend monitor and/or patch/seal.

Recommendation

Recommend monitoring.

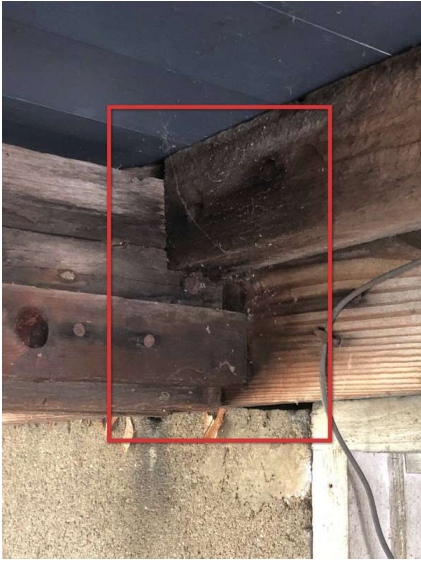
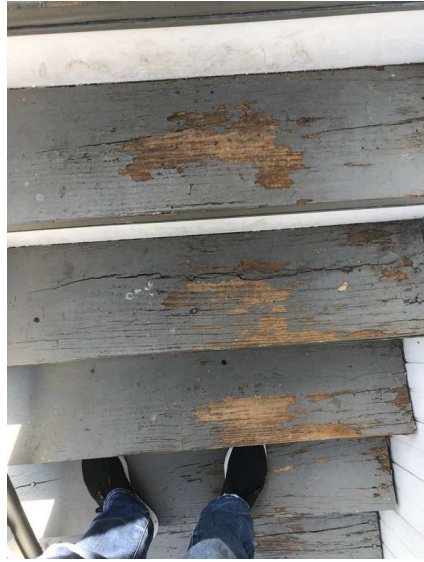
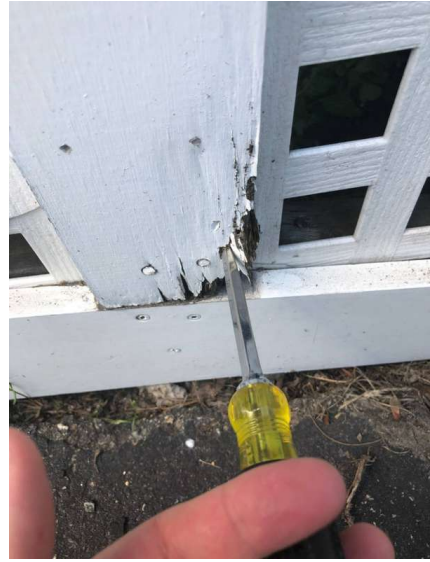
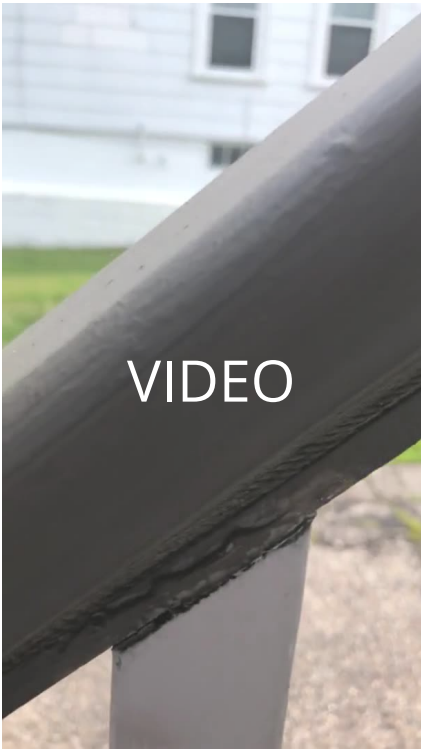
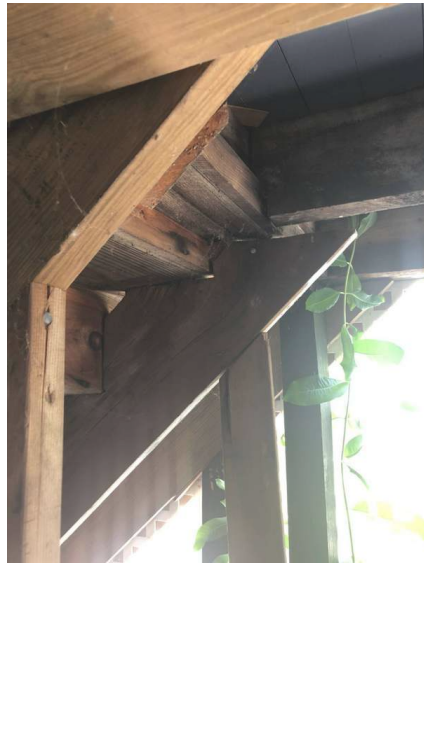
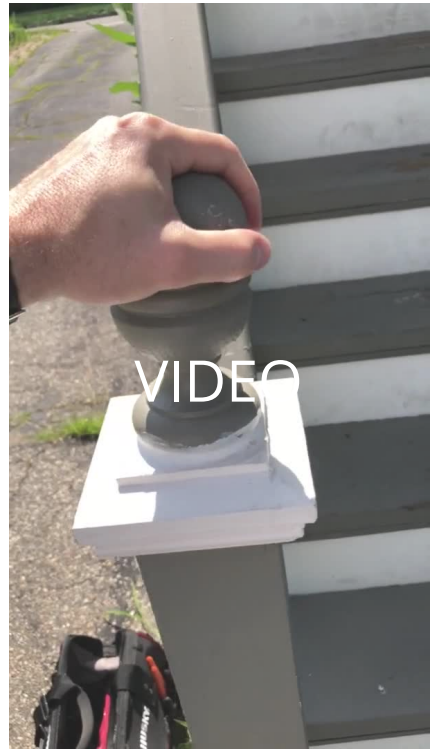
### 3.2.1 Decks, Balconies, Porches & Steps

#### **IMPROPER DECK CONSTRUCTION PRACTICES**

Recommend qualified deck contractor evaluate. These construction practices may have been normal at time of original construction, but do not meet current safety standards. Issues of not are not joist or stair stringer hangers present, loosely nailed stairs, stair supports move freely, peeling paint, cracked/weathered boards that need replacing, loose guardrails, improper supports and more.

Rot

Improper Supports

Recommendation

Contact a qualified deck contractor.

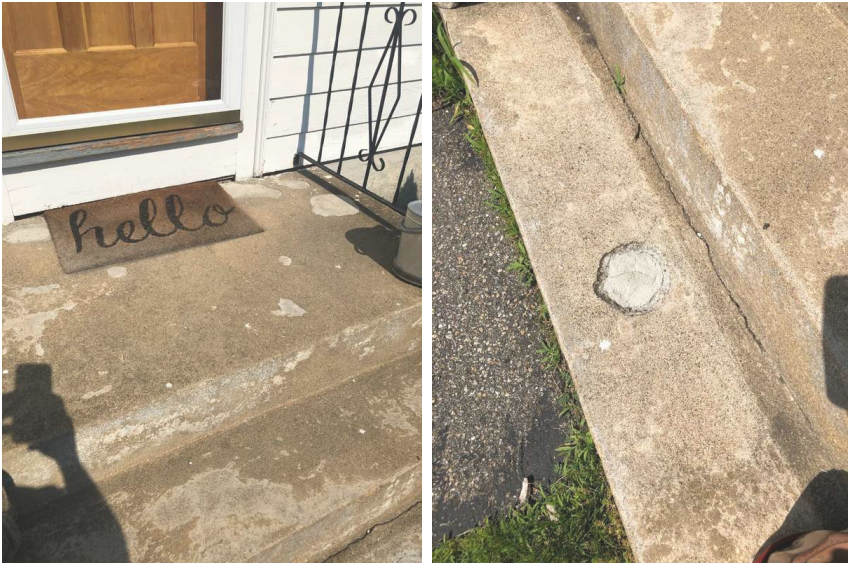
3.2.2 Decks, Balconies, Porches & Steps

**FRONT STOOP DAMAGE**

Entryway stoop concrete is damaged recommend licensed contractor to repair/replace

Recommendation

Contact a qualified concrete contractor.

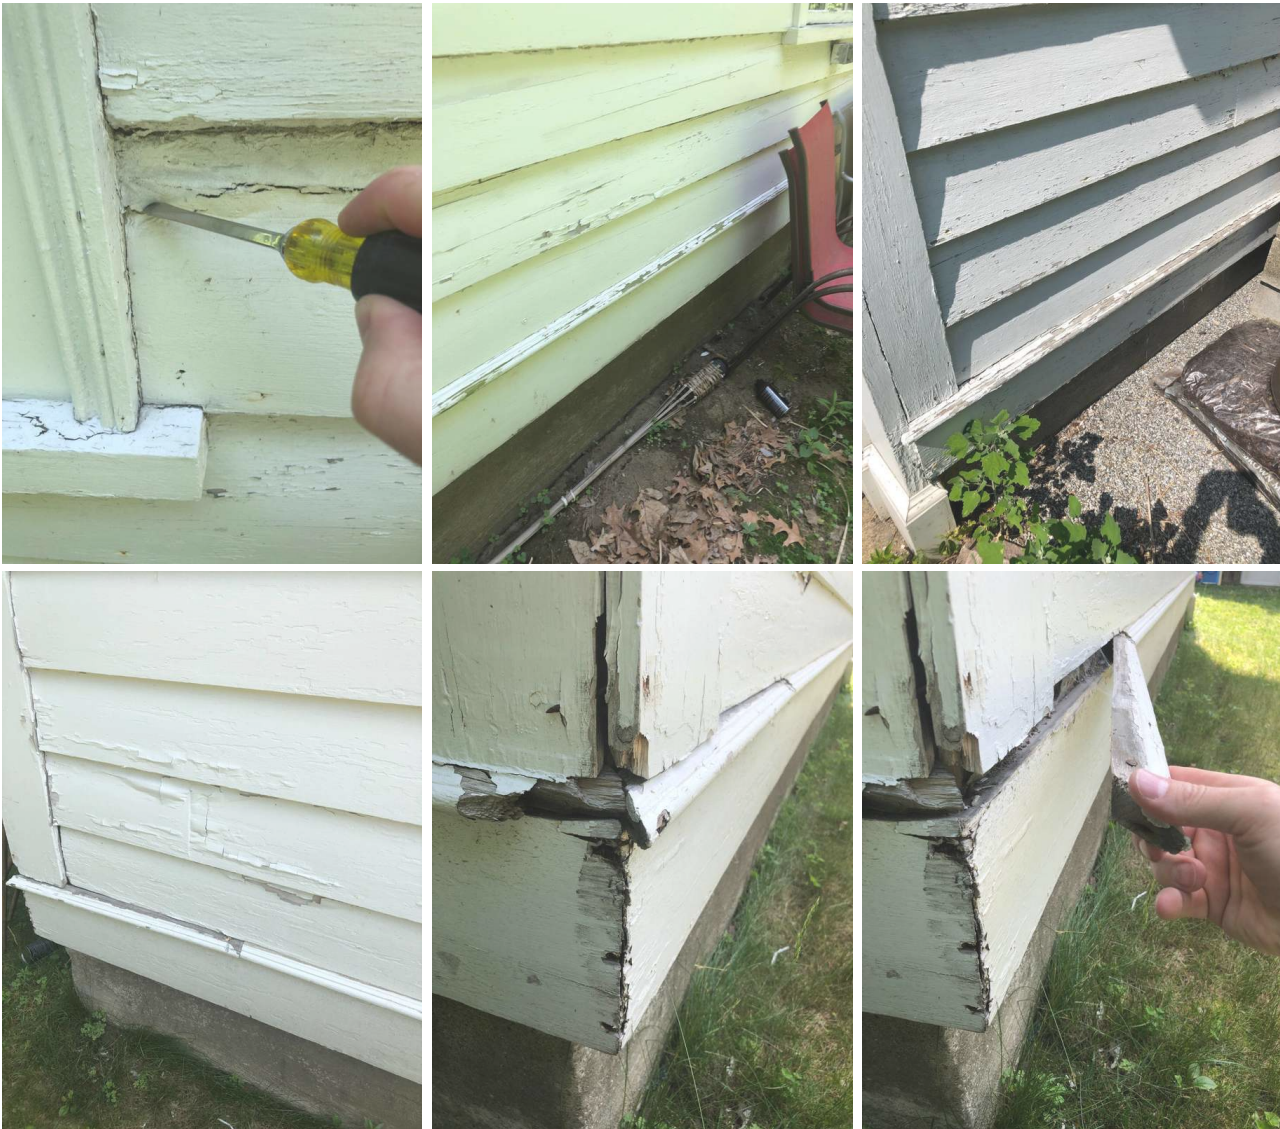
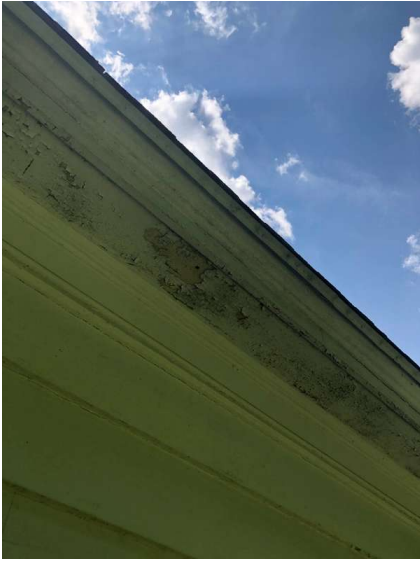
### PEELING PAINT / DAMAGED SIDING

Peeling paint along with damaged areas was observed on exterior surfaces, such as Siding, Trim, Fascia, Soffits, and Eve edges. Recommend qualified contractor to perform normal paint maintenance to prevent moisture damage to these areas.

Recommendation

Contact a qualified painting contractor.

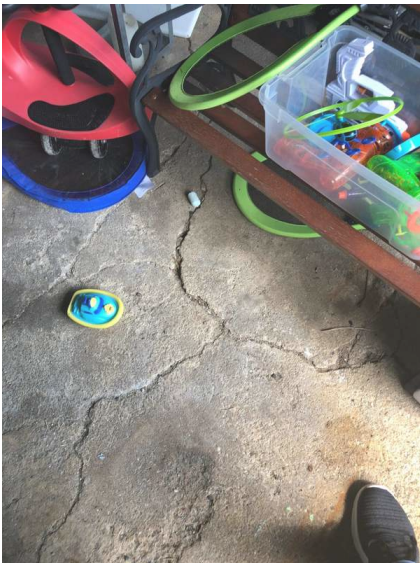
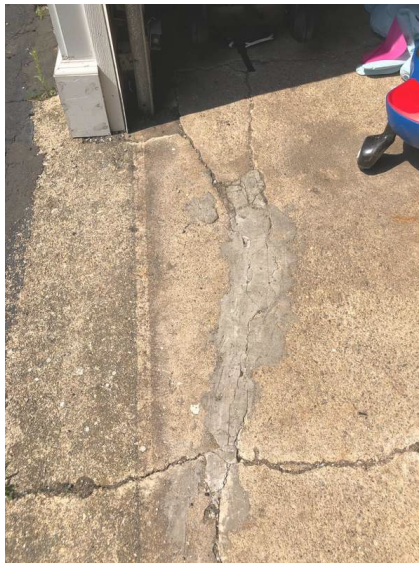
4.4.1 Floor

**SETTLING/CRACKING**

Recommendation

Contact a qualified concrete contractor.

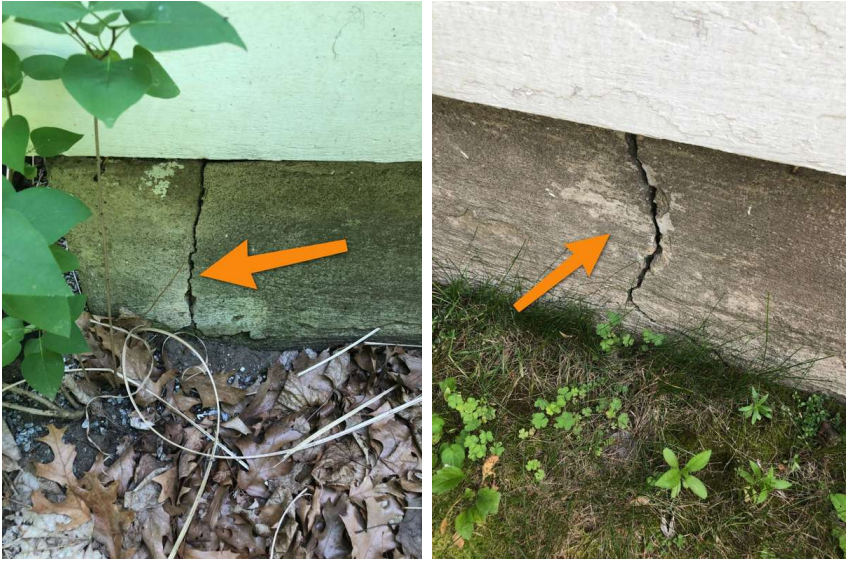
4.5.1 Walls, Ceiling & Firewalls

**FOUNDATION CRACKING-MINOR**

Observed a crack(s) in the foundation wall of the garage. There were no signs of moisture intrusion at the time of inspection.

Recommendation

Recommend monitoring.

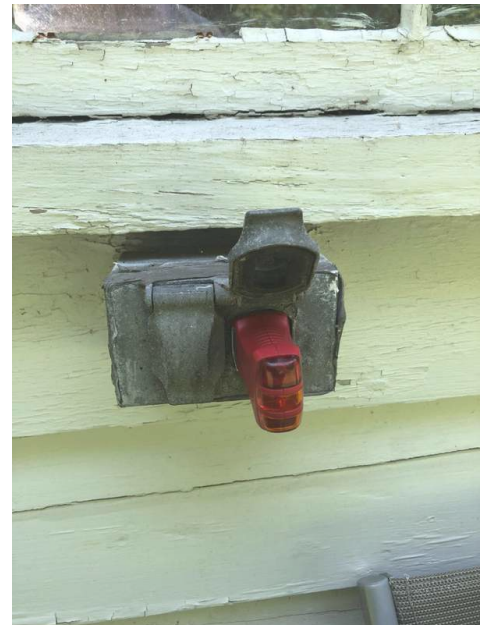
## 4.6.1 Garage Electrical

Recommendation / Needed Improvement**OUTLETS OKAY,  
NO GFCI PROTECTION**

At the time of the inspection, the Inspector observed no deficiencies in the condition of electrical receptacles in the garage, but receptacles in the garage had no ground fault circuit interrupter (GFCI) protection. Although this condition may have been commonly considered safe or acceptable at the time the home was originally constructed, as general knowledge of safe building practices has improved with the passage of time, building standards have changed to reflect current understanding. Consider having GFCI protection installed as a safety precaution. This can be achieved by: 1. Replacing the current standard receptacles with GFCI outlets 2. In the garage circuit, replacing the receptacle nearest the main electrical service panel with a GFCI outlet. 3. Replacing the breakers currently protecting garage electrical circuits with GFCI breakers.

Recommendation

Contact a qualified professional.

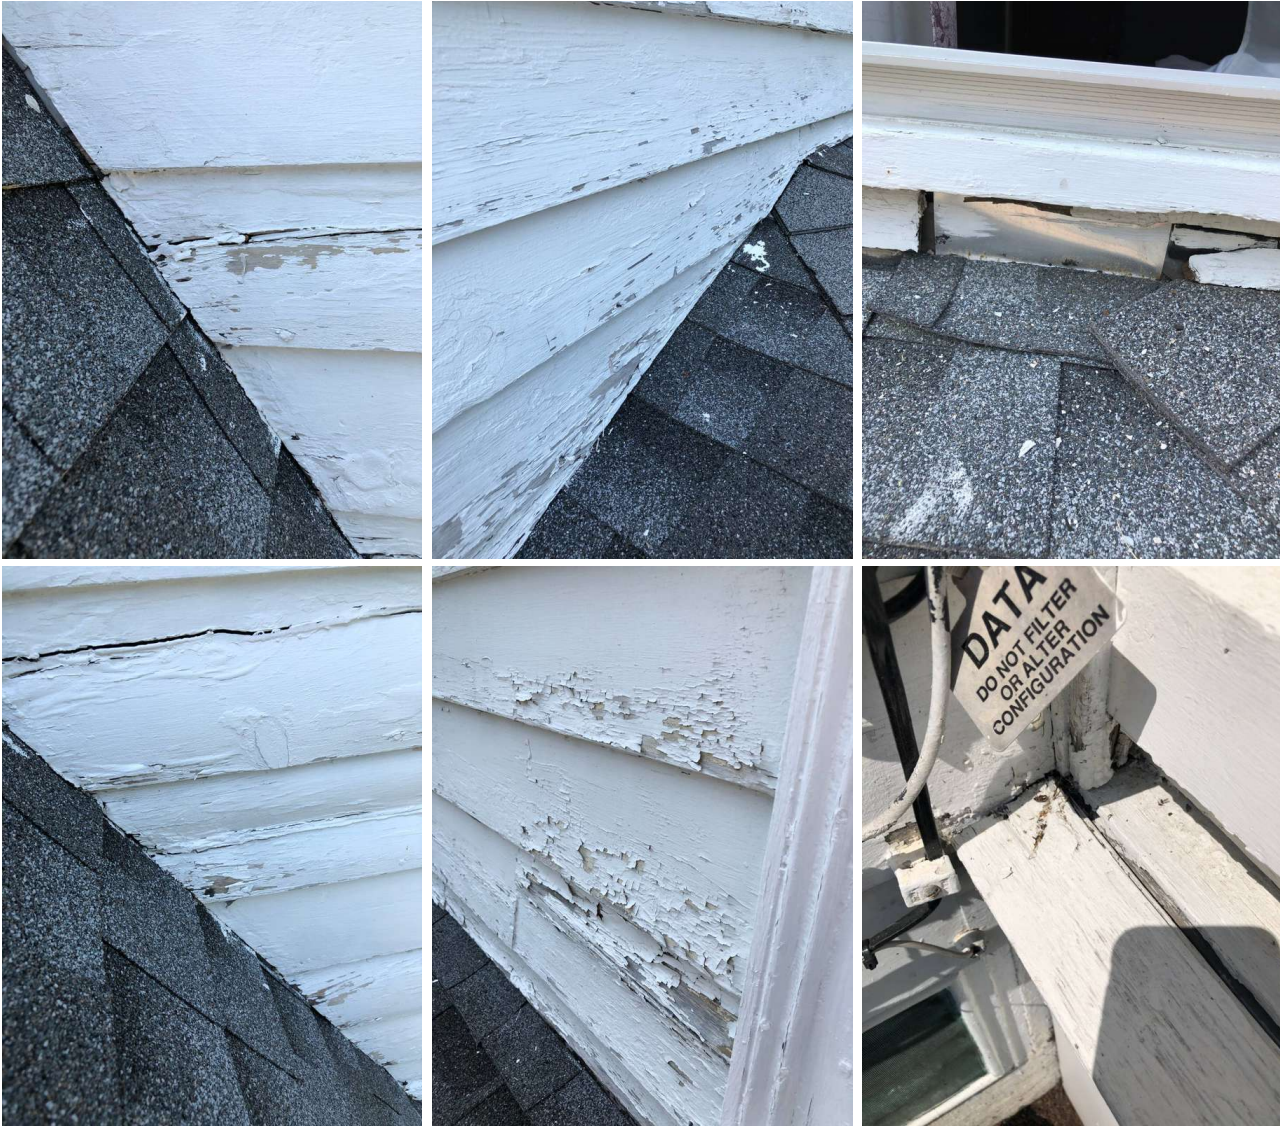
#### 5.1.1 Siding, Flashing & Trim

#### **PEELING/WEATHERED PAINT & ROTTING/DAMAGE**

Peeling paint along with areas of minor rotting and damage was observed on exterior surfaces, such as Siding, Trim, Fascia, Soffits, and Eve edges. Recommend qualified contractor to perform normal paint maintenance to prevent moisture damage to these areas.

Recommendation

Contact a qualified painting contractor.

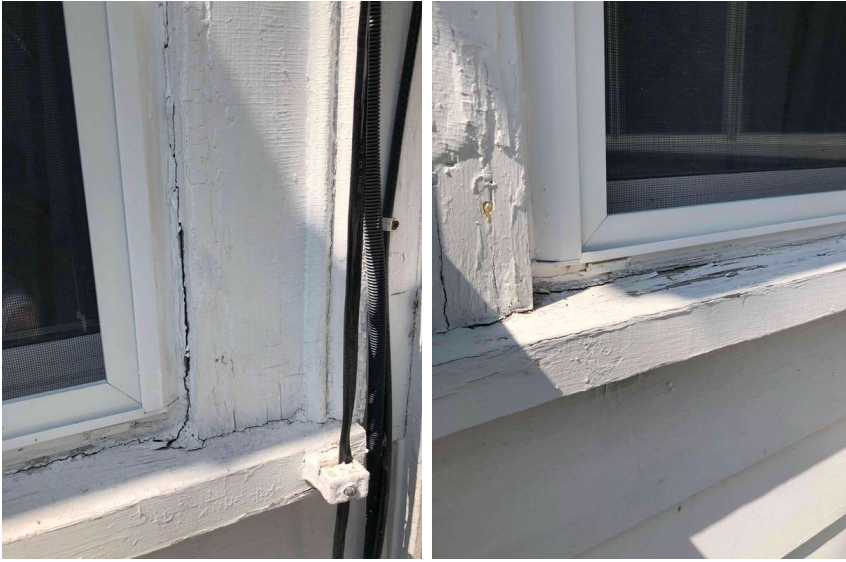
5.2.1 Exterior Windows

**PEELING PAINT**

Exterior windows have painted components that are peeling, recommend qualified contractor to perform normal paint maintenance as needed to prevent potential damage.

Recommendation

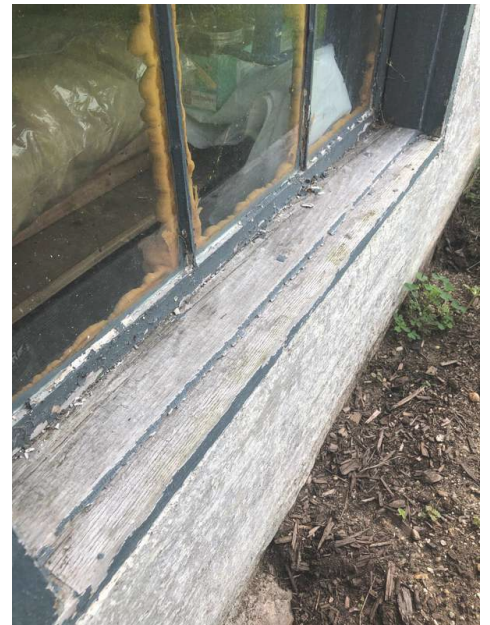
5.4.1 Basement windows

Exterior windows have painted components that are peeling, recommend qualified contractor to perform normal paint maintenance as needed to prevent potential damage.

Recommendation

Contact a qualified painting contractor.

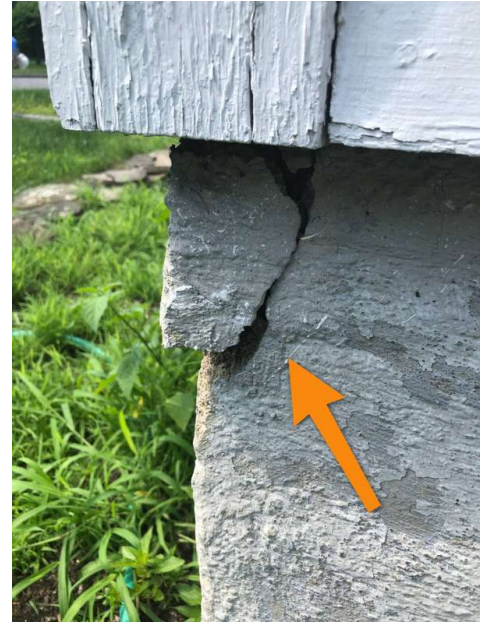
5.5.1 Exterior foundation

**MINOR DAMAGE**

Concrete foundation block has minor damage recommend licensed foundation contractor to repair

Recommendation

Contact a foundation contractor.

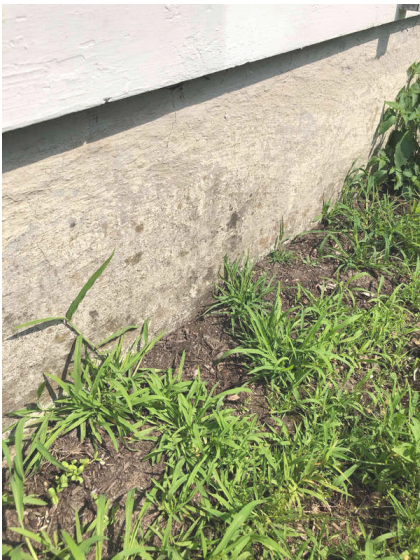
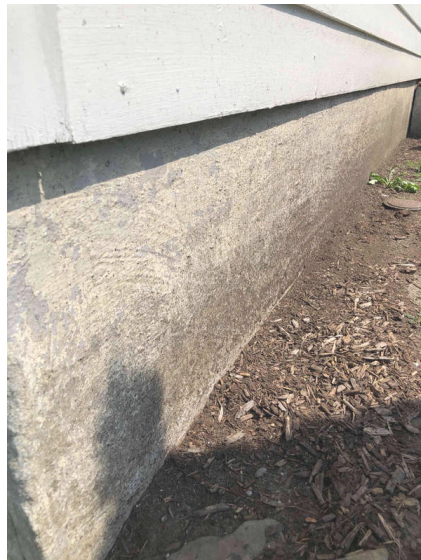
### 5.5.2 Exterior foundation

#### PARGING

Evidence of Parging was observed. Recommend monitoring for changes in condition.

Parging is a low-cost alternative to **repointing**, providing structural cohesiveness to masonry walls whose mortar has begun to fail.

Recommendation

Recommend monitoring.

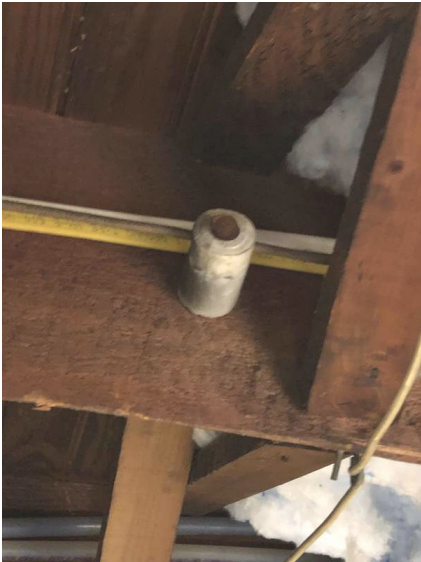
7.2.2 Branch Wiring Circuits, Breakers & Fuses

This home and garage was originally wired using Knob and Tube wiring. This older wiring can become a safety hazard and is recommended to be replaced or repaired to prevent possible injury. Recommend licensed electrician evaluate further and removed as needed.

Recommendation

Contact a qualified electrical contractor.

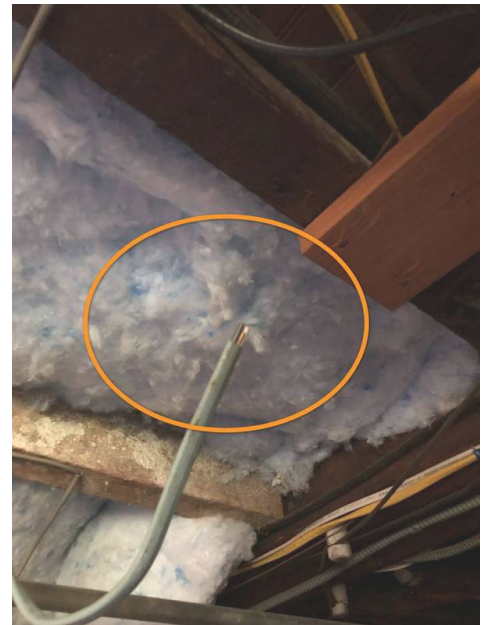
### 7.2.3 Branch Wiring Circuits, Breakers & Fuses

Miscellaneous abandoned wiring visible in the basement should be evaluated by a qualified electrical contractor to determine whether any wiring is still energized. Improperly terminated, energized wiring is a shock/electrocution hazard.

Near panel

##### Recommendation

Contact a qualified electrical contractor.

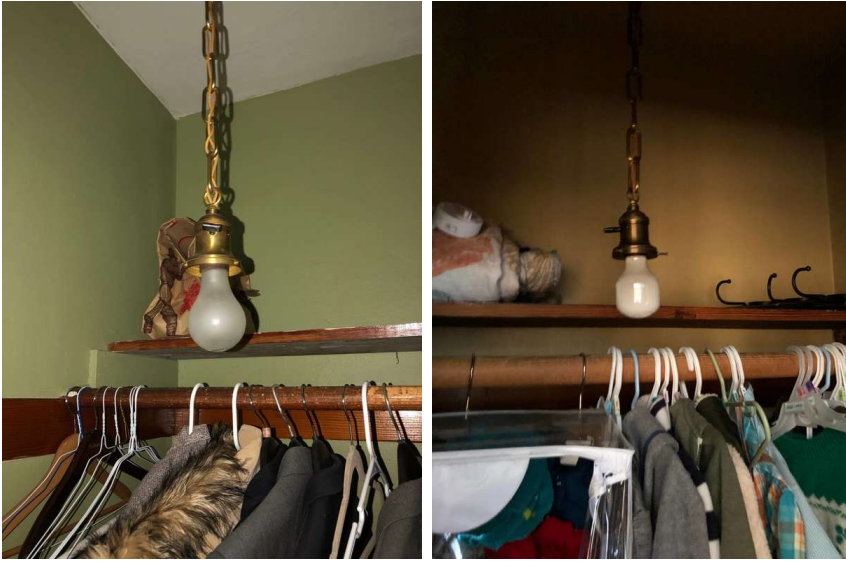
### 7.3.1 Electrical Fixtures, Switches and Receptacles

Exposed incandescent light bulbs are no longer permitted inside a closet space. Closet light should only be recessed light or surface mount fixture. Recommend licensed electrician evaluate and repair as needed. Not all closets are photographed.

##### Recommendation

Contact a qualified electrical contractor.

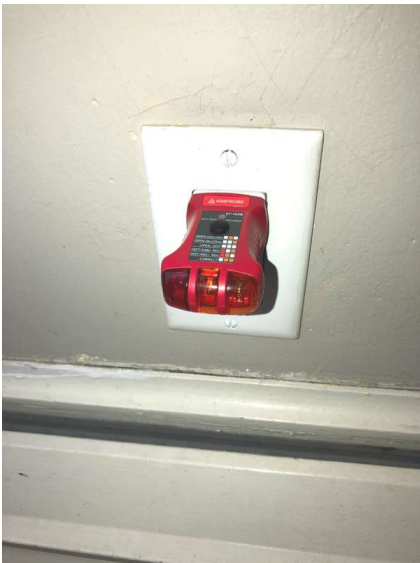
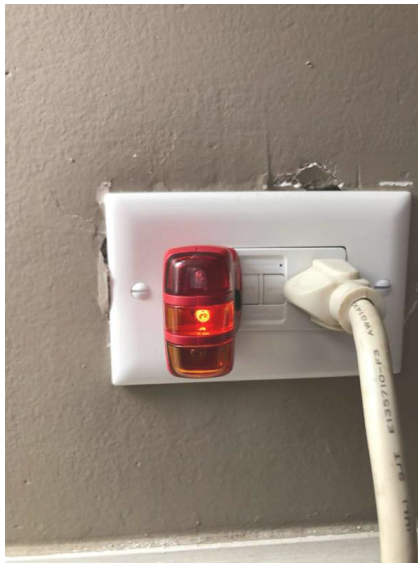
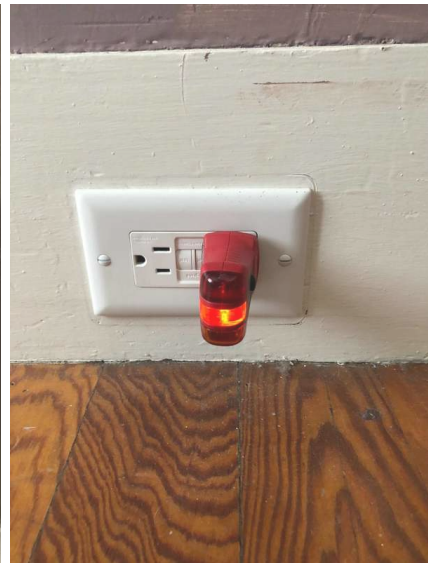
### 7.3.2 Electrical Fixtures, Switches and Receptacles

One or more receptacles are ungrounded. An open ground means that a missing grounding conductor or unconnected grounding conductor at the receptacle, or one is missing at an upstream receptacle. To eliminate safety hazards, all 3 prong outlets should be grounded. Where grounding is not possible (no ground wire present), a 2 prong receptacle or GFCI protected receptacle can be installed. Many of the receptacles in these areas have GFCI receptacles in place.

Note: GFCI protection of an ungrounded 3 prong outlet will not protect electronics. A physical ground system is required to protect electronics or allow surge protectors to function properly. Have a licensed electrician evaluate further and repair as necessary for safest operation.

##### Recommendation

Contact a qualified electrical contractor.

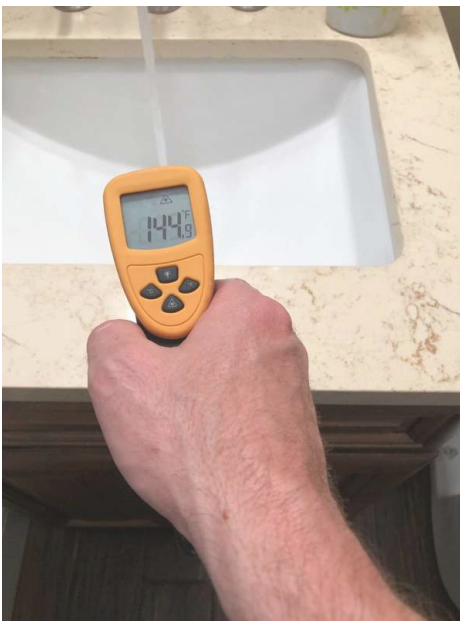
**General: Water Temperature**

The water temperature at the time of inspection was excessively hot in all areas. Recommend temp turned down to 120 degrees for safety.

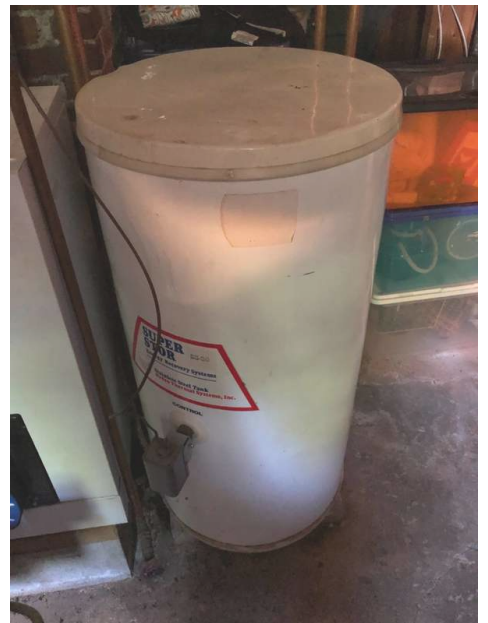
### INDIRECT WATER HEATER

The home had an indirect water heater, sometimes called a sidearm water heater. An indirect water heater typically has no direct means (such as a burner) for heating water installed, but uses a fluid heated by another source such as a boiler. The hot fluid then circulated through coils in the water tank, transferring heat to water in the tank.

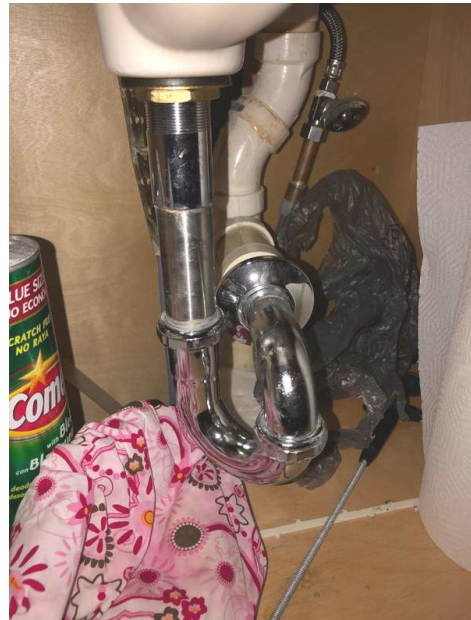
9.4.1 Drain, Waste, & Vent Systems (DWV)

### CHROME PLATED BRASS DRAIN PIPE-CORROSION

Recommendation

Contact a qualified plumbing contractor.

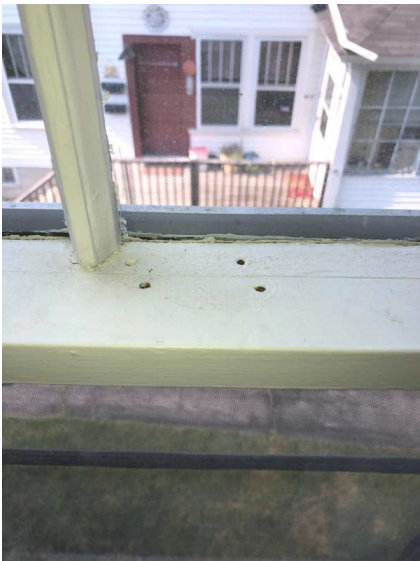
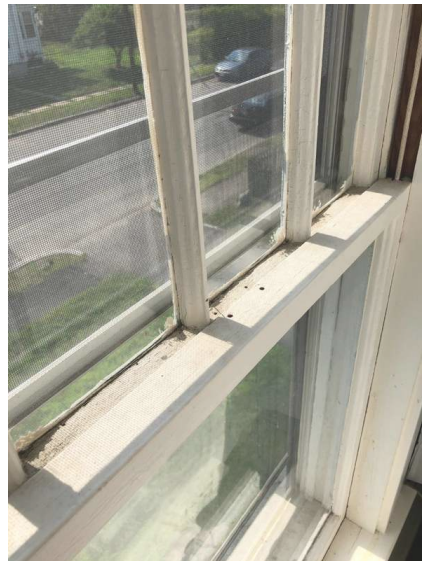
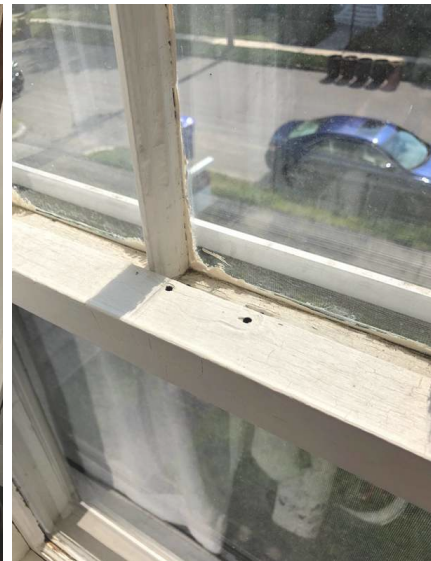
11.2.2 Interior Windows

**MISSING HARDWARE**

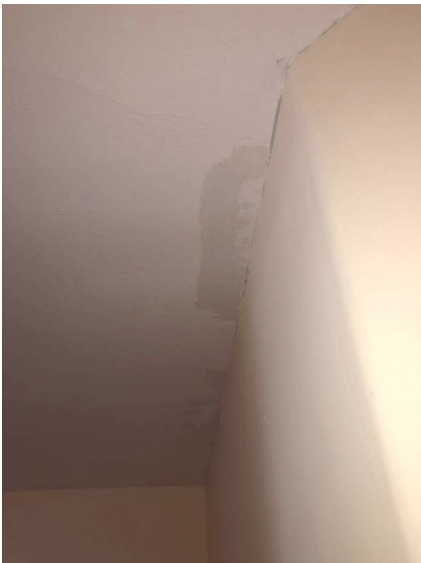
11.5.2 Walls and Ceilings

**POOR PATCHING**

2nd Floor

Recommendation

Contact a qualified drywall contractor.

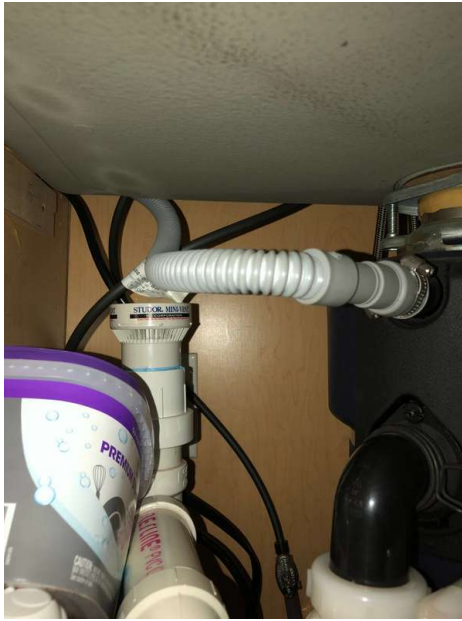
## Dishwasher: High Loop Present

The dishwasher had a high loop installed in the drain line at the time of the inspection. The high loop is designed to prevent wastewater from contaminating the dishwasher. This is a proper condition.
