PLATINUM HOME INSPECTIONS

RESIDENTIAL HOME INSPECTION REPORT

1234 Main St.
Merrimack NH 03054

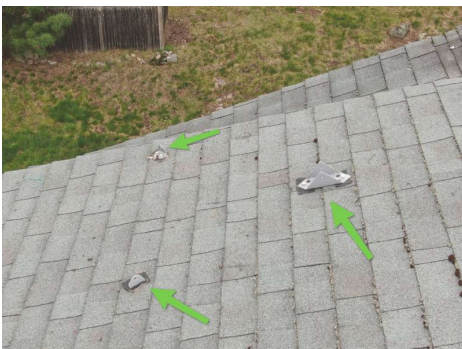
Coverings: Satellite Dish Penetration

Old Satellite dish mounts have penetrated roof coverings which could allow moisture intrusion if not kept sealed. Recommend periodic monitoring to ensure sealant used is in good condition and reapply as needed.

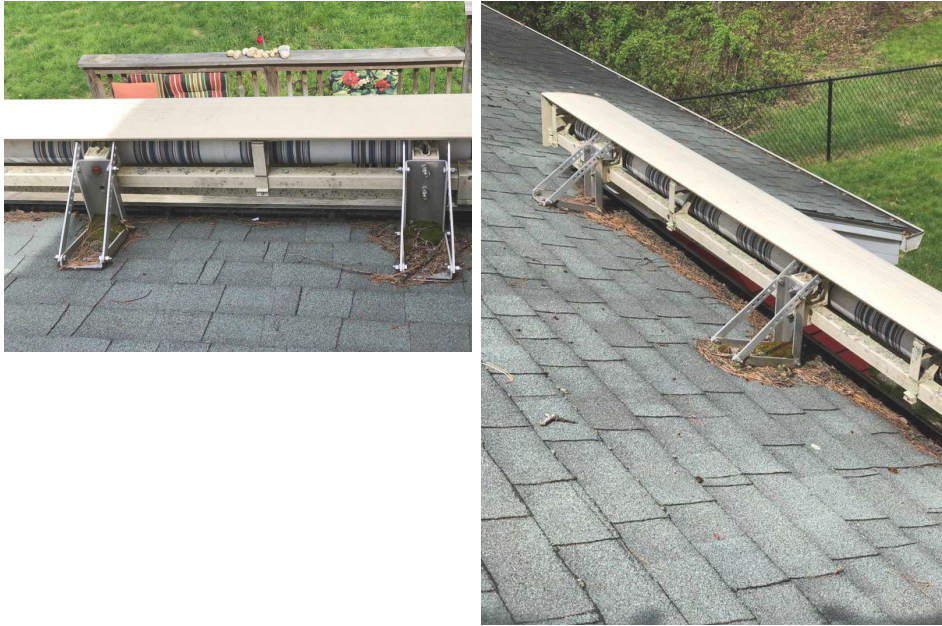
Roof coverings at the area where the awning is present have debris from the above trees. Recommend cleaning periodically to extend the life of the roof covering.

Contact a qualified professional.

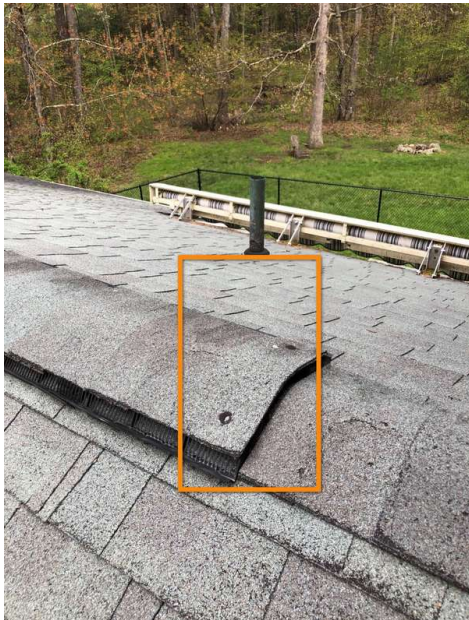
2.1.2 Coverings

DAMAGED RIDGE CAP SHINGLES

Cap shingles/ridge vent shingles are damaged/aging. Cap shingles are shingles that cover areas where the roof changes direction, like at roof peaks and hips. Recommend roofing professional evaluate and repair as needed.

Cracking at ridge vent

Contact a qualified roofing professional.

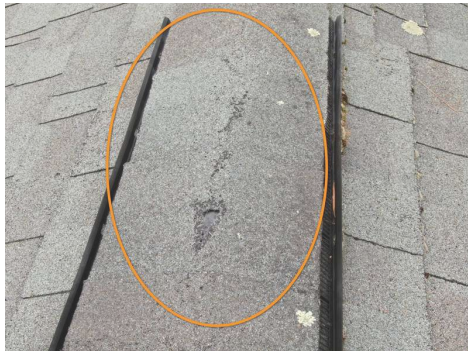
Shingle worn through

Need sealant over roof penetrations.

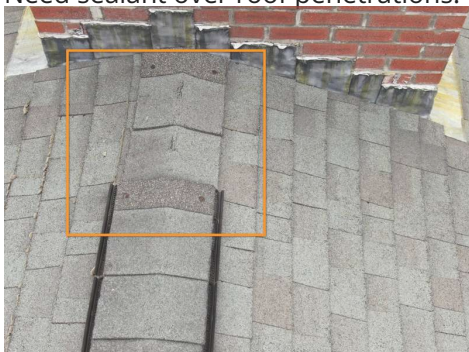
Cracking present and sealant is needed over penetrations.

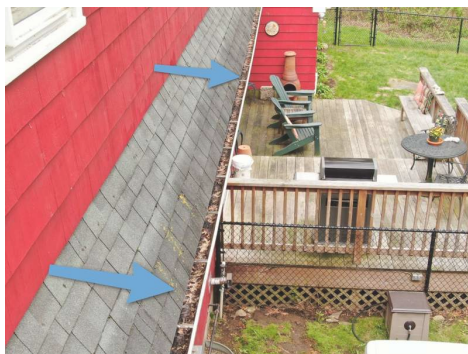
2.2.1 Roof Drainage Systems

Debris has accumulated in the gutters. Recommend cleaning to facilitate water flow.

Contact a qualified handyman.

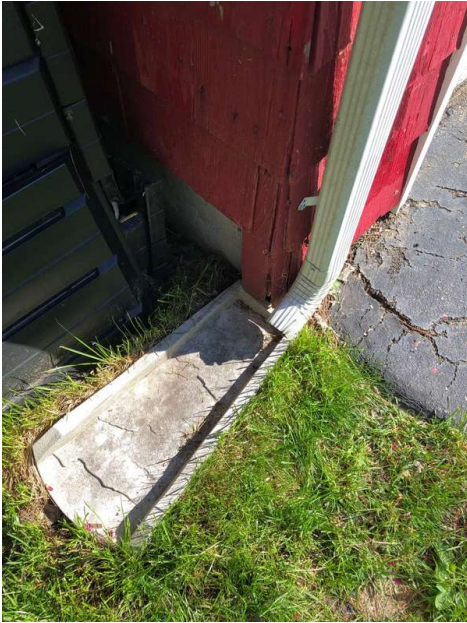
2.2.2 Roof Drainage Systems

One or more downspouts drain too close to the home's foundation. This can result in excessive moisture in the soil at the foundation, which can lead to foundation/structural movement. Recommend a qualified contractor adjust downspout extensions to drain at least 6 feet from the foundation.

Contact a handyman or DIY project

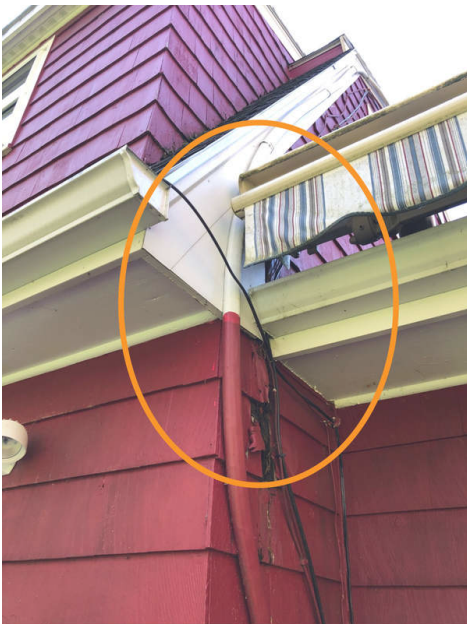
2.3.1 Flashings

MISSING KICK-OUT FLASHING

Kick-out flashing was missing where walls extended past roof edges.

Contact a qualified roofing professional.

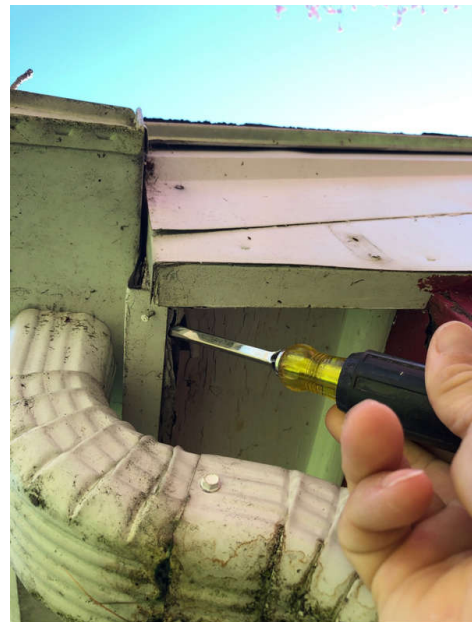
2.4.1 Eaves, Soffits & Fascia

SOFFIT - ROTTED

One or more sections of the fascia are rotted. Recommend qualified roofer evaluate & repair.

Contact a qualified roofing professional.

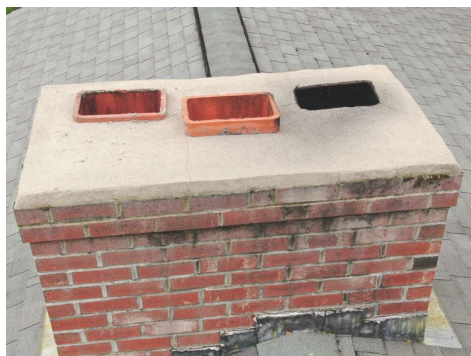
2.5.1 Skylights, Chimneys & Other Roof Penetrations

CHIMNEY CAP MISSING

Chimney cap was not observed or improper. This is important to protect from moisture intrusion and protect the chimney. Recommend a qualified roofer or chimney expert install.

Example photo represents a proper chimney cap, recommend installing to prevent moisture/pest intrusion.

Contact a qualified chimney contractor.

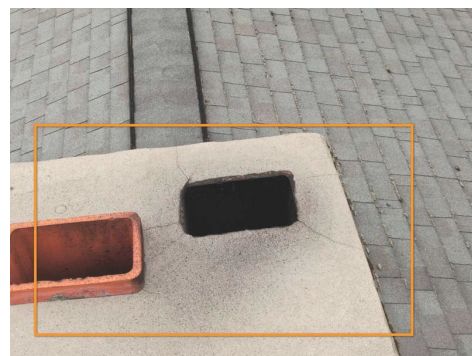
2.5.2 Skylights, Chimneys & Other Roof Penetrations

CRACKED/DAMAGED CHIMNEY CROWN

Observed the crown of the chimney to have cracks and should be repaired by a qualified contractor to prevent moisture instruction into the chimney liner and chase.

Contact a qualified chimney contractor.

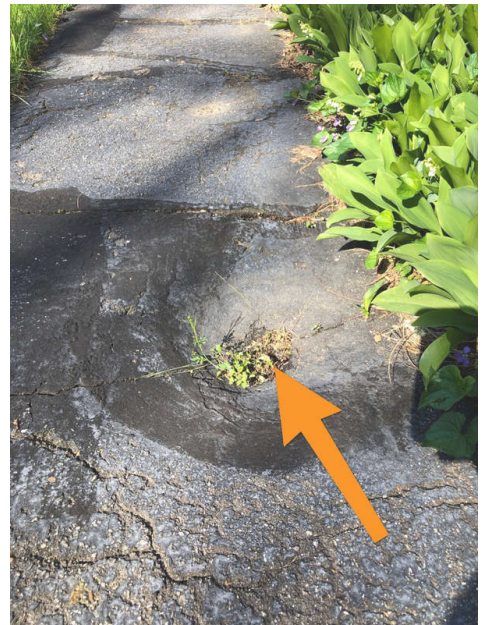
3.2.2 Walkways, Patios & Driveways

WALKWAY TRIP HAZARD

Trip hazards observed. Patch or repair recommended.

Contact a qualified concrete contractor.

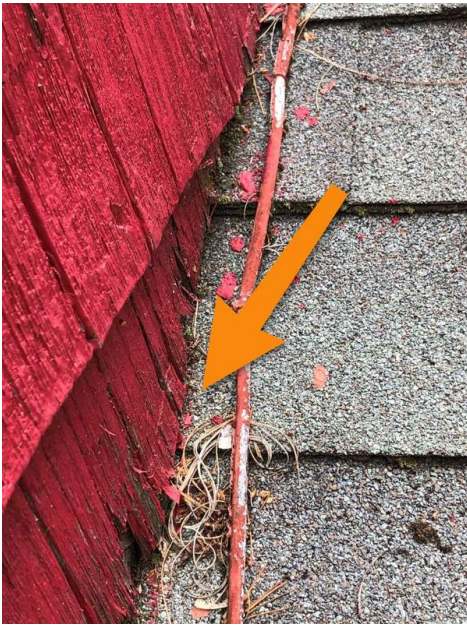
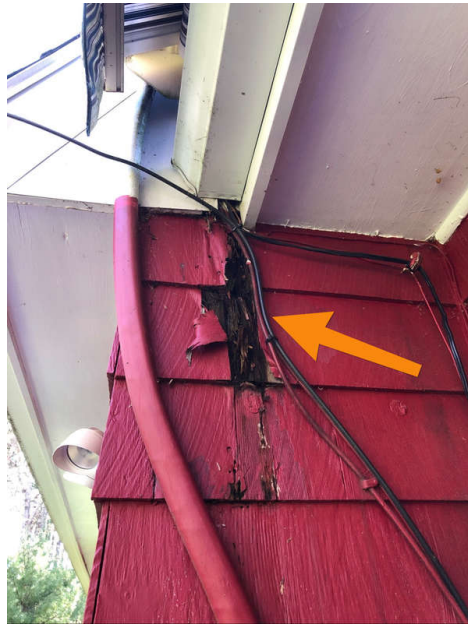
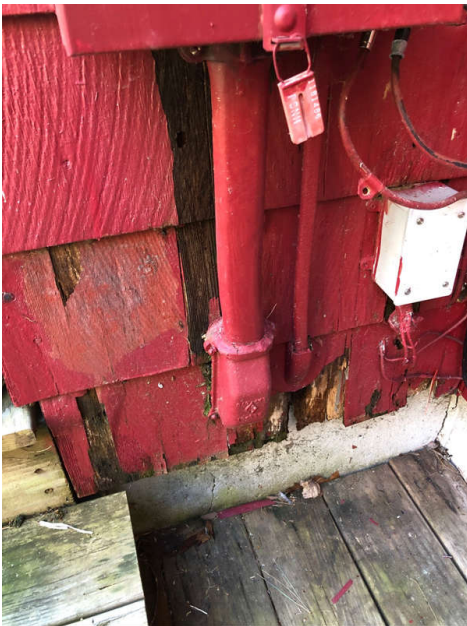
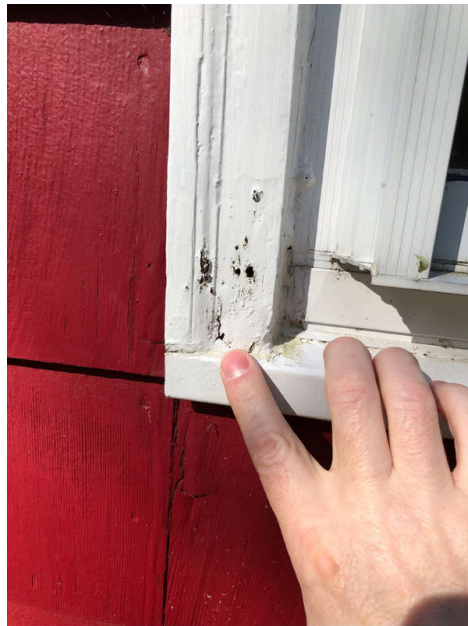
5.1.2 Siding, Flashing & Trim

Evidence of wood rot/damage on siding and trim boards throughout various areas of the structure such as but not limited too; all window trim on the right side, above and below the electrical meter as well as along areas where the roof covering meet the siding. Recommend licensed contractor to repair/replace as needed.

Right Side

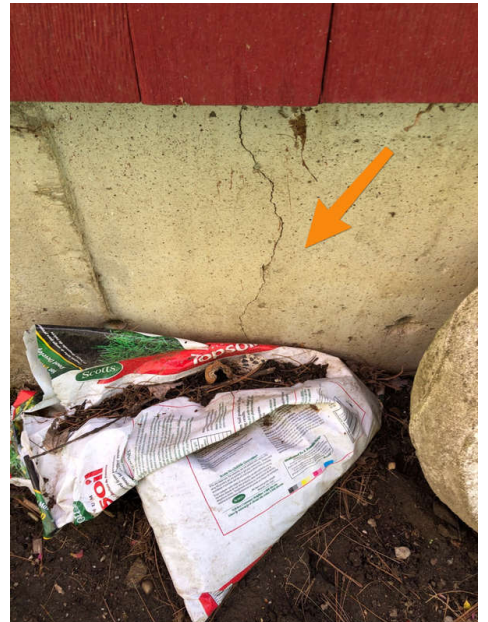
5.5.1 Exterior foundation
TYPICAL CRACKING

Exterior foundation contains typical cracks due to shrinkage and normal freeze thaw cycle. Recommend patching as needed to prevent moisture intrusion.

Left side

Recommendation
 Recommend monitoring.

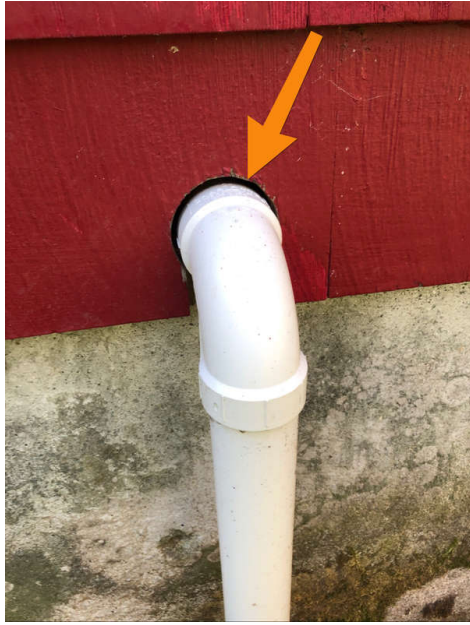
Exterior wall penetrations left gaps that needed to be sealed with an appropriate sealant to prevent moisture and insect entry. All work should be performed by a qualified contractor.

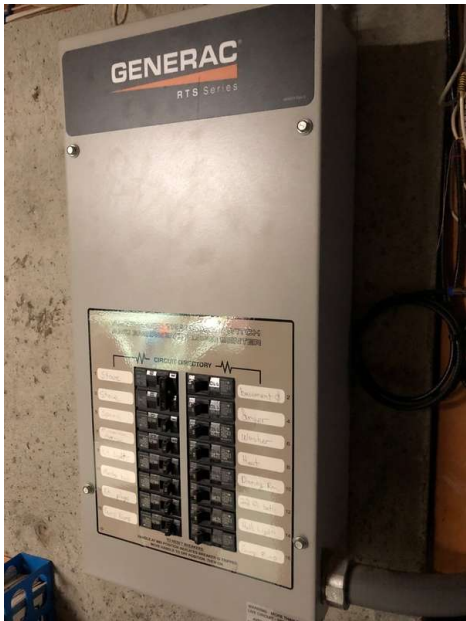
Main & Subpanels, Service & Grounding, Main Overcurrent Device: Generator Service/Equipment Present

Equipment for a generator system was found. Generators, transfer switches and any associated wiring are excluded from this inspection. Recommend that the client consult with the property owner or review documentation to familiarize themselves with the operation of this system.

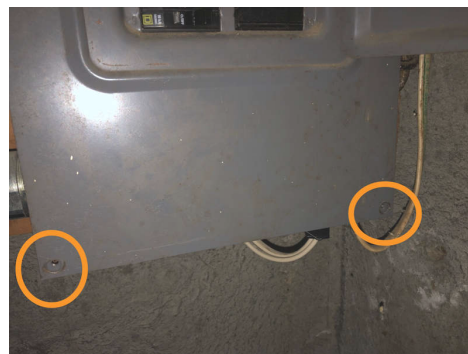
MISSING SCREWS

One or more screws that attach the cover or dead front to panel(s) were missing or not installed. Recommend installing screws where missing so the cover or dead front is secure. Only screws with blunt tips approved for this purpose should be installed, so wiring inside the panel is not damaged. Because energized wires may be located directly behind screw holes, the client should consider replacing missing screws.

Recommended DIY Project

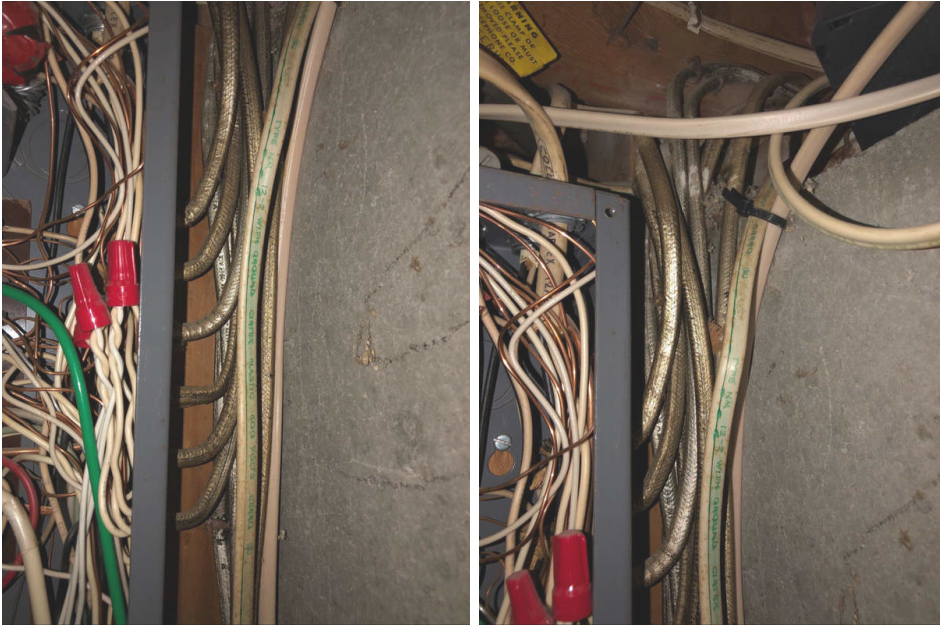
7.2.1 Branch Wiring Circuits, Breakers & Fuses

There is visible cloth wiring in the main panel being used as branch wiring. There is a rubber coating below the cloth on the wiring, the rubber coating deteriorates and cracks as the wires age. This can lead to electrical shorts. Recommend to have any cloth wiring replaced with modern wires.

Contact a qualified electrical contractor.

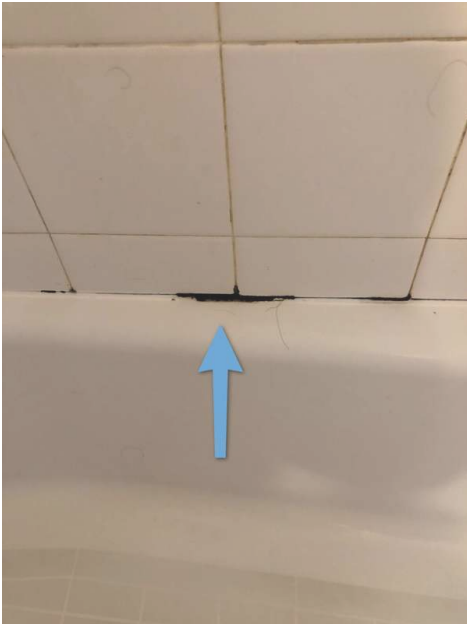
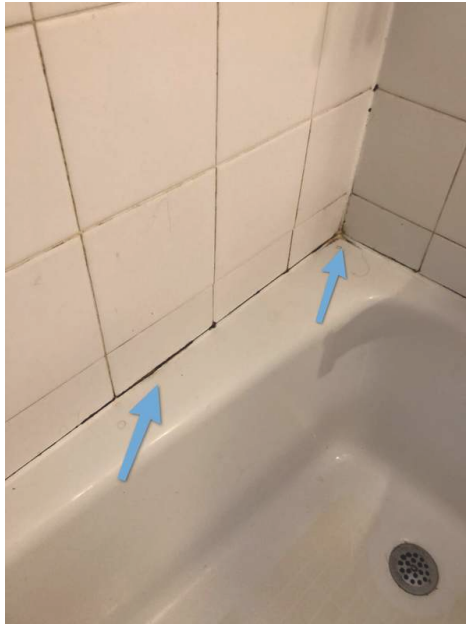
10.4.2 Fixtures, Toilets, Tubs & Showers

IMPROPER CAULKING

Shower/Tub surround is improperly caulked, moisture stains were evident. Recommend contractor to repair to prevent moisture damage.

Contact a qualified professional.

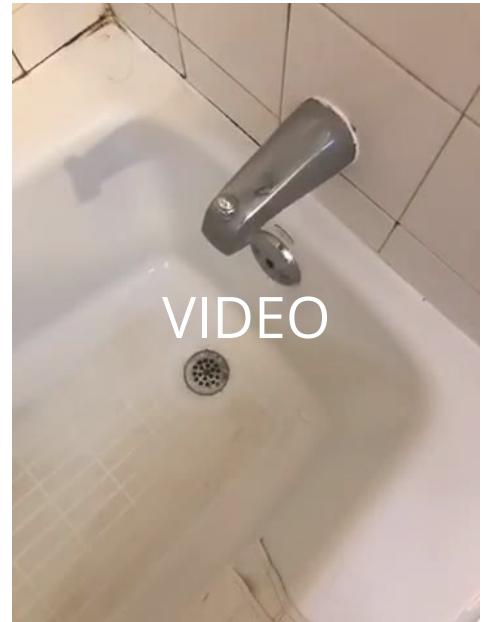
10.4.3 Fixtures, Toilets, Tubs & Showers

LOOSE TUB SPOUT

2nd floor tub spout is loose and moves freely which can allow water intrusion. Recommend filling behind spout with expanding spray foam which will secure the spout in place.

Contact a qualified professional.

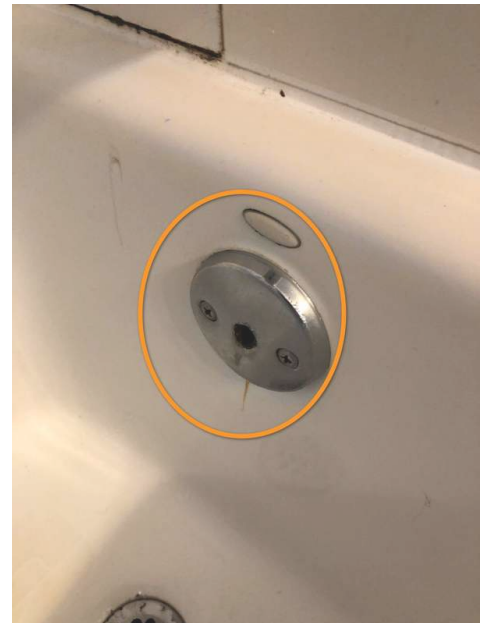
10.4.4 Fixtures, Toilets, Tubs & Showers

BATHTUB STOPPER - BROKEN

The bathtub stopper handle was broken/missing at the time of inspection.

Contact a qualified professional.

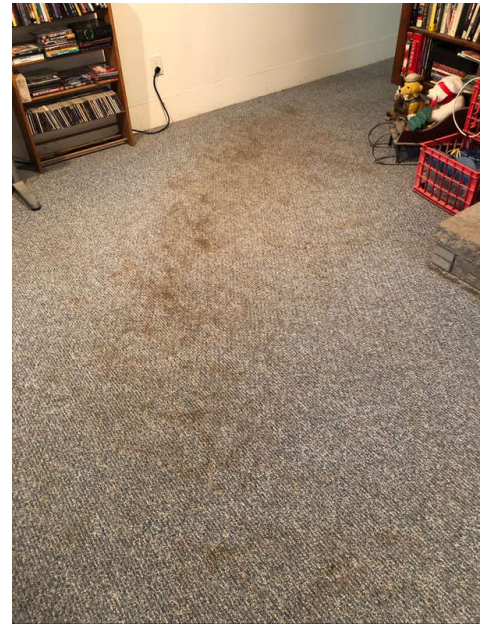
CARPET STAINS

Carpet had areas of staining or discoloration. Recommend a thorough steam clean by a qualified carpet cleaning company

Basement

Contact a qualified cleaning service.

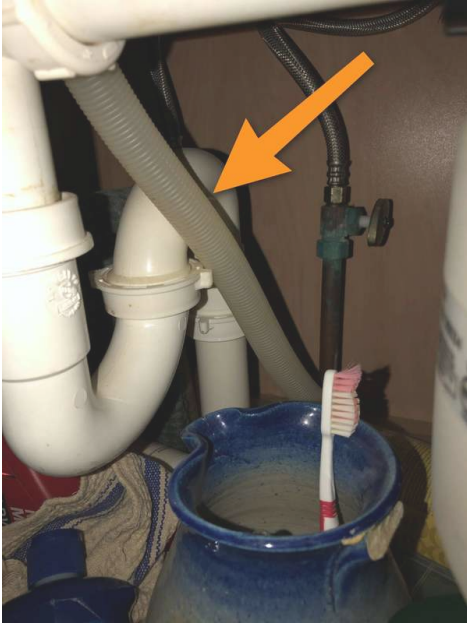
A high loop prevents the dirty water that is being drained from being inadvertently pulled back into the dishwasher or even siphoned back into the water system. Recommend high loop be installed by plumbing contractor.

Example

Contact a qualified plumbing contractor.

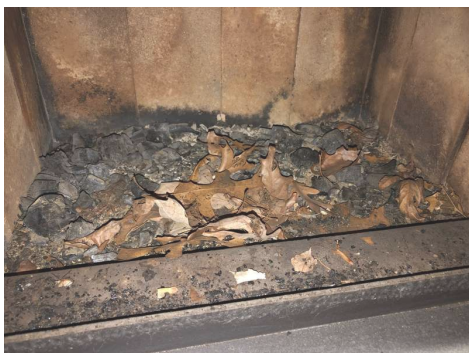
15.1.1 Fireplaces, Stoves & Inserts

The firebox of the wood-burning fireplace(s) in the basement and living room needed cleaning at the time of the inspection.

Basement

Contact a qualified chimney sweep.

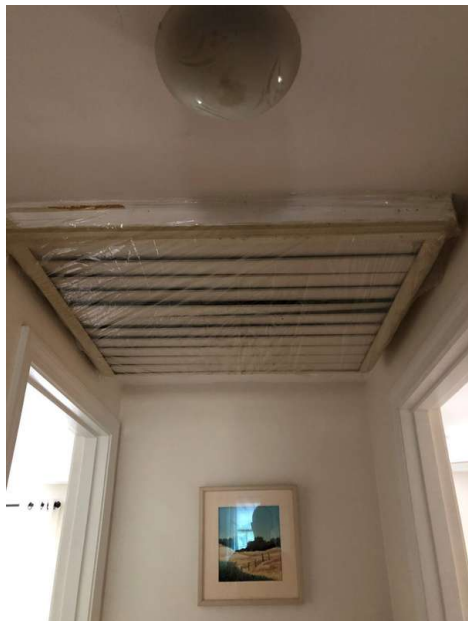
Fan was unable to be tested as it is currently wrapped in plastic. Recommend inquiring with the seller as to its current operational status.

Wrapped in Plastic
