INSPECT ALL HOME INSPECTIONS REPORT

1234 Main St.
LANSDALE PA 19446

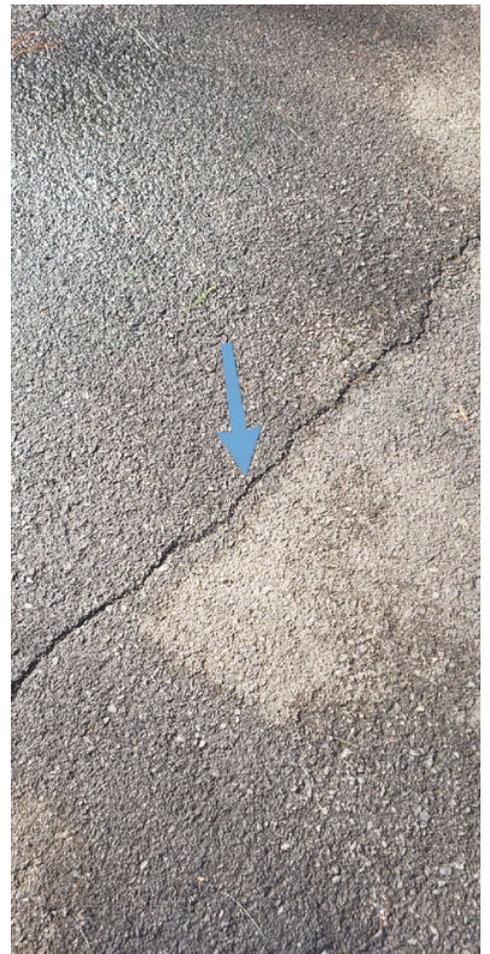
DRIVEWAY CRACKS MINOR

Cracks observed at the driveway. Seal and monitor to prevent further damage.

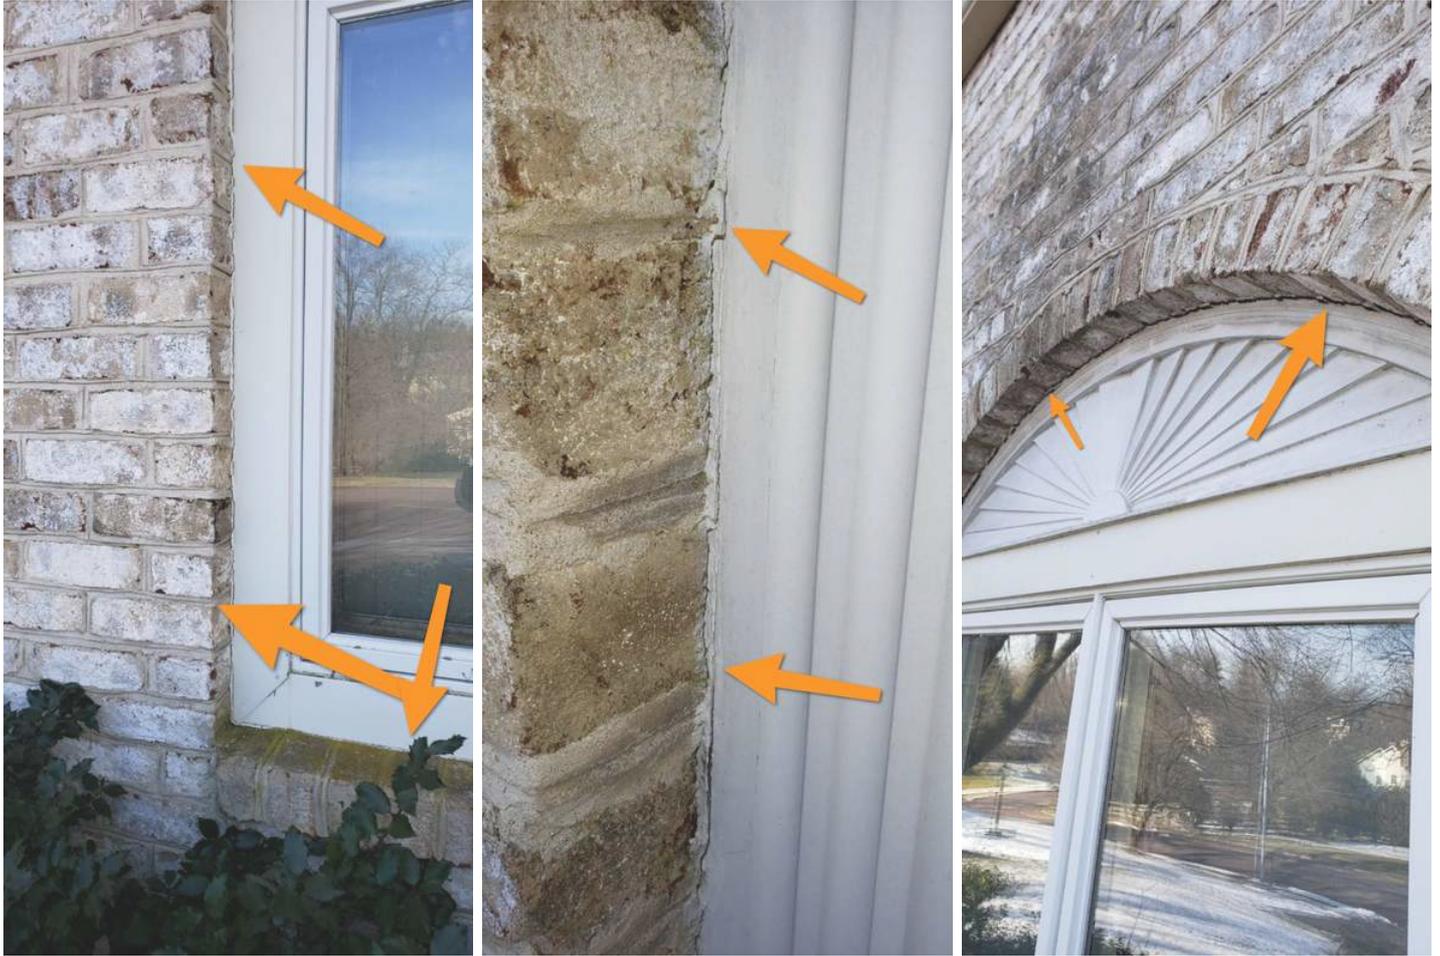
2.4.1 Siding, Flashing & Trim

CAULKING NEEDED

Caulking is needed to create a weather seal and prevent moisture intrusion. Caulk should be applied to all window and door openings on the exterior to prevent water intrusion.

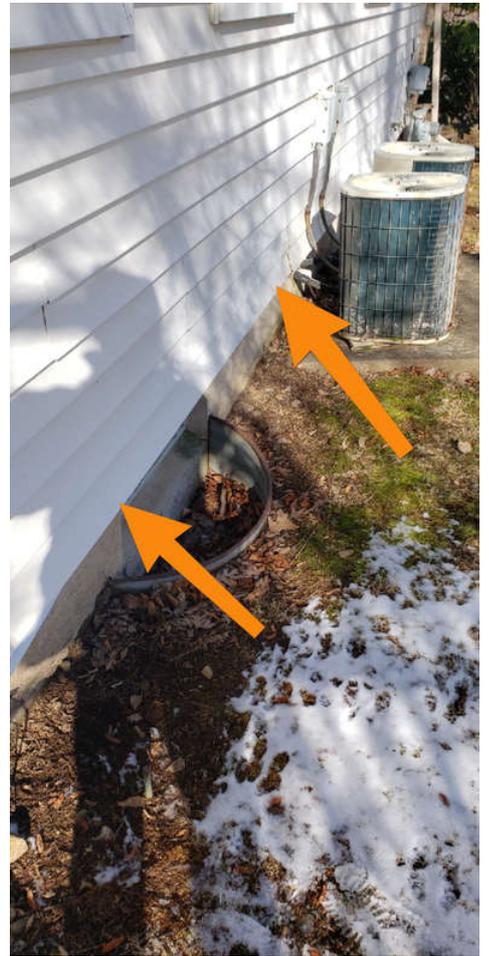
2.4.2 Siding, Flashing & Trim

VINYL SIDING LOOSE

One or more areas of siding were loose. Recommend qualified contractor evaluate and repair as necessary.

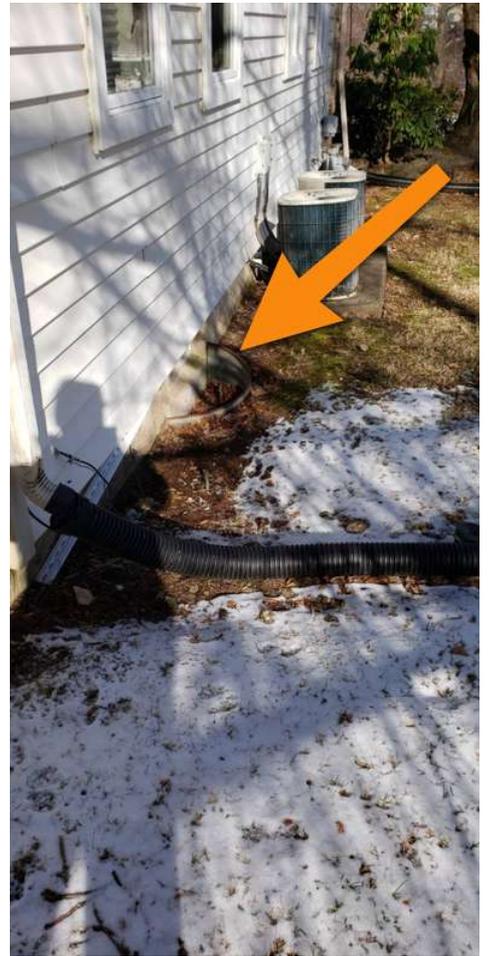
2.7.1 Window Exteriors

There are no basement window well covers. Window well covers prevent leaves which bring wood destroying organisms. Also prevents water and snow buildup that may leak into the window or foundation. Recommend qualified contractor evaluate and install .

Contact a qualified professional.

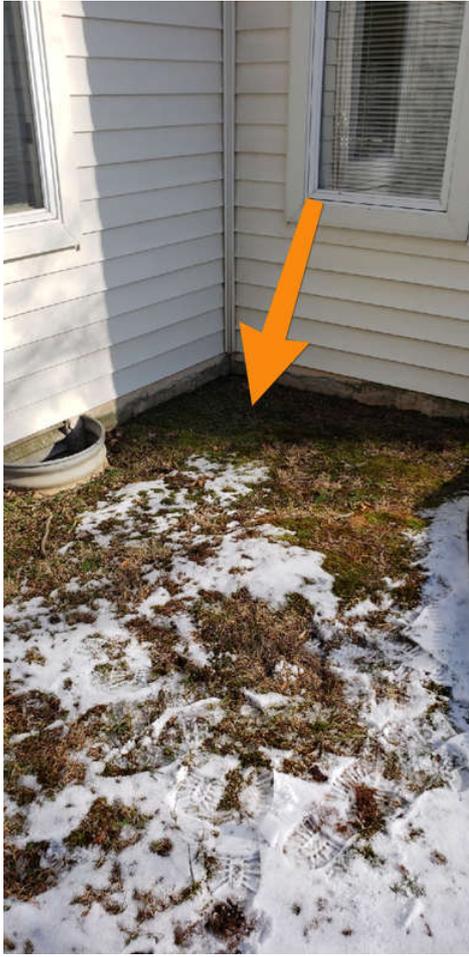
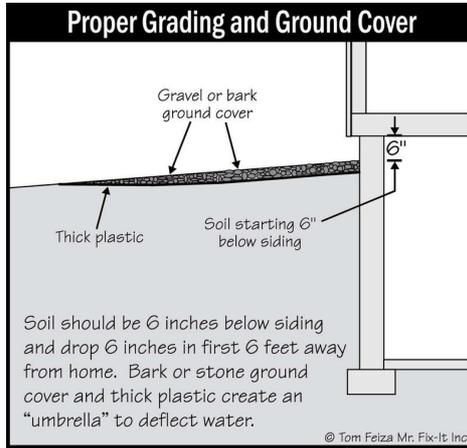
2.9.1 Vegetation, Grading, Drainage & Retaining Walls

NEGATIVE GRADING

Grading is sloping towards the home in some areas. This could lead to water intrusion and foundation issues. [Regrade so water flows away from home.](#)

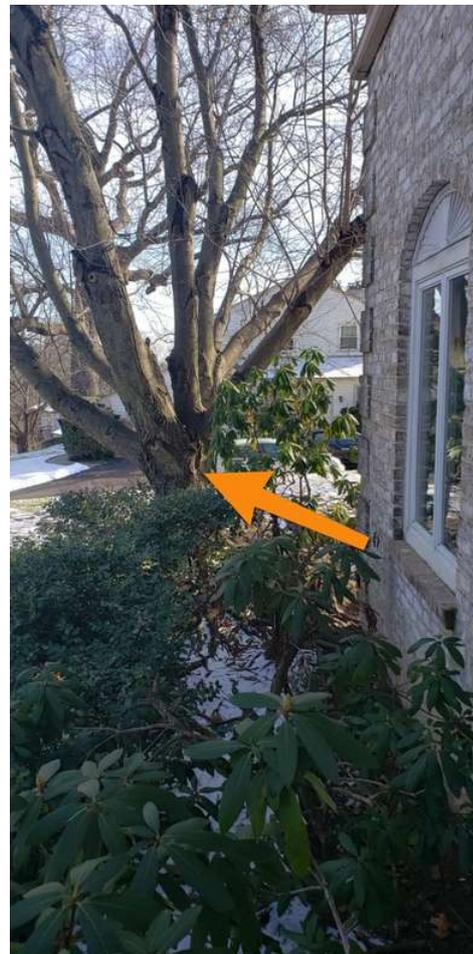
2.9.2 Vegetation, Grading, Drainage & Retaining Walls

Trees were in contact with or were close to the building at one or more locations. Damage to the building can occur, especially during high winds, or may have already occurred (see other comments in this report). Roots can damage the foundation. Recommend that a qualified tree service contractor or certified arborist remove trees as necessary to prevent damage to the building exterior.

Contact a qualified professional.

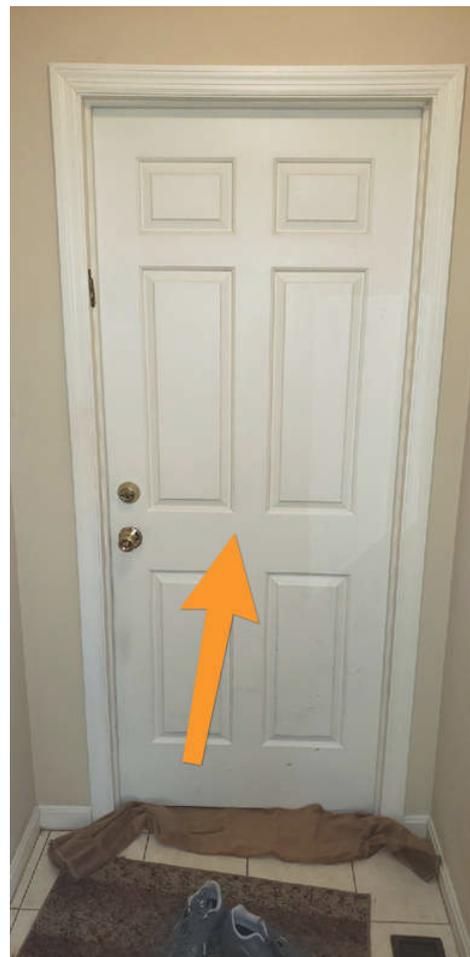
Doors in firewalls must be at least 1 3/8-inch thick, metal/steel, or a 20-minute fire-rated door.

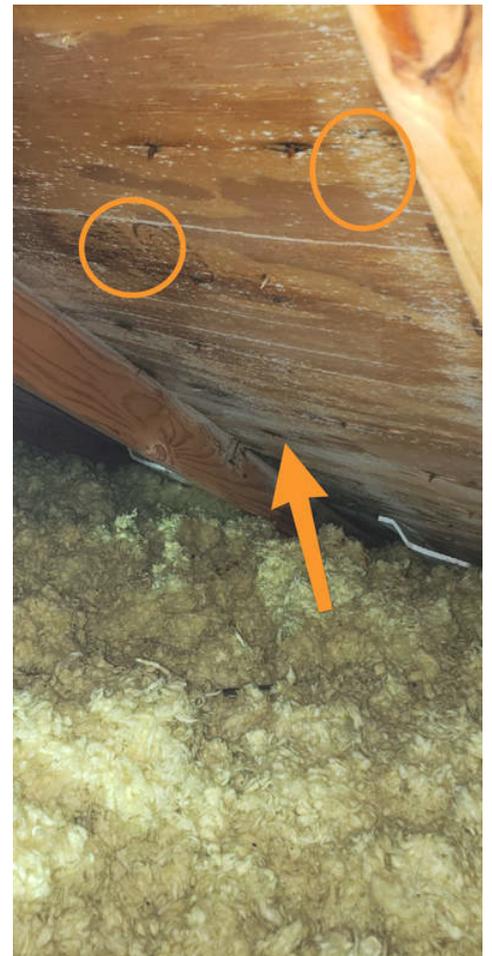
Attic showed areas of discoloration and possible mold growth. Recommend qualified contractor evaluate. An attic exhaust fan may be an option.

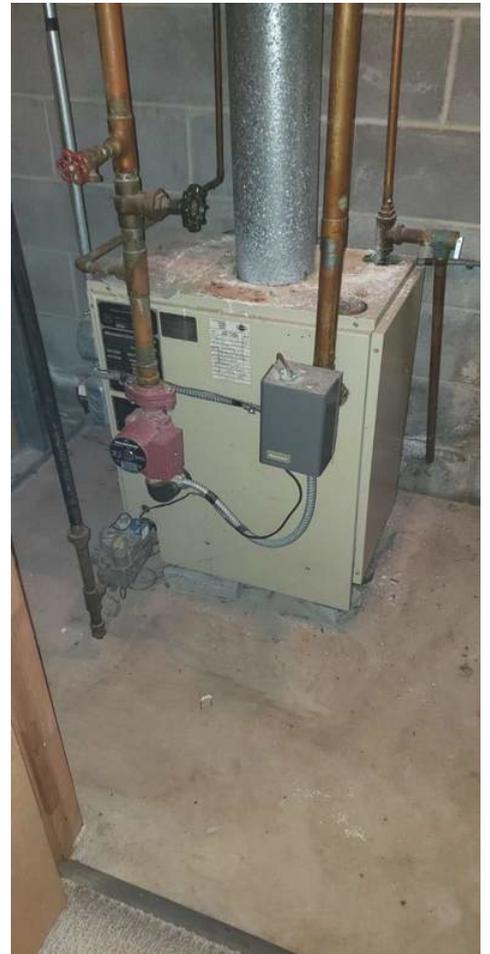
The estimated useful life of most steel boilers is 20 years. This boiler appears to be at this age and may need replacing or significant repairs at any time. Recommend budgeting for replacement in the near future.

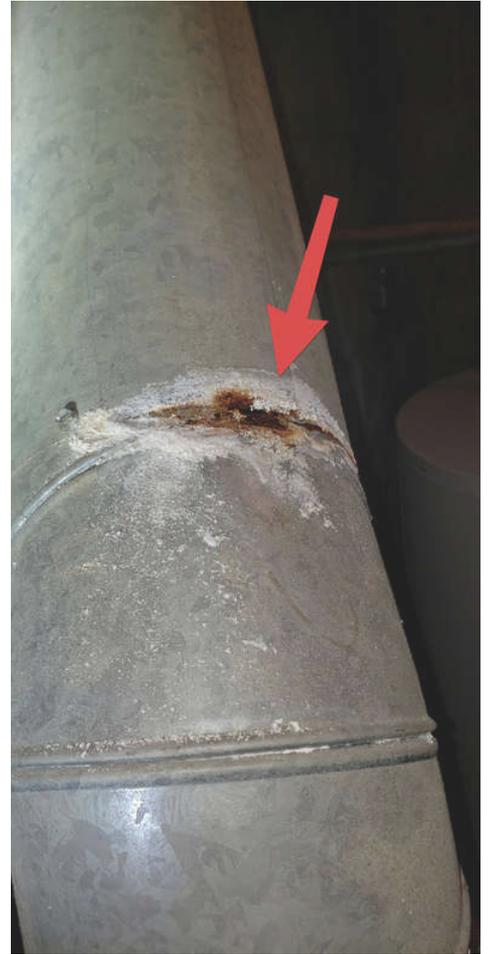
7.3.1 Vents, Flues & Chimneys

FLUE VENT DETERIORATING

The flue for the boiler is rusting and may lead to carbon monoxide escaping into the home. Recommend qualified contractor evaluate and repair as necessary

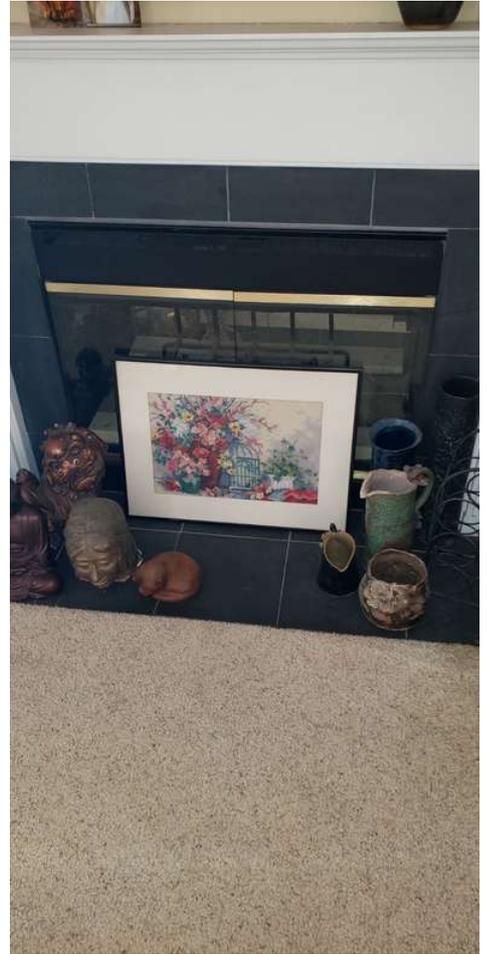
7.5.1 Wood-Burning Fireplace, Insert, or Stove

NFPA RECOMMENDATION

The wood-burning fireplace should be inspected and cleaned prior to burning solid fuel initially and annually. The National Fire Protection Association (NFPA) recommends that chimneys burning solid fuelwood, coal, or pellets be inspected yearly and cleaned as often as needed. Such upkeep helps to ensure structural integrity, identify defects that might allow deadly combustion gases to vent into living spaces, and prevent chimney fires caused by the buildup of creosote, a natural byproduct of burning wood.

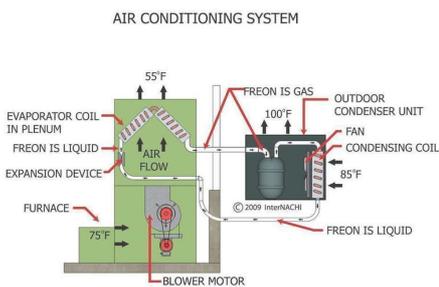
Split A/C System

The air conditioning system was a split system in which the cabinet housing the compressor, cooling fan and condensing coils was located physically apart from the evaporator coils. As is typical with split systems, the compressor/condenser cabinet was located at the home's exterior so that the heat collected inside the home could be released to the outside air. Evaporator coils designed to collect heat from the home interior were located inside a duct at the furnace and were not directly visible.

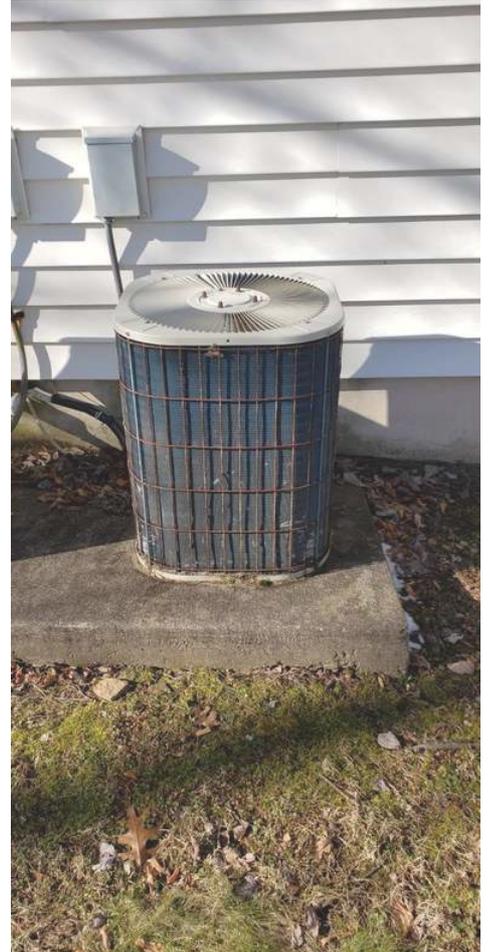
The estimated useful life for most heat pumps and air conditioning condensing units is 10-15 years. This unit appeared to be near this age and/or its useful lifespan and may need replacing or significant repairs at any time. Recommend budgeting for a replacement in the near future.

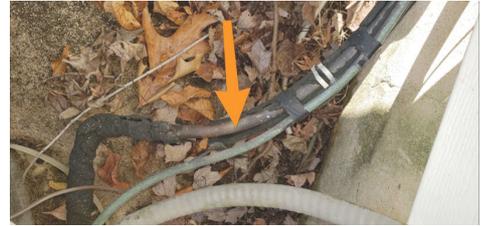
INSULATION MISSING OR DAMAGED

Refrigerant line insulation is missing and/or damaged. Missing or damaged insulation on refrigerant lines can cause energy loss and condensation.

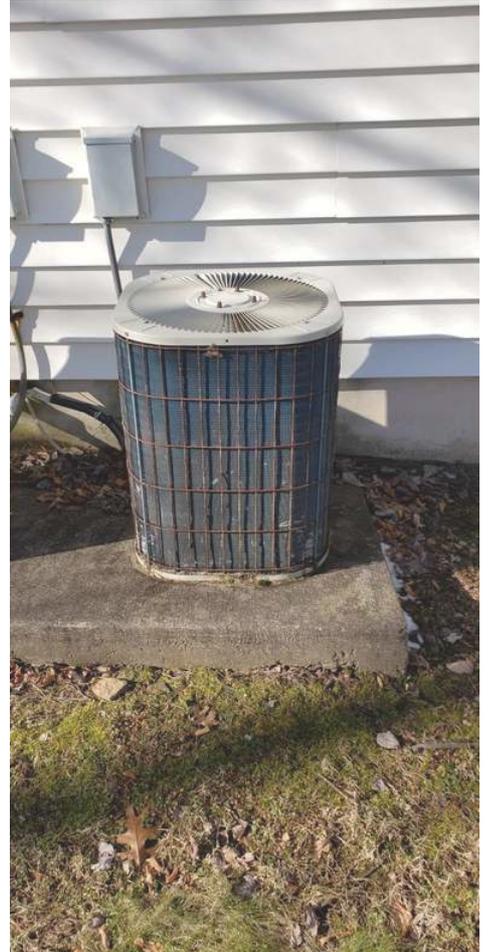
8.2.2 Outdoor Equipment 2

LIFESPAN 10-15 YEARS

The estimated useful life for most heat pumps and air conditioning condensing units is 10-15 years. This unit appeared to be near this age and/or its useful lifespan and may need replacing or significant repairs at any time. Recommend budgeting for a replacement in the near future.

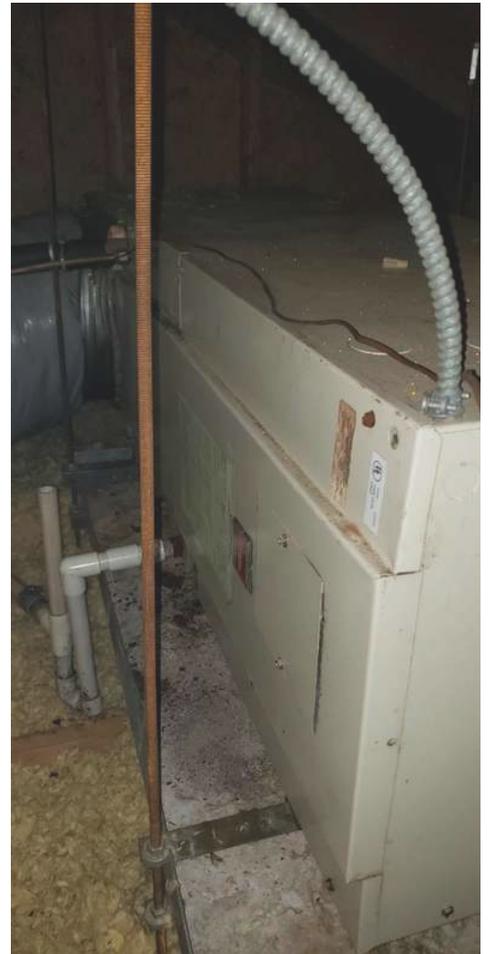
Air handler for air conditioner is dirty and should be cleaned and serviced by a licensed HVAC professional. [Here is a resource](#) on the importance of furnace maintenance.

The estimated useful life for most forced air Handlers is 15-20 years. This air handler appeared to be near, at or beyond this age and/or its useful lifespan and may need replacing or significant repairs at any time. Recommend budgeting for a replacement in the near future.

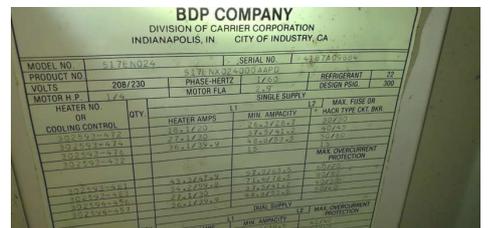
8.4.1 Indoor HVAC Equipment 2

Air Handler for air conditioner is dirty and should be cleaned and serviced by a licensed HVAC professional. [Here is a resource](#) on the importance of furnace maintenance.

The estimated useful life for most forced air Handlers is 15-20 years. This Air handler appeared to be near, at or beyond this age and/or its useful lifespan and may need replacing or significant repairs at any time. Recommend budgeting for a replacement in the near future.

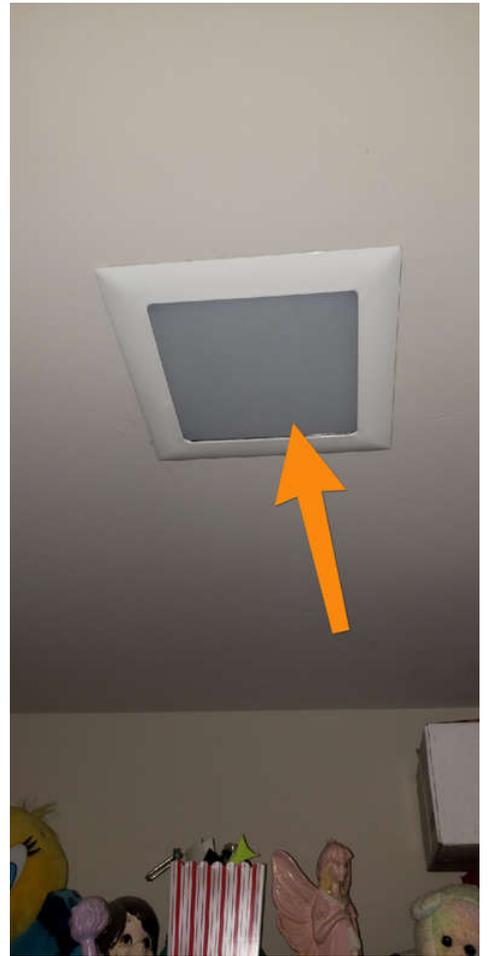
Light fixture did not respond to the switch. The bulb may need to be replaced or there may be a problem with the switch, wiring or light fixture.

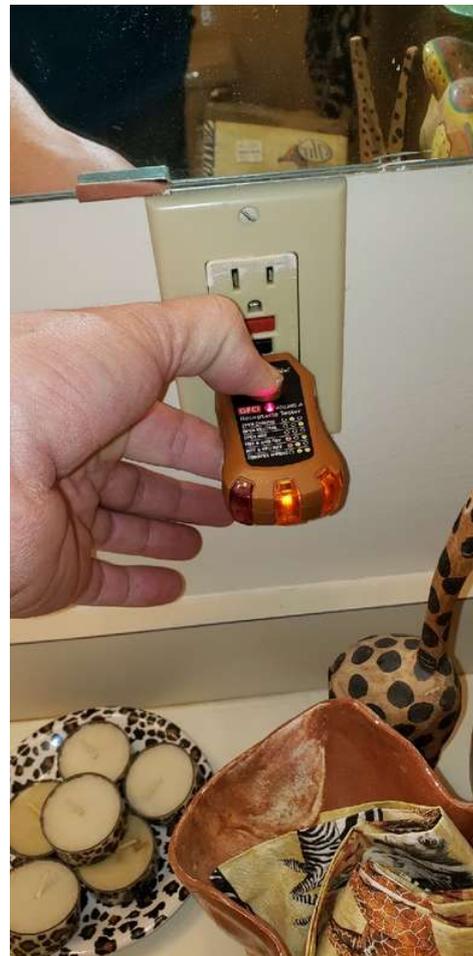
9.5.1 GFCI & AFCI

GFCI FAILURE

A ground fault circuit interrupter (GFCI) electrical receptacle did not respond to testing, did not re-set, was slow to re-set or made a buzzing sound when re-set. The Inspector recommends replacement of the receptacle to ensure that it works correctly when required. All work should be performed by a licensed electrician.

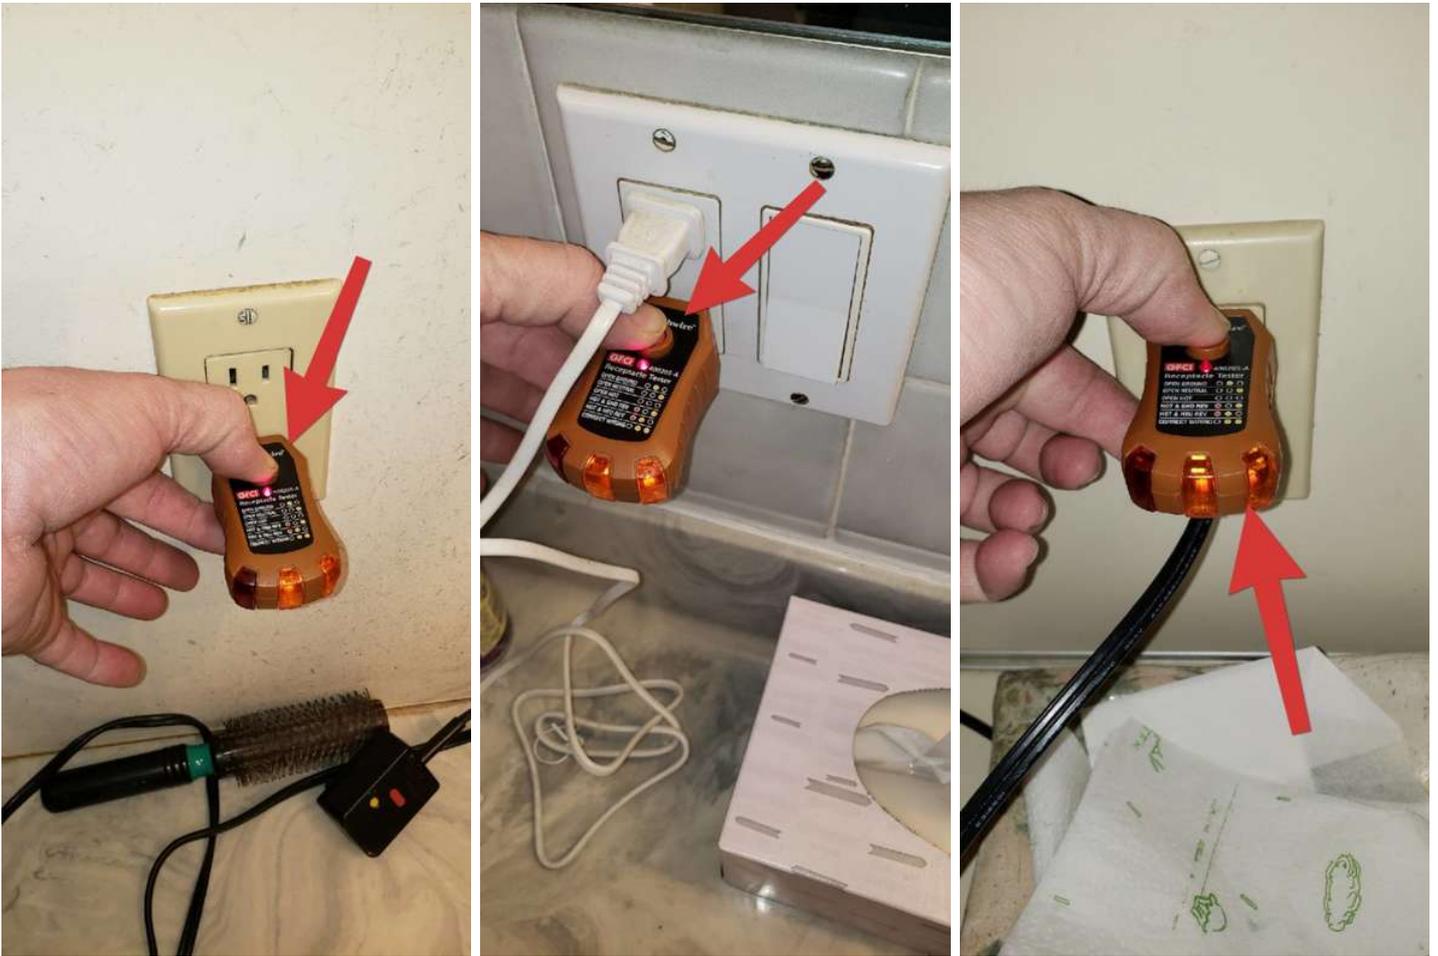
9.5.2 GFCI & AFCI

GFI BREAKER MALFUNCTION

GFI Breaker for bathrooms was inoperable. The breaker did not trip when outlets were tested with device. Recommend qualified contractor evaluate and repair as necessary.

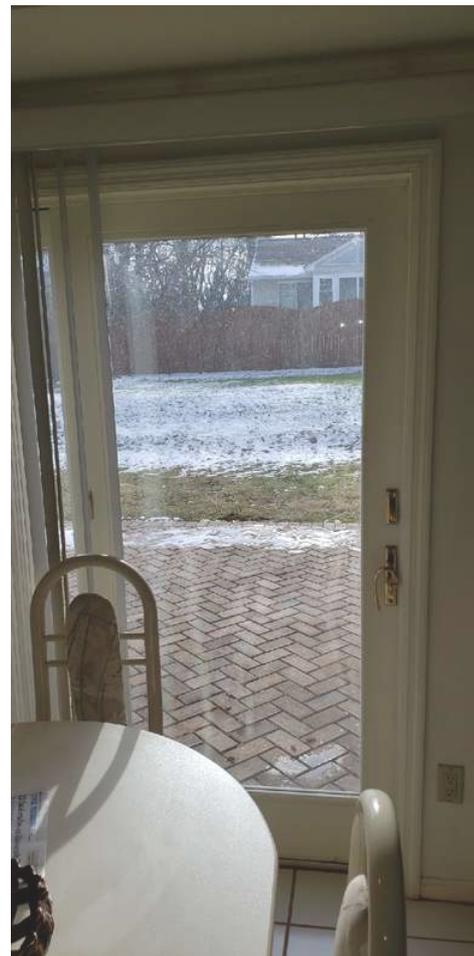
SLIDING GLASS DOOR- DIFFICULT TO OPERATE, TRACK DAMAGE

At the time of the inspection, the sliding glass door would not open in the dining room. The Inspector recommends service by a qualified contractor.

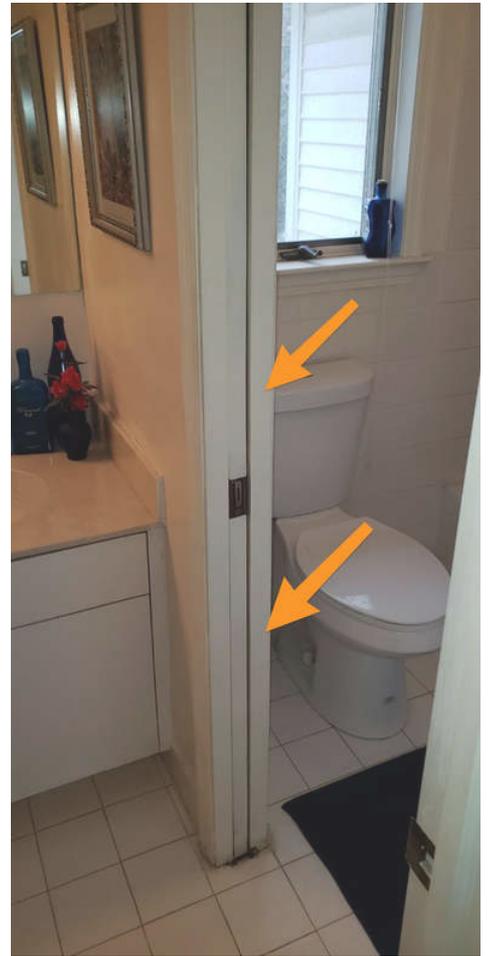
10.2.2 Doors

BATHROOM SLIDER INOPERABLE

The pocket door in the 2nd floor bathroom was not operating at the time of the inspection. Recommend qualified contractor evaluate and repair as necessary.

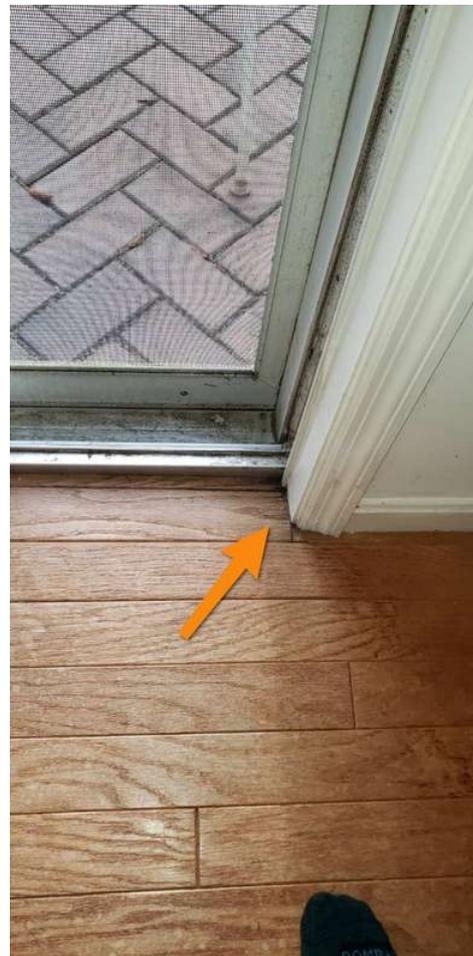
10.2.3 Doors

PRIOR WATER DAMAGE

An exterior door showed signs of water damage at the floor.
Recommend qualified contractor evaluate and repair as necessary.

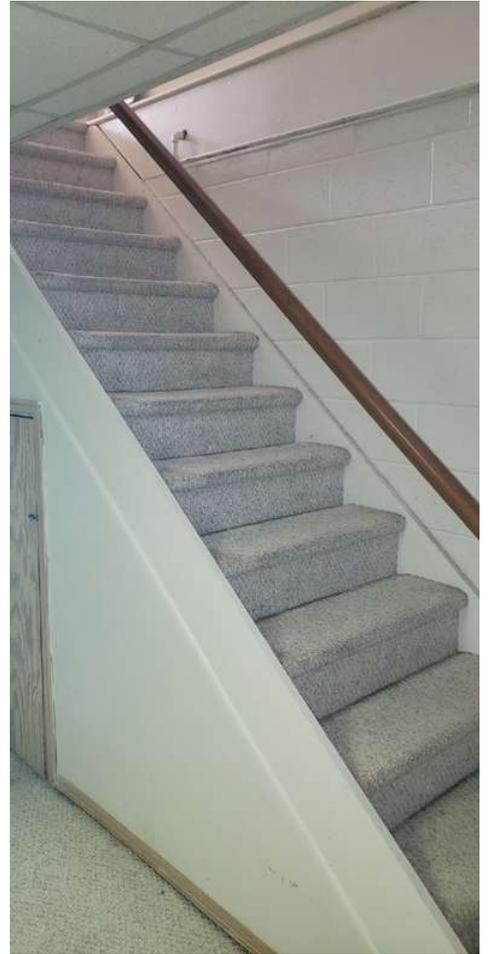
Guardrails at one or more locations with drop-offs higher than 30 inches were missing. This poses a fall hazard. Guardrails should be installed where walking surfaces are more than 30 inches above the surrounding grade or surfaces below. Recommend that a qualified contractor install guardrails where missing and per standard building practices.

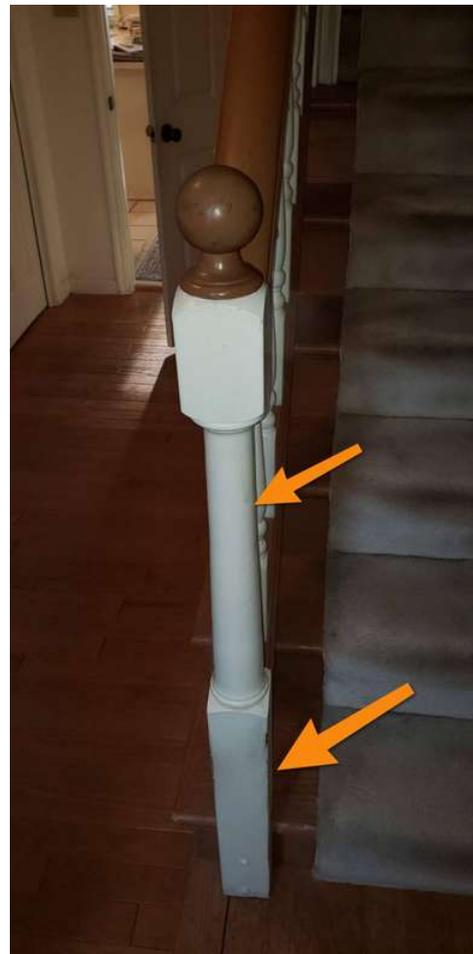
10.6.2 Steps, Stairways & Railings

LOOSE HANDRAIL

The handrails at one or more locations was loose. This is a safety hazard. Recommend qualified contractor evaluate and repair as necessary. The newel post is loose.

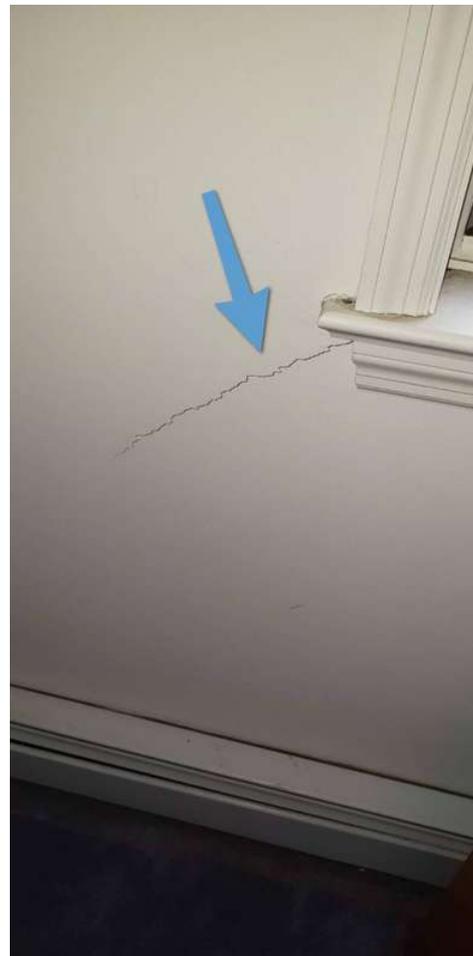
10.7.1 Walls

MINOR CRACKS

Minor cracks observed. Monitor.

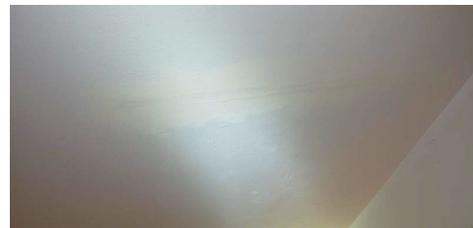
10.7.2 Walls

MOISTURE DAMAGE- PAST LEAKS

Stains on the walls were visible at the time of the inspection and appeared to be the result of moisture intrusion. The moisture meter showed no elevated moisture levels in the affected areas at the time of the inspection. The source of moisture may have been corrected, or leakage may be intermittent. You should ask the owner about this condition, and consult with qualified contractors to discuss options and costs for re-painting the ceiling and ensuring that the leak source has been corrected.

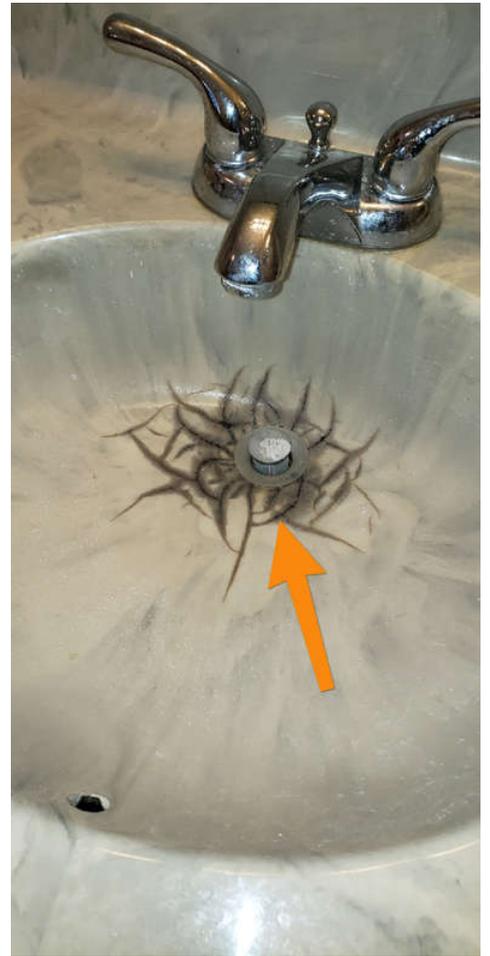
10.9.1 Countertops & Cabinets

DAMAGED SINK

One or more bathroom sinks were damaged. Recommend qualified contractor evaluate and repair as necessary.

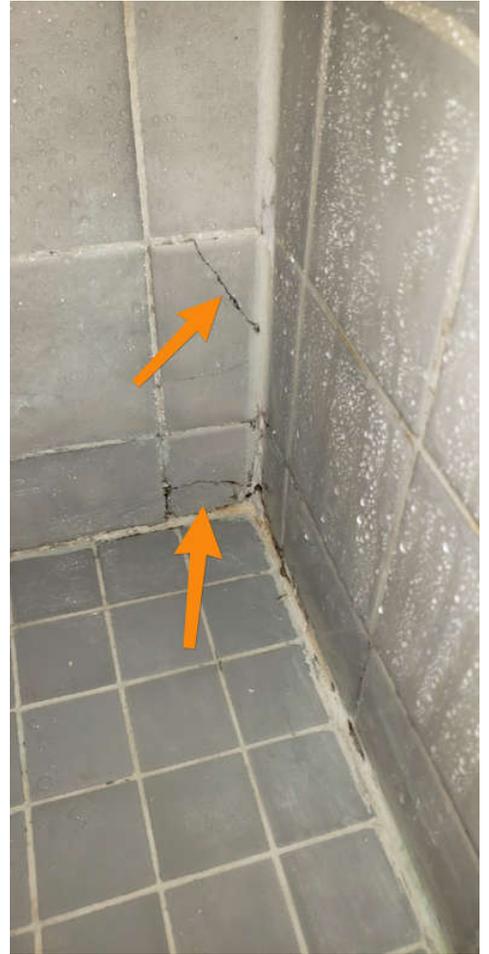
10.10.1 Tiled Areas- Kitchen, Bath & Laundry

SHOWER TILE BROKEN

Tile was found to be damaged at one or more locations in a shower or tub. This can be a leak hazard. Recommend qualified contractor evaluate and repair as necessary.

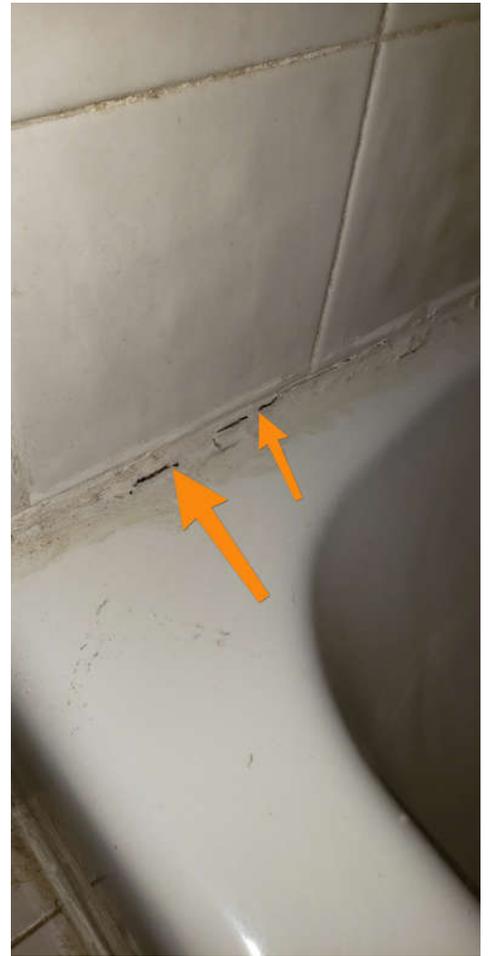
10.10.2 Tiled Areas- Kitchen, Bath & Laundry

CAULK AT TUB

Caulk in one or more tubs or shower locations is cracking or deteriorating. This can cause potential leaks. Recommend qualified contractor evaluate and repair as necessary.
