UP AND UP HOME INSPECTIONS

RESIDENTIAL REPORT

1234 Main St.
Northport AL 35475

05/03/2018 9:00AM

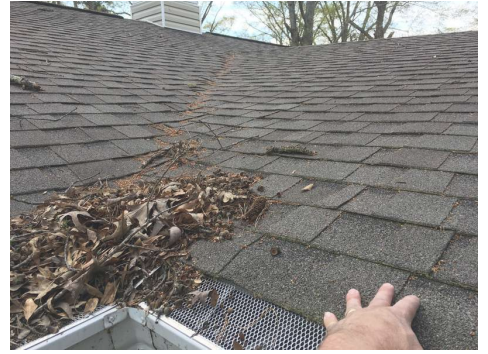
2.2.1 Roof Drainage Systems GUTTER DEBRIS

Debris has accumulated in the gutters. Recommend cleaning to facilitate water flow.

Recommendation

Contact a handyman or DIY project

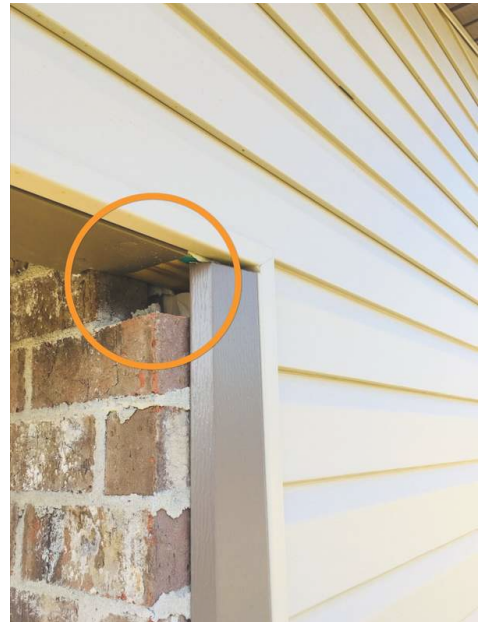
3.1.1 Siding, Flashing & Trim

BRICK MISSING

Observed that a partial brick had become dislodged and is missing. This can create a situation in which water penetration can occur. Recommend a qualified professional replace and seal.

Contact a qualified professional.

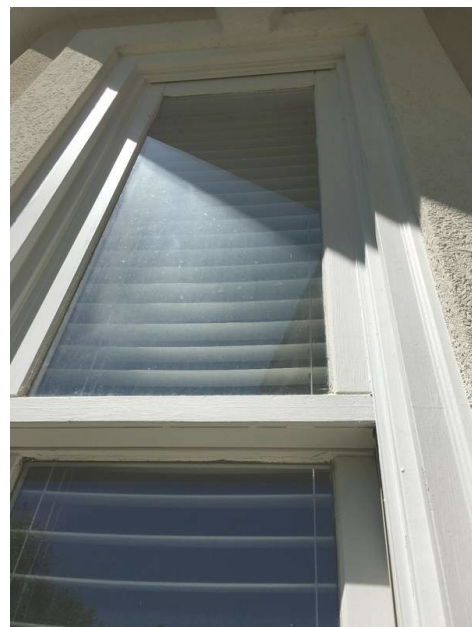
7.2.1 Windows

FAILED SEAL

One or more windows appeared to have condensation between the window panes, which indicates a failed seal. Recommend qualified window contractor evaluate & replace.

Contact a qualified window repair/installation contractor.

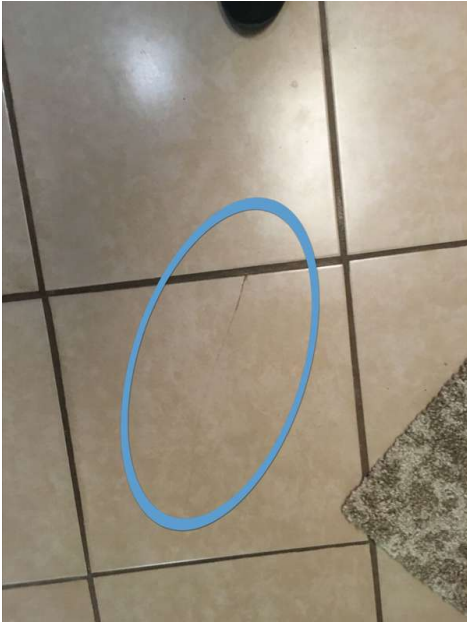
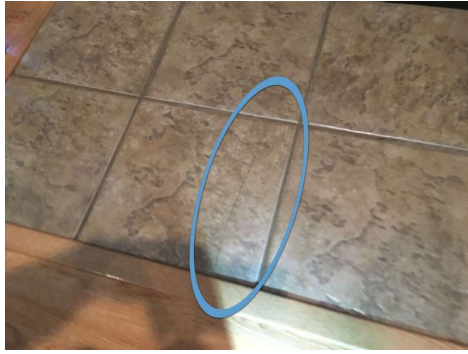
7.3.1 Floors

MINOR TILE CRACKS

A few areas had tile cracks. Recommend monitoring for further damage.

Recommend monitoring.

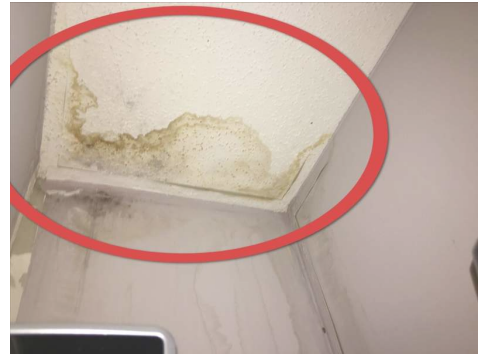
7.5.1 Ceilings

RECENT ROOF LEAK DAMAGE

Stains on the ceiling appear to be the result of roof leaks or a leaking water pipe. The source of leakage should be identified and corrected, and the ceiling repaired and re-painted. This should be handled by a qualified professional.

Contact a qualified professional.

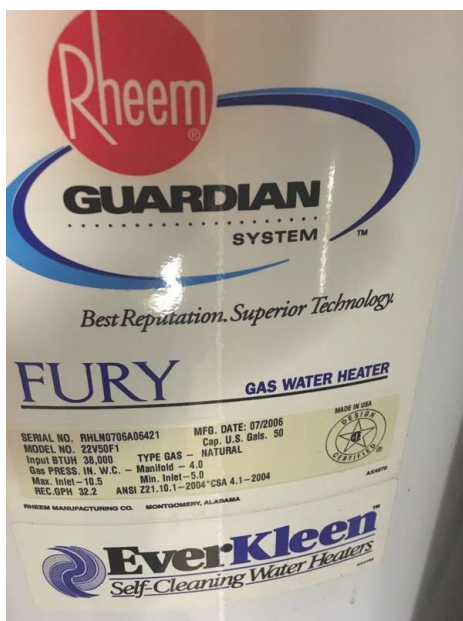
Hot Water Systems, Controls, Flues & Vents: Manufacture Date

2006

50 gallons

Gas

Rheem

I recommend flushing & servicing your water heater tank annually for optimal performance. Water temperature should be set to at least 120 degrees F to kill microbes and no higher than 130 degrees F to prevent scalding.

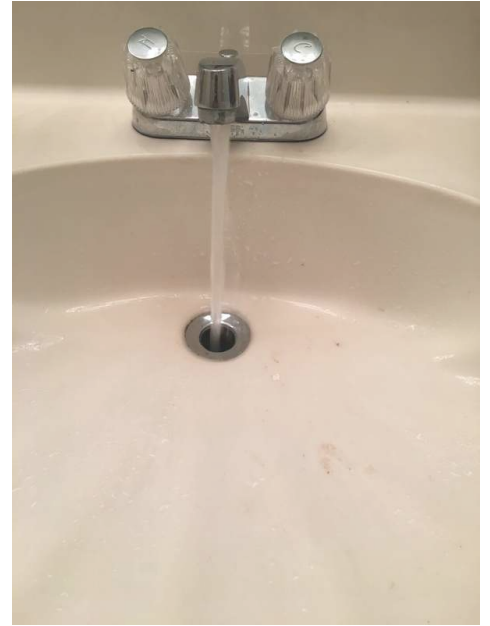
9.3.1 Water Supply, Distribution Systems & Fixtures

DRAIN SEAL MECHANISM NOT PRESENT

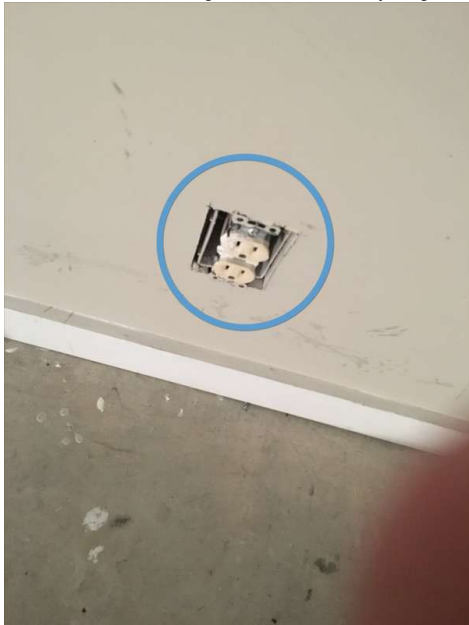
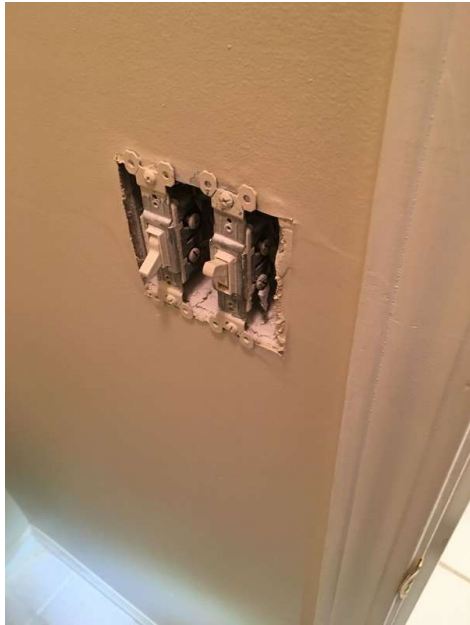
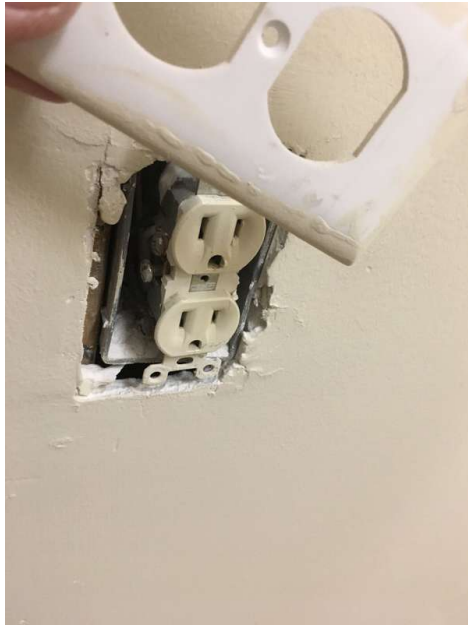
10.4.1 Lighting Fixtures, Switches & Receptacles

COVER PLATES MISSING

One or more receptacles are missing a cover plate. This causes short and shock risk. Recommend installation of plates.

Contact a handyman or DIY project

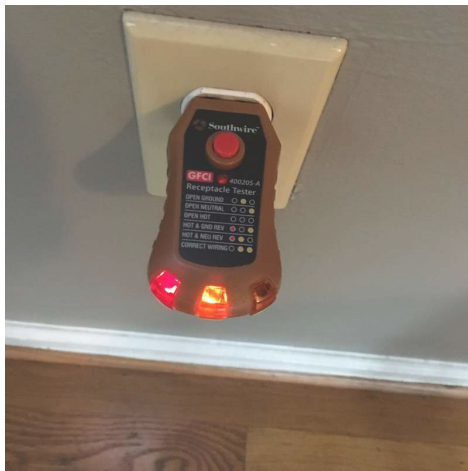
10.4.2 Lighting Fixtures, Switches & Receptacles

REVERSE POLARITY

One or more receptacles have been wired with reverse polarity. This can create a shock hazard. Recommend licensed electrician evaluate & repair.

Contact a qualified professional.

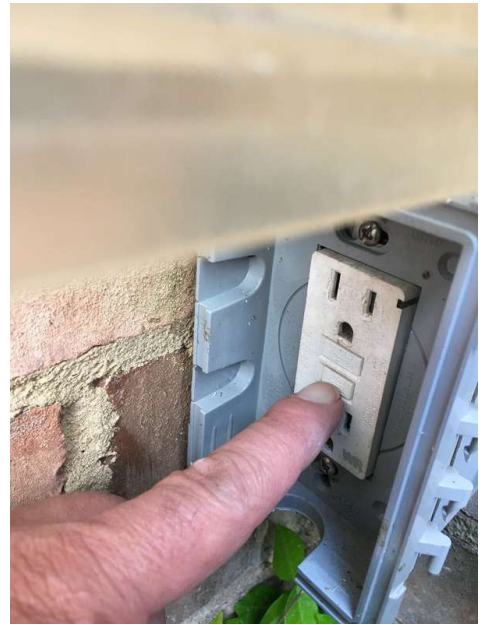
10.5.1 GFCI Protection

GFCI PLUG DID NOT HAVE ELECTRICITY

GFCI Plug by front door did not have power so a test could not be conducted. Recommend that the plug be checked by a qualified professional and replaced.

Contact a qualified professional.

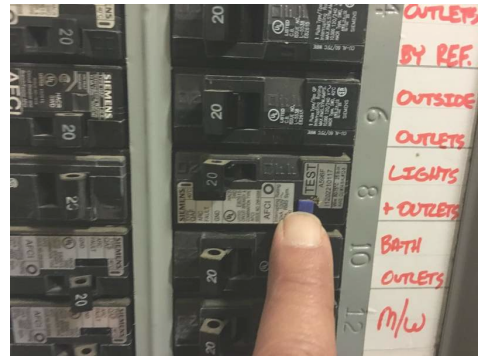
10.7.1 AFCI Protection

AFCI BREAKER DID NOT TEST PROPERLY

Recommend Replacement

Contact a qualified professional.

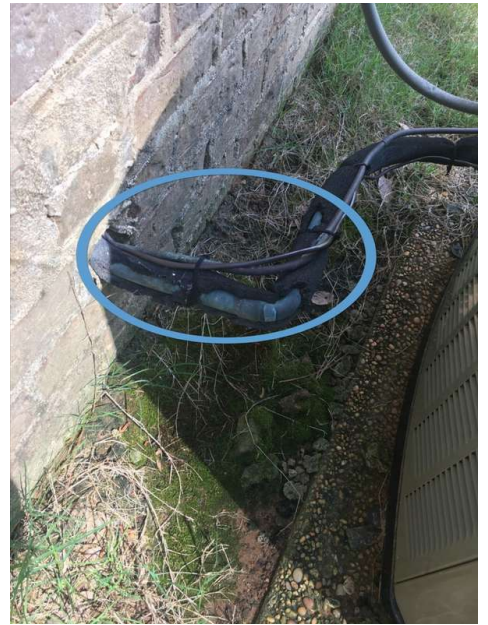
11.2.1 Equipment

INSULATION OF GAS LINE NEEDS TO BE REPAIRED

Recommend a handyman or HVAC professional repair or replace.

Contact a qualified handyman.
