VETERAN INSPECTIONS & SERVICES

1234 Main St.
Jenison Michigan 49428

SUMMARY

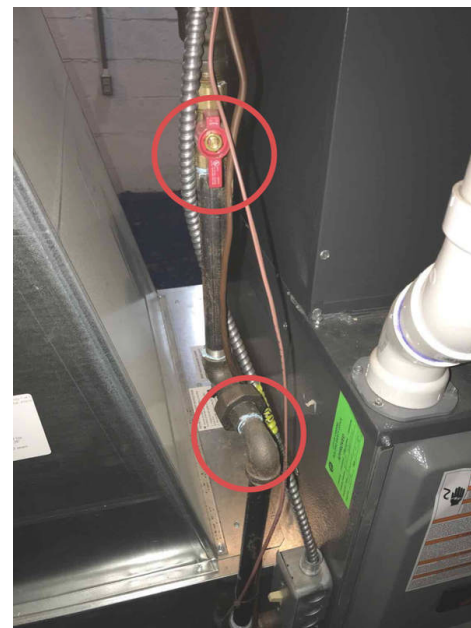
GAS LEAK DETECTED

A gas leak as was detected which is a safety hazard. Further evaluation and repair by a licensed HVAC technician is strongly recommended.

Contact a qualified HVAC professional.

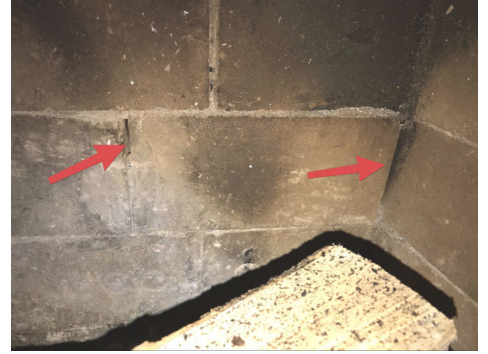
MISSING MORTAR IN FIREBOX

There is mortar missing between bricks/blocks of the chimney box. Over time, the bricks and the mortar may fail due to the expansion and contraction of the materials as they expand from room temperature to several hundred degrees Fahrenheit and back again. These gaps are dangerous because fire can potentially jump between the fire box and behind the fire bricks into the wood framed cavity wall by way of the mortar gaps. Repair by a certified chimney sweep is recommended.

Contact a qualified chimney sweep.

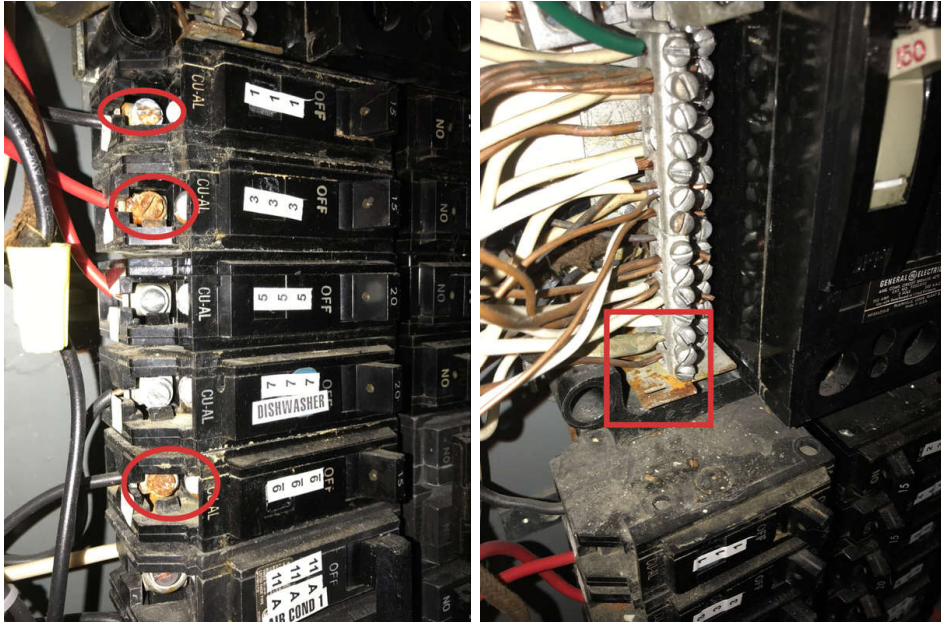
RUST PRESENT

Rust is present inside the electric panel indicating the presence of moisture. Moisture inside an electrical panel is a potential safety hazard and should be further evaluated by a licensed electrician.

Contact a qualified electrical contractor.

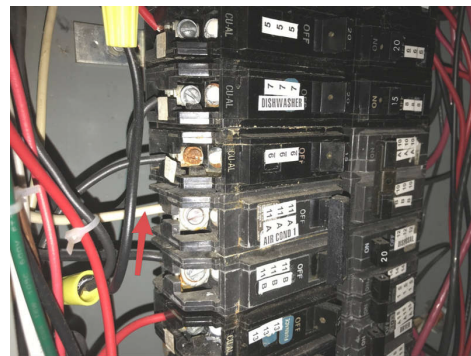
IMPROPERLY MARKED WIRE(S)

One or more neutral wires are being utilized as a "hot" wire and is connected to a breaker. This is improper and all wires being utilized as a hot wire must be marked. The standard solution is to wrap them with black electrician's tape. Due to the risk of accidentally touching the bus bar or other energized components, this should be performed by a licensed electrician.

Contact a qualified electrical contractor.

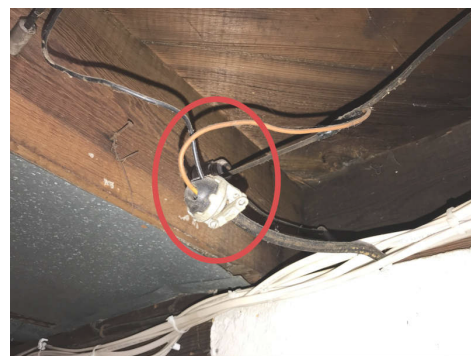
Mechanical Room

IMPROPERLY SECURED WIRE(S)

Improperly secured wiring was observed and should be secured as to prevent accidental bumping or snagging. Correction by a licensed electrician is recommended.

Contact a qualified electrical contractor.

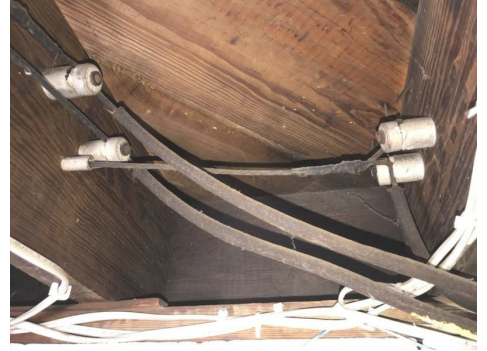
This property has knob and tube wiring which was commonly installed prior to 1950. It is ungrounded, and considered unsafe by today's standards. Over time, the wires' insulation becomes brittle and falls apart, resulting in exposed conductors and a risk of shock and/or fire. This wiring is also easily damaged by covering it with insulation (a common practice), and incorrectly tapping new wiring into it.

Some energized knob and tube wiring was found during the inspection. It is not within the scope of this inspection to determine what percentage of this property's wiring is of the knob and tube type or to determine what percentage of the knob and tube wiring is energized vs. abandoned. A qualified electrician should evaluate this wiring and make repairs or replace wiring as necessary.

Contact a qualified electrical contractor.

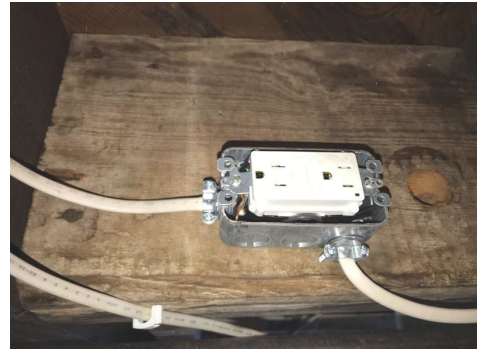
Rec Room

MISSING RECEPTACLE COVER(S) - EXPOSED WIRING

Receptacle cover is missing and exposing electrical contacts and is a safety hazard. Installing a cover plate is recommended.

Recommended DIY Project

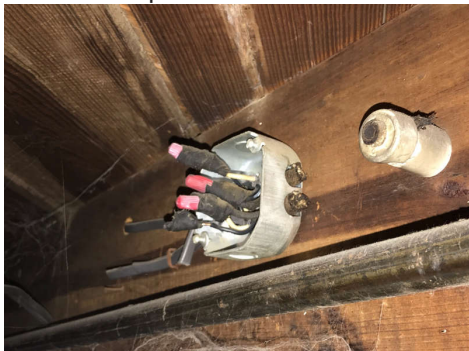
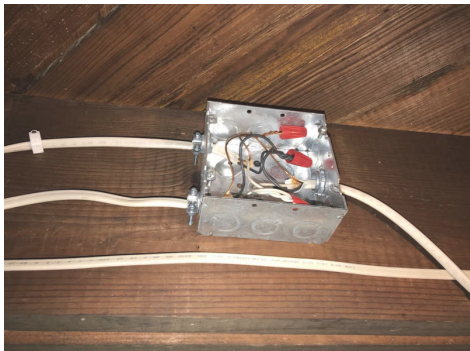
MISSING BOX COVER

A junction box cover is missing which exposes wiring inside and is a safety hazard. Correction by a licensed electrician is recommended.

Contact a qualified electrical contractor.

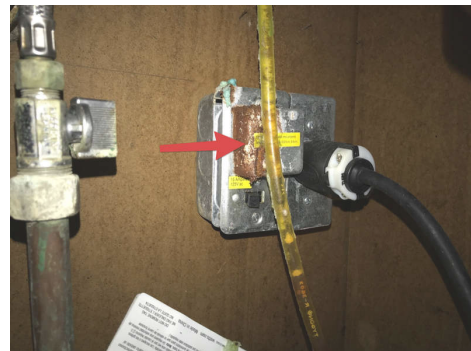
Kitchen Sink

RUST ON RECEPTACLE(S)

Rust is present on one or more receptacles indicating the presence of moisture and is a potential safety concern. Further review and replacement is recommended.

In this particular instance the rust seems to have been caused by the nearby water tube and should be relocated away from the receptacle.

Contact a qualified electrical contractor.

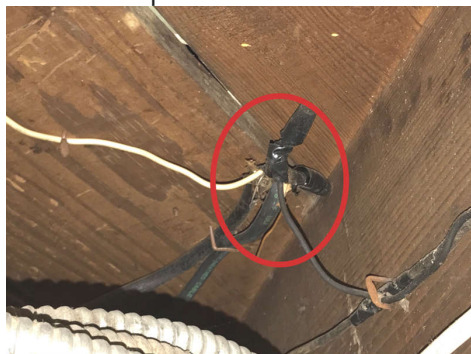
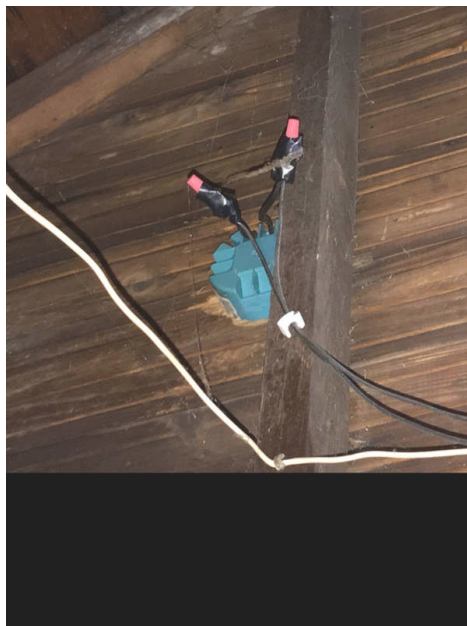
All exposed splices must be secured in a proper box with cover plate to prevent electric shock. Correction by a licensed electrical contractor is recommended.

Contact a qualified electrical contractor.

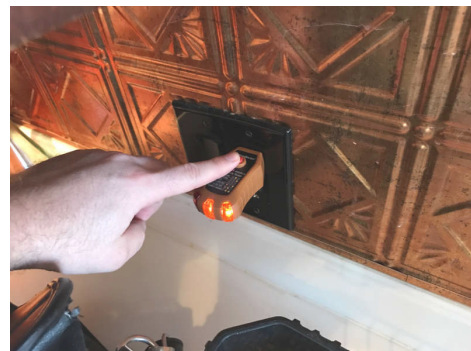
KITCHEN OUTLET(S) - NOT GFCI PROTECTED

All outlets within 6' of a water or moisture source should be GFCI protected in accordance with today's standards. Updating by a licensed electrician is recommended.

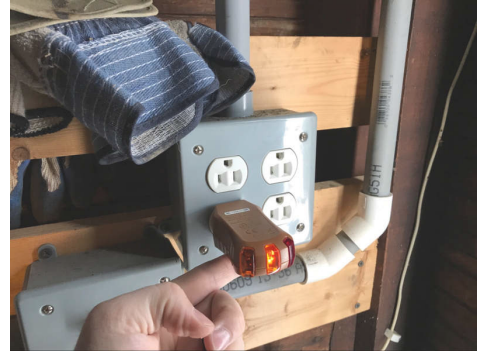
The garage outlets are not GFCI protected and are not compliant to today's standards. Upgrading is recommended by a licensed electrician.

Contact a qualified professional.

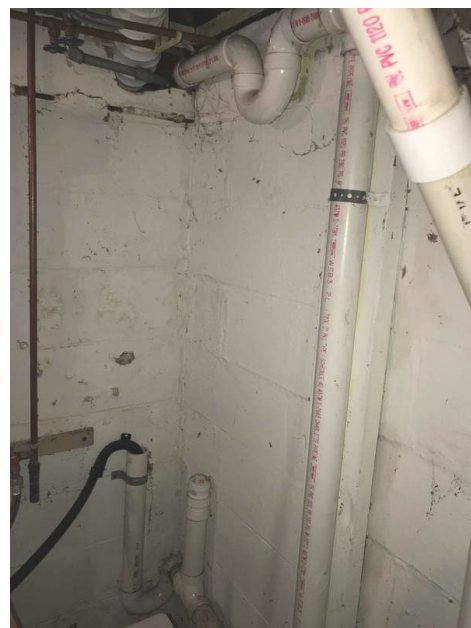
A sewer odor was detected when the washing machine was tested for functionality. Further review by a licensed plumber to confirm proper waste & drain pipe installation, and traps serving floor drains (if any) is recommended.

Contact a qualified plumbing contractor.

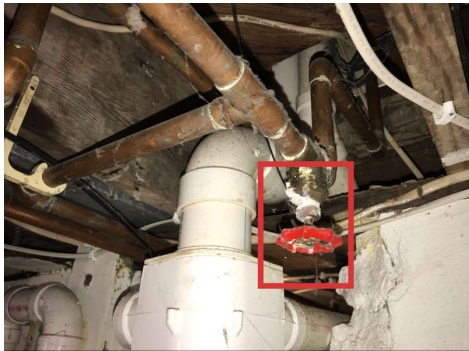
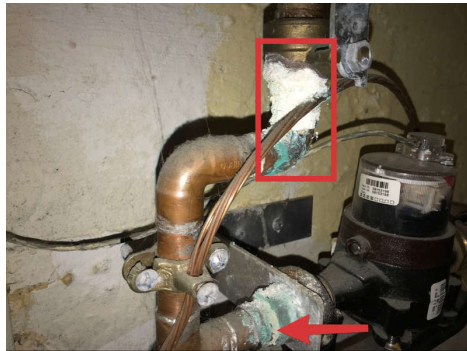
Water Meter

CORROSION ON SHUTOFF VALVE(S)

Corrosion is present on one or more shut off valves. Replacement by a licensed plumber is recommended.

Contact a qualified plumbing contractor.

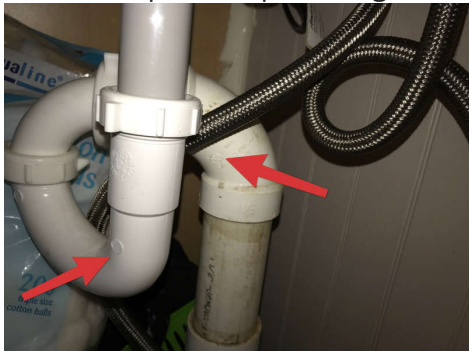
1st Floor Bathroom

IMPROPER S-TRAP INSTALLED- REPLACE WITH P-TRAP & VENT

A common plumbing defect found in many older houses is an S trap. An S trap is named so because it looks like an S on its side it basically consists of a normal trap, and then another trap installed right up against it in an upside-down fashion. "P" traps have the potential to suck, or siphon, water out of the trap as the water flows down the drain which can allow unpleasant sewer odors and sewer gas to enter the living space. Correction by a licensed plumber is recommended.

Contact a qualified plumbing contractor.

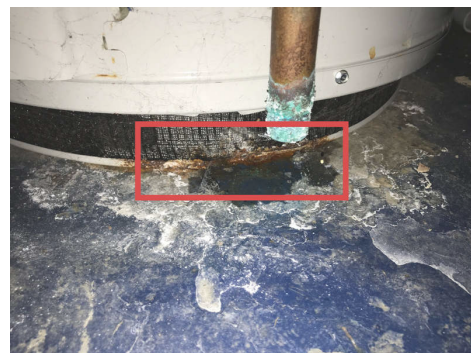
WATER HEATER LEAK

There is a leak observed at the bottom of the water heater. The cause of the leak could be from a faulty TPR valve or be originating from underneath the water heater. Further evaluation by a licensed plumber is recommended.

Contact a qualified plumbing contractor.

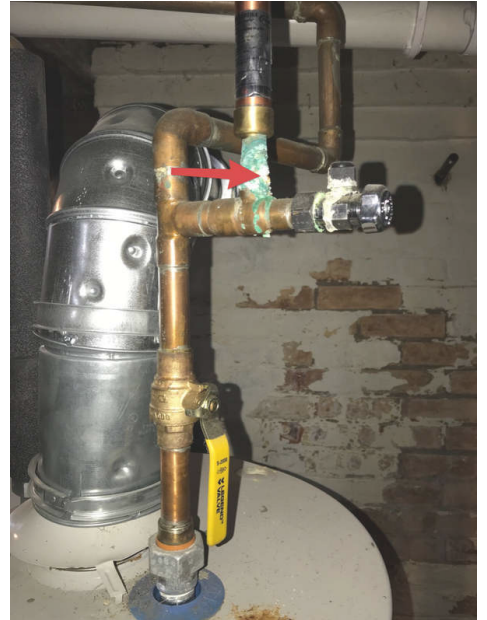
CORROSION AT COLD WATER CONNECTION

Corrosion is present at the cold water supply connection of the water heater. This is a possible result of a galvanic reaction between dissimilar metals touching, such as brass and galvanized metals, or excessive condensation causing the metal to rust. Replacement by a licensed plumber is recommended.

Contact a qualified plumbing contractor.

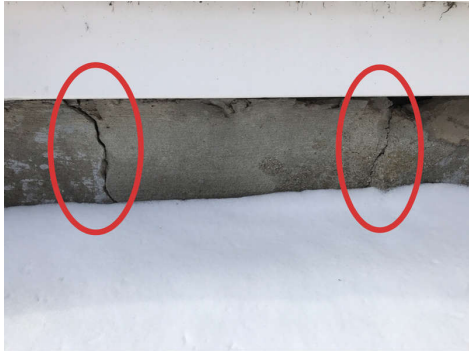
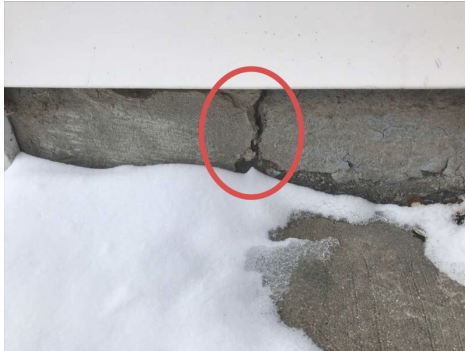
EXTERIOR SETTLING CRACKS

Recommended DIY Project

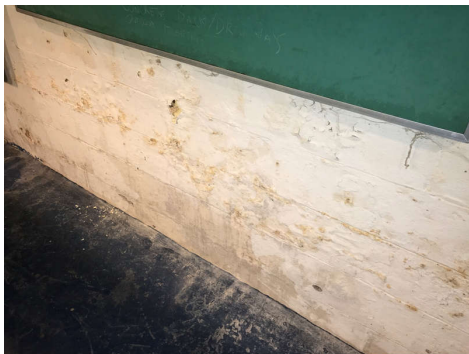
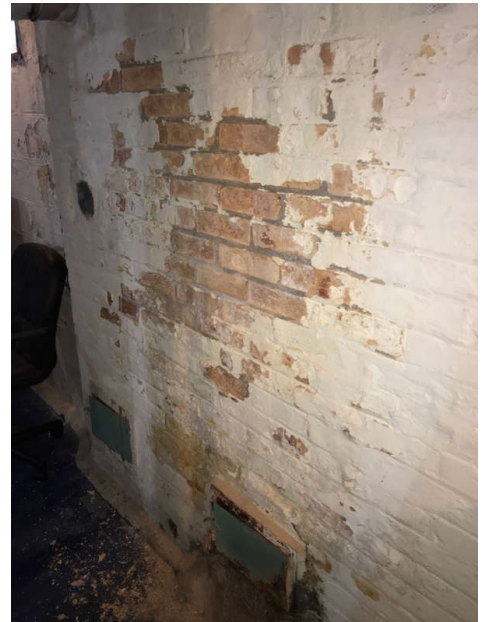
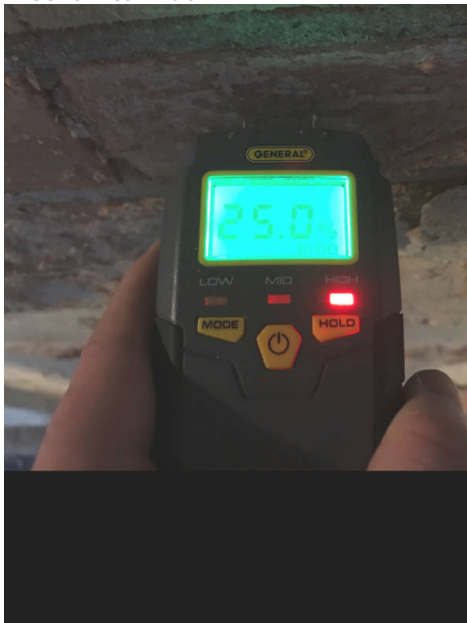
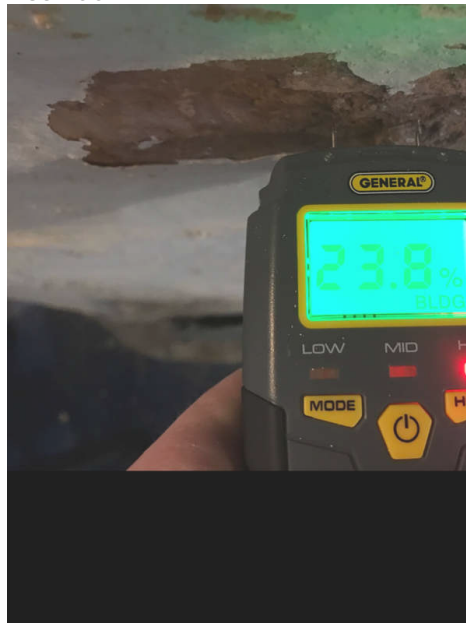
EXCESSIVE FOUNDATION WALL CRUMBLING/SPALLING

Contact a foundation contractor.

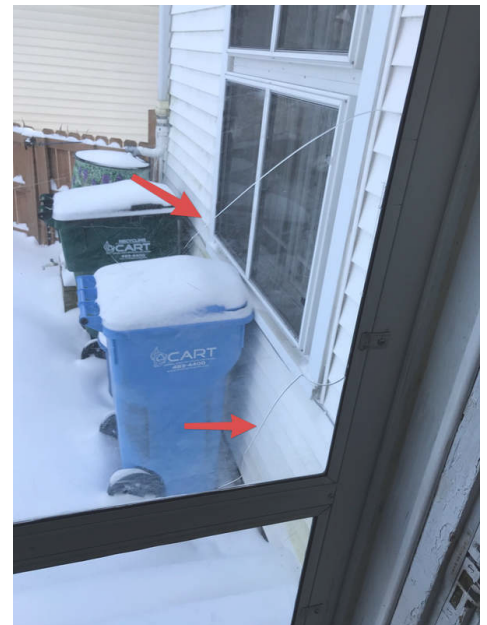
CRACKED GLASS

Cracked glass is present on one or more doors and is in need of replacement.

Contact a qualified door repair/installation contractor.

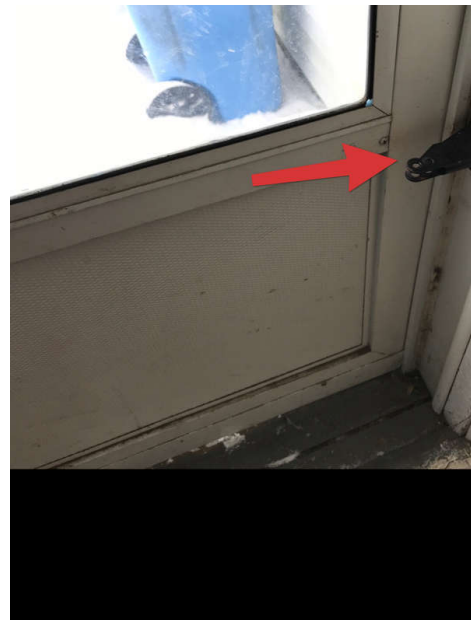
MISSING DOOR PROP

A door prop is missing and is in need of replacement.

Recommended DIY Project

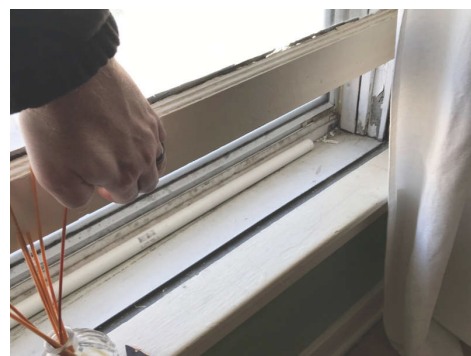
2nd Floor Master Bedroom

One or more windows do not remain open on their own and are in need of repair/replacement by a qualified professional.

Contact a qualified window repair/installation contractor.

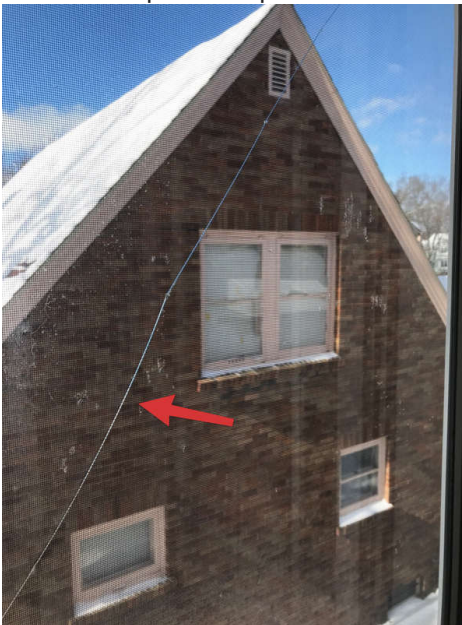
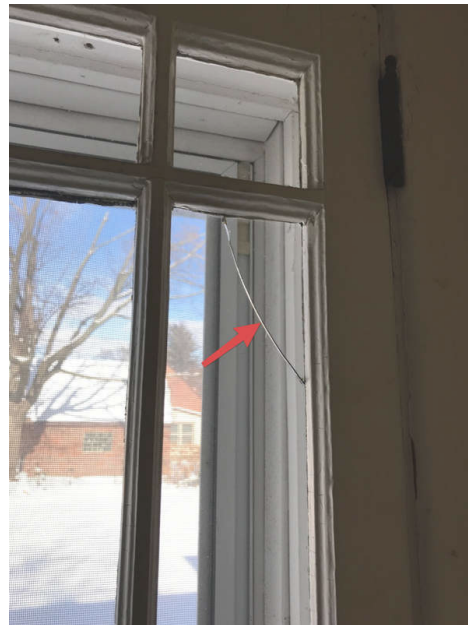
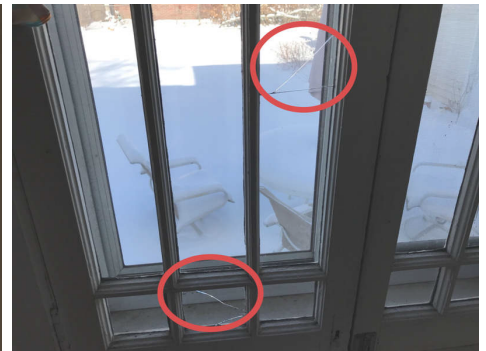
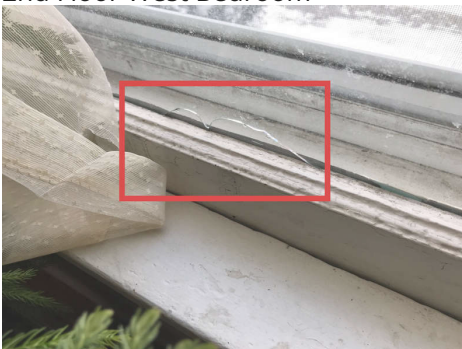
CRACKED GLASS PANE(S)

One or more glass panes is crack and in need of replacement by a licensed contractor.

Contact a qualified professional.

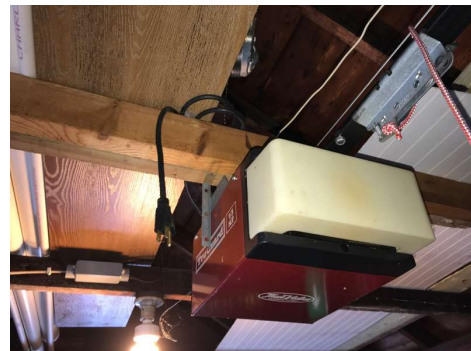
Garage Door Operators (Report whether or not doors will reverse when met with resistance)

INOPERABLE/UNPLUGGED

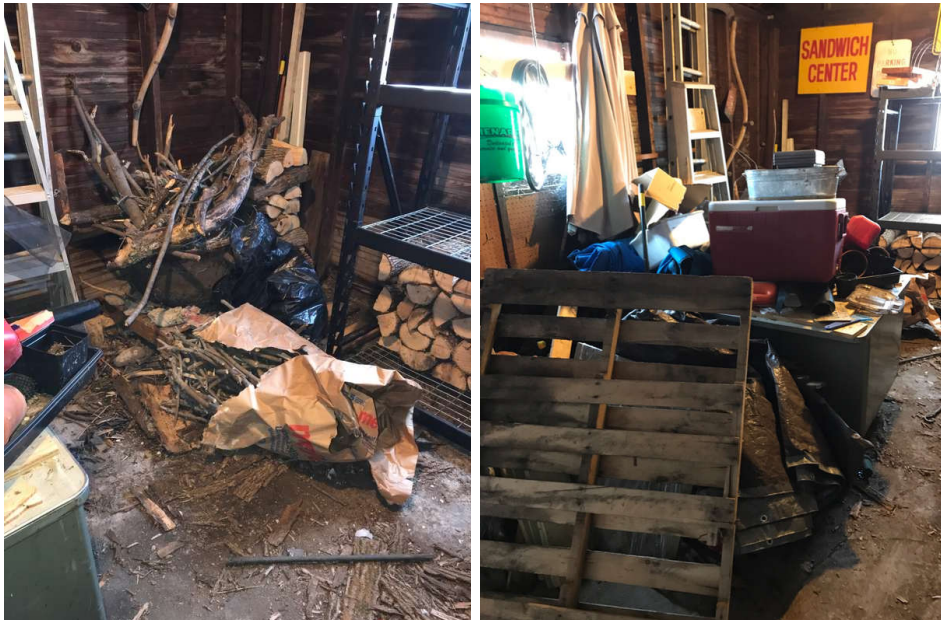
DEBRIS/PERSONAL BELONGING OBSTRUCTION(S)

The garage was full of debris and/or personal belongings. While we attempt to inspect as much area as possible we sometimes cannot inspect walls, floors, etc. that are obstructed by personal belongings or debris.

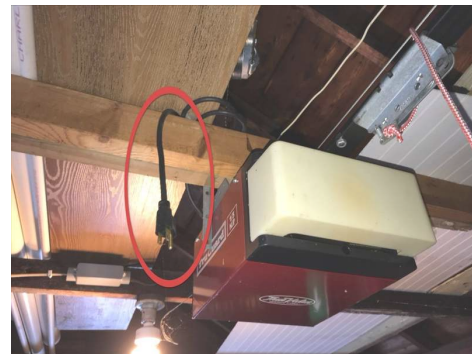
DOOR OPENER(S) NOT OPERATIONAL

The garage door openers are in place but are not operational or not plugged in and were not tested.

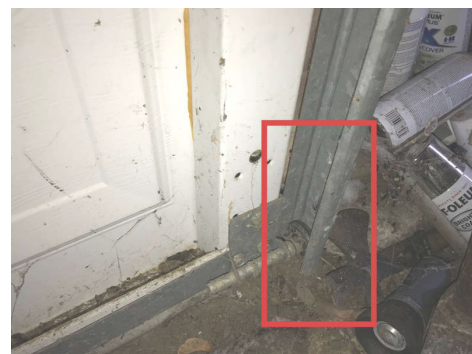
Photoelectric sensors are not installed and is a safety concern. Garage doors sensors is an important safety feature to prevent injury from the automatic garage door. Installation of photoelectric sensors to the manufacturer's instructions is recommended.

Contact a qualified professional.

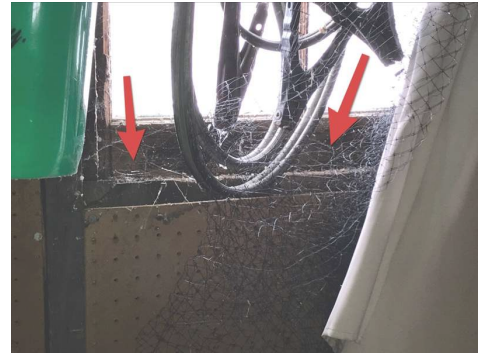
The window wood frame/trim appears to be rotting and is in need of repair/replacement by a qualified contractor.

Contact a qualified window repair/installation contractor.

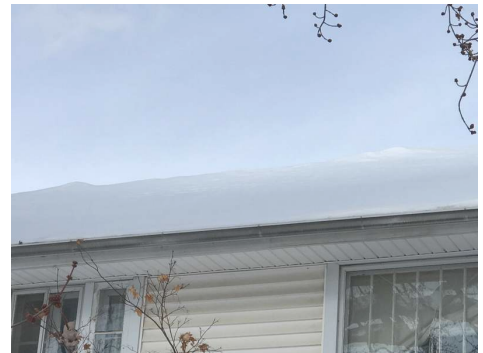
NOT INSPECTED - SNOW COVERED

Snow conditions have made the roof unwalkable. While we make every effort to inspect the roof, there are sometimes conditions outside our control that make traversing a roof unsafe.

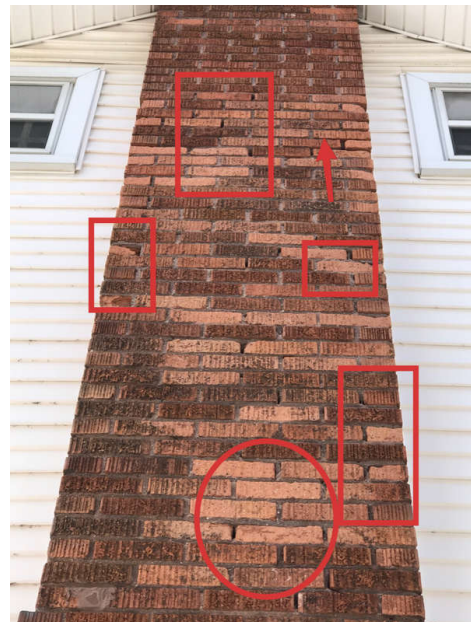
East Chimney

CHIMNEY - DETERIORATED MORTAR

Chimney mortar has deteriorated in areas to prevent water intrusion which can cause future brick spalling and cracking. Repair is recommended by a licensed chimney contractor.

Contact a qualified chimney contractor.

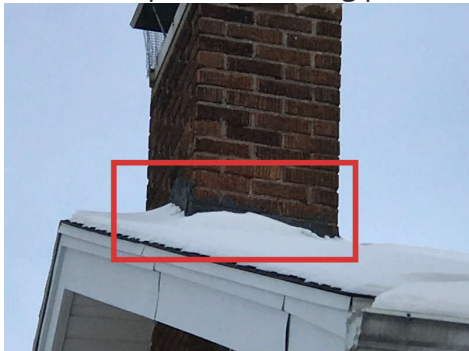
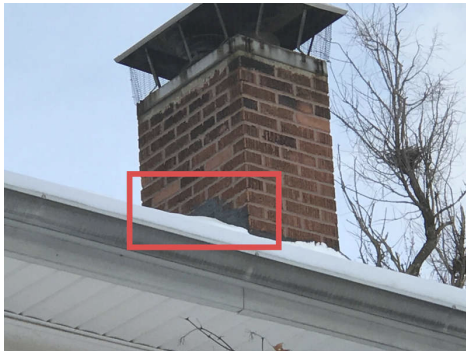
Heavy sealing is present at the chimney flashing. This may have been to correct a past water intrusion issue. Further review by a licensed roofer is recommended.

Contact a qualified roofing professional.

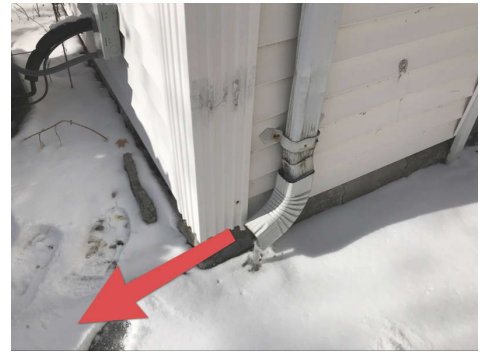
Gutter extension(s) are needed or redirected in a way to direct water away from the foundation to prevent erosion of soil and damage to the foundation structure.

Recommended DIY Project

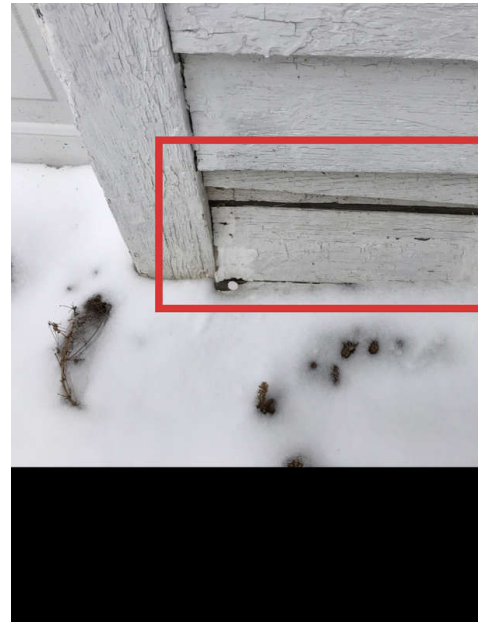
Garage

MINOR SIDING DAMAGE

Minor damage was observed on the siding of the home. In most cases, patching/caulking or replacement is all that is needed to prevent water and/or insect intrusion.

Recommended DIY Project

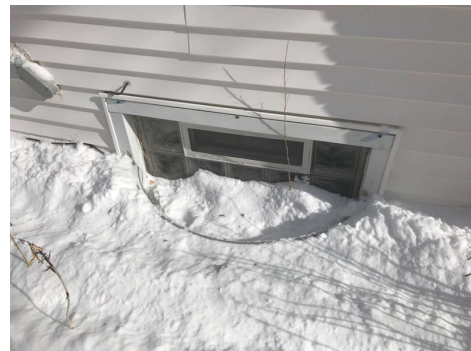
West

The basement window wells are in need of a well cover to prevent water intrusion or erosion of the foundation near the foundation wall.

Recommended DIY Project

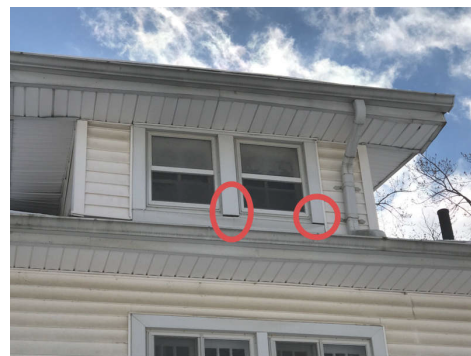
Rear Dormer

Gaps are present on the window fascia/trim which can allow water and insects to enter the wall structure. Capping or sealing areas is recommended. For large gaps or openings a qualified siding contractor is recommended.

Contact a qualified siding specialist.

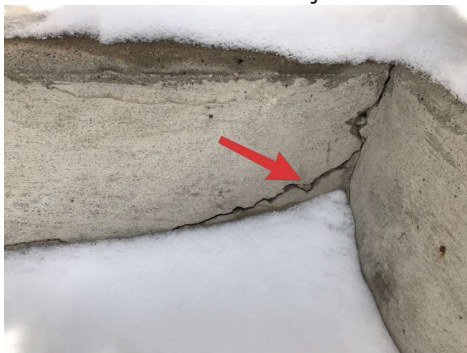
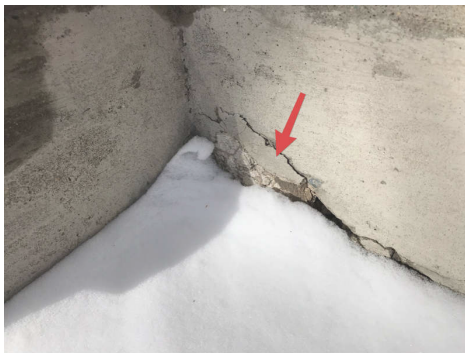
PORCH SETTLING CRACKS

Settling cracks are present on the front steps. Sealing is recommended to prevent and monitor future cracking.

Recommended DIY Project
