# NORTHBANK HOME INSPECTION

## RESIDENTIAL REPORT

1234 Main St.  
Vancouver WA 98663

03/31/2019 9:00AM

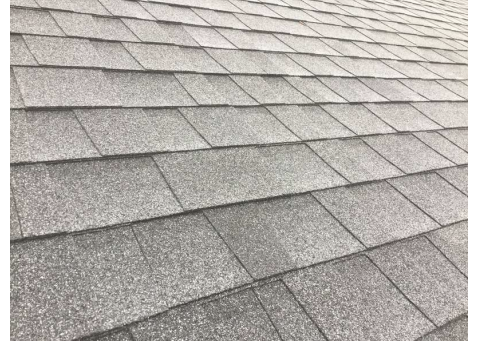
**Coverings: Material**

Asphalt, Metal, Architectural,  
Standing seam

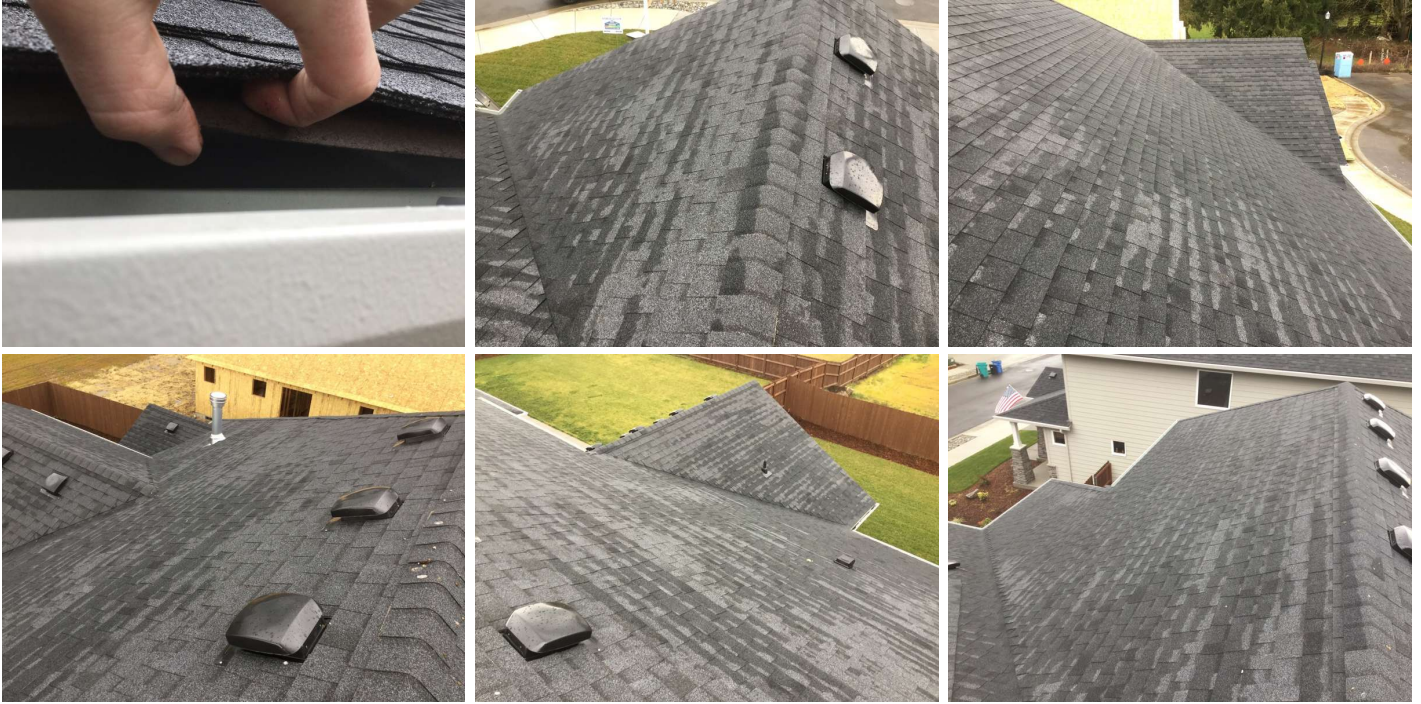
**Coverings: Roof coverings**

Roof coverings were observed by ladder and walking portions of the roof.

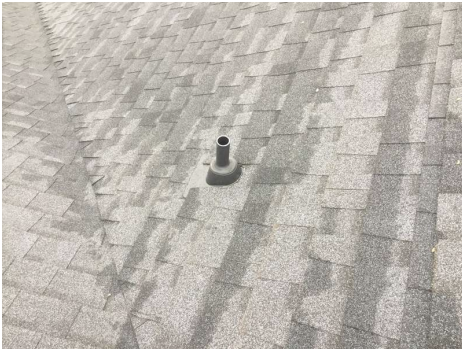
**Chimneys, Skylights, & Other Roof Penetrations: Plumbing vents**

Plumbing vent boots typically need to be replaced every 10-15 years. Recommend monitoring for deterioration, cracks in the vent boot, and leaks.

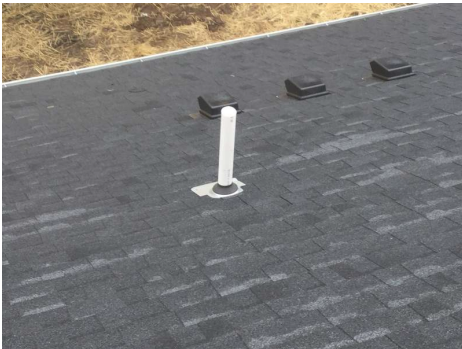
**Chimneys, Skylights, & Other Roof Penetrations: High-efficiency gas appliance exhaust**

Exhaust for high-efficiency gas appliance. Recommend monitoring boot gasket for deterioration. These boots typically need replacement every 10 years.

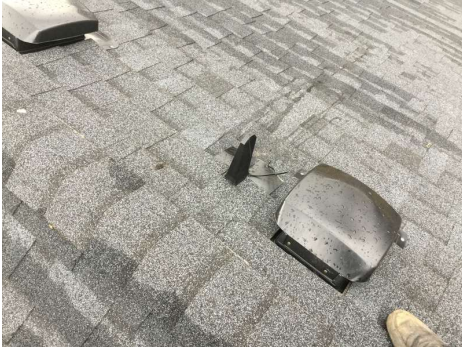
## Chimneys, Skylights, & Other Roof Penetrations: Roof anchor(s)

A roof anchor, typically used during the roofing of the home, is still installed. These are prone to leaks because they are typically not meant to be permanent, although some installations can be used for roof maintenance. Recommend monitoring, and if needed, periodic evaluation by a qualified roofing contractor for leaks; seal or repair as needed.

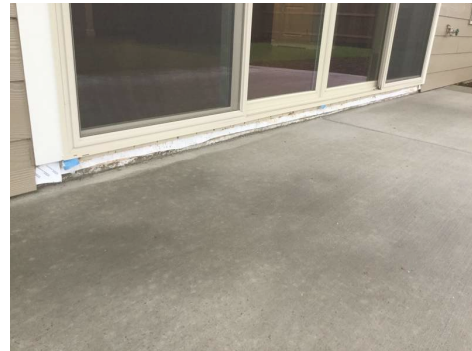
**MISSING TRIM**

Trim is missing in one or more areas of the home, exposing the sheathing. Recommend a qualified contractor install trim in appropriate areas.

Recommendation  
Contact your builder.

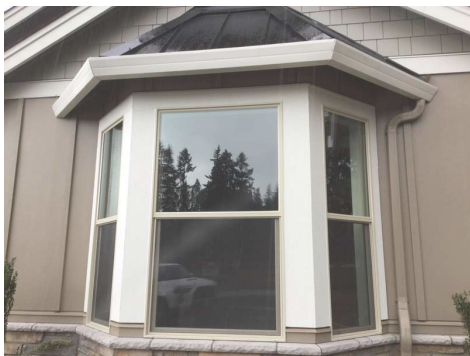
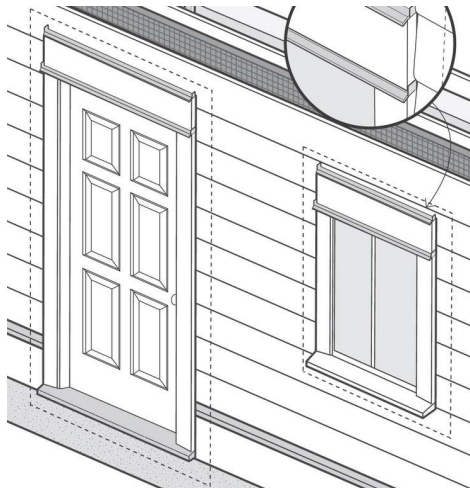
3.1.4 Siding, Flashing & Trim

Windows in one or more areas are missing flashing. This can lead to water intrusion and damage if exterior seals fail. Windows should have flashing installed above them to help shed water. This is a modern building standard. Recommend monitoring and maintaining sealant or installation of window flashing by a qualified contractor if needed.

Window flashing detail

Recommendation  
Contact a qualified siding specialist.

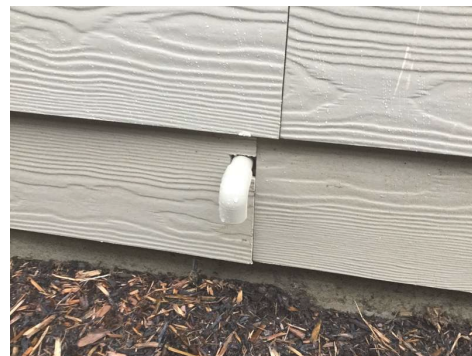
3.1.5 Siding, Flashing & Trim

Penetrations in the siding are not sealed or flashed properly in one or more areas. This can lead to water intrusion, which can potentially cause damage, including rot, of siding and framing components. Recommend a qualified contractor repair with appropriate sealant and/or flashing.

Recommendation  
Contact a qualified siding specialist.

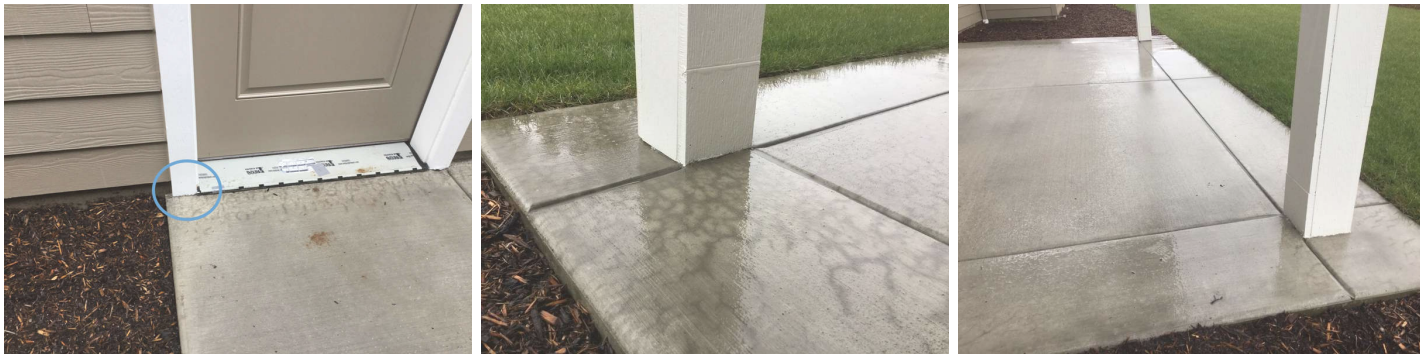
**TRIM GROUND CLEARANCE**

Trim in one or more areas does not have enough clearance from the ground. Trim should be a minimum of 2 inches above hardscape, ie concrete, or 6-8 inches above soil to prevent water wicking up into the trim and causing damaged. Recommend a qualified contractor repair.

Contact a qualified handyman.

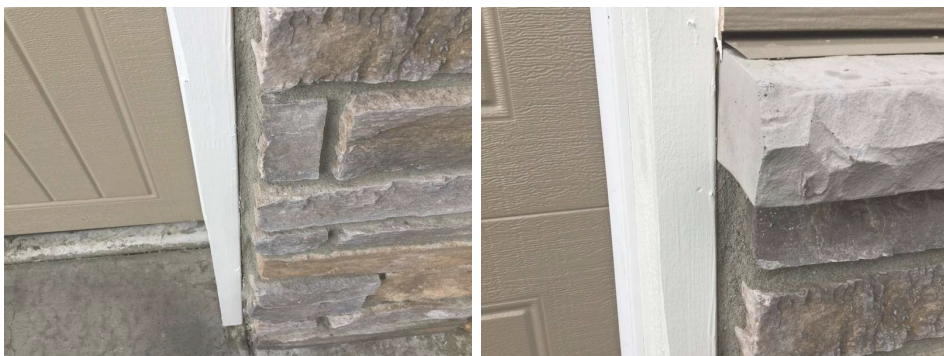
**MASONRY MISSING SEALANT**

Masonry cladding is missing edge sealant. This can allow moisture intrusion behind the masonry, which can eventually lead to damage, including wood rot. Recommend a qualified contractor repair.

Contact a qualified masonry professional.

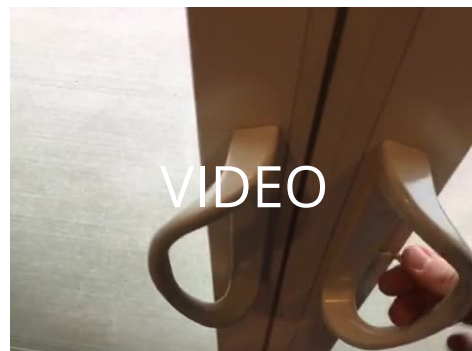
**SLIDING GLASS DOOR-  
DIFFICULT LATCH**

The locking mechanism on the sliding screen door is difficult to latch. This can be a security issue. Recommend a qualified contractor repair.

Contact a qualified handyman.

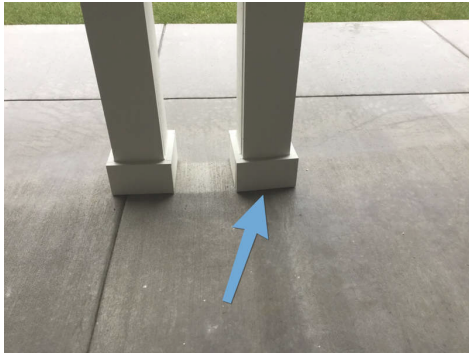
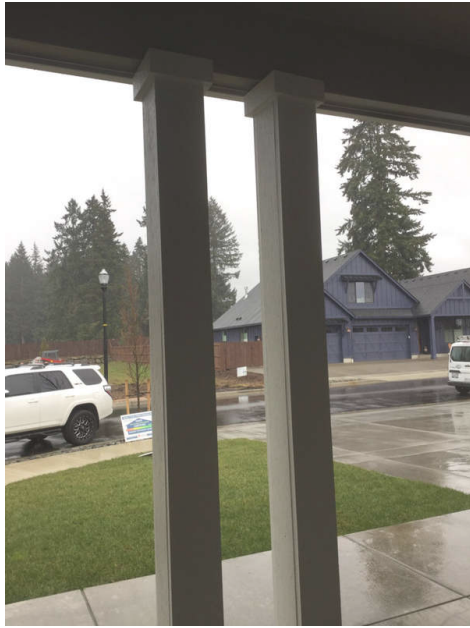
3.4.1 Decks, Balconies, Porches & Steps

A post is installed in a substandard manner - the post is twisted and not square. This can sometimes indicate stress of the post from the load its bearing. Additionally, the double post design of the front patio is also atypical. Recommend asking builder about design and function of the posts, and to correct if necessary. It may be prudent to review original planned drawings to determine if deviations were made and for what purpose.

Contact your builder.

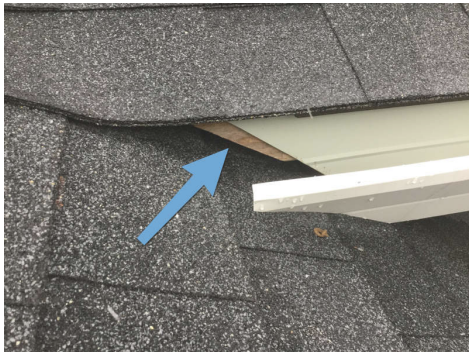
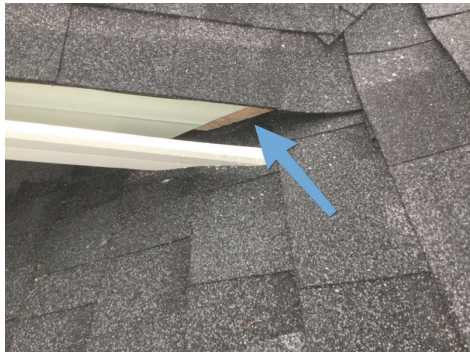
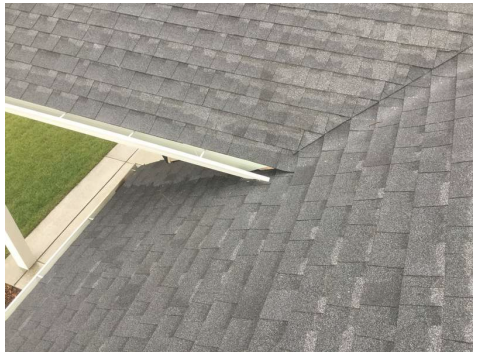
3.5.1 Eaves, Soffits & Fascia

Portions of the fascia and/or rafter tails are not painted. Unpainted exterior wood should be painted to help protect it from moisture. Recommend a qualified contractor paint appropriate areas.

Contact a qualified painting contractor.

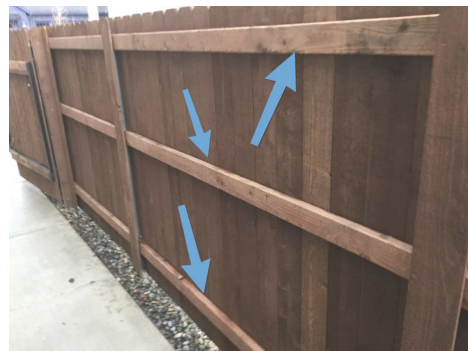
### 3.7.1 Fence

The exterior fence is constructed with non-treated materials. Untreated components can deteriorate quickly in wet environments and lead to premature fence failure. Recommend maintaining stain of installed members regularly or replacing untreated members with treated wood.

Recommend monitoring.

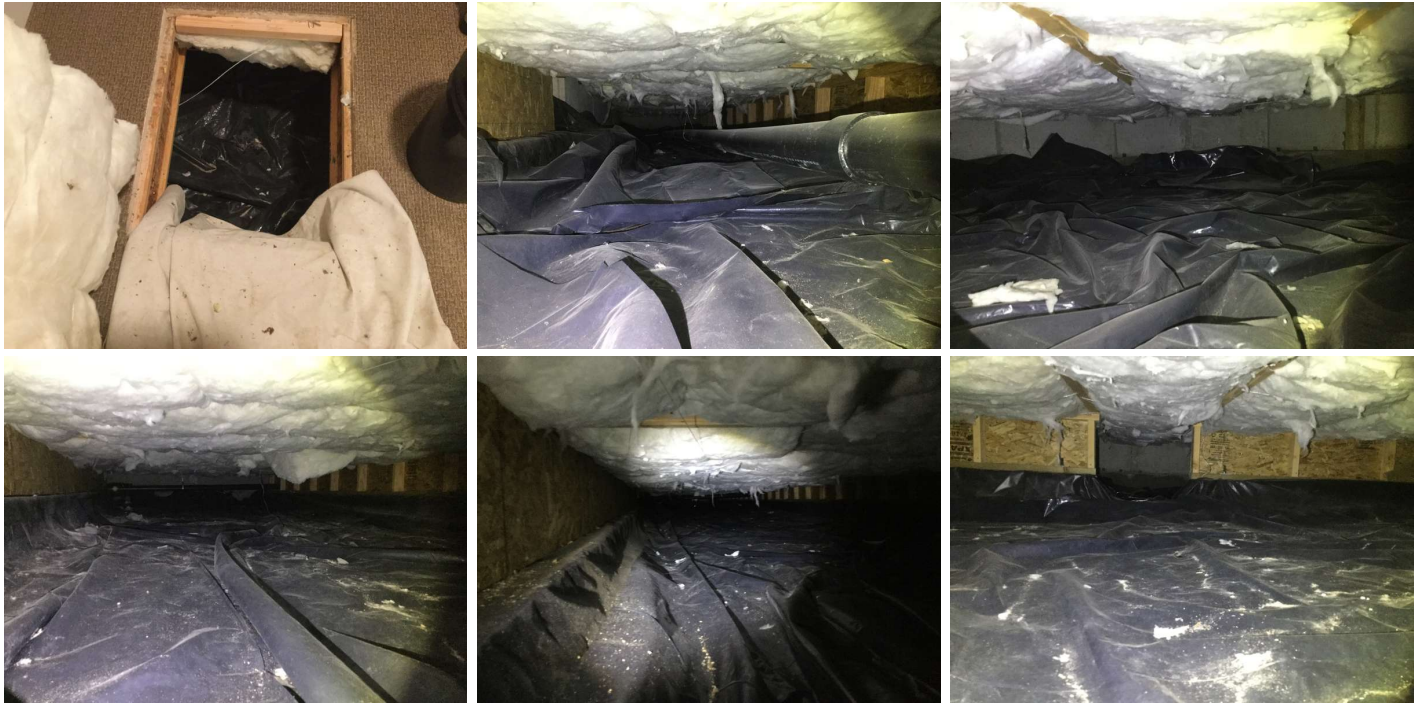
**Basements & Crawspaces: Crawlspace and/or basement**

Crawlspace and/or basement was accessed for the inspection.

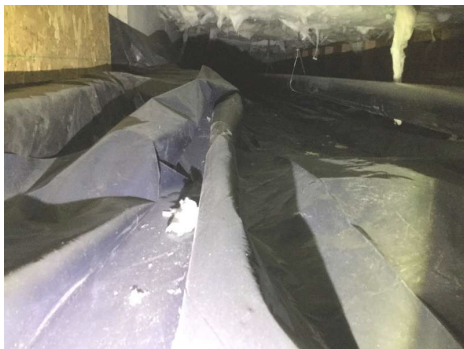
A vapor barrier was observed in the crawlspace. Vapor barriers can help limit moisture and radon exposure when installed correctly.

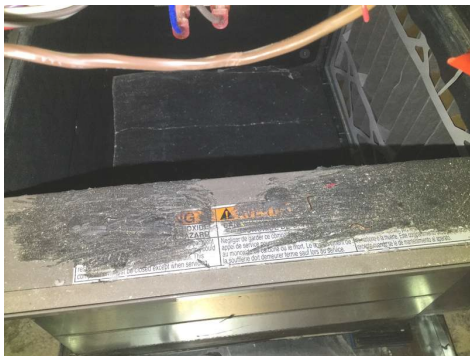
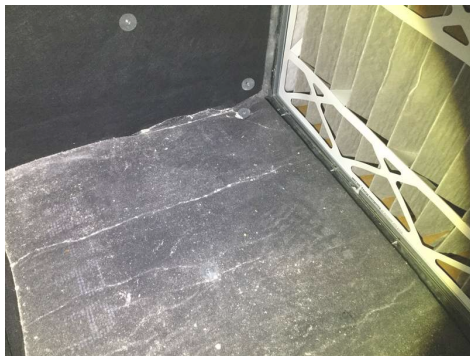
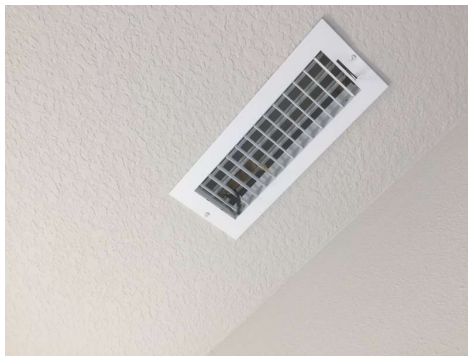
The furnace and duct system need servicing. During construction, if the HVAC system is not properly sealed off, construction debris can enter the duct system. This can impact energy efficiency and negatively impact air quality. Recommend builder service HVAC system.

Contact a qualified HVAC professional.

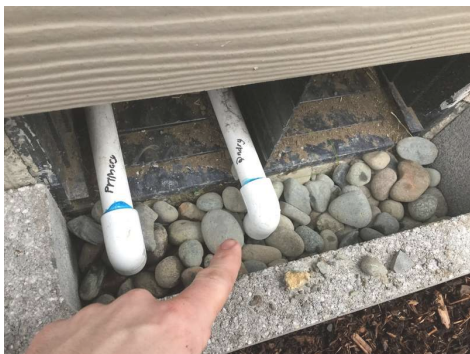
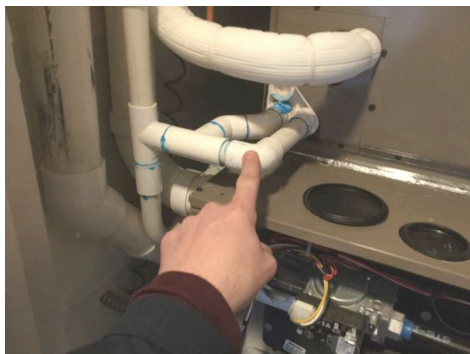
**IMPROPER INSTALL - SECONDARY CONDENSATE LINE**

A secondary condensation drain is installed inappropriately - this drain discharges to the exterior next to the primary drain. This drain is a backup drain intended to catch condensation if the primary is clogged. The secondary drain should be routed to a conspicuous area where it can be easily noticed and accessed. If water is coming out of this drain the primary drain has failed and repairs to the system are likely needed. Recommend a qualified contractor properly install a secondary drain.

Contact a qualified HVAC professional.

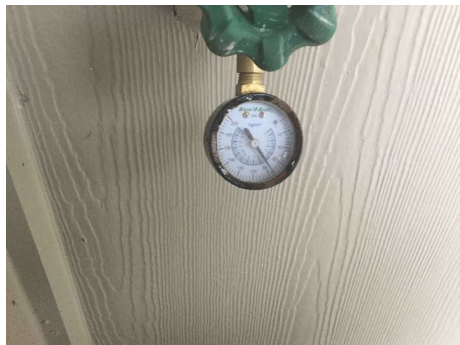
75 psi

The recommended range is between 40-80 psi.

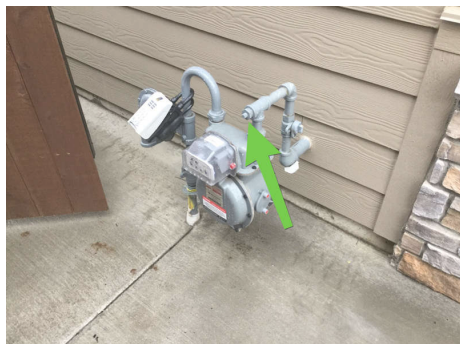
**Location**

Gas Meter

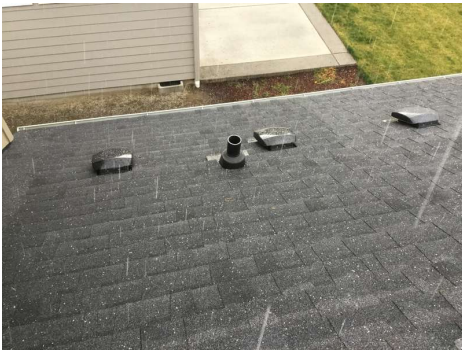
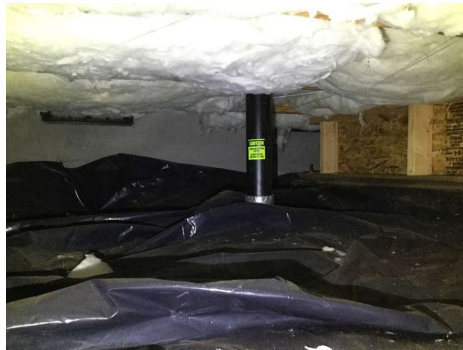
## Radon reduction system: Passive Radon-reduction system

A passive radon-reduction system was observed -- a passive pipe that runs from the crawlspace up through the house and exits the roof. These systems are not active (they are not connected to a powered exhaust fan) and generally do not provide effective radon ventilation for the home, which is why radon testing is prudent. Additionally, this pipe needs to be located centrally and the vapor barrier should be completely sealed to maintain a gas barrier for this system to be effective. Recommend periodic radon testing to determine accurate and safe radon levels.

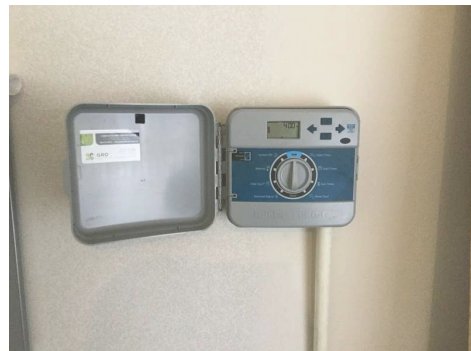
Irrigation system noted but not inspected.

Recommend flushing the irrigation system to prepare for winter months. This help prevent the water inside the pipes from freezing, expanding, and bursting the pipes.

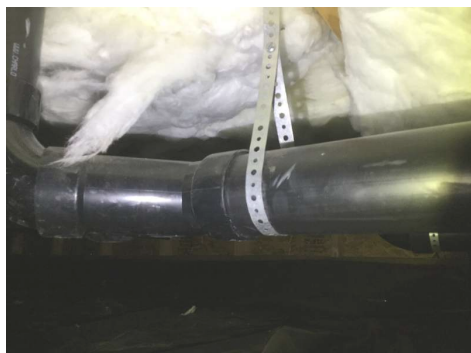
### 6.2.1 Drain, Waste, & Vent Systems

The ABS (plastic) drain lines are hung with metal straps. Metal straps can damage the ABS piping over long periods of time. Recommend a qualified maintenance person re-hang pipes with plastic material.

Contact a qualified handyman.

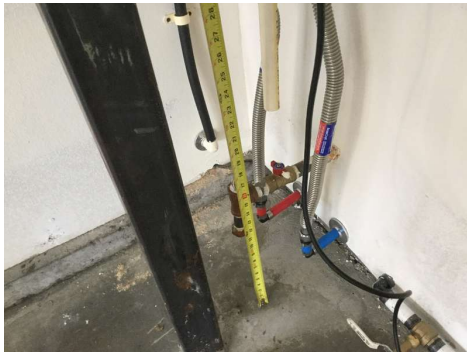
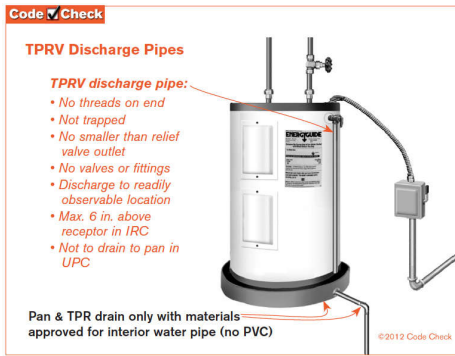
#### TPR DISCHARGE INADEQUATE

The temperature pressure relief (TPR) valve pipe does not extend within 6 inches of the ground. If tripped due to high pressure, the steam released could scald someone nearby. Recommend a qualified professional extend the TPR valve pipe to prevent injury.

Contact a qualified plumbing contractor.

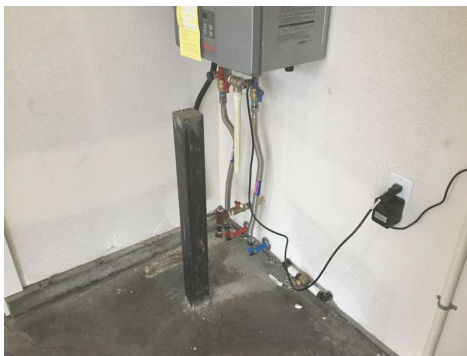
6.4.2 Hot Water Systems, Controls, Flues & Vents

An expansion tank is not installed on the water heater. Expansion tanks allow for the thermal expansion of water in the plumbing system -- basically water expands when heated. Without an expansion tank, thermal expansion can put stress on plumbing connections and fixtures and eventually lead to premature failure. These tanks are standard in new installations. Recommend a qualified plumber evaluate and install.

Contact a qualified plumbing contractor.

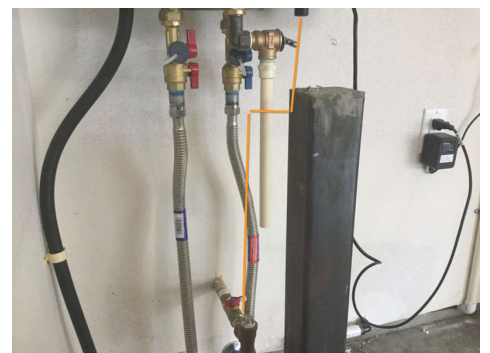
6.4.3 Hot Water Systems, Controls, Flues & Vents

The gas water heater gas line is not connected. Gas is the energy source for this system; it will not function without it. Recommend a qualified plumbing contractor connect gas line to the water heater.

Contact a qualified plumbing contractor.

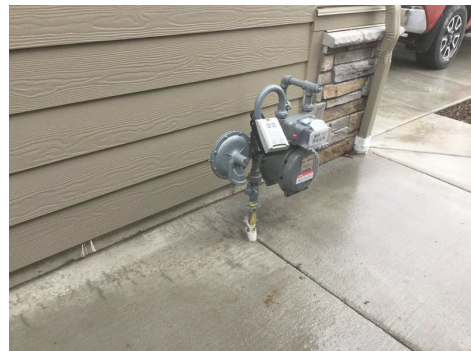
6.5.1 Fuel Storage & Distribution Systems

A gas valve shut-off wrench was not found in a reasonable range from the main gas shut-off. This is not required, but is helpful in the event of an emergency involving the natural gas systems of the home. Recommend installation of a gas valve shut-off wrench near the main gas valve.

Recommended DIY Project

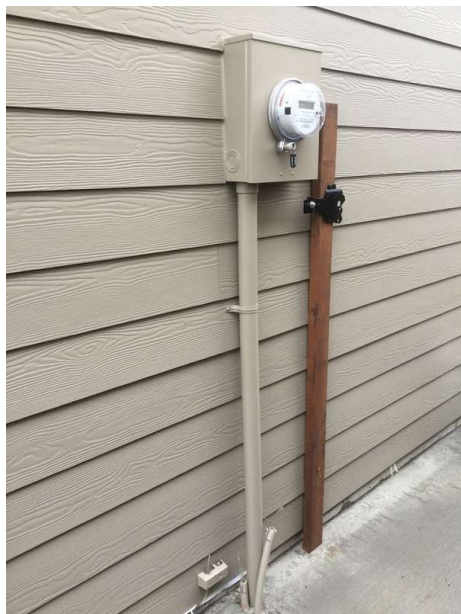
Electrical service entrance.

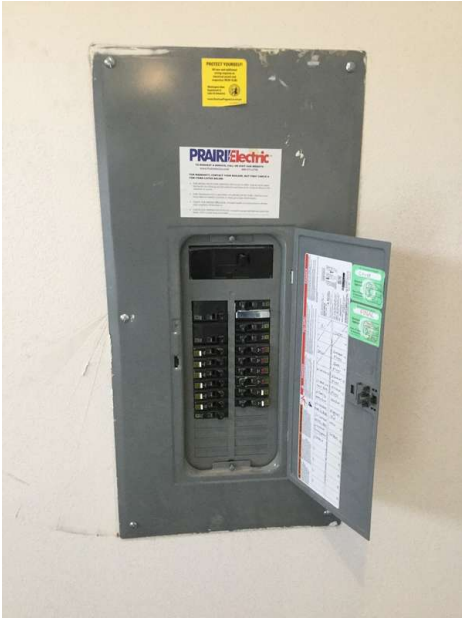
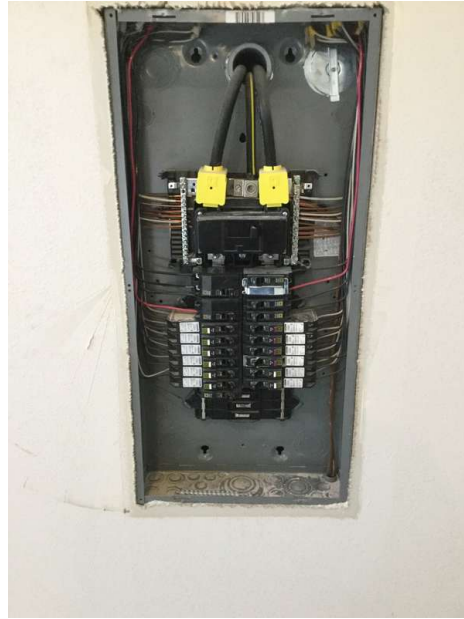
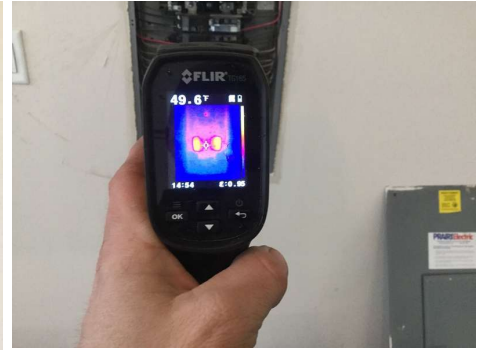
**Main & Subpanels, Service & Grounding, Main Overcurrent Device: Panel Manufacturer Square D**

**Branch Wiring Circuits, Breakers & Fuses: Main disconnect**

The switch (or switches) circled in green is the main electrical disconnect.

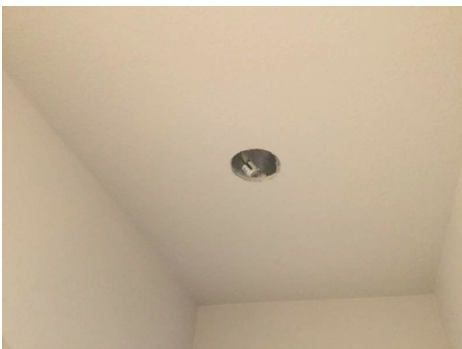
**Lighting Fixtures, Switches & Receptacles: Receptacle installation in progress**

Electrical fixture installation was in progress at the time of inspection. Recommend testing fixtures prior to closing.

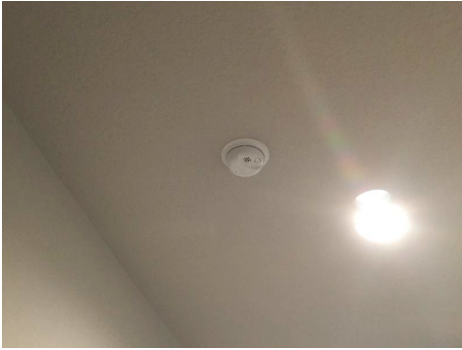
**Smoke Detectors: Smoke detectors**

Smoke detectors were operational at time of inspection, but should be tested again upon moving into the home. Replace at least every 10 years.

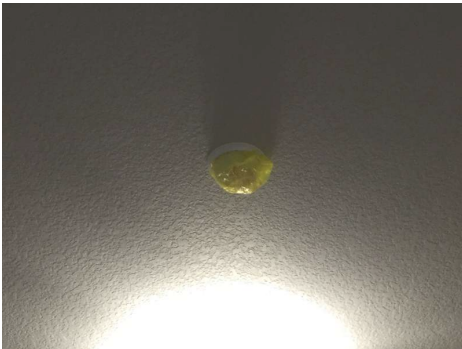
**Carbon Monoxide Detectors: CO detectors**

Carbon Monoxide detectors were operational at time of inspection, but should be tested upon moving into the home.

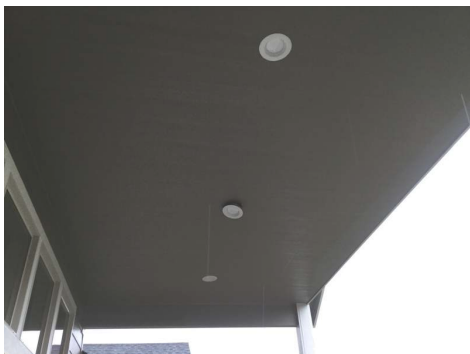
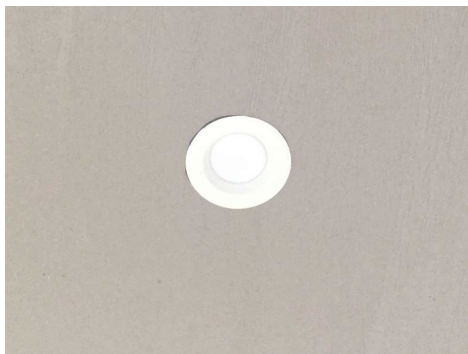
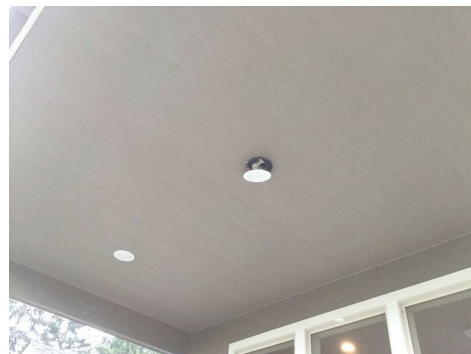
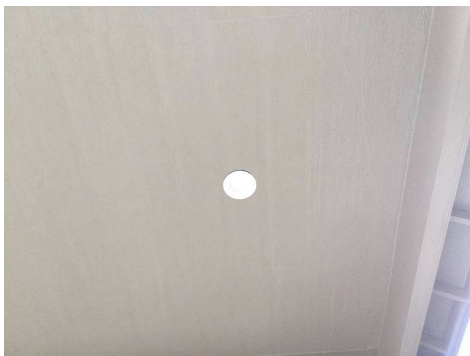
Receptacles, fixtures, or switches are installed poorly in one or more areas. Recommend reinstallation by a qualified contractor.

Contact a qualified handyman.

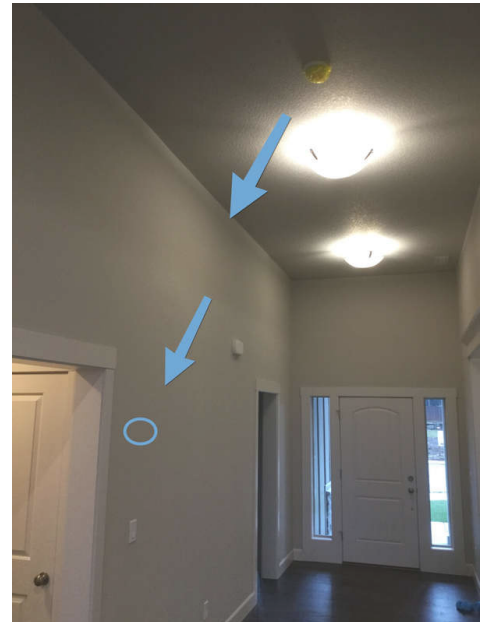
7.7.1 Carbon Monoxide Detectors

Carbon monoxide detector effectiveness may be compromised due to location -- detector should be 5 feet from the ground -- where CO floats -- to properly function. CO detectors are required in common areas outside of each sleeping room on every floor and living space. If this unit is a dual smoke/CO detector, consider installing a stand-alone CO detector in an appropriate location. Recommend relocating according to manufacturer's instructions.

Recommendation  
Recommended DIY Project

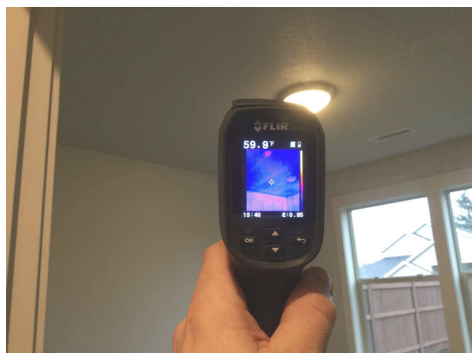
Attic insulation is insufficient or missing in one or more areas. Dark blue areas of the thermal images indicate measured cold temperatures, which is typically where insulation is insufficient or missing. This can lead to energy loss and affect the comfort of the home. Recommend a qualified insulation contractor evaluate and remedy as needed.

Back left bedroom - Thermal image measured cold temperatures indicating ceiling insulation is missing or inadequate

Contact a qualified insulation contractor.

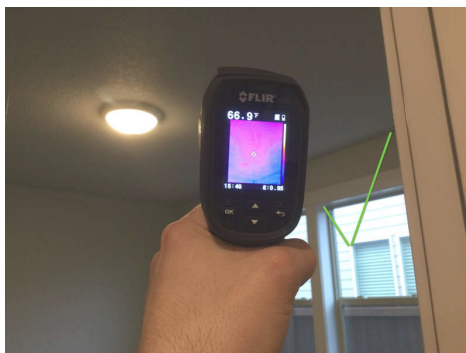
Thermal image of room with insulation

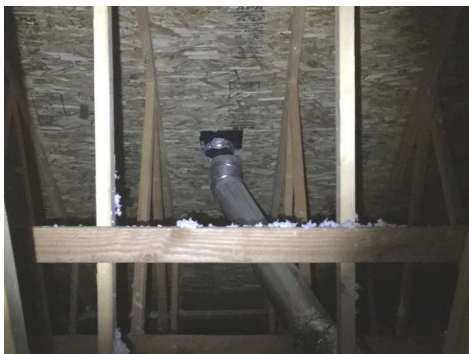
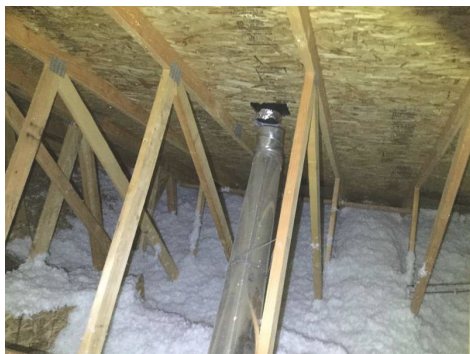
**DUCTS LOOSE OR DISCONNECTED**

Ductwork is loose or disconnected. This can promote moisture in the areas through which the ducting runs and create an environment conducive to mold, wood-destroying insects, and fungi. Recommend a qualified HVAC professional repair duct and terminate it to the exterior.

Contact a qualified HVAC professional.

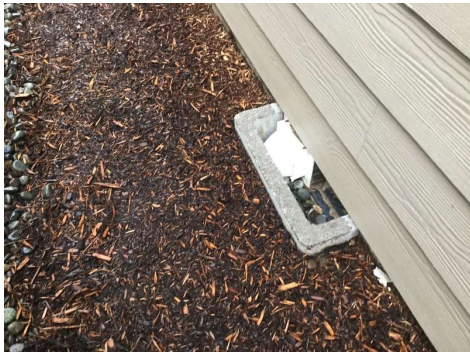
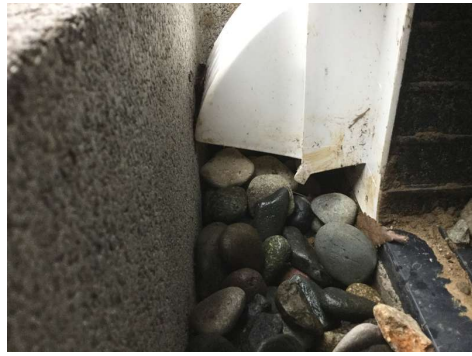
**DRYER VENT HEIGHT**

Dryer vent does not terminate to an appropriate height. This can be a safety issue because it could become blocked more easily by obstructions, such as tree debris, and become fire hazard. Recommend a qualified contractor evaluate and reinstall exhaust at an appropriate height, at least 12 inches above grade.

Contact a qualified HVAC professional.

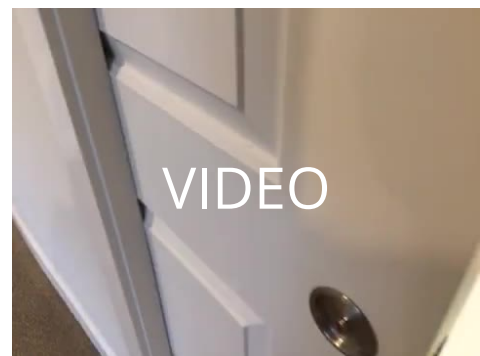
### 9.1.1 Doors

One or more doors stick and are difficult to use. Recommend a qualified contractor repair.

Contact a qualified handyman.

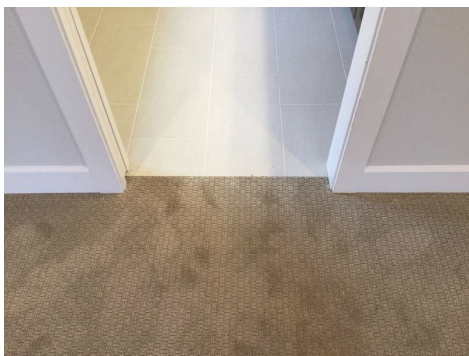
#### MISSING TRANSITION

A flooring transition is missing in one or more areas. Transition pieces help protect flooring between different types of flooring. Recommend a qualified contractor install a transition piece.

Contact a qualified flooring contractor

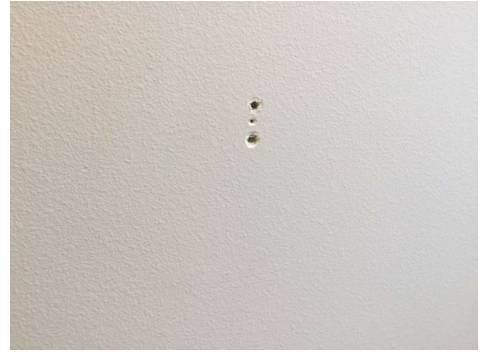
#### MINOR DAMAGE

General damage and disrepair of the walls was observed in one or more areas. Recommend a drywall contractor repair as needed.

Contact a qualified drywall contractor.

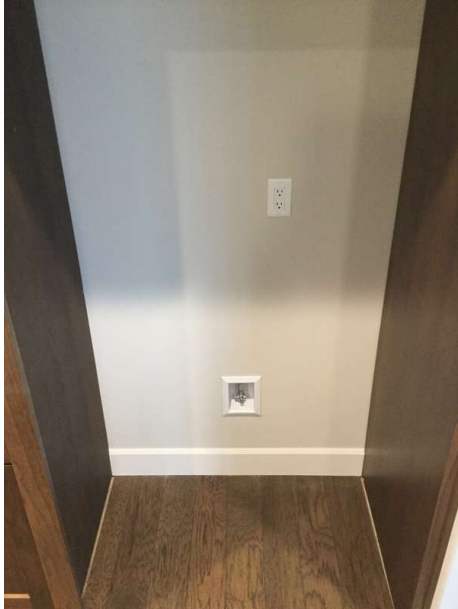
**Refrigerator: Brand**

Not present

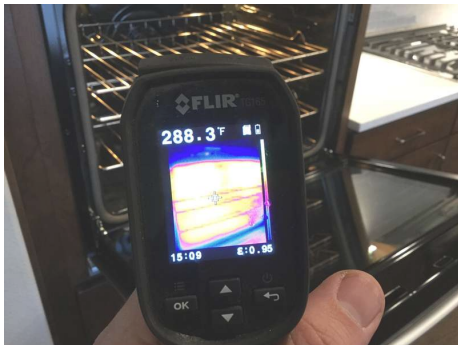
**Range/Oven/Cooktop: Oven operational**

The oven operational at the time of inspection.

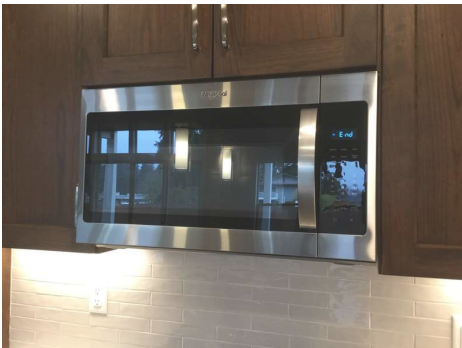
**Built-in Microwave: Microwave operational**

The built-in microwave was operational at time of inspection.

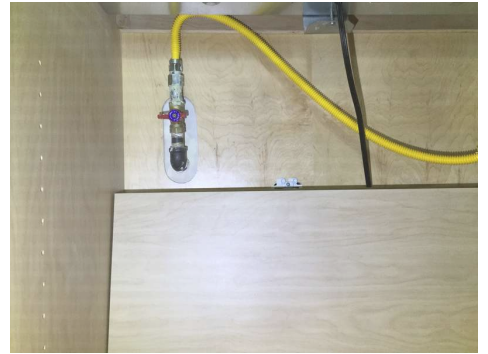
### **GAS SUPPLY OFF**

The cooktop gas supply was shut off at the time of inspection and not tested. Recommend testing cooktop prior to closing.

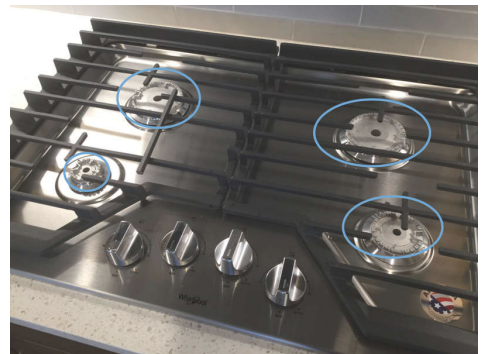
### **MISSING BURNER PLATES**

The cooktop is missing burner plates that help to evenly distribute flame. This appliance did not appear to be fully installed at the time of inspection. Recommend ensuring appliance is properly installed and functional prior to closing.

Contact a qualified appliance repair professional.

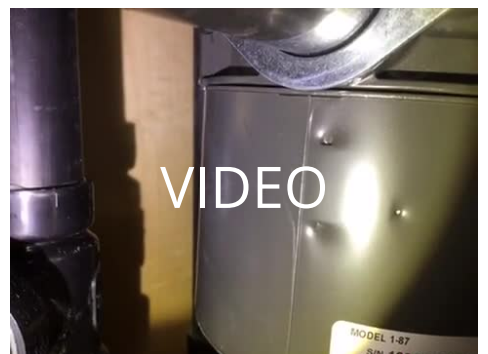
10.4.1 Garbage Disposal

The garbage disposal malfunctioned during testing and began to smoke. This is a fire hazard. A qualified contractor should evaluate this installation and repair or replace unit.

Contact a qualified appliance repair professional.

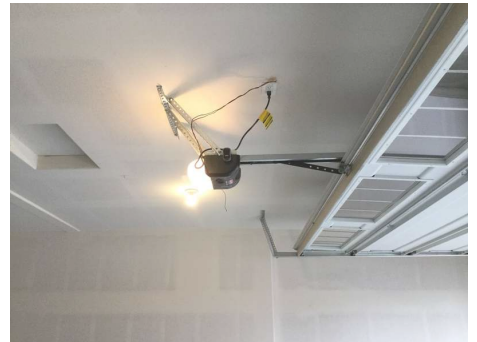
### Garage Door Opener: Opener

The garage door opener was operational at the time of inspection.

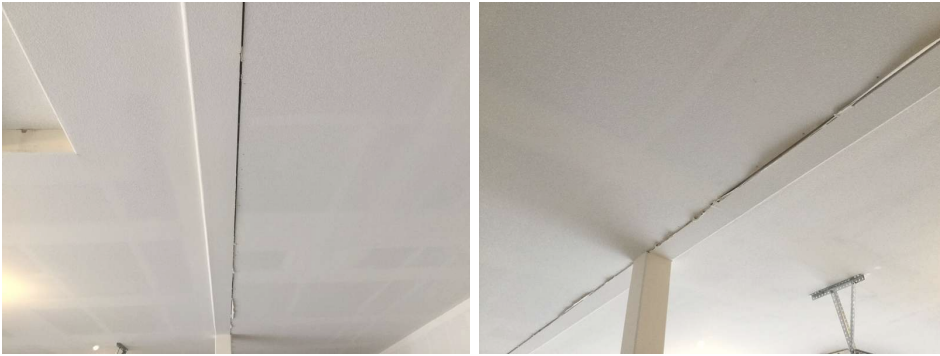
### 11.3.1 Walls & Firewalls

The firewall is compromised in one or more areas. This can allow a garage fire to spread more easily to the interior. Combustibles are more likely to be stored in the garage, and therefore, fires are more likely to start there. No gaps should exist and all firewall materials should be made of fire-resistant material. Gaps should be sealed with a fire-resistant sealant or other appropriate material. Recommend repair of compromised areas by a qualified contractor.

Contact a qualified professional.

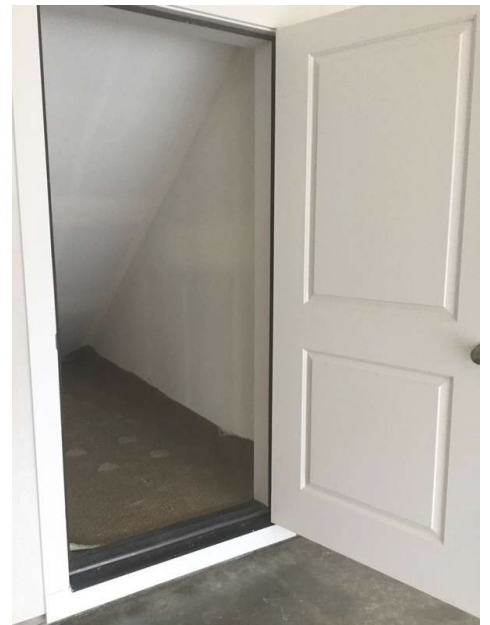
### 11.6.1 Occupant Door (From garage to inside of home)

A door from the garage to the interior of the home has inadequate self-closing hinges or may need adjustment. Self-closing doors between the garage and home help to prevent the spread of a fire to the living space in the event of a garage fire. Combustible materials are more likely to be stored in the garage, and therefore, fires are more likely to begin there. Additionally, self-closing doors can help reduce the chance of vehicle- and gas appliance-created carbon monoxide from entering the home. Recommend a qualified contractor properly install or adjust self-closing hinges.

Contact a handyman or DIY project
