SLAB TO SLATE HOME INSPECTIONS, LLC

HOME INSPECTION REPORT

1234 Main St.
Newport KY 41071

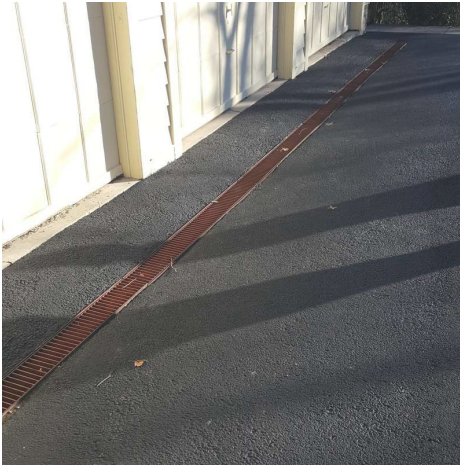
Walkways, Patios & Driveways: Drains Toward The Home

The driveway has a negative slope and drains towards the structure. The drain will need to be kept clean and in good repair to prevent water entry into the garage / basement.

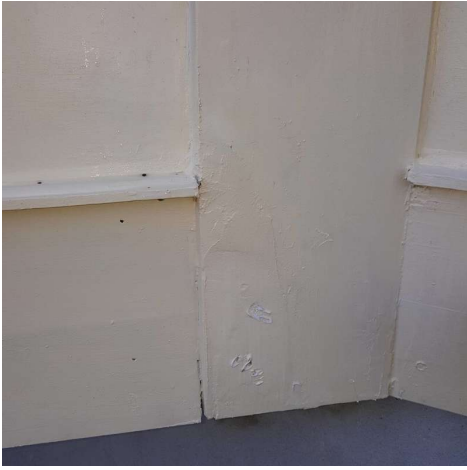
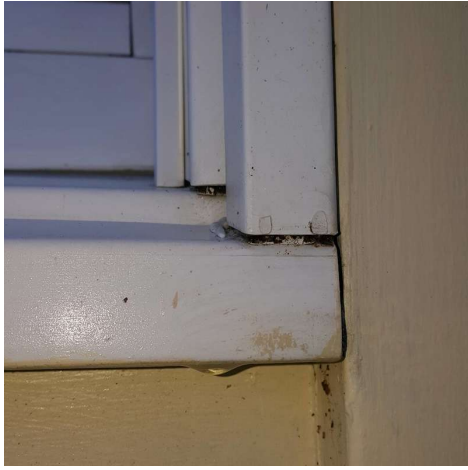
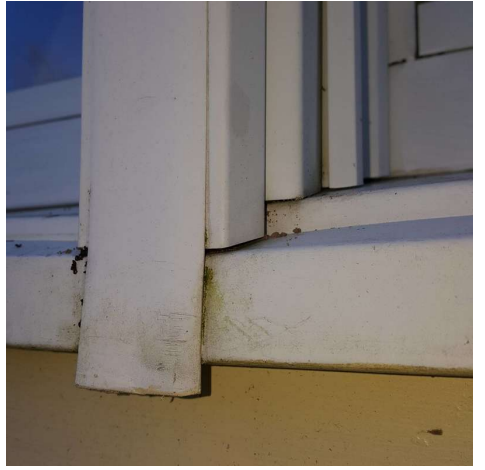
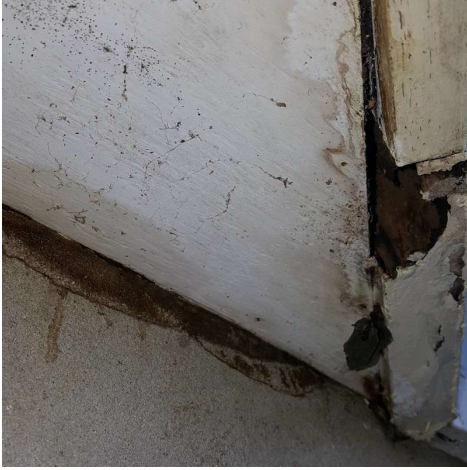
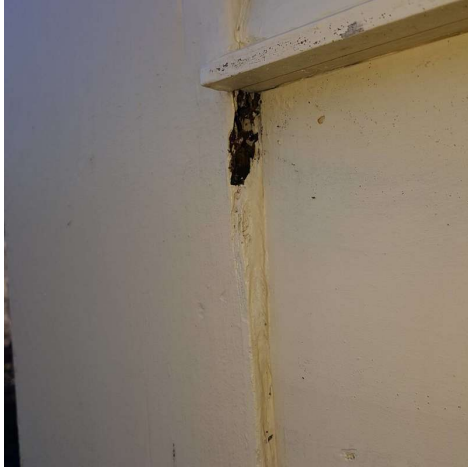
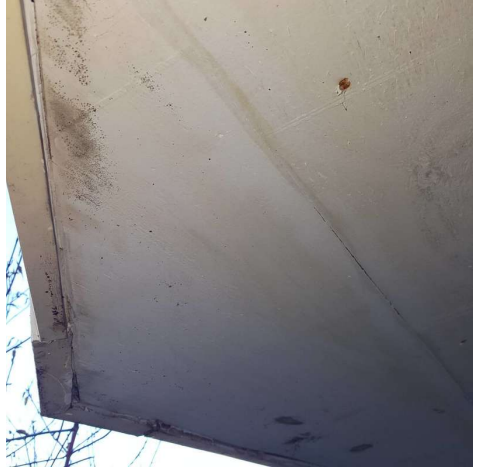
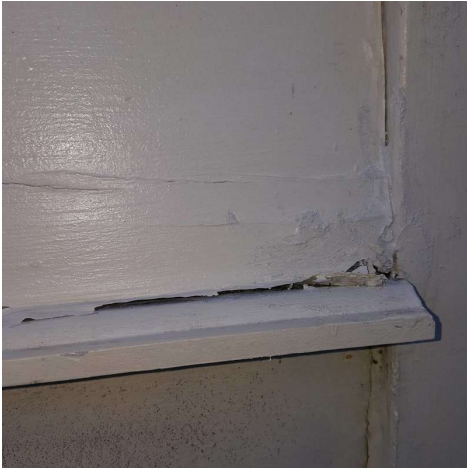
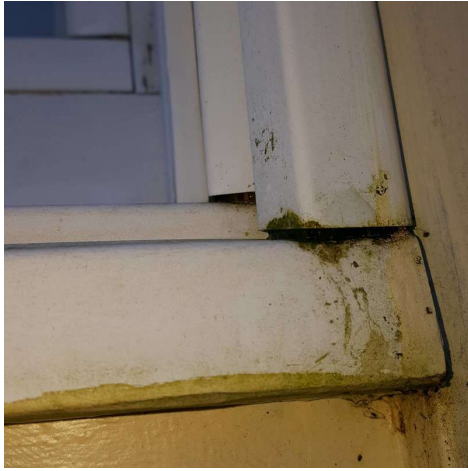
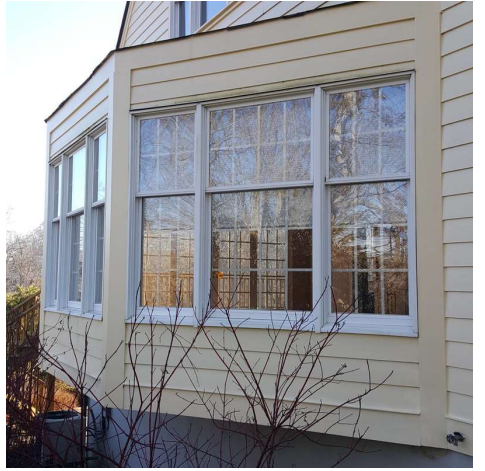
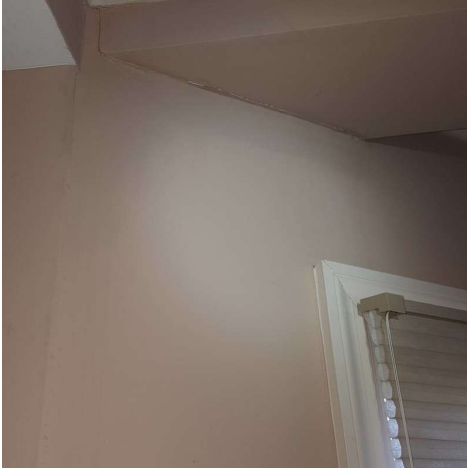
Siding showed signs of water intrusion. Water and wood rot is visible inside the window cladding, behind and below the trim, and some trim is rotted. One area was repaired very recently and the paint and filler was still wet. Water stains were visible on the inside of this area. The windows and some portions of the siding will likely need replacement. A complete and invasive evaluation to determine the cause of the water entry and the extent of the damage is necessary

Contact a qualified professional.

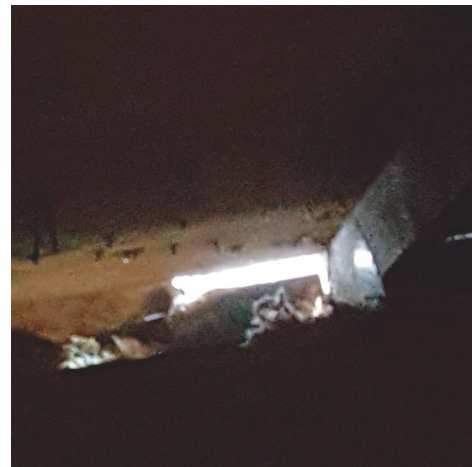
Gaps in the siding can allow moisture, insects, or rodents to penetrate the structure. Repair the gap in the siding.

Contact a qualified professional.

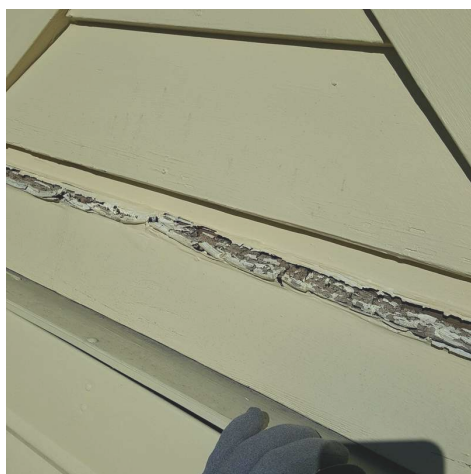
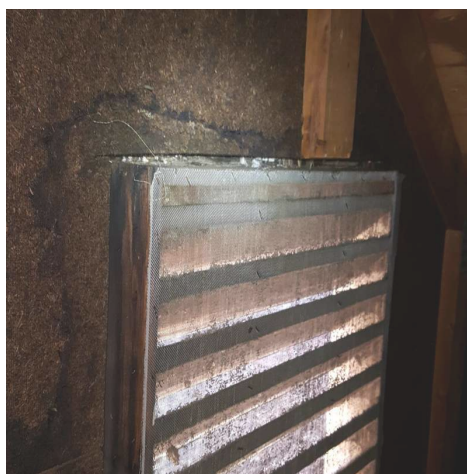
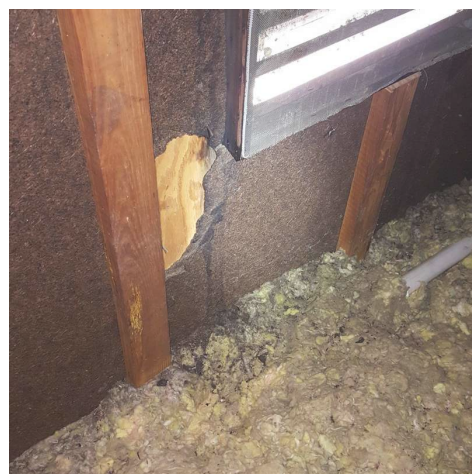
3.2.3 Siding, Flashing & Trim

Rotting siding / trim can allow water entry which can cause hidden damage. Areas above the installed attic vents are rotted and allowing water entry. Have a qualified contractor locate and replace all rotted siding / trim on the house. The areas behind any rotted areas should be fully evaluated for water damage and repaired as necessary.

Contact a qualified carpenter.

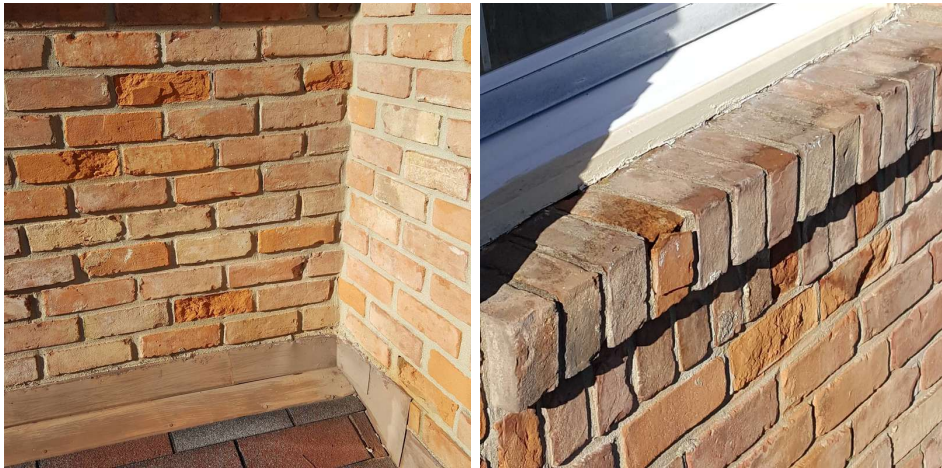
3.2.4 Siding, Flashing & Trim

DAMAGED BRICK

The brick is damaged. Once the brick face has come detached the brick is no longer sealed. Water will easily absorb and release from the area. Water can absorb into the home. The condition will only worsen and can damage subsequent bricks. Rebuilding areas will be necessary as replacing the bricks is the only resolution.

Contact a qualified masonry professional.

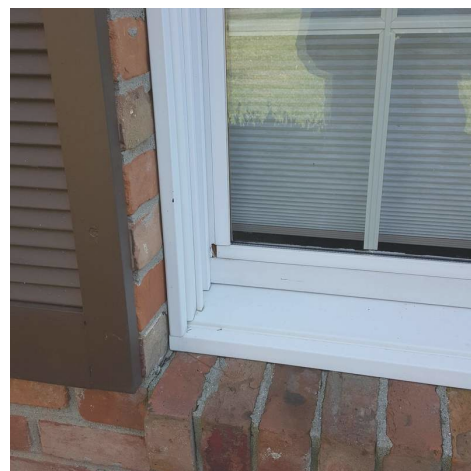
3.2.6 Siding, Flashing & Trim

CAULK HAS AGED

Caulk has aged or the surrounding materials have shrunken leaving gaps that can allow moisture penetration. Recommend removing the old caulk and applying new caulk.

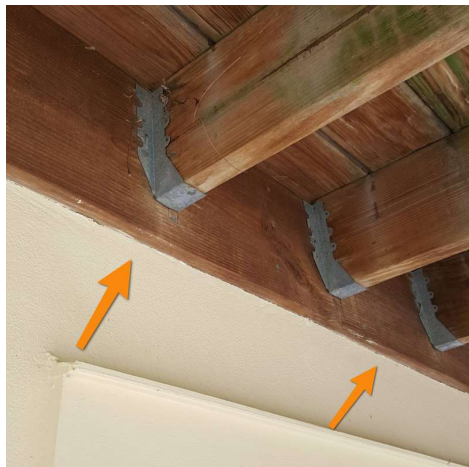
Ledger is set into the stucco

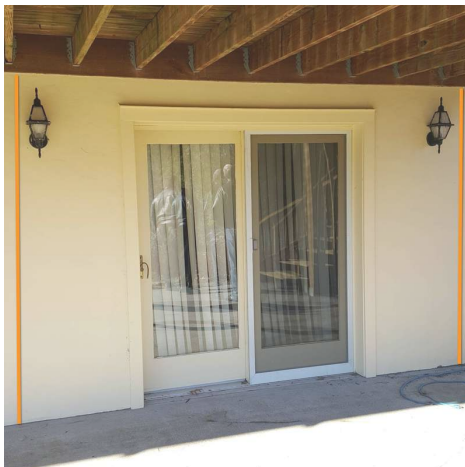
Wood framing and stucco extends beyond the light fixtures.

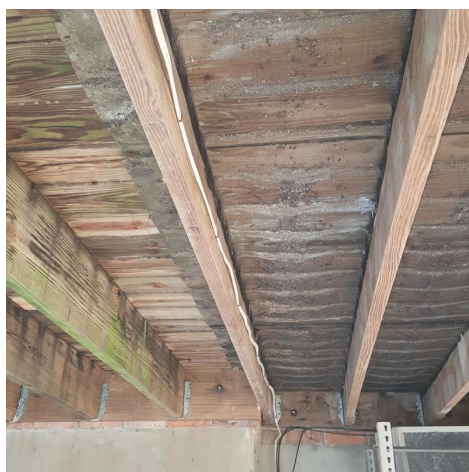
IMPROPER ROOM ADDITION CONSTRUCTION PRACTICES

Deck was observed to be installed in a manner that is not recommended. A room structure has been added to the deck without any additional load bearing provisions having been added. A portion of the wall structure that also supports the roof above is supported only by the decking boards. No joists have been doubled and the wall does not rest on a joist. Stress cracking can be seen at the brick veneer and the foundation in immediate area.

A structural engineer needs to evaluate the entire roof structure and supporting deck to provide all recommendations for proper structural support. A qualified contractor should implement all recommended repairs. The engineer should return to certify all installed repairs.

Contact a qualified structural engineer.

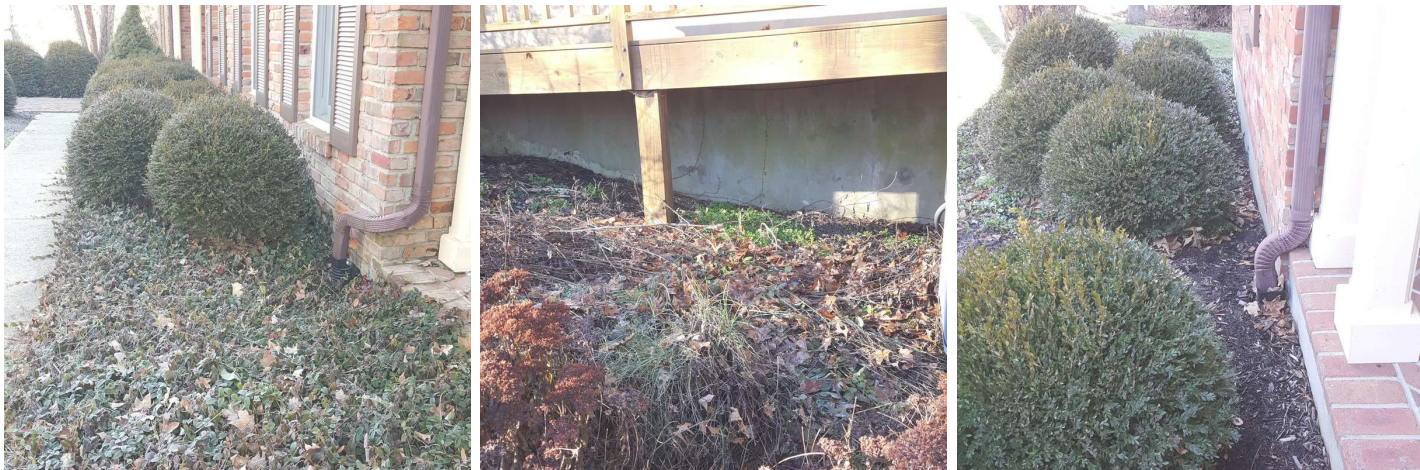
Grading is sloping towards the home in some areas. Directing more moisture towards the foundation increases the risk of moisture intrusion and subsequent foundation issues. **SEE ALSO FOUNDATION - Foundation cracks, water entry, and past waterproofing is noted in the adjacent area in the basement.**

Water should be directed away from all standing foundations to prevent potential water intrusion. The drainage strategy of the foundation is important. The minimum recommendation is 1/2in / Foot for 10 feet in grade slope. The soil should not be raised more than 4 inches below the top of the foundation.

Recommend regrading the area to achieve a slope away from the home. If regrading is not possible, add drain tile to re-direct water away from the home.

Contact a qualified grading contractor.

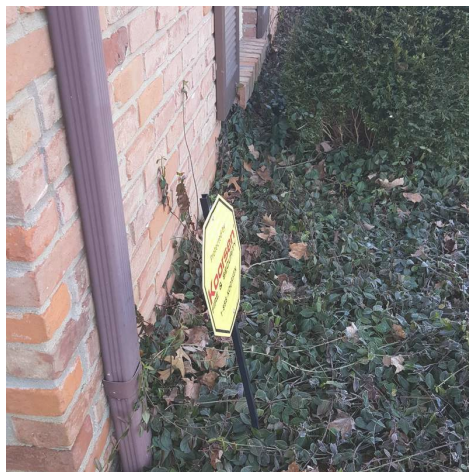
3.8.2 Vegetation, Grading, & Drainage

SOIL IS RAISED HIGHER THAN THE FOUNDATION

High soil levels surrounding the house can cause water damage to wood framing and brick and create an easy access point for termite infestation or mice. **SEE ALSO WALL STRUCTURE** - *Damage was noted to the wall structure and termite infestation is noted in this area.*

Recommend lowering the soil level to 4 inches or more below the top of the foundation. The proper slope of grade away from the house should be maintained. The minimum recommendation is 1/2in / Foot for 10 feet in grade slope. If grade slope can not be maintained, add drain tile to re-direct water away from the home.

Contact a qualified landscaping contractor

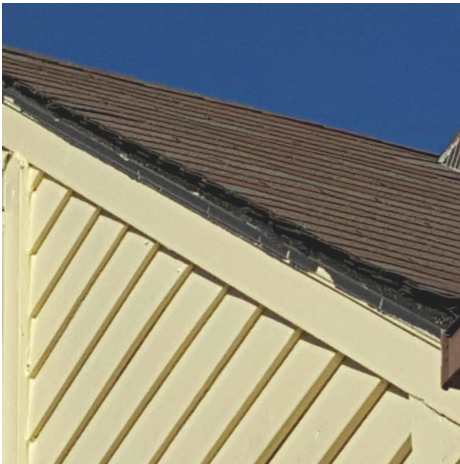
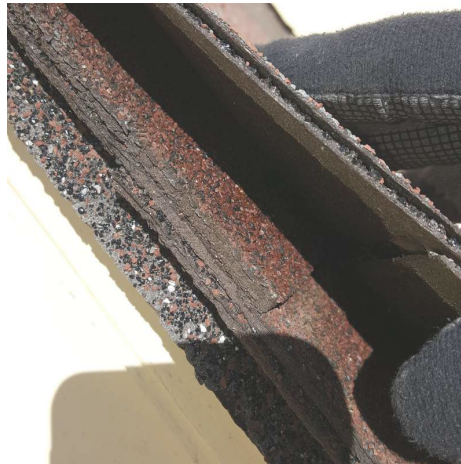
This can add extra weight on the roof structure. Lead to decreased shingle life by overheating the shingles and reduce impact resistance from hail. Accelerated moisture damage to the roof sheeting can occur. Insurance companies may have specific rules/requirements regarding more than one layer of shingles. **You may want to check with your insurance company to be sure this will be an acceptable installation.**

At the next roof replacement all layers of shingles should be removed.

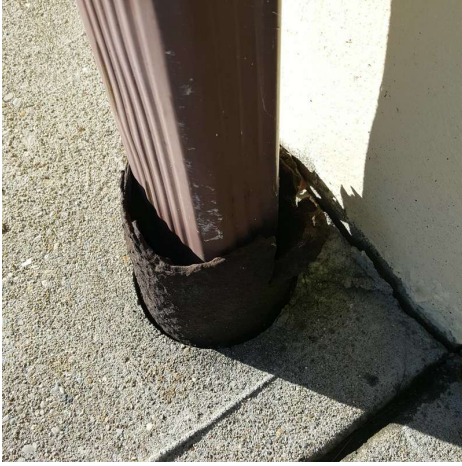
Gutters / Downspouts: Orangeburg Piping

The underground drainage pipe appears to be Orangeburg piping, all of which is considered to be at the end of its life (It was most widely used in the 1950's and 1960's). Orangeburg piping is essentially tar - impregnated cardboard and over time will crush and deteriorate. If this piping is prevalent for all of the downspout drains or any of the house sewer line, significant repairs may be necessary. If left damaged and unrepaired these drains can damage the foundation. **SEE ALSO FOUNDATION** - *Water entry, foundation cracks, and previous waterproofing is noted in the basement.*

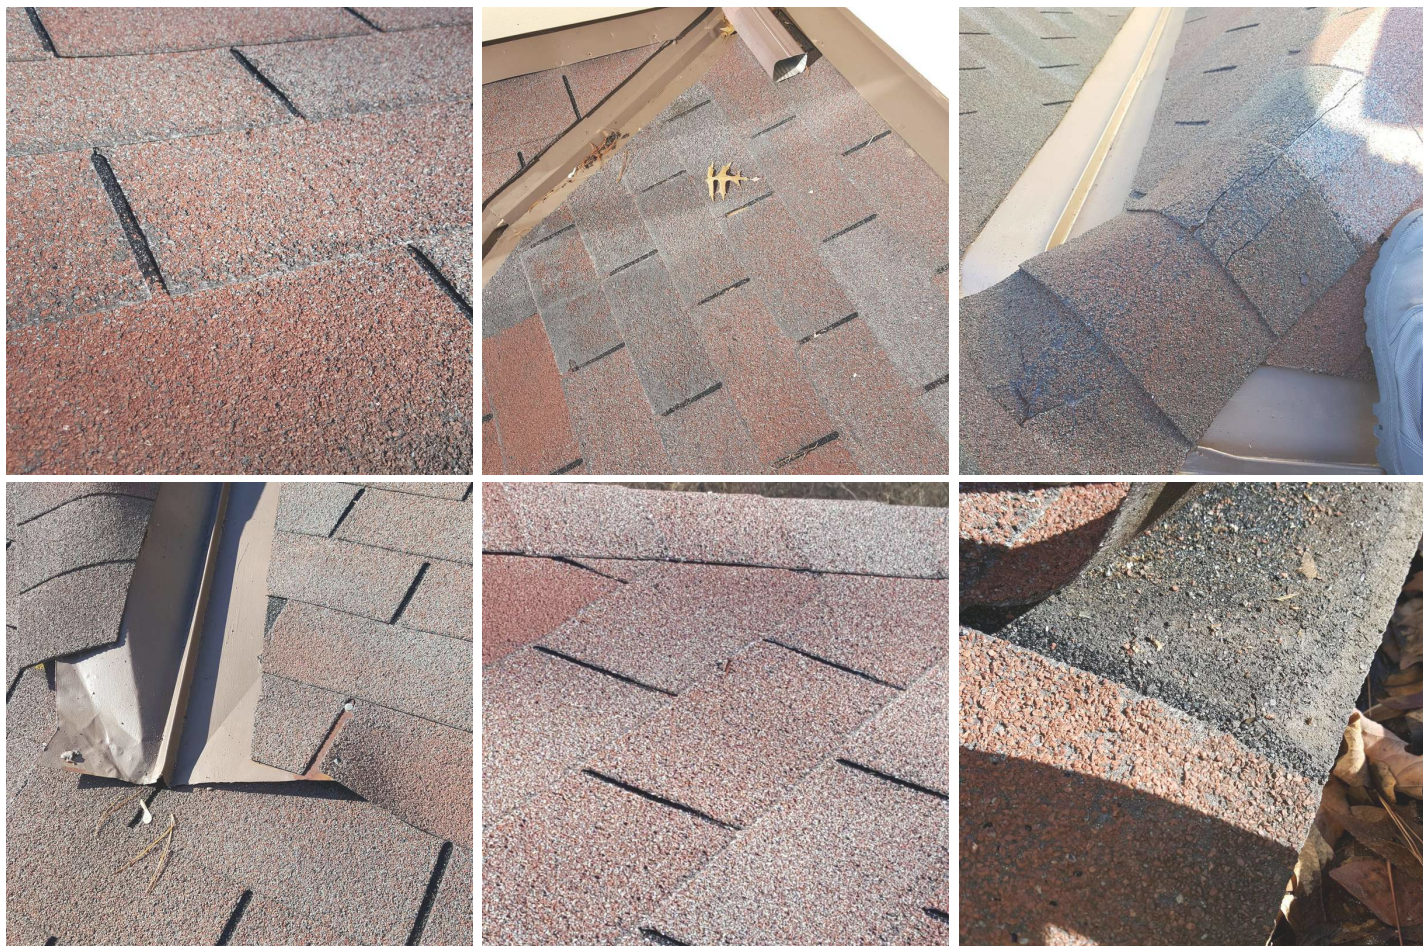
This roof shows one or more conditions consistent with being near end of life. Damaged shingles, granule loss, loose flashing, and persistent leaking at the garage is noted. Budget to replace the roof in the near future. If obtaining a roofing inspection, be certain the roofing company provides a written remaining life estimate; if any. If replacement is not opted for at this time a full evaluation to determine necessary immediate repairs should take place and subsequent yearly inspections take place.

Contact a qualified roofing professional.

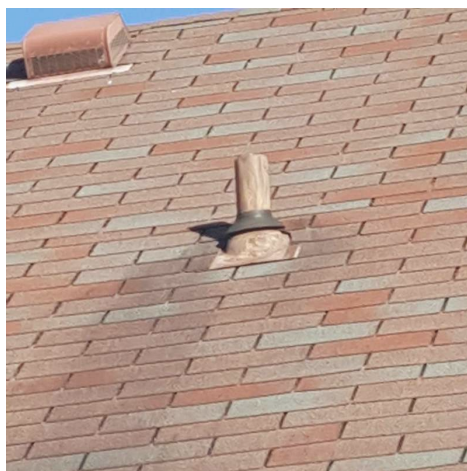
DETERIORATED BOOT FLASHINGS

The purpose of the boot flashing is to keep water on the surface of the roof where a penetration exists. Deteriorated boot flashing can allow water entry and subsequent damage. It is also a sign that the roof is aging. These flashings typically last 12 - 15 years before beginning to deteriorate.

Contact a qualified roofing professional.

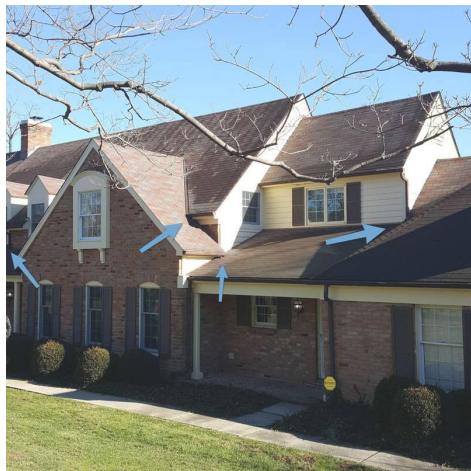
This is common practice done for aesthetic reasons but is not recommended. This can deteriorate the roof leading to early leaks and also void the shingle manufacturer warranty.

Recommend routing the gutter so it empties into the gutter below.

Contact a qualified gutter contractor

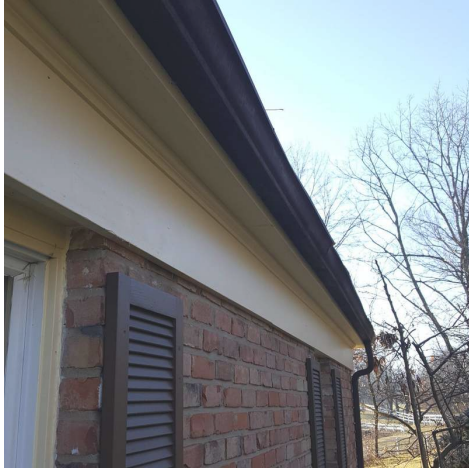
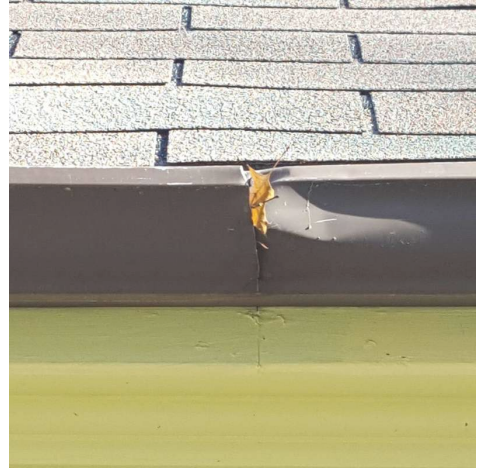
4.6.4 Gutters / Downspouts

GUTTER DAMAGED

Gutters were damaged. This can result in excessive moisture in the soil at the foundation, which can lead to foundation/structural movement or water entry and damage to the structure. **SEE ALSO WALL STRUCTURE** - Damage to the adjacent wall structure is noted and termite activity is noted in the attic in the adjacent area of one damage portion.

Recommend a qualified contractor evaluate and repair.

Contact a qualified gutter contractor

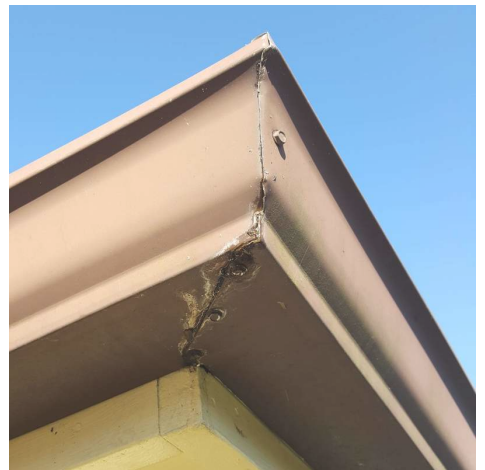
4.6.5 Gutters / Downspouts

GUTTER LEAKAGE

Gutters were observed to be leaking in one or more areas. This can result in excessive moisture in the soil at the foundation or deterioration to the deck below. This can also cause ice buildup and become a safety hazard. Recommend a qualified contractor evaluate and repair gutters to proper functionality.

Contact a qualified gutter contractor

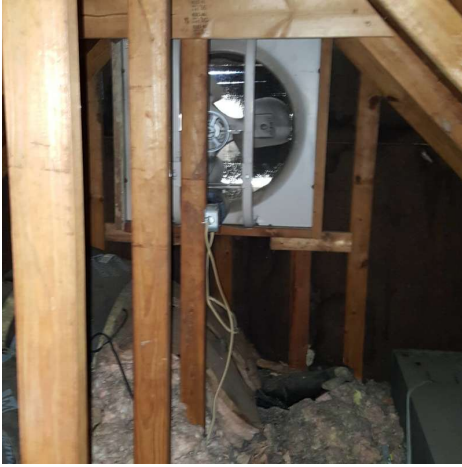
Ventilation: Powered Attic Fan Present

A powered attic fan is installed. These fans are not recommended unless an accurate balance of intake ventilation is provided for the amount of exhaust ventilation (CFM) the fan provides. Other exhaust ventilation should be factored in as well. This type of system will mostly only draw conditioned air up from the home if the system is not accurately balanced. The end result can be reduced efficiency and in extreme cases moisture issues in the attic.

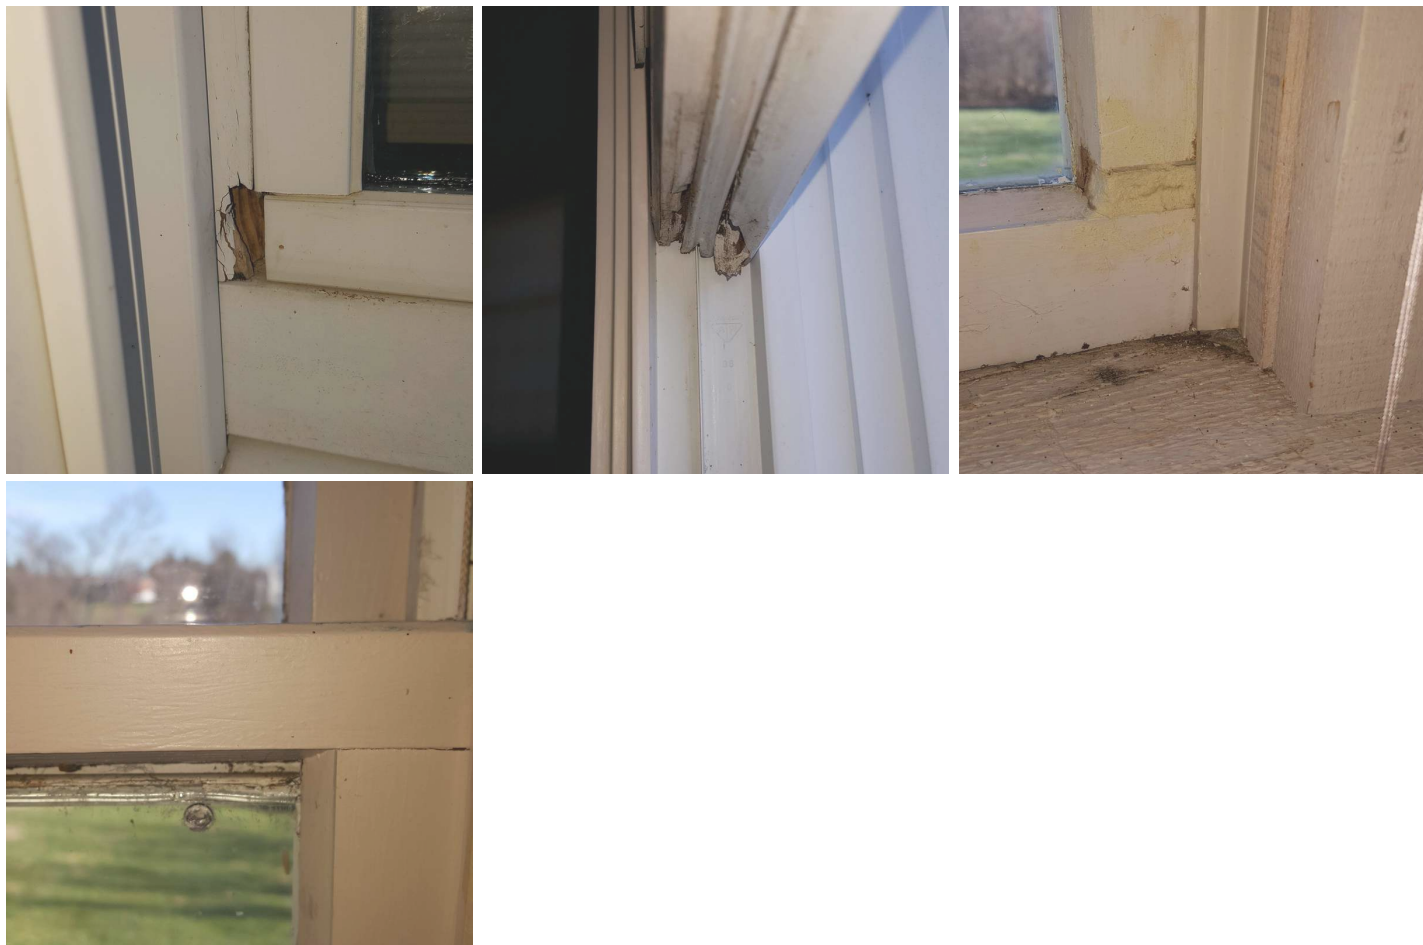
6.3.4 Windows

SASH IS DAMAGED

Some windows have damaged sashes. Some Anderson windows faced a class-action lawsuit for this very issue. We can not determine if these particular windows are involved in the class action. Replace any windows with damaged sashes.

Recommendation

Contact a qualified window repair/installation contractor.

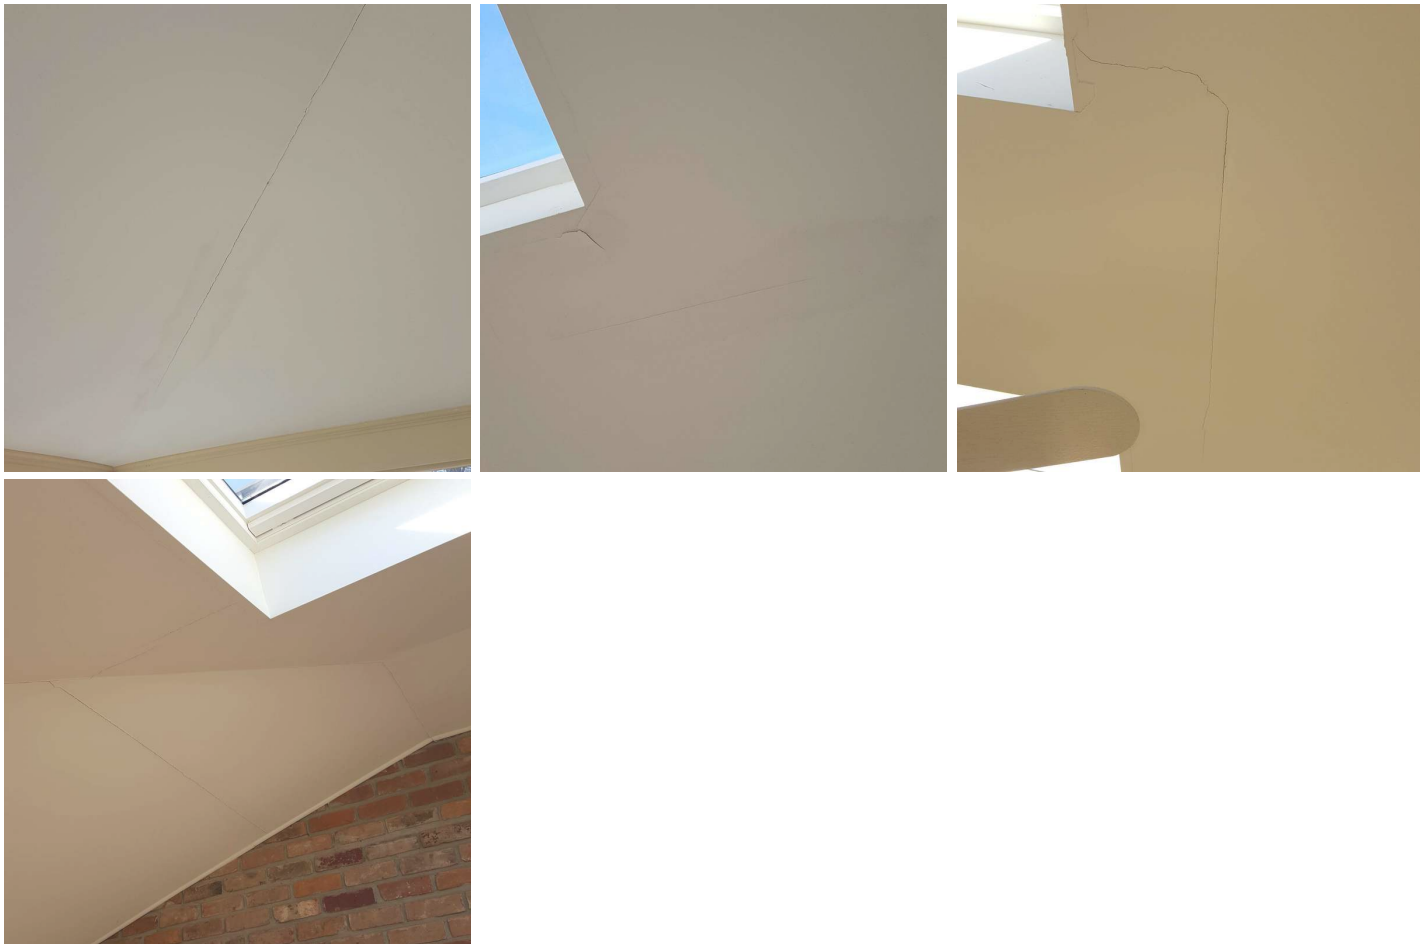
6.7.2 Ceilings

STAIN(S) ON CEILING

There is a stain on ceiling/wall that requires attention. This may represent a prior, periodic, or on-going leak/high moisture. We were unable to determine the cause. The source of the staining should be determined. Recommend further evaluation and action as necessary. All water damaged materials should be removed to prevent mold and allow future leaks to be more easily detected.

Recommendation

Contact a qualified professional.

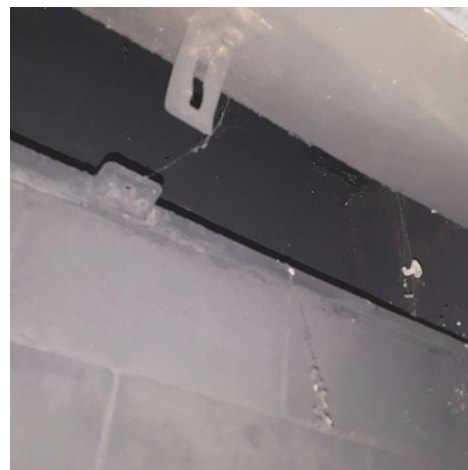
Damper was inoperable, which can prevent proper operation of the fireplace. Recommend a qualified fireplace contractor evaluate and repair.

Recommendation

Contact a qualified chimney contractor.

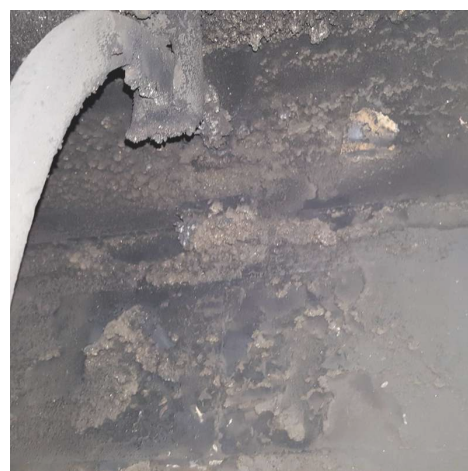
7.3.2 Solid Fuel Heating Device (Fireplace, Woodstove)

Significant creosote buildup is noted. Recommend having the chimney cleaned by a qualified chimney sweep prior to using.

Recommendation

Contact a qualified chimney sweep.

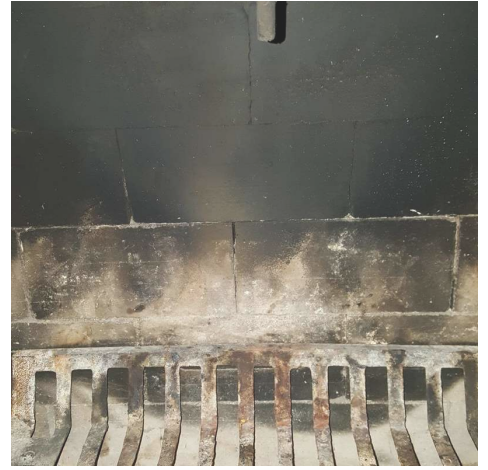
7.3.3 Solid Fuel Heating Device (Fireplace, Woodstove)

MISSING MORTAR

Missing mortar can allow heat or embers into the chimney chase.
Repair the mortar.

Recommendation

Contact a qualified chimney contractor.

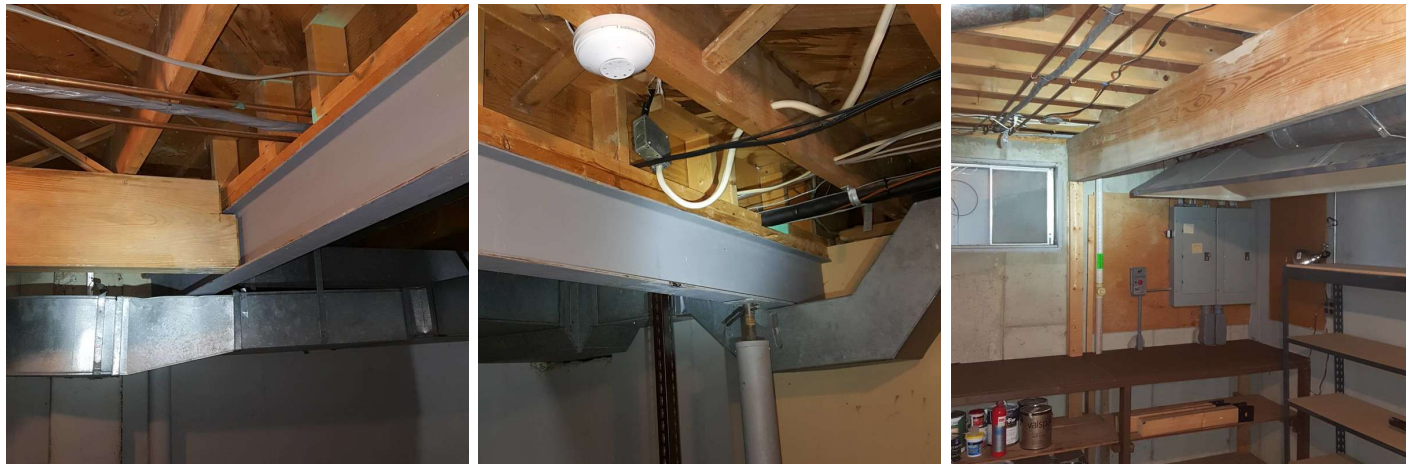
Basement Right Side

Previous repairs have been made to the floor structure below the kitchen. A steel beam has been added and a double beam has been added. Inquire with the seller as to the reason for these repairs and obtain design documents for this repair. If design documents are not available have the repair evaluated by a structural engineer.

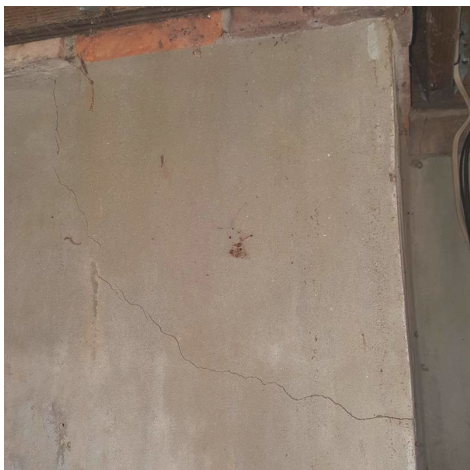
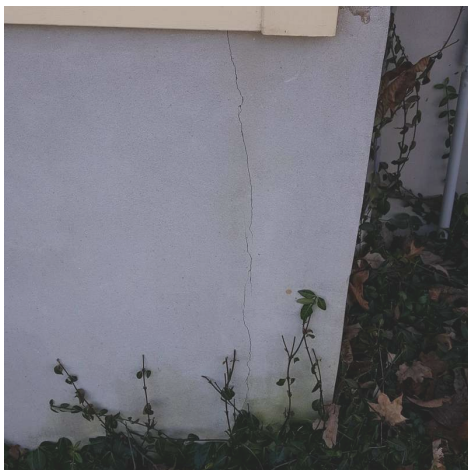
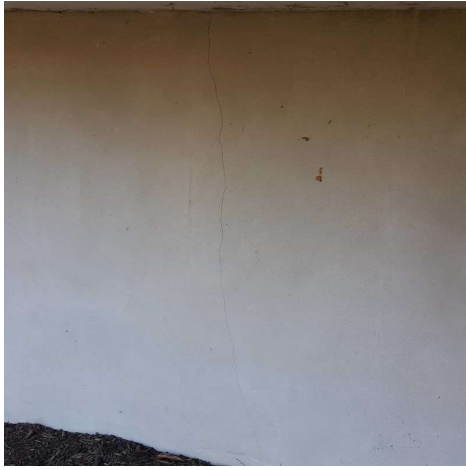
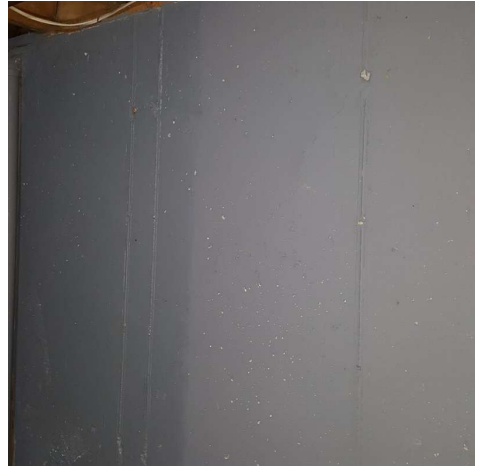
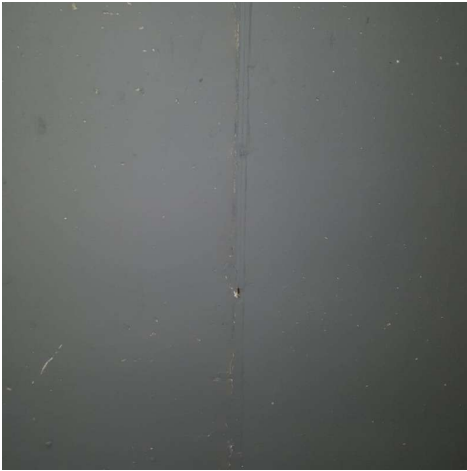
8.2.2 Foundation

FOUNDATION CRACKS - MODERATE

Moderate cracking is noted at the foundation. This is typically consistent with soil movement or soil pressure and could lead to serious damage to structural components, foundation and/or slabs.

Make all necessary grading, drainage, and gutter repairs. Recommend a structural engineer or qualified foundation repair specialist evaluate and provide a report on course of action and remedy. If a structural engineer designs a repair that same engineer should return after the repairs are made to certify the repairs.

Recommendation

Contact a foundation contractor.

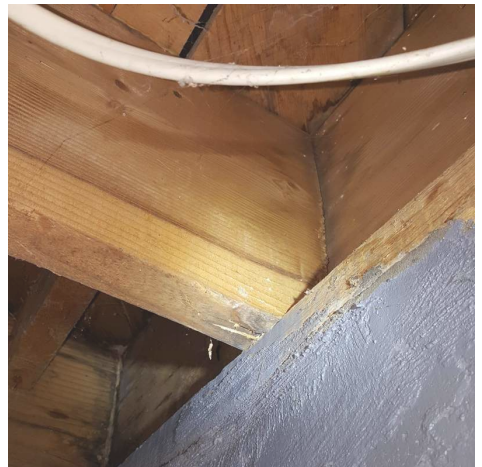
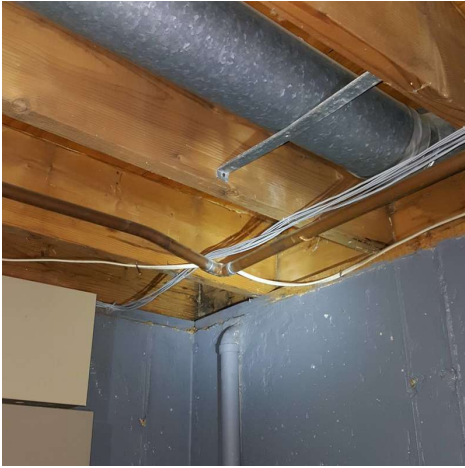
8.4.1 Floor Structure

EVIDENCE OF STRUCTURAL DAMAGE

Recommendation

Contact a qualified structural engineer.

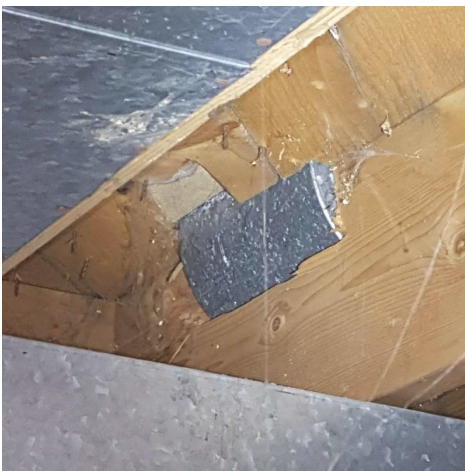
8.4.2 Floor Structure

Moderate Concern

Recommendation

Contact a qualified structural engineer.

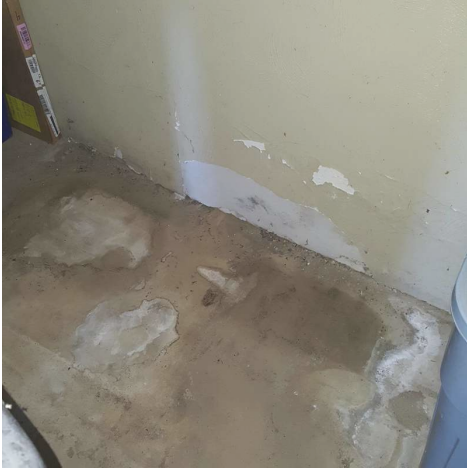
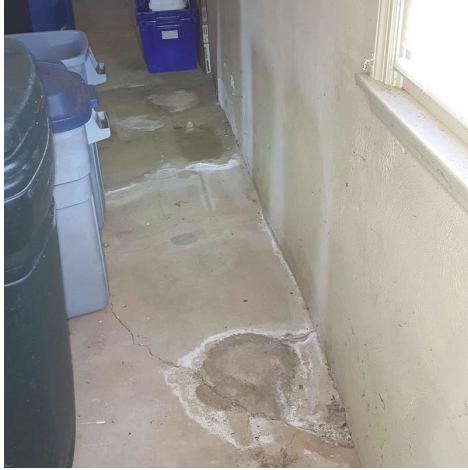
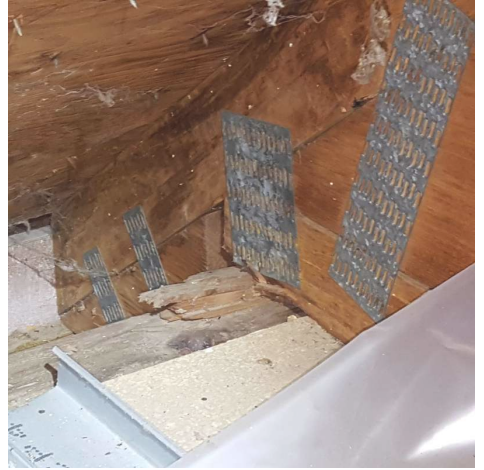
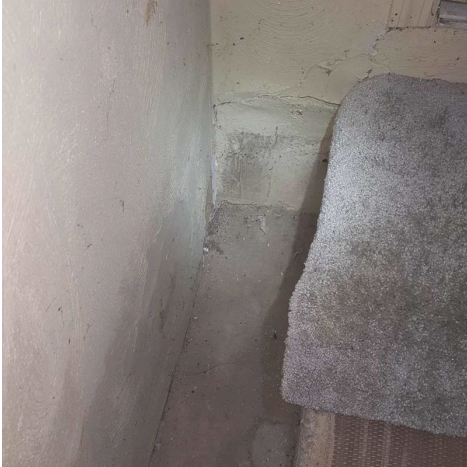
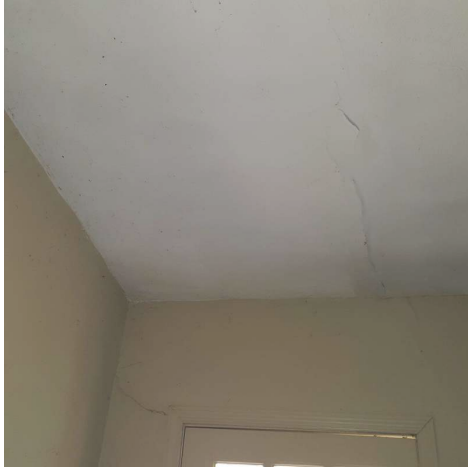
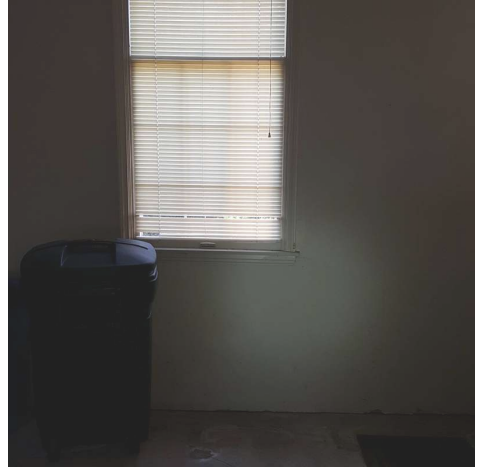
8.5.1 Wall Structure

Major Concern

Recommendation

Contact a qualified structural engineer.

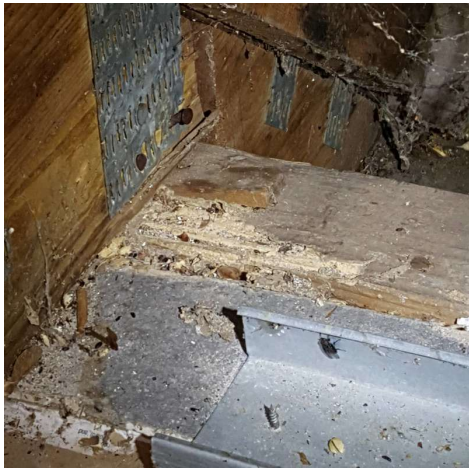
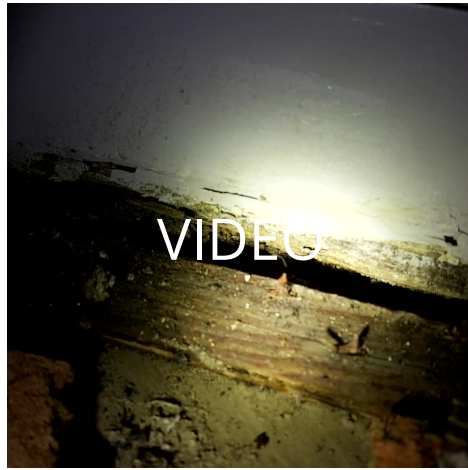
8.5.2 Wall Structure

TERMITE DAMAGE TO WALL STRUCTURE

Recommendation

Contact a qualified professional.

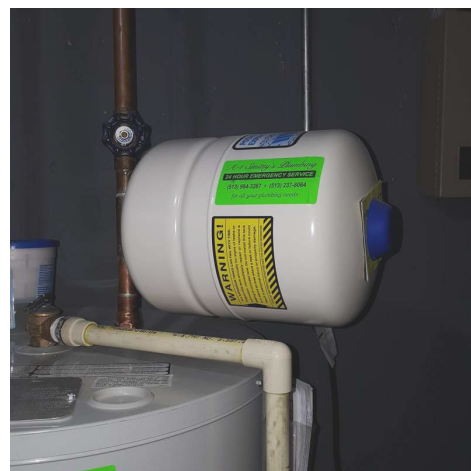
13.3.1 Water Heating Appliance 2

EXPANSION TANK IS NOT SUPPORTED

Recommendation

Contact a handyman or DIY project

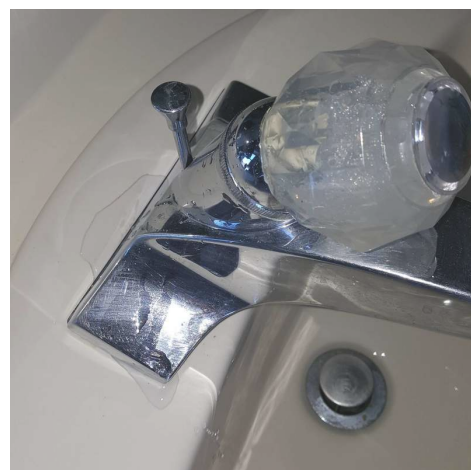
13.11.1 Sinks

FAUCET IS IN NEED OF SERVICE

Recommendation

Contact a qualified plumbing contractor.

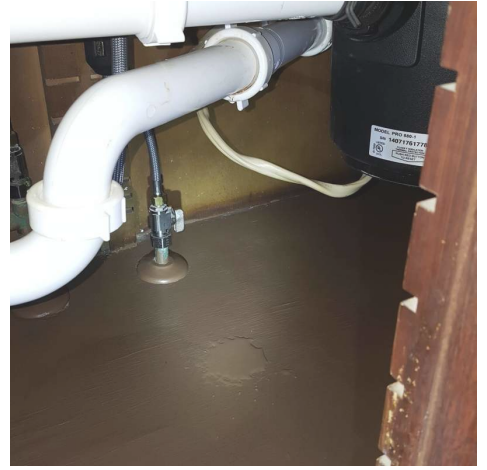
13.11.2 Sinks

LEAKING DRAIN

Recommendation

Contact a qualified plumbing contractor.

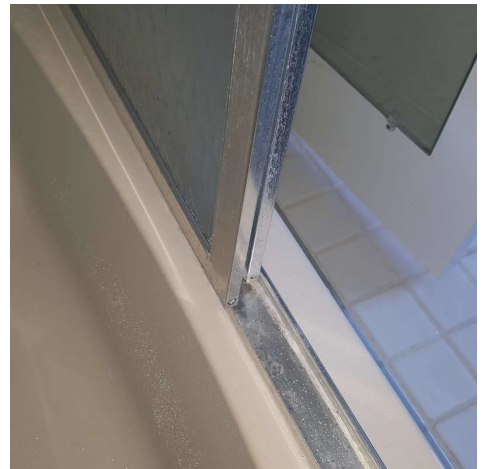
13.12.1 Shower/Tub

DRAIN STOPPER IS NOT WORKING

Recommendation

Contact a qualified handyman.

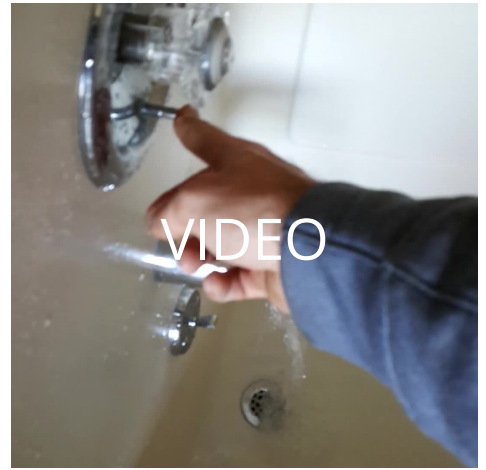
13.12.3 Shower/Tub

HOT AND COLD WATER LINES ARE REVERSED

Recommendation

Contact a qualified plumbing contractor.

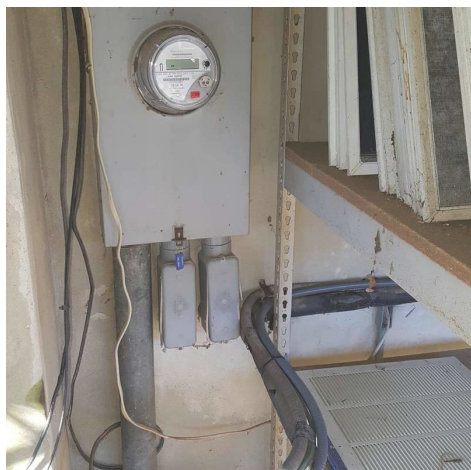
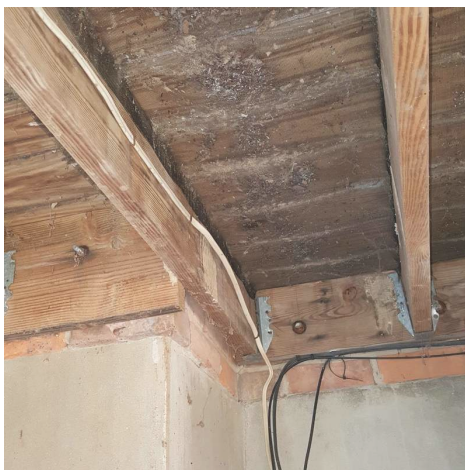
Wires can be damaged. Exposed wiring susceptible to damage is recommended to be installed in conduit.

Contact a qualified electrical contractor.

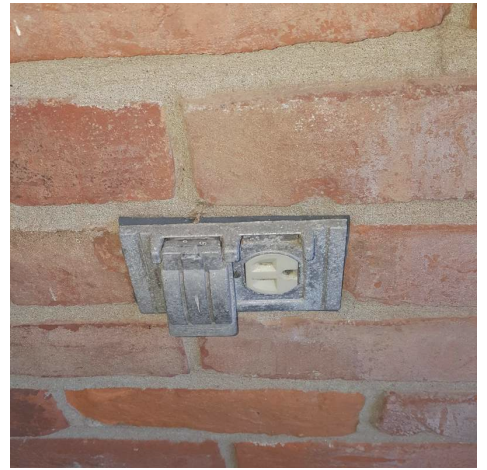
COVER PLATES DAMAGED

One or more receptacles have a damaged cover plate. Recommend replacement.

Contact a qualified electrical contractor.

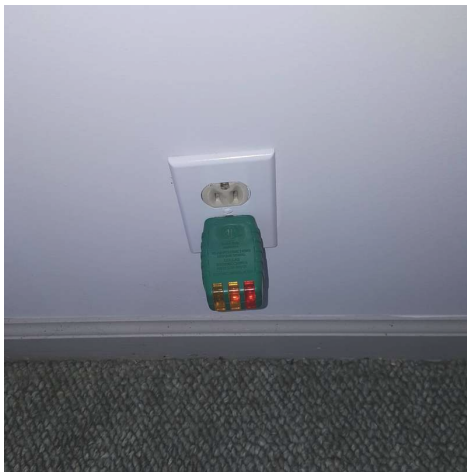
14.6.2 Lighting Fixtures, Switches & Receptacles

REVERSE POLARITY

One or more receptacles have been wired with reverse polarity. This can create a shock hazard and potentially damage appliances or items connected to this receptacle. Recommend licensed electrical contractor evaluate and repair as necessary.

Contact a qualified electrical contractor.

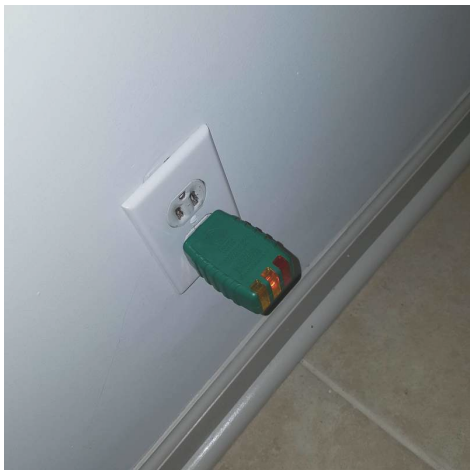
14.6.3 Lighting Fixtures, Switches & Receptacles

UNGROUNDED RECEPTACLE

One or more receptacles are ungrounded. To eliminate safety hazards, all 3-prong receptacles should be grounded. Where grounding is not possible (No ground wire present) a 2-prong receptacle or GFCI protected receptacles can be installed.

Have a licensed electrical contractor make further evaluation and repair as necessary for the safest operation.

Contact a qualified electrical contractor.

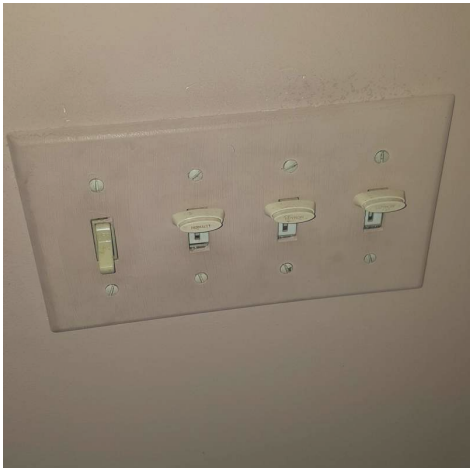
14.6.4 Lighting Fixtures, Switches & Receptacles

This may be a sign of a faulty switch. Have a licensed electrical contractor make further evaluation and repair as necessary.

Contact a qualified electrical contractor.

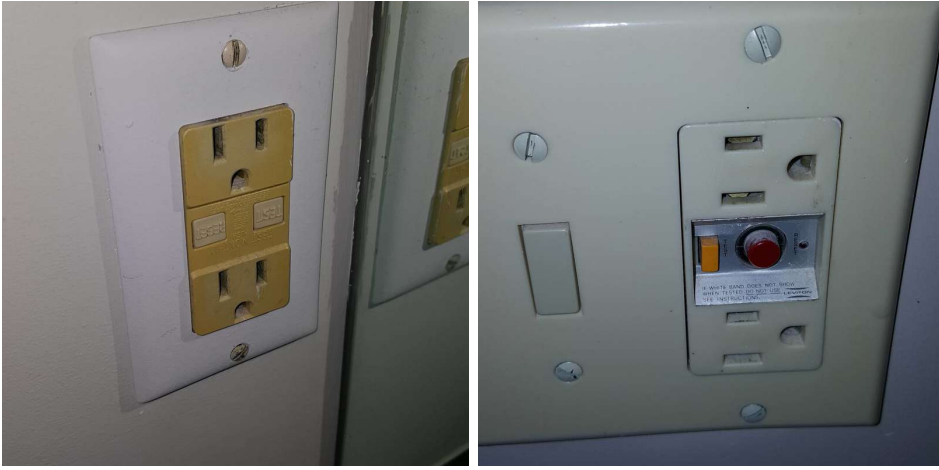
14.7.1 GFCI & AFCI

A GFCI that does not trip or reset does not provide the safety protection it was designed for. Have a licensed electrical contractor replace the receptacle.

Contact a qualified electrical contractor.
