SLAB TO SLATE HOME INSPECTIONS, LLC

HOME INSPECTION REPORT

1234 Main St.
Newport KY 41071

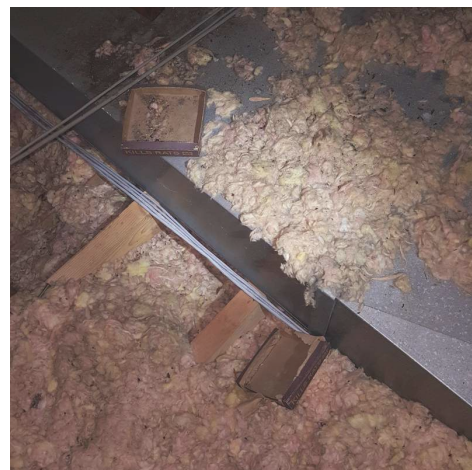
Rodents are best dealt with using a combination of exclusion (keeping mice out) and treatment by a professional pest control company. Rodents can cause hidden damage to insulation and other building materials.
