## RESIDENTIAL REPORT

1234 Main St.  
STANWOOD Washington 98292

03/25/2018 9:00AM

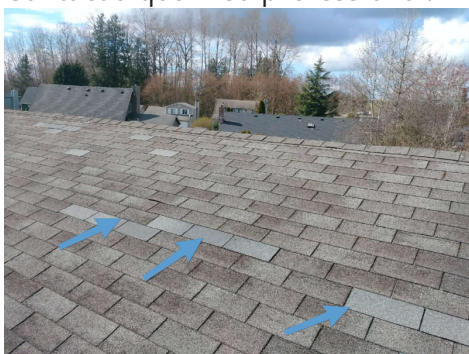
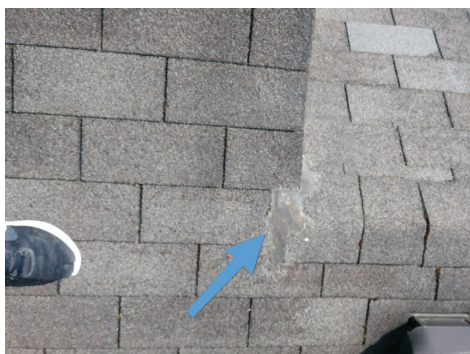
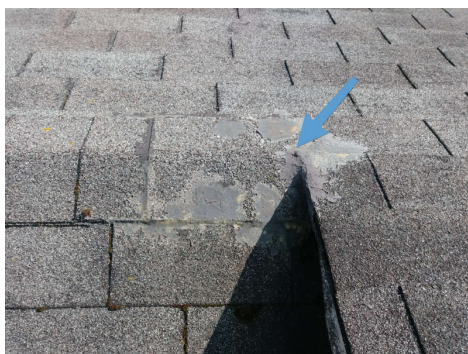
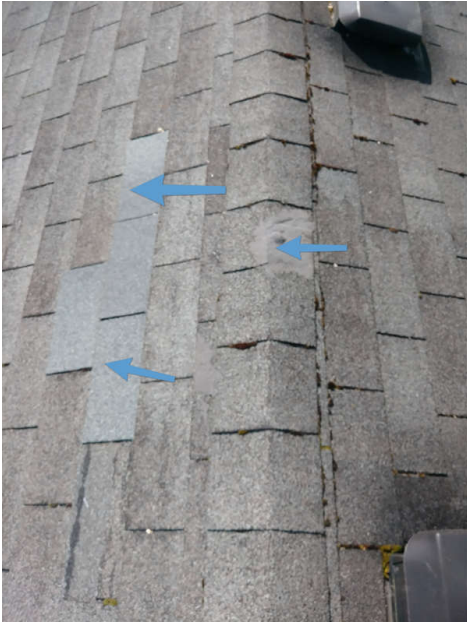
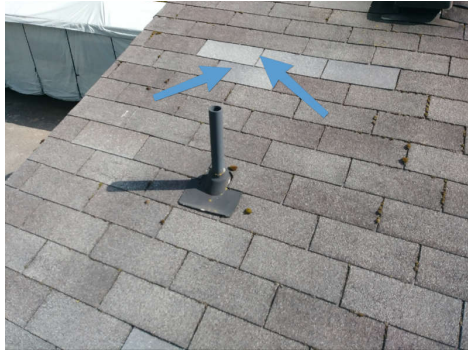
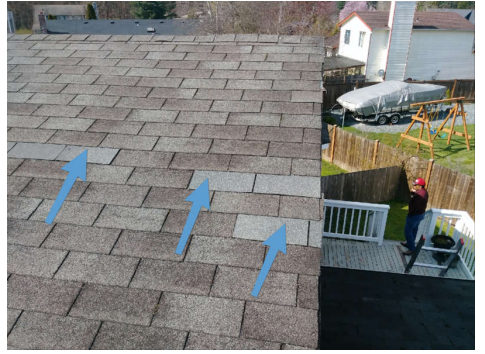
2.1.1 Coverings

**REPLACEMENT**

Roof is at or beyond expected life span. Shingles are cracked, warped, and delaminating. Multiple repairs have been made. Recommend replacement of the roof by a licensed/qualified roofer.

Recommendation

Contact a qualified professional.

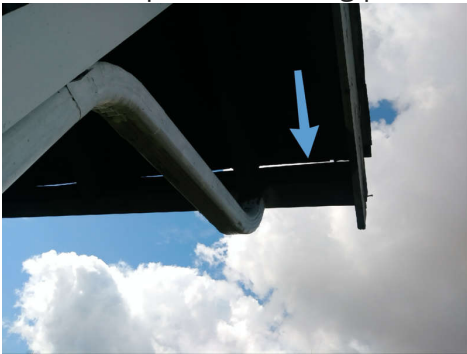
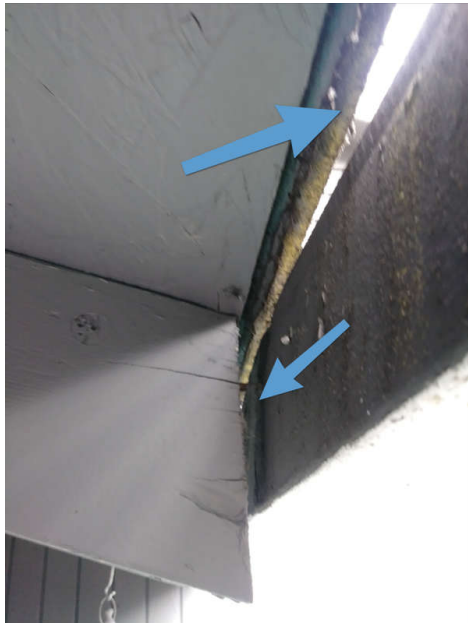
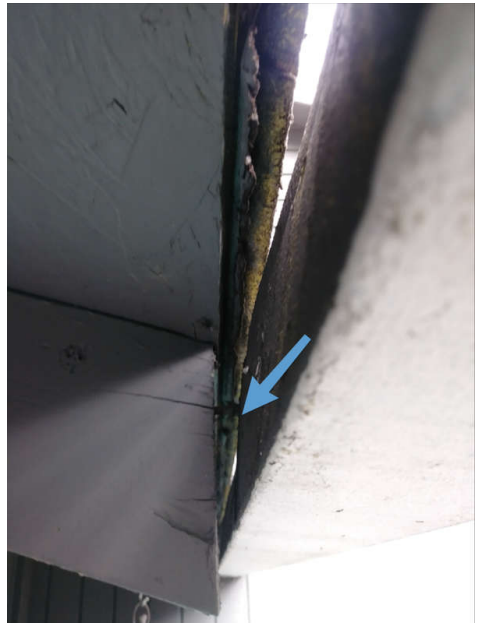
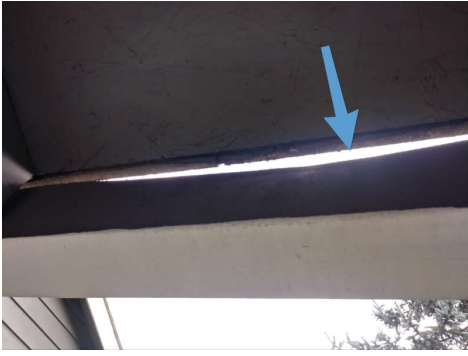
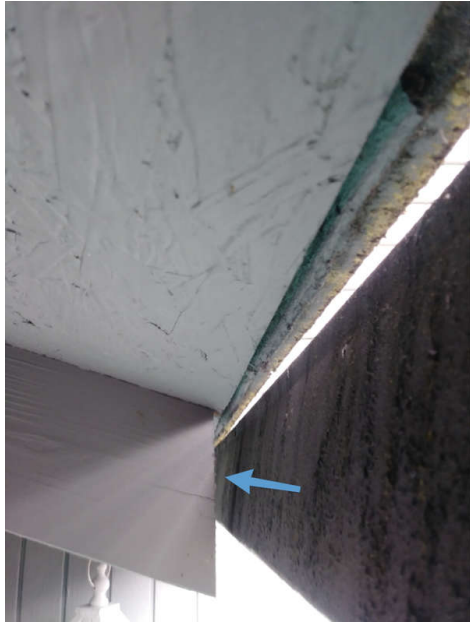
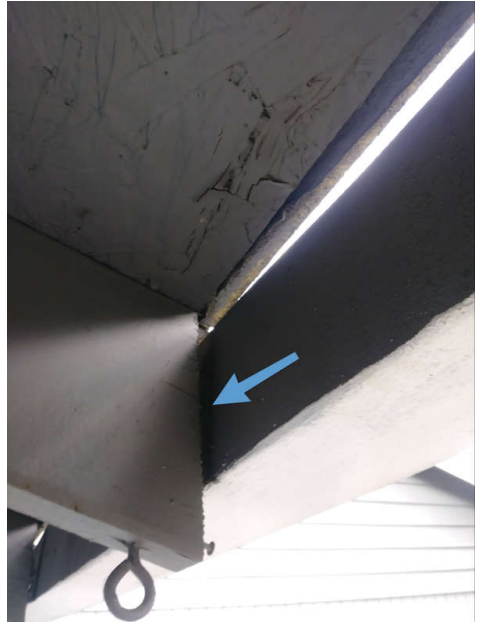
2.2.1 Roof Drainage Systems

**GUTTERS INSTALLATION IS LOOSE**

In one or more places the gutters were coming away from the house. I recommend having gutters re-installed and secured to the house.

When the new roof is installed, make sure there is proper overhang into the gutters.

Recommendation

Contact a qualified roofing professional.

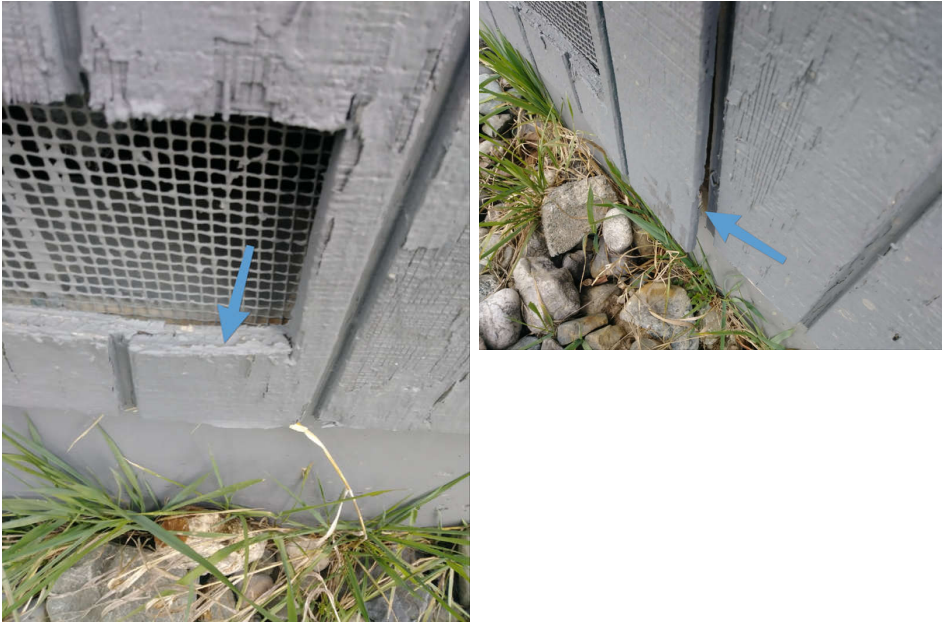
### 3.1.1 Siding, Flashing & Trim

#### LOOSE BOARDS

One or more siding boards were loose, which could result in moisture intrusion. Recommend a qualified siding contractor secure and fasten.

#### Recommendation

Contact a qualified professional.

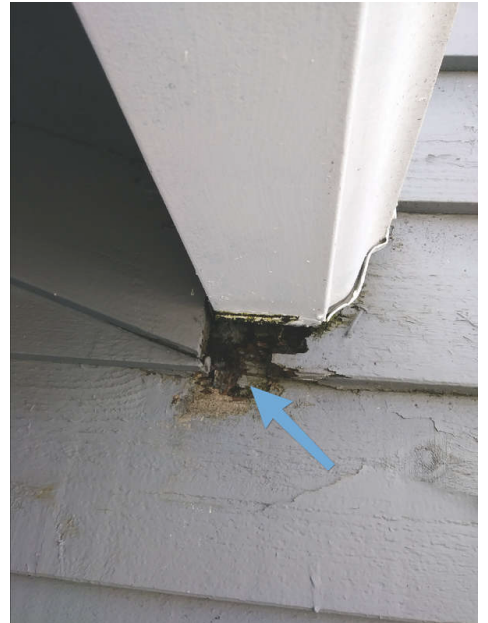
### 3.1.2 Siding, Flashing & Trim

#### **ROT - MINOR**

Signs of rot in the siding was noted in several locations around the house. Gutter end appears to be leaking, causing water damage and rot to the siding. Recommend further evaluation and repairs as needed to prevent further damage.

#### Recommendation

Contact a qualified professional.

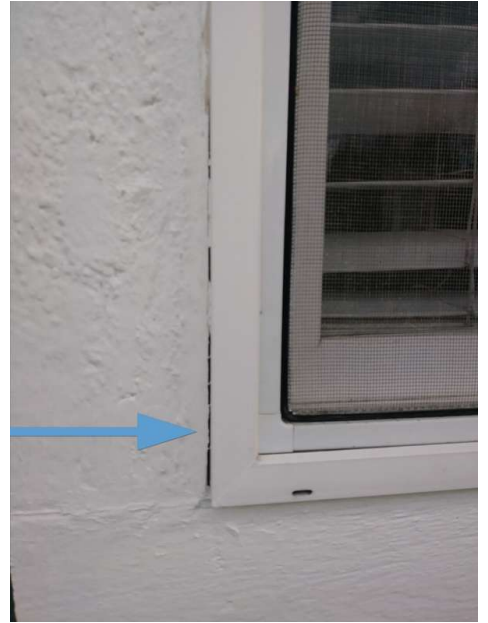
### 3.1.3 Siding, Flashing & Trim

#### **CAULKING CRACKING**

Caulking around one or more windows was cracking. I recommend cleaning out old caulking, and sealing with new caulking to prevent any potential moisture intrusion issues.

#### Recommendation

Recommended DIY Project

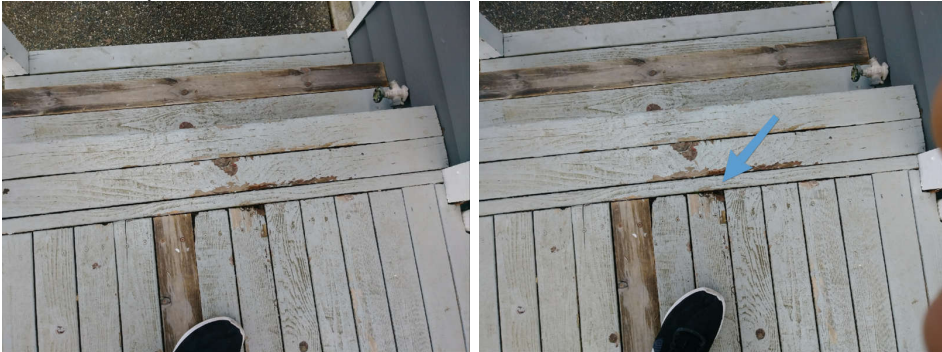
3.4.1 Decks, Balconies, Porches & Steps

**DECK - ROTTED BOARDS**

One or more deck boards are showing signs of rot. Recommend a qualified deck contractor replace.

Recommendation

Contact a qualified deck contractor.

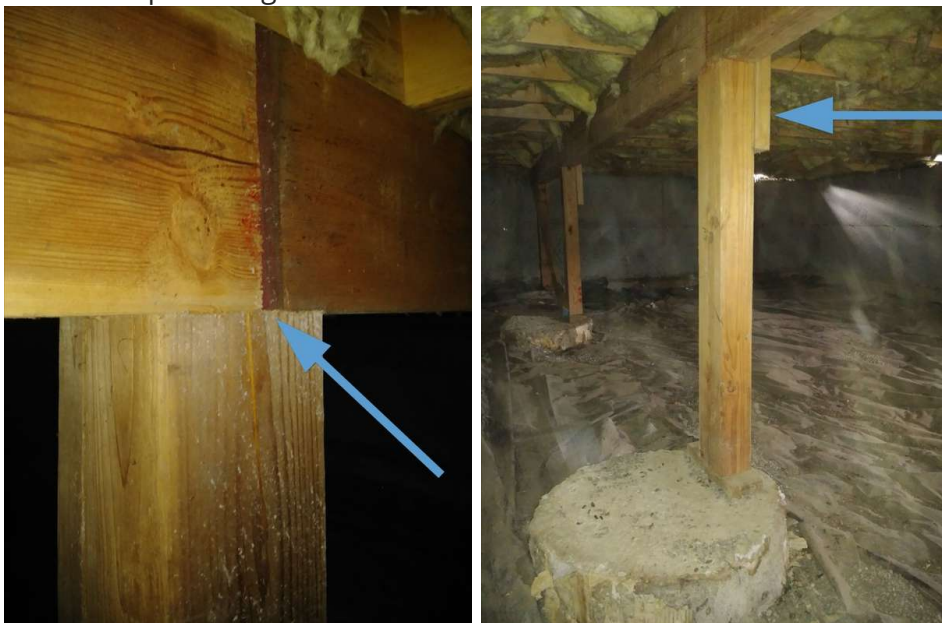
### 4.2.1 Basements & Crawlspace

#### BEAM CONNECTIONS

Under the house in the crawl space, the post and beam connections are only made on one side of each post/beam. I recommend installing positive connections on each side of every post/beam.

Recommendation

Contact a qualified general contractor.

I recommend duplicating this on the opposite side of each post.

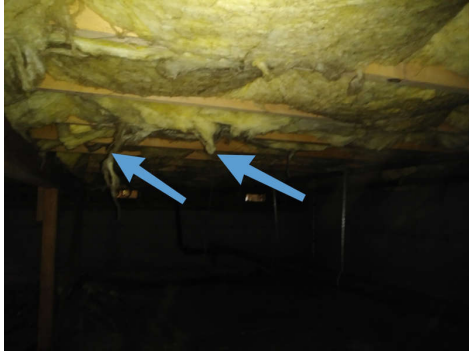
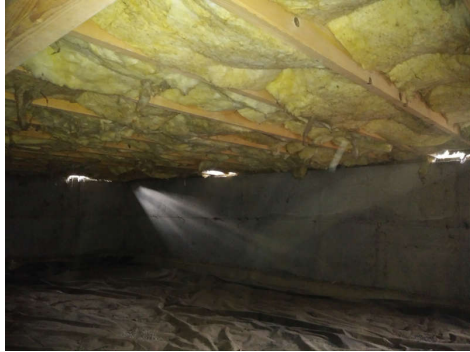
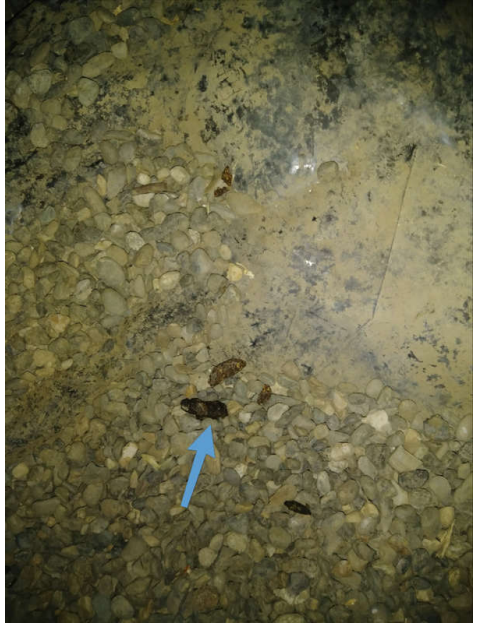
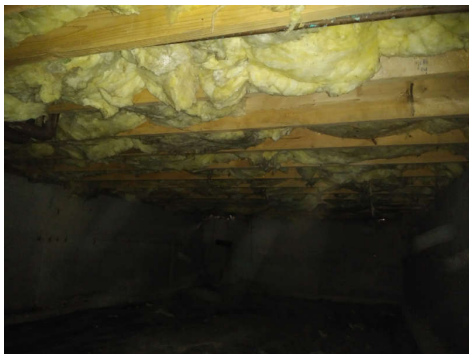
4.2.2 Basements & Crawlspaces

**RODENT**

Rodent evidence was present in the crawl space. Droppings on the vapor barrier and one dead carcass found. Reccommend monitoring and having pest control contractor evaluate if necessary.

Recommendation

Contact a qualified professional.

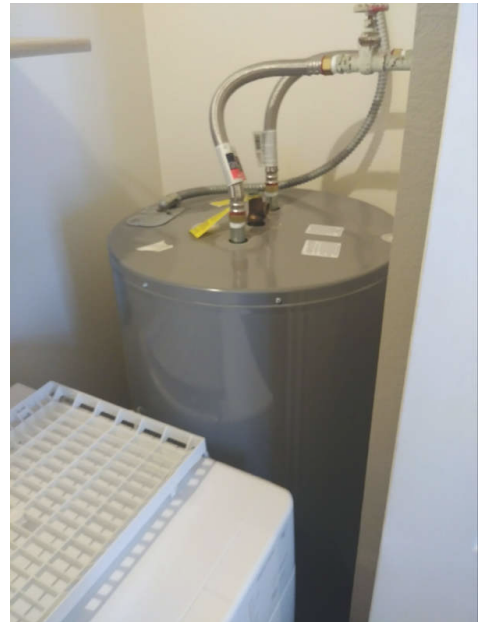
**Observations****6.4.1 Hot Water Systems, Controls, Flues & Vents****NO EXPANSION TANK**

No expansion tank was present. Expansion tanks allow for the thermal expansion of water in the pipes. These are required in certain areas for new installs. Recommend a qualified plumber evaluate and install.

## Recommendation

Contact a qualified plumbing contractor.

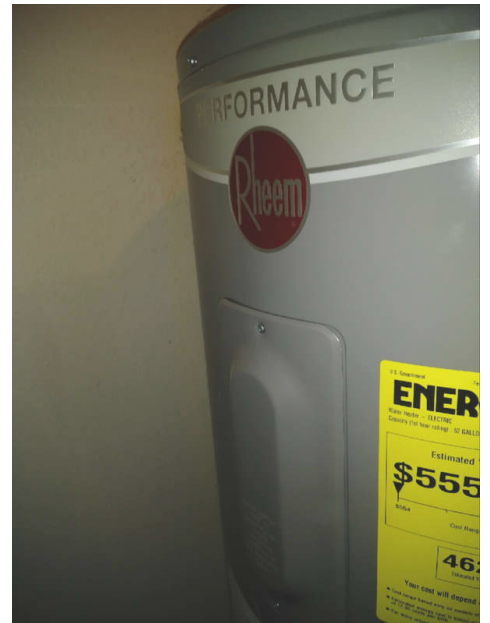
## 6.4.2 Hot Water Systems, Controls, Flues &amp; Vents

**EARTHQUAKE STRAPS MISSING**

At the time of inspection no earthquake straps were installed. The home owner showed me the straps and said they plan on installing. Recommend verifying installation of straps.

## Recommendation

Contact a qualified professional.

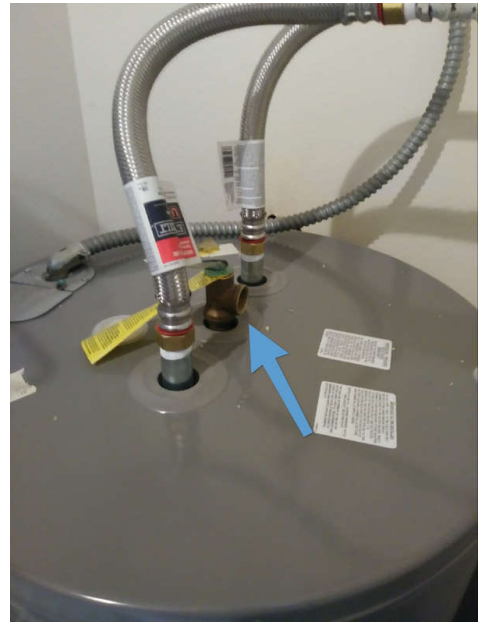
## 6.4.3 Hot Water Systems, Controls, Flues &amp; Vents

**TPR VALVE NOT CONNECTED**

TPR valve was not connected. It is important that these are connected properly. I recommend licensed plumber connects the TPR properly.

## Recommendation

Contact a qualified professional.

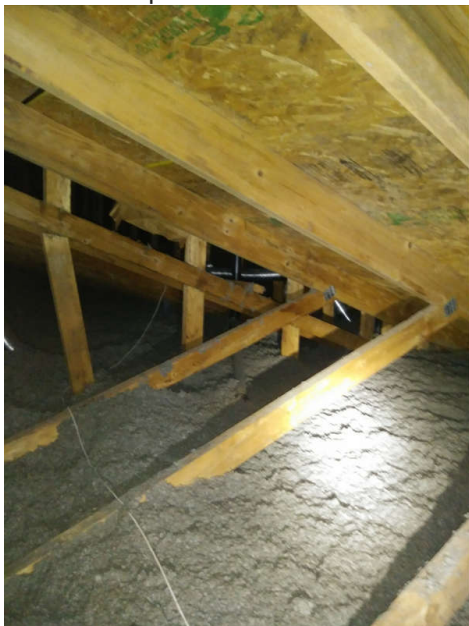
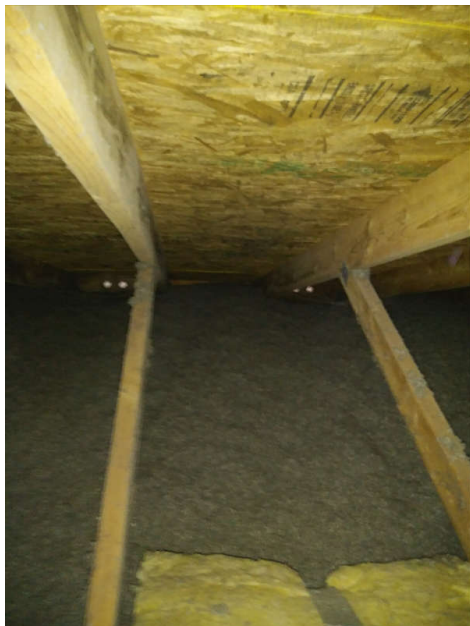
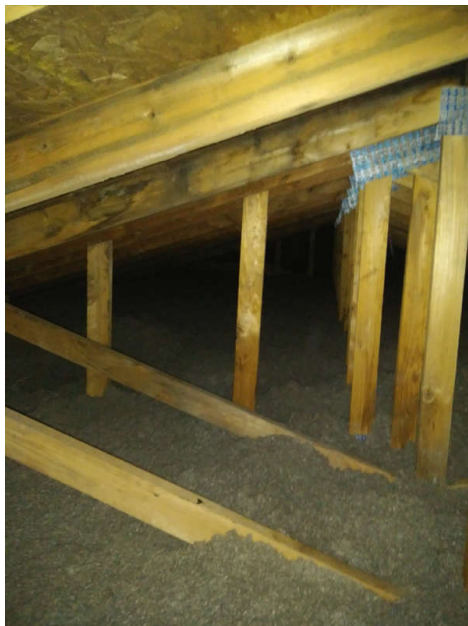
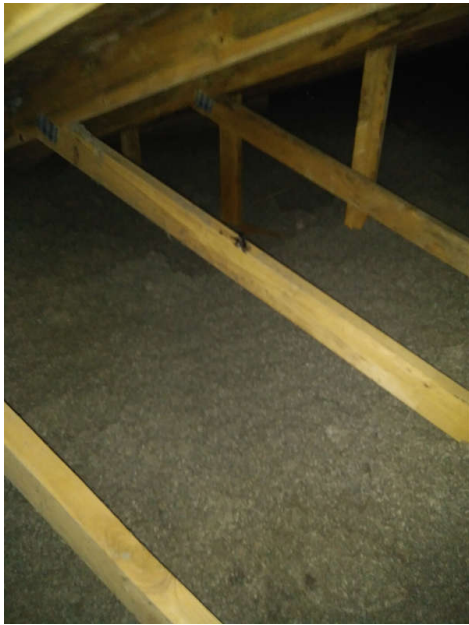
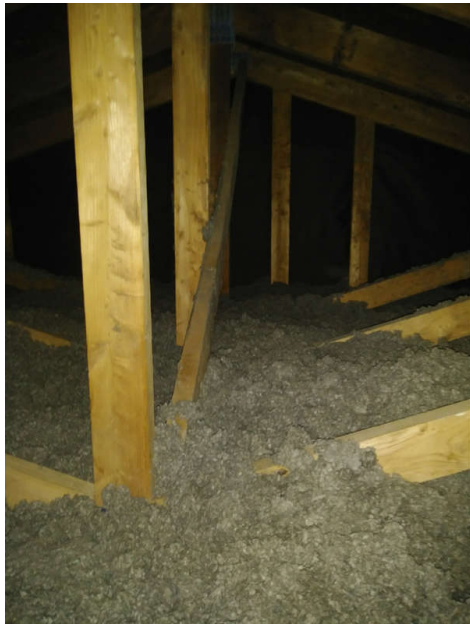
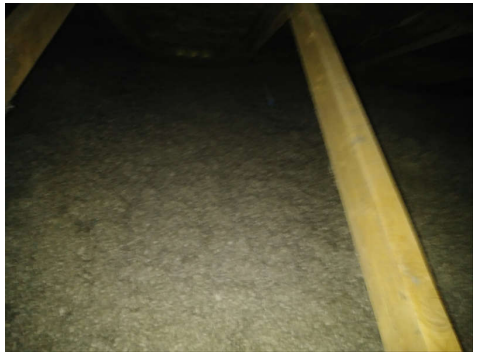
### 8.1.1 Attic Insulation

#### INSUFFICIENT INSULATION

Insulation depth was inadequate. Recommend a qualified attic insulation contractor install additional insulation. Approximately 12" thick will achieve a R38 value in the attic.

#### Recommendation

Contact a qualified insulation contractor.

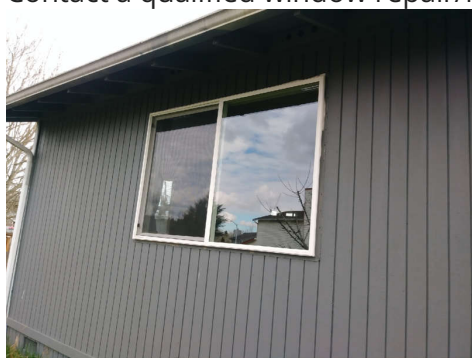
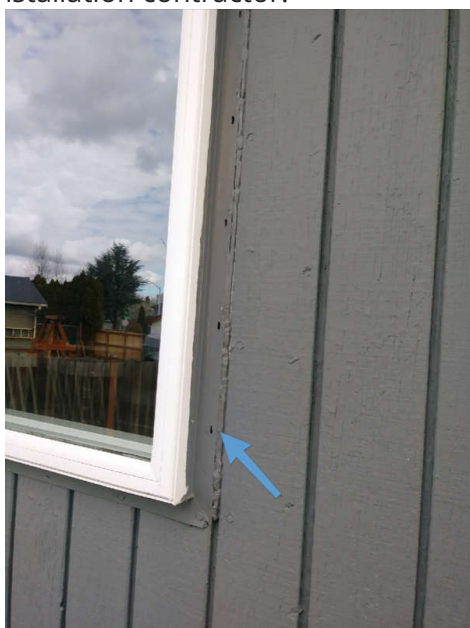
9.2.1 Windows

**IMPROPER INSTALLATION**

Windows was installed directly over the siding with no window trim installed. The flange is nailed and caulked to the siding. Exterior window trim should be installed, and sealed to prevent any potential water intrusion issues.

Recommendation

Contact a qualified window repair/installation contractor.

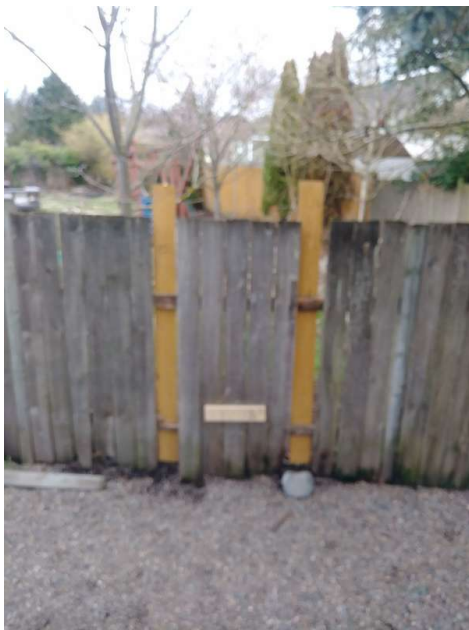
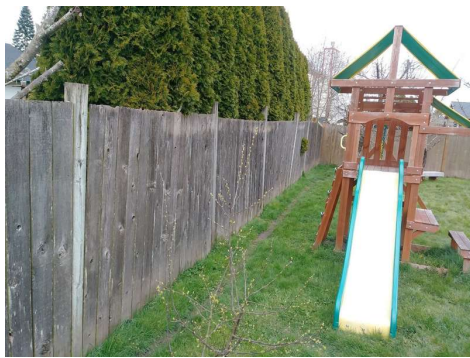
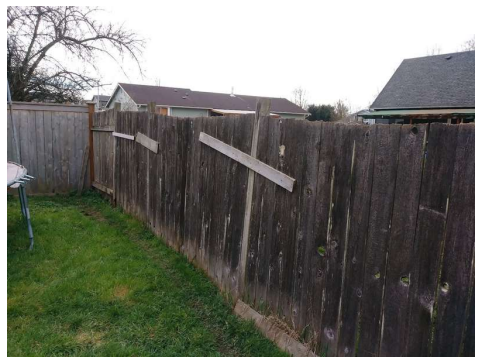
### 11.1.1 Fence Condition

#### **FENCE WORN OUT**

In one or more places the fence showed signs of wear and in need of repairs/replacement. I recommend a licensed contractor evaluates and repairs/replaces as needed.
