RESIDENTIAL INSPECTION (NJ STANDARDS)

1234 Main St.
Laurelton NJ 08723

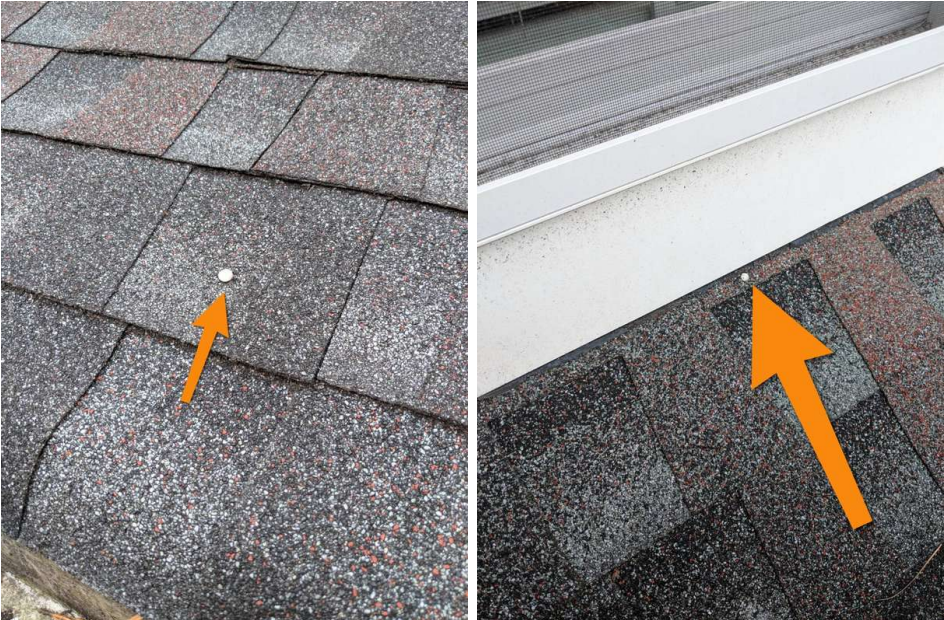
2.1.2 Coverings

CRACKED/BROKEN/BUCKLED/MISSING

The roof had one or more cracked/broken/buckled/missing shingle/s. Recommend a qualified roof contractor repair or replace to prevent moisture intrusion.

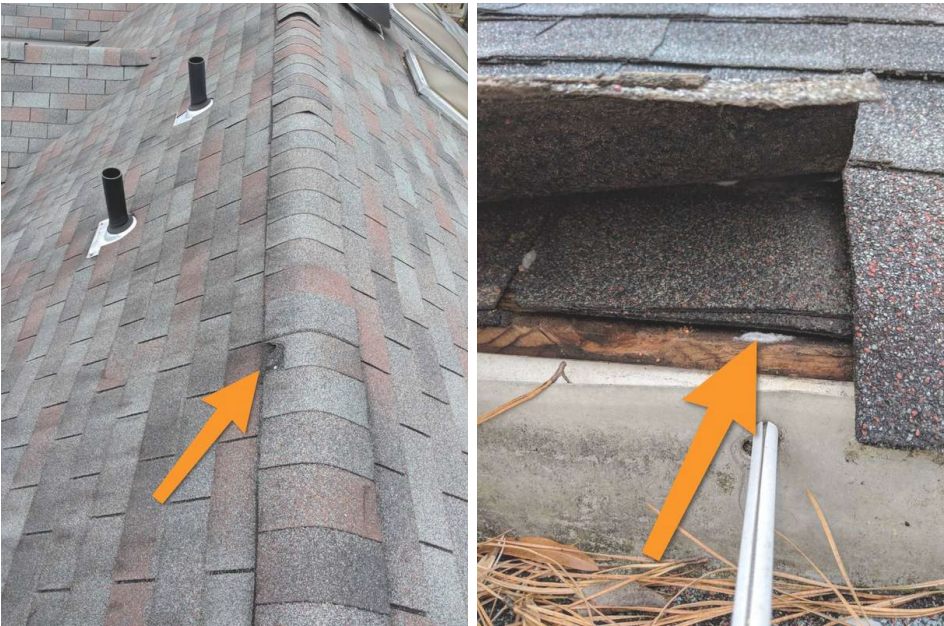
2.1.3 Coverings

MODERATE ROOF DETERIORATION WITH DEFICIENCIES

At the time of the inspection, asphalt composition shingles covering the roof exhibited moderate general deterioration commensurate with the age of the roof.

The inspector recommends budgeting for and replacing the roof coverings as soon as possible.

The inspector also recommends if the roof is not replaced immediately, to repair any roof deficiencies listed, so any near future deterioration will be limited until a new roof covering is installed.

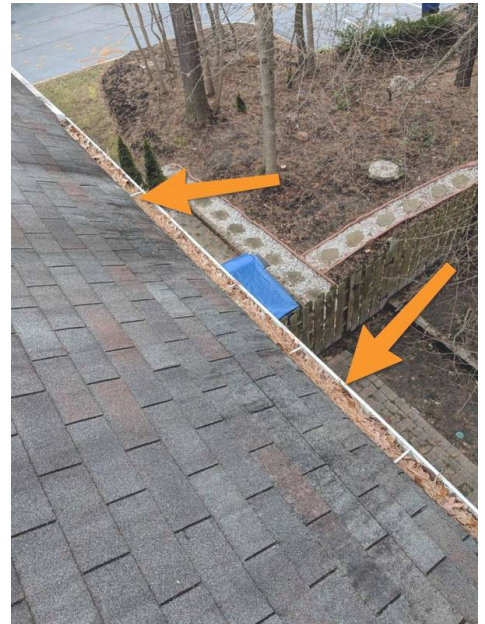
2.2.2 Roof Drainage Systems

GUTTER DAMAGED

In some areas, the gutters were damaged and the aluminum nails holding the gutter were backing out in others. This can result in excessive moisture in the soil at the foundation, which can lead to foundation/structural movement.

Recommend a qualified contractor evaluate and repair.

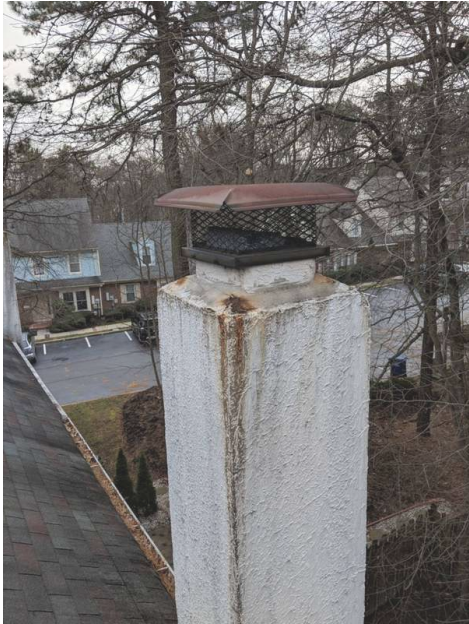
2.4.2 Chimney Exterior

CHIMNEY MASONRY PAINT/STUCCO DETERIORATED

The Chimney masonry paint/stucco showed signs of being deteriorated. To extend the lifespan of the chimney and to ensure that safe conditions exist, the Inspector recommends evaluation and any necessary work be performed by a qualified masonry contractor.

Recommendation
Contact a qualified professional.

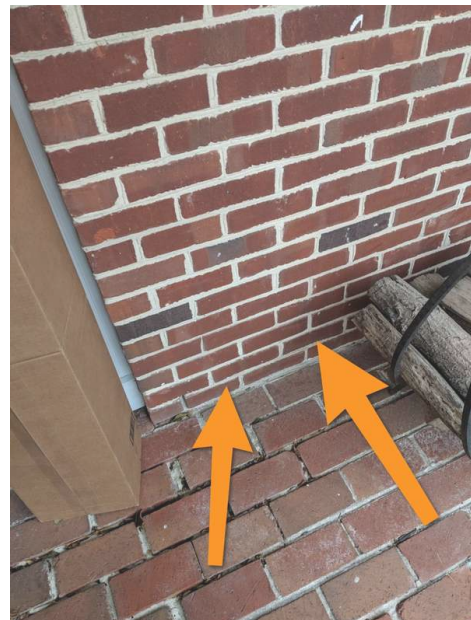
3.2.1 Siding, Flashing & Trim
WEEP HOLES MISSING

Weep holes were not apparent on the brick or stone veneer siding. Weep holes are small holes in the base of a brick or stone veneer walls, they are exit points for humidity that has permeated into the walls.

Excessive humidity can deteriorate prematurely the wall structure. Recommended qualified siding contractor evaluate and correct.

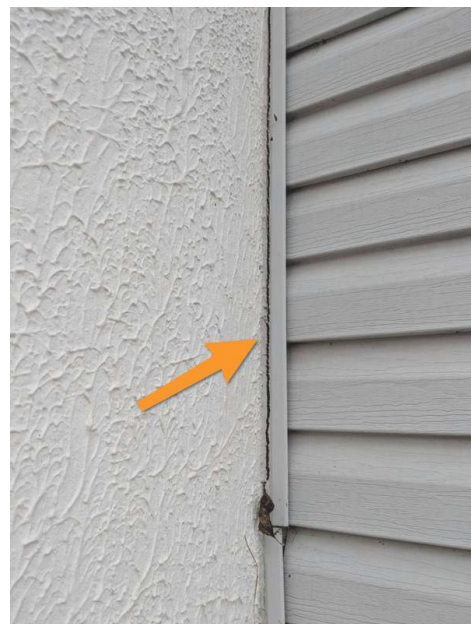
3.2.2 Siding, Flashing & Trim

CAULKING DETERIORATIONS

Caulkings around the exterior showed signs of deterioration. These caulking keep water from entering the wall cavities.

Recommend assessment of all caulking and re-caulking where needed by a qualified person.

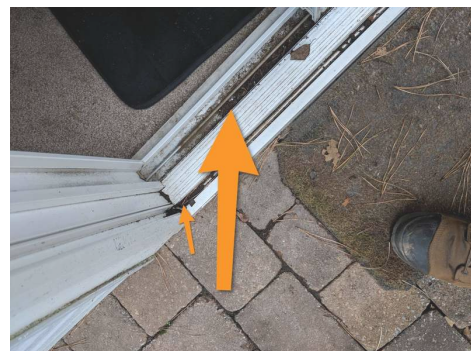
3.4.1 Exterior Doors/Slider

SLIDER TRACKS DEBRIS

Recommend cleaning of track and weep holes to prevent any water from entering the home.

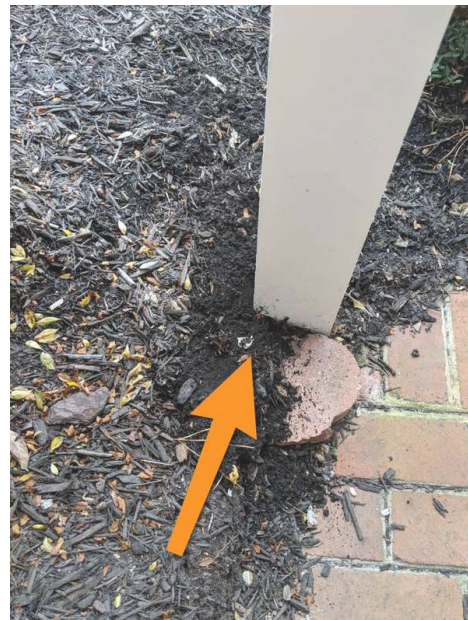
3.5.1 Decks, Balconies, Porches, and Steps

POST DETERIORATED

Recommend a qualified person repair the post and make the necessary corrections to keep the mulch from covering the post.

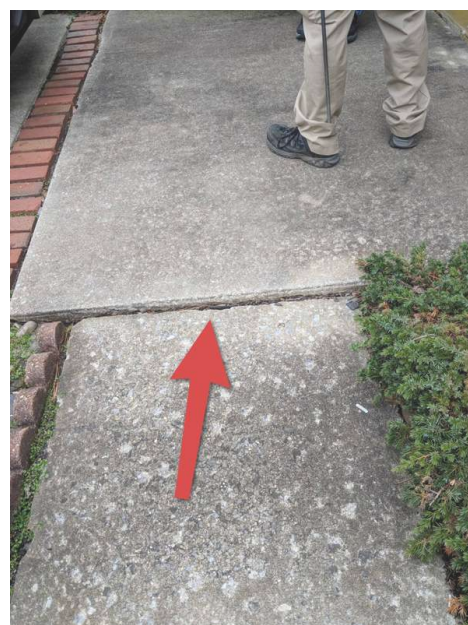
3.6.1 Walkways, Patios & Driveways

(WALKWAY) TRIP HAZARD

Trip hazards (vertical difference of 3/8 or higher) in the (walkway) appeared to be the result of the expansion or contraction (heaving or settling) of the underlying soil. For safety reasons and at a minimum, I highly recommend beveling the edge to a slope no steeper than a 1:2 ratio. Recommend a complete evaluation by a qualified contractor.

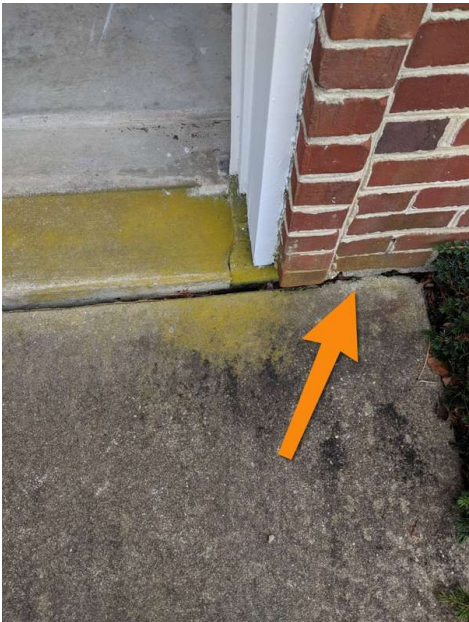
3.6.2 Walkways, Patios & Driveways

GENERAL SETTLEMENT AND HEAVING

The inspector recommends a qualified contractor assess and make any repairs as deemed necessary.

Also recommend at minimum if nothing else is done, to caulk any cracks or openings with a masonry caulk to limit the process of further deterioration.

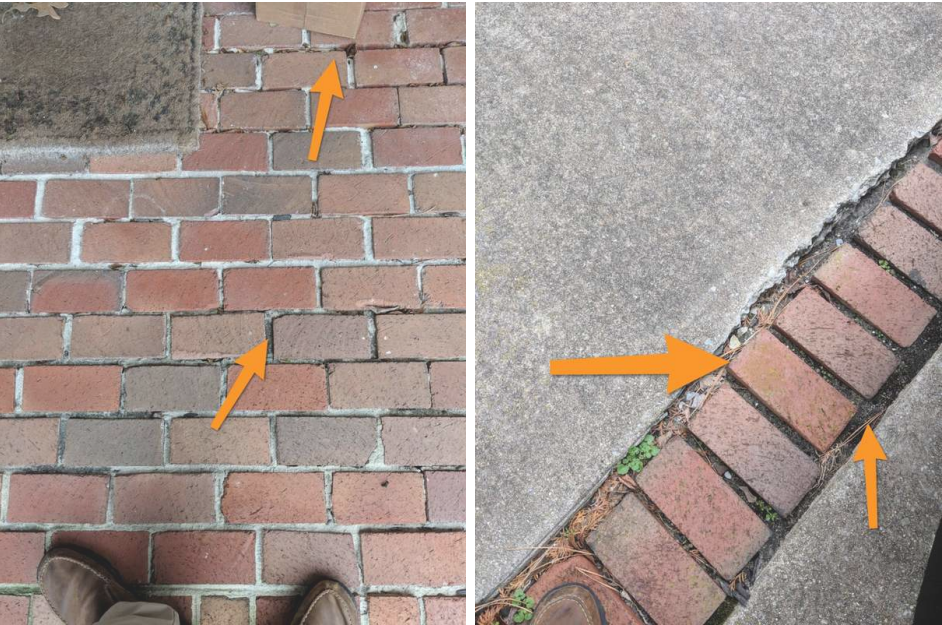
3.6.3 Walkways, Patios & Driveways

BRICK PAVER DETERIORATION

Bricks were used as pavers in the front of the house and show signs of deterioration.
Most notably the mortar joints.
Recommend repair by a qualified contractor.

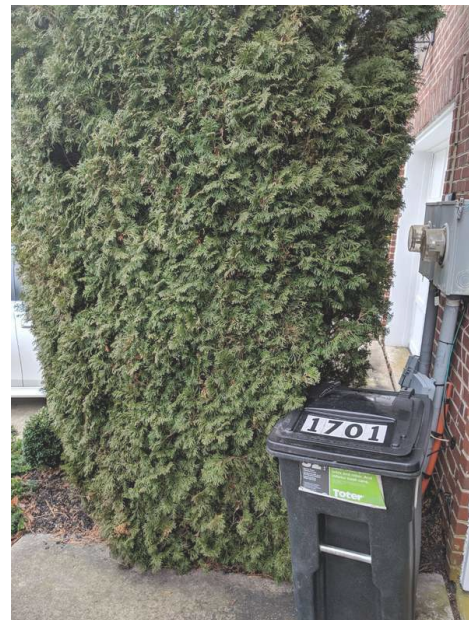
3.7.1 Vegetation, Grading, & Drainage

TREES NEAR DWELLING

Trees were observed within 10 ft of the dwelling. Trees should be more than 10ft from a home. The tree's root system can put pressure on the foundation, and exposed roots can be a trip hazard. Recommend evaluation and correction by a qualified contractor.

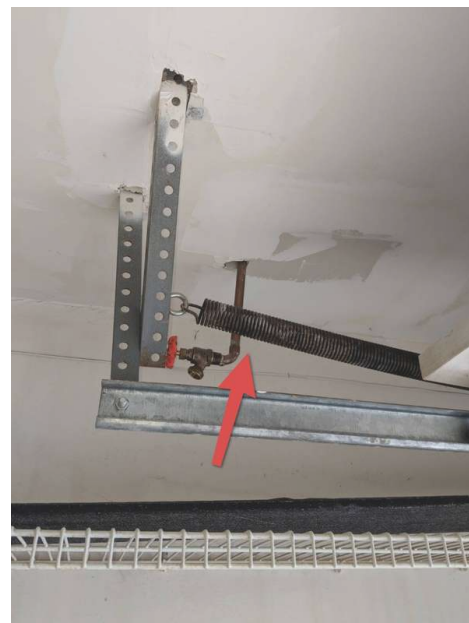
MISSING SAFETY CABLES

Installing garage door safety cables can help reduce the risk of damage and serious injury should a garage door spring break when it is under pressure. The garage door safety cable will prevent the spring from flying across the garage if it breaks. If a spring breaks it is usually when it is under pressure, and that is when it is most dangerous.

Recommend installation of safety cables by a qualified person.

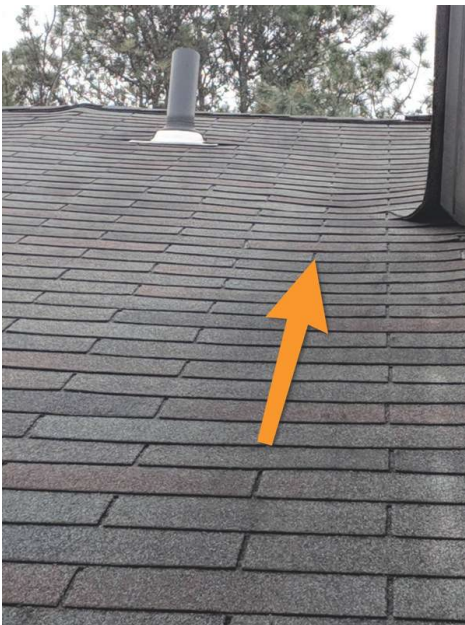
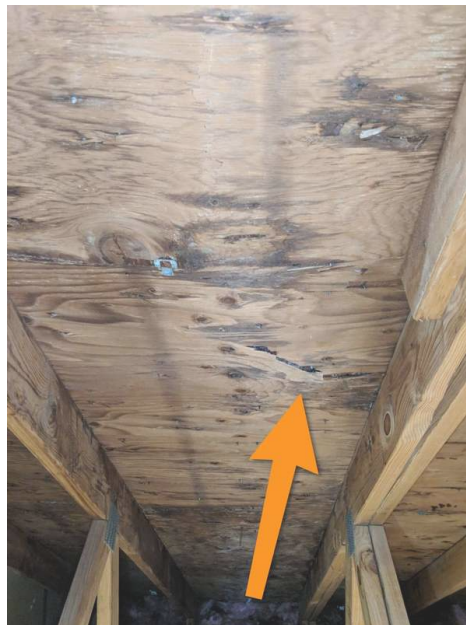
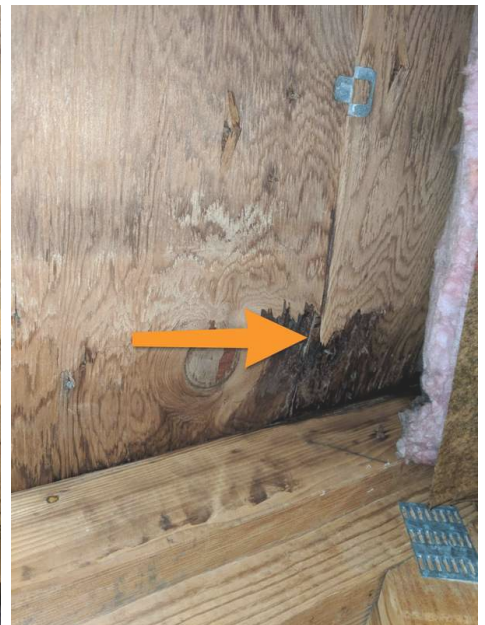
4.5.1 Roof Structure & Attic
SHEATHING DAMAGE

The sheathing showed visible signs of damage near the firewalls separating the dwelling units.

They said that the fire rated plywood deteriorates much more rapidly than normal plywood and that the plywood found in areas that are covering vaulted ceilings are prone to deterioration from lack of ventilation.

These conclusions seem consistent with what was observed.

Visible dips

Cracked Sheathing

The inspector recommends qualified contractor assess the situation and repair as necessary.

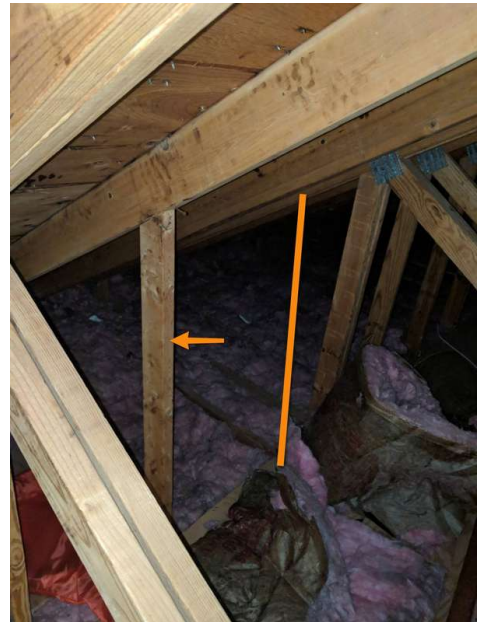
4.5.2 Roof Structure & Attic

MISSING REINFORCEMENTS

It appears the extra supports may be installed incorrectly and missing altogether in some areas.

Arrow indicates added support. The line indicates missing support

Recommend a qualified contractor evaluate and repair as necessary

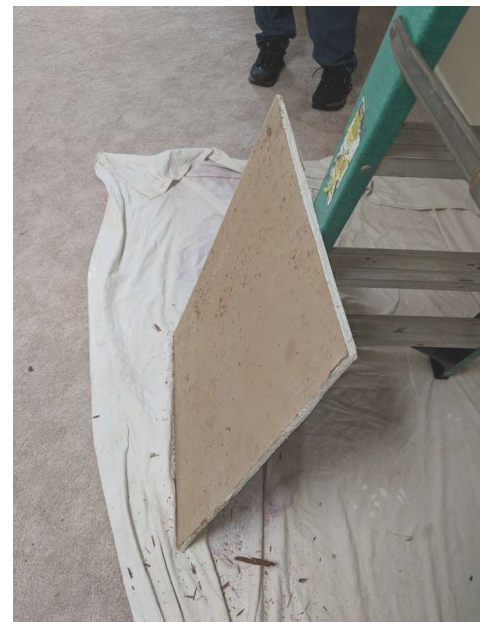
5.2.2 Attic Insulation

NON INSULATED ATTIC ACCESS

The attic access trap was not insulated. To reduce heat loss through this area, recommend installing an insulated access panel.

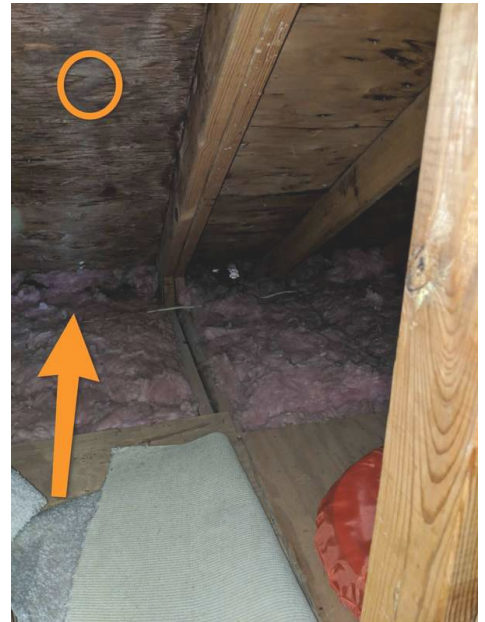
5.5.1 Ventilation

ATTIC VENTILATION INSUFFICIENT

Modern standards recommend 1.5 square feet of venting area for every 300 square feet of attic floor space.

Evidence of past condensation was visible in areas. (water stained wood)

The sheathing appeared to be deteriorated in areas where the ceiling is vaulted. (More than likely due to insufficient and/or no ventilation in these areas.)

Baffles, which permit air to flow above the insulation were missing in certain areas.

A new attic vent fan appeared to be installed recently and seems to have helped reduce the general humidity since no excessive humidity was measured in the wood sheathing at the time of inspection.

Arrow- Missing baffles Circle - Evidence of condensation (Water stains)

Nonetheless, recommend a qualified contractor evaluate and remedy.

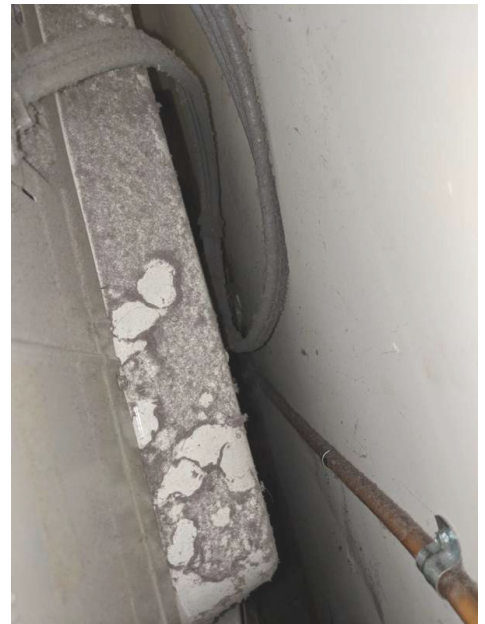
5.7.1 Exhaust Systems Dryer

DUCTS LOOSE

Excessive lint was found around the dryer, this could be a result of loose ductwork or clogged ductwork.

Fires from unkept dryer vents are a major cause of household fires.

Recommend a qualified person evaluate repair and clean ductwork as necessary.

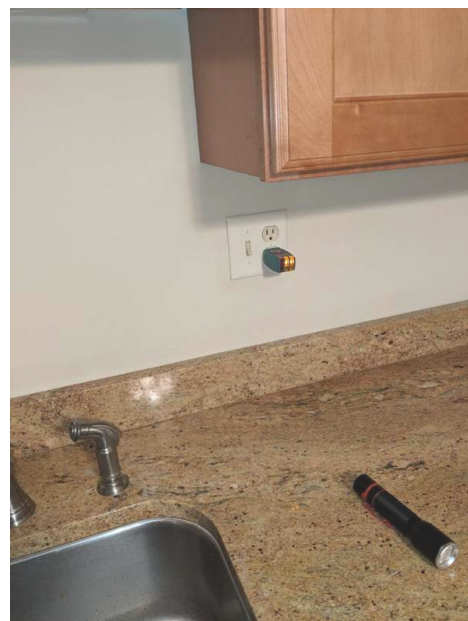
7.7.1 GFCI

NO GFCI PROTECTION INSTALLED

Recommend licensed electrician upgrade by installing ground fault receptacles in all places required by current standards.

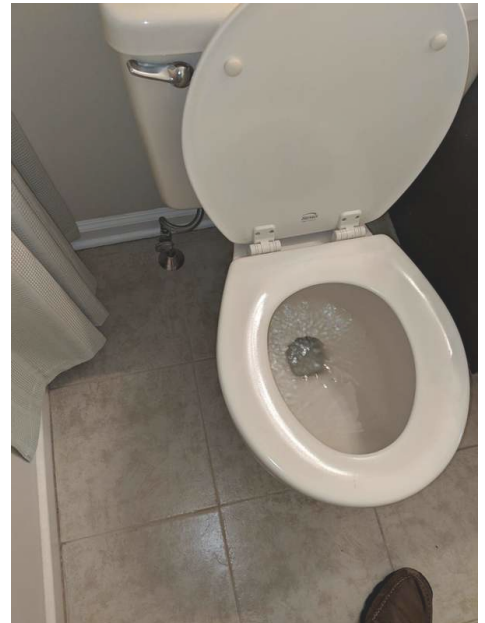
9.4.2 Fixtures / Faucets

TOILET NOT SECURED WELL

The toilet in the main bathroom 2nd floor was not secured well and have a little movement. Recommend a qualified plumber secure the toilet

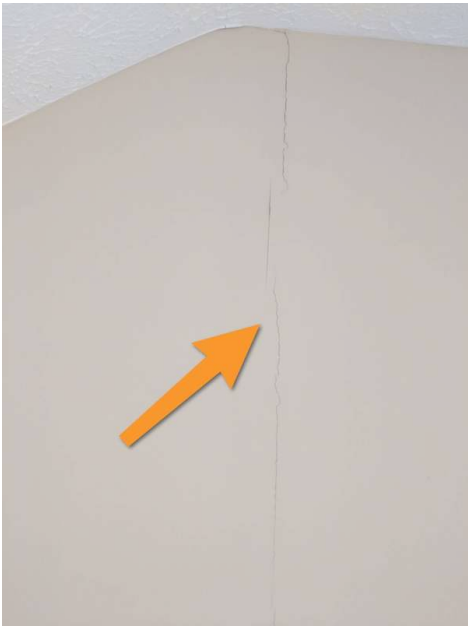
SHEETROCK CRACK
COMMON AREA 3RD FLOOR

A crack along sheetrock seams in the wall was visible at the time of the inspection.

This problem is often reoccurring and very common when sheetrock is fixed directly to wood framing members.

Recommend repair by a qualified contractor

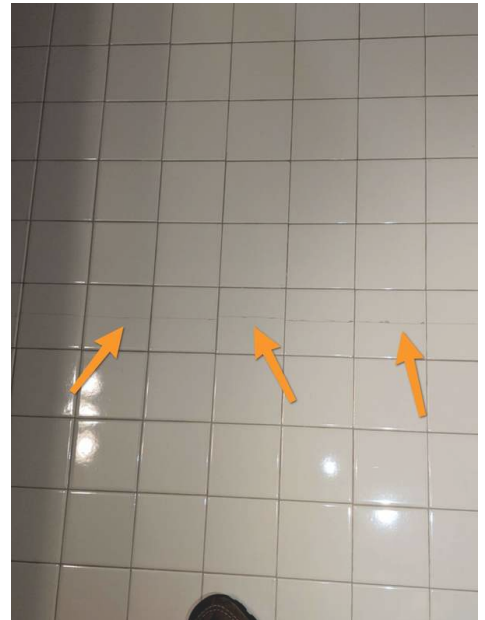
10.3.1 Floors

TILES CRACKED

The floor tiles in the bathroom had cracks.

Recommend repair by a qualified person.

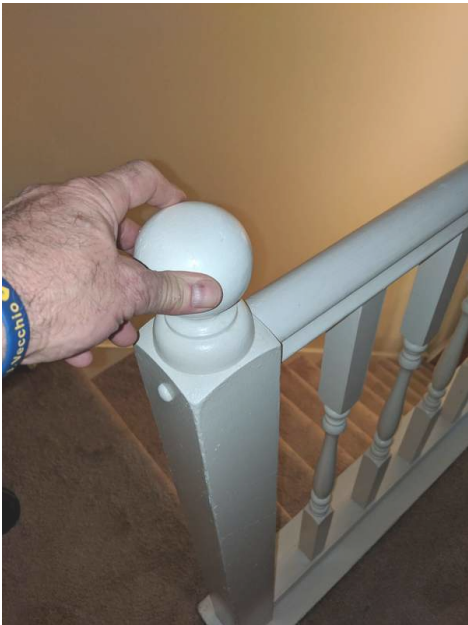
10.4.2 Steps, Stairways & Railings

LOOSE POST

A stair case post was becoming loose. This could eventually pose a safety hazard.

Recommend a qualified handyman evaluate and repair.
