HOOSIER HOME INSPECTION, LLC

## CONFIDENTIAL HOME INSPECTION REPORT

1234 Main St.  
Indianapolis IN 46222

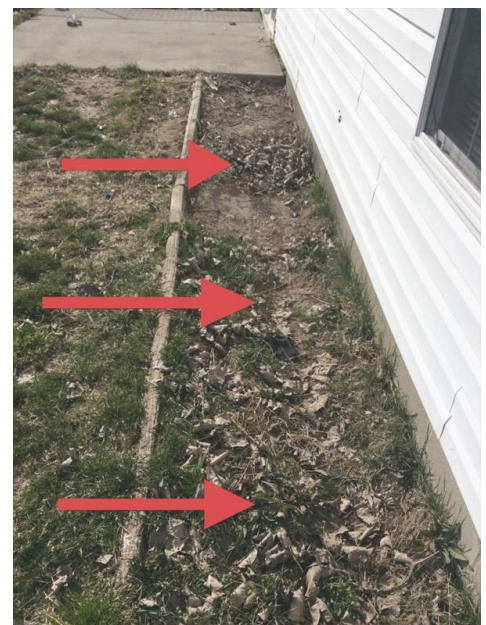
2.8.1 Grading/Landscaping

**FLAT/NEGATIVE GRADING**

One or more areas of flat/negative grading were observed. This condition can lead to standing water near the foundation.

Low/Negative Slope

Recommend adding additional backfill to create a positive slope away from the foundation.

Contact a qualified grading contractor.

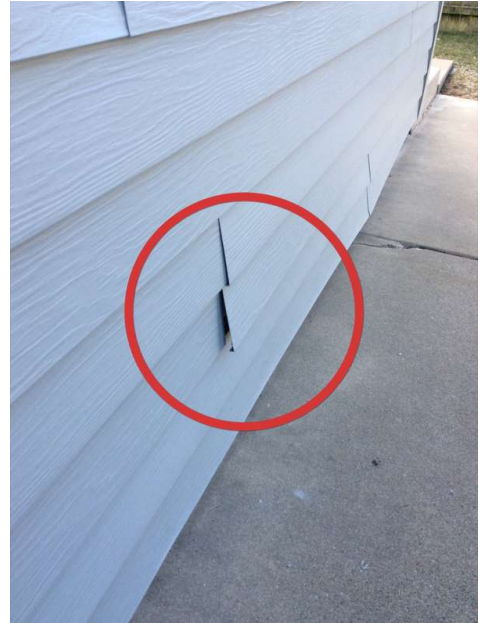
#### 4.1.1 Siding

#### **LOOSE/SEPARATED/MISSING**

One or more areas of loose/separated/missing siding were observed at the time of the inspection. Recommend qualified contractor evaluate/repair as necessary.

Loose Vinyl SidingWest Exterior

Contact a qualified professional.

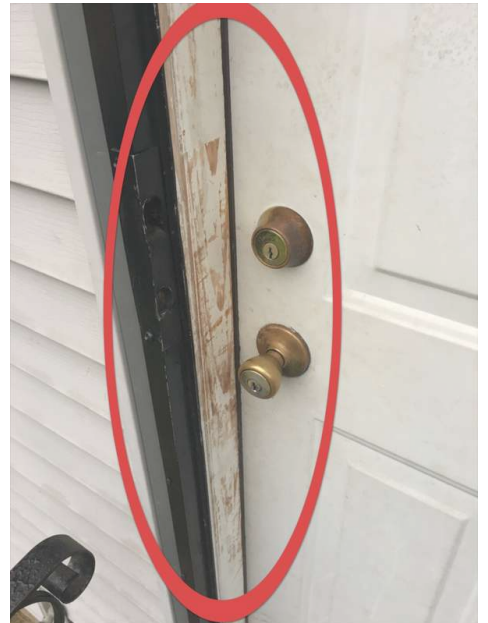
#### 4.2.1 Soffit, Fascia and Trim

### **DETERIORATING/MISSING PAINT**

Deteriorating/missing paint was observed on wood trim.  
Deteriorating/missing paint can lead to wood rot. Recommend qualified painter evaluate/repair as necessary.

Deteriorating/Missing PaintGarage Exterior Door

Contact a qualified painter.

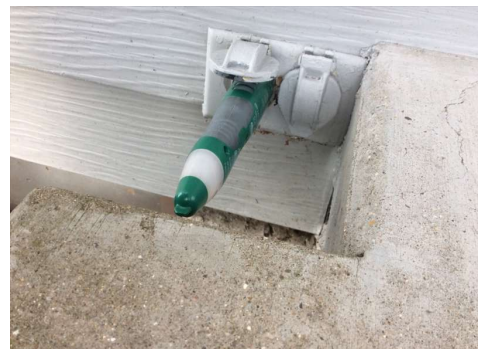
#### 4.6.1 Exterior Electrical Receptacles

### **NO GFCI PROTECTION ON EXTERIOR RECEPTACLES**

Exterior electrical receptacles were not GFCI protected. This is a potential safety hazard. GFCI protection is required on receptacles in water prone areas. Recommend qualified electrician evaluate/repair as necessary.

Not GFCI ProtectedWest Exterior

Contact a qualified electrical contractor.

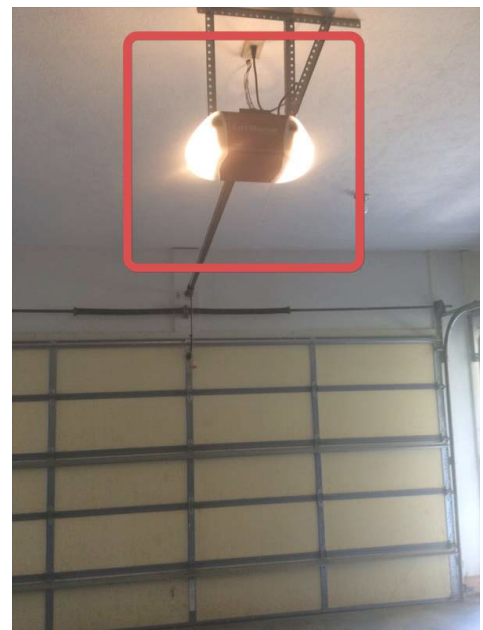
5.2.1 Safety Reverse

### SAFETY REVERSE NOT OPERATIONAL

Automatic garage door safety reverse was not operational and needs adjustment. This is a potential safety hazard. Recommend qualified garage door contractor evaluate/repair as necessary.

Safety Reverse Needs Adjustment  
Garage Exterior Door

Contact a qualified garage door contractor.

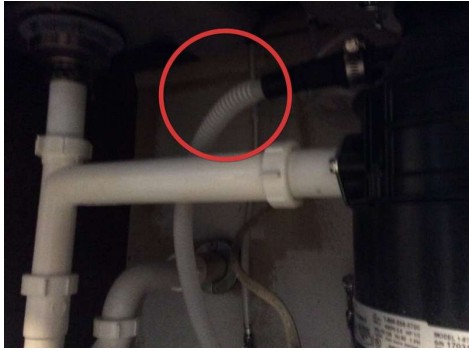
7.7.1 Appliances

**DISHWASHER DRAIN LINE NOT LOOPED**

The dishwasher drain line did not have a high loop. A high loop is recommended to keep dirty water from back-siphoning into the dishwasher or water supply. Recommend qualified plumber evaluate/repair as necessary.

No High LoopKitchen

Dishwasher High Loop Drain Line  
Proper High Loop

Contact a qualified plumbing contractor.

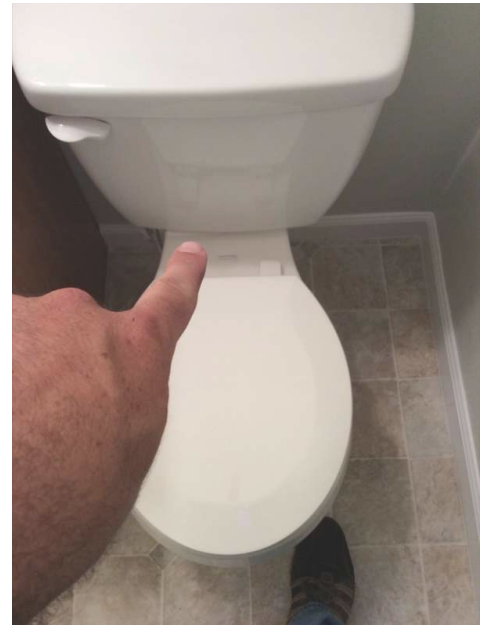
## 8.3.1 Toilets

**TOILET BOWL LOOSE**

The toilet bowl was loose. Recommend qualified plumber evaluate/repair as necessary.

Toilet Loose  
Downstairs Half  
Bathroom

Contact a qualified plumbing contractor.

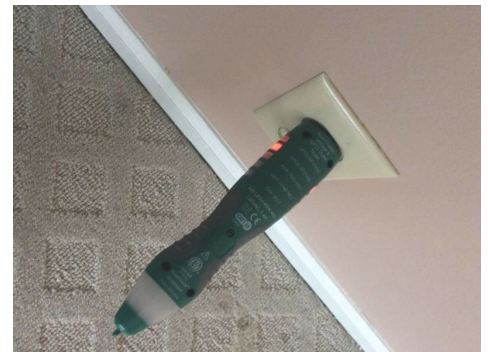
9.3.1 Electrical

### OPEN GROUND

One or more bedroom electrical receptacles tested as having an open ground. Recommend qualified electrician evaluate/repair as necessary.

Open GroundMaster Bedroom

Contact a qualified electrical contractor.

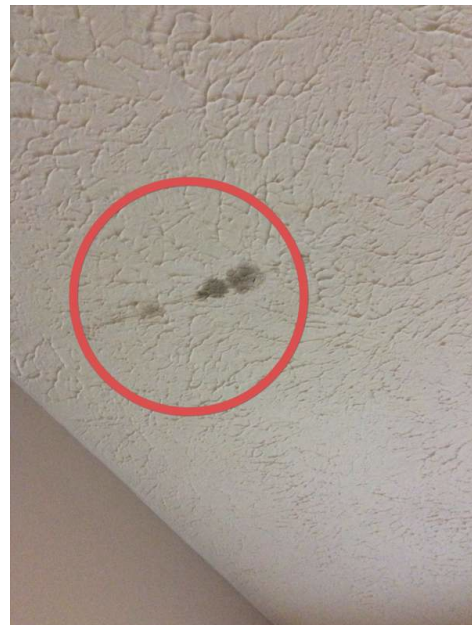
### 10.1.1 Walls and Ceilings

#### MOISTURE STAINING

Moisture staining was observed on living room ceiling. This staining did not appear to be active. Recommend painting over this area and monitoring it for future moisture. If future moisture is observed, recommend qualified contractor evaluate/repair as necessary.

Moisture Staining

Recommend monitoring.

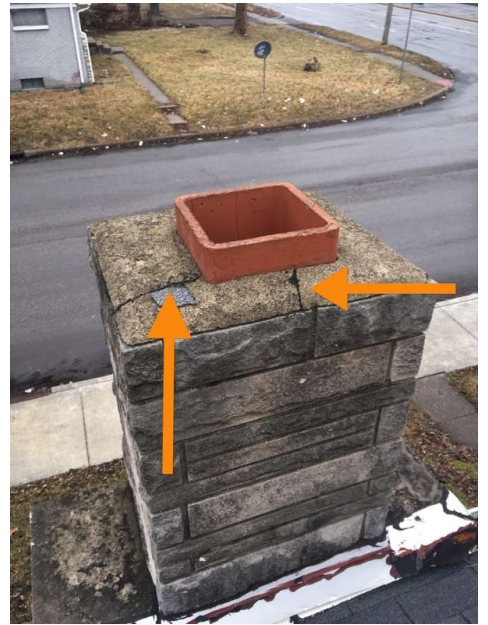
13.2.1 Chimney

#### CRACKED CHIMNEY CAP

A cracked concrete chimney cap was observed. Cracks in the chimney cap can allow moisture into the chimney and eventually into the living space. Recommend qualified chimney repair contractor evaluate/repair as necessary.

Cracked Chimney Cap

Contact a qualified chimney contractor.

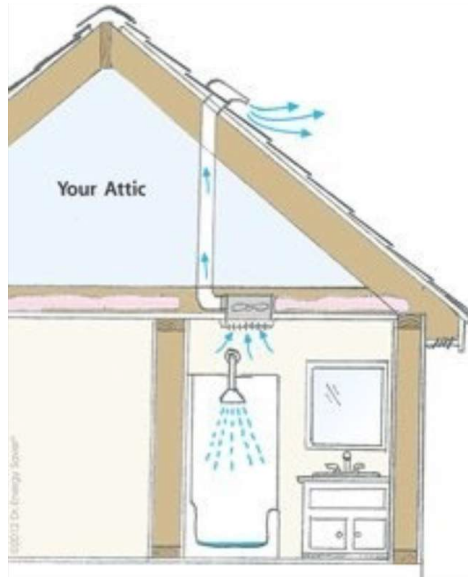
Bathroom exhaust fans were vented into the attic. It is recommended that all exhaust fans vent to the exterior to prevent unwanted moisture in the attic. Recommend qualified contractor evaluate/repair as necessary.

Proper Venting

Bathroom Fans Exhausted to Attic

Contact a qualified professional.
