RESIDENTIAL INSPECTION REPORT

1234 Main St.
Friendswood TX 77546

PROPERTY INSPECTION REPORT

Concerning: 1234 Main St. Friendswood TX 77546

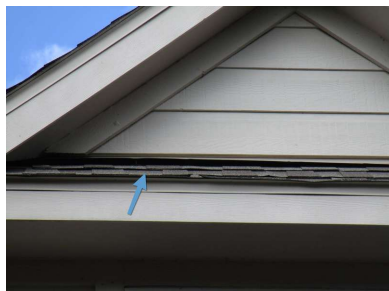
1: Flashing: Lifted

Front Slope

Flashing sections are lifted. Remedy as needed.

Recommendation: Contact a qualified roofing professional.

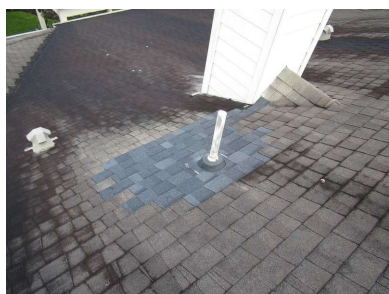
2: Patched roofing materials

Previous repairs or patched areas of the roofing were observed. Repair documentation from the seller/property owner is recommended in case warranty protections apply.

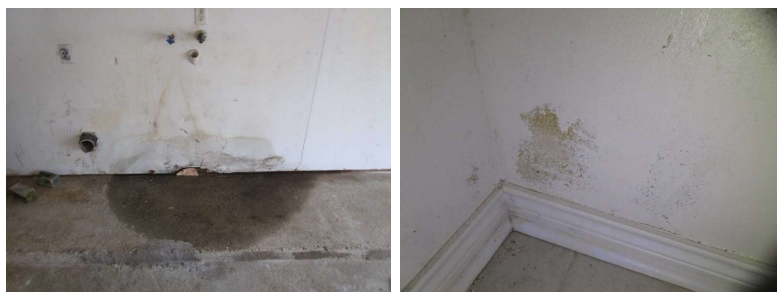
2: Interior: Active Water Damage

Garage and Front Entry

Active moisture was identified on the drywall at the time of inspection. The exact cause could not be determined.

Recommendation: Contact a qualified professional.

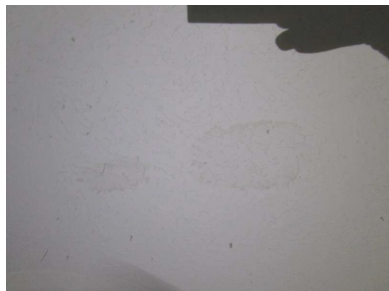
1: Ceiling: Evidence of Water Intrusion

Master Bedroom

Discolored drywall ceiling indicates water contact. Active moisture was detected at the time of inspection using a surface moisture meter. The cause could not be determined.

Recommendation: Contact a qualified professional.

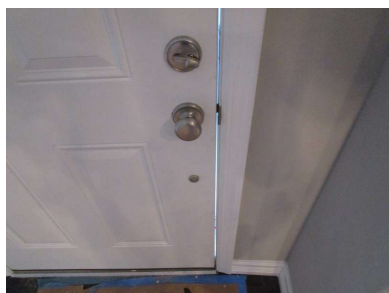
2: Weatherstripping Insufficient

Back Door

Door is missing standard weatherstripping. This can result in significant energy loss and moisture intrusion. Recommend installation of standard weatherstripping.

Recommendation: Recommended DIY Project

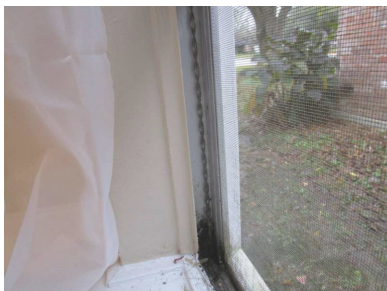
1: Window ballasts/springs are broken

Living Room

Window ballasts (or guidesprings depending on the window style) were detached or damaged. These mechanisms serve to hold the window sash up, and if they are damaged the window may not stay open. Remedy as needed.

Recommendation: Contact a qualified window repair/installation contractor.

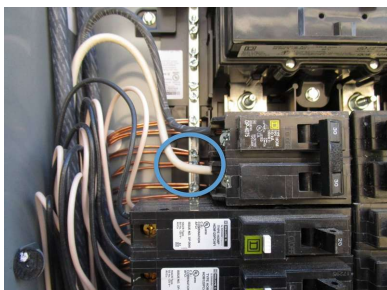
1: White wires not marked

White wires connected to breakers are not marked with black or red electrical tape to indicate that they are "hot". Remedy as needed.

Recommendation: Contact a qualified professional.

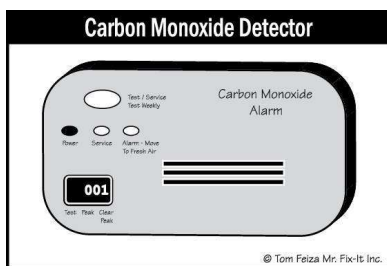
1: Carbon Monoxide Detector Missing

Bedrooms

A carbon monoxide detector was not present. As gas appliance(s) were installed in the living portion of the home, installation of carbon monoxide detectors is recommended for safety. Remedy as needed.

Recommendation: Recommended DIY Project

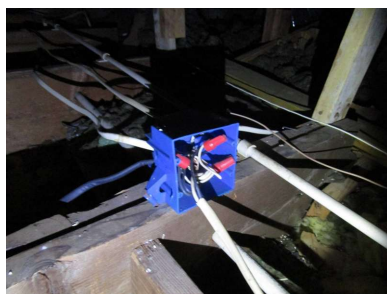
3: Open Junction Box

Attic

An open junction box was present. Remedy as needed.

Recommendation: Recommended DIY Project

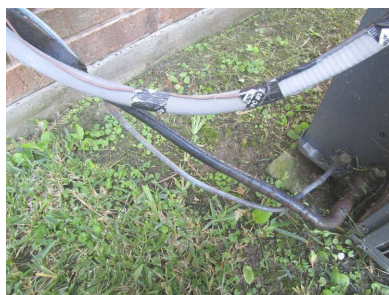
1: Refrigerant Lines: Insulation Missing or Damaged

Missing or damaged insulation on refrigerant line can cause energy loss and condensation. Remedy as needed.

Recommendation: Contact a qualified HVAC professional.

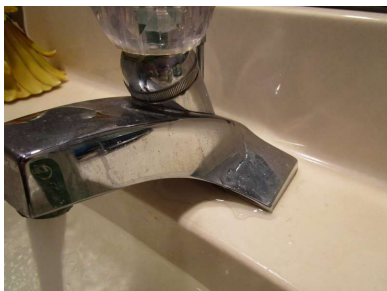
2: Faucet: Stem leaking

Half Bathroom

The faucet stem leaked when operated. Remedy as needed.

Recommendation: Contact a qualified professional.

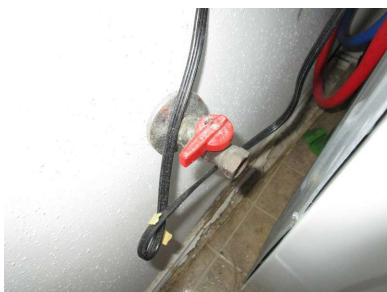
3: Gas piping: Un-capped gas supply

Utility Room

An uncapped gas supply pipe was present. Gas supply pipes should be capped for safety when not in use. Remedy as needed

Recommendation: Contact a qualified professional.

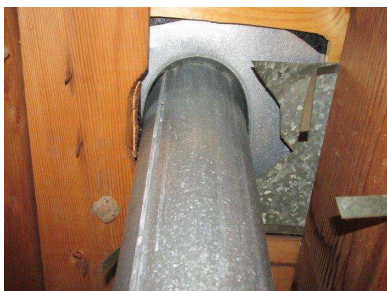
1: Venting System: Combustible Clearance

The vent pipe (flue) is in direct contact with combustible materials. The required clearance should be 1" at minimum. This is a safety hazard, and should be further evaluated.

Recommendation: Contact a qualified professional.

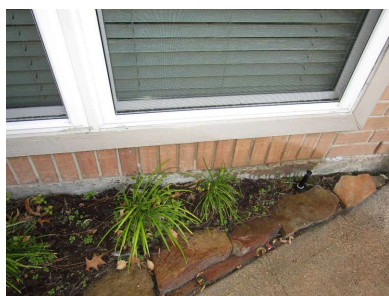
1: Adjust heads aimed at structure

Sprinkler heads were spraying the structure. Sprinkler heads should be adjusted to spray away from the structure(s). Remedy as needed.

Recommendation: Contact a qualified professional.
