OORAH INSPECTIONS, LLC.

SINGLE FAMILY HOME

1234 Main St.
Shawnee OK 74804

Buyer Name
10/29/2018 9:00AM

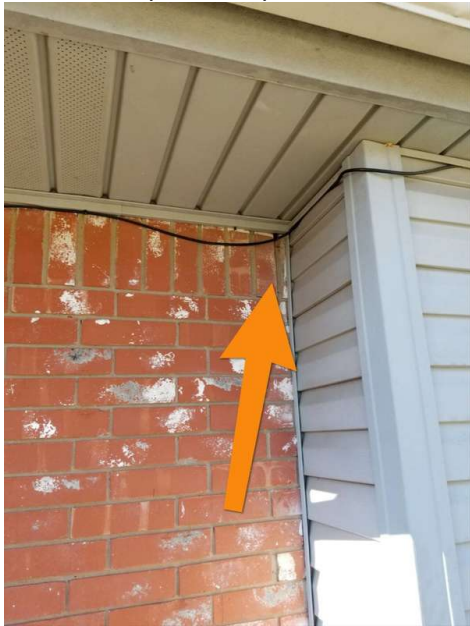
2.1.1 Exterior Walls & Trim

BRICK - REPOINT NEEDED/CRACKED/DAMAGED

FRONT OF HOME NEXT TO MASTER BED WINDOW.

Joints in the masonry have deteriorated and should be repointed. (Repointing is the restoration of the mortar joints in the masonry).

Contact a qualified professional.

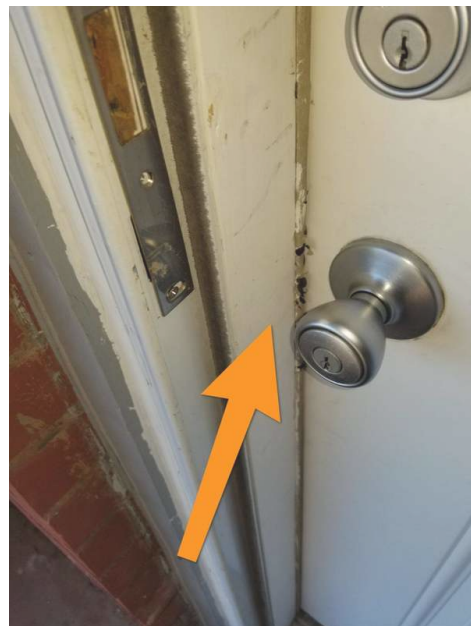
2.2.1 Exterior Doors

DOOR SILL/TRIM

FRONT DOOR.

Door sill and/or trim is loose, deteriorated or worn and repair or replacement should be considered.

Contact a qualified door repair/installation contractor.

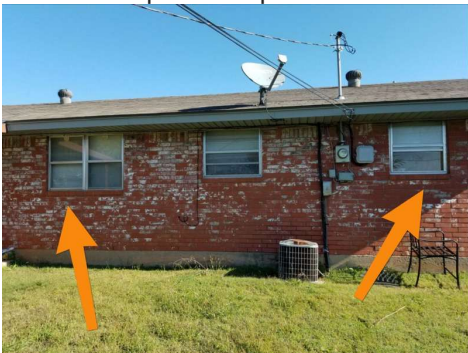
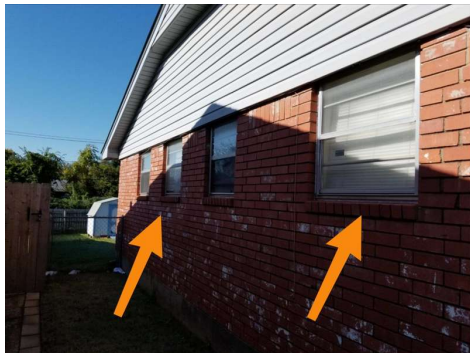
2.3.1 Windows

MISSING SCREEN OR DAMAGED

REAR AND SIDE OF HOME.

Missing screen or damaged at windows

Contact a qualified professional.

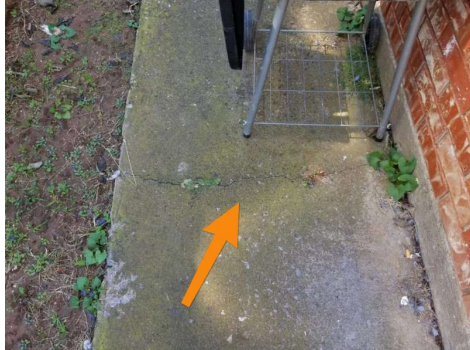
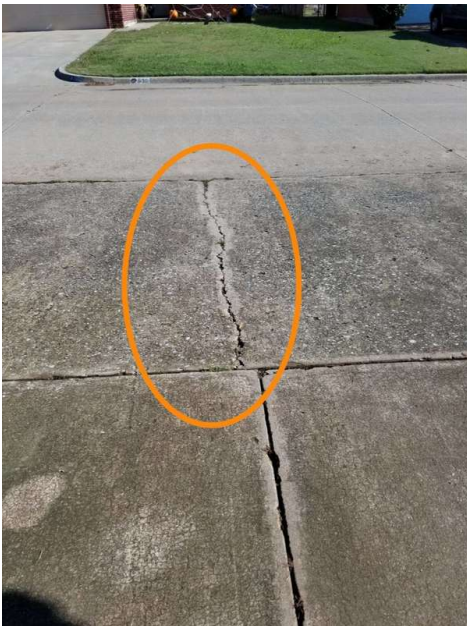
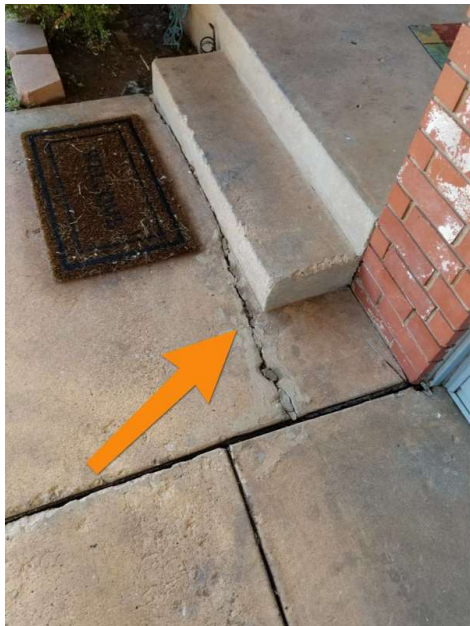
2.4.1 Walkways, Patios & Driveways

CRACKING - MINOR

REAR, FRONT AND SIDE OF HOME.

Minor cracks observed, Recommend patching/sealing and monitor cracks. This is also a potential trip hazard. Should crack widen, recommend contacting a qualified professional.

Recommend monitoring.

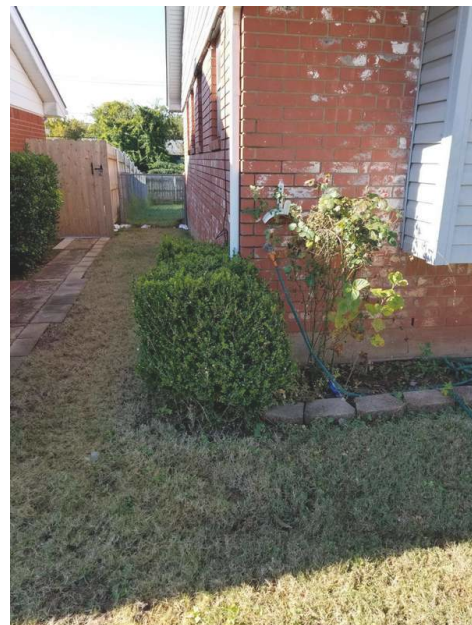
2.7.1 Vegetation, Grading, Drainage & Retaining Walls

VEGETATION NEAR HOME

FRONT OF HOME.

Recommend to remove vegetation that is in contact with exterior of home. This can allow ants/critters to enter the home.

Recommended DIY Project

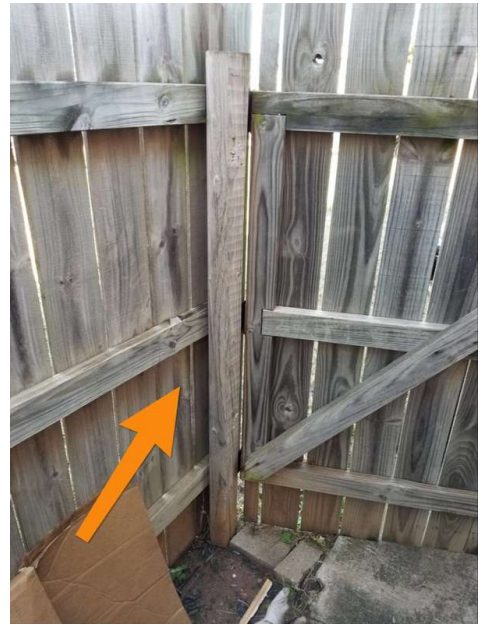
2.8.1 Fences/Gates

FENCE REPAIR

MAIN POST SUPPORTING GATE TO BACK YARD.

Fences and/or gates are damaged and/or deteriorated in some areas. A qualified contractor should evaluate and make repairs or replace sections as necessary.

Contact a qualified fencing contractor

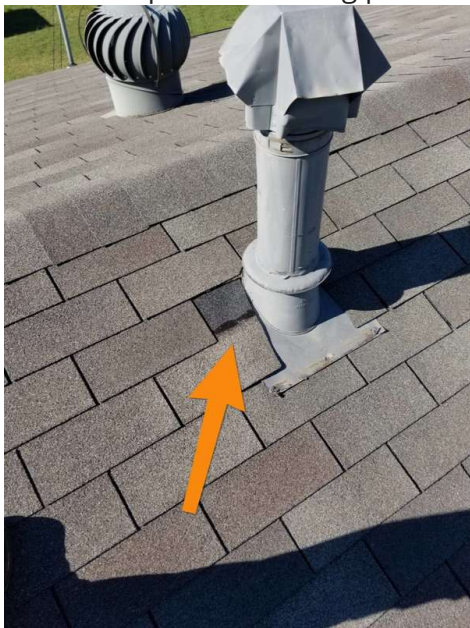
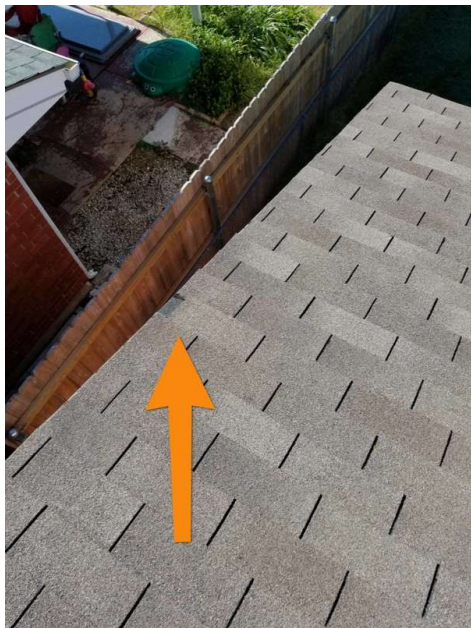
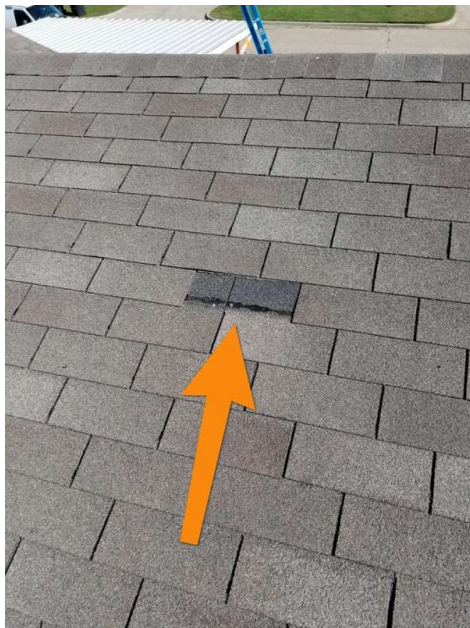
3.2.2 Roof Coverings

SHINGLES MISSING

Observed areas that appeared to be missing sufficient coverings. Recommend qualified roofing contractor evaluate & repair.

Contact a qualified roofing professional.

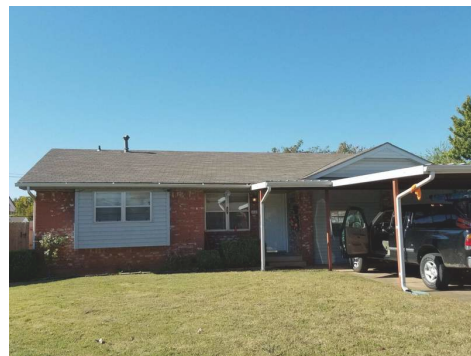
3.2.4 Roof Coverings

MULTIPLE LAYERS

Multiple layers of shingles were observed. This may add excess weight to the structure and may also void the manufacturers warranty.

Contact a qualified roofing professional.

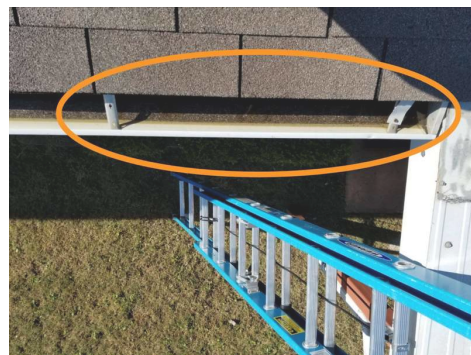
3.3.1 Roof Drainage Systems

DEBRIS

FRONT OF HOME.

Debris has accumulated in the gutters. Recommend cleaning to facilitate water flow. Here is a DIY resource for cleaning your gutters.

Contact a handyman or DIY project

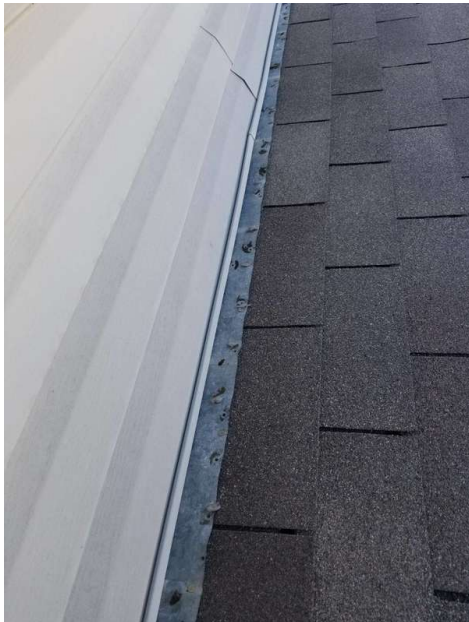
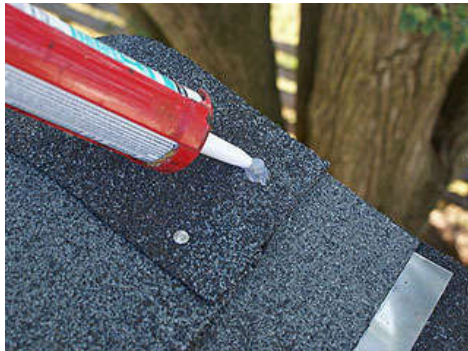
3.5.1 Flashings

CAULK NAIL HEADS

ABOVE CARPORT.

As part of ongoing home maintenance, recommend caulking/sealing nail heads.

Contact a qualified professional.

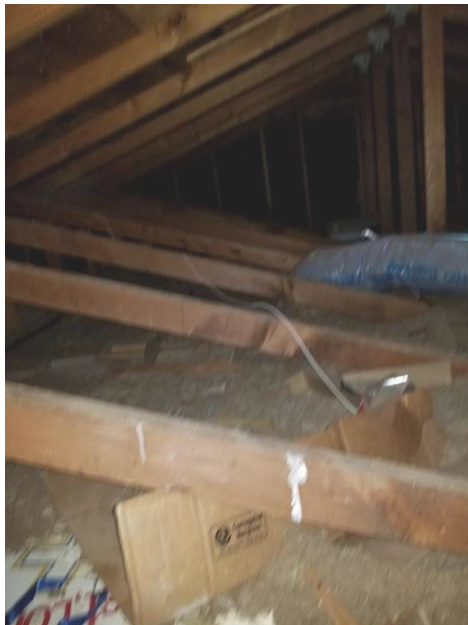
3.7.1 Attic Insulation

INSUFFICIENT INSULATION

Insulation depth was inadequate in comparison to current industry standards and building energy efficiency guidelines. Recommend a qualified attic insulation contractor install additional insulation.

Contact a qualified insulation contractor.

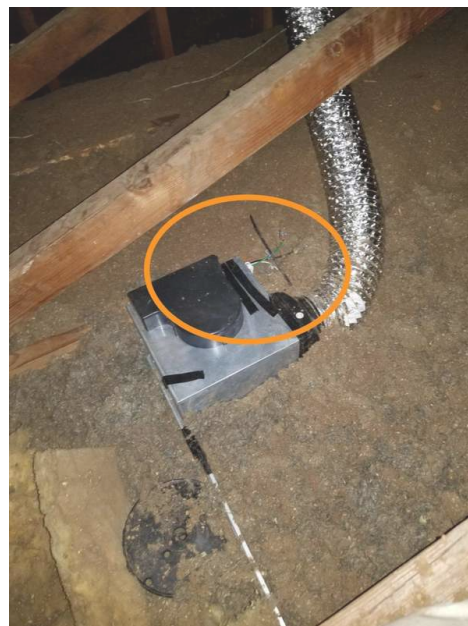
3.9.2 Exhaust Systems

EXHAUST FAN WIRING

GUEST BATHROOM

Electrical wiring connection for exhaust fan in bathroom should be contained in an approved junction box. Recommend repair.

Contact a qualified electrical contractor.

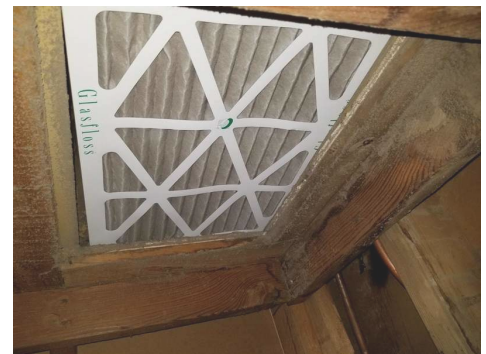
FILTER DIRTY

The furnace filter is dirty and needs to be replaced per the manufacturer recommendations.

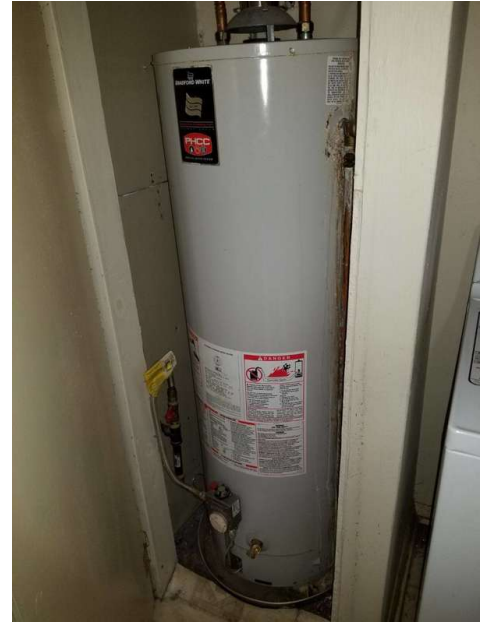
Water heater showed normal signs of wear and tear. Recommend monitoring it's effectiveness and replacing in the near future. The average life expectancy of a water heater is 6-12 years.

Recommendation
Recommend monitoring.

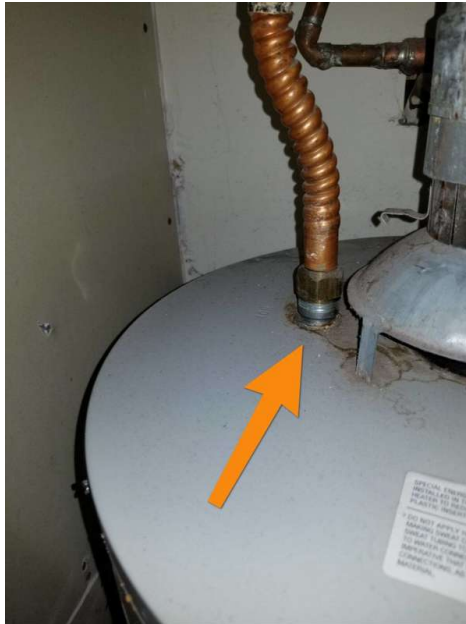
7.3.2 Hot Water Systems, Controls, Flues & Vents

CORROSION

Corrosion was noted at pipe fitting on water heater. Recommend a qualified plumber evaluate for repair/replacement.

Contact a qualified plumbing contractor.

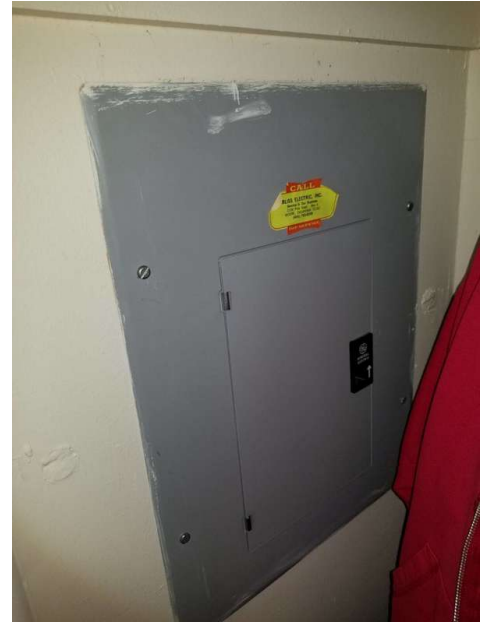
MISSING LABELS ON PANEL

At the time of inspection, panel was missing labeling. Recommend a qualified electrician or person identify and map out locations.

Recommended DIY Project

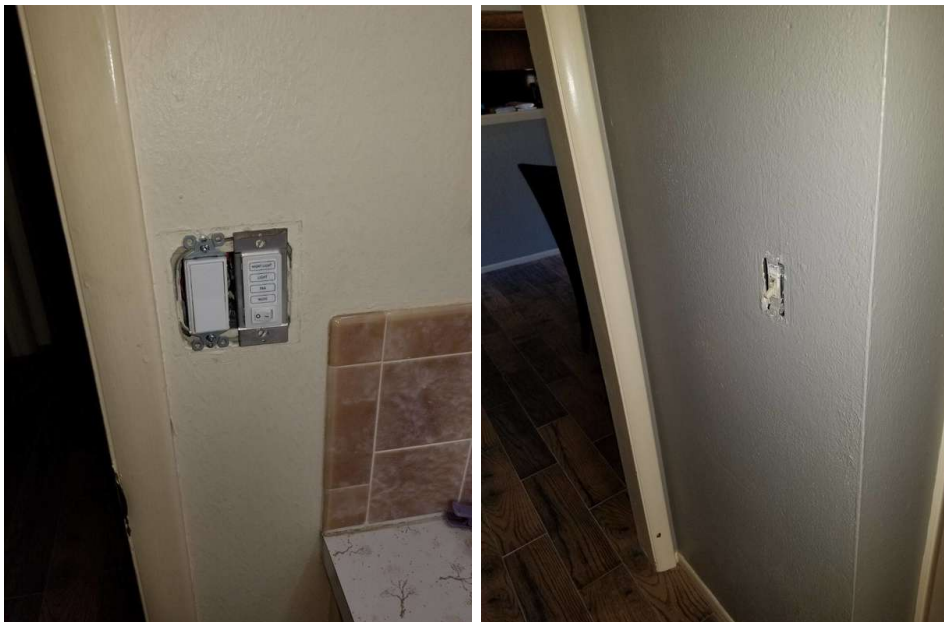
8.3.2 Lighting Fixtures, Switches & Receptacles

COVER PLATES MISSING

One or more receptacles are missing a cover plate. This causes short and shock risk. Recommend installation of plates.

Contact a qualified electrical contractor.

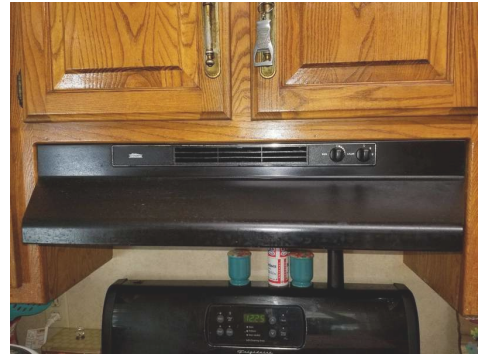
9.11.1 Ventilation

FAN RECIRCULATES

The exhaust fan over the range recirculated the exhaust air back into the kitchen. This may be due to no duct being installed, baffles not being installed, or problems with duct work. This can be a nuisance for odor and grease accumulation. Where a gas-fired range or cook top is installed, carbon monoxide and excessive levels of moisture can accumulate in living spaces. Recommend that a qualified contractor evaluate and repair as necessary so exhaust air is ducted outdoors.

Contact a qualified professional.

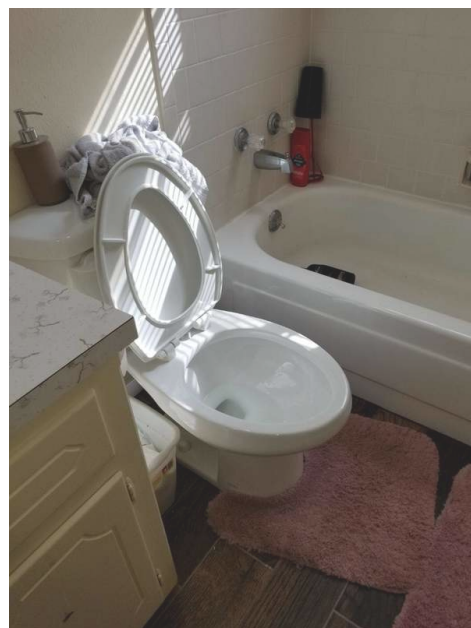
TOILET - LOOSE BOWL

Toilet was not securely fastened to the floor. Recommend a qualified plumber repair.

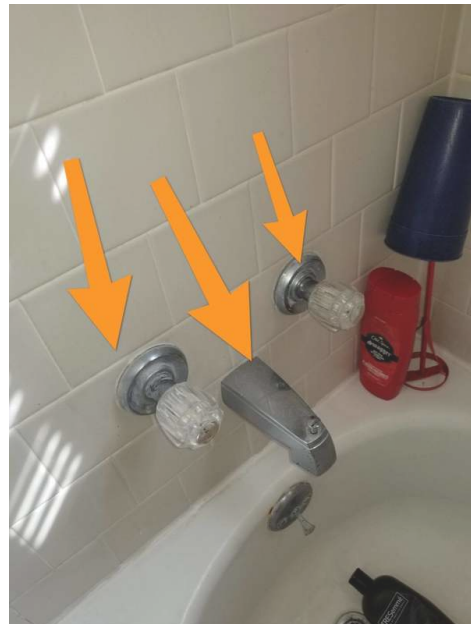
12.3.3 Plumbing & Fixtures

Caulking at spout area is in need of repair. Recommend caulking as part of preventative home maintenance.

Contact a handyman or DIY project

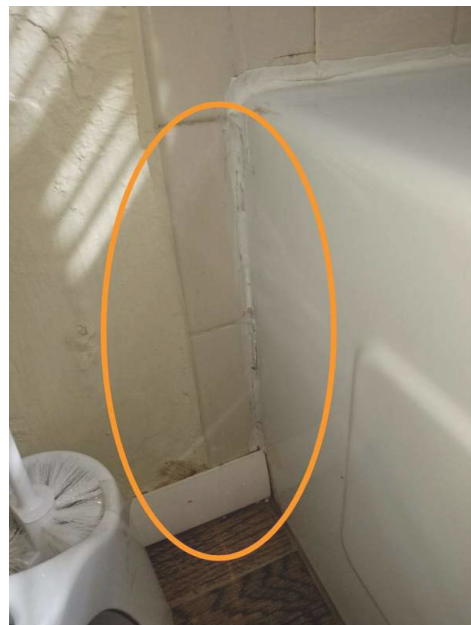
12.3.4 Plumbing & Fixtures

Recommend caulking at intersection of wall and tub to prevent moisture intrusion.

Contact a handyman or DIY project
