PACWEST HOME INSPECTIONS

RESIDENTIAL REPORT

1234 Main St.
Beaverton OR 97006

Buyer Name
05/22/2019 9:00AM

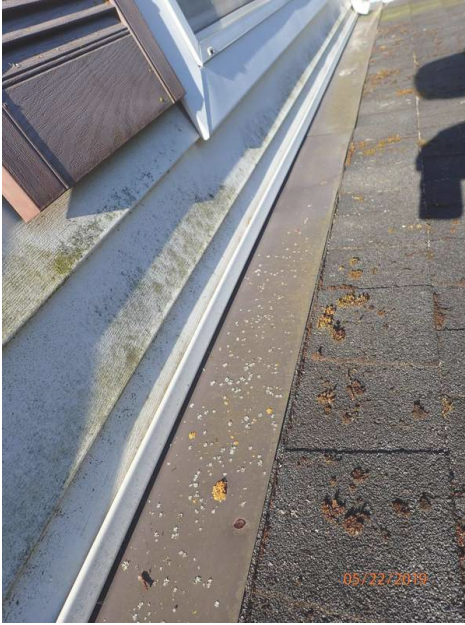
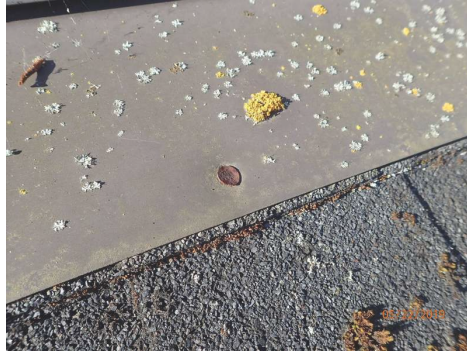
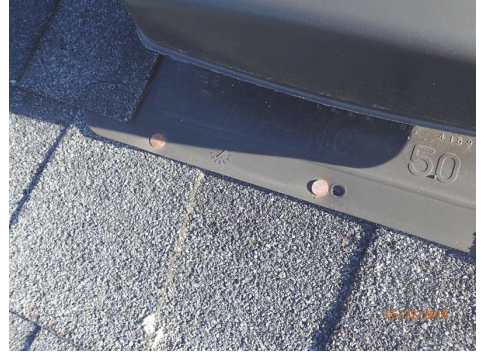
2.1.3 Coverings

FASTENERS - SEAL

During the inspection one or more nails/fasteners was observed to be lacking sealant or a rubber gasket to prevent a leak. Recommend a qualified roofing contractor evaluate and repair.

Contact a qualified roofing professional.

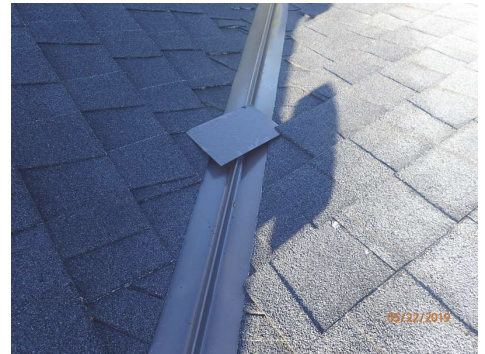
2.1.4 Coverings

DEBRIS - CONSTRUCTION

A piece of flashing was found lodged into the valley. This flashing was not able to be identified from anything necessary in the area and no leaks were noted in the attic. Recommend removing this and monitoring the roof closely as it ages.

Contact a qualified professional.

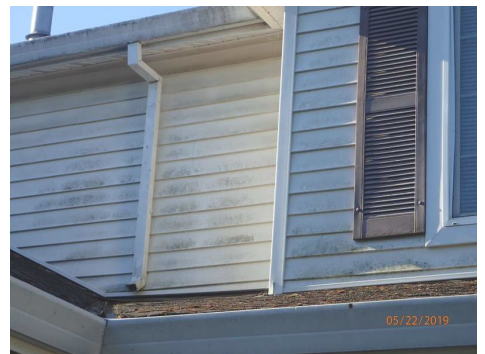
Moss and dirt are heavy on several locations of the vinyl siding. Recommend cleaning to help Maximize life span.

Contact a qualified professional.

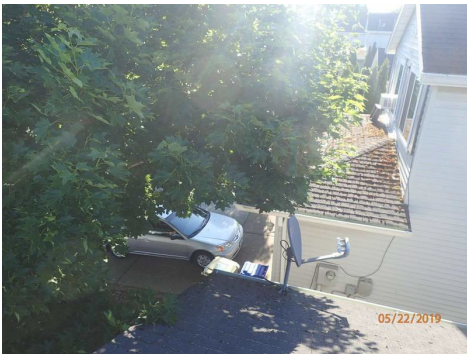
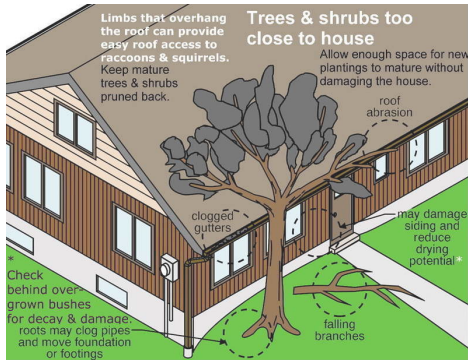
3.8.1 Vegetation, Grading, Drainage & Retaining Walls

Trees observed overhanging the roof. This can cause damage to the roof and prevent proper drainage. Recommend a qualified tree service trim to allow for proper drainage.

Contact a qualified landscaping contractor

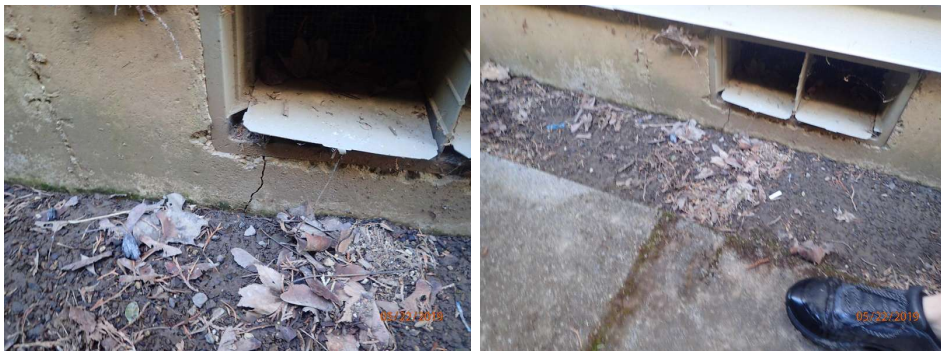
4.1.1 Foundation

SETTLING CRACKS

Settling cracks were noted at the foundation. This is common as concrete ages and shrinkage surface cracks are normal near breathing vents where the concrete is weakest. Recommend monitoring for more serious shifting/displacement.

Recommend monitoring.

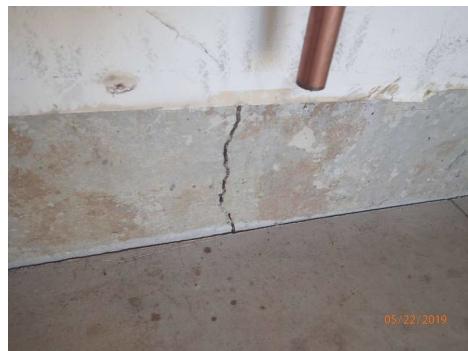
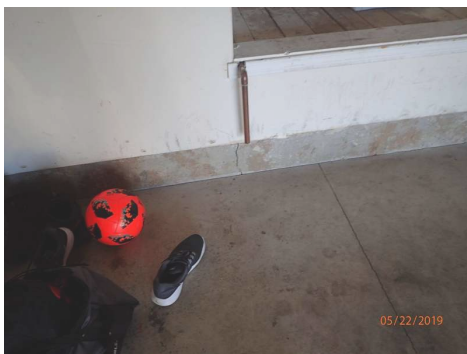
4.1.2 Foundation

FOUNDATION CRACKS-

Moderate cracking was noted at the foundation in one or more locations. This is common as concrete ages and shrinkage but cracks of this size are generally influenced by additional settling. Recommend monitoring for more serious shifting/displacement.

A foundation contractor should be consulted if the crack ever grows.

Recommend monitoring.

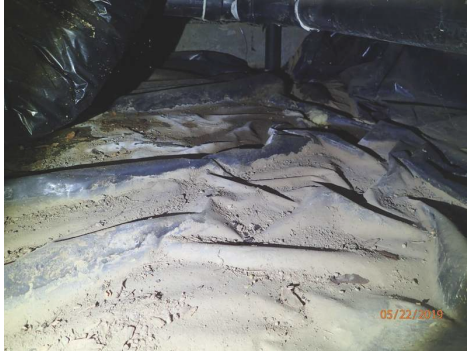
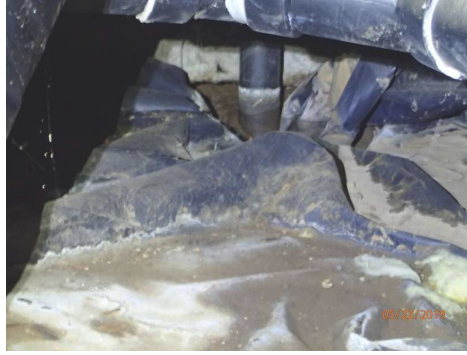
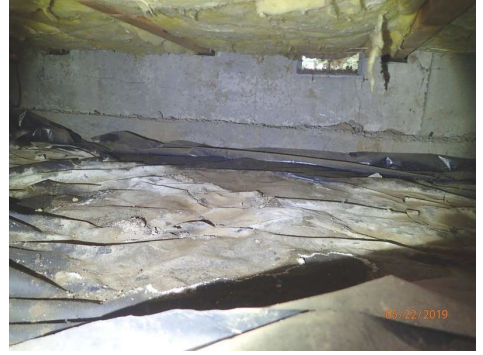
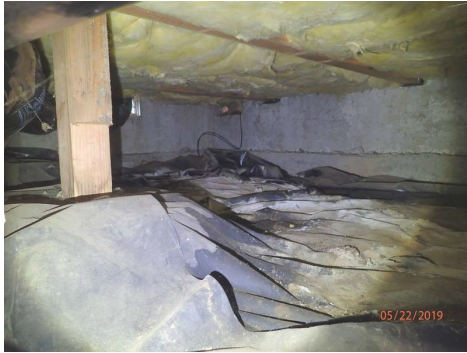
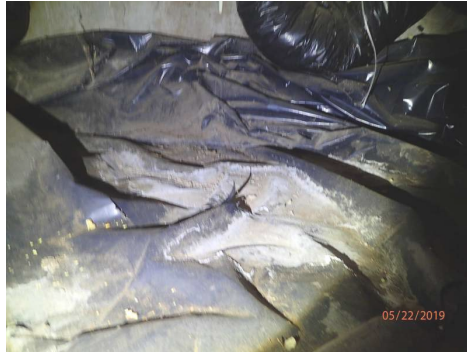
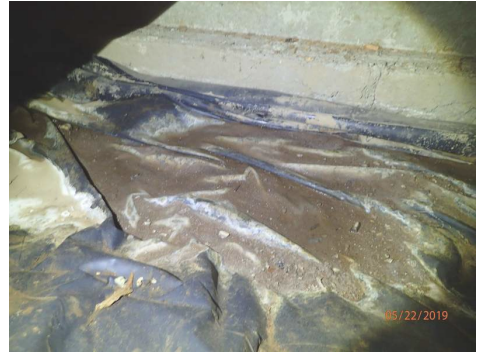
4.2.1 Basements & Crawlspaces

SILT STAINS/DIRT ON PLASTIC/FLOOR

Silt, water stains, and/or mud/dirt on the floor of a basement or the plastic of a crawl space generally indicate there was moisture there at one time. Recommend monitoring for future moisture intrusion.

Recommendation
Recommend monitoring.

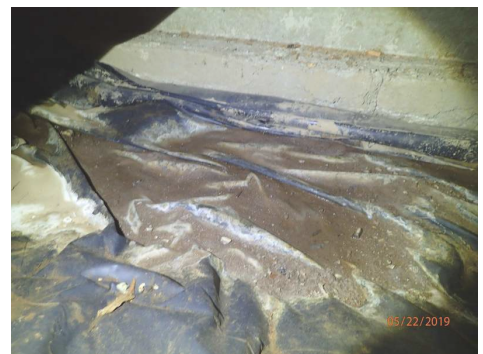
4.2.2 Basements & Crawlspaces

Standing water is present on basement / crawl space floor. Recommend a qualified contractor evaluate and locate potential source of moisture. A water mitigation system may be necessary for proper moisture management.

Contact a qualified environmental contractor

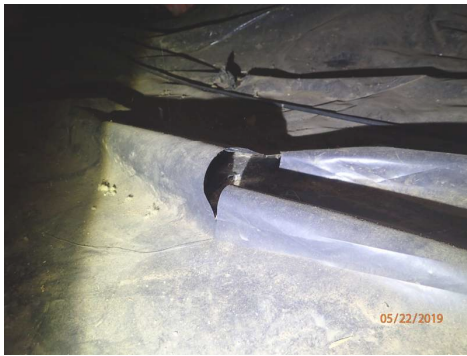
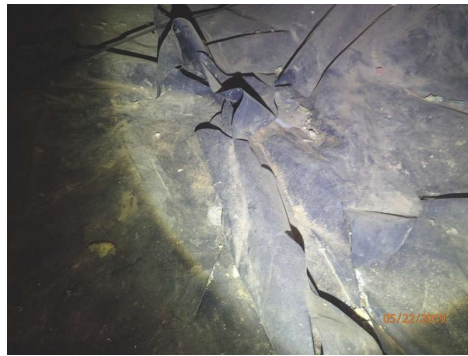
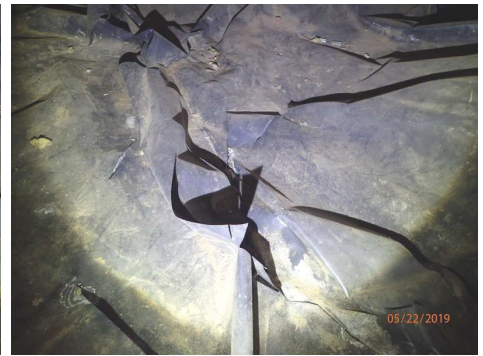
4.2.3 Basements & Crawlspaces

The vapor barrier / visqueen was found cut during the inspection. This is generally an indication that there has been standing water at one point. As moisture gets on top of the plastic sheeting (whether from a leaking pipe or groundwater) it has a hard time draining and has to evaporate over time. This will typically leave silt stains that can show us how much moisture there might have been. The cuts in the plastic allow this moisture to drain and keep moisture levels low. The cuts in the plastic also defeat a small part of the purpose of having the vapor barrier (keeping the vapor/moisture under the plastic and away from the home). Recommend monitoring the crawl space during winter months for excess moisture and be prepared to install a water mitigation system if necessary. In the following years if there is no moisture, it would be advised to replace the cut vapor barrier.

Recommend monitoring.

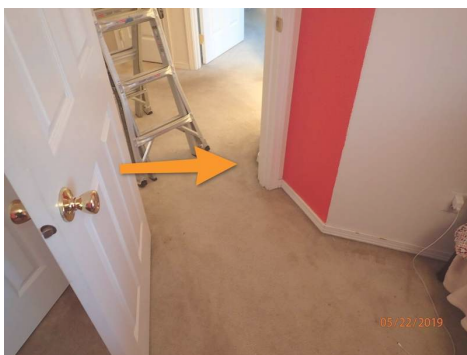
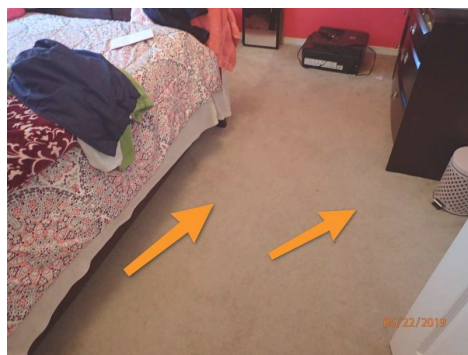
4.3.1 Floor Structure

SUBFLOOR - SQUEAKING

The subfloor in one or more locations was creaking and squeaking more than typically found. Recommend a licensed carpenter to further evaluate and repair as desired.

Contact a qualified carpenter.

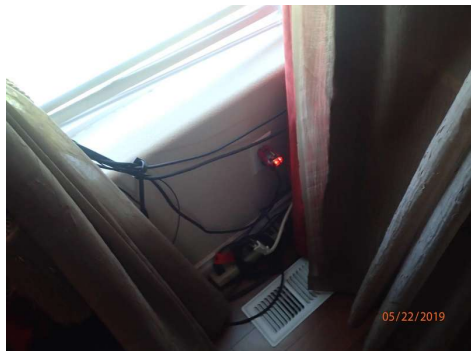
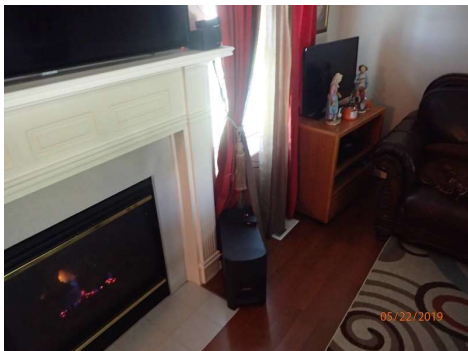
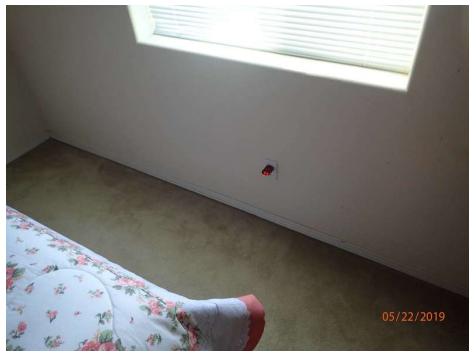
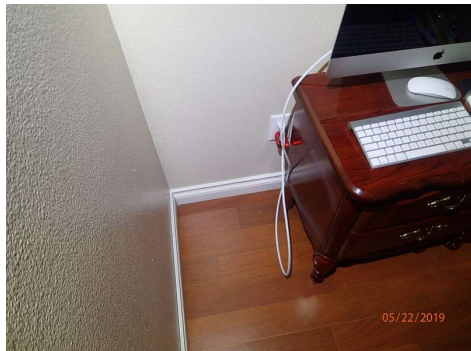
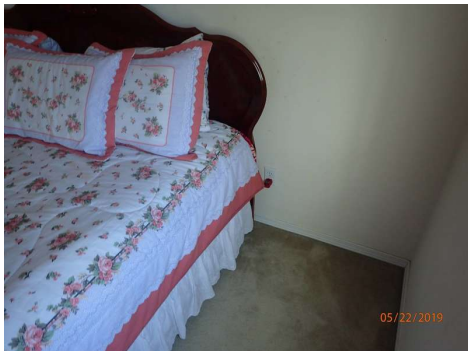
OUTLET - LOOSE

One or more outlets is loose. Recommend tightening the receptacle and or the plate cover. Recommend hiring a licensed electrical contractor for safety if you are not comfortable with this repair.

Contact a qualified electrical contractor.

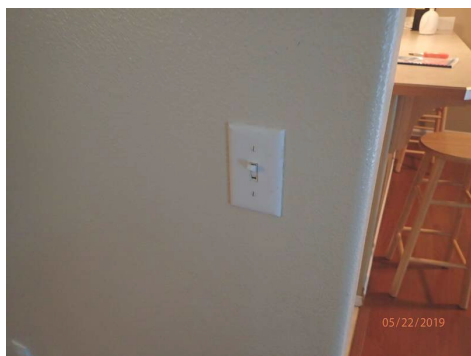
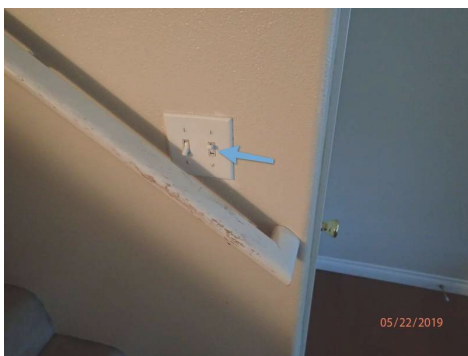
5.4.2 Outlets, Switches, Fixtures & Junction Boxes

During the inspection a use for this switch could not be verified, recommend asking the seller to clarify the purpose of this switch.

Contact a qualified professional.

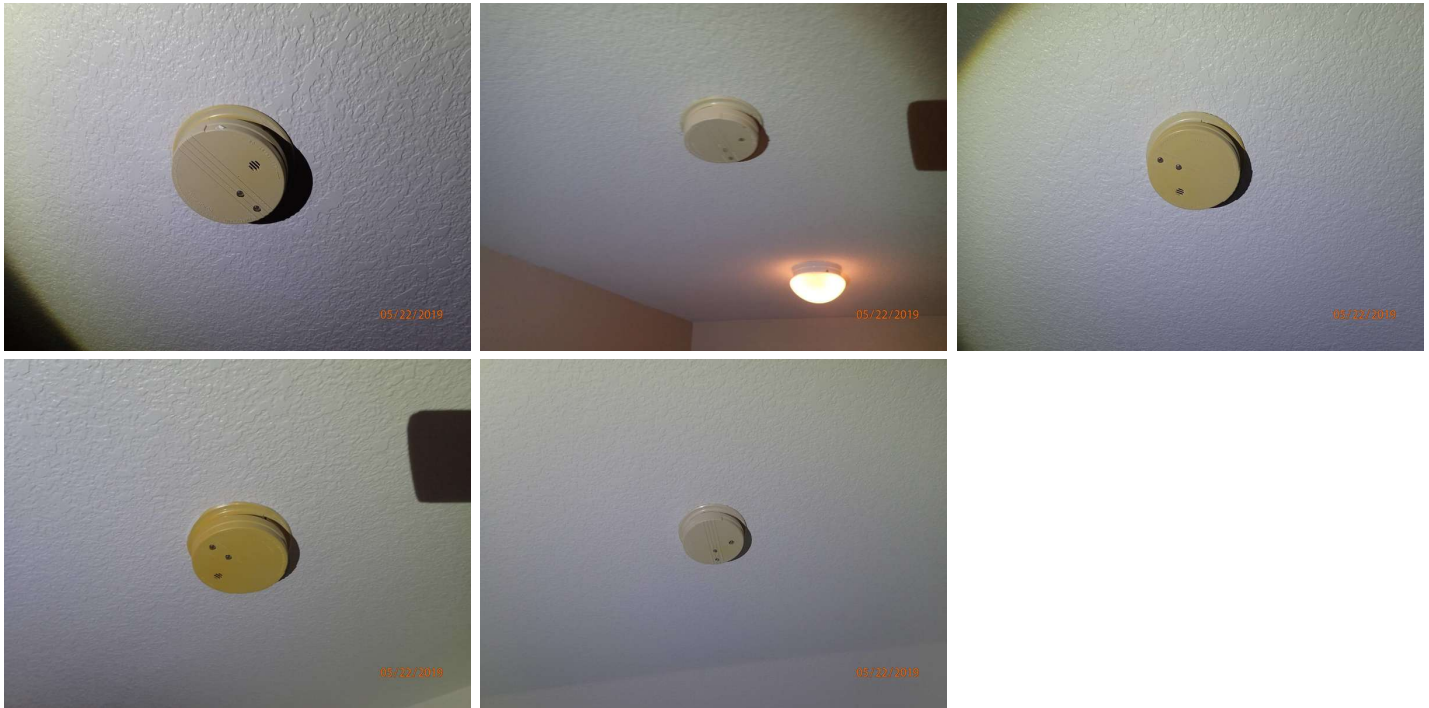
5.6.1 Smoke Detectors

Some of the present smoke detectors are more than 10 years old. Nearly all smoke detectors and alarms are rated for 10 years or less. For safety it is recommend that any smoke detector or alarm older than 10 years be replaced and then tested. If the unit is wired, it must be replaced by another wired unit.

Contact a qualified professional.

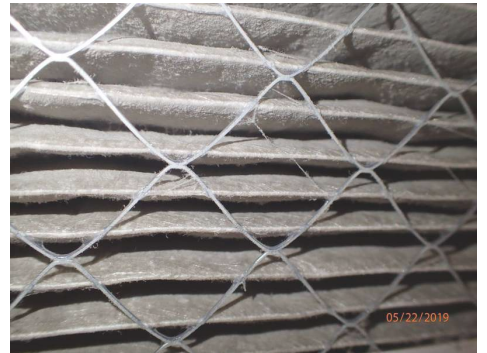
The furnace filter is dirty and needs to be replaced every 2-3 months for 1" thick filters and 4-6 months for 4" thick filters.

Contact a handyman or DIY project

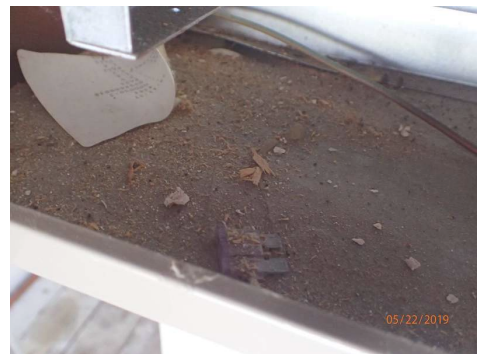
6.1.2 Equipment

FURNACE - SERVICING/CLEANING

Furnace should be cleaned and serviced annually. Recommend a qualified HVAC contractor clean, service and certify furnace.

Contact a qualified HVAC professional.

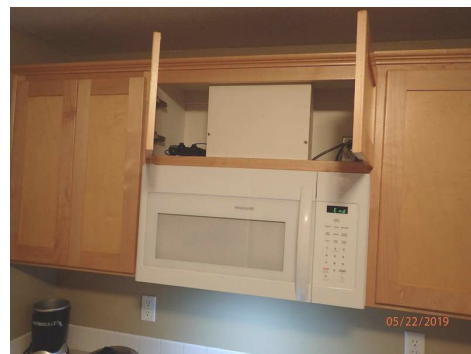
7.5.3 Exhaust Systems

RANGE HOOD - DISCHARGE

The diverter plate needs to be removed or adjusted to allow for use of the exterior venting.

Contact a qualified professional.

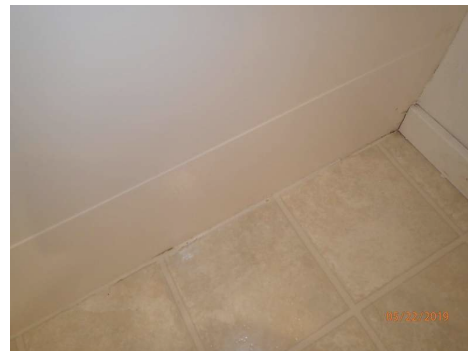
8.6.1 Tub / Shower

CAULKING/GROUT FAILING

Some of the caulking or grout in the bath and or shower area is failing. Caulking/grout is one of the most common items to fail in the bathroom. Because of its common failure rate it is also one of the largest contributors moisture damage in the bathroom. Recommend removing, cleaning, caulking/grouting, and inspecting on a regular basis to control the moisture in the bathroom.

Contact a handyman or DIY project

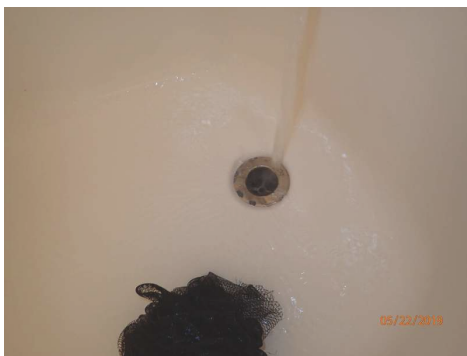
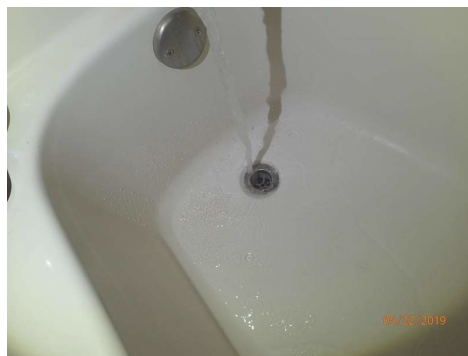
2ND FLOOR HALL BATHROOM, MASTER BATHROOM

During the inspection there was no way to properly plug the drain and fill the tub. Recommend replacing with a new drain stop of plug.

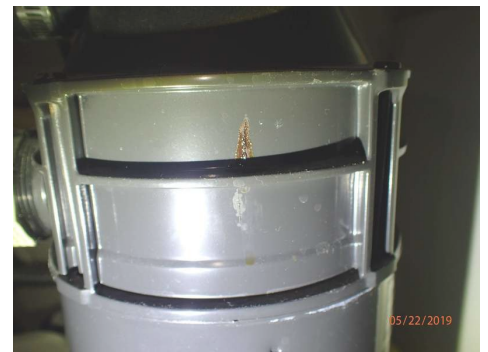
A hole/crack was found in the garbage disposal causing a leak. Often times parts can be found to repair this but it tends to be more economical to just replace the unit.
