MONARCH HOME INSPECTIONS

RESIDENTIAL REPORT

1234 Main St.
Virginia Beach VA 23464

05/17/2018 9:00AM

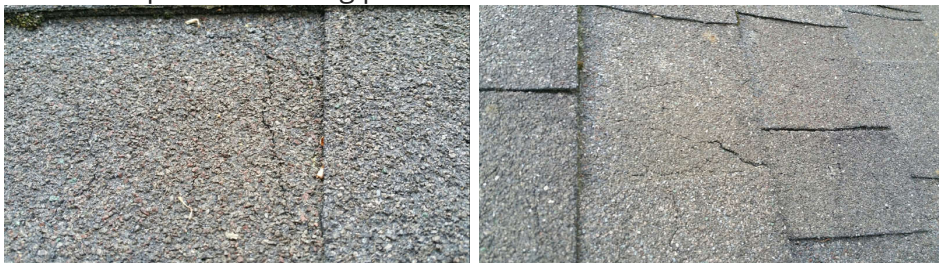
2.1.1 Coverings

ROOF IS NEAR THE END OF SERVICE LIFE

The roof is near the end of its service life. It's showing signs of wear and cracking is visible in places.

Contact a qualified roofing professional.

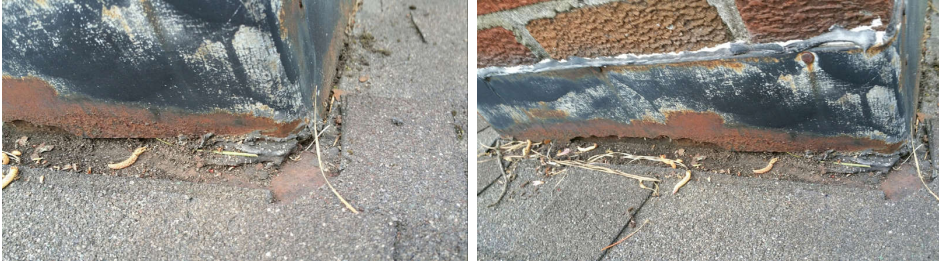
2.3.1 Flashings

CORRODED - SEVERE

Roof flashing around the chimney showed signs of severe corrosion, which can lead to moisture intrusion and/or mold. Recommend a qualified roofing contractor evaluate and repair.

Contact a qualified roofing professional.

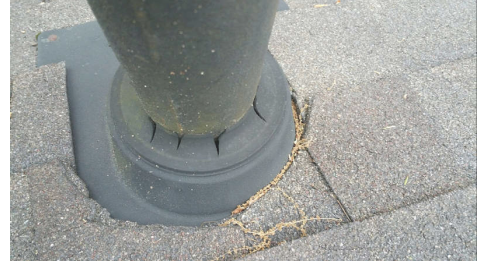
2.3.2 Flashings

PLUMBING BOOT CRACKED

The plumbing boot is cracked which can lead to moisture intrusion. Recommend further evaluation by a roofing contractor.

Contact a qualified roofing professional.

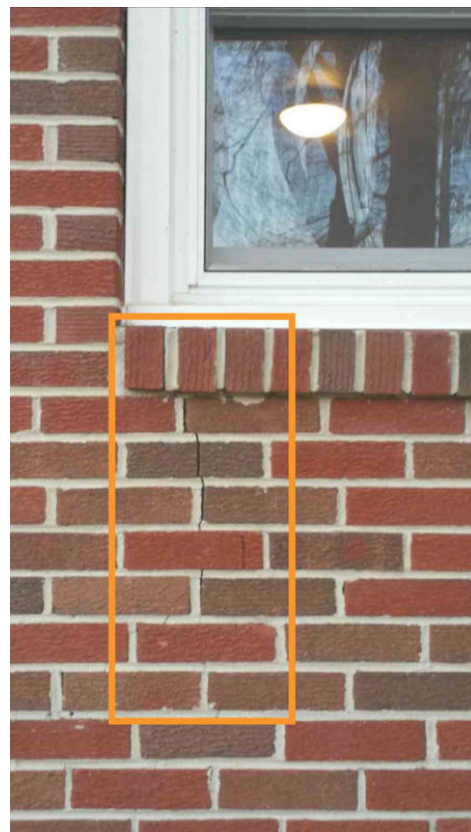
3.1.1 Siding, Flashing & Trim

CRACKING - MINOR

There was minor cracking under the kitchen window. Recommend a masonry contractor for repair.

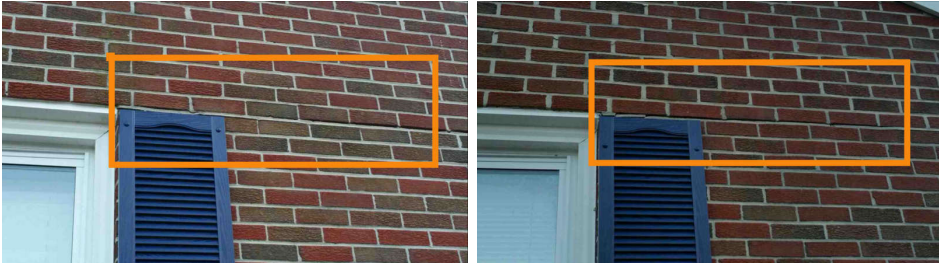
3.1.2 Siding, Flashing & Trim

CRACKING - MINOR

There was some cracking because of a rusted lintel on the left side of the house at the bedroom windows. Recommend a masonry contractor for repair.

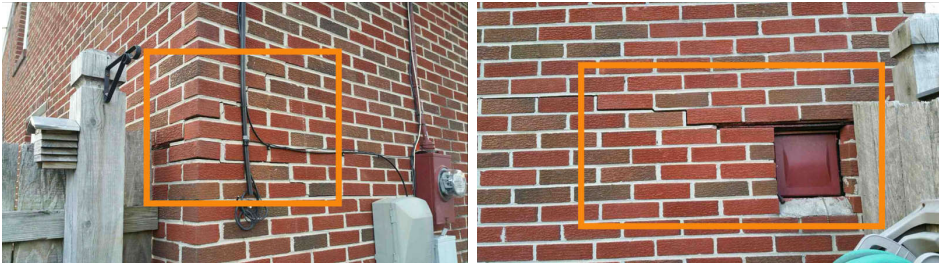
3.1.3 Siding, Flashing & Trim

CRACKING - MINOR

There was cracking in the bricks around an old, unused vent. The rusted lintel has pushed the bricks apart. Recommend a masonry contractor to remove the vent and fill in the hole and cracks.

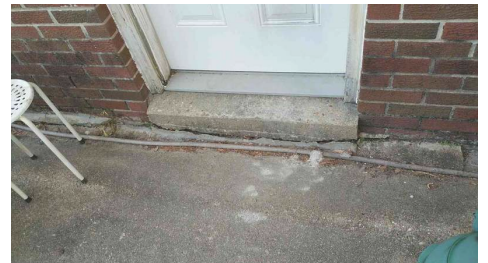
3.3.1 Driveways, Walkways, & Patios

WALKWAY SETTLING

The walkway has settled near the back door. This is likely due to the water undermining the concrete.

Contact a qualified professional.

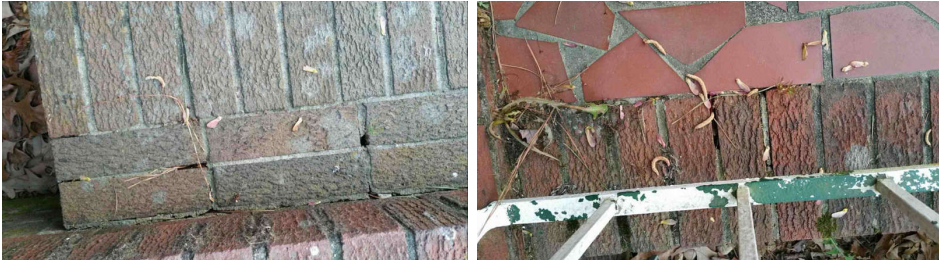
3.4.1 Decks, Balconies, Porches & Steps

REPOINTING OF BRICK MORTAR RECOMMENDED

The mortar between the bricks has deteriorated. The mortar should be repointed to protect the bricks and prevent water intrusion.

Contact a qualified masonry professional.

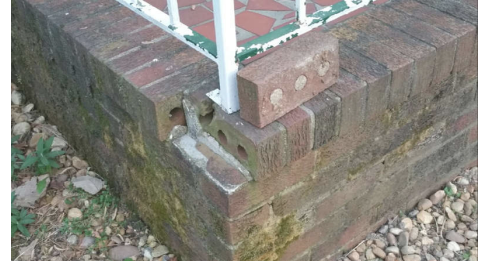
3.4.2 Decks, Balconies, Porches & Steps

LOOSE BRICK

There is a brick that has broken off the corner and should be replaced. A masonry contractor is recommended for further evaluation.

Contact a qualified masonry professional.

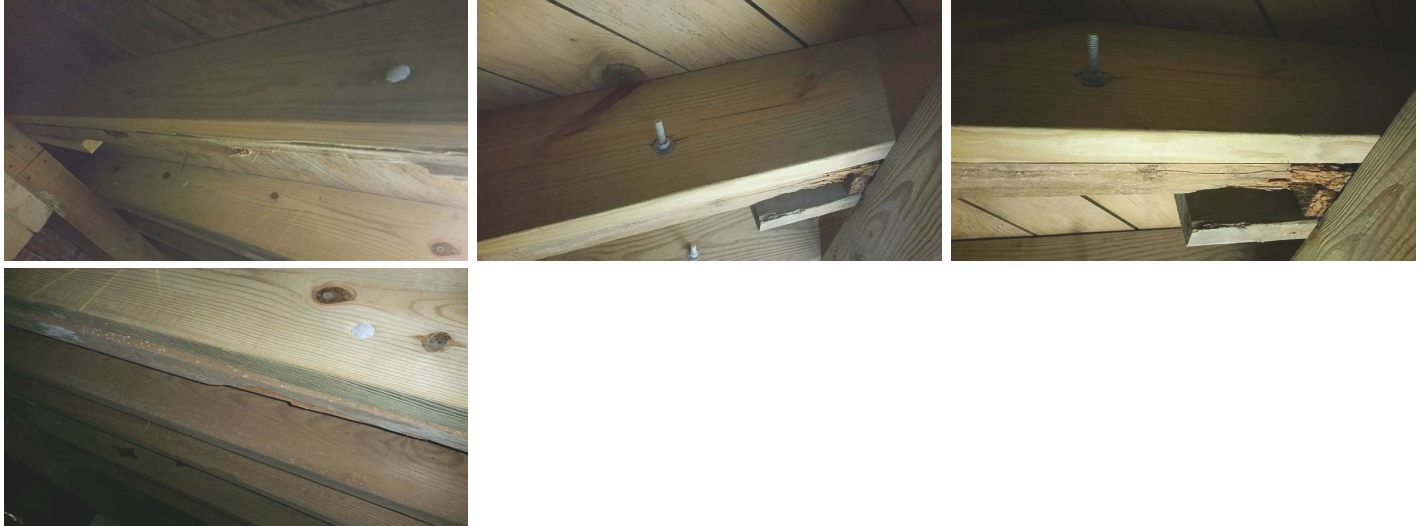
Floor Structure: Evidence of floor joist repair

There were multiple areas where new floor joists were sistered to the original joists and bolted together. This is informational only as the repairs appear sound.

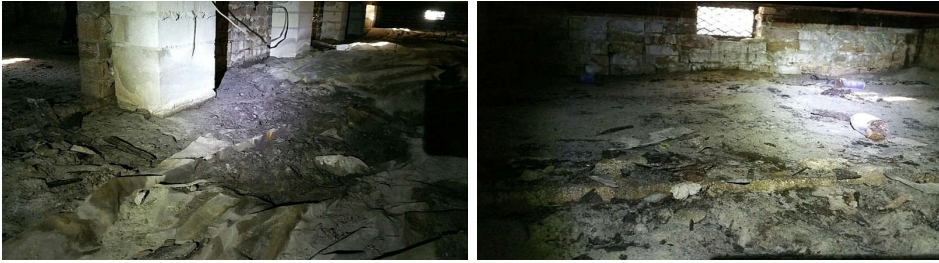
4.2.1 Crawlspace

HIGH MOISTURE LEVELS

High levels of moisture were noted in the Crawlspace near the front stoop. High moisture levels can result in mold and deterioration of the foundation and floor. Recommend a crawlspace or foundation contractor to determine a remediation plan.

Contact a qualified professional.

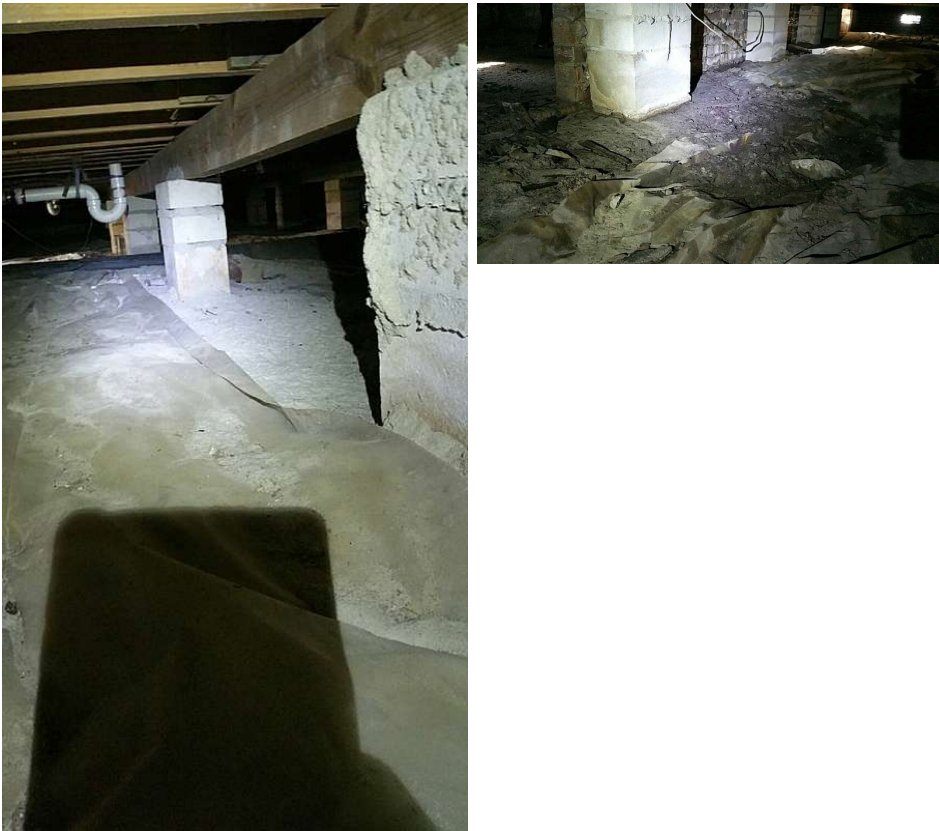
4.3.1 Vapor Retarders (Crawlspace or Basement)

VAPOR BARRIER DAMAGED AND INADEQUATE

The vapor barrier is damaged and there are also gaps limiting coverage. Recommend insulation contractor repair or replace.

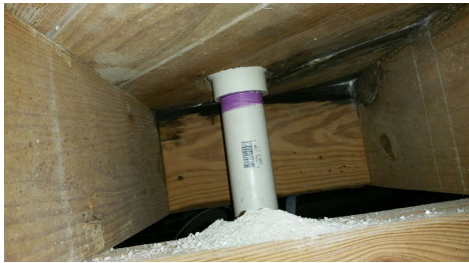
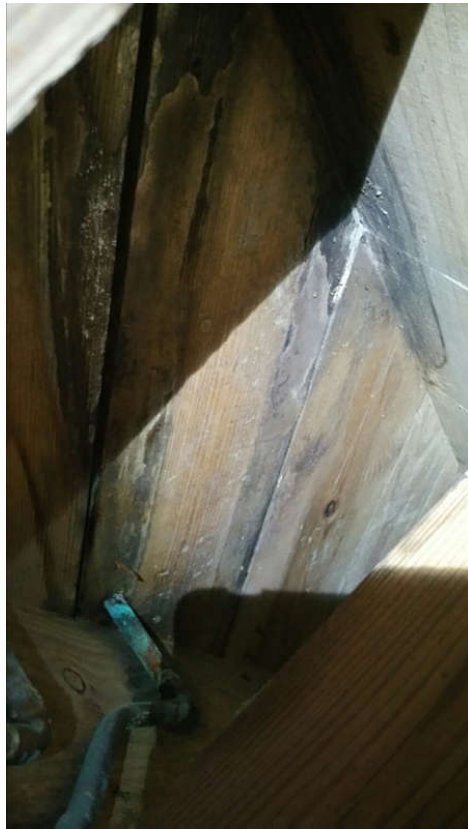
4.4.1 Floor Structure

EVIDENCE OF PRIOR LEAKS

There was evidence of prior leaks below the bathtub of the hallway bathroom. Recommend monitoring and contact a licensed plumber if it gets worse.

Contact a qualified plumbing contractor.

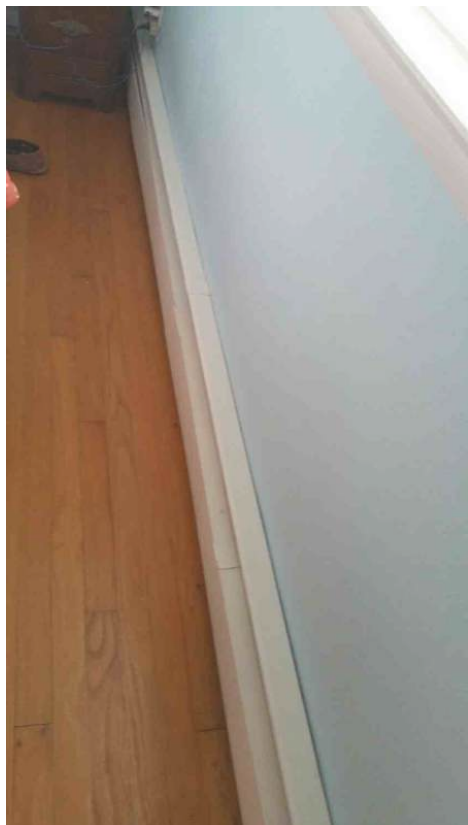
Distribution Systems: Abandoned floor radiators

There are abandoned floor radiators that don't appear to be in use since the house is now equipped with a heat pump.

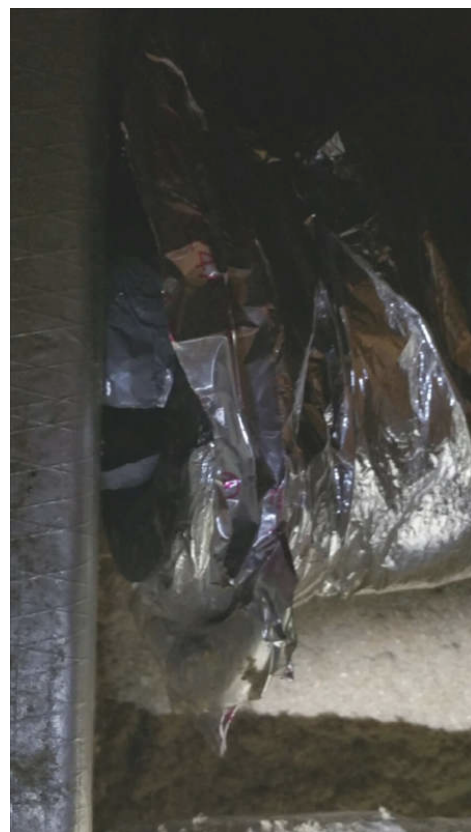
6.3.1 Distribution System

LOOSE DUCT IN THE ATTIC

There is a loose duct in the attic allowing conditioned air to escape. Recommend licensed HVAC contractor resecure.

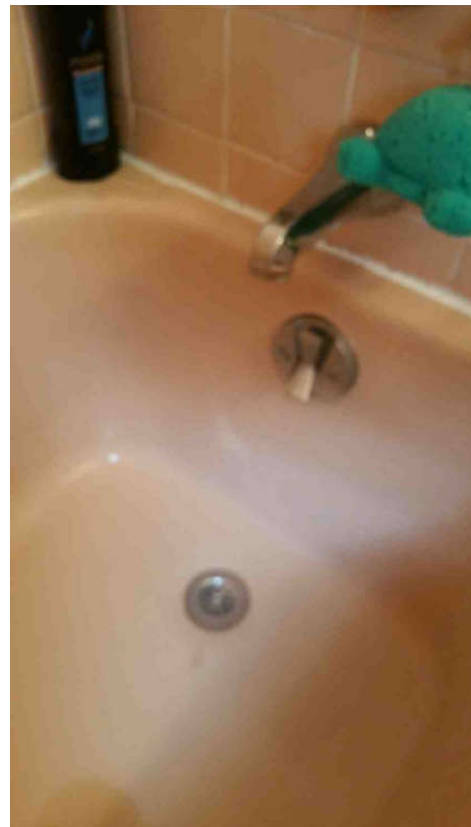
7.6.1 Shower/Bathtub

LEAKING BATH FAUCET

The faucet in the bathtub in the hallway bathroom continued to leak after it was shut off. Recommend further evaluation by a licensed plumber.

Contact a qualified plumbing contractor.

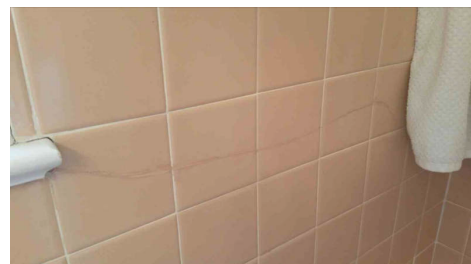
7.6.2 Shower/Bathtub

CRACKED TILE

There was cracked tile in the hallway bathroom that was previously repaired. Recommend monitoring.

Contact a qualified professional.

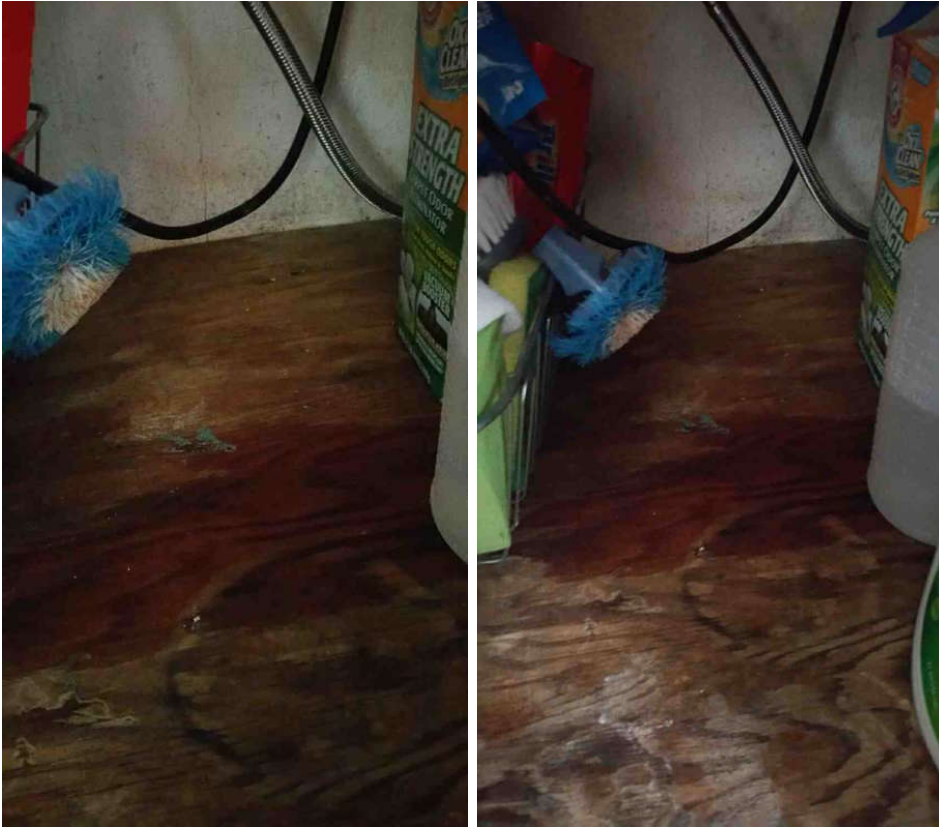
7.7.1 Sinks/Faucets

SIGNS OF PRIOR WATER DAMAGE WAS OBSERVED

Water damage was observed under the kitchen sink but the leak didn't appear to be active at the time of the inspection. Recommend monitoring and contacting a licensed plumber if an active leak is observed.

Recommend monitoring.

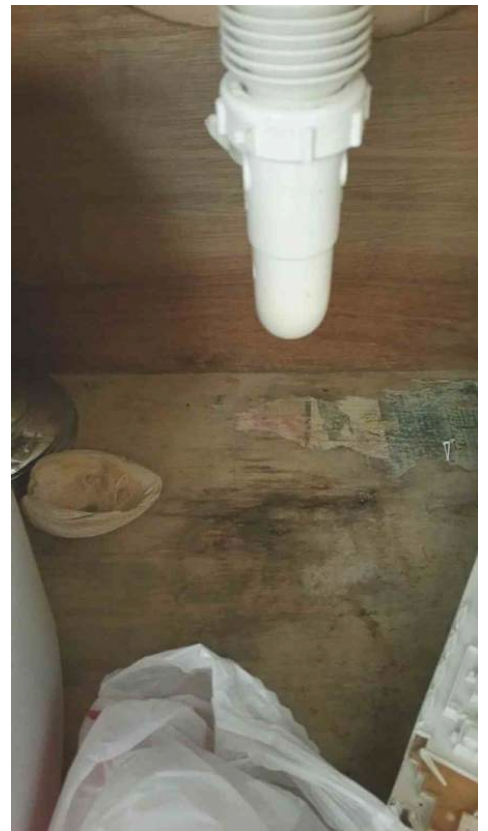
7.7.2 Sinks/Faucets

SIGNS OF PRIOR WATER DAMAGE WAS OBSERVED

Water damage was observed in the hallway sink but the leak didn't appear to be active at the time of the inspection. Recommend monitoring and contacting a licensed plumber if an active leak is observed.

Recommend monitoring.

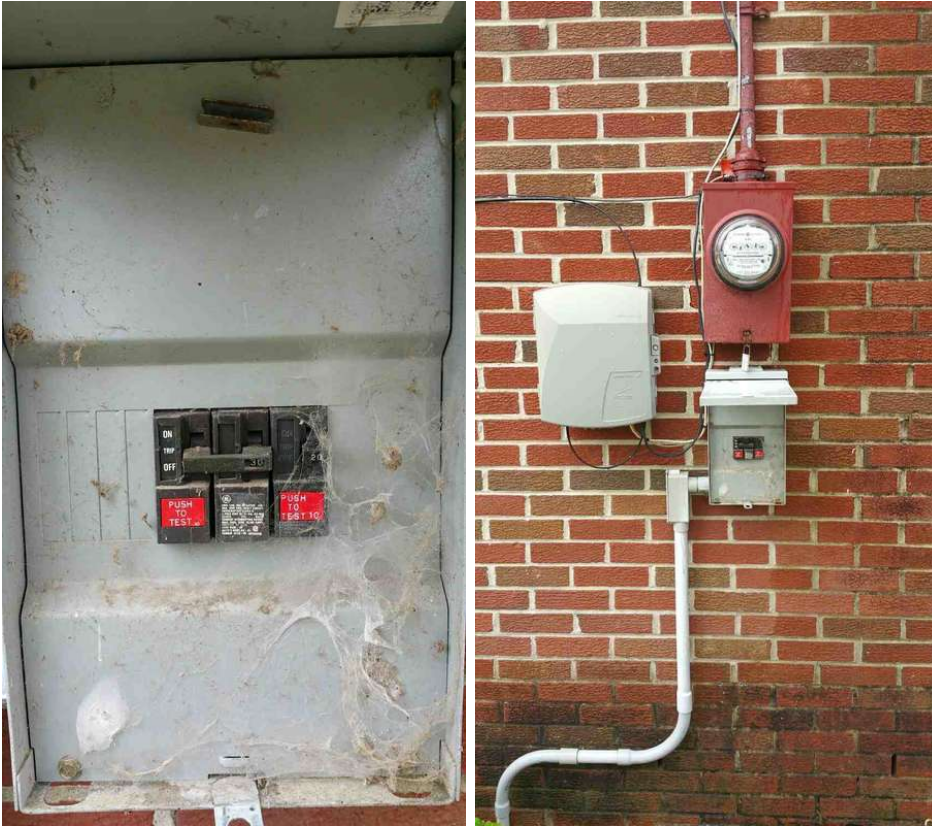
Main & Subpanels, Service & Grounding, Main Overcurrent Device: Abandoned subpanel

There is a subpanel located outside that appears to be unused as the breakers are turned off.

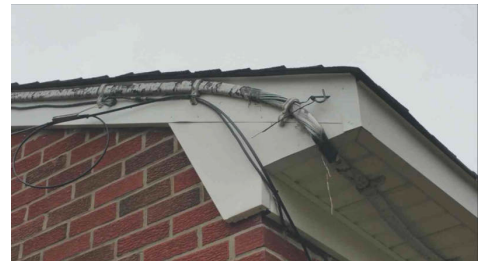
8.1.1 Service Entrance Conductors

FRAYED SHEATHING

Wires on service entrance are damaged or frayed. Recommend contacting your electric utility company or a qualified electrician to evaluate and repair.

Contact a qualified electrical contractor.

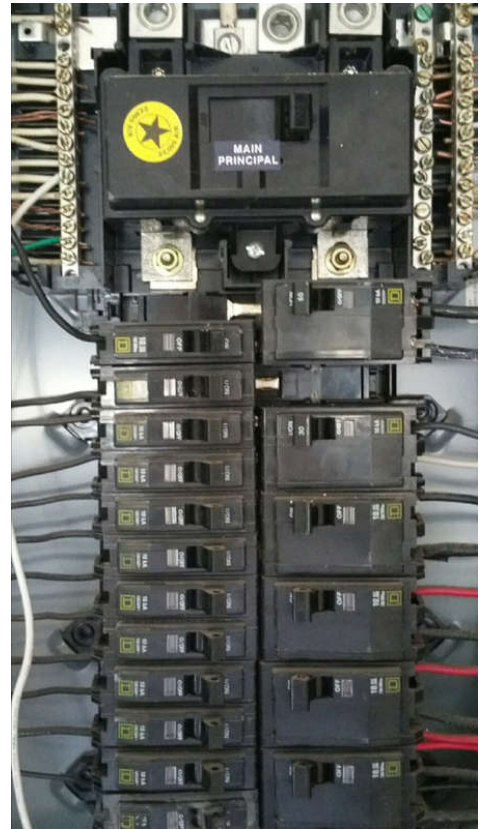
8.2.1 Main & Subpanels, Service & Grounding, Main Overcurrent Device

POSSIBLE MISSING GROUND

The electrical panel doesn't appear to be grounded. This corresponds with what the tester was showing at the outlets also. Recommend a licensed electrician for further evaluation to bring up to current safety standards.

Contact a qualified electrical contractor.

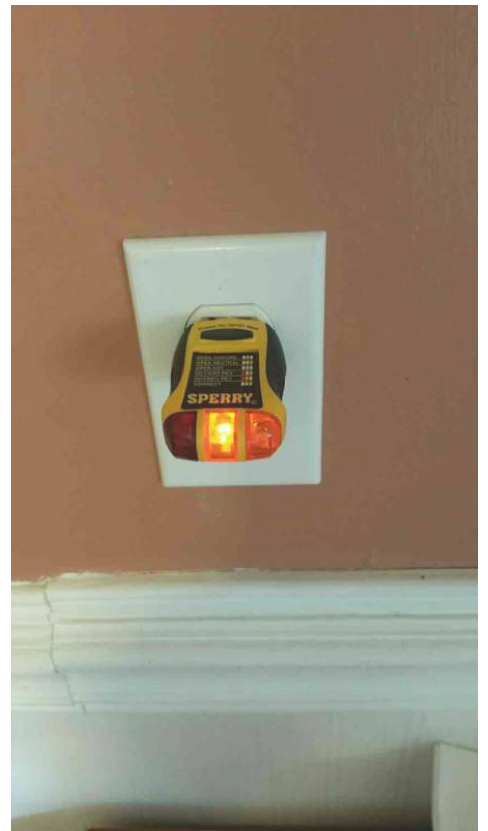
8.4.1 Lighting Fixtures, Switches & Receptacles

UNGROUND RECEPTACLES

The receptacles in the original part of the house are reading ungrounded. The sunroom addition is reading grounded. To help alleviate safety hazards, all receptacles should be grounded. A licensed electrician is recommended for further evaluation.

Contact a qualified electrical contractor.

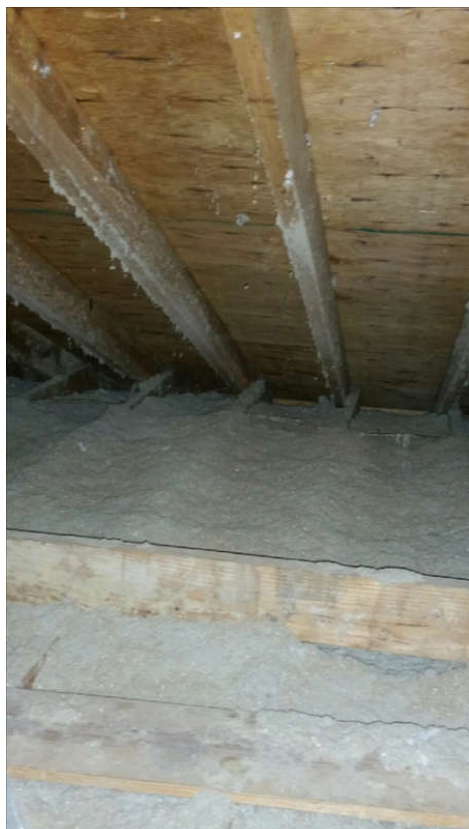
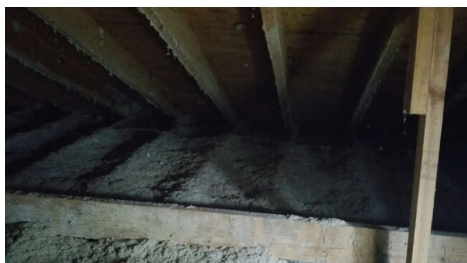
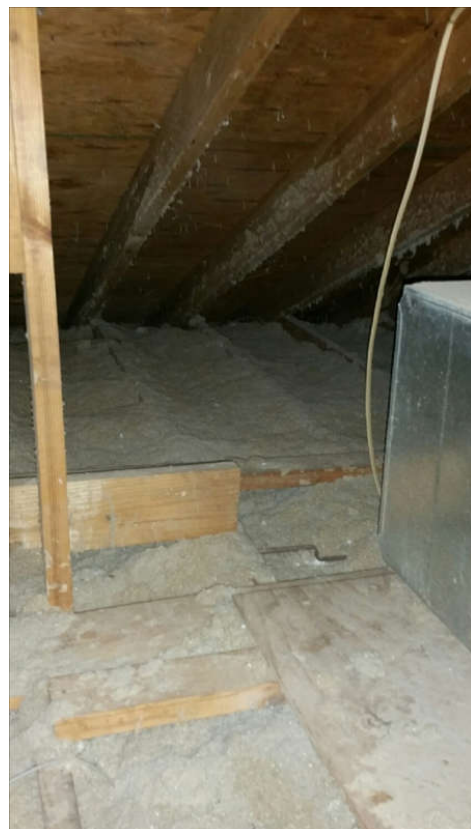
INSUFFICIENT INSULATION

Insulation depth was inadequate. Recommend a qualified attic insulation contractor install additional insulation.

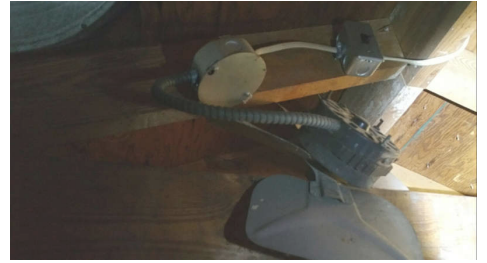
9.2.1 Attic Ventilation

There was an abandoned fan in the attic that was still wired. Recommend removal of the fan and capping the wires by a qualified electrician.

Contact a qualified electrical contractor.

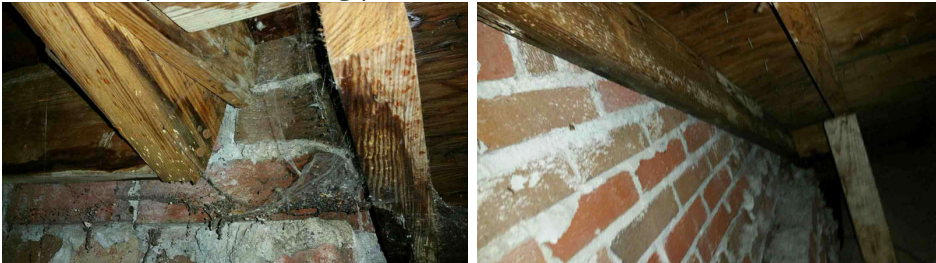
9.4.1 Roof Sheathing

INDICATIONS OF A LEAK

There was a leak observed in the attic at the high side of the chimney. This corresponds with the chimney flashing issue noted in the roofing section. Recommend a qualified roofer for further evaluation.

Contact a qualified roofing professional.

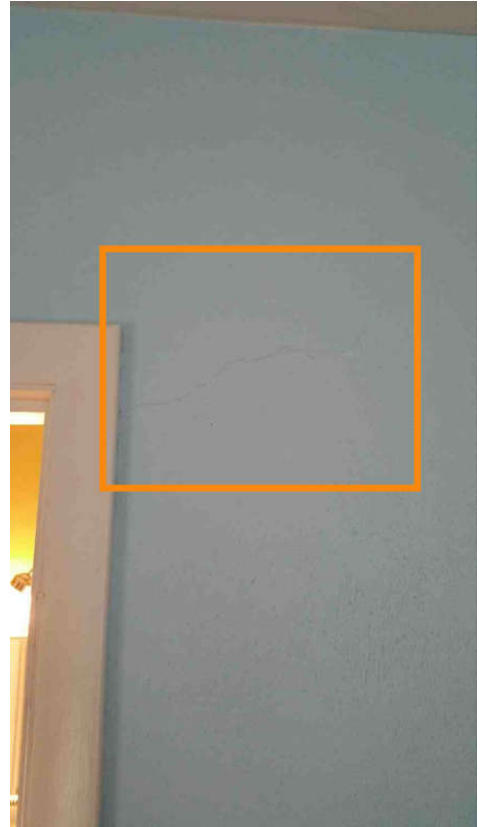
MINOR CORNER CRACK

Minor crack at the master bathroom door that has been repaired. Some settling is not unusual in a home of this age and these cracks are not a structural concern. Recommend monitoring.

Recommend monitoring.

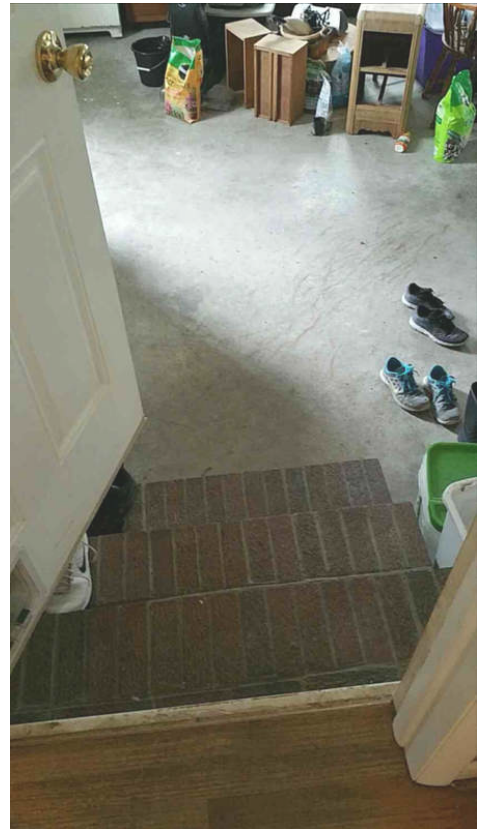
10.6.1 Steps, Stairways & Railings

NO HANDRAIL

Steps leading into the garage had no handrails. This is a safety hazard. Recommend a qualified handyman install a handrail.

Contact a qualified handyman.

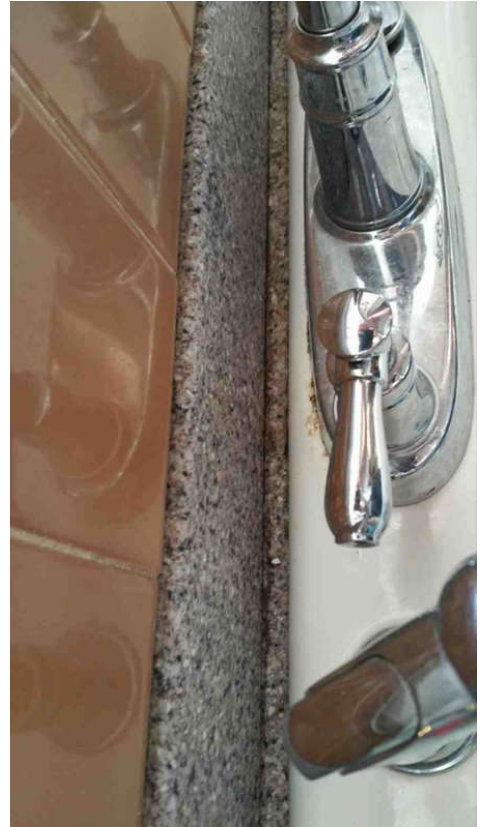
10.7.1 Countertops & Cabinets

POOR/MISSING CAULK

Kitchen countertop was missing sufficient caulk/sealant at the wall. This can lead to water damage. Recommend adding sealant at sides and corners where counters touch walls.

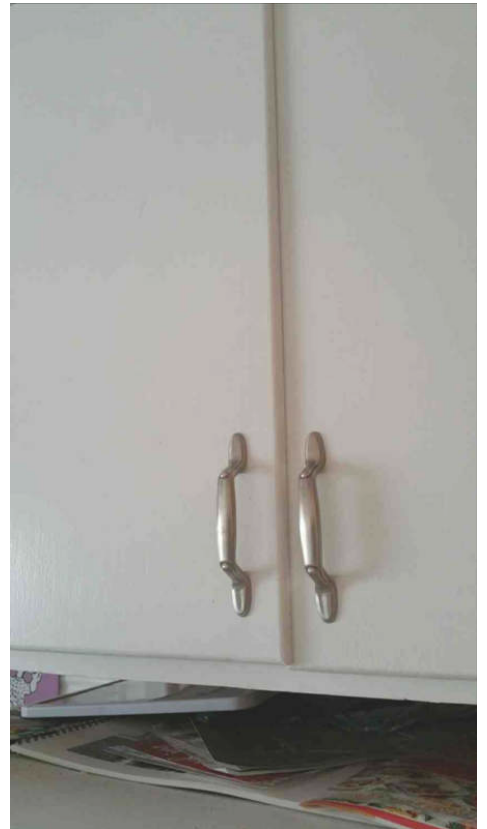
10.7.2 Countertops & Cabinets

CABINET DOORS NOT CLOSING PROPERLY

The cabinet doors above the refrigerator don't line up and close properly. Recommend adjusting by a handyman.

Contact a handyman or DIY project

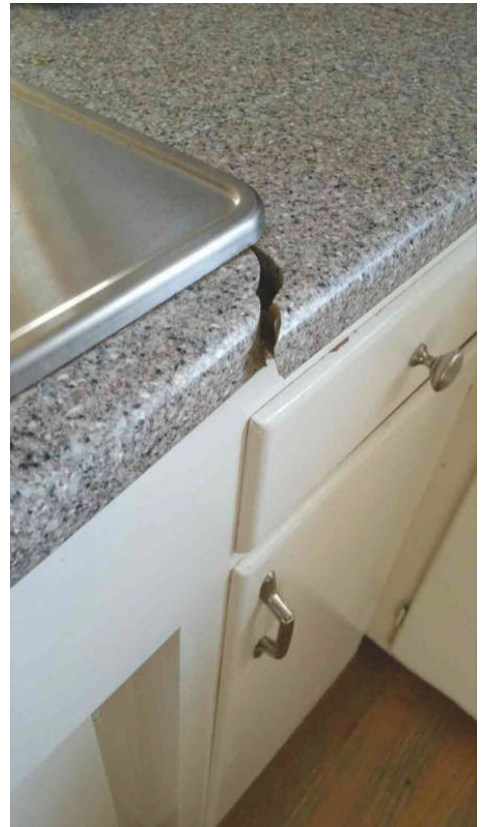
10.7.3 Countertops & Cabinets

**CRACKS IN THE KITCHEN
COUNTERTOP**

There is a crack next to the stove on the countertop. Recommend further evaluation by a countertop repair

Contact a qualified professional.

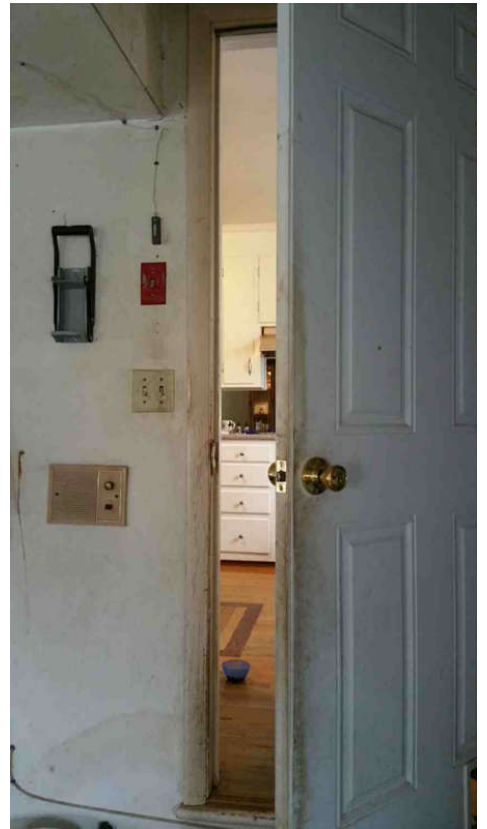
Door from garage to home should have self-closing hinges to help prevent spread of a fire to living space. Recommend a qualified contractor install self-closing hinges.

Contact a qualified handyman.
