PGR HOME INSPECTIONS

RESIDENTIAL REPORT

1234 Main St.
Charleston SC 29414

08/18/2018 9:00AM

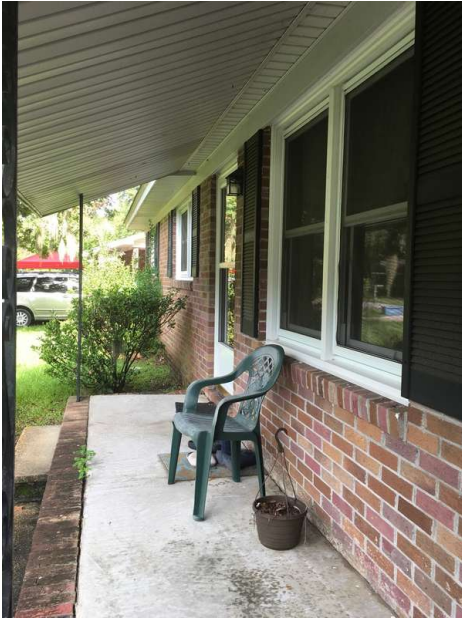
Siding, Flashing, Trim : Siding, Flashing, Trim Inspection Method

These components were inspected looking for damage, potential water entry points, missing pieces, wood rot, etc. No deficiencies were observed at the time of inspection unless otherwise noted in this report.

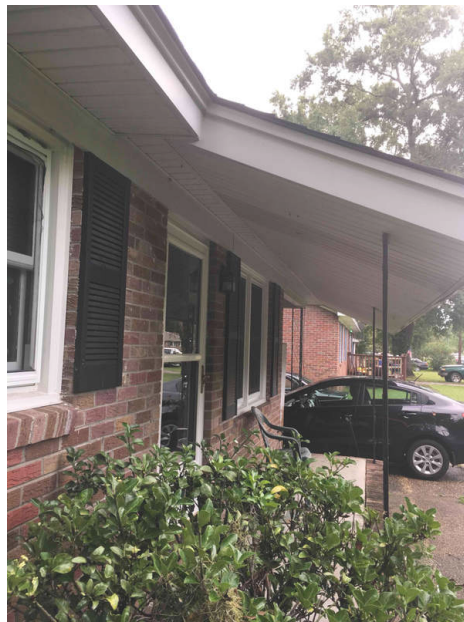
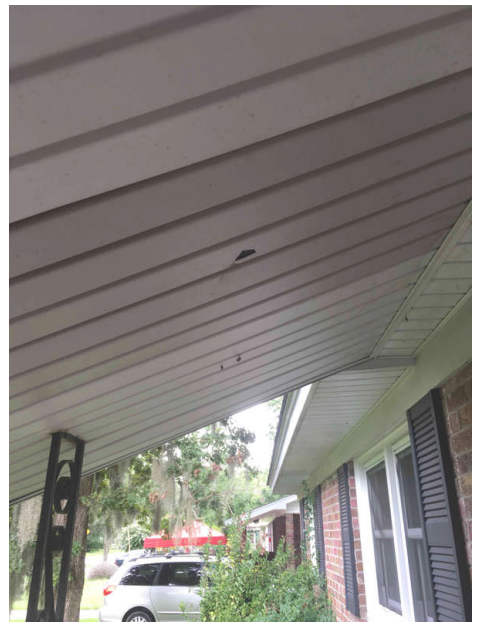
Eaves, Soffits & Fascia: Eaves, Soffit, Fascia Inspection Method

The eaves, soffit and fascia was inspected at visible portions looking for any water damage or other significant defects. No reportable conditions were present at the time of inspection unless otherwise noted in this report.

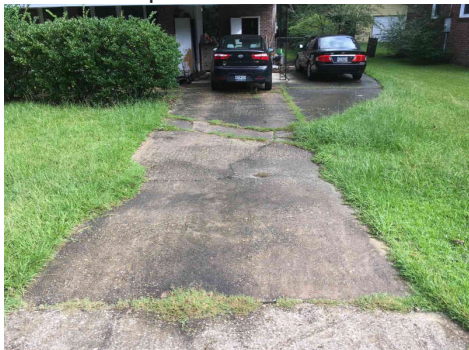
-   2.1.1 Exterior - Walkways, Patios & Driveways: Driveway Cracking - Minor/ moderate
-   2.2.1 Exterior - Siding, Flashing, Trim : Cracking - Major
-   2.2.2 Exterior - Siding, Flashing, Trim : Through Brick Cracks

Recommendation

Contact a qualified concrete contractor.

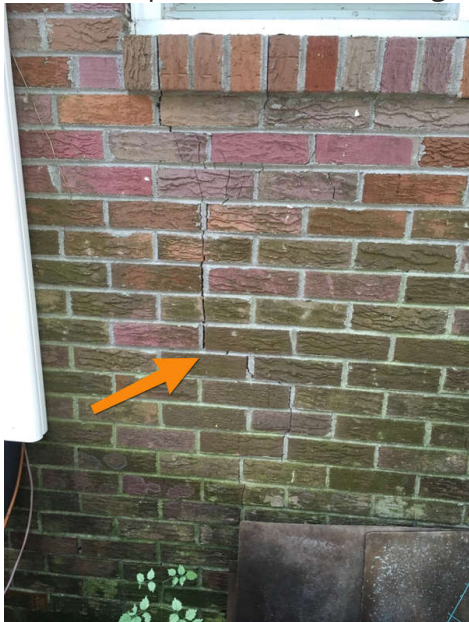
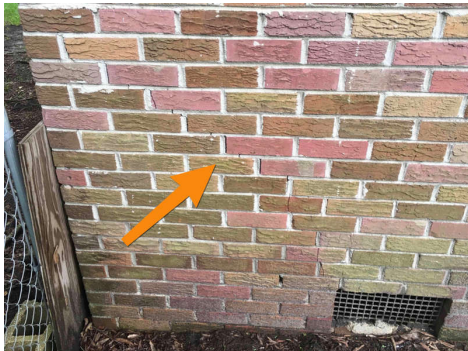
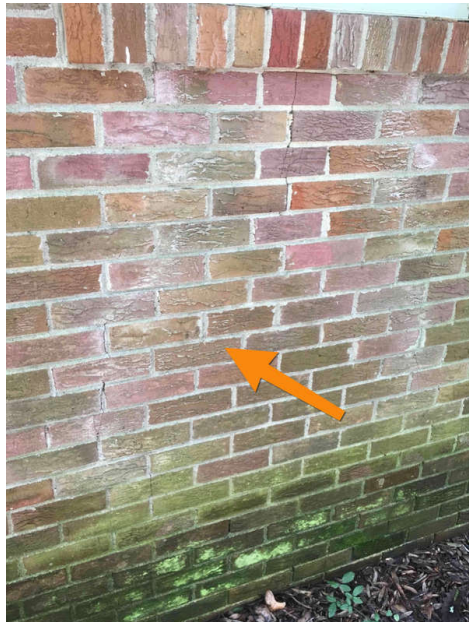
2.2.1 Siding, Flashing, Trim

Significant Defect/ Safety Hazard

Recommendation

Contact a qualified structural engineer.

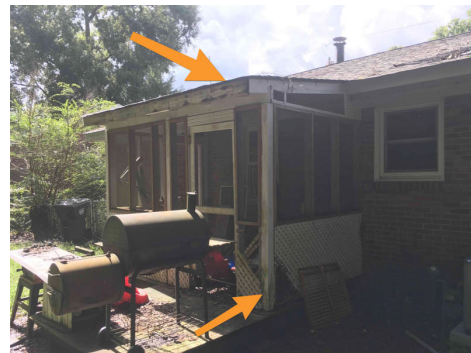
-   6.1.1 Doors, Windows & Interior - Doors: Door broke and rotted at bottom
-   6.3.1 Doors, Windows & Interior - Floors: Cupping Floors
-   6.4.1 Doors, Windows & Interior - Walls: Drywall cracking at seams

Recommendation

Contact a qualified professional.

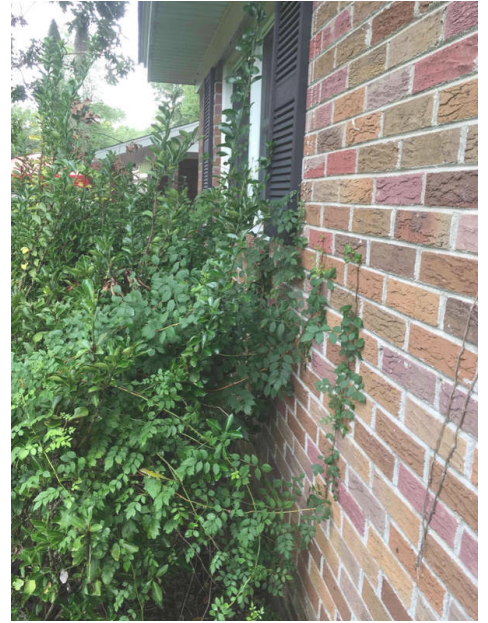
-   2.5.1 Exterior - Decks, Porches & Steps: Possible wood rot
-   2.6.1 Exterior - Vegetation, Grading, Drainage & Retaining Walls: Bushes/Flowers/Shrubbery Too Close to Foundation

Recommendation

Contact a qualified lawn care professional.

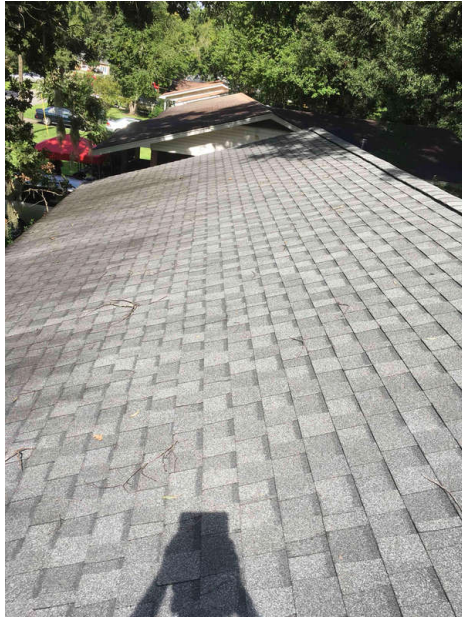
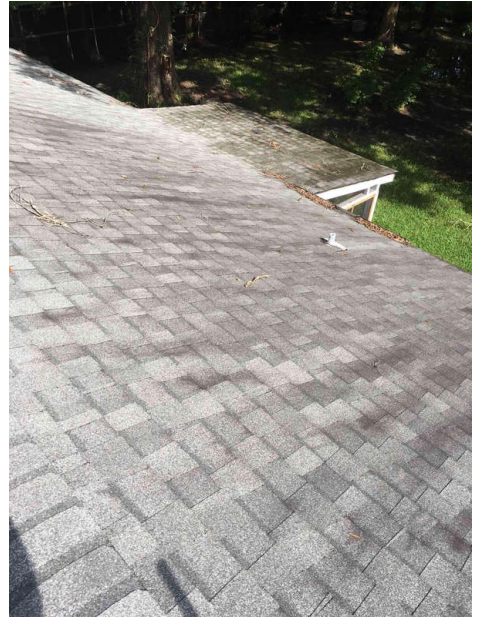
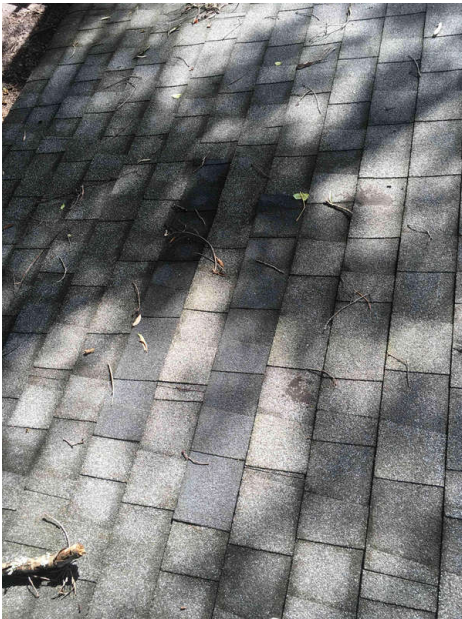
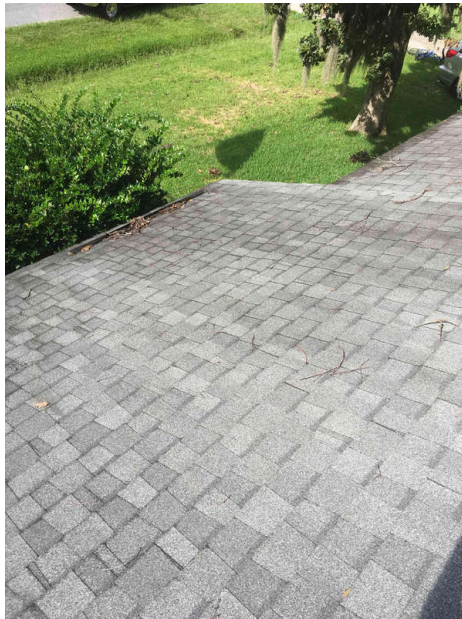
Roofing Material: Roofing Material Condition Information: Shingles

The shingles were inspected at visible portions for excessive granule loss, signs of curling or delamination, loss of adhesion between the shingles, and any other signs of damage or excessive age. The shingles appeared to be in satisfactory condition, allowing for normal wear and tear, at the time of inspection. No deficiencies were observed unless otherwise noted in this report.

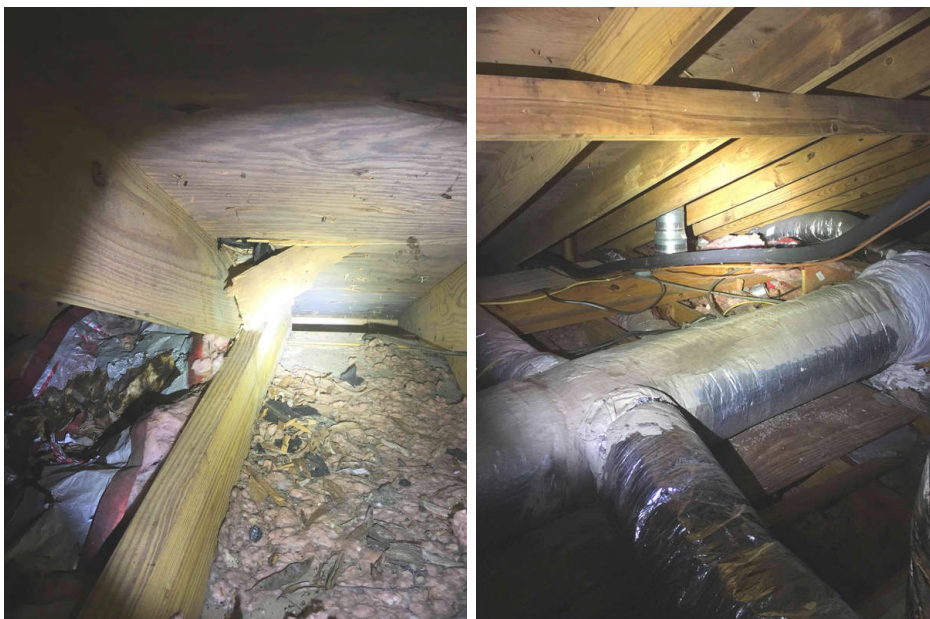
The roof structure was inspected at visible portions looking for any signs of moisture infiltration, damage, or other deficiencies. No reportable conditions or indications of past or present leaks were observed at the time of inspection unless otherwise noted in this report.

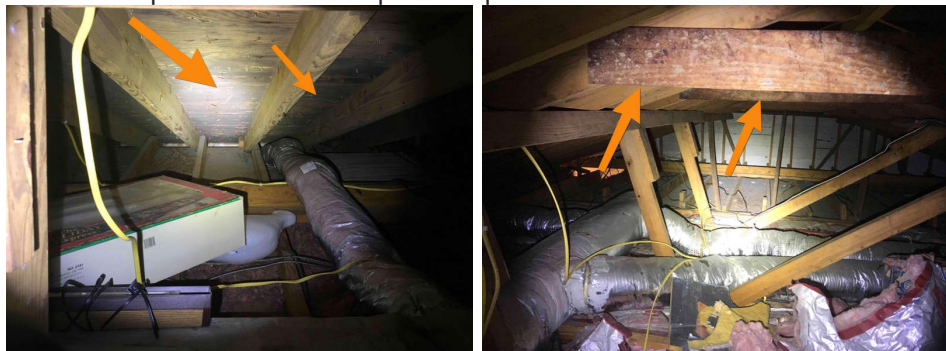
-   4.2.1 Attic, Insulation & Ventilation - Roof Structure & Attic: Possible organic growth
-   4.2.2 Attic, Insulation & Ventilation - Roof Structure & Attic: Hole in roof decking. Repaired

Recommendation

Contact a qualified mold inspection professional.

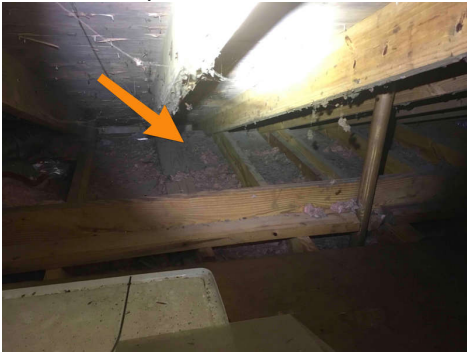
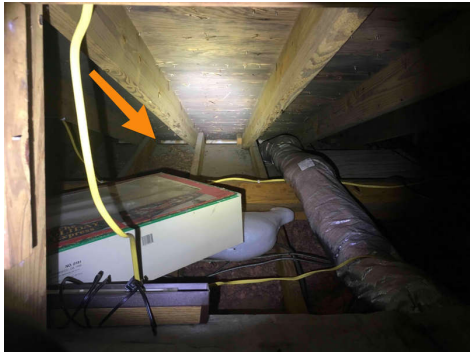
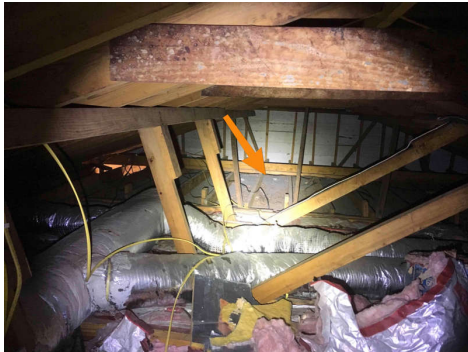
4.3.1 Attic Insulation

-   4.3.1 Attic, Insulation & Ventilation - Attic Insulation: Insufficient Insulation or missing
-   4.3.2 Attic, Insulation & Ventilation - Attic Insulation: Recommend adding weatherstripping to attic hatch

Recommendation

Contact a qualified insulation contractor.

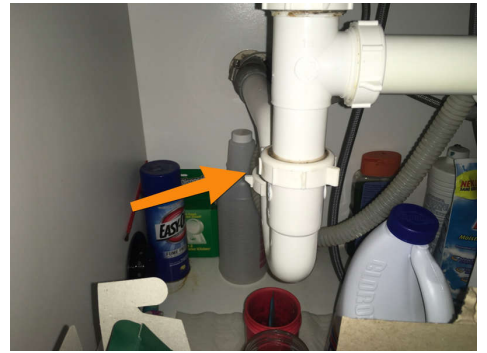
5.2.1 Sink, Plumbing

ACTIVE LEAK PRESENT

Leak present underneath sink. Recommend repair by a qualified plumbing contractor.

Contact a qualified plumbing contractor.

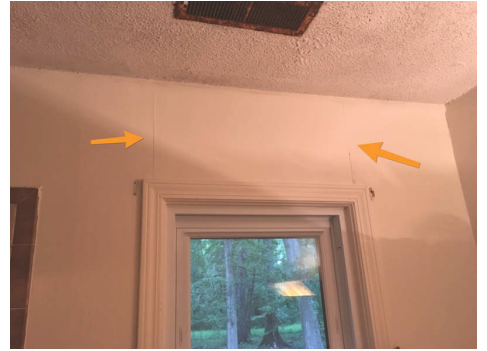
DRYWALL CRACKING AT SEAMS

Occurring in multiple locations. Most likely due to expansion/contraction of the material or settling of the home. Monitor for future movement and repair as needed.

Example, multiple areas throughout the home exhibited these cracks

Contact a handyman or DIY project

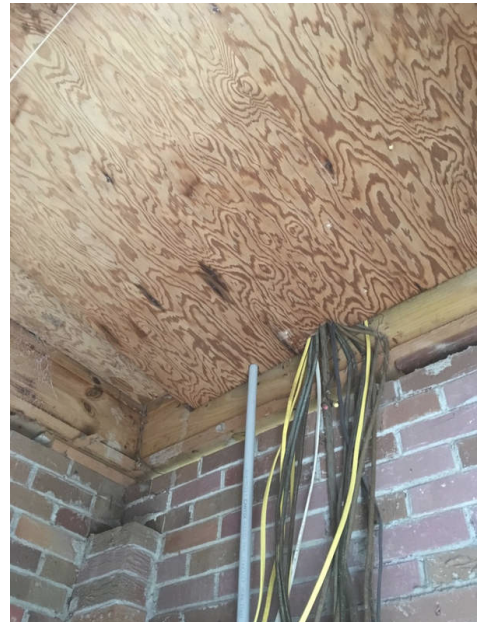
6.5.1 Ceilings

WATER INTRUSION/ HIGH MOISTURE/ MOLD GROWTH POSSIBLE/ MOISTURE STAIN

Several areas exhibited moisture stains. None of these areas showed any signs of active leaking during time of inspection. One or more areas showed signs of possible mold growth. Samples were taken. Please defer to the lab results.

Recommend monitoring areas for continued leakage and recommend contacting a qualified roofing contractor to further evaluate and repair as needed if the issue gets worse.

Contact a qualified professional.

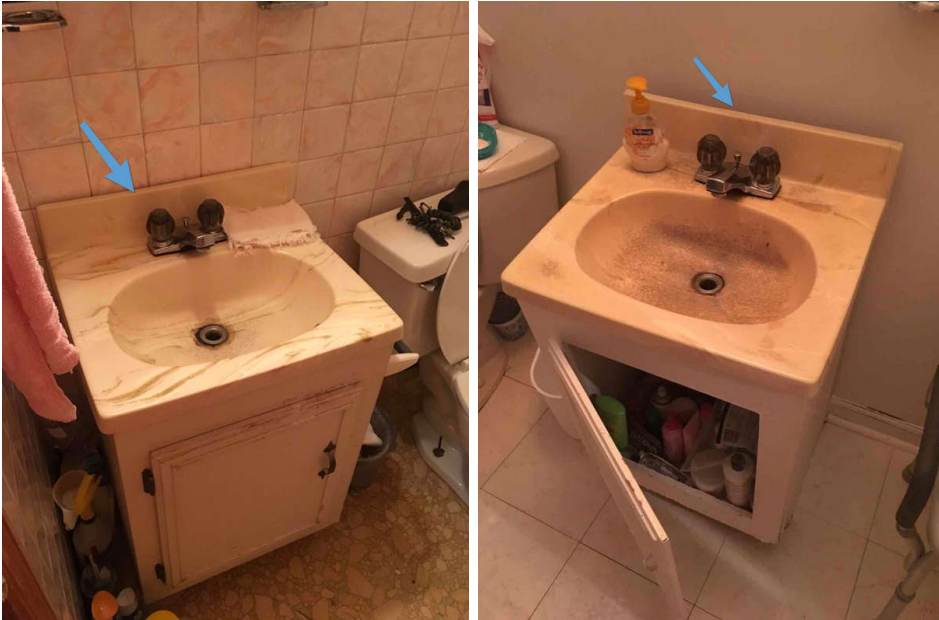
RECOMMEND ADDITIONAL CAULK/ GROUT

Recommend additional caulk/ grout to help prevent moisture/water intrusion behind wall and vanity.

Contact a handyman or DIY project

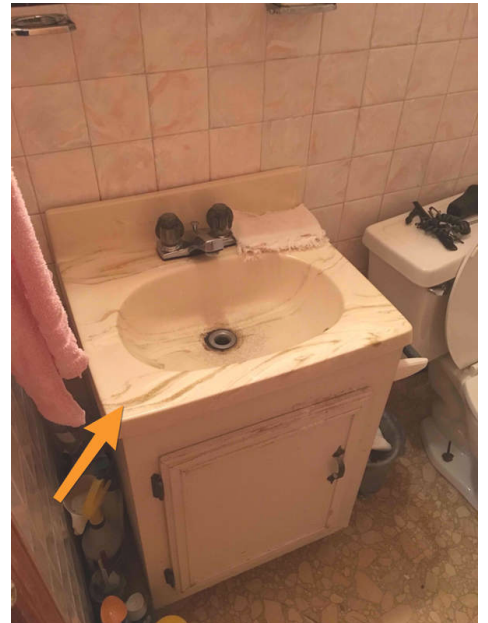
7.1.2 Cabinets, Countertops

LOOSE

Vanity is a little loose. Recommend securing it properly to the wall.

Contact a qualified professional.

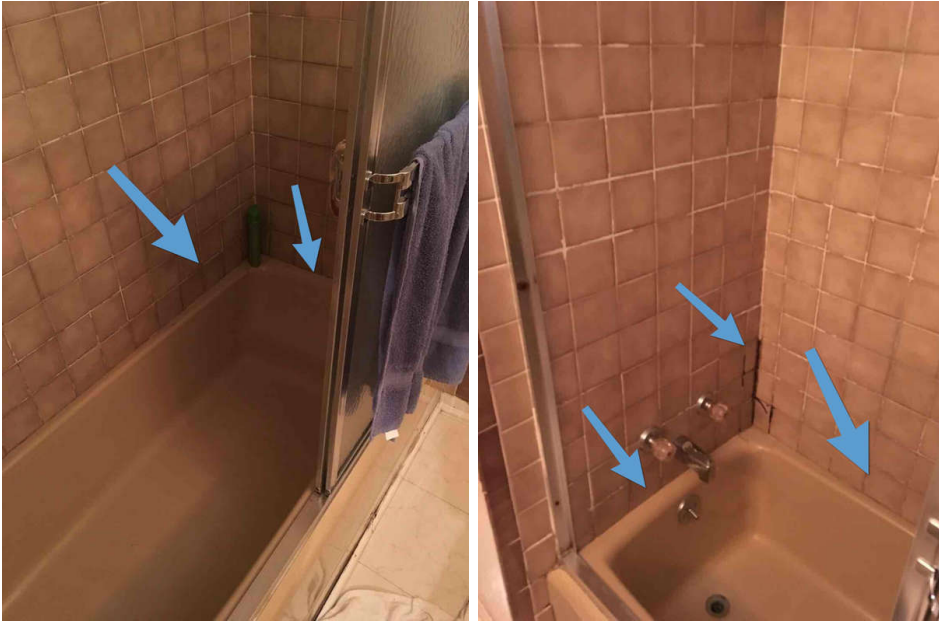
7.2.1 Sinks, Tubs/showers, Toilets, Plumbing

Current caulk has a lot of mildew and possibly mold on it. Recommend removing, cleaning thoroughly, and replacing caulk around the shower stall to prevent water intrusion behind the shower liner.

Contact a handyman or DIY project

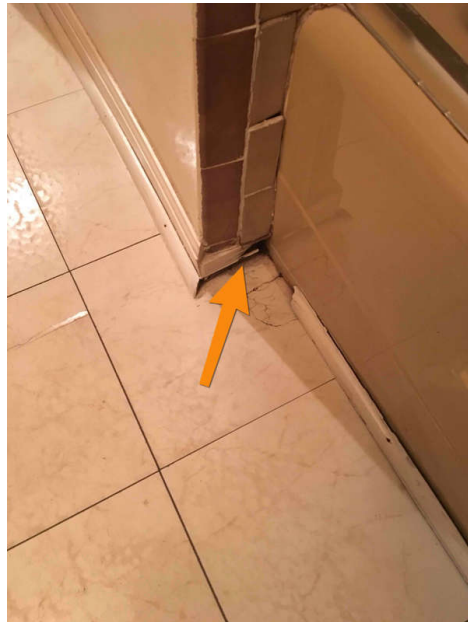
**LOOSE TILES/ HIGH MOISTURE/ POSSIBLE MOLD**

Shower area had multiple loose tiles due to moisture or water intrusion behind the wall. It is likely there is some mold present however due to the non-invasive nature of the inspection it is not possible to accurately determine that without tearing into the wall. Recommend a licensed contractor correct the moisture issue in the bathroom and then repair or replace the damaged tile as needed.

Contact a qualified professional.

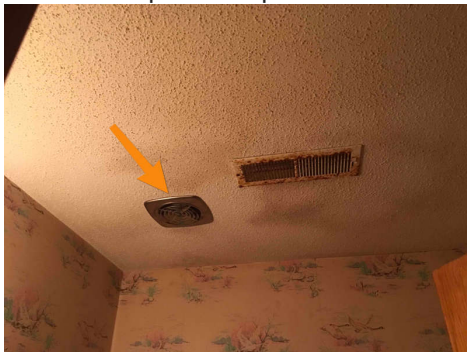
7.3.1 Exhaust Fans

Bathroom fan should fully vent to the exterior to prevent moisture build up in attic. Recommend a qualified professional attached an approved hose and terminate to the exterior.

Contact a qualified professional.

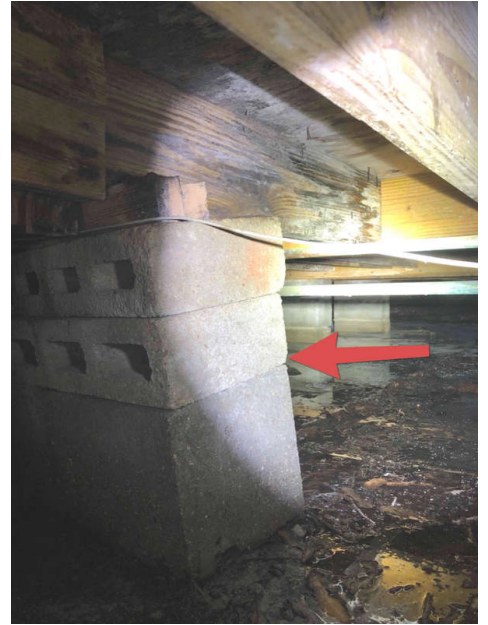
9.1.1 Foundation

One or More foundation supports appears to be leaning. Based on its location it could be playing a factor in the sagging bathroom floor issue. Recommend contacting a licensed foundation contractor and repair as needed.

Contact a foundation contractor.

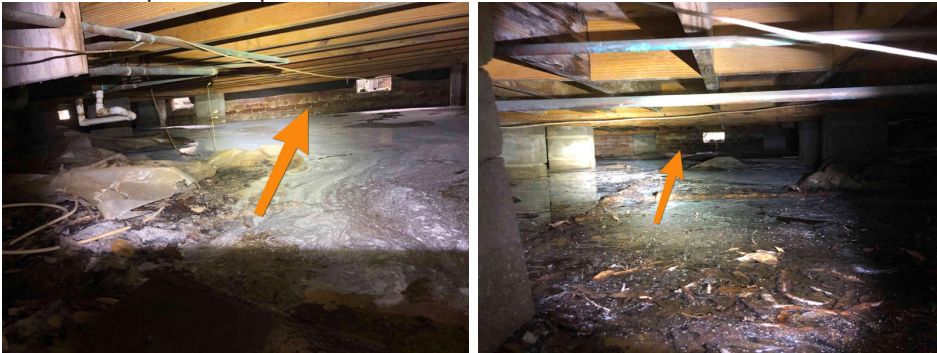
9.2.1 Basements & Crawlspace

Efflorescence noted on the crawlspace surface. This is a white, powdery deposit that is consistent with moisture intrusion. This can compromise the soil's ability to support the home structure and/or lead to mold growth. Recommend a qualified contractor identify source or moisture and correct.

Contact a qualified professional.

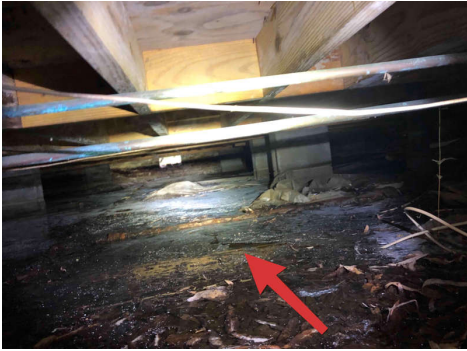
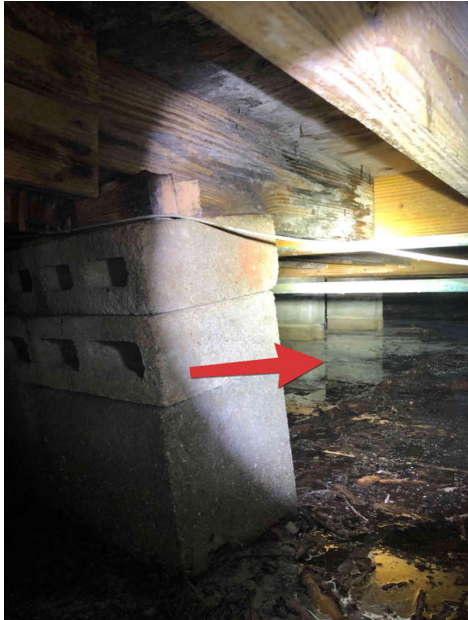
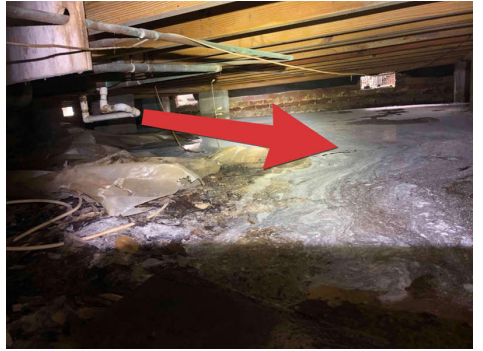
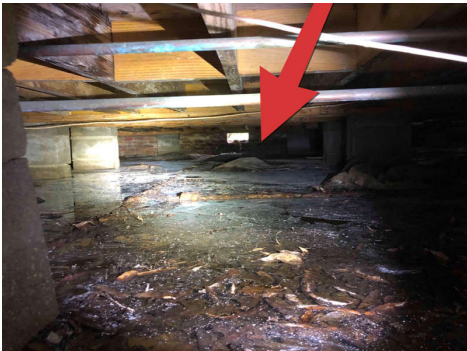
9.2.2 Basements & Crawlspace

Crawlspace had a few inches of water throughout the entire space. The large amounts of recent rain we have been getting and the significant water leak from a distribution pipe in the crawlspace share the blame. Recommend the water leak be corrected ASAP and the remaining water be pumped out safely and the vapor barrier's condition be evaluated and repaired if need be.

Contact a qualified professional.

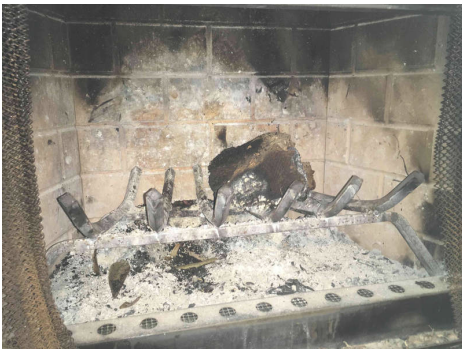
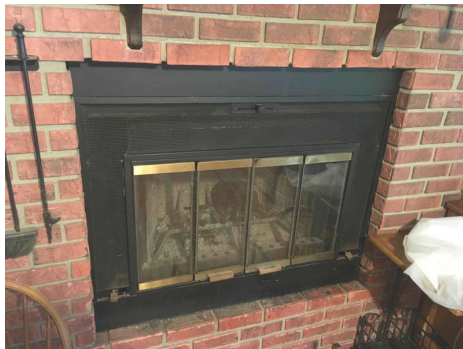
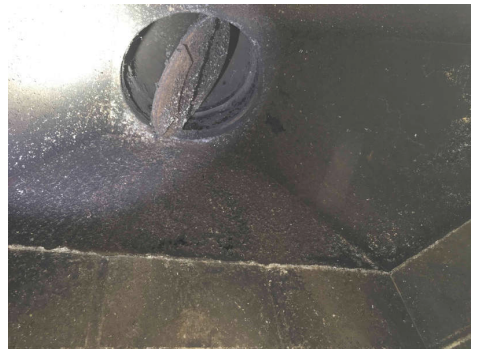
-The gas fireplace (if applicable) was tested for satisfactory operation and for potential gas leaks around the supply. No deficiencies were found unless otherwise noted in the report.

- The wood burning fireplace was visually inspected for proper hearth dimensions, door/ screen condition, firebox and damper condition.

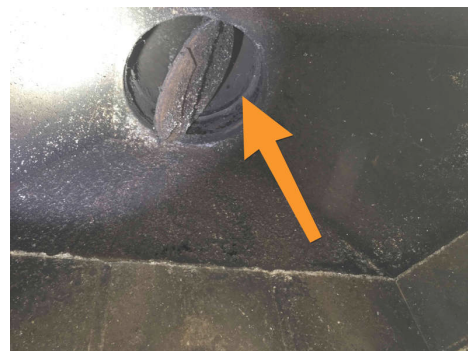
There was a notable amount of creosote buildup in the flue. Recommend a qualified fireplace or chimney contractor inspected and sweep on annual basis.

Contact a qualified fireplace contractor.

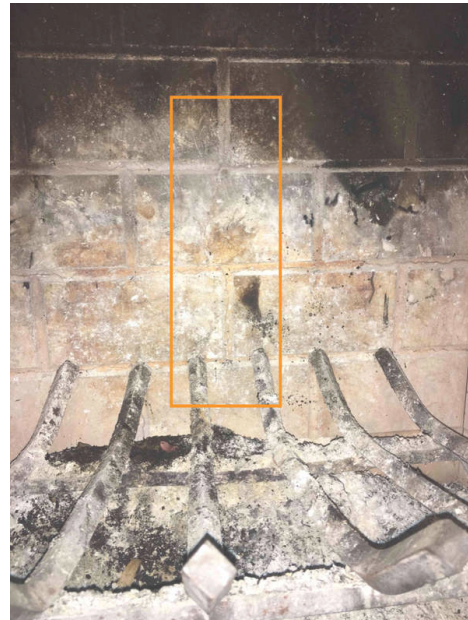
10.5.2 Gas/LP Firelogs & Fireplaces

FIRE BRICK CRACKED

Fire brick on the inside of fireplace is cracked in several places. Recommend replacing if planning on using fireplace regularly by a qualified professional.

Contact a qualified professional.

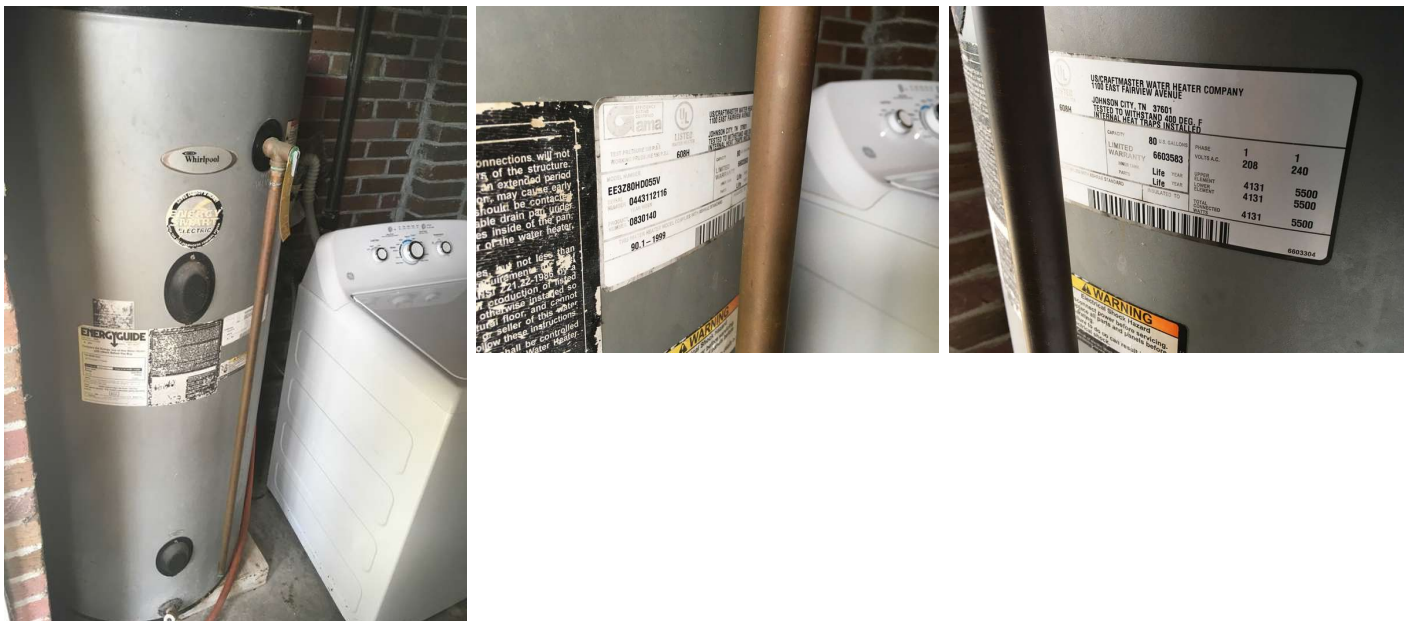
The water heater produced hot water at the time of inspection. No reportable deficiencies were observed with the unit unless otherwise noted in this report.

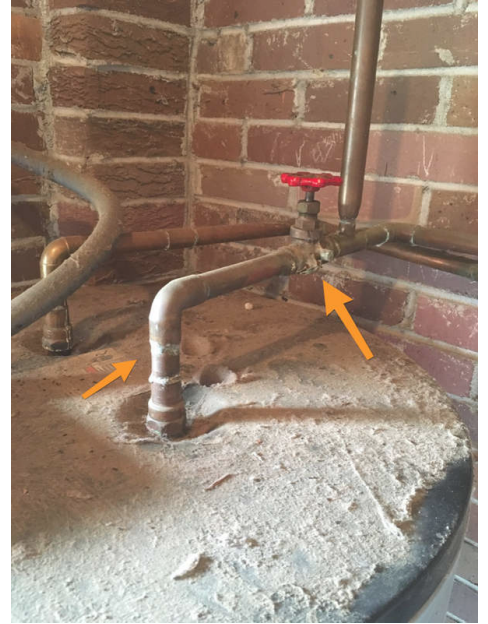
Corrosion was noticed on the supply lines. Recommend a qualified plumber evaluate and repair or replace as needed.

Contact a qualified plumbing contractor.

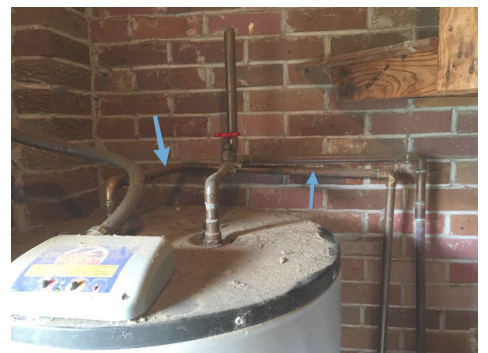
Maintenance Item**MISSING PIPE INSULATION**

Recommend installing pipe wrap insulation on the first 3 feet of the hot water line or until the pipe terminates to the wall to improve energy efficiency.

Contact a handyman or DIY project

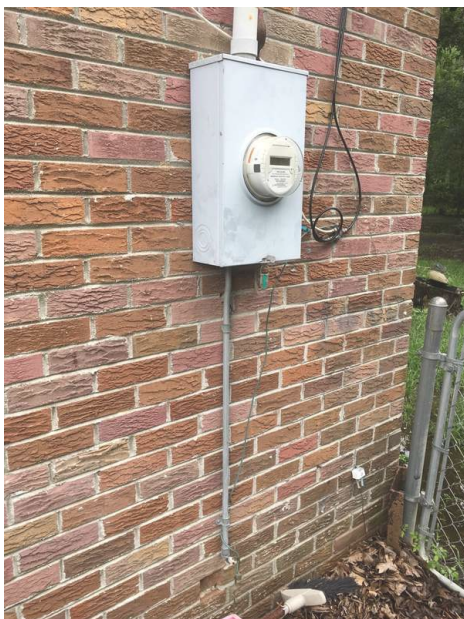
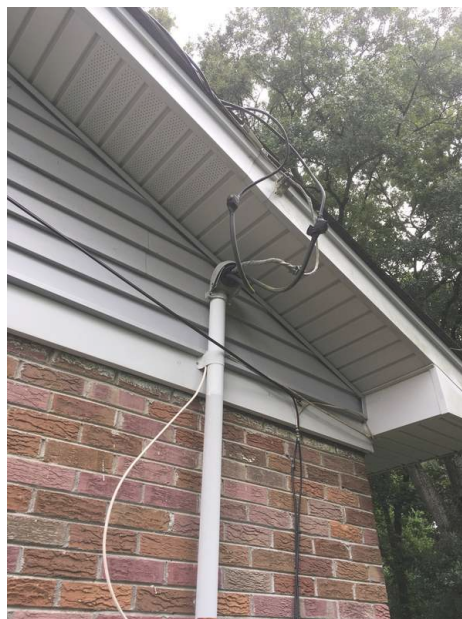
Power was supplied to the home via an overhead service. The meter and conduit appeared to be in satisfactory condition. No deficiencies were observed unless otherwise noted in this report.

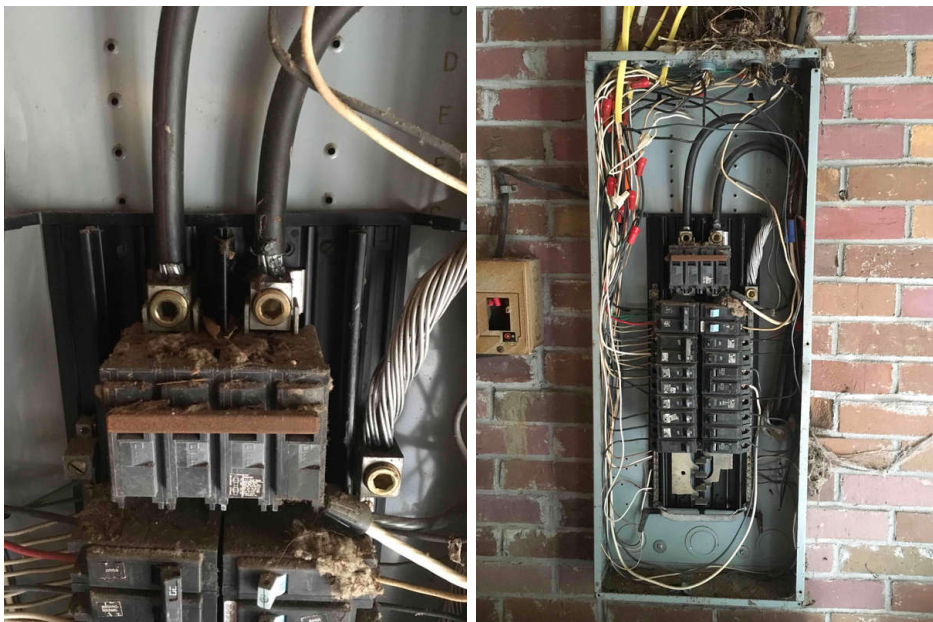
Main & Subpanels, Service & Grounding, Main Overcurrent Device: Breaker Inspection Method

The breakers were inspected looking for any visible signs of damage due to arcing, heat, loose connections, etc. Corresponding conductors were inspected looking for multiple lugging, sizing, damage, etc. No deficiencies were present at the time of inspection unless otherwise noted in this report.

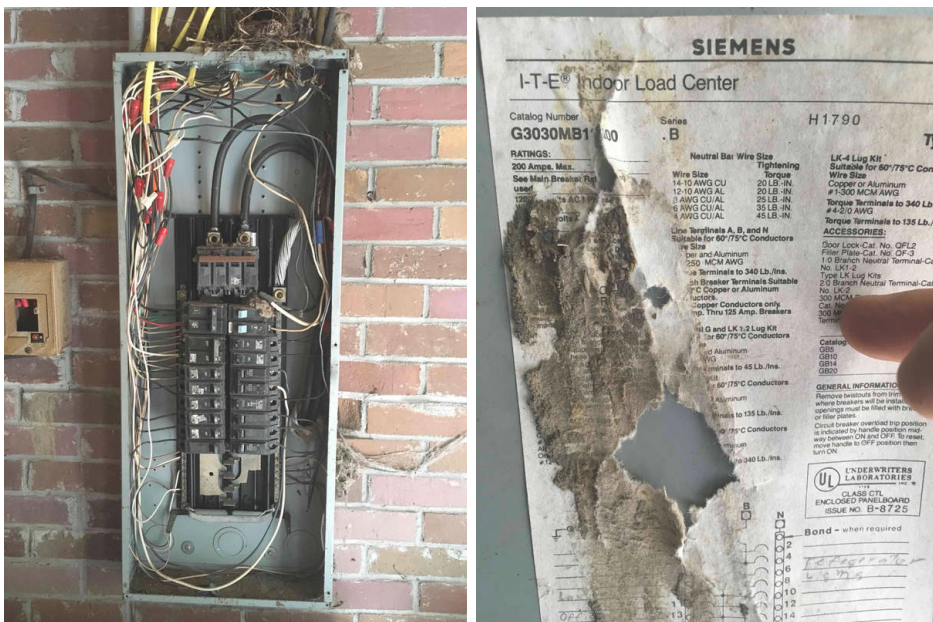
Main & Subpanels, Service & Grounding, Main Overcurrent Device: Electrical Panel/ Service Equipment Inspection Method

The main electrical panel (called service equipment when it contains the service disconnect) was inspected looking for any wiring deficiencies or damage that may be present in the panel. No indications of reportable conditions were present at the time of inspection unless otherwise noted in this report.
