# DONE RIGHT INSPECTING AND ADJUSTING

1234 Main St.  
Killeen TX 76547

# PROPERTY INSPECTION REPORT

Concerning: 1234 Main St. Killeen TX 76547  
(Address or Other Identification of Inspected Property)

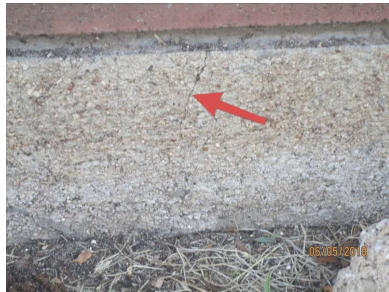
Foundation has multiple small cracks (North side of home). These cracks should be monitored for further deterioration.

However, multiple settlement cracks in the brick (North and South walls) will be addressed later in this report. An expert evaluation is going to be recommended to address overall structure of home.

Multiple minor cracks in foundation  
(North side of home)

Recommendation: Contact a foundation contractor.

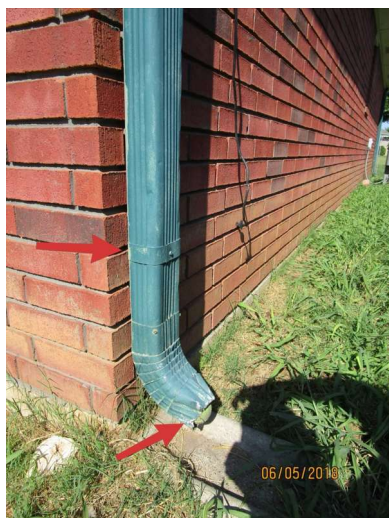
Two downspouts were loose and damaged (Southwest and Southeast corners of home). This can lead to improper drainage and foundation issues. Recommend a handyman or gutter company fix the discrepancies.

Downspout not secured properly, damaged, and plugged. (Southwest corner of home)

Recommendation: Contact a qualified gutter contractor

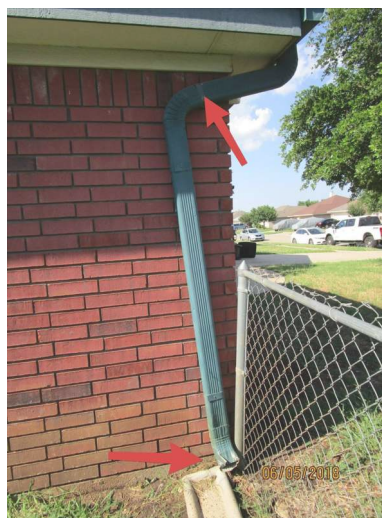
Downspout loose, damaged, and not aligned with splash block. (Southeast corner of home)

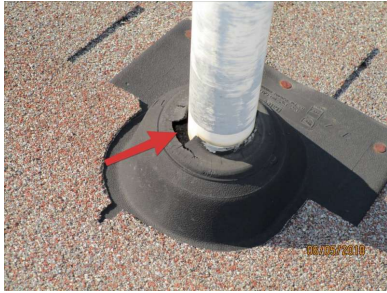
Multiple vent "boots" were deteriorated (North, South, and West sides of roof). This could cause both pest and water intrusion and needs to be corrected. Recommend a qualified roofer evaluate and repair.

Multiple vent "boots" were deteriorated (South, North, and West sides of home).

Recommendation: Contact a qualified roofing professional.

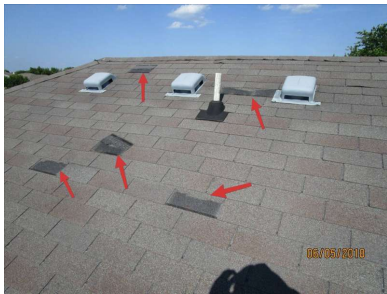
Numerous shingles missing, and other shingles not laying properly (West side of roof facing backyard). Recommend qualified roofing contractor evaluate & repair.

Numerous shingles missing, and other shingles not laying properly. (this pic is on West side of roof facing backyard).

Recommendation: Contact a qualified roofing professional.

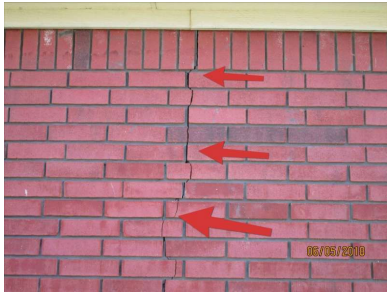
Major cracking observed in exterior wall structure (North and South sides of home). This could lead to significant costs to correct this, and will most likely get worse over time. This needs to be addressed. Recommend a qualified structural engineer and/or licensed foundation company evaluate and advise on course of action.

Significant cracking in bricks and mortar noticed in multiple locations on North and South sides of home.

Recommendation: Contact a foundation contractor.

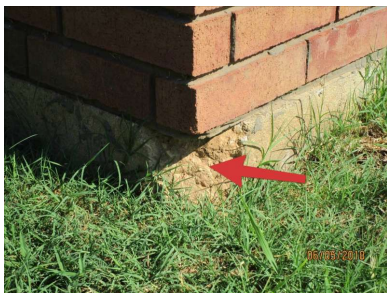
Foundation on both Southwest and Northwest corners of home chipping away, commonly called "Corner Pops." This is typically not serious and tends to happen when the concrete cures over time. Recommend monitoring for further deterioration

Foundation on both Southwest and Northwest corners of home chipping away, commonly called "Corner Pops."

Recommendation: Recommended DIY Project

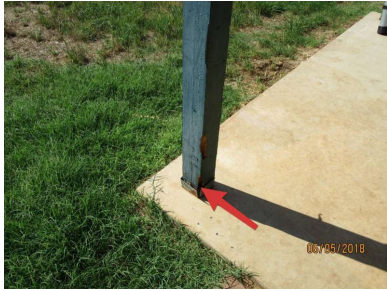
Support column on back patio shows signs of water damage. This could lead to structural failure, so it needs to be addressed. Recommend a handyman or contractor assess and correct the deficiency.

Support column on back patio shows evidence of water damage.

Recommendation: Contact a qualified handyman.

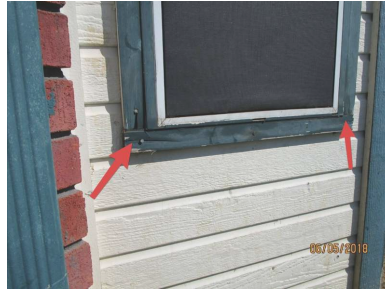
Wood trim around multiple windows in backyard (mainly around bay window) and back door show signs of water intrusion, which could lead to more serious structural damage. Recommend a qualified contractor identify and fix source of moisture, and replace all damaged wood.

Trim around window shows signs of water damage. (Northwest corner of home)

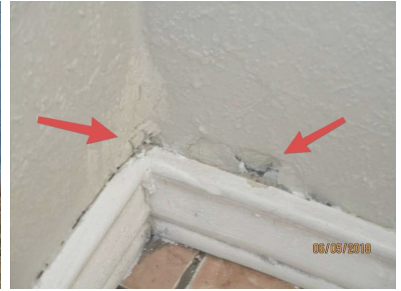
Drywall shows signs of previous water damage (master bedroom closet on wall opposite side of sinks). Recommend a handyman and/or plumber ensure there is no active leak, and repair the damaged area.

Drywall shows signs of previous water damage (master bedroom closet on wall opposite side of sinks)

Gap between wall and sink in master bathroom. This gap is most likely the cause of drywall damage in closet on opposite side of wall. Recommend a handyman caulk this gap.

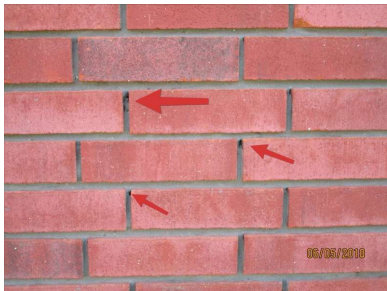
Multiple holes in mortar are present around the home (mainly East and North sides of home). This could lead to water and/or pest intrusion. Recommend a mortar specialist evaluate and repair the defective areas.

Multiple openings in mortar noticed around home. This photo is on North side of home.

Recommendation: Contact a qualified masonry professional.

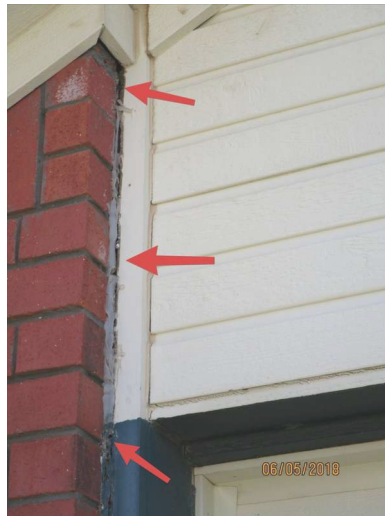
Caulking around multiple exterior walls (near windows) is dry rotted and is creating openings. This could lead to water and/or pest intrusion. Recommend a handyman or contractor re-caulk all gaps and cracks around home.

Caulking around multiple windows is dry rotted. This photo taken in front (East side) of home.

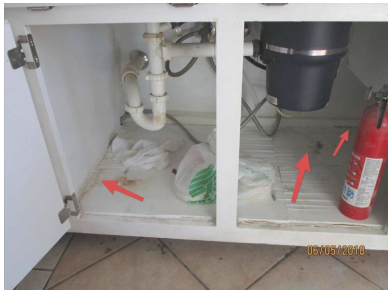
Wood cabinetry under the kitchen sink shows signs of previous water damage. Depending on extent of previous water damage, this could pose a health issue. Recommend a handyman replace water damaged wood under sink.

Wood cabinetry under the kitchen sink shows signs of previous water damage.

Recommendation: Contact a qualified handyman.

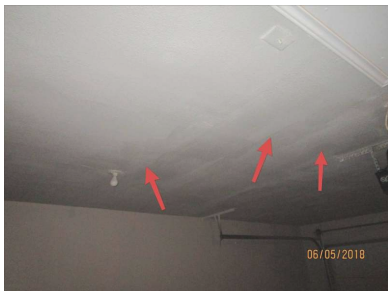
Ceiling drywall sagged visibly at the time of the inspection. This situation should be monitored for further deterioration.

Drywall on ceiling in garage is sagging in multiple locations.

Recommendation: Recommended DIY Project

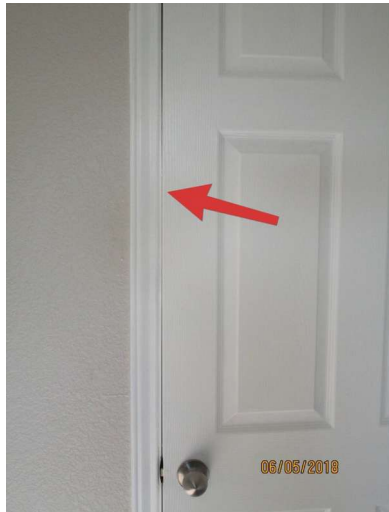
Multiple doors throughout home stick when opening and closing, to include pantry door. Recommend a handyman repair all doors that stick.

Door sticks when opening and closing.  
(This pic is in Northeast bedroom)

Recommendation: Contact a qualified handyman.

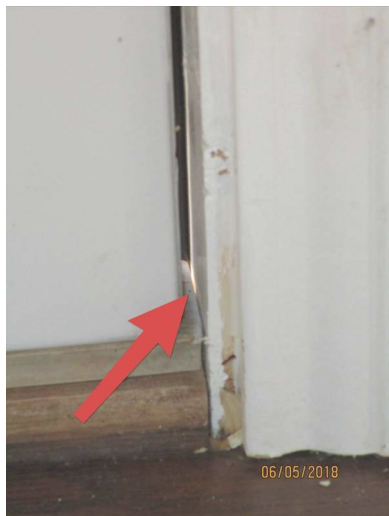
Gap in bottom (right) of back door. This could result in in energy loss, water and/or pest intrusion. Recommend handyman or door contractor evaluate and repair as necessary.

Noticeable gap on bottom (right) of  
back door.

Recommendation: Contact a qualified door repair/installation contractor.

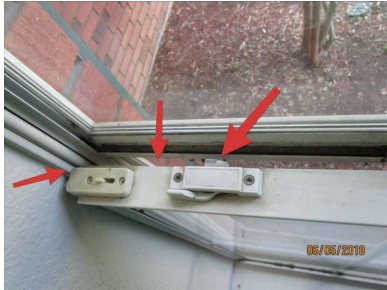
Window in front bedroom (right of front door) is out of adjustment, and cannot be secured. This is a security risk and needs to be addressed. Recommend a window specialist evaluate.

Window in front bedroom (right of front door) is out of adjustment, and cannot be secured.

Recommendation: Contact a qualified window repair/installation contractor.

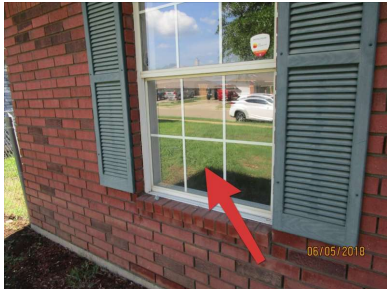
One window (Southeast corner facing street) was missing a screen, and multiple other screens around the home were either torn, or did not fit properly. Recommend a handyman or window specialist repair and/or replace damaged screens.

Window screen missing (Southeast corner of home facing street)

Recommendation: Contact a qualified window repair/installation contractor.

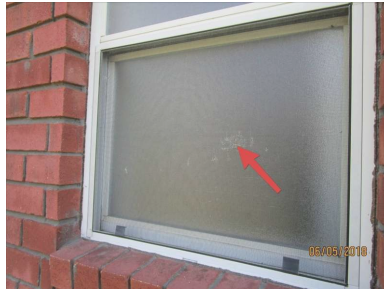
Multiple screens have holes in them (this is on North side of home)

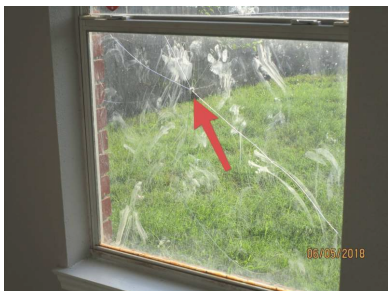
Glass in window (bedroom in Southwest corner of home) is cracked. This presents an unsafe situation and needs to be fixed. Recommend a window repair specialist replace the cracked glass.

Glass is cracked in window  
(Southwest bedroom)

Recommendation: Contact a qualified window repair/installation contractor.

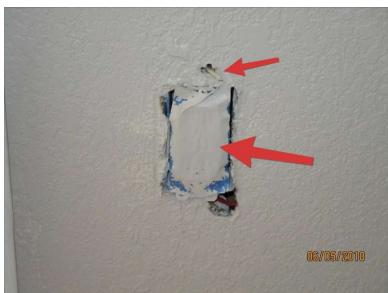
No cover plate on receptacle and questionable exposed wire above receptacle in closet (across from sink in master bathroom). This causes a short and/or shock risk. Recommend a licensed electrician assess the wiring and corrects the discrepancy.

No cover plate on receptacle and questionable exposed wire above receptacle. This photo taken in closet (across from sink) in master bathroom.

Recommendation: Contact a qualified electrical contractor.

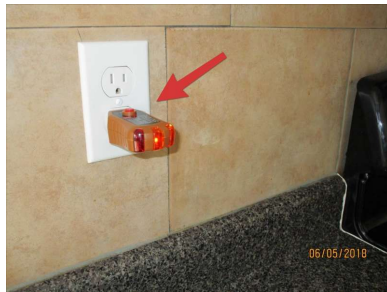
No GFCI protection found in receptacle "left" of stove in kitchen. (could not get GFCI tester into receptacle to the "right" of stove to test it).

GFCI protection is required for receptacles in kitchen and bathrooms, so this must be corrected. Recommend a licensed electrician assess all GFCI receptacles in the home, and repair and/or replace as necessary.

No GFCI protection detected (outlet left of stove).

Recommendation: Contact a qualified electrical contractor.

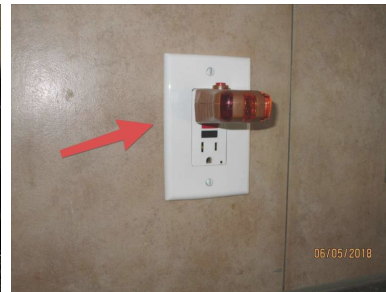
No electricity detected on GFCI outlet to the "left" of sink.

No electricity detected at GFCI receptacle to the "left" of kitchen sink.

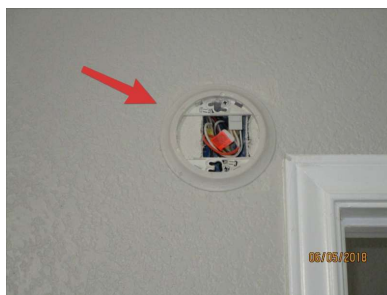
Smoke detectors missing throughout home. This is a safety issue that must be corrected. Recommend installation of smoke detectors.

Smoke detector missing (front bedroom to "right" of front door).

Recommendation: Contact a handyman or DIY project

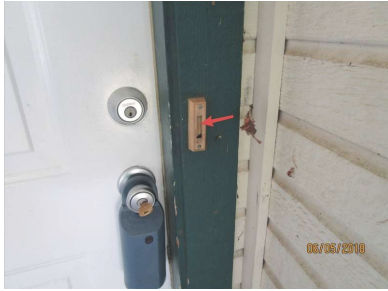
Doorbell does not operate properly. Recommend a handyman replace the doorbell.

Doorbell does not function properly.

Recommendation: Contact a qualified handyman.

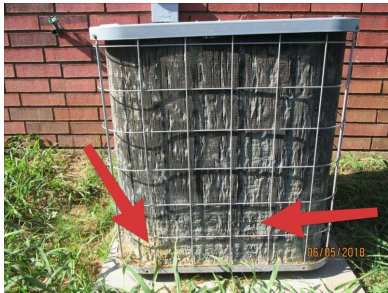
Condenser unit fins in very poor condition, and unit seems to be near end of it's useful life. Air flow to the air conditioner condenser was restricted. This may result in inefficient operation. Recommend a licensed HVAC professional assesses the unit and gives the client their opinion on unit's condition.

Condenser unit fins in very poor shape.

Recommendation: Contact a qualified HVAC professional.

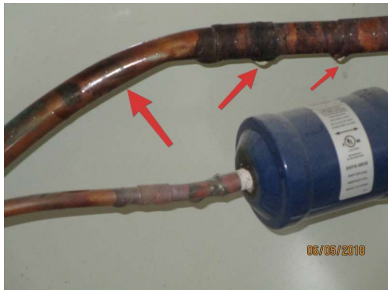
Insulation on Suction line missing on both inside (HVAC closet) and outside (near condenser unit) lines. Inside suction line was also "sweating," which could cause damage to surrounding structure. Missing or damaged insulation can also cause energy loss. Recommend a handyman correct the deficiency.

Insulation missing from Suction line, and line is "sweating." (this photo taken in HVAC closet on inside of home).

Recommendation: Contact a qualified handyman.

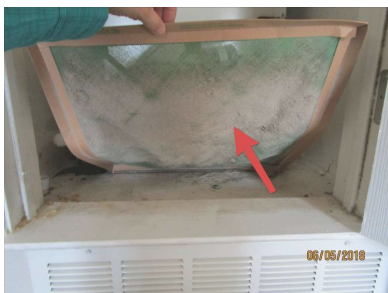
A/C filter was dirty and was being sucked up into evaporator. This decreases efficiency, and could cause mechanical problems. Recommend a new (more sturdy) filter is installed.

A/C filter dirty and flimsy.

Recommendation: Recommended DIY Project

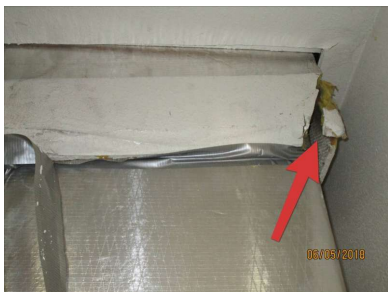
Duct system (above evaporator unit in HVAC closet) not sealed properly. This results in loss of efficiency, and needs to be corrected. Recommend a qualified HVAC contractor seal ducts.

Duct system (above evaporator unit in HVAC closet) not sealed properly.

Recommendation: Contact a qualified HVAC professional.

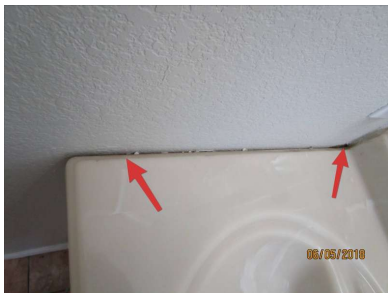
Gap between wall and sink in master bathroom.

Recommendation: Contact a qualified handyman.

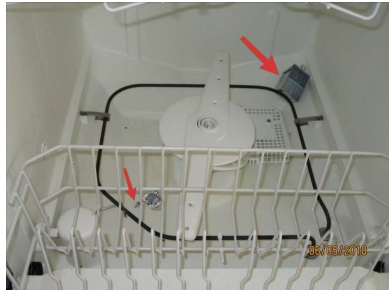
Did not operate due to spare parts located inside dishwasher.

Spare parts inside dishwasher.

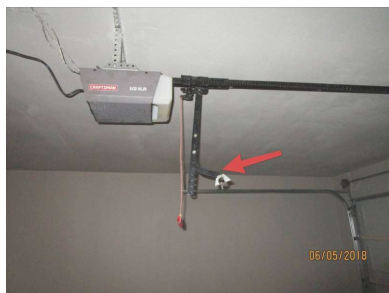
Did not operate garage door due to it being disconnected, and sensors were removed as well.

Garage door opener disconnected.
