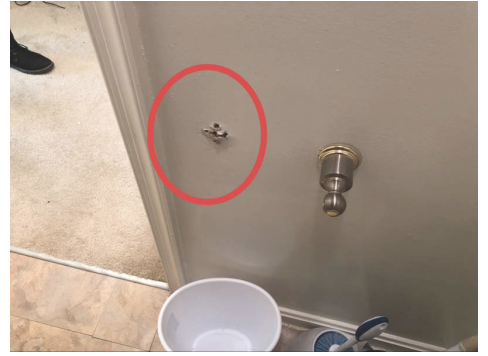
DAMAGED WALLS

MASTER BATHROOM

This wall is damage where the T.P. holder came out.

Recommendation
Contact a qualified drywall contractor.

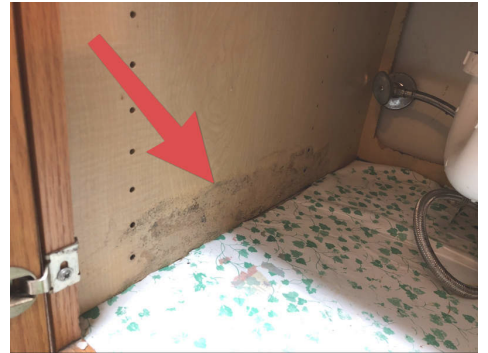
WATER DAMAGED CABINET

KITCHEN

There are stains and minor water damage under the kitchen sink. Any leakage will be noted in the plumbing section.

Recommendation
Contact a qualified cabinet contractor.

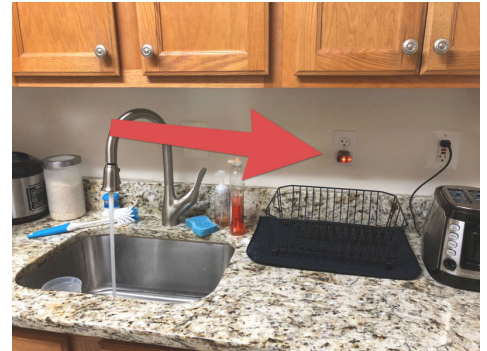
NOT GFCI PROTECTED

KITCHEN

One or more areas of the home are not GFCI protected as required by modern safety standards. GFCI receptacles or breakers are important safety features that can protect one from accidental electrocution in wet locations such as kitchens and bathrooms.

Contact a qualified electrical contractor.

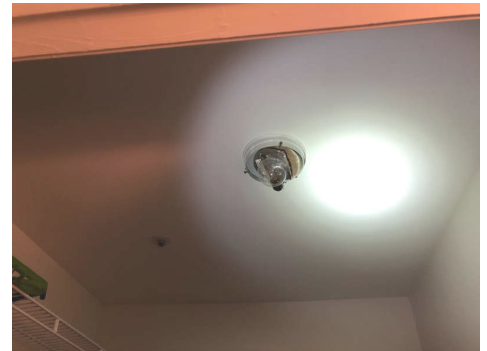
LIGHT COVERS MISSING

GUEST BEDROOM CLOSET, MASTER BATHROOM

Covers are missing leaving the lightbulbs exposed.

Contact a qualified handyman.

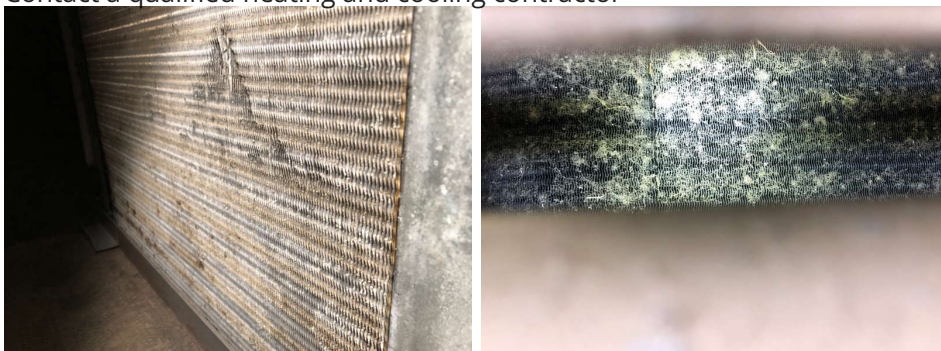
DIRTY REFRIGERANT COILS

The evaporator and condenser coils are dirty and should be cleaned. Dirty refrigerant coils are the primary cause of major repairs and causes the equipment to work less efficiently.

Contact a qualified heating and cooling contractor

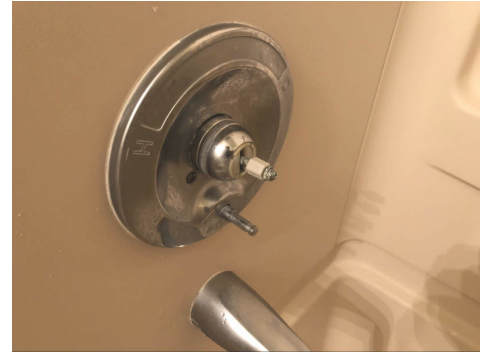
MISSING BATHTUB FAUCET HANDLE

HALLWAY BATHROOM

This bathtub faucet handle was missing. Any other problems with this faucet will be noted in this report.

Contact a qualified plumbing contractor.

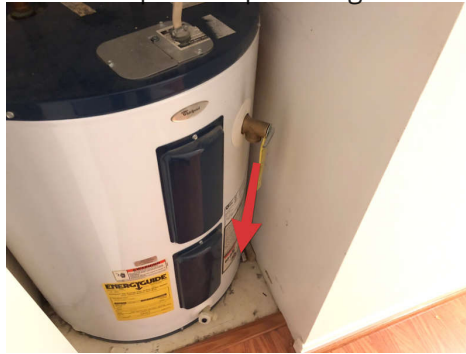
NO TPR DISCHARGE PIPE

A temperature pressure relief valve (TPR) should have a discharge pipe that extends to within 6 inches of the floor to prevent scalding if the valve discharges overheated water.

Contact a qualified plumbing contractor.

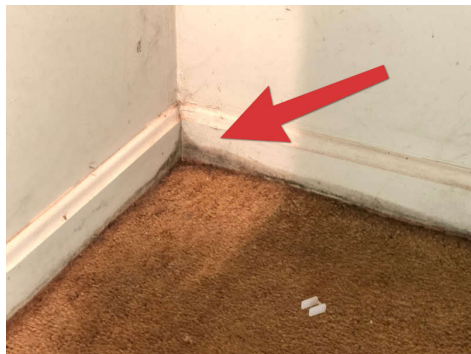
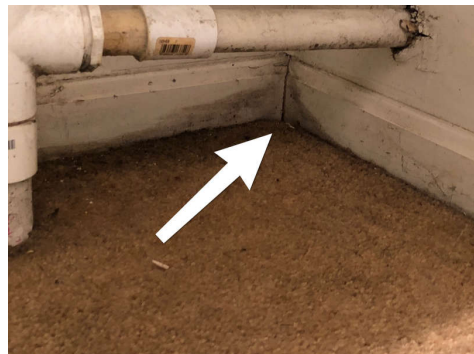
POSSIBLE MOLD GROWTH IN UTILITY CLOSET

UTILITY CLOSET

What may be fungal, or mold growth was observed in the utility closet under the heating and cooling equipment.
