### 3.1.1 Driveway / Sidewalk / Patio

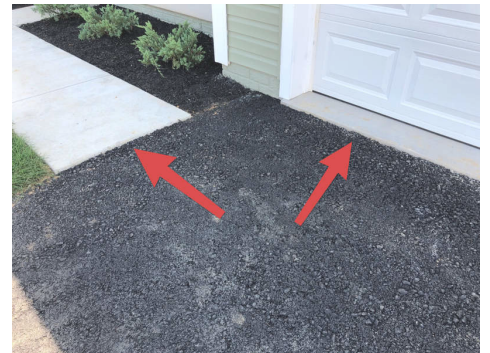
#### **TEMPORARY TRIP HAZARD**

The final layer of asphalt had not been applied at the time of inspection. Caution should be exercised as there will be trip hazards in the driveway until the asphalt is complete.

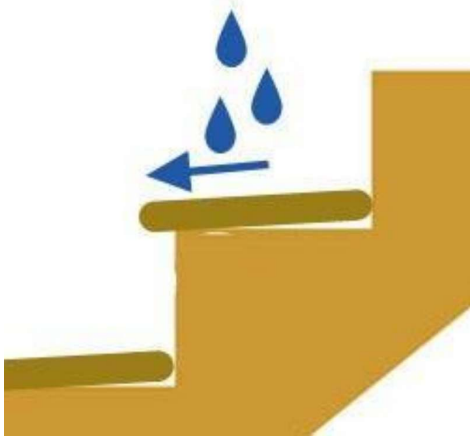
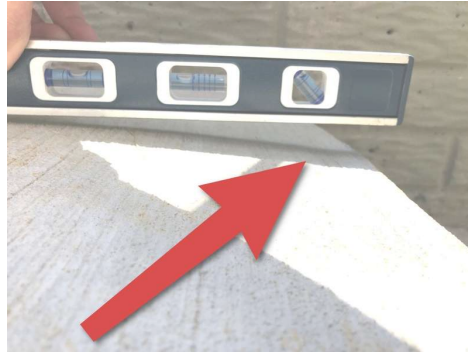
### 3.2.1 Steps / Porch / Deck

#### **STAIR TREADS EXCESSIVELY SLOPED**

REAR BASEMENT STAIRWAY

One or more stair treads are excessively sloped and may be a trip/fall hazard. Exterior stair treads should be sloped to prevent water from collecting but not more than a maximum of 1/4 inch per foot.

Slope should not exceed 1/4 inch per foot

Contact a qualified concrete contractor.

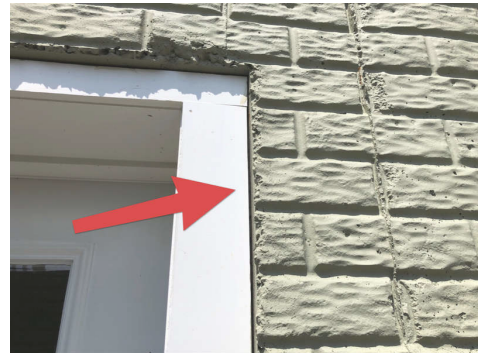
### 3.3.1 Siding / Trim / Flashing

#### **GAPS AT TRIM**

There are gaps at the exterior trim that should be filled to keep water and pests out.

Rear Basement Door

Contact a qualified painter.

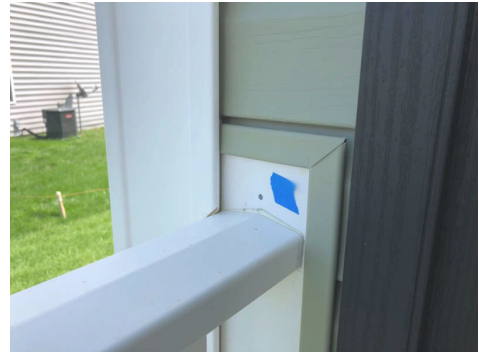
### 3.3.2 Siding / Trim / Flashing

#### **EXPOSED NAILS IN TRIM**

There are exposed nails in the exterior trim that should be filled or sealed to prevent corrosion.

Contact a qualified painter.

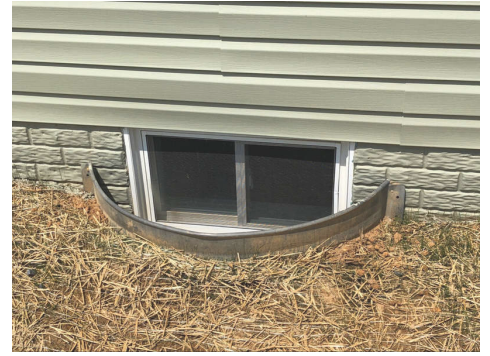
3.4.2 Doors / Windows

**WINDOW WELLS UNCOVERED**

Window wells should be covered to keep water, children, and pests, such as foxes or skunks out of the window well. This is a common cause of wet basements.

Recommendation  
Contact a qualified handyman.

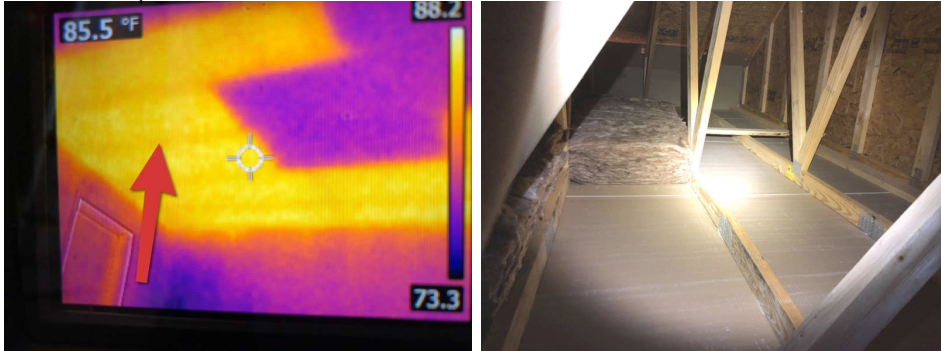
4.2.1 Insulation Condition

**MISSING INSULATION IN ATTIC**

ABOVE FAMILY ROOM

Portions of the insulation was observed to be missing. This condition cause moisture problems and contribute to energy loss during the heating and cooling seasons if not corrected.

Yellow areas are hot due to missing insulation

Recommendation  
Contact a qualified insulation contractor.

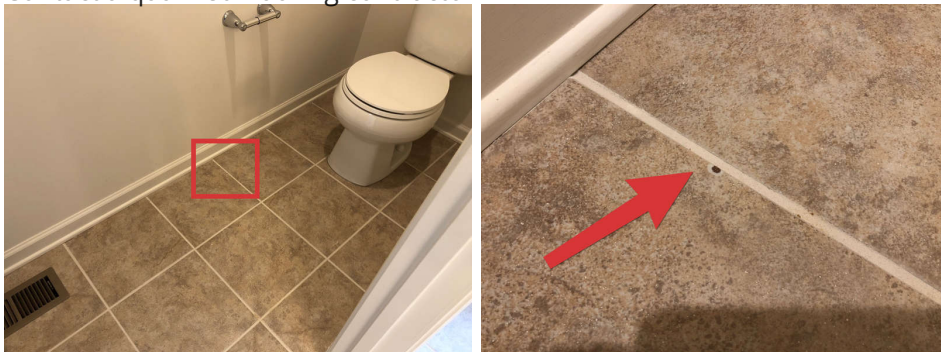
6.1.1 Walls / Ceilings / Floors

**DAMAGED FLOOR TILES**

MASTER BATHROOM

There is a chipped floor tile in the master bathroom. This is a cosmetic defect that should not affect the durability of the tile.

Recommendation  
Contact a qualified flooring contractor

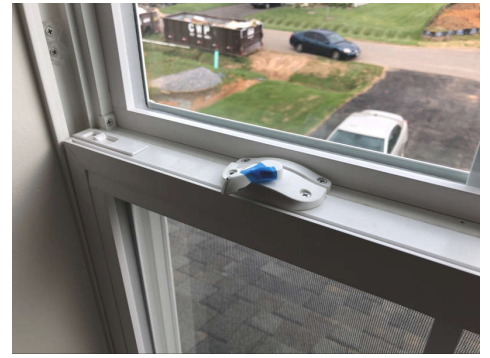
6.2.1 Windows / Doors / Closets

## WINDOWS DIFFICULT TO LATCH

MASTER BEDROOM

One or more windows were difficult to latch and require some adjustment.

Contact a qualified window repair/installation contractor.

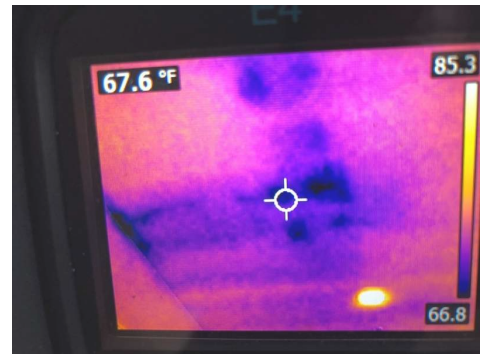
10.4.1 Drain, Waste and Vent Piping

## LEAK IN CEILING UNDER BATHROOM

KITCHEN

There is a leak underneath the master bathroom. The thermal image of the kitchen ceiling indicates cold spots (dark blue) that were confirmed to be wet with a moisture meter.

Contact a qualified plumbing contractor.
