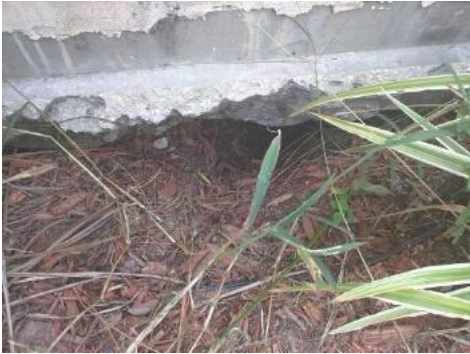
2.1.1 Grading & Vegetation
ANIMAL BURROWING

Animal burrowing was found at one or more areas. It is unknown what type of animal this is or if this is active. Client should follow up with seller, or monitor moving forward. An animal removal expert/trapper may need to be called.

Recommendation
 Contact a qualified pest control specialist.

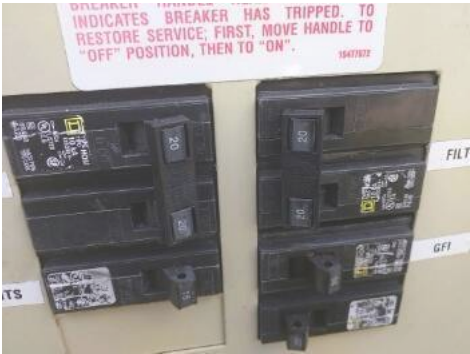
4.5.1 Electrical
GFCI PUMP

GFCI protection was not visible for one or more pumps. Pumps are now required to have GFCI protection. It is recommended GFCI protection be installed for overall safety. A qualified electrician should evaluate and repair as necessary.

Recommendation
 Contact a qualified electrical contractor.

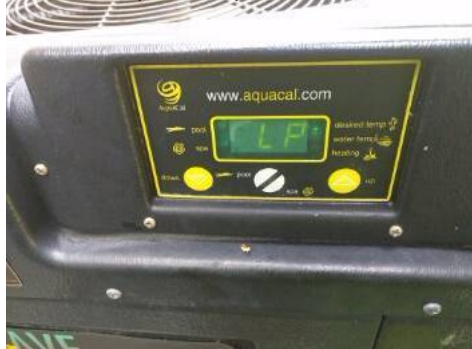
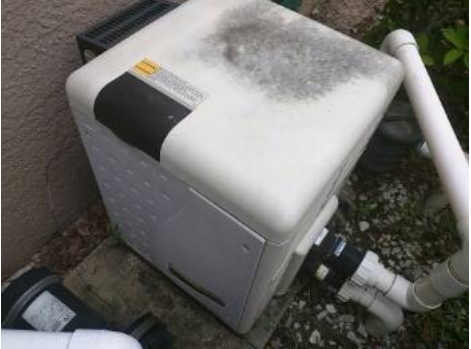
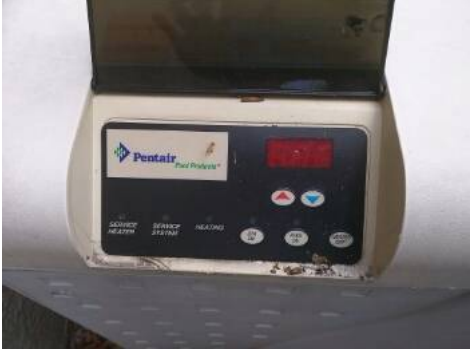
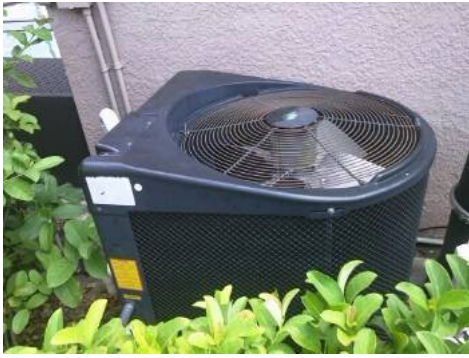
4.6.1 Heater
HEATER INOPERABLE

The pool and spa heaters were inoperable. A qualified contractor should evaluate and repair as necessary.

Recommendation
 Contact a qualified professional.

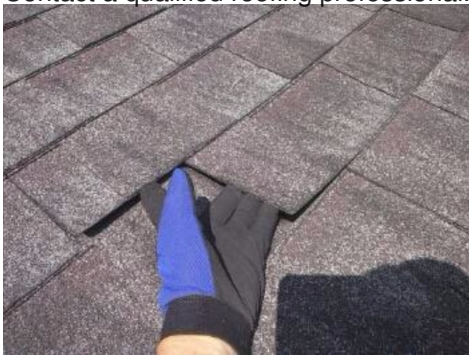
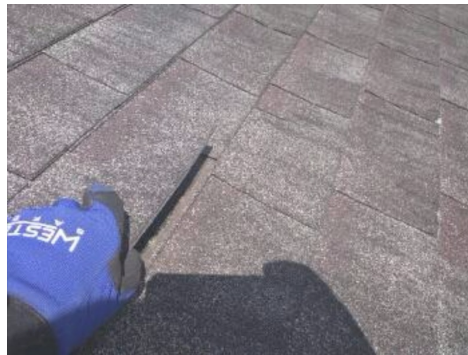
6.2.1 Shingles

SELF SEAL STRIPS LOOSE

Composition shingles were loose because the adhesive, self-sealing strips weren't sealed. Leaks can occur as a result. Self-sealing strips secure the lower edge of shingles and reduce vulnerability to wind damage. Strips may not be sealed because the sealant has failed or because the sealant never activated and cured after the original installation. Recommend that a qualified contractor repair as necessary. For example, by hand sealing shingles with an approved sealant.

Right

Contact a qualified roofing professional.

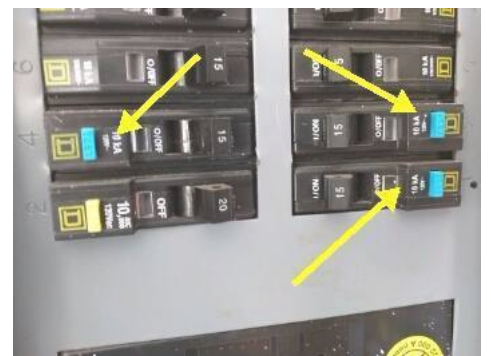
9.3.1 Panel Wiring & Breakers

RECALL GFCI SQUARE D BLUE

One or more circuit breakers appeared to be of a type that have been recalled (Square D or Homeline AFCI, from, with a blue test button). Recommend that a qualified electrician evaluate and replace circuit breakers if necessary.

Contact a qualified electrical contractor.

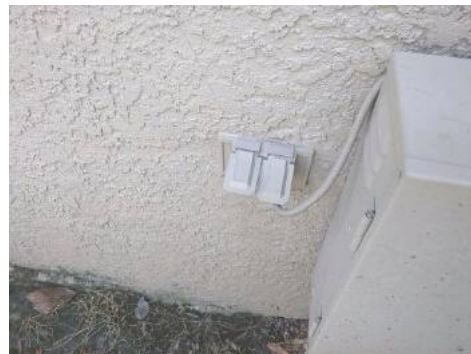
9.5.1 Receptacles

IN USE COVER

EXTERIOR, LEFT

One or more standard exterior electric receptacles (outlets) were being used for appliances or systems that were constantly in use. Recommend that a qualified person install "while in use" receptacle covers as necessary.

Contact a qualified electrical contractor.

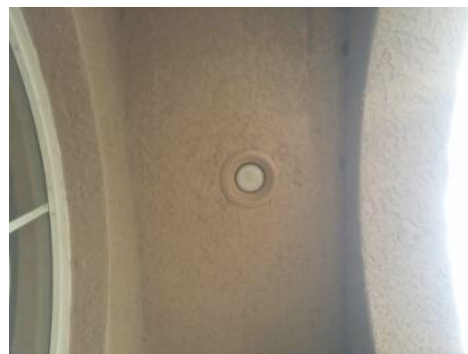
9.6.1 Lighting & Fans

LAMPS INOPERABLE

FRONT, EXTERIOR

One or more light fixtures were inoperable (didn't turn on when nearby switches were operated). Recommend further evaluation by replacing bulbs and/or consulting with the property owner (perhaps on a switch that was not identified). If replacing bulbs doesn't work and/or no other switch(es) can be found, then recommend that a qualified electrician evaluate and repair or replace light fixtures as necessary.

Contact a qualified electrical contractor.

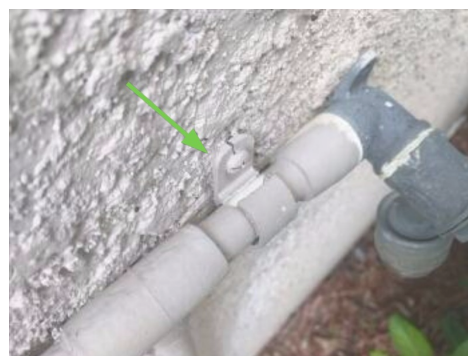
10.2.1 Supply Lines

SUBSTANDARD SUPPORT

RIGHT BACK EXTERIOR

One or more water supply pipes had substandard support or were loose. Leaks may occur as a result. Recommend that a qualified person install hangers or secure pipes per standard building practices.

Contact a qualified plumbing contractor.

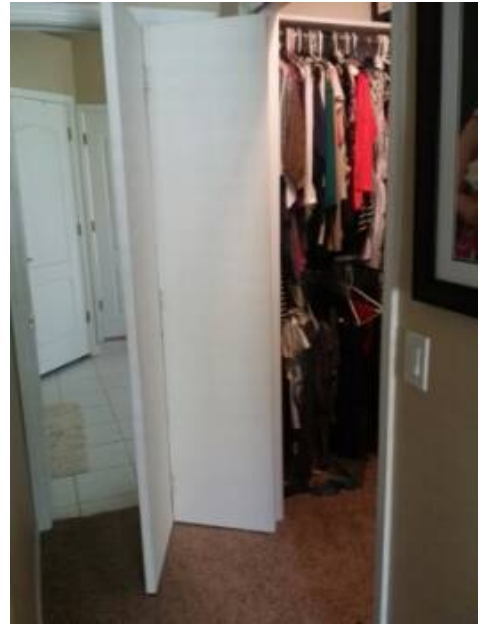
12.2.1 Doors

CLOSET OUT OF TRACK

GUEST BEDROOM

The closet doors in one or more locations were out of track. Recommend repair for proper functionality.

Contact a qualified handyman.

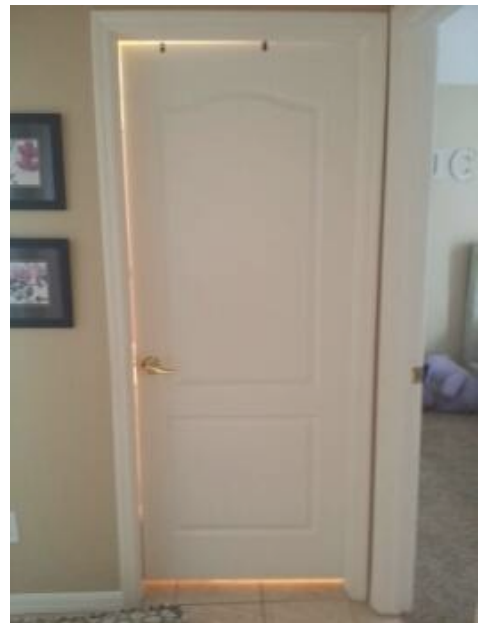
12.2.2 Doors

GHOST DOOR

GUESTBATHROOM

One or more interior doors would not stay open on it's own, commonly referred to as a 'ghost door'. This is caused by the door not being hung plumb. A simple fix is to remove the door hinge pin and hammer it on a concrete surface a few times to add a slight bend to the door pin. Reinstall the door pin. This slight bend will cause a minor bit of friction in the hinge, allowing the door to stay open. If this does not work with one hinge, keep trying on all 2-3 hinges till door stays open.

Contact a qualified handyman.

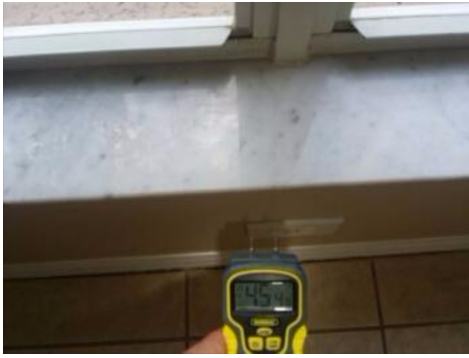
Dining Room

WINDOWS LEAKING

One or more windows appeared to be leaking. Water can or may have damaged areas behind the wall or floor. Recommend contractor evaluate and repair.

Contact a qualified general contractor.

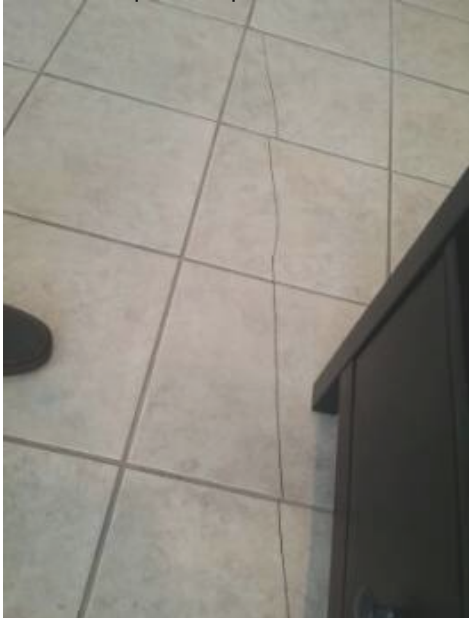
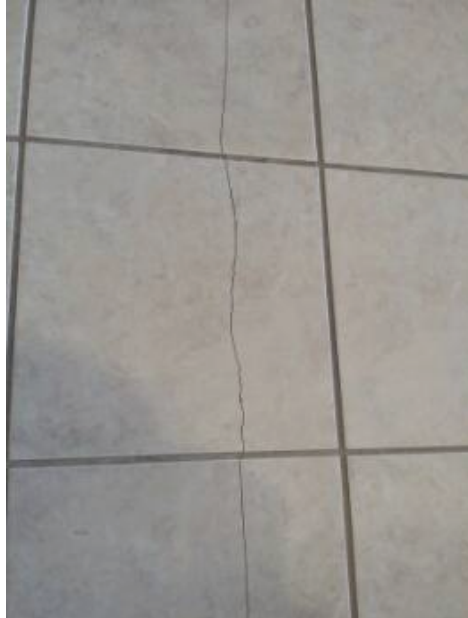
12.5.1 Floors

TILE DAMAGED

Tile or grout in the flooring in one or more areas was damaged or deteriorated. Recommend that a qualified contractor repair as necessary.

Contact a qualified professional.
