SUMMARY

1234 Main St. Palmer AK 99645

Benjamin Hornak
Alaska Home Inspector License...
907 Home Inspections, LLC
907-830-8443
907homeinspectionsllc@gmail.com

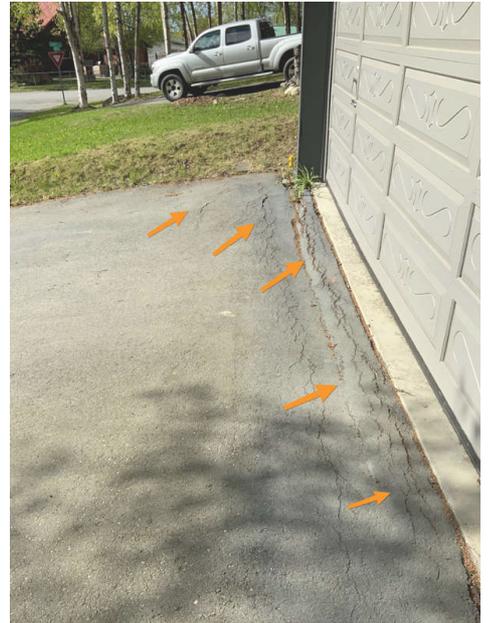
3.1.1 Walkways, Patios & Driveways

DRIVEWAY CRACKING - MAJOR

Major cracks observed. Recommend driveway contractor evaluate and replace.

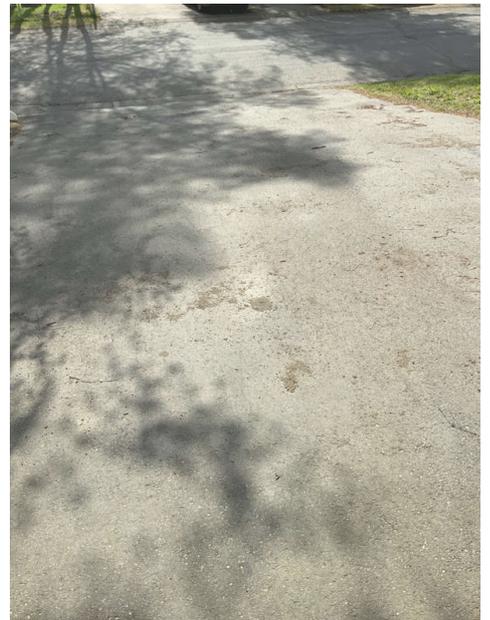
3.1.2 Walkways, Patios & Driveways

RESEAL ASPHALT

The asphalt driveway surface was worn and is prone to developing cracks from water penetration. Recommend that a qualified person reseal the driveway.

Recommendation
Contact a qualified professional.

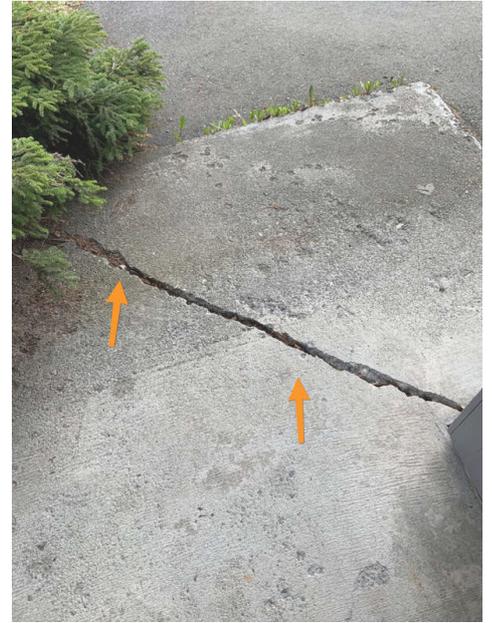
3.1.3 Walkways, Patios & Driveways

WALKWAY CRACKING - MAJOR

Major cracks observed. Recommend concrete contractor evaluate and correct to prevent trip hazard & preserve appearance.

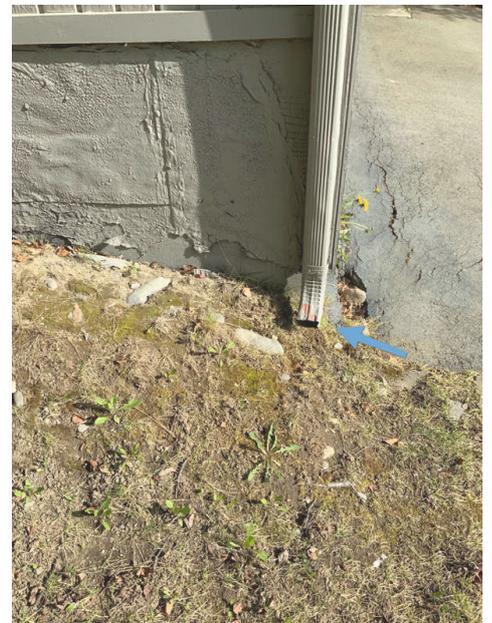
3.2.1 Vegetation, Grading, Drainage & Retaining Walls

DOWNSPOUT EXTENSION

Extensions such as splash blocks or drain pipes for one or more downspouts were *missing / poorly sloped / misaligned / clogged / substandard / damaged*. Water can accumulate around the building foundation or inside crawl spaces or basements as a result. Recommend that a qualified person install, replace or repair extensions as necessary so rainwater drains away from the structure.

Contact a qualified professional.

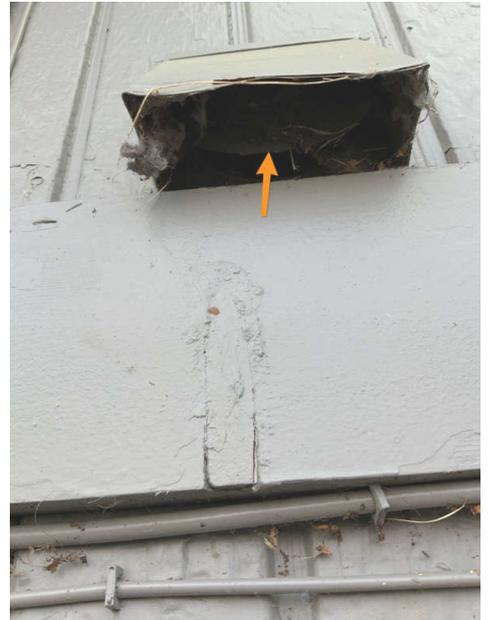
The dryer vent is clogged and needs to be cleaned. A clogged dryer vent can lead to dryer failure and extended dry times as well as being a fire hazard.

Recommend cleaning.

Replace screen after cleaning to prevent animal intrusion.

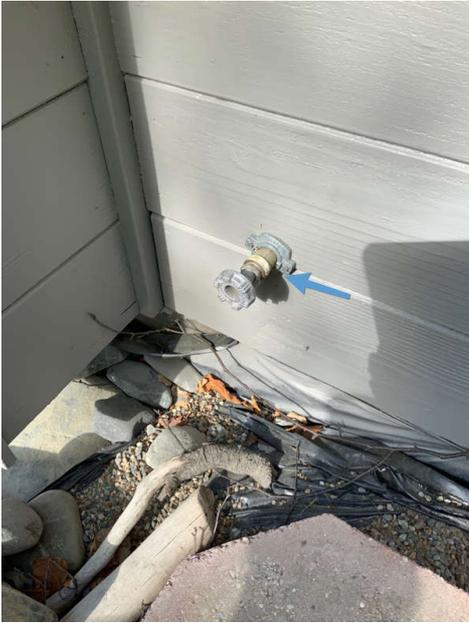
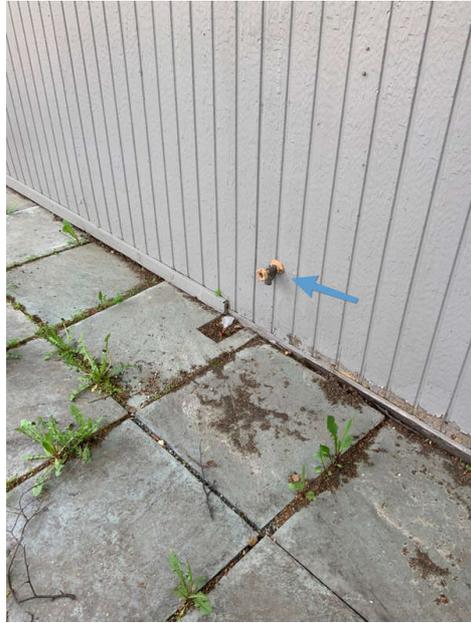
One or more hose bibs were missing backflow prevention devices. These devices reduce the likelihood of gray water entering the potable water supply. Recommend installing backflow prevention devices on all hose bibs where missing. They are available at most home improvement stores and are easily installed.

Recommendation

Contact a handyman or DIY project

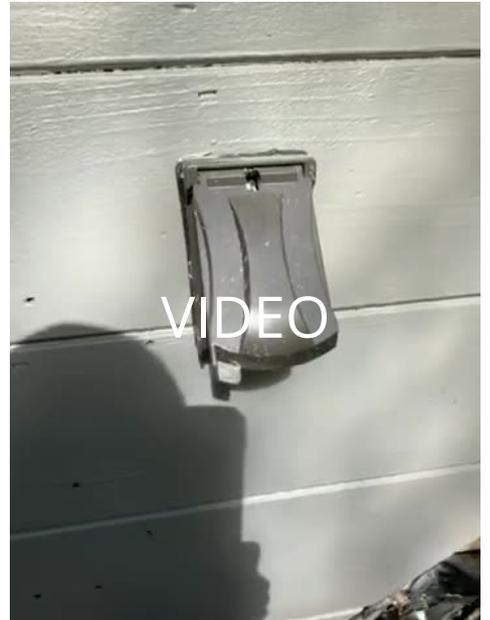
One or more exterior outlets were not GFCI protected as required recommend consulting a licensed electrician to evaluate and remedy as needed.

Recommendation
Contact a qualified electrical contractor.

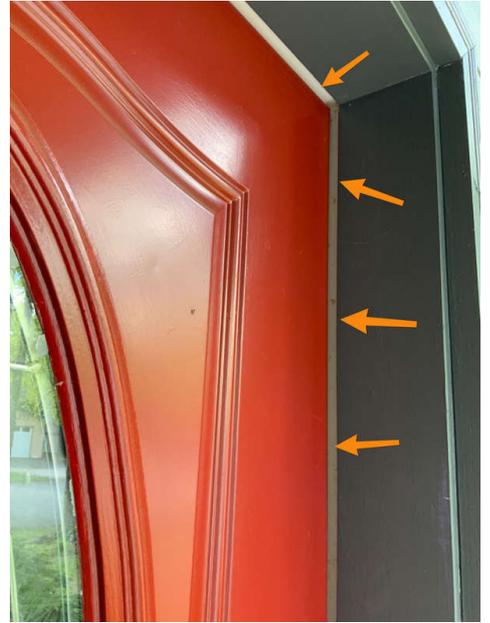
3.7.1 Exterior Doors **DOOR DOES NOT SEAL PROPERLY**

Recommend a qualified contractor evaluate and repair as necessary to ensure the door seals as intended.

Recommendation
Contact a qualified professional.

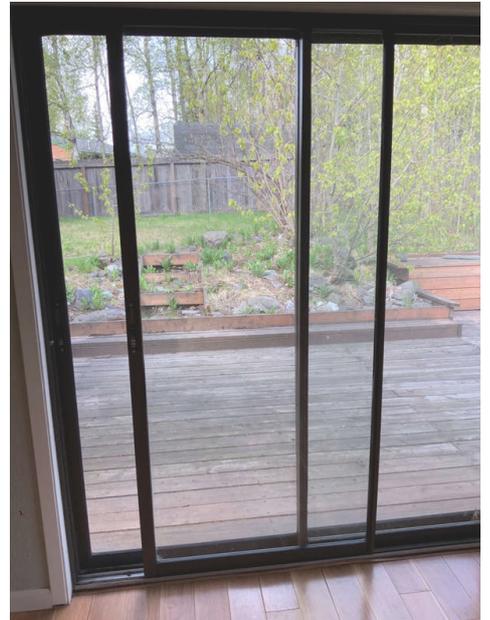
3.7.2 Exterior Doors

SLIDING GLASS DOOR DIFFICULT TO OPERATE

The sliding glass door was difficult to operate when tested. Recommend in cleaning and or lubricating the tracks to make the door operate as intended.

Recommendation
Contact a qualified professional.

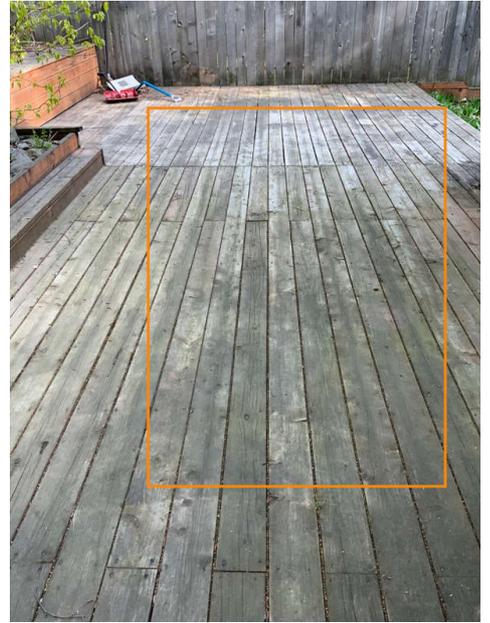
3.8.1 Decks, Balconies, Porches & Steps

DECK - WATER SEALANT REQUIRED

Deck is showing signs of weathering and/or water damage. Recommend water sealant/weatherproofing be applied.

Recommendation
Contact a qualified painting contractor.

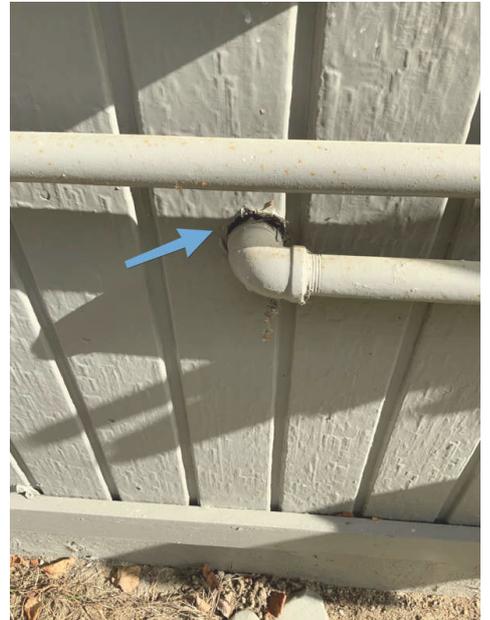
3.9.1 Siding, Flashing & Trim **CAULKING AT JOINTS**

Caulk was *missing / deteriorated / substandard* in some areas. For example, *around windows / around doors / at siding butt joints / at siding-trim junctions / at wall penetrations*. Recommend that a qualified person renew or install caulk as necessary. Where gaps are wider than 1/4 inch, an appropriate material other than caulk should be used.

Recommendation
Contact a handyman or DIY project

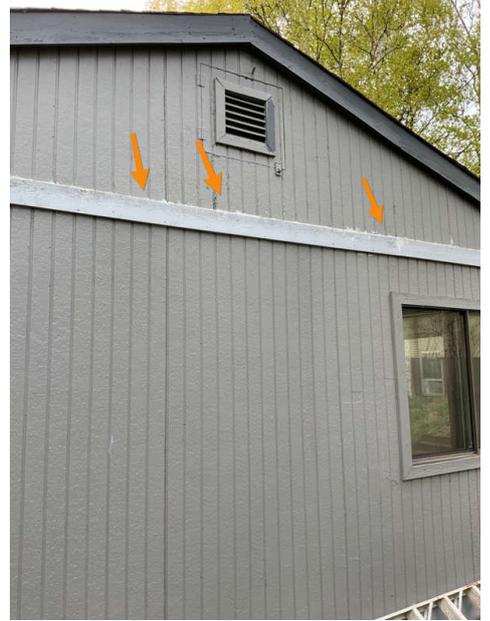
3.9.2 Siding, Flashing & Trim **EVIDENCE OF WATER INTRUSION**

Siding showed signs of water intrusion. This could lead to further siding deterioration and/or mold. Recommend a qualified siding contractor evaluate and repair.

Recommendation
Contact a qualified siding specialist.

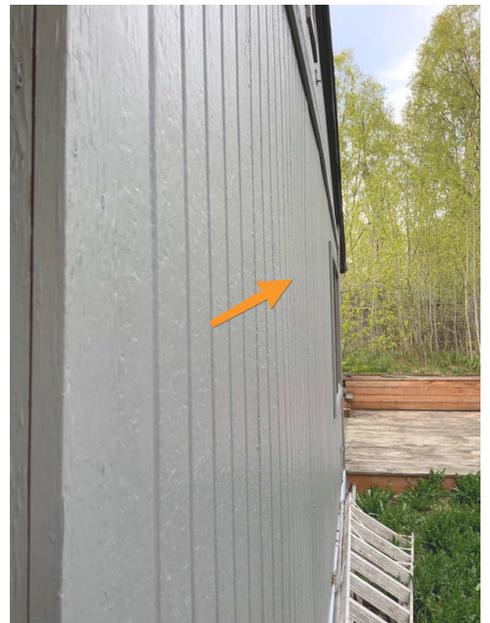
3.9.3 Siding, Flashing & Trim

IMPROPER CONSTRUCTION PRACTICES

Siding appears to be installed improperly and not up to standards. This could lead to moisture damage or deterioration of the home structure. Recommend a siding specialist evaluate and repair/replace.

Contact a qualified siding specialist.

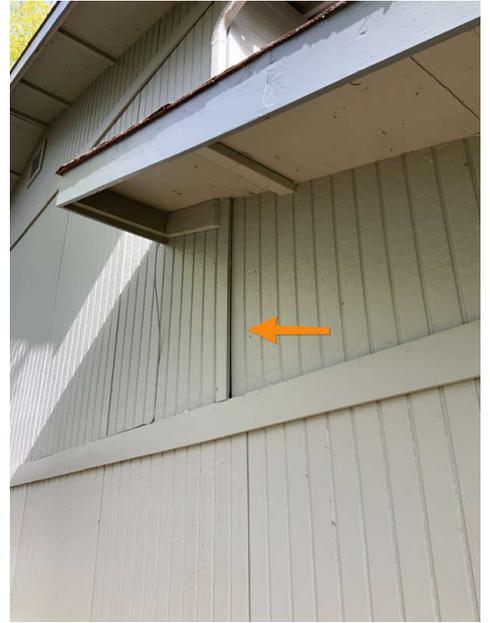
Sections of siding and/or trim were *deteriorated / loose / split / warped / missing / damaged / substandard / rotten*. Recommend that a qualified person repair, replace or install siding or trim as necessary.

Recommendation

Contact a qualified professional.

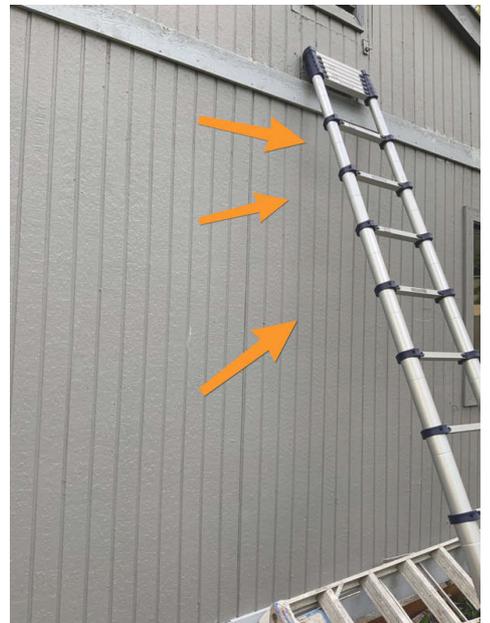
Siding at the exterior of the house was bowed out in one or more locations. Recommend a qualified contractor evaluate and repair/remedy/replace as necessary.

Contact a qualified professional.

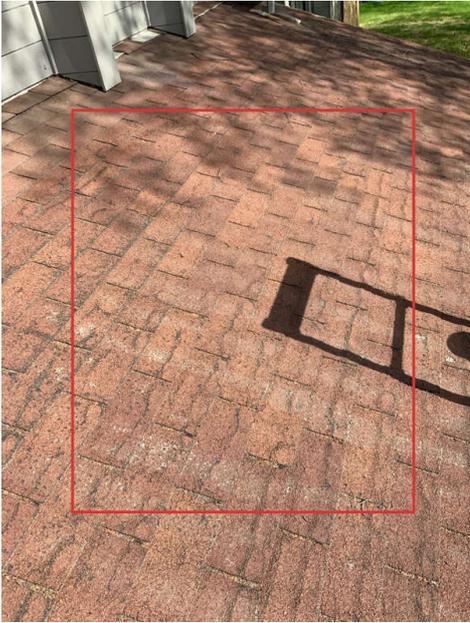
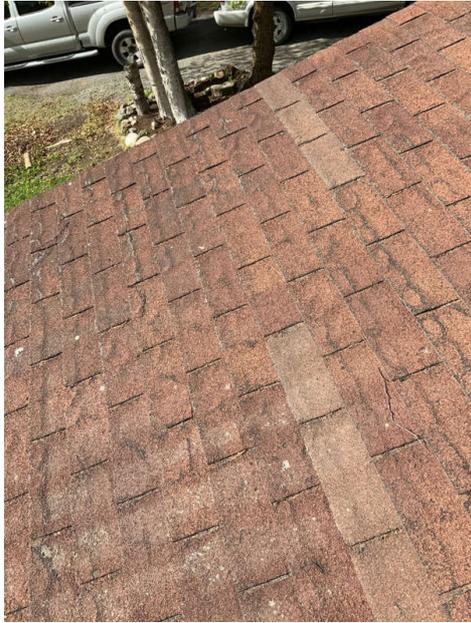
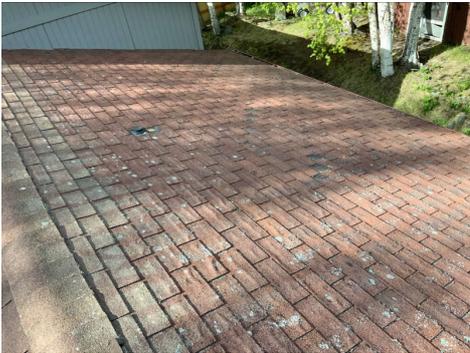
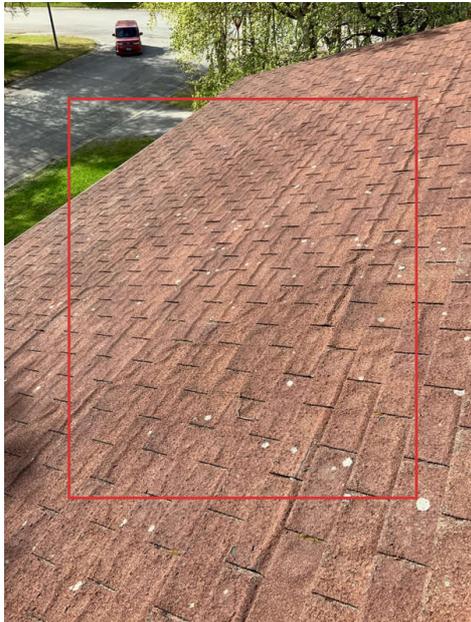
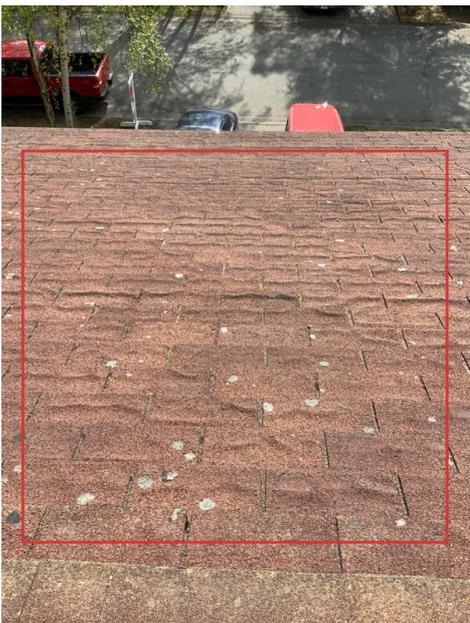
The roof surface was significantly deteriorated and appeared to be at or beyond its service life. It needs replacing now. This is a conducive condition for wood-destroying organisms and water penetration. Consult with a qualified contractor to determine replacement options. Note that some structural repairs are often needed after old roof surfaces are removed and the structure becomes fully visible. Related roofing components such as flashings and vents should be replaced or installed as needed and per standard building practices.

Recommendation

Contact a qualified roofing professional.

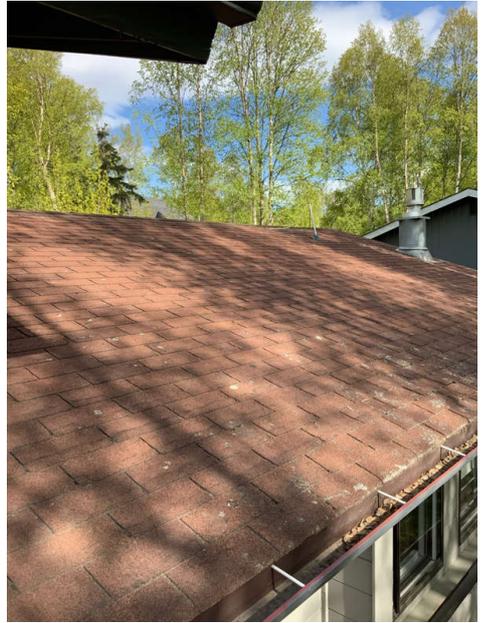
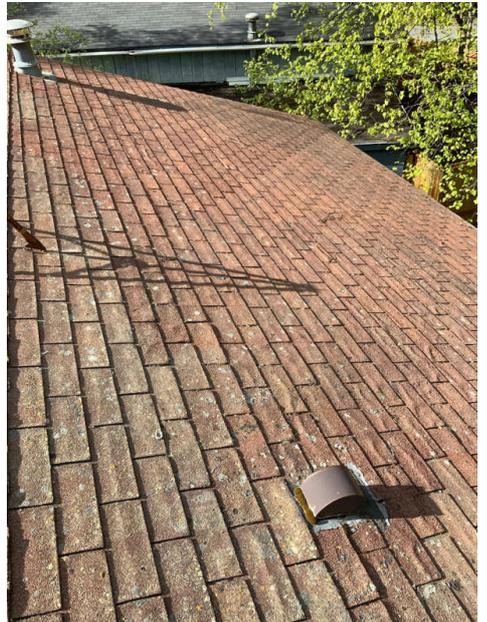
4.1.1 Coverings

END OF LIFE EXPECTANCY

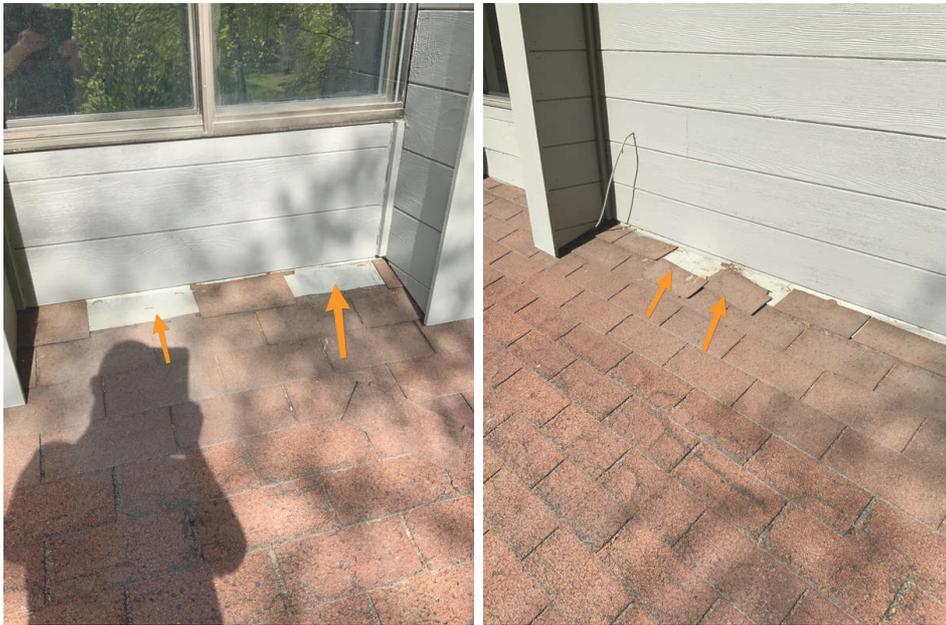
4.1.2 Coverings

SHINGLES MISSING

Observed areas that appeared to be missing sufficient coverings. Recommend qualified roofing contractor evaluate & repair.

Contact a qualified roofing professional.

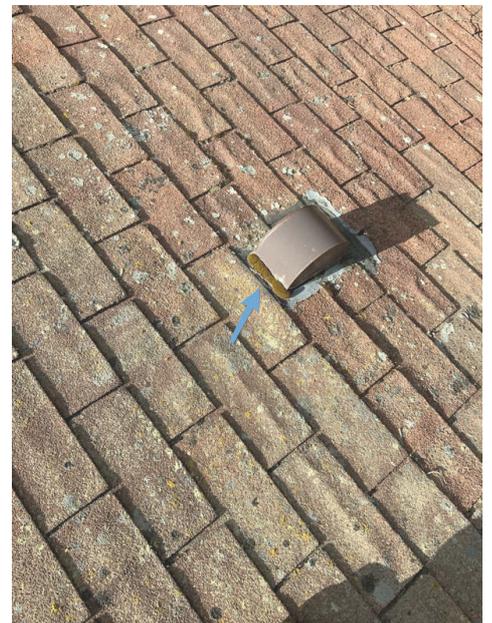
4.1.3 Coverings

MOSS ON ROOF SURFACE

Moss or other organic growth was observed of one or more locations on the roof recommend treating and removing the moss to prevent further deterioration.

Contact a qualified professional.

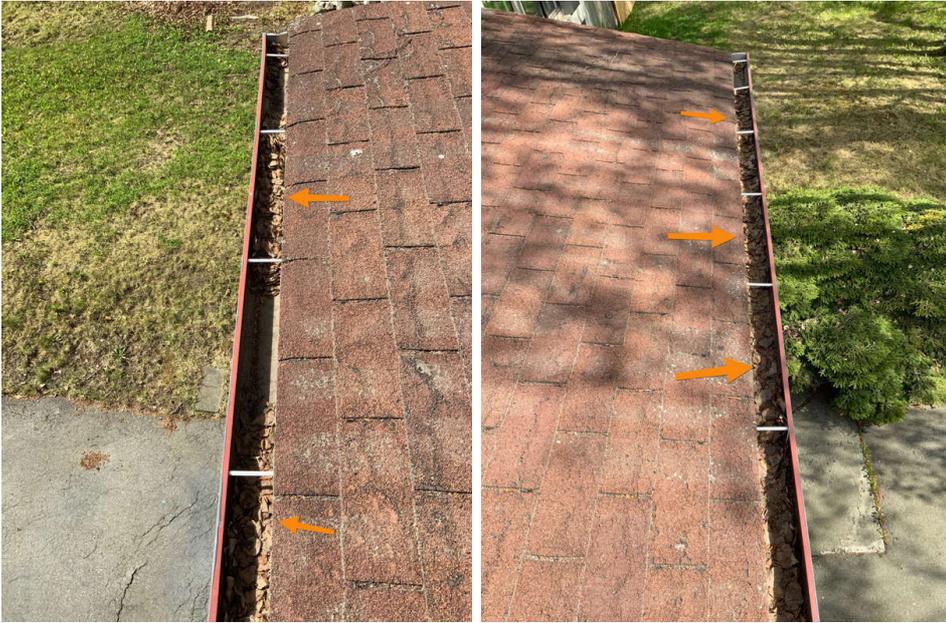
4.2.1 Roof Drainage Systems

DEBRIS

Debris has accumulated in the gutters. Recommend cleaning to facilitate water flow.

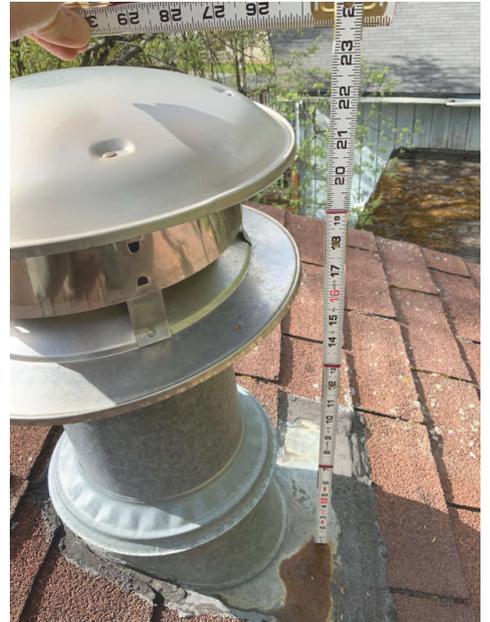
4.4.1 Skylights, Chimneys & Roof Penetrations

CHIMNEY HEIGHT ABOVE ROOF INCORRECT

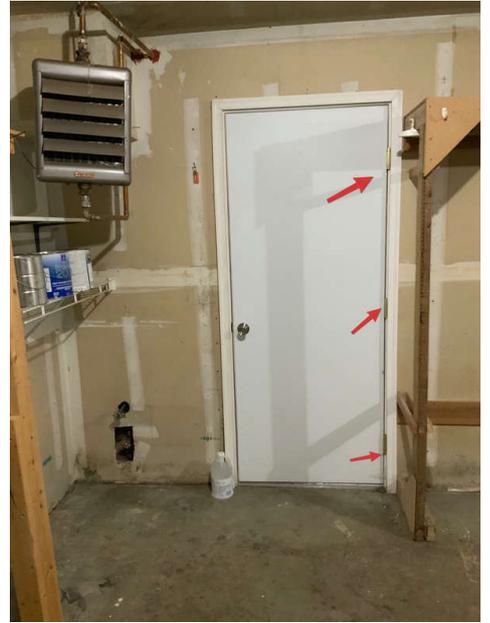
5.1.1 Interior-Exterior doors- Windows

ADJUST SELF-CLOSING HINGES

The garage-house door is equipped with an automatic closing device such as spring hinges that need to be adjusted or replaced.

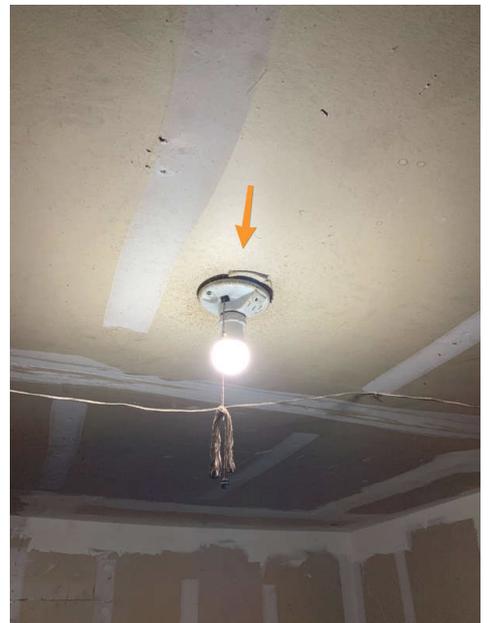
5.2.1 Electrical

DETERIORATED FIXTURES

One or more light fixtures are damaged and/or deteriorated. A qualified electrician should evaluate and repair or replace where necessary.

Contact a qualified electrical contractor.

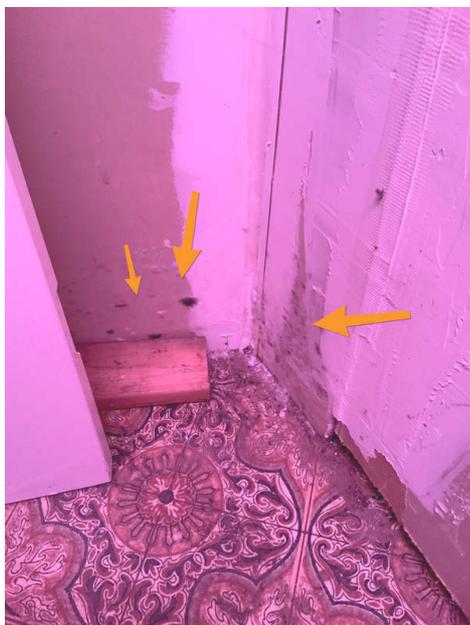
5.3.1 Floors, walls, Ceiling
MICROBIAL GROWTH

HEATING CLOSET

Surface Microbial growth was found on one or more walls/ceilings of the garage. This appears to be due to items previously stored and should be cleaned

Recommendation
Contact a qualified professional.

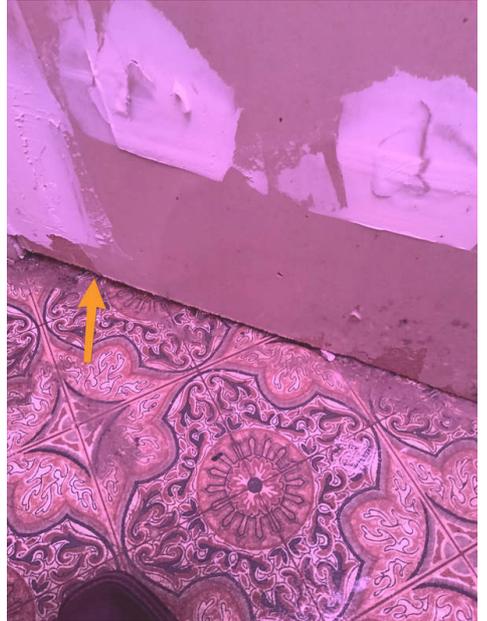
There are one or more penetrations in the wall or ceiling of the garage. All penetrations (open areas) from holes made for wiring or anything else need to be sealed to keep out gases and/or fumes such as carbon monoxide, gas fumes and paint thinners etc. It is recommended to have ALL penetrations sealed to keep the fumes from entering the living space of the house.

Contact a qualified professional.

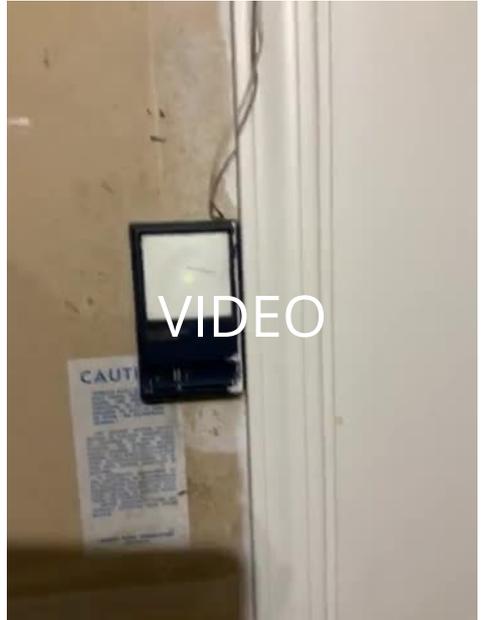
5.4.1 Vehicle door

OPENER INOPERABLE

One or more garage vehicle door openers are inoperable. A qualified contractor should evaluate and make repairs as necessary.

Contact a qualified garage door contractor.

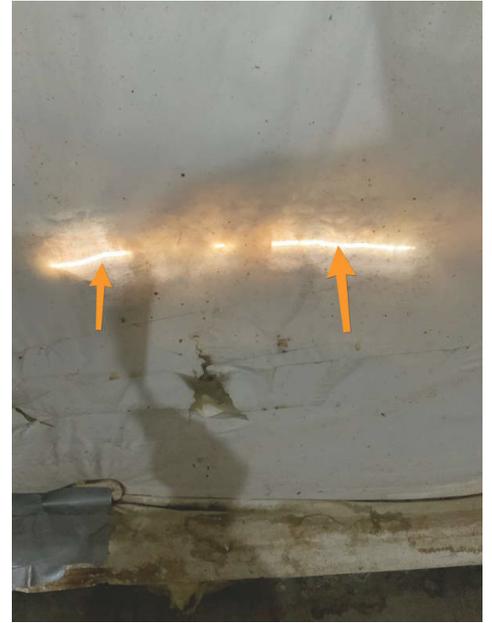
5.4.2 Vehicle door

PANEL DAMAGE

Garage door panel is damaged and may need repair/replacement. Recommend a qualified garage door contractor evaluate.

Contact a qualified garage door contractor.

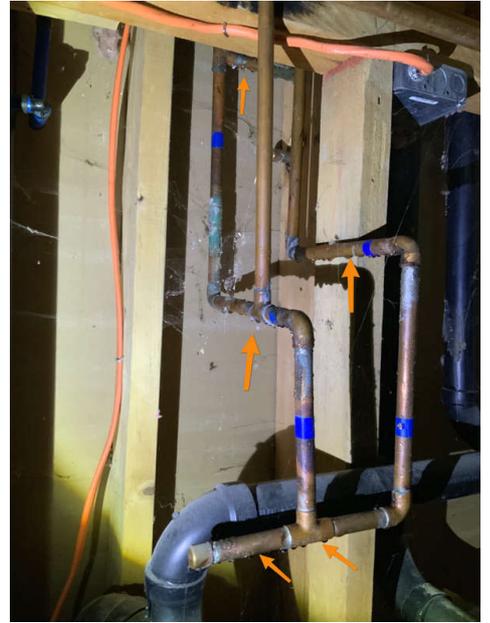
POSSIBLE LEAK

Evidence of condensation or pipes potentially leaking in the crawlspace recommend consulting a licensed plumber for evaluation.

Contact a qualified plumbing contractor.

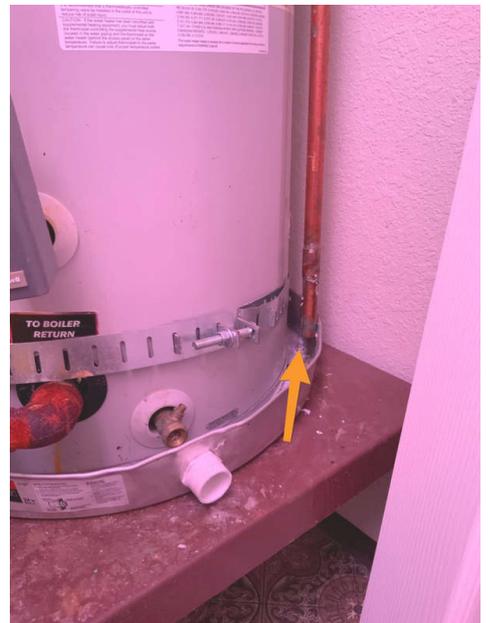
6.4.1 Water Heater **TPR TOO SHORT**

The TPR (temperature-pressure relief) valve drain line was too short. This is a potential safety hazard due to the risk of scalding if someone is standing next to the water heater when the valve opens. Recommend that a qualified plumber repair per standard building practices. For example, by extending the drain line to within 6 inches of the floor for indoor hot water heaters, or within 24 inches of exterior grade for outdoor water heaters.

Recommendation
Contact a qualified plumbing contractor.

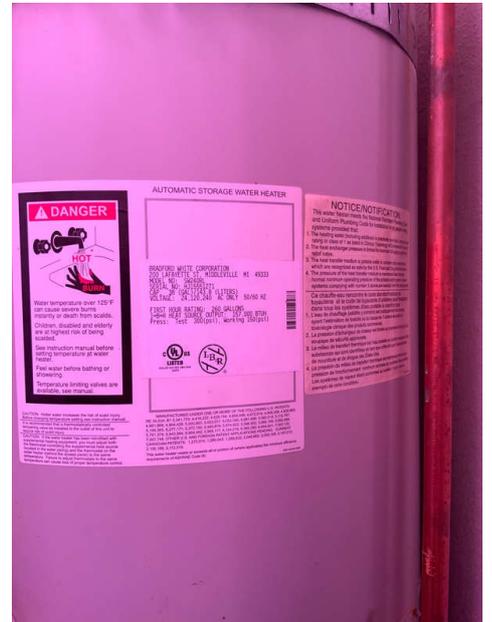
6.4.2 Water Heater **UNKNOWN AGE**

The estimated useful life for most water heaters is 8 to 12 years. The inspector was unable to determine the age of the water heater due to the manufacturer's label being obscured, no serial number being visible, or the serial number not clearly indicating the age. The clients should be aware that this water heater may be near, at, or beyond its useful life and may need replacing at any time. Recommend attempting to determine the water heater's age, and budgeting for a replacement if necessary.

Recommendation
Contact a qualified plumbing contractor.

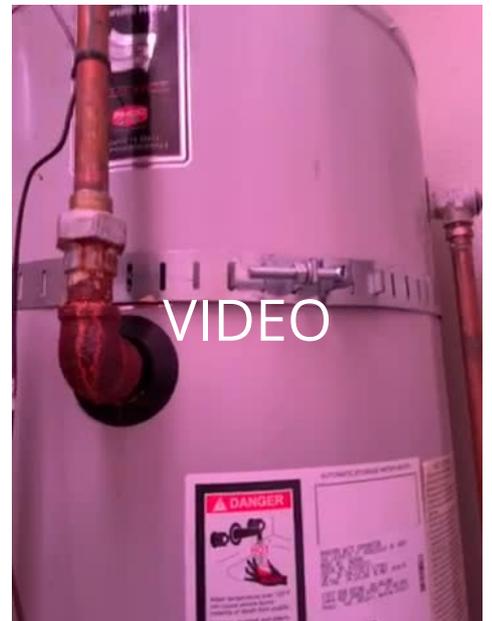
6.4.3 Water Heater

EARTHQUAKE STRAPS NEED ADJUSTMENT

Earthquake straps were not installed as per standard building practices recommend adjusting the earthquake straps.

Contact a handyman or DIY project

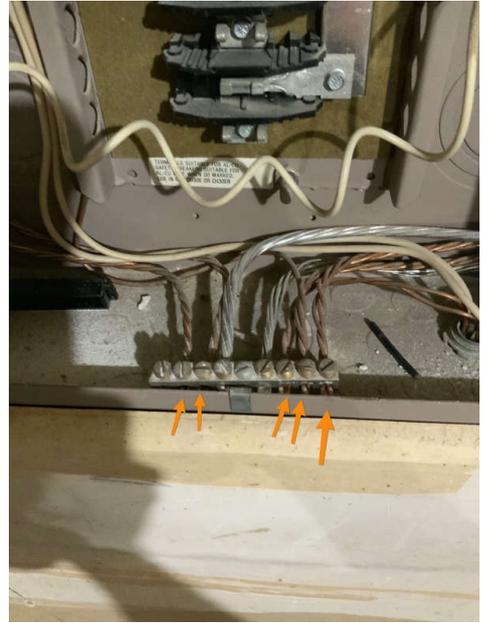
7.1.1 Electric Panel

DOUBLE GROUNDS

Grounding wires are doubled or bundled together on the grounding bus bar. This is unsafe due to one of the grounding wires could come loose from the lug allowing a circuit to become an ungrounded circuit. A qualified electrician should evaluate and repair as necessary.

Contact a qualified electrical contractor.

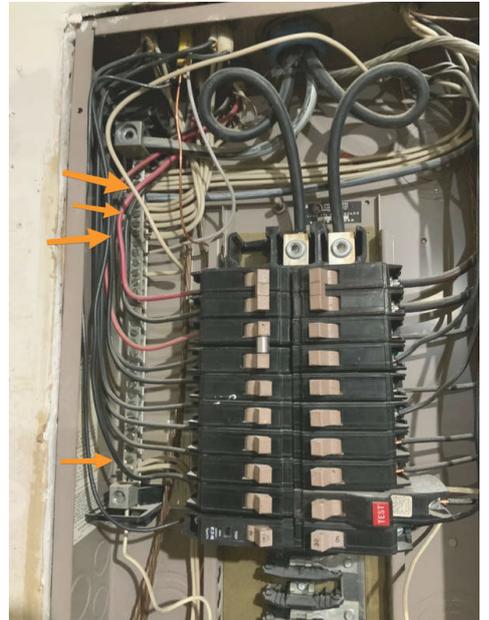
7.1.2 Electric Panel

DOUBLE TAP, NEUTRAL BAR

Neutral wires were doubled or bundled together under the same lug on the neutral bus bar in panel. This is a potential safety hazard in the event that one of the circuits needs to be isolated during servicing. For one neutral to be disconnected, other neutrals from energized circuits sharing the same lug will be loosened. Power surges may result on the energized circuits and result in damage or fire. Also, multiple wires under the same lug may not be secure, resulting in loose wires, arcing, sparks and fire. Recommend that a qualified electrician repair per standard building practices.

Contact a qualified electrical contractor.

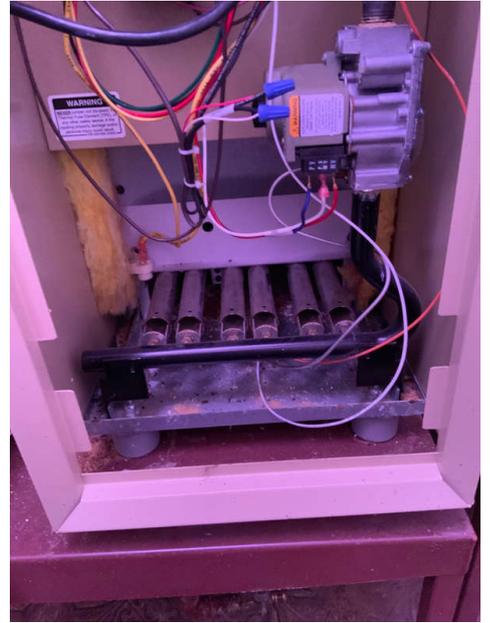
8.1.1 Heating Equipment

NEEDS SERVICING/CLEANING

Boiler or furnace should be cleaned and serviced annually. Recommend a qualified HVAC or Heating/Mechanical contractor clean, service and certify furnace.

Contact a qualified heating and cooling contractor

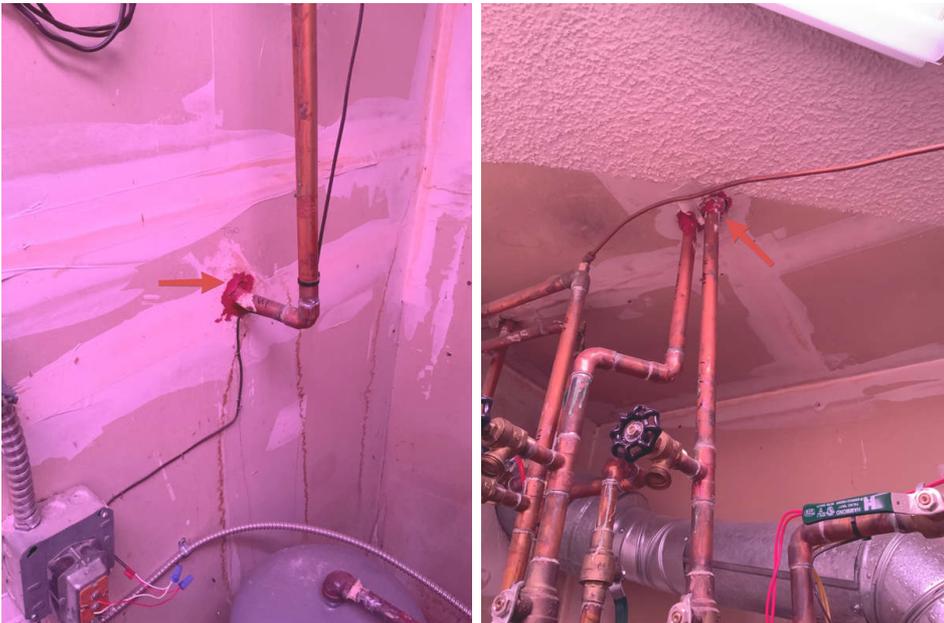
8.1.2 Heating Equipment

FIRE CAULKING REQUIRED

Penetrations observed in the heating unit room. All penetrations must be sealed with approved fire caulking.

Contact a qualified professional.

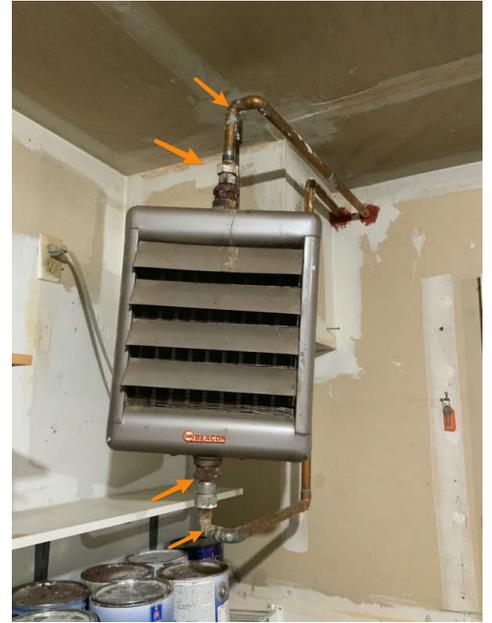
8.1.3 Heating Equipment

EVIDENCE OF PAST LEAK

The garage heating unit supply and return water piping is significantly corroded with evidence of past leaks. Recommend consulting a qualified mechanical contractor to repair or replace as necessary.

Contact a qualified heating and cooling contractor

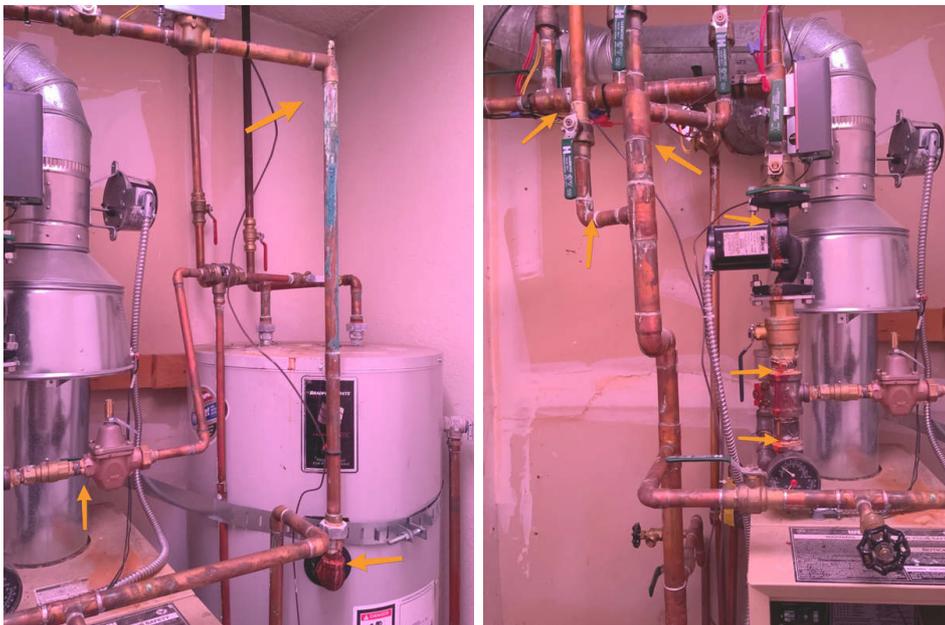
8.1.4 Heating Equipment **CORROSION PRESENT**

Corrosion was observed on one or more plumbing or heating pipes in the heating area. Recommend a qualified mechanical contractor evaluate and repair or replace as needed.

Recommendation
Contact a qualified professional.

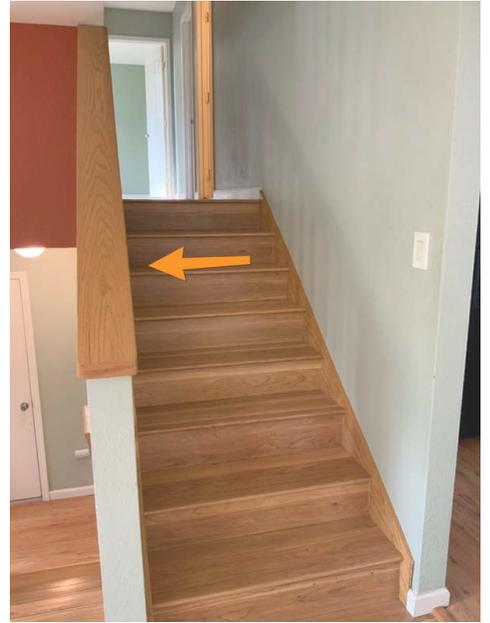
9.4.1 Steps, Stairways & Railings **HANDRAIL NOT GRASPABLE**

Handrails at one or more flights of stairs were not graspable and posed a fall hazard. Handrails should be 1 1/4 - 2 inches in diameter if round, or 2 5/8 inches or less in width if flat. Recommend that a qualified person install graspable handrails or modify existing handrails per standard building practices.

Recommendation
Contact a qualified professional.

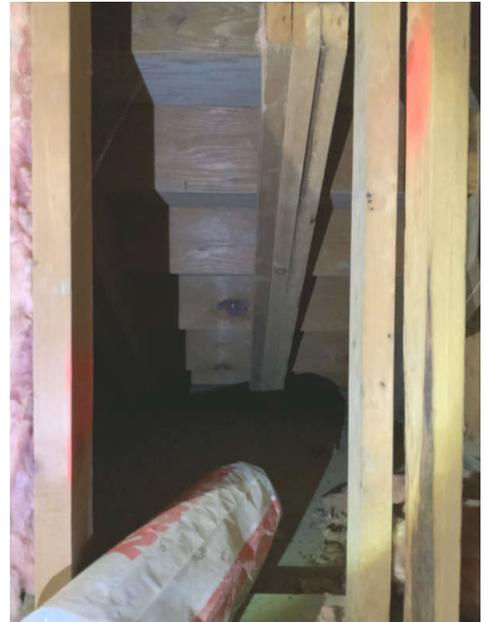
9.4.2 Steps, Stairways & Railings
NEEDS SHEETROCK UNDER STAIRS

One or more areas on the underside of staircases was not properly sheet rocked and fire taped. Recommend installing sheet rock drywall gypsum board and fire taping is necessary to allow for proper egress time. Repairs to be completed by a licensed contractor .

Recommendation
Contact a qualified professional.

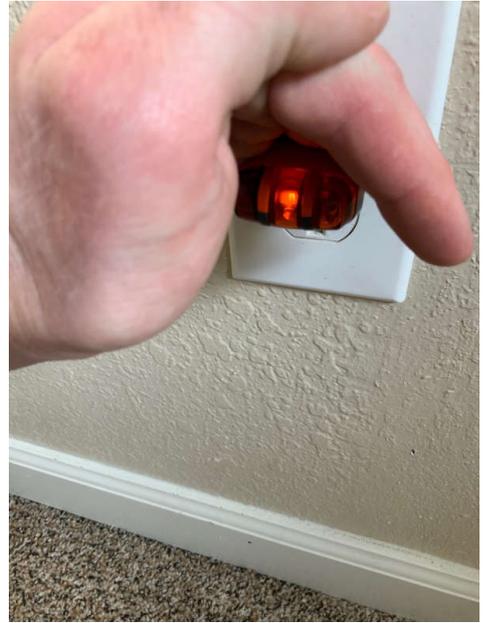
9.5.1 Electrical
OUTLET(S) NOT GROUNDED
BEDROOM 3 E WALL

One or more outlets are not grounded. Recommend a qualified electrician replace non-grounded outlets with grounded ones.

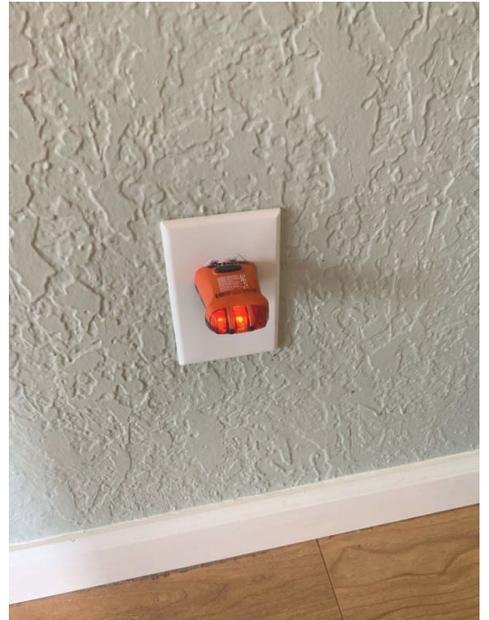
9.5.2 Electrical

HOT-NEUTRAL REVERSE

One or more electric receptacles had reverse-polarity wiring, where the hot and neutral wires were reversed. This is a shock hazard. Recommend that a qualified electrician repair as necessary.

Contact a qualified electrical contractor.

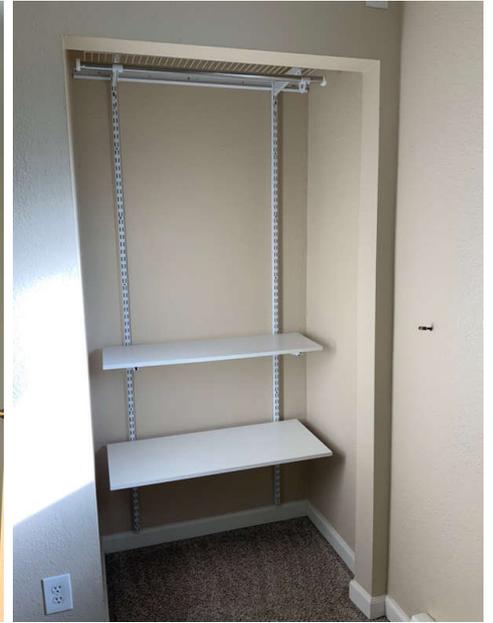
9.7.1 Windows and Door

CLOSET DOORS

One or more closet doors are missing, damaged or need repairs. It is recommended to have the necessary repairs or replacement of the closet door (s).

Contact a qualified door repair/installation contractor.

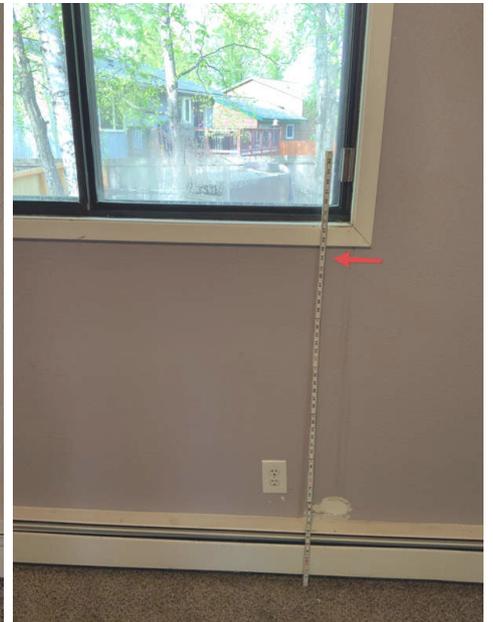
9.7.2 Windows and Door

IMPROPER SILL HEIGHT

Maximum sill height for an egress window is 44 inches from the floor. Recommend consulting with a qualified person to lower sill height or install a permanent step below egress windows.

Contact a qualified professional.

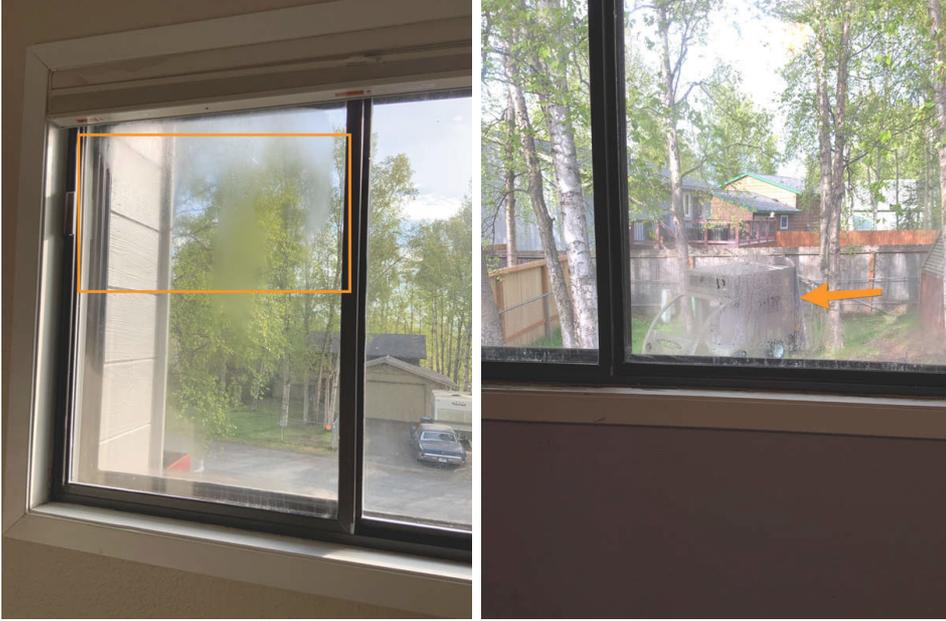
9.7.3 Windows and Door

WINDOW-DOUBLE PANE SEAL

Seals between double-pane glass in one or more windows appear to have failed based on condensation or stains between the panes of glass. A qualified contractor should evaluate and replace glass where necessary.

The client(s) should be aware that evidence of broken seals may be more or less visible from one day to the next depending on the temperature, humidity, sunlight, etc. Windows or glass doors other than those that the inspector identified may also have failed seals and need glass replaced too.

Contact a qualified window repair/installation contractor.

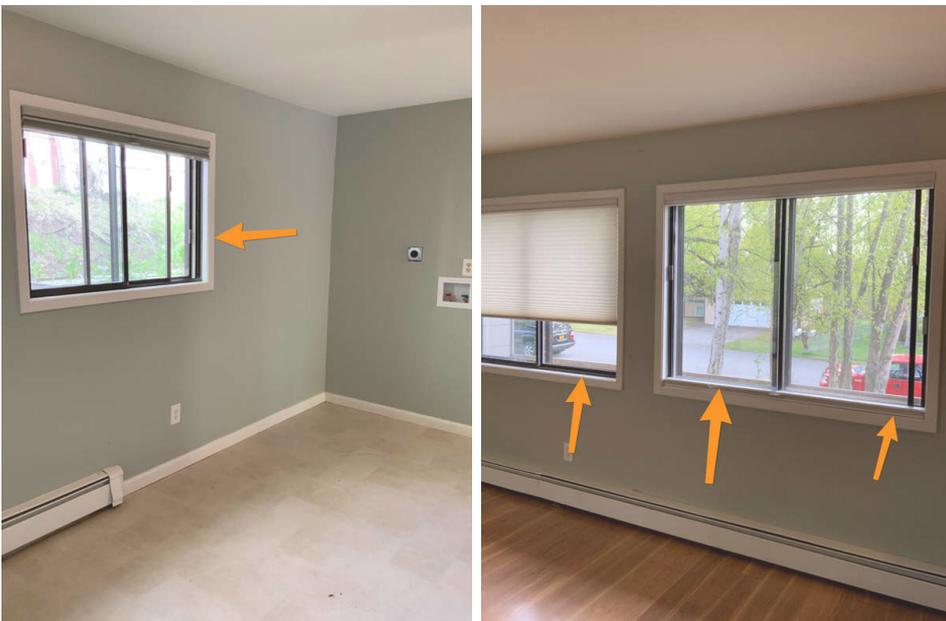
9.7.4 Windows and Door

WINDOW HARD TO OPEN

One or more windows are difficult to open and close. The windows should be adjusted so that they will open and close freely all necessary repairs should be made.

Contact a qualified professional.

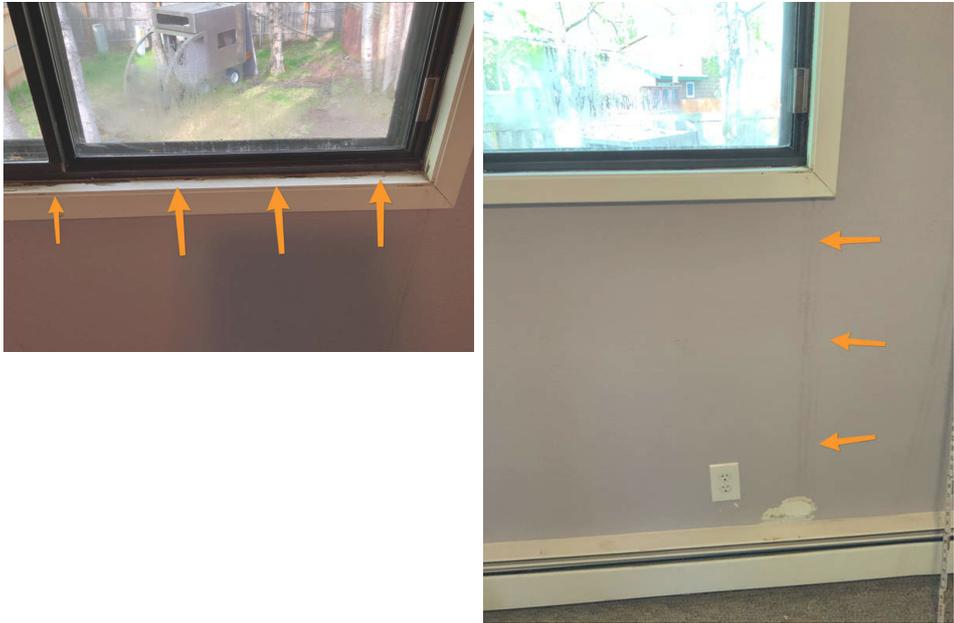
9.7.5 Windows and Door

EVIDENCE OF PAST LEAK

Evidence of a past leak was observed at one or more bedroom windows. Recommend consulting a qualified window professional to ensure that the leak is remediated.

Recommendation
Contact a qualified professional.

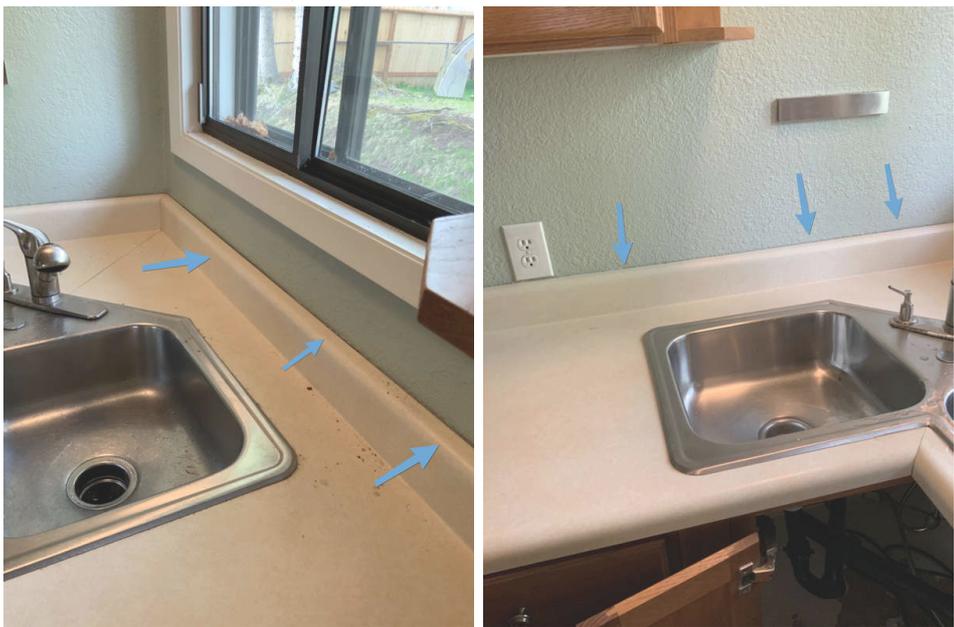
10.2.1 Countertops-Backsplash

CAULKING

One or more areas of the kitchen counter top(s) are recommended to be re-sealed (caulked) to keep any moisture and or water out and prevent future damage.

Recommendation
Recommended DIY Project

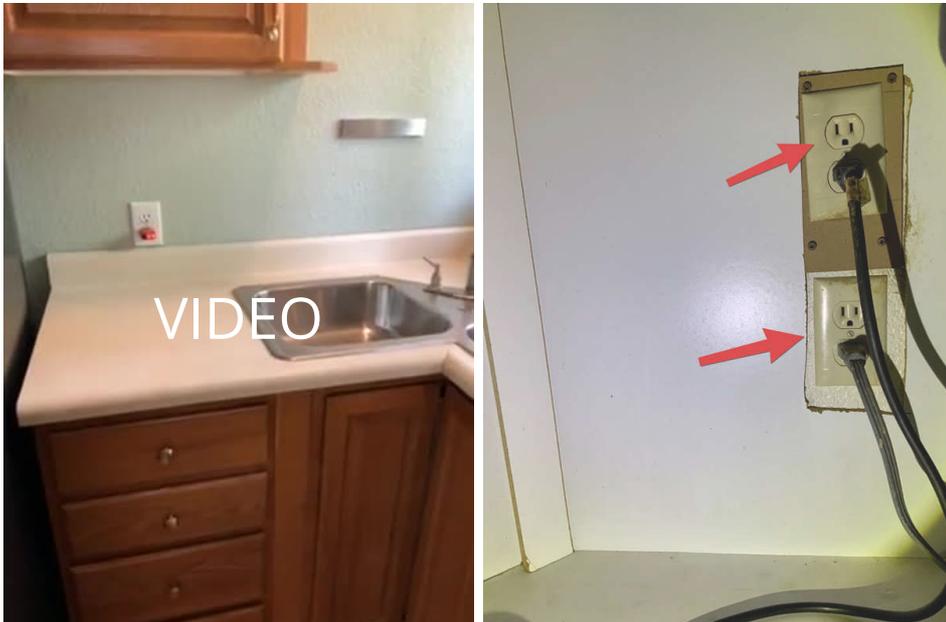
10.3.1 Electrical

GFCI MISSING

One or more electric receptacles at the kitchen had no visible ground fault circuit interrupter (GFCI) protection, or the inspector was unable to determine if GFCI protection was present. If not GFCI-protected, receptacles in wet areas pose a shock hazard. Recommend that a qualified electrician evaluate and install GFCI protection if necessary and per standard building practices. General guidelines for GFCI-protected receptacles include the following locations:

Contact a qualified electrical contractor.
