SUMMARY

1234 Main St. Palmer AK 99645

Benjamin Hornak
Alaska Home Inspector License...
907 Home Inspections, LLC
907-830-8443
907homeinspectionsllc@gmail.com

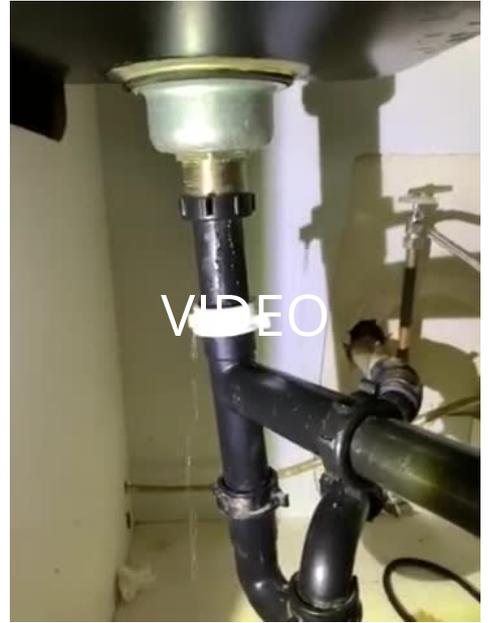
10.5.1 Sink

DRAIN LEAK

One or more sink drains have an active leak. For example, at pipe fittings and/or junctions between pipe and sink. A qualified plumber should evaluate and repair as necessary.

Contact a qualified plumbing contractor.

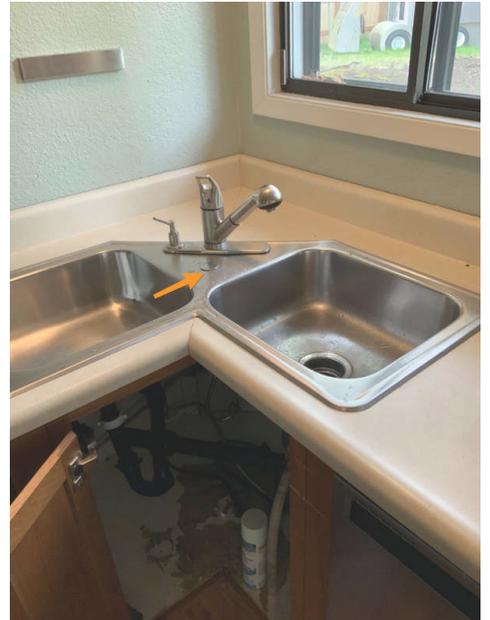
11.1.1 Dishwasher
AIR GAP MISSING

The air gap for a dishwasher prevents water in the sink drain from backing up into the dishwasher and potentially contaminating the dishes. Recommend a qualified professional install an air gap for the dishwasher.

Recommendation
Contact a qualified professional.

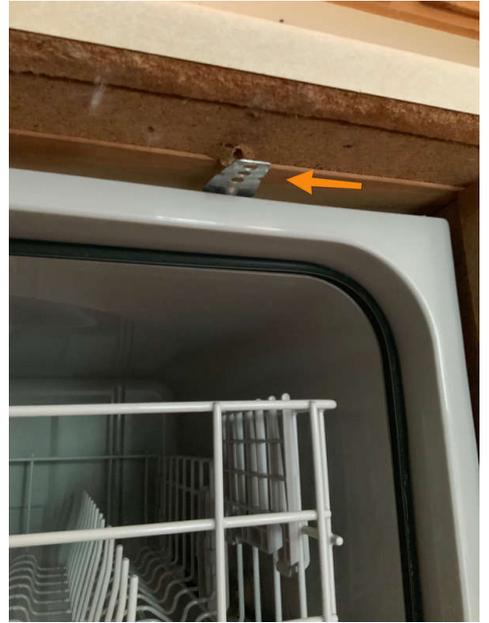
11.1.2 Dishwasher
DISHWASHER BRACKET

The bracket that attaches the dishwasher to the underside of the countertop is loose, missing or installed in a substandard way. Repairs should be made as necessary, such as installing or reinstalling the bracket, and by a qualified contractor if necessary.

Recommendation
Contact a qualified appliance repair professional.

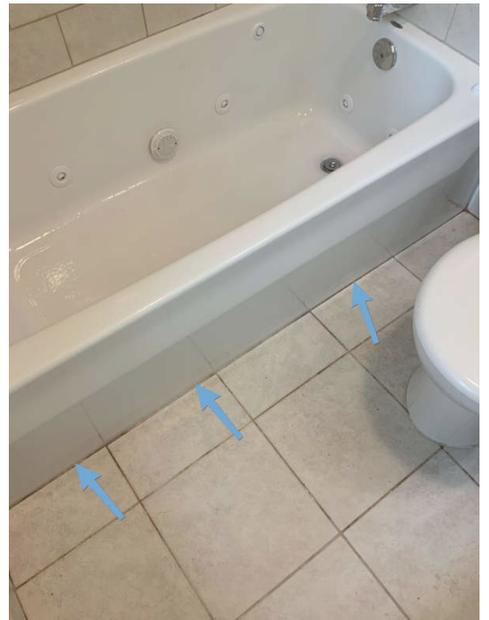
Caulk is missing or deteriorated along the base of one or more bathtubs, where flooring meets the tub. It should be replaced where deteriorated and/or applied where missing to prevent water intrusion and damage to the floor structure.

Recommended DIY Project

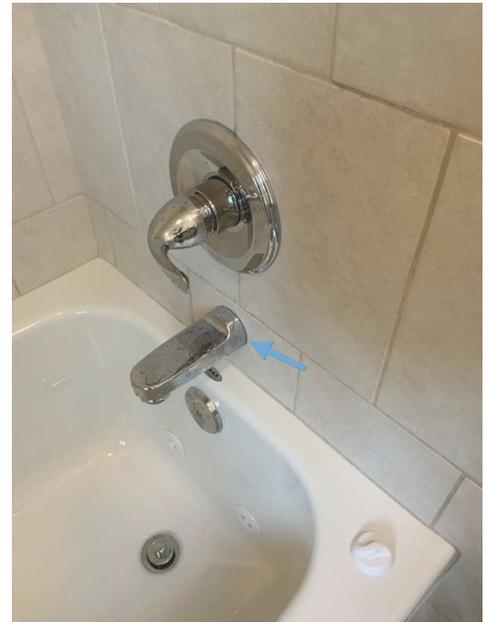
12.2.2 Bathub

CAULK AT SPOUT

Caulk is missing or deteriorated around the base of the bathtub spout. It should be replaced where deteriorated and/or applied where missing to prevent water intrusion and damage to wall structures.

Recommended DIY Project

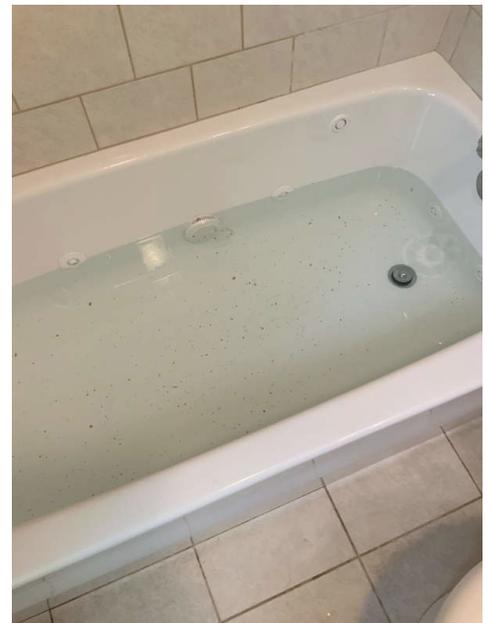
12.2.3 Bathub

JETTED TUB NEED CLEANING

Recommended DIY Project

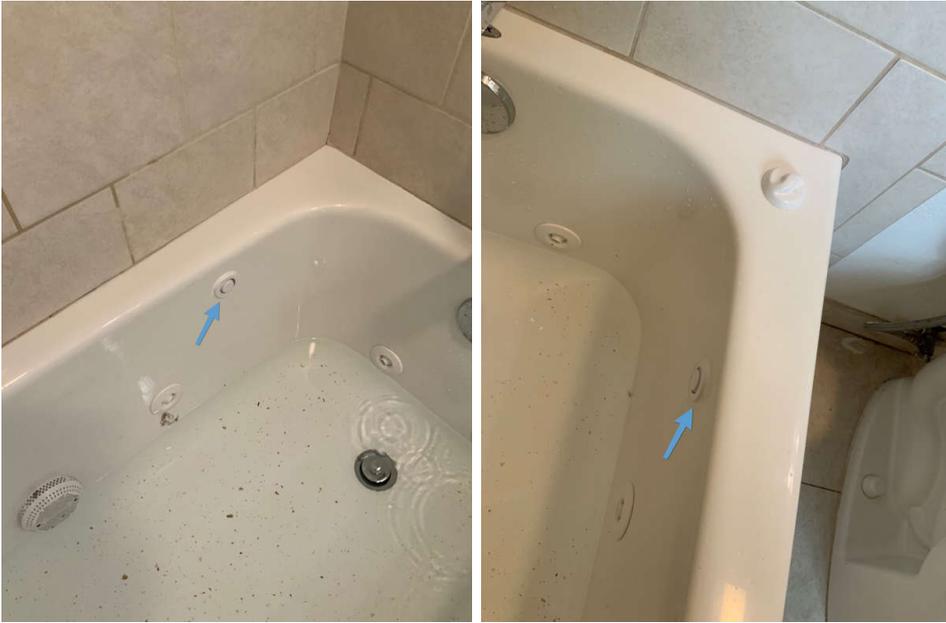
12.2.4 Bathub

CONTROLS DETACHED

The controls for the jetted tub controls have been detached recommend re-fixing the controls as intended.

Contact a qualified professional.

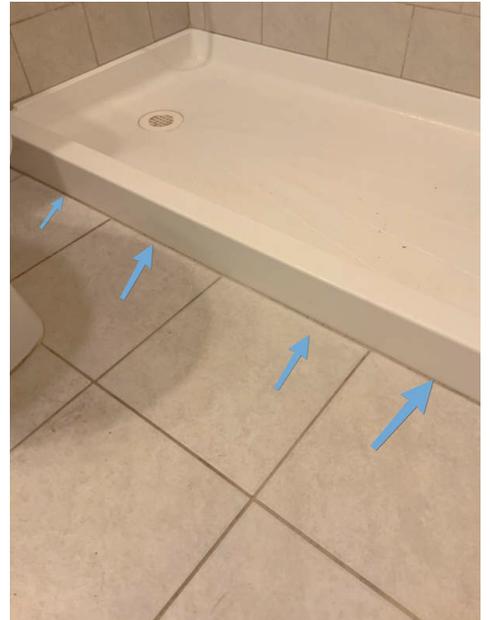
12.3.1 Shower

CAULK AT FLOOR

Caulk is missing or deteriorated along the base of the shower, where flooring meets the shower. It should be replaced where deteriorated and/or applied where missing to prevent water intrusion and damage to the floor structure.

Recommendation
Recommended DIY Project

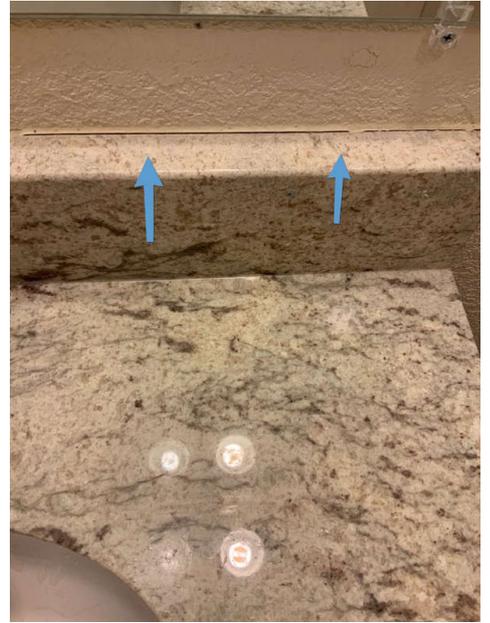
12.4.1 Sink/Countertop

BACKSPLASH SEALANT

Caulk is missing and/or deteriorated where counter tops meet back splashes in wet areas, such as around sinks. Caulk should be replaced where deteriorated and/or applied where missing to prevent water damage.

Recommendation
Recommended DIY Project

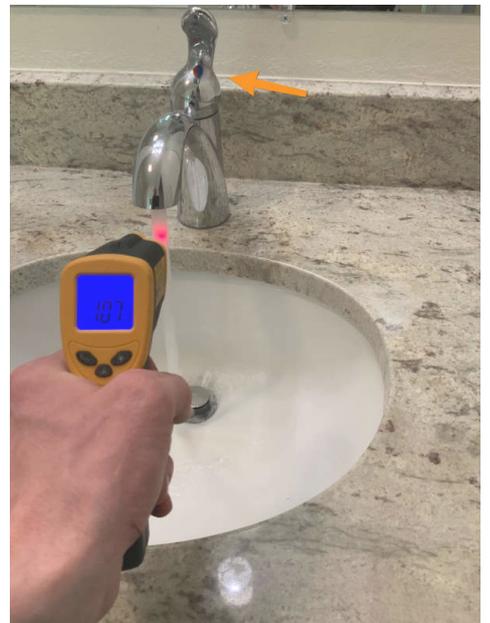
12.4.2 Sink/Countertop
REVERSED PLUMBED

One or more bathroom faucets appear to be reversed plumbed. The cold water comes on in the hot water position and the hot water comes on in the cold position. A certified plumbing contractor should evaluate the fixture and make the necessary repairs.

Contact a qualified plumbing contractor.

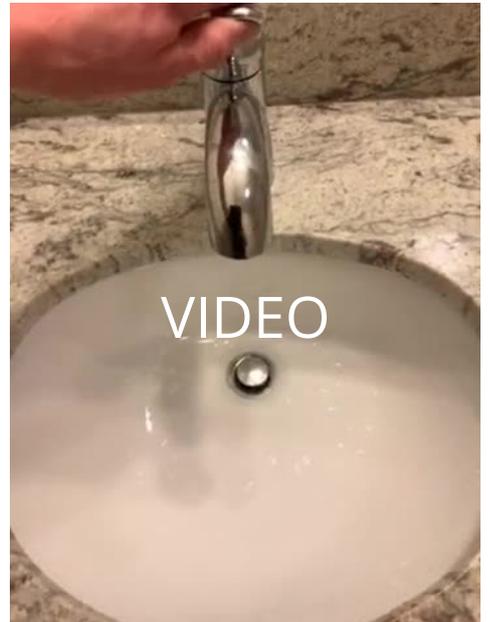
12.4.3 Sink/Countertop
AERATOR MISSING

The aerator for the bathroom sink is missing and recommend replacing to prevent splattering.

Recommended DIY Project

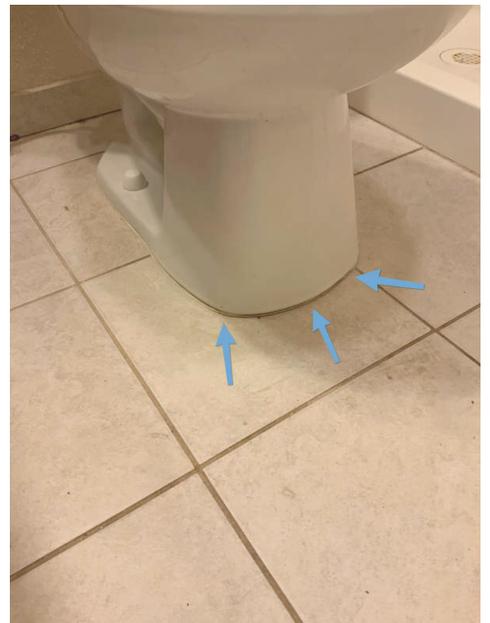
12.5.1 Toilets

NO OR BAD CAULK BASE

Caulk around the base of the toilet was missing, substandard and/or deteriorated. Modern standards require caulk to be installed around the entire toilet base where it meets the floor for sanitary reasons. Without it, soiled water can soak into flooring and sub-floor materials if the toilet overflows. Condensation from the toilet can also soak into the flooring. Recommend that a qualified person caulk around toilet bases per standard building practices.

Recommended DIY Project

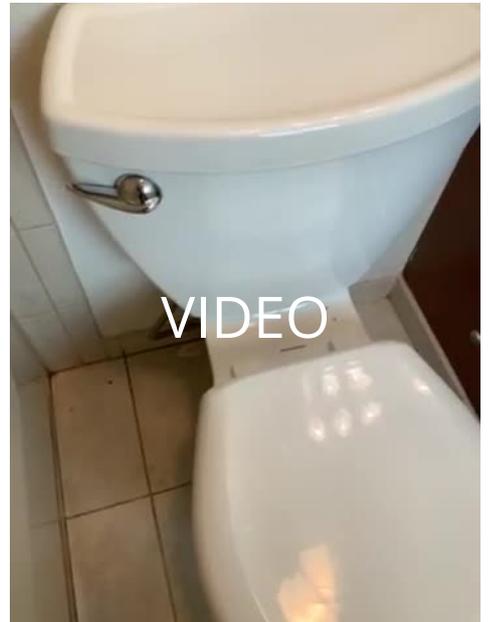
12.5.2 Toilets

RUNS

Contact a qualified plumbing contractor.

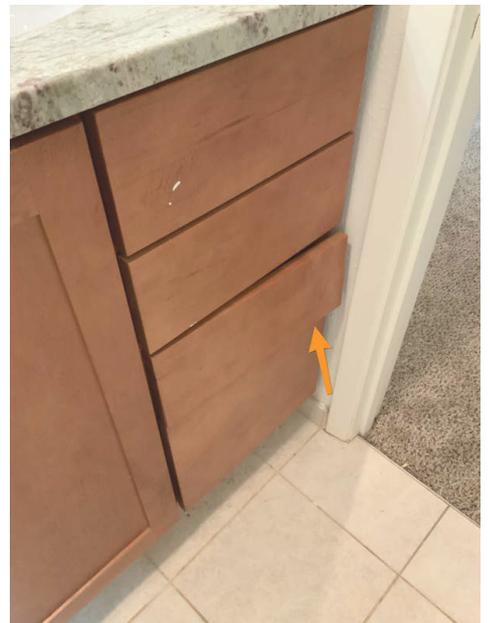
12.6.1 Cabinets

CABINET DOOR ADJUSTMENT

Contact a qualified professional.

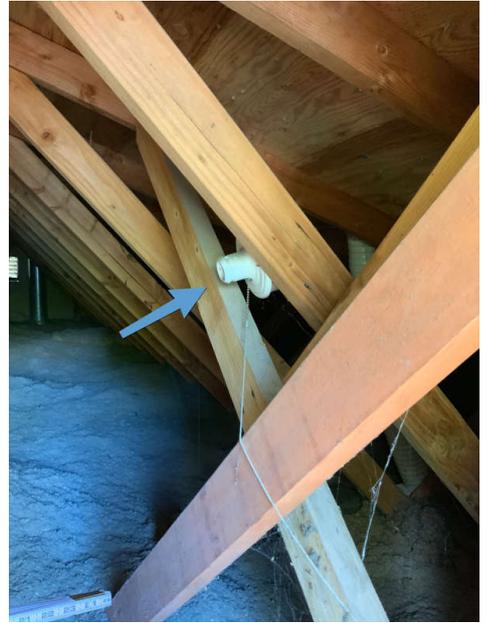
14.4.1 Electrical

MISSING BULB

Recommended DIY Project

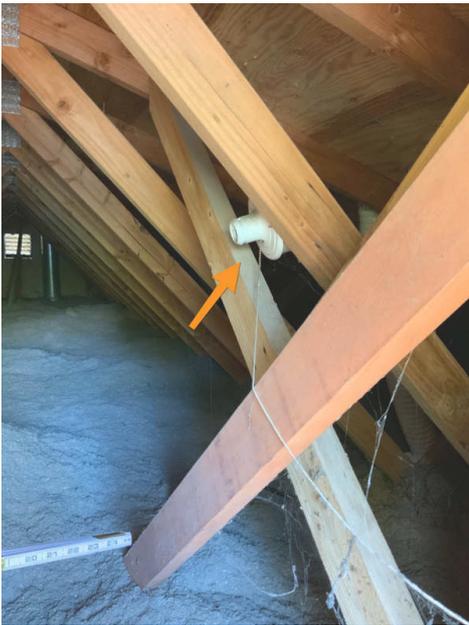
A safety cage is needed for the light fixtures in the attic.

Recommendation
Recommended DIY Project

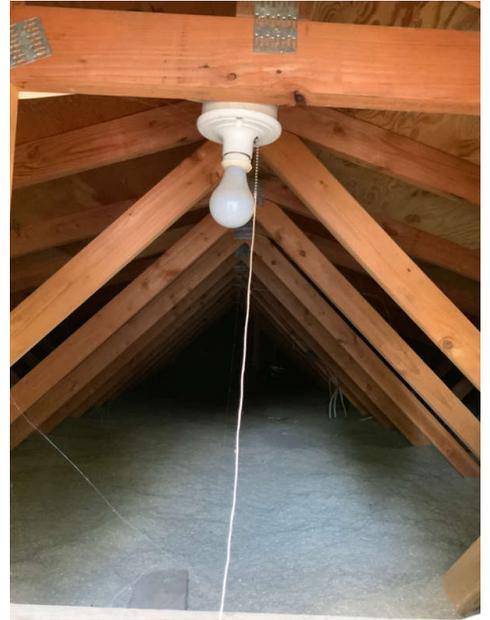
14.4.3 Electrical
FIXTURE INOPERABLE

The bulb was inoperable at one or more fixtures in the attic.
Recommend replacing the bulb(s).

Recommendation
Recommended DIY Project

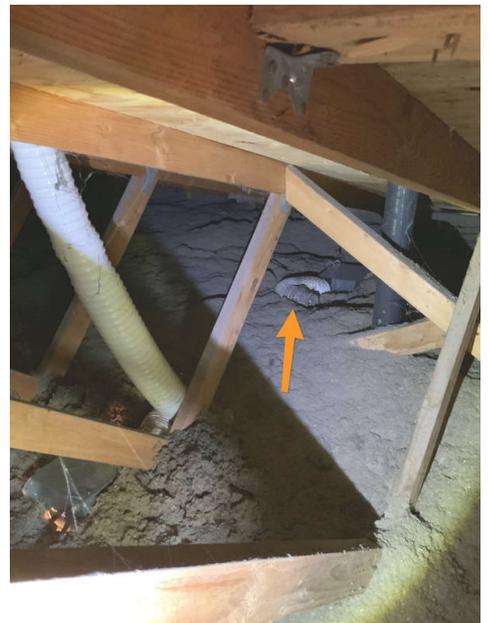
14.6.1 Ventilation

EXHAUST TERMINATE IN ATTIC

Contact a qualified HVAC professional.

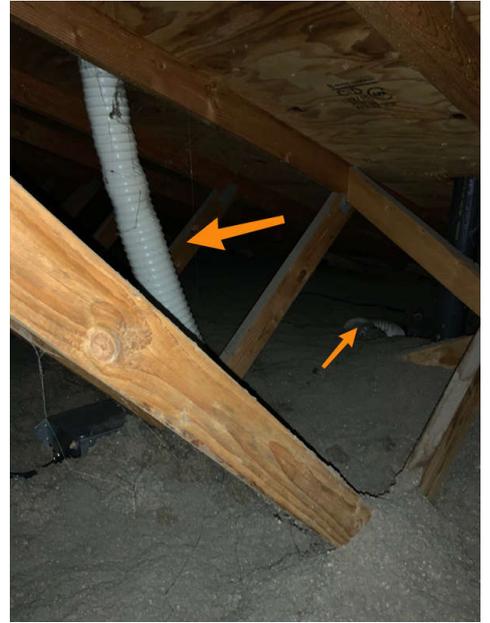
14.6.2 Ventilation

EXHAUST FLEX DUCTING

Contact a qualified professional.

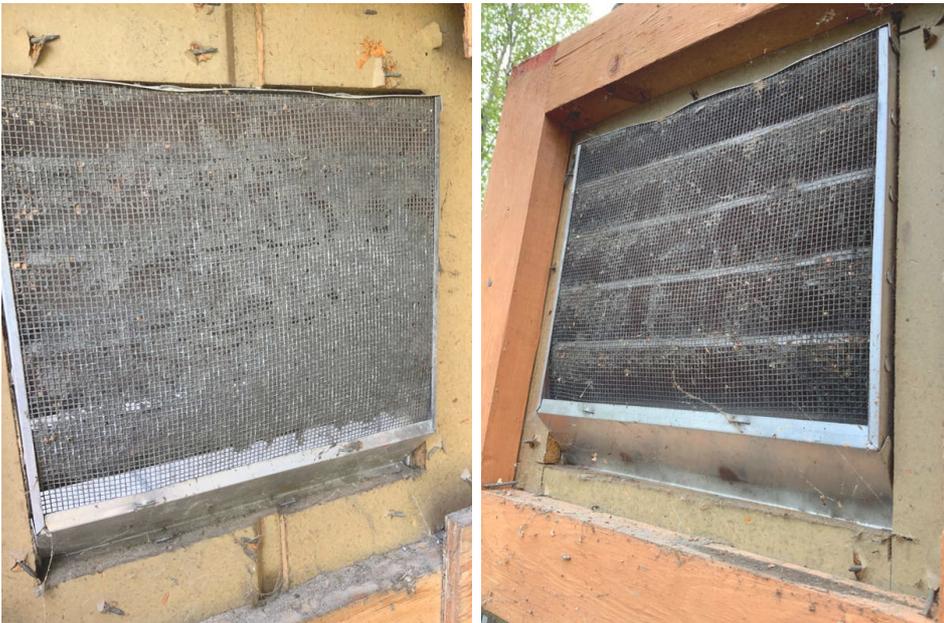
14.6.3 Ventilation

GABLE/RIDGE/SOFFIT VENTS CLOGGED

Contact a qualified professional.

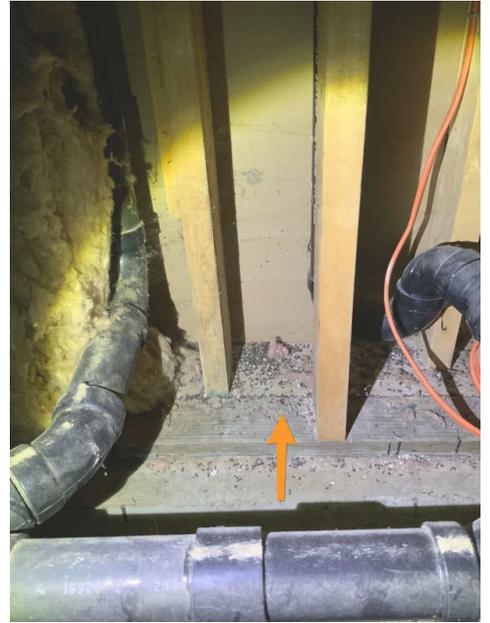
15.1.1 General

PEST EVIDENCE

Evidence of rodent infestation was found in the form of *feces / urine stains / traps / poison / dead rodents / damaged insulation* in the *attic / crawl space / basement / garage / interior rooms*. Consult with the property owner about this. A qualified person should make repairs to seal openings in the structure, set traps, and clean rodent waste as necessary.

Recommendation
Contact a qualified professional.

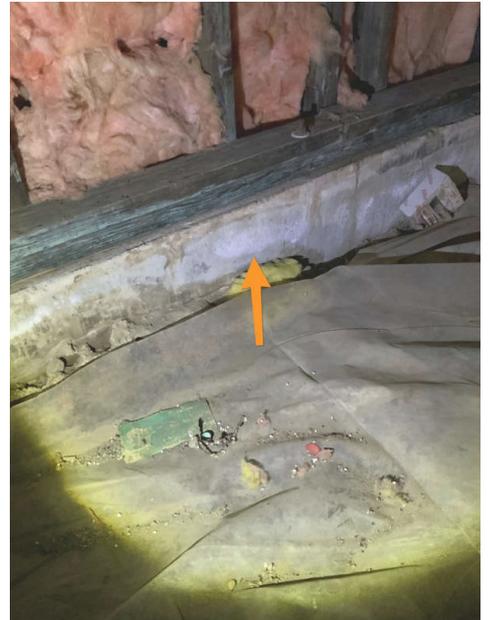
15.2.1 Foundation, Basement & Crawlspace

EFFLORESCENCE

Efflorescence noted on the crawlspace surface. This is a white, powdery deposit that is consistent with moisture intrusion. This can compromise the soil's ability to support the home structure and/or lead to mold growth. Recommend a qualified contractor identify source or moisture and correct.

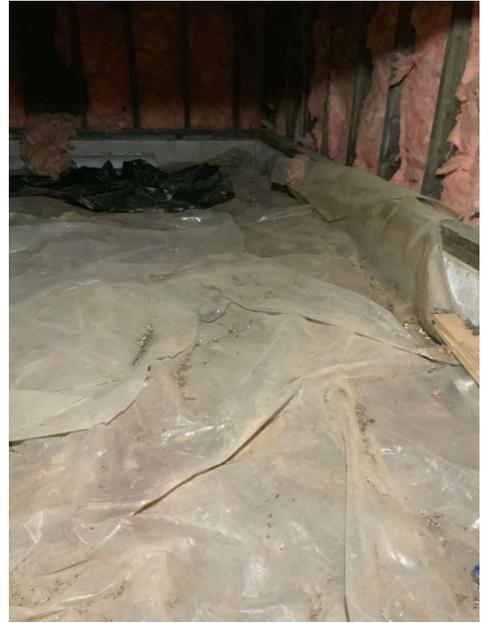
15.4.1 Vapor Retarder (Barrier)

IMPROPER INSTALLATION

Vapor barrier is improperly installed. This can result in unwanted moisture. Recommend insulation contractor evaluate and repair/replace as needed.

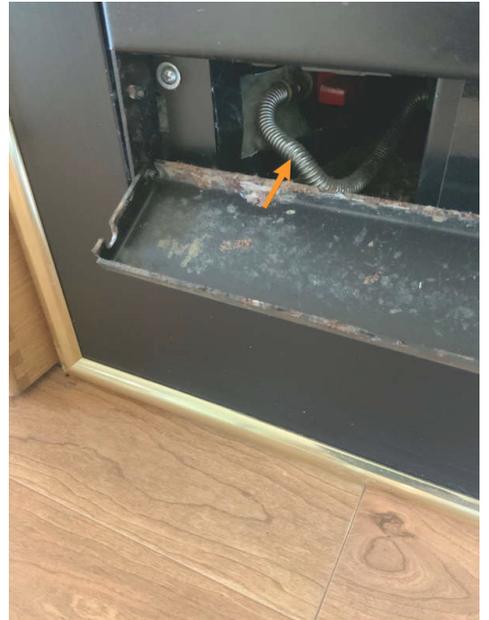
16.1.1 Fireplaces, Stoves & Inserts

REPLACE GAS LINE

Contact a qualified professional.
