Below is a summary of all deficiencies found at the property. Estimated costs are added as a courtesy and must be verified by a licensed contractor in their respectable trade.

Truview Inspections Page 1 of 12

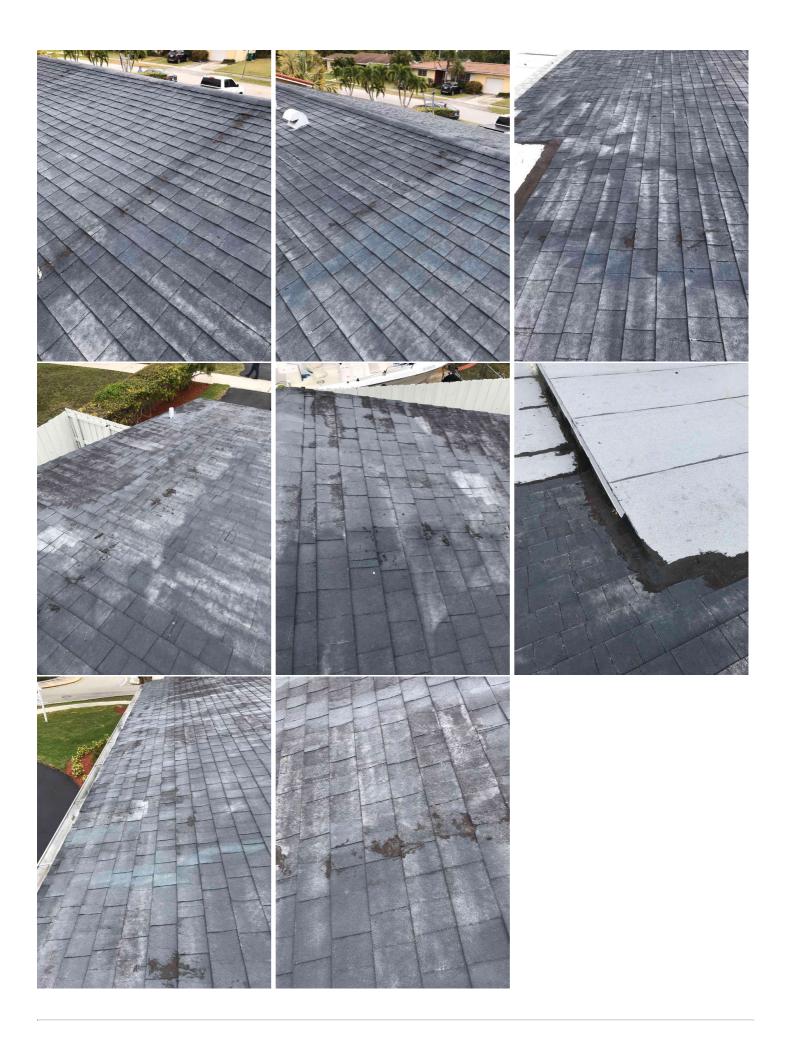
2.1.1 Coverings

REPLACEMENT RECOMMENDED

Roof is damaged and deteriorated; replacement recommended. Roof is 24 years old, shingles are deteriorating, leaks observed, improper patching, and flat roof seems to have been replaced without a permit.

Recommendation Contact a qualified roofing professional. Estimated Cost \$10,000

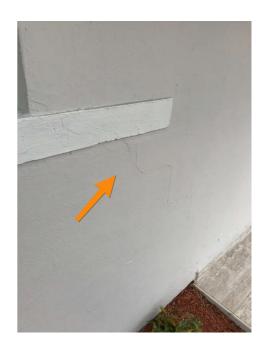
3.2.1 Siding, Flashing & Trim

CRACKING - MINOR

Siding showed cracking in one or more places. This is a result of temperature changes, and typical as homes with stucco age. Recommend monitoring.

Contact a qualified general contractor.

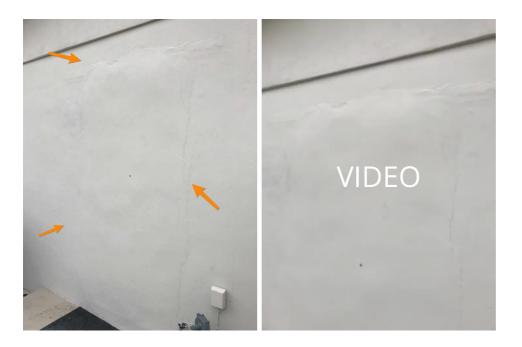
4.4.1 Wall Structure

IMPROPER CONSTRUCTION

Exterior door on right elevation was closed using wood frame and not concrete. Also, patchwork observed was sub-par.

Contact a qualified general contractor.

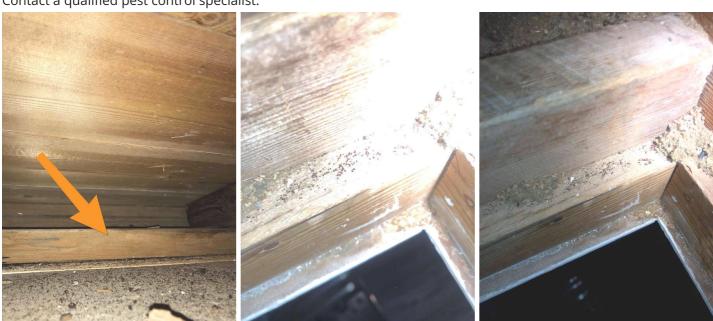
4.5.1 Wood Destroying Organisms **VISIBLE EVIDENCE**

Wood destroying organisms evidence observed at the property. Treatment is recommended.

Contact a qualified pest control specialist.

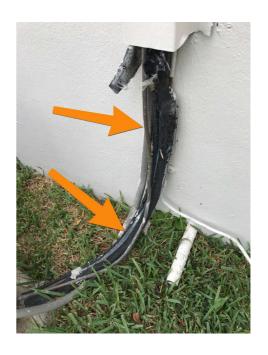
6.1.1 Cooling Equipment

INSULATION MISSING OR DAMAGED

Missing or damaged insulation on refrigerant line can cause energy loss and condensation.

Recommendation Contact a qualified heating and cooling contractor Estimated Cost \$10 - \$200

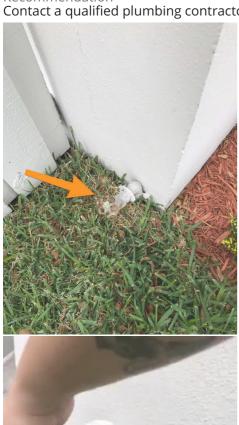
7.3.3 Water Supply, Distribution Systems & Fixtures

NO WATER PRESSURE

Faucet located on front elevation has no water pressure.

Recommendation Contact a qualified plumbing contractor.

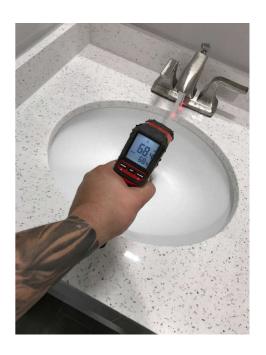
7.4.1 Hot Water Systems, Controls, Flues & Vents

NO HOT WATER

There was no hot water at the time of inspection. Water heater must be evaluated by a licensed plumber.

Contact a qualified plumbing contractor.

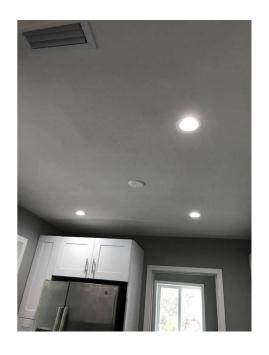
8.6.1 Smoke Detectors

NOT PRESENT

Smoke detectors are not present.

Recommendation Contact a qualified fire suppression contractor. Estimated Cost \$10 - \$200

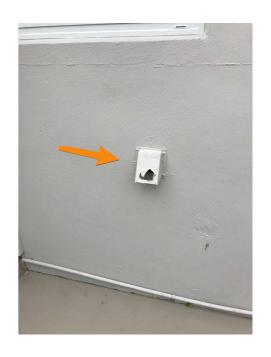
12.6.1 Dryer

VENT IS DAMAGED

Observed damaged dryer vent. Dryer must properly vent in order to avoid a fire.

Recommendation Contact a qualified appliance repair professional. Estimated Cost \$10 - \$100

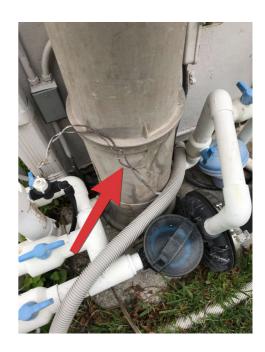
16.1.2 Installed Equipment

NOT BONDED

Pool is not bonded.

Recommendation Contact a qualified Swimming Pool Contractor
