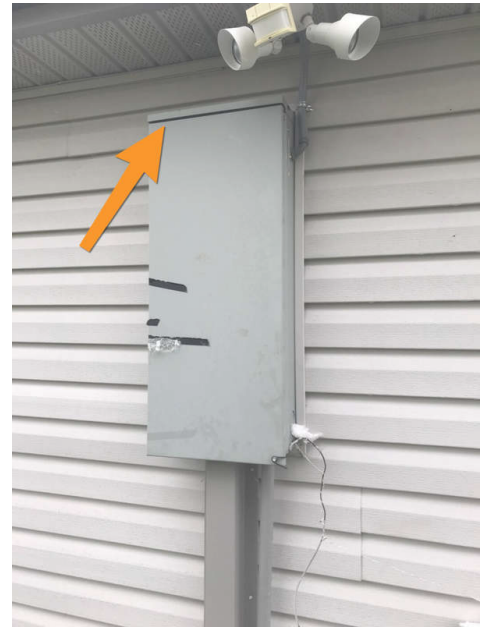
PANEL DOESNT CLOSE PROPERLY

Electrical panel door does not close properly. Additionally the exterior electrical panel is exposed to potential moisture intrusion. Recommend having door repaired to prevent water from infiltrating panel and electrical wiring.

Contact a qualified electrical contractor.

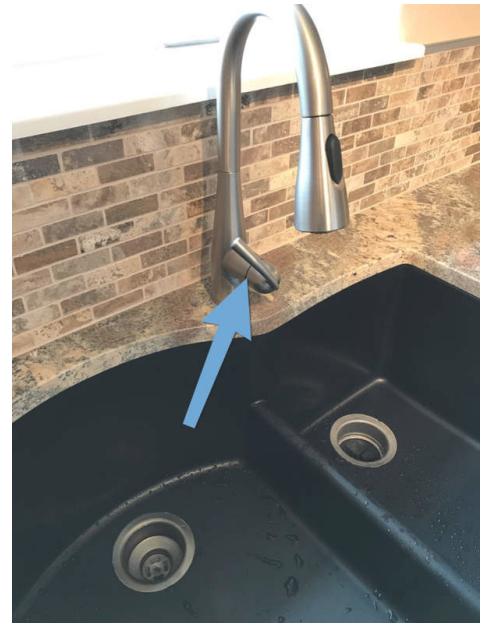
IMPROPER PLUMBING

Sink faucet was installed incorrectly. Recommend turning faucet 90 degrees to the right. Additionally, this will help prevent occupants from accidental scalding by turning the faucet in the wrong direction.

Recommendation
Contact a qualified plumbing contractor.
