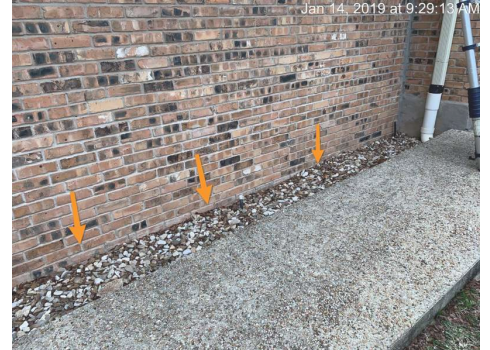
SOIL ELEVATIONS:

Deficient: Soil elevations are too high on right side of garage. Industry standards call for a minimum of 4-6' inches of the foundation be visible on all elevations.

Should be 4-6' inches of foundation visible.

Recommendation
Contact a qualified landscaping contractor

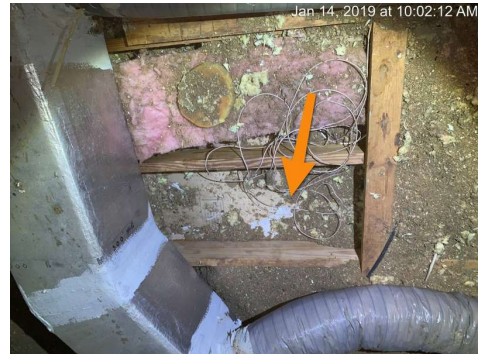
ATTIC INSULATION- MISSING

Deficient: Attic insulation is missing in several locations. Have a insulation specialist provide needed repairs.

Missing attic insulation.

Recommendation
Contact a qualified insulation contractor.

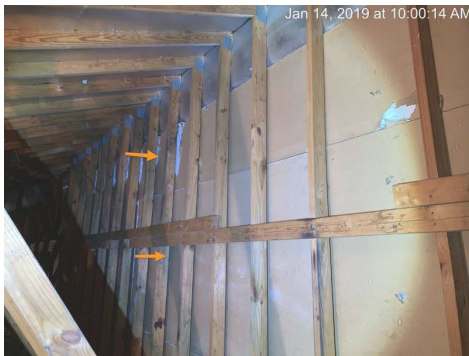
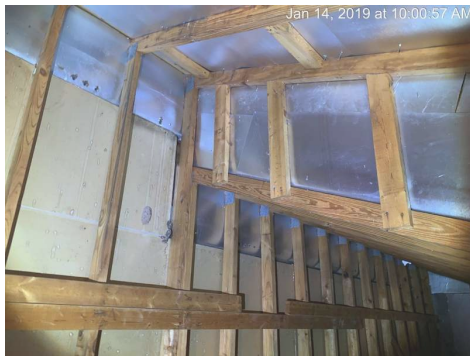
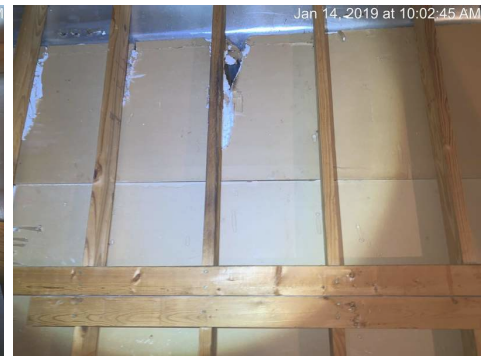
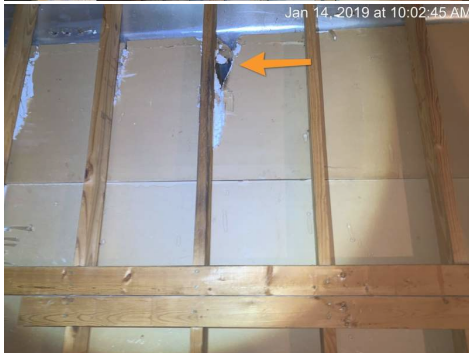
2.4.3 D. Roof Structure & Attic **INCOMPLETE DRAFT STOP**

Deficient: Party wall in between units in attic space is required to be sealed to prevent fire from easily moving from one unit to the next. Pipe penetrations and incomplete sheet-rock was observed. Have a drywall specialist perform needed repairs.

Opening in draft stop

Recommendation
Contact a qualified drywall contractor.

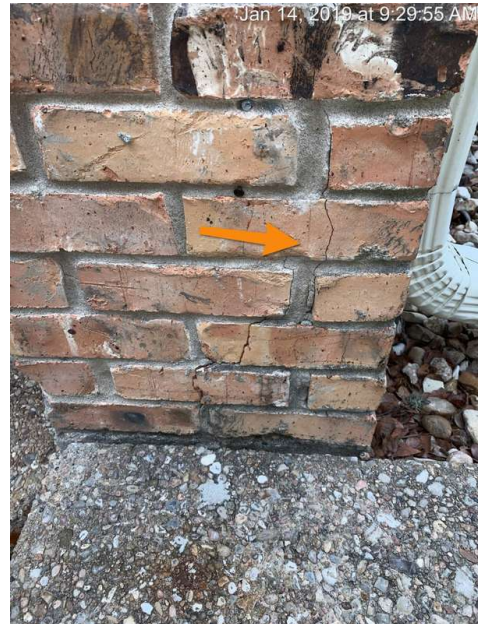
2.5.1 E. Walls (Interior and Exterior) **CRACKS - MINOR**

Minor cracking was observed in wall structure. This is common in homes this age. Recommend monitoring.

Minor cracking in brick veneer. Recommend monitoring to determine if any additional movement is occurring.

Recommendation
Recommended DIY Project

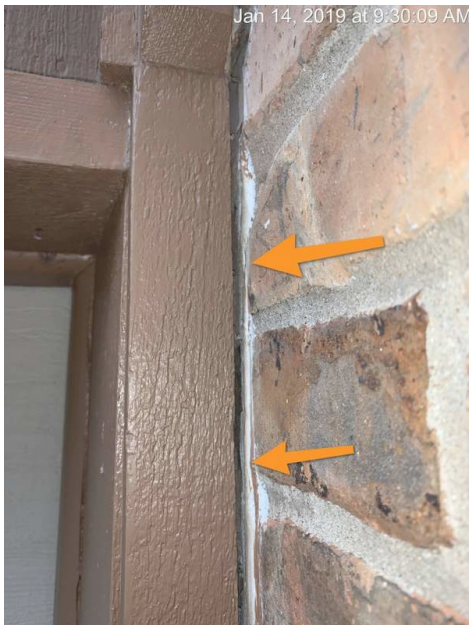
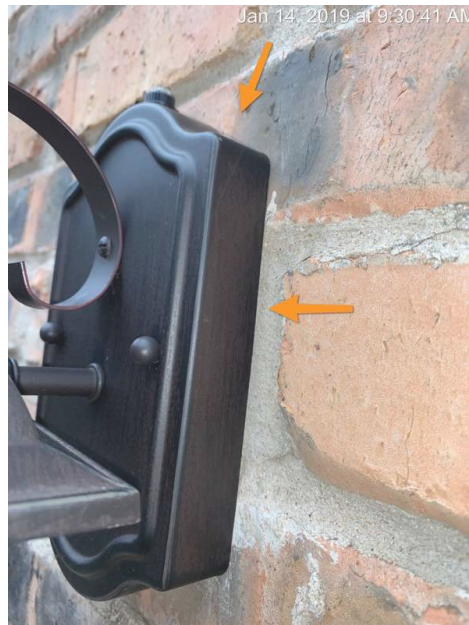
EXTERIOR OPENINGS:

Deficient: Seal all dissimilar materials such as wood to brick and light fixtures to brick to prevent water penetration.

Seal to prevent water intrusion.

Recommend using urethane based sealant such as NP-1. here is a link:

Contact a qualified painter.

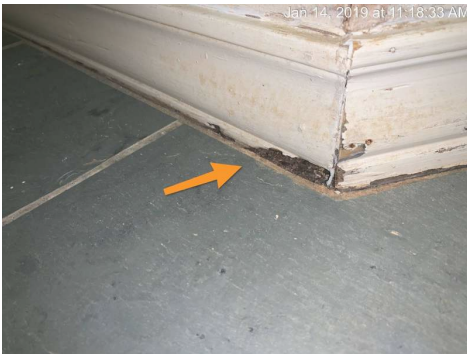
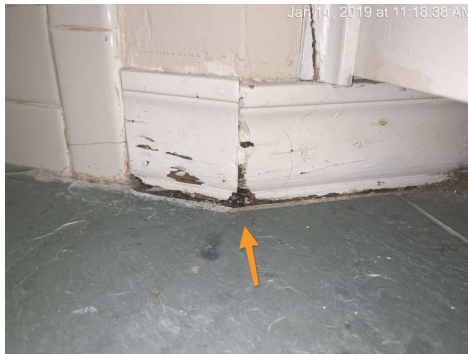
ROTTED WOOD:

Deficient: Rotted wood was observed at the base board in the hallway bathroom. Have a carpentry specialist perform needed repairs.

Rotted wood.

Recommendation
Contact a qualified carpenter.

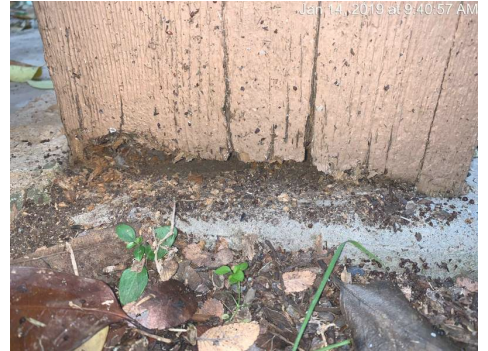
SUPPORT BEAM FOR PATIO:

Deficient: First support beam for patio is showing evidence of rot and deterioration. Recommend installing post base to prevent additional damage. Have a carpentry specialist inspect all support beams and perform needed repairs.

Recommendation
Contact a qualified carpenter.

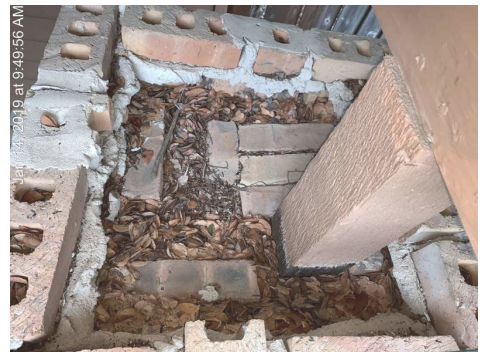
BRICK COLUMN AT ENTRY NOT SEALED

Deficient: Brick column at front entry does not have a cap on the top to prevent moisture entry. Have a carpentry provide needed repairs.

No cap for brick column.

Recommendation
Contact a qualified carpenter.

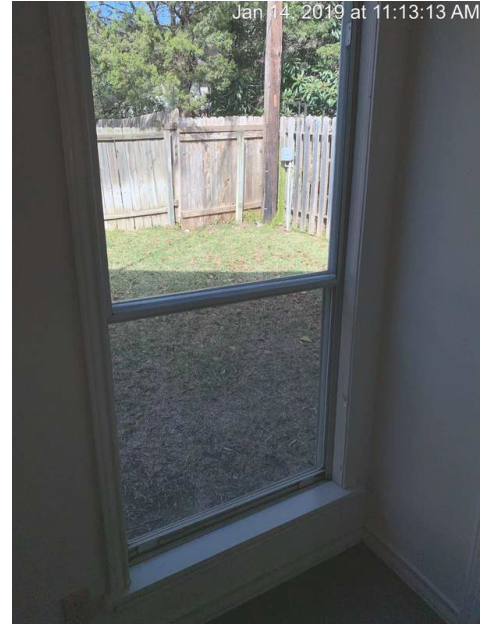
WINDOW ISSUES:

Deficient: The following issues were discovered concerning windows:

1.) Back corner window in master bedroom is not opening.

Recommendation
Contact a qualified window repair/installation contractor.

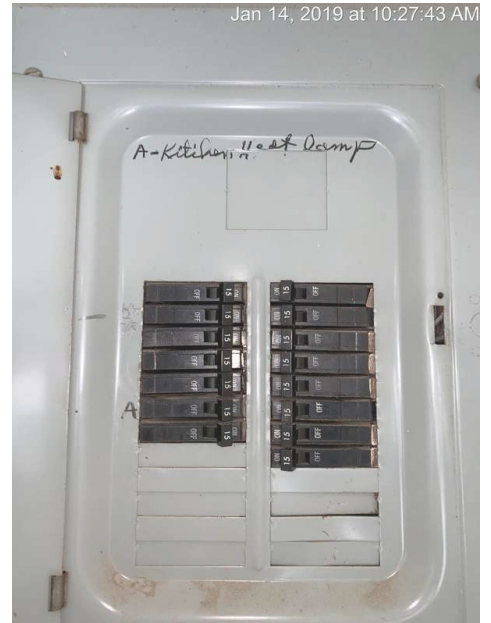
PANEL NOT LABELED:

Deficient: Sub-panel circuits are not labeled as required. All circuits are required to be properly labeled indicating what area the circuit is servicing. Recommend having a licensed electrician perform needed repairs.

Recommendation
Contact a qualified electrical contractor.

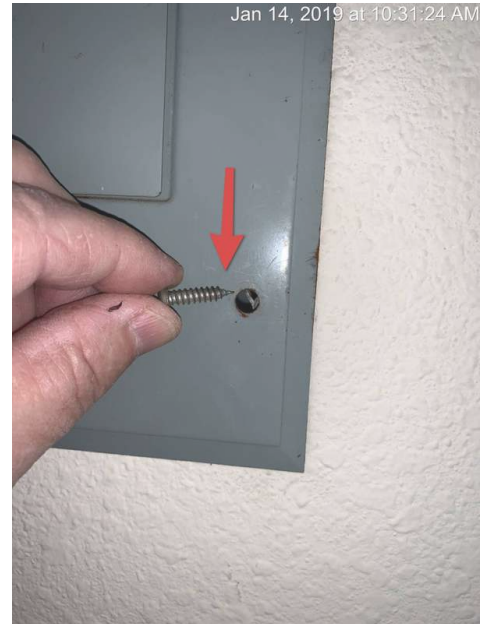
SUB-PANEL ISSUES: SHARP SCREWS USED

Deficient: Sub-panel front has been installed with sharp pointed screws. This is prohibited, sharp screws could pierce a wire and cause a shock and possible fire. Have an electrical specialist perform needed repairs.

Sharp screws used to install panel cover.

Contact a qualified electrical contractor.

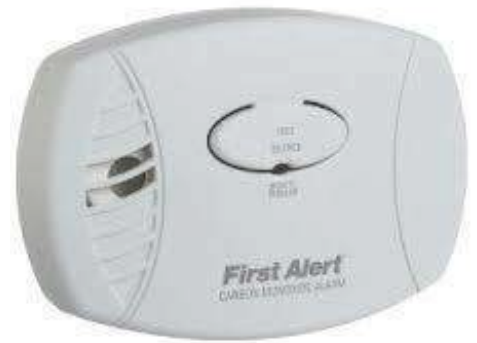
CARBON MONOXIDE DETECTOR MISSING

Deficient: Carbon monoxide detector is not present at time of inspection. Recommend installation one near kitchen before closing.

Contact a qualified electrical contractor.

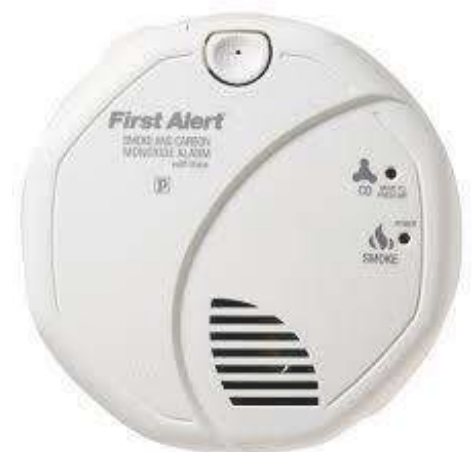
CARBON MONOXIDE DETECTORS REQUIRED

Deficient: All smoke detectors must now be a combination smoke/carbon monoxide detector. Please have an electrical specialist replace all existing units to meet current requirements.

Contact a qualified electrical contractor.

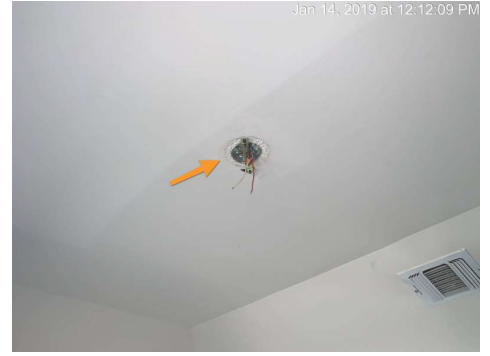
LIGHT FIXTURE MISSING

Deficient: Light fixture is missing in dining room leaving exposed wiring. Have an electrical specialist perform needed repairs.

Fixture missing leaving exposed wiring.

Contact a qualified electrical contractor.

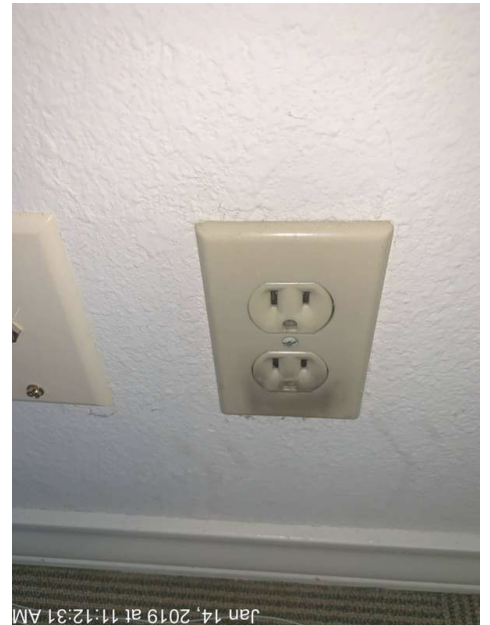
OVERHEATED RECEPTACLE

Deficient: One receptacle located in master bedroom appears to have overheated. Have an electrician provide needed repairs.

Overheated Receptacle.

Contact a qualified electrical contractor.

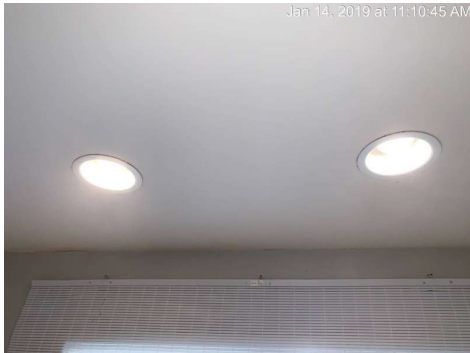
RECESS LIGHTING ABOVE TUB/SHOWER NOT RATED

Deficient: Recess lighting above tub/shower are not rated for use in a wet location . Have an electrician provide needed repairs.

Recess lighting not rated for use in a wet location.

Contact a qualified electrical contractor.

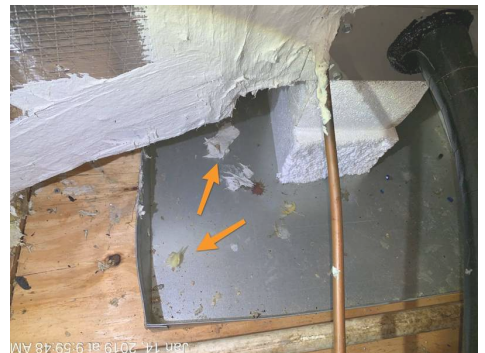
OVERFLOW HVAC PAN:

Deficient: Overflow pan located below attic condenser unit has trash, debris, and loose insulation in the pan. This can cause the overflow drain line to clog resulting in water damage to interior finishes. Recommend having a handyman provide needed repairs.

Debris in condensate pan should be cleaned.

Contact a handyman or DIY project

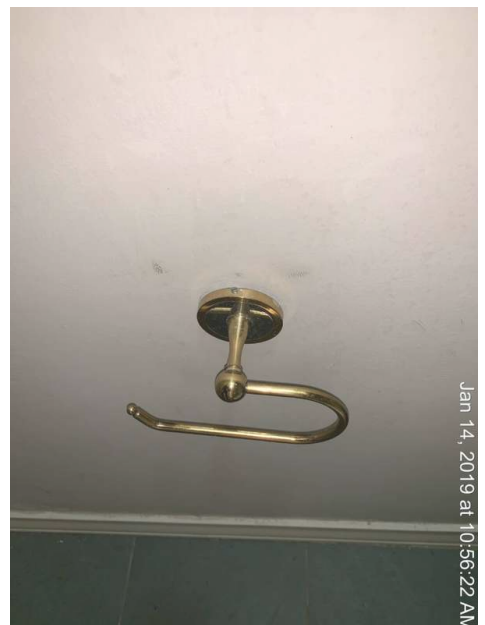
BATHROOM FIXTURES LOOSE

Deficient: Several towel bars, toilet paper holders, and towel bars are not properly secured. Have a handyman provide needed repairs.

Contact a qualified handyman.

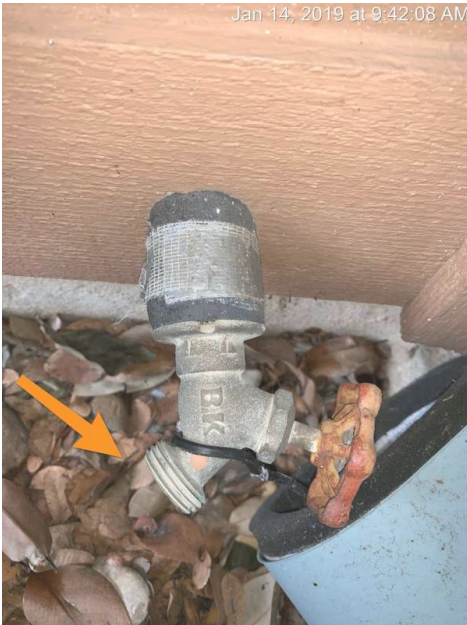
5.1.2 A. Plumbing Supply, Distribution Systems, and Fixtures
EXTERIOR FAUCET LACKS ANTI-SIPHON DEVICE

Deficient: All exterior faucets are required to have an anti-siphon device installed . Have a handyman provide needed repairs.

No anti-siphon device in place as required.

Recommendation
Contact a qualified handyman.

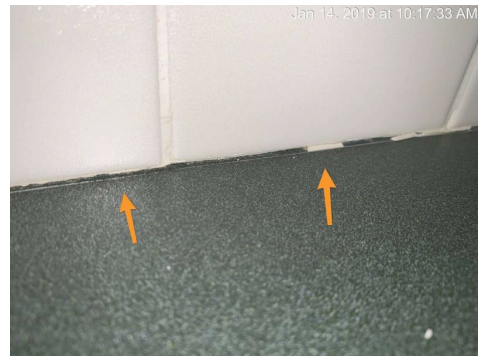
KITCHEN BACK SPLASH NOT SEALED:

Deficient: Kitchen back-splash will need to be sealed to prevent water intrusion into area behind counters. Moisture in this area could develop into mildew or mold. have a handyman perform needed repairs.

Seal kitchen back splash to prevent moisture intrusion.

Recommendation
Contact a qualified handyman.

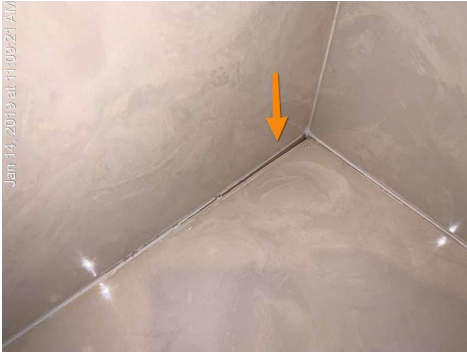
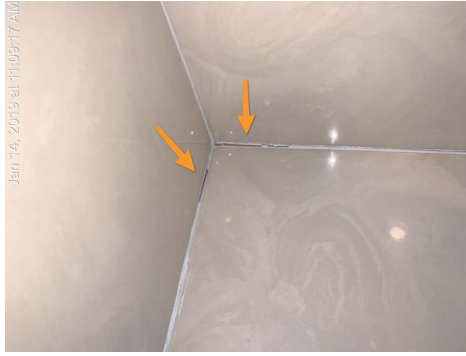
5.1.4 A. Plumbing Supply, Distribution Systems, and Fixtures
SHOWER BENCH

Deficient: Shower bench in master bathroom needs to be sealed along the back side with approved sealant. Have a handyman provide needed repairs.

Seal master bathroom bench.

Recommendation
Contact a qualified handyman.

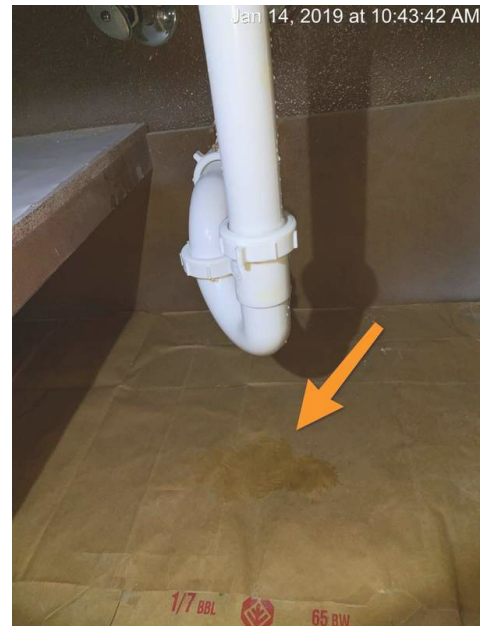
LEAKING DRAIN:

Deficient: Drain line under hallway bathroom sink and bar sink is leaking. Recommend a plumbing specialist perform needed repairs.

Bar sink leaking.

Recommendation
Contact a qualified plumbing contractor.

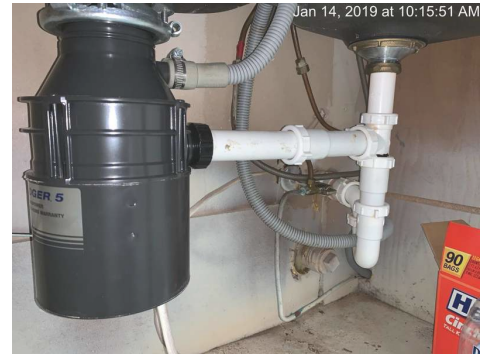
INOPERABLE

Deficient: Garbage disposal was inoperable at the time of inspection. Recommend qualified plumber repair.

Contact a qualified plumbing contractor.

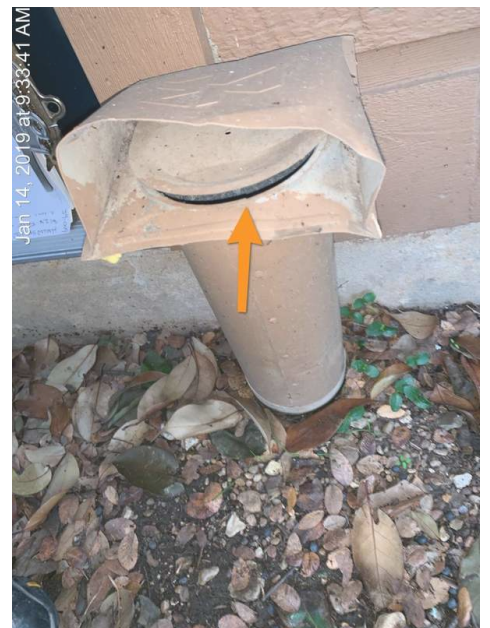
DRYER VENT FLAPPER NOT CLOSING

Deficient: Flapper not closing on dryer vent. Recommend having a handyman replace.

Flapper on dryer vent not closing. Recommend replacement.

Recommendation
Contact a qualified handyman.
