SUMMARY

1234 Main St.San Rafael California
94903

Buyer Name
02/26/2019 9:00AM

Dandy Buckley
DB Home Inspection Service
4157933163
dandybuckley@gmail.com

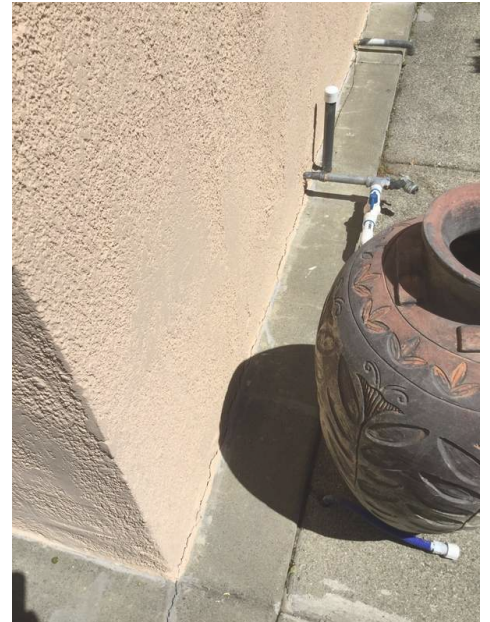
3.2.1 Foundation

FOUNDATION CRACKS - MINOR

Minor cracking was noted at the foundation meeting the stucco

Usually I would like to see a bottom screed on the stucco and separation from the concrete

This should be monitored for water intrusion

This is common as concrete ages and shrinkage surface cracks are normal. Recommend monitoring for more serious shifting/displacement.

Recommend monitoring.

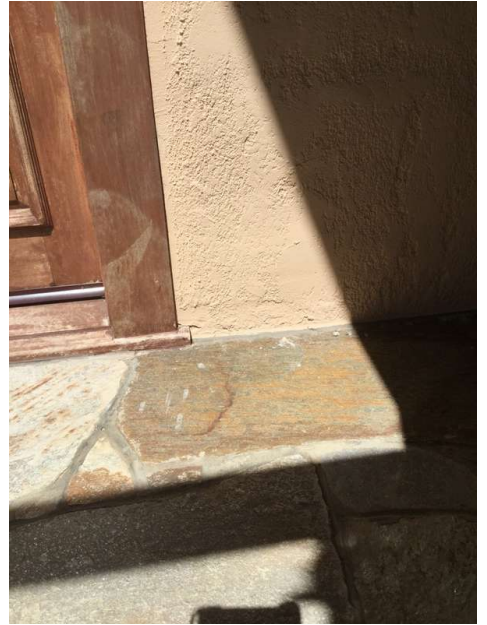
3.3.1 Siding, Flashing & Trim

CRACKING - MINOR

Siding showed cracking in one or more places. This is a result of temperature changes, and typical as homes with stucco age.

Recommend monitoring.

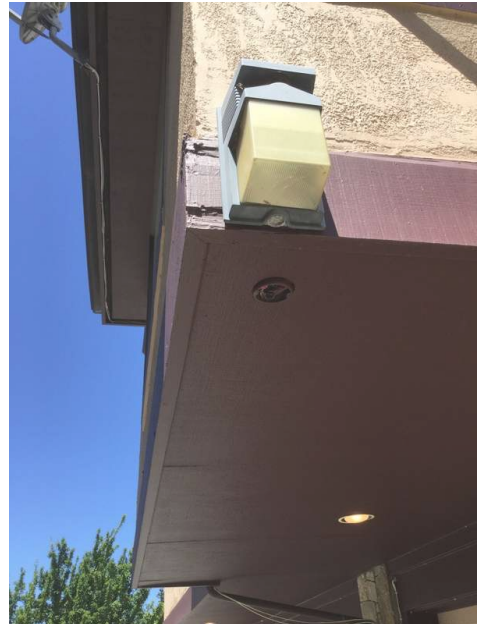
3.3.2 Siding, Flashing & Trim

DAMAGE TO TRIM BEHIND FIXTURE

The trim behind the exterior light fixture appeared to have some previous damage that was painted over, it is not possible to know the cause of that damage due to the paint coverage. Check with owner or replace with new piece of wood.

Contact a qualified professional.

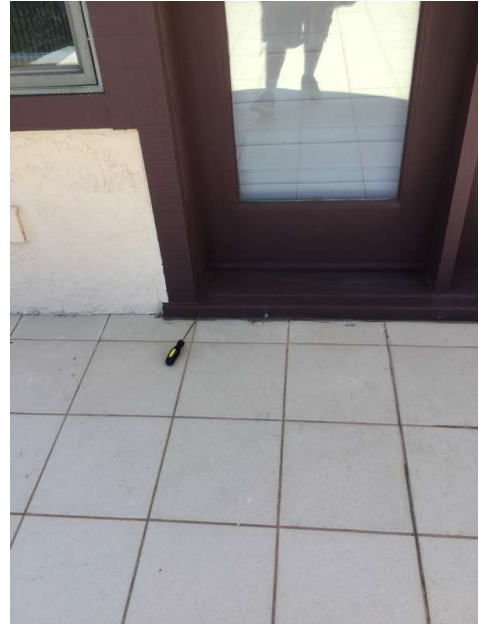
3.4.1 Exterior Doors

DOOR SILL/TRIM

LIVING ROOM

Door sill and/or trim is loose, deteriorated or worn and repair or replacement should be considered.

Contact a qualified door repair/installation contractor.

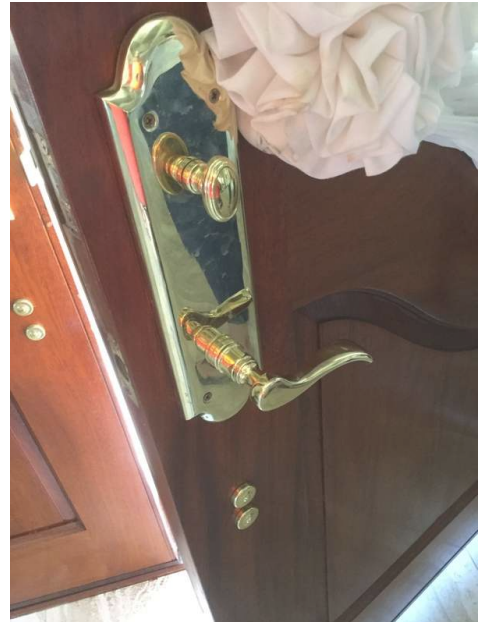
3.4.2 Exterior Doors

HARDWARE DAMAGED

One or more pieces of door hardware are damaged. Recommend repair or replace.

Recommended DIY Project

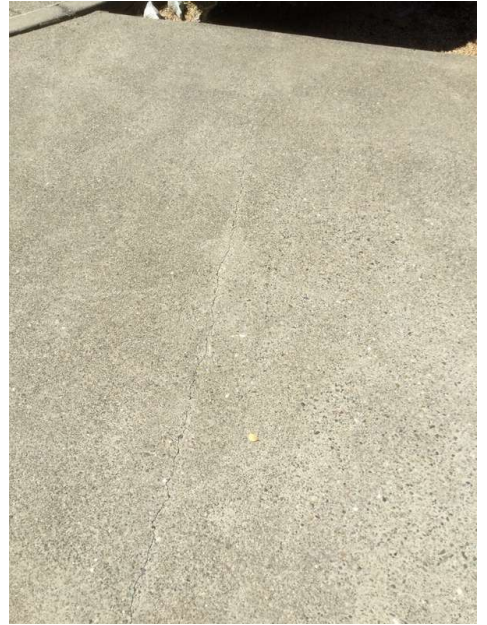
3.5.1 Walkways, Patios & Driveways

DRIVEWAY CRACKING - MINOR

Minor cosmetic cracks observed, which may indicate movement in the soil. Recommend monitor and/or have concrete contractor patch/seal.

Contact a qualified concrete contractor.

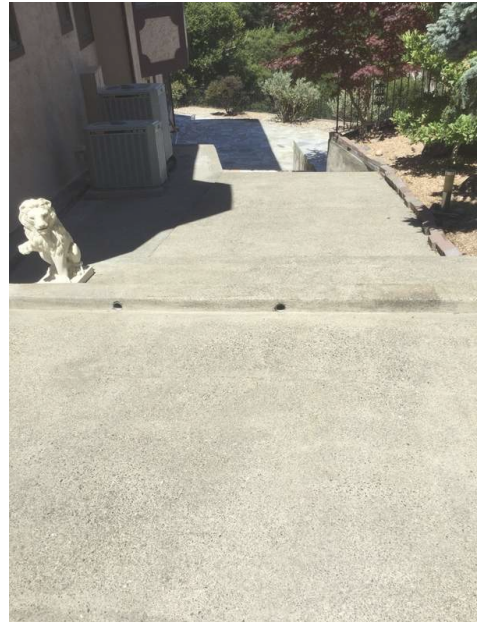
3.5.2 Walkways, Patios & Driveways

DRIVEWAY TRIP HAZARD

Trip hazards observed. This ridge is important in the role of drainage but may need to be marked in some way to prevent tripping

Recommended DIY Project

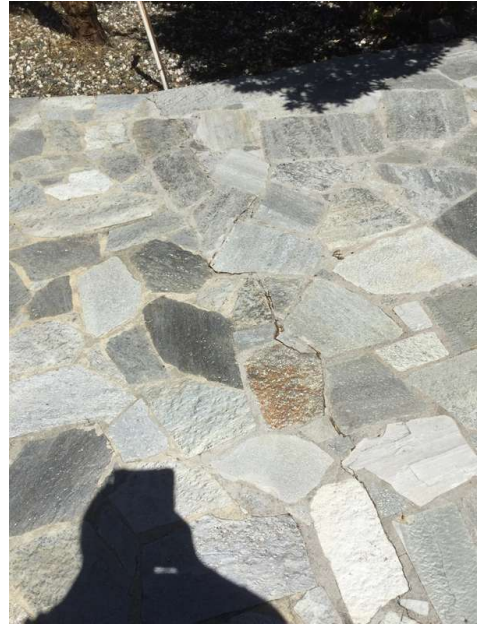
3.5.3 Walkways, Patios & Driveways

PATIO CRACKING - MINOR

Normal settling & cracking observed. Recommend monitor and/or patch/seal.

Recommended DIY Project

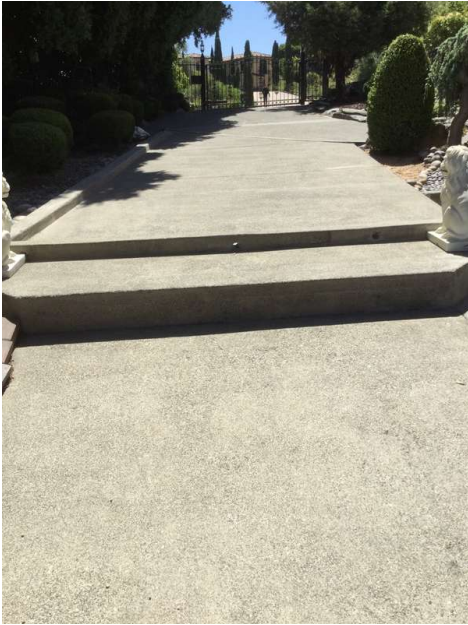
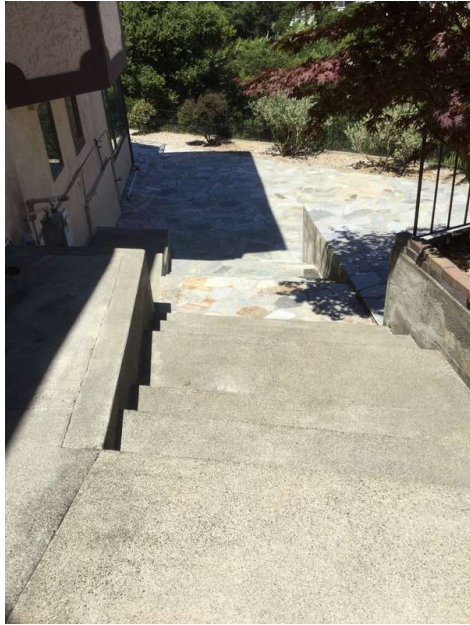
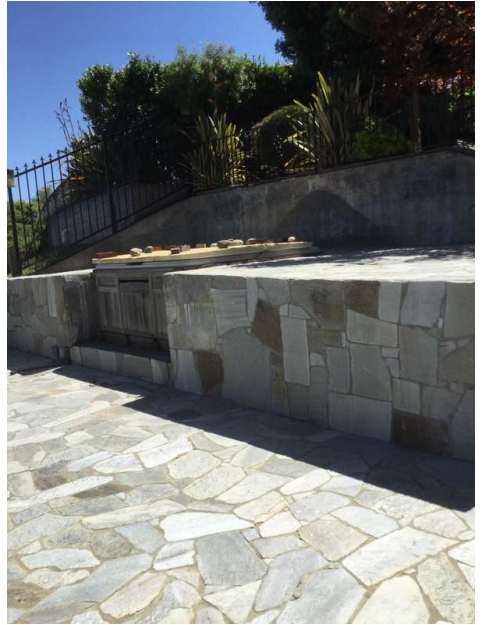
3.5.5 Walkways, Patios & Driveways

RAILINGS

This is a steep step with no railing

Recommend installing handrails in places where needed for safety

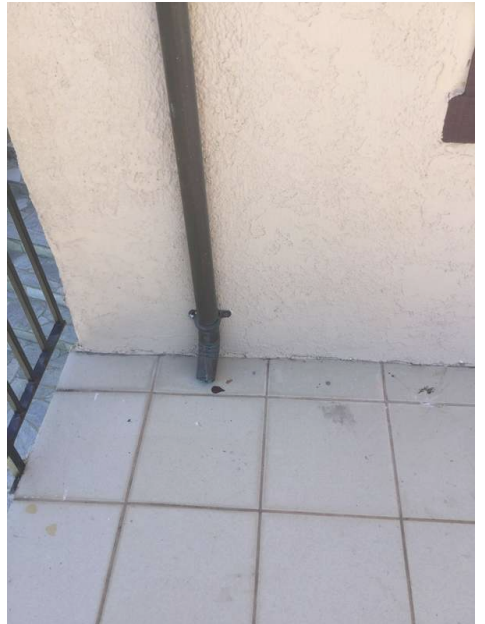
3.6.1 Decks, Balconies, Porches & Steps

GUTTERS DRAINING ONTO DECK

even though this part of the deck drains into the gutter on the edge of the deck, i would like to see the downspout itself returned into that lower gutter rather than allowing gravity alone to take care of it

Contact a qualified professional.

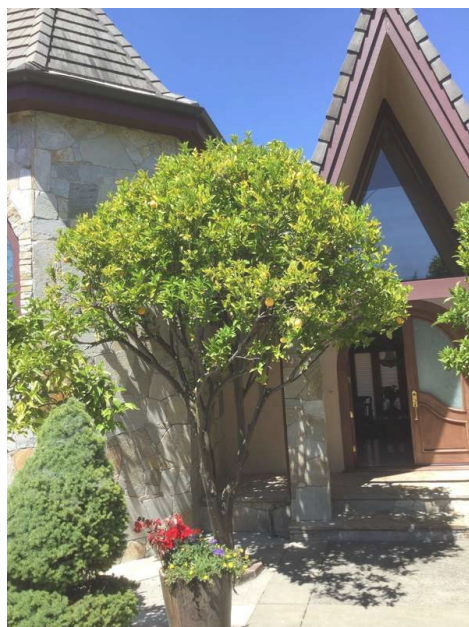
3.8.1 Vegetation, Grading, Drainage & Retaining Walls

TREE OVERHANG

Trees observed overhanging onto the siding and or roof .This can cause damage over time

Recommendation
Contact a qualified tree service company.

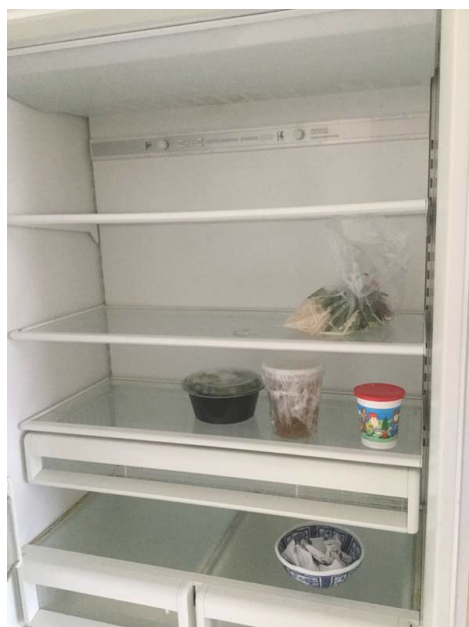
6.2.1 Refrigerator

NO LIGHT

the light is not working in the fridge

Recommendation
Contact a qualified professional.

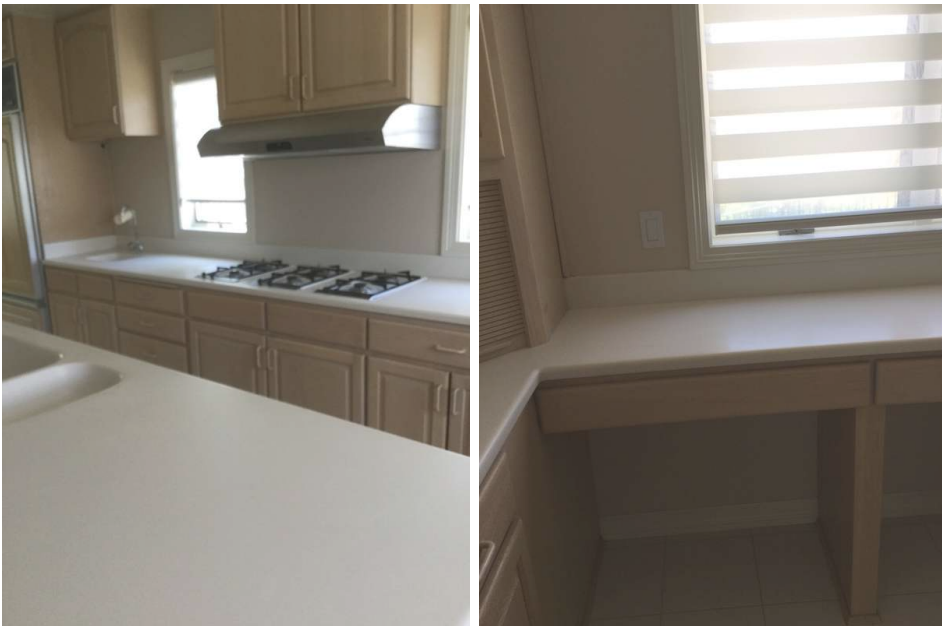
6.7.1 GFCI

TODAYS STANDARDS CALL FOR MORE OUTLETS IN THE KITCHEN AREA

Contact a qualified professional.

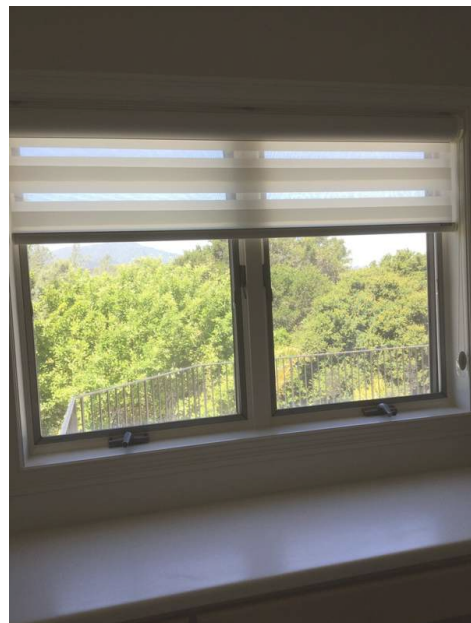
6.10.1 Windows

MORE THAN ONE WINDOW WAS INOPERABLE DUE TO HARDWARE

The kitchen windows were some of the first windows i checked for operability.

These windows opened stiffly , but then came off their hardware and had to be manually closed from the outside and pushed back into place.

As i started to look at other windows around the house i noticed that several of the hardware handle pieces were cracked. I therefore deemed it necessary to stop checking the windows for operability in case they also came off their tracks or snapped off the handles. The windows should be all checked by an Anderson dealer and assessed for replacement hardware as the plastic hardware appears to be having issues.

Contact a qualified professional.

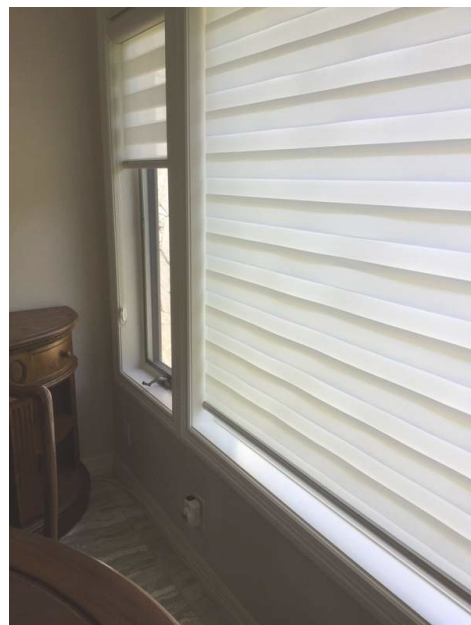
7.2.1 Windows

INOPERABLE

not able to easily open , do not wish to break handle

Contact a qualified professional.

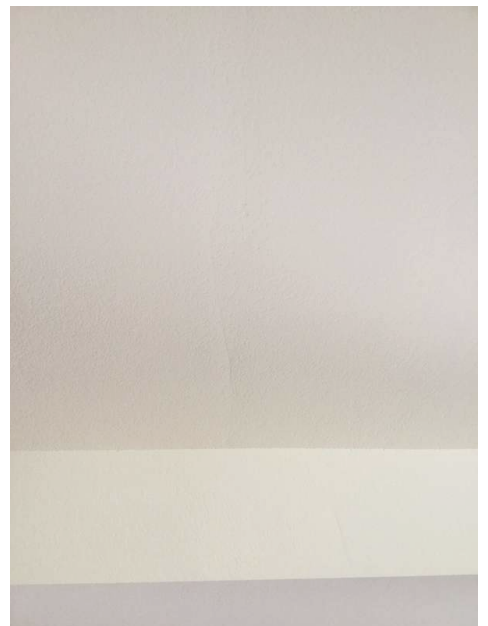
9.5.1 Ceilings

MINOR DAMAGE

Minor damage or deterioration to the ceiling was visible at the time of the inspection.

Contact a qualified professional.

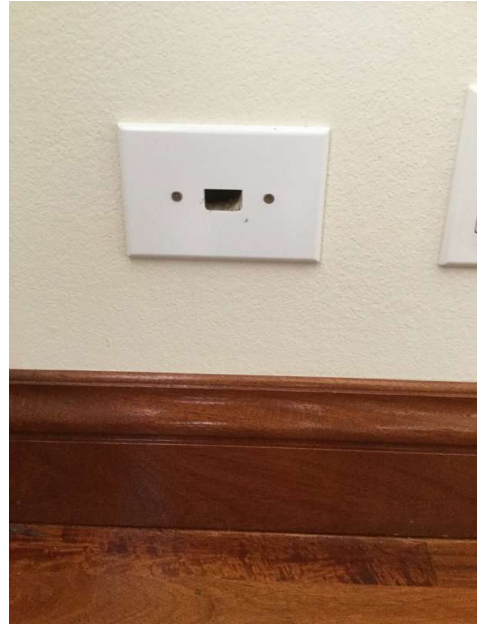
9.7.1 Lighting Fixtures, Switches & Receptacles

COVER PLATES DAMAGED

One or more receptacles have a damaged cover plate. Recommend replacement.

Contact a qualified electrical contractor.

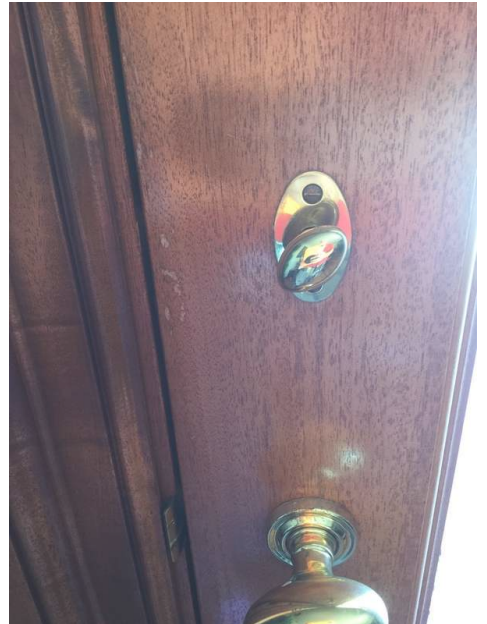
10.1.1 Doors

DOOR LATCH ALIGNMENT

Does not lock

Door latch and/or strike plate is out of alignment. Recommend a handyman repair.

Contact a qualified door repair/installation contractor.

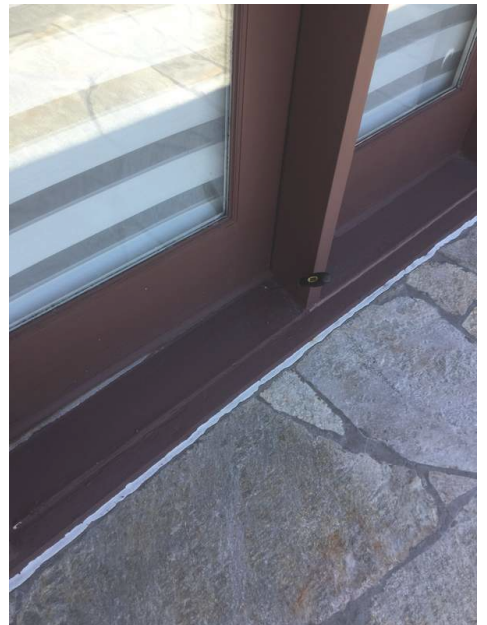
11.2.2 Doors

MINOR ROT ON EXTERIOR

Contact a qualified professional.

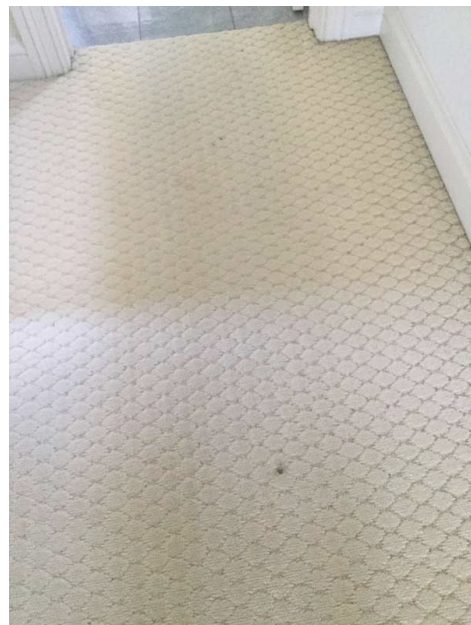
11.4.1 Floors

CARPET STAINS

Carpet had areas of staining or discoloration. Recommend a thorough steam clean by a qualified carpet cleaning company

Recommendation
Contact a qualified cleaning service.

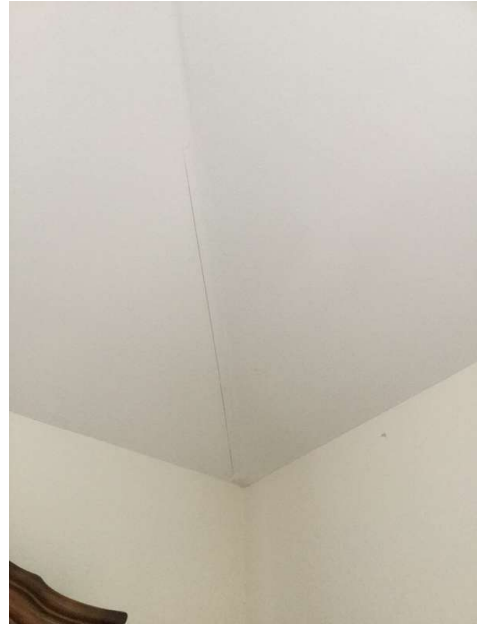
11.6.1 Ceilings

MINOR DAMAGE

Minor damage or deterioration to the ceiling was visible at the time of the inspection.

Monitor in case it is caused by water intrusion

Recommendation
Contact a qualified professional.

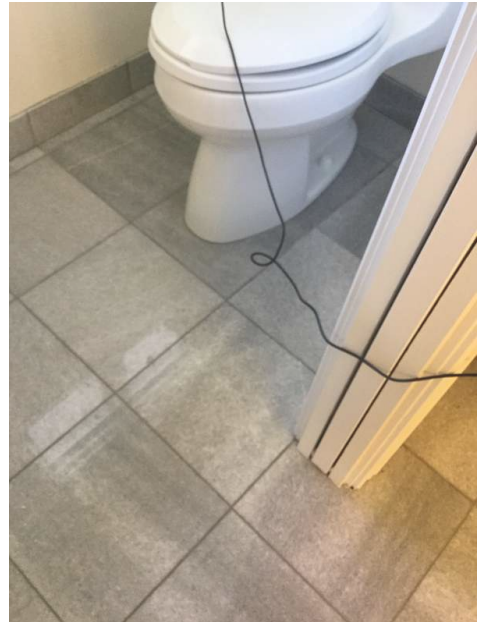
12.1.1 Toilet

NEEDS CAULKING

The toilet needs caulking to ensure seal

Contact a qualified professional.

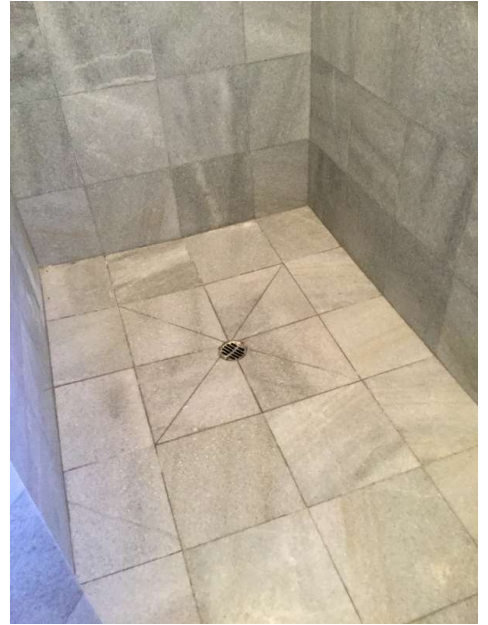
12.2.1 Shower

GAPS IN CAULK SEAL

Both grout and caulk should be reapplied to ensure water tightness

Contact a qualified professional.

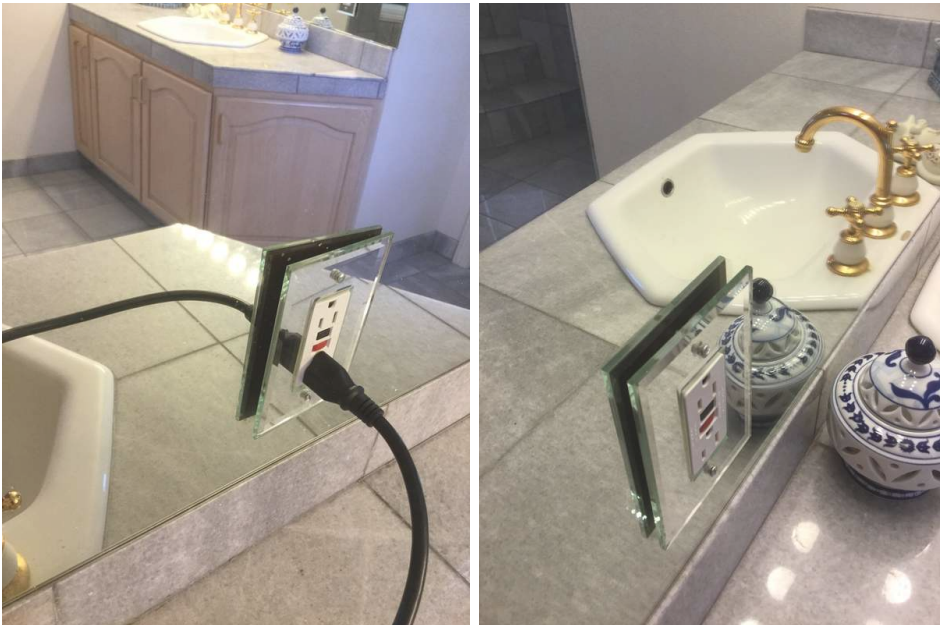
12.5.1 Lighting Fixtures, Switches & Receptacles

COVER PLATES DAMAGED

The glass cover plates are not flush to the mirror
this creates a safety hazard and needs to be fixed

Contact a qualified electrical contractor.

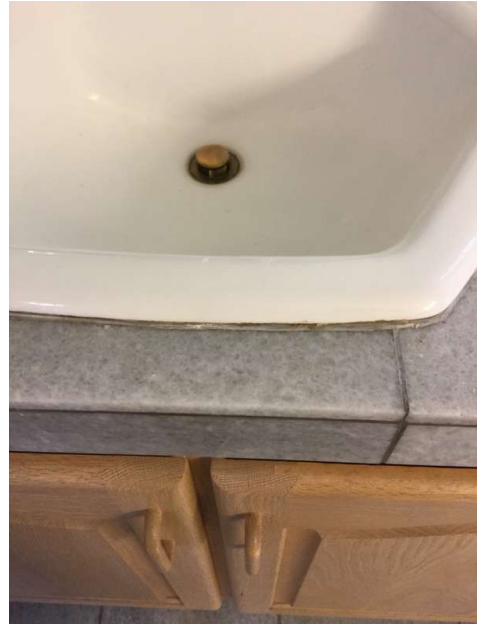
12.6.1 Sink

SINK COUNTERTOPS

Both countertops should be caulked and regouted to ensure water seal

Contact a qualified professional.

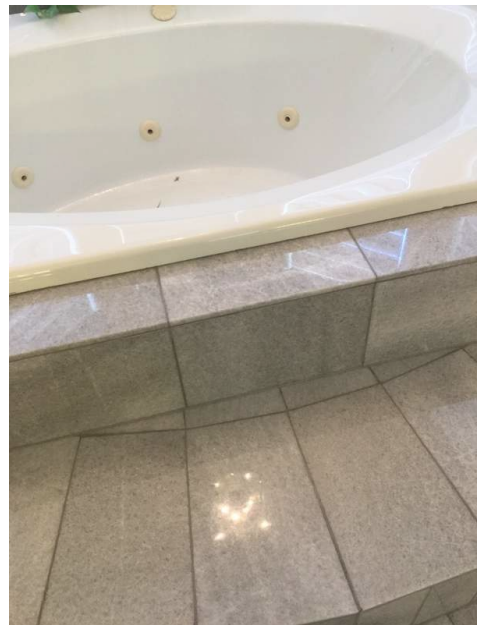
12.7.1 Tub

NEEDS CAULKING

to ensure water does not start to intrude under the tub , this should have a caulk seal in place

Contact a qualified professional.

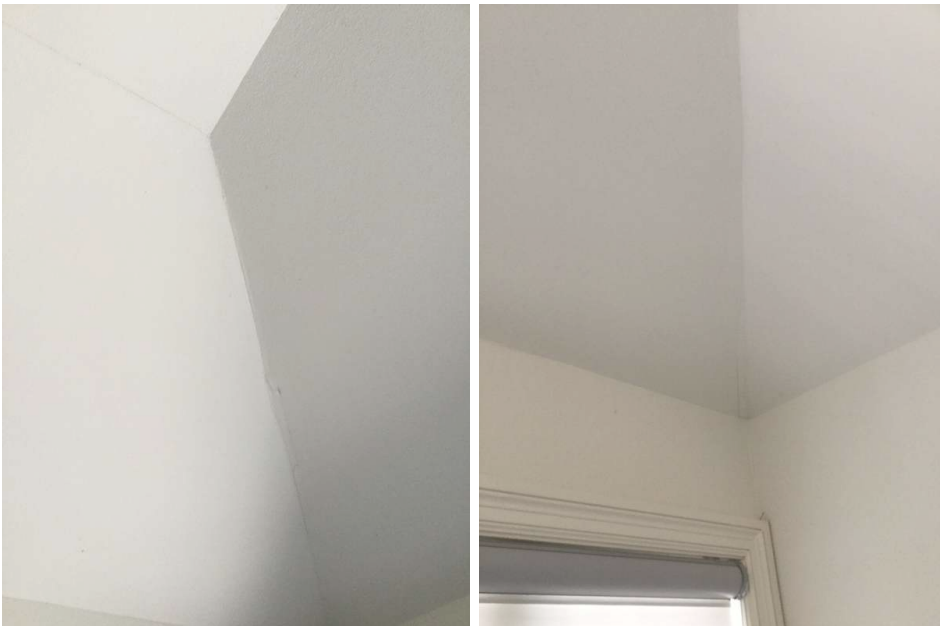
13.6.1 Ceilings

MINOR DAMAGE

Minor damage or deterioration to the ceiling was visible at the time of the inspection.

This should be monitored for change or deterioration

Contact a qualified professional.

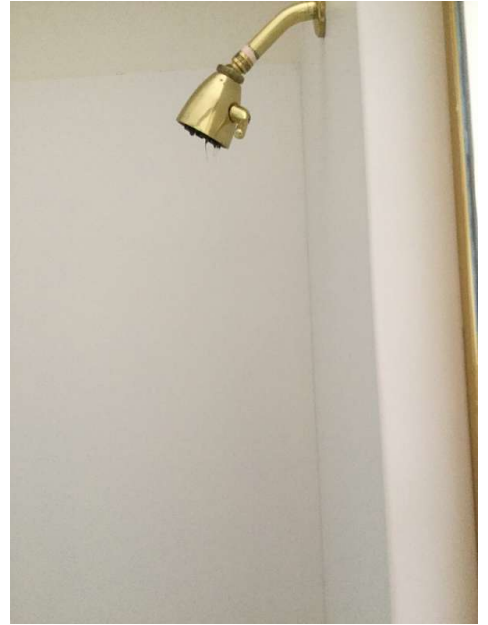
14.5.1 Shower

SHOWER KEEPS DRIBBING WATER

Shower dribbles water for about 25 seconds after shut off

Contact a qualified professional.

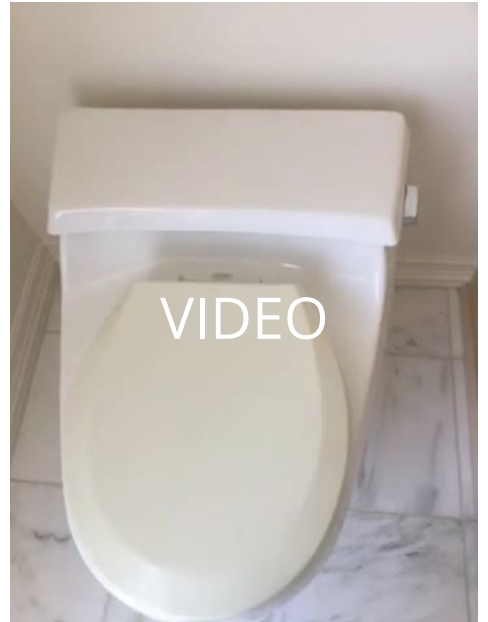
14.6.1 Toilet

NOISY FLUSH

there is an issue with the internal mechanics of the tank, this should be fixed.

Contact a qualified professional.

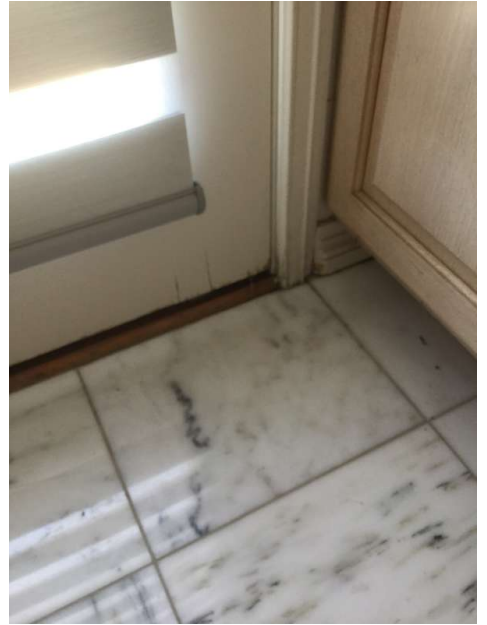
15.2.1 Doors

ROT OR WATER INTRUSION

on the door to the outside there appeared to be damage.

Contact a qualified professional.

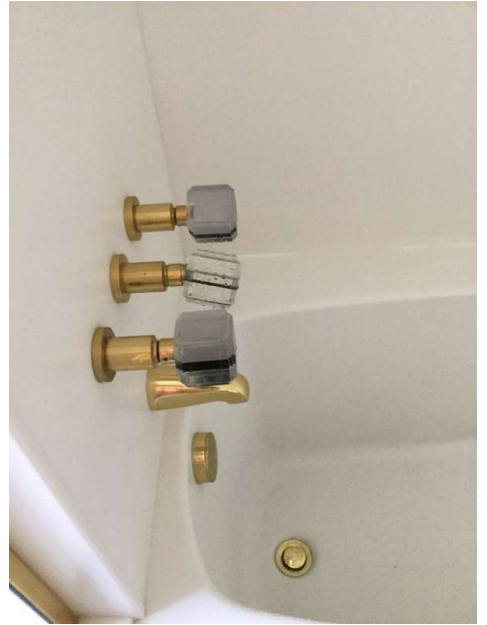
16.5.1 Shower

SHOWER DIVERTOR LOOSE

This causes the change from tub to shower some difficulty

Contact a qualified professional.

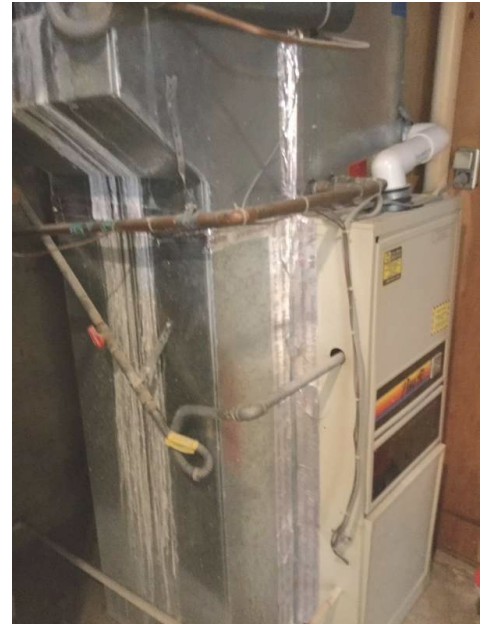
26.1.1 Heating Equipment

CORROSION

Furnace was corroded in one or more areas. This could be the result of improper venting, which the source would need to be identified. Recommend a HVAC contractor evaluate and repair.

Contact a qualified HVAC professional.

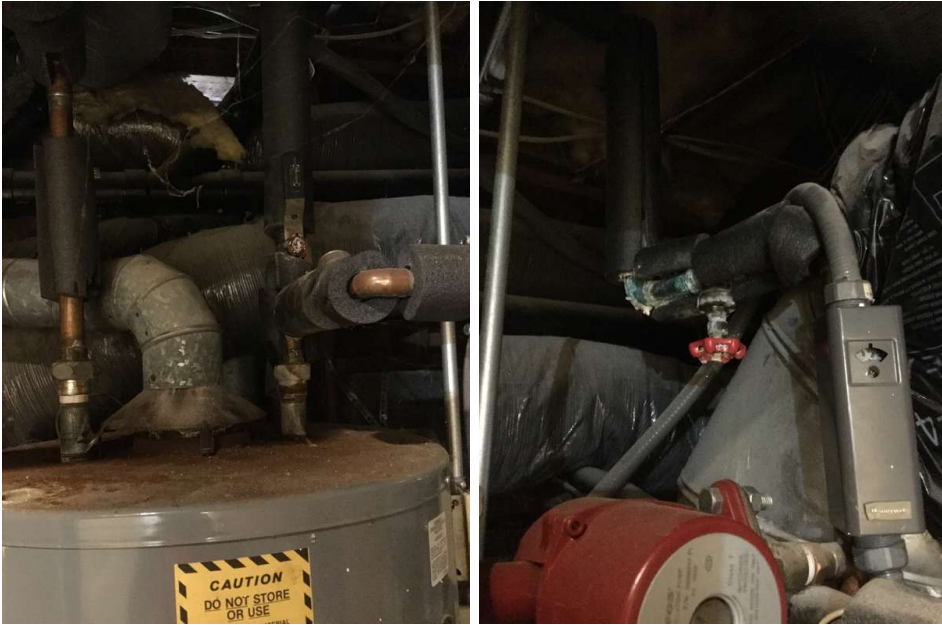
26.4.3 Hot Water Systems, Controls, Flues & Vents

CORROSION

Safety Hazard

Corrosion was noted at the pipe serving the water heater, and on several pipes around and above it.

Recommend a qualified plumber evaluate for repair/replacement.
