SUMMARY
1234 Main St. Lansdale Pennsylvania
19446
Buyer Name
05/08/2019 9:00AM

Donald Nagle
L&L Home Inspections, LLC
(484)-942-7344
ll.homeinspectionsllc@gmail.com

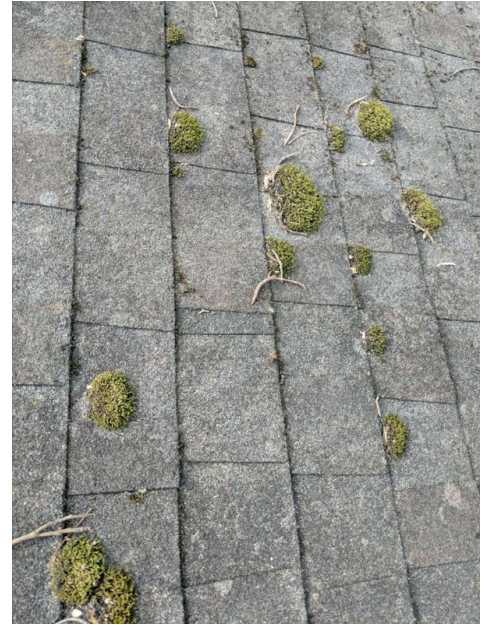
MOSS ON SHINGLES

Moss was growing on the roof. As a result, shingles can lift or be damaged. Leaks can result and/or the roof surface can fail prematurely. Efforts should be made to kill the moss during its growing season (wet months). Typically, zinc or phosphate-based chemicals are used for this and must be applied periodically.

Contact a qualified professional.

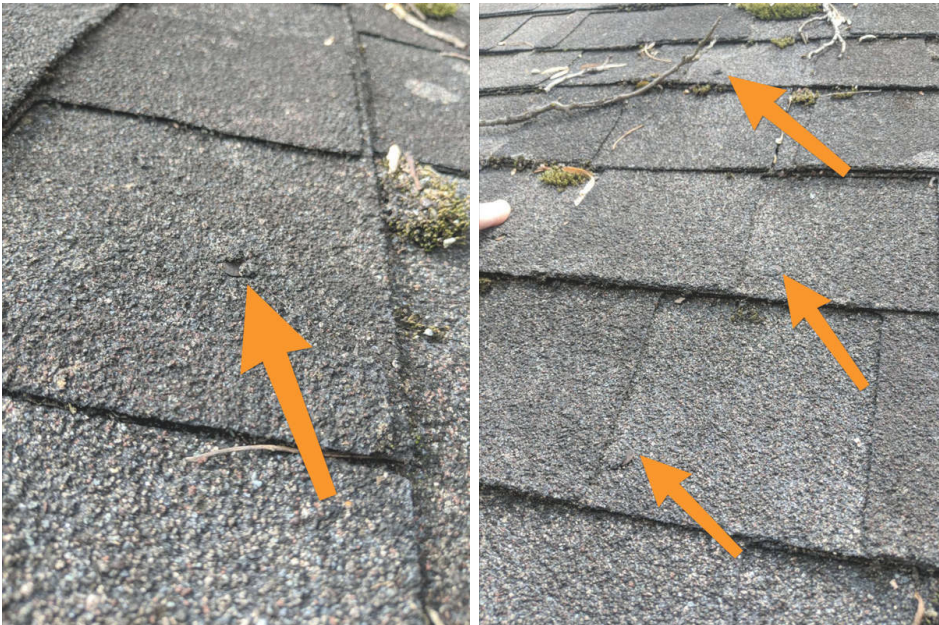
2.3.2 Shingles **NAIL POPS**

One or more roofing nails weren't fully seated and shingles were lifting or nail heads were protruding through shingle surfaces. The nails may have loosened, or were not pounded in fully when installed. Shingles are likely to be wind damaged, and leaks can occur as a result. Recommend that a qualified contractor repair as necessary. For example, by replacing shingles.

Contact a qualified roofing professional.

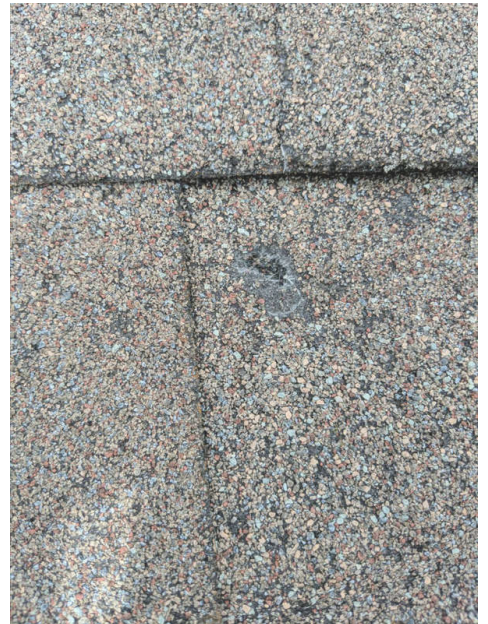
2.3.3 Shingles **SHINGLE CRACKING**

Several shingles are cracking. Cracking can occur from shingle age and/or ventilation issues. Roof leaks may occur. A certified roofing contractor should evaluate as the shingles may be at the end of life expectancy.

Recommendation
Contact a qualified roofing professional.

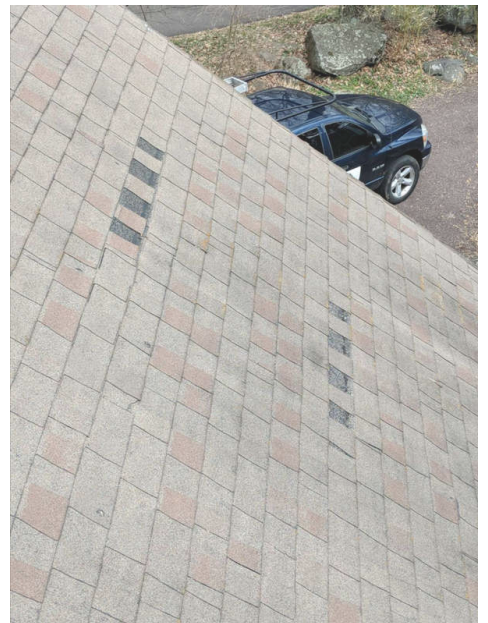
SHINGLES MISSING

Roofing shingles were missing. This can cause deterioration and moisture intrusion. Leaks can occur as a result. This is a conducive condition for wood-destroying organisms, e.g. wood fungi. Recommend that a qualified contractor repair as necessary. For example, by replacing shingles.

Recommendation
Contact a qualified roofing professional.

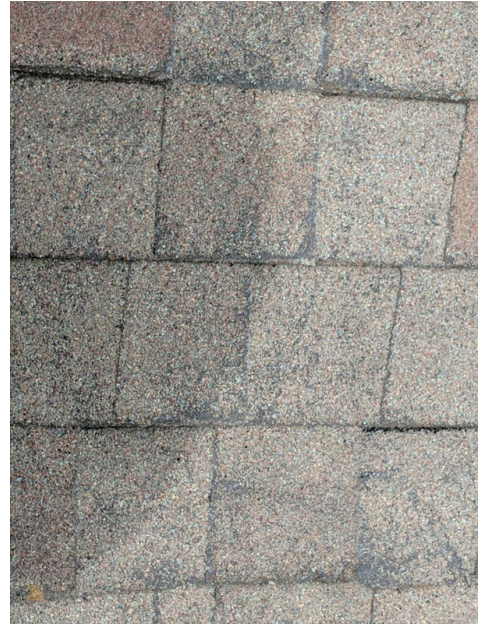
GRANULE LOSS

There is granule loss on the shingles. Based on the age of this roof the granule loss is considered normal. It is recommended to have the roof evaluated by a certified roofing contractor.

Recommendation
Contact a qualified roofing professional.

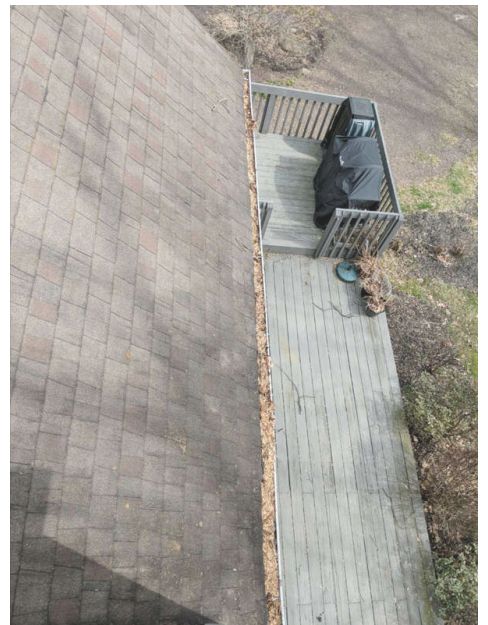
CLOGGED GUTTERS/DOWNSPOUTS

Significant amounts of debris have accumulated in one or more gutters or downspouts. Gutters can overflow and cause water to come in contact with the building exterior, or water can accumulate around the foundation. This is a conducive condition for wood-destroying organisms. Recommend cleaning gutters and downspouts now and as necessary in the future.

Recommended DIY Project

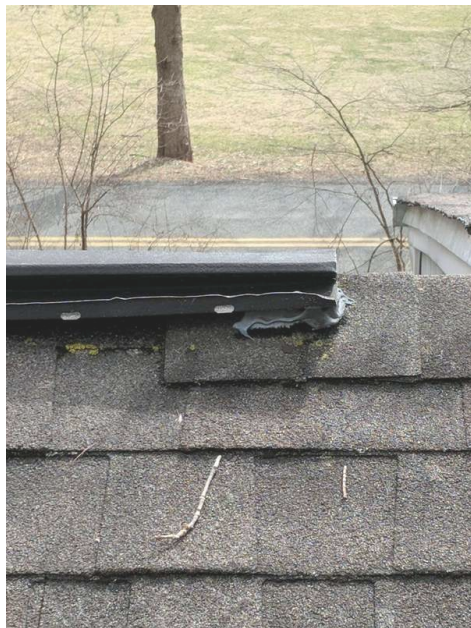
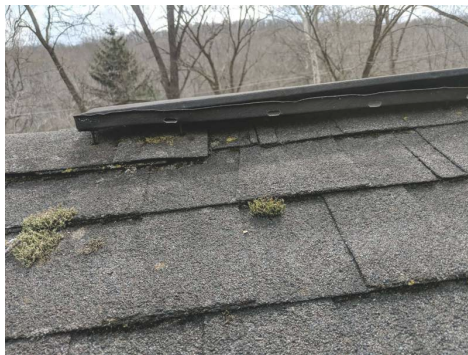
RIDGE VENTS LIFTED

The ridge vents we're lifted or loose. A licensed roofer should repair the ridge vents

Contact a qualified roofing professional.

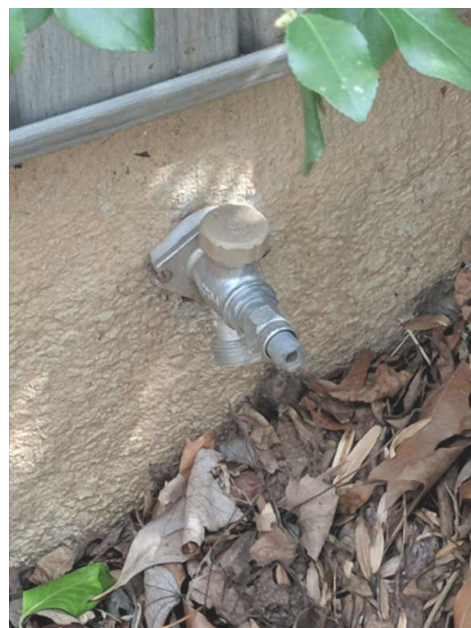
FAUCET HANDLE ISSUE

One or more hose faucet handles were *missing / loose / broken*. Recommend that a qualified person replace handles or make repairs as necessary.

Contact a qualified professional.

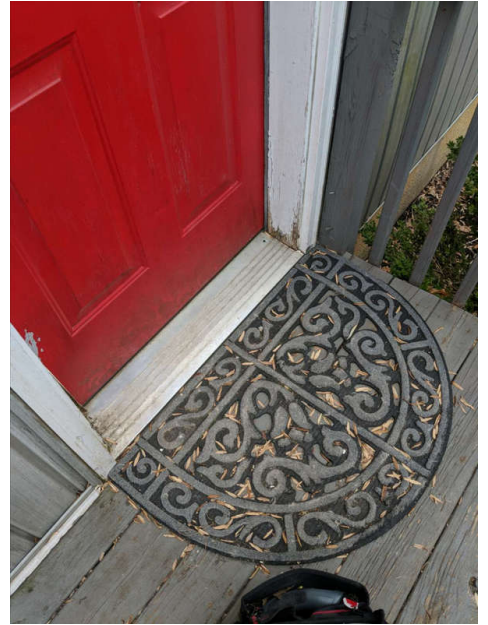
PAINT FAILING

The paint or stain finish in some areas was failing (e.g. peeling, faded, worn, thinning). Siding and trim with a failing finish can be damaged by moisture. Recommend that a qualified contractor prep (e.g. clean, scrape, sand, prime, caulk) and repaint or restain the building exterior where necessary and per standard building practices.

Contact a qualified painting contractor.

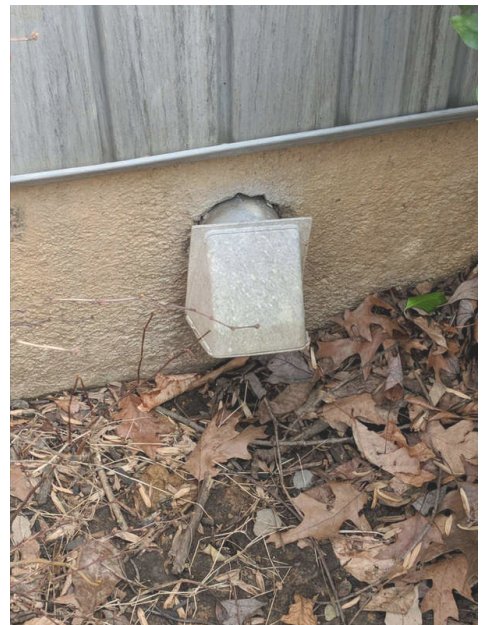
SEALANT DETERIORATED AROUND EXTERIOR FIXTURES

Sealant is deteriorated around exterior fixtures where they exit the wall (i.e. Hose faucets, conduit, lights, wires). These areas should be properly sealed to help prevent moisture intrusion.

Contact a handyman or DIY project

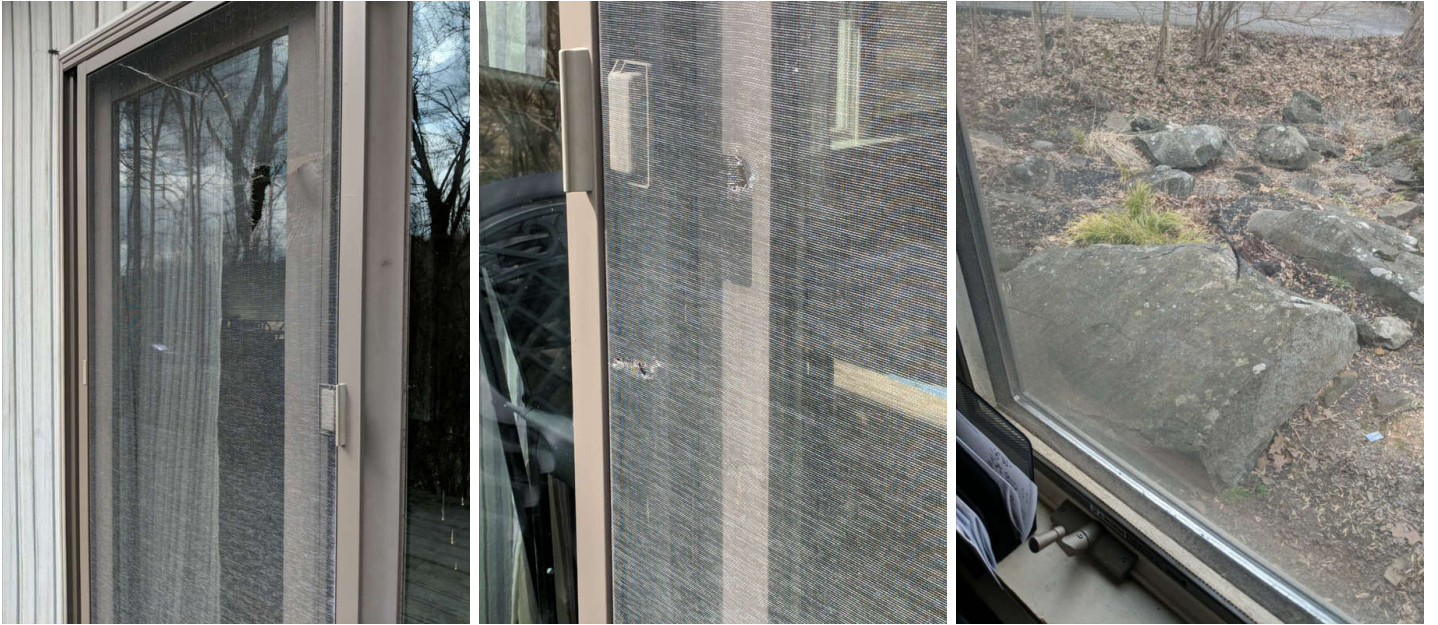
SCREEN TORN

One or more screens are torn in the frame(s).

Contact a qualified professional.

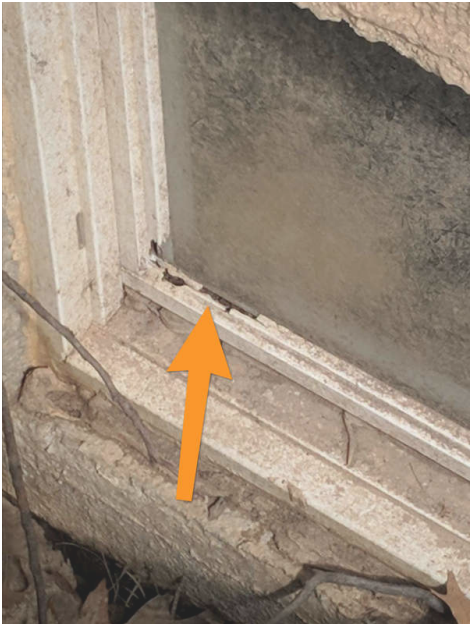
WINDOW TRIM DAMAGED

The window trim is damaged. We recommend it be repaired or replaced

Contact a qualified professional.

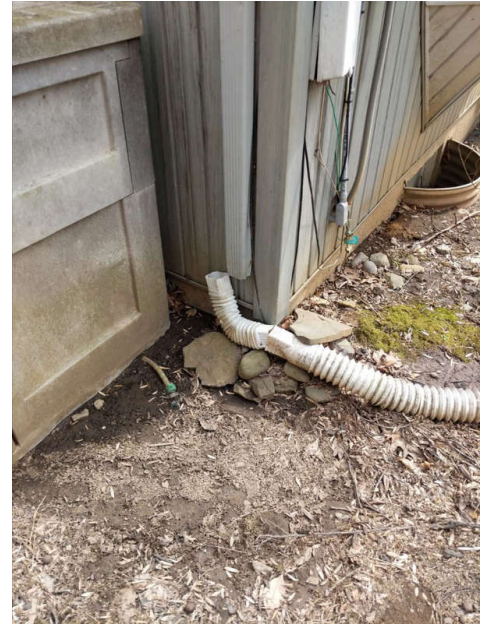
DOWNSPOUT DISCHARGE

One or more of the downspouts terminate next to the house. We recommend extending the downspout is charge away from the home to prevent water pooling at the foundation

Contact a qualified professional.

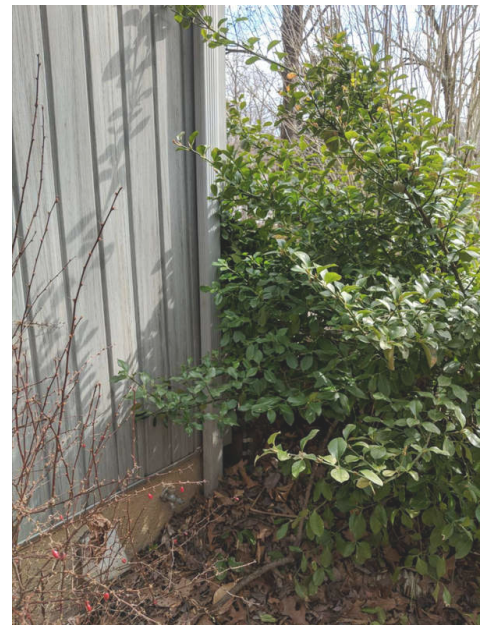
VEGETATION

Vegetation such as trees, shrubs and/or vines was in contact with or close to the building exterior. Vegetation can serve as a pathway for wood-destroying insects and can retain moisture against the exterior after it rains. This is a conducive condition for wood-destroying organisms. Recommend pruning, moving or removing vegetation as necessary to maintain at least 6 inches of space between it and the building exterior. A 1-foot clearance is better.

Contact a qualified landscaping contractor

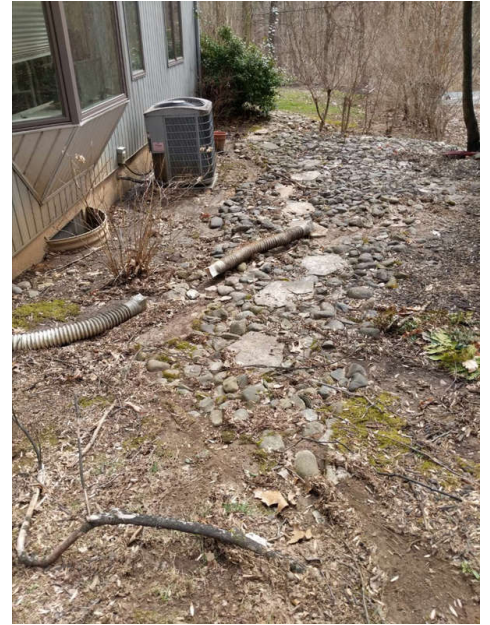
EROSION

Significant erosion was found in one or more areas. Recommend having a qualified person evaluate and make repairs as necessary to repair erosion, and to prevent erosion in the future.

Contact a qualified landscaping contractor

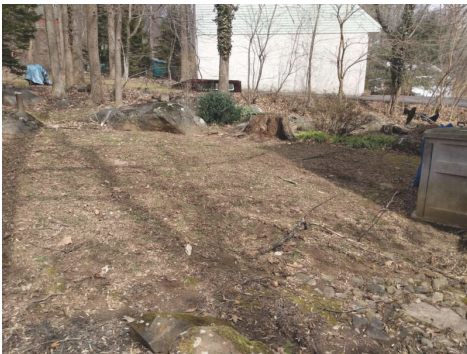
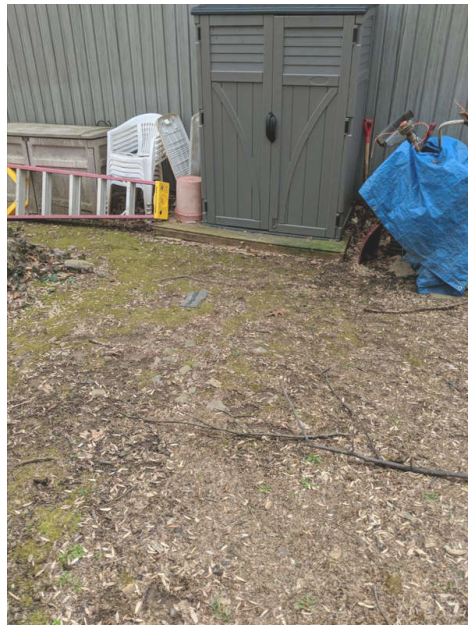
SURFACE TOWARD BUILDING

Surfaces sloped down towards building perimeters in one or more areas. This may result in water accumulating around building foundations or underneath buildings. Monitor these areas in the future, especially during and after periods of rain. If significant amounts of water are found to accumulate, then recommend that a qualified contractor evaluate and repair as necessary. For example, by installing drain(s) or removing old pavement and installing new.

Contact a qualified professional.

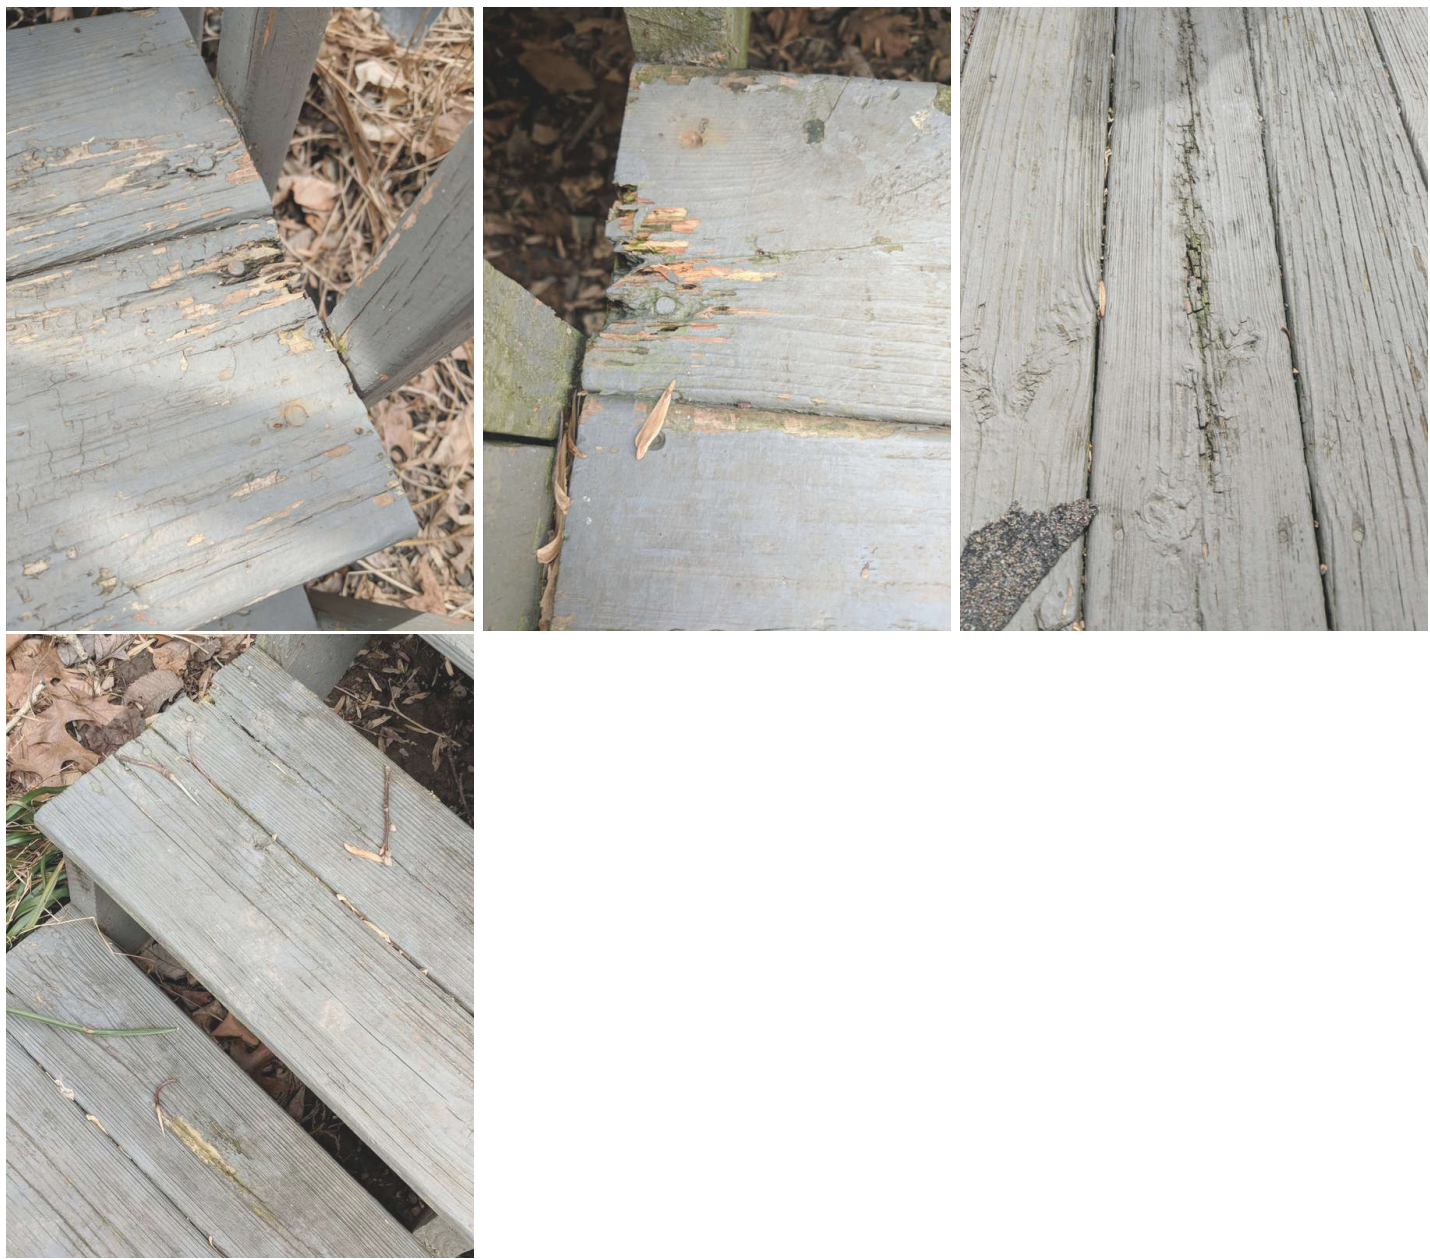
DECK BOARD ROT

Fungal rot was found in decking boards at one or more decks or porches. The boards were generally in serviceable condition during the inspection, but it's likely that the fungal rot will spread and require all boards to be replaced. Boards with significant rot should be replaced now and in the future until the deck or porch is rebuilt. Recommend budgeting for replacement decking in the near future. Note that when decking boards are replaced, other structural repairs may be needed.

Recommendation
Contact a qualified professional.

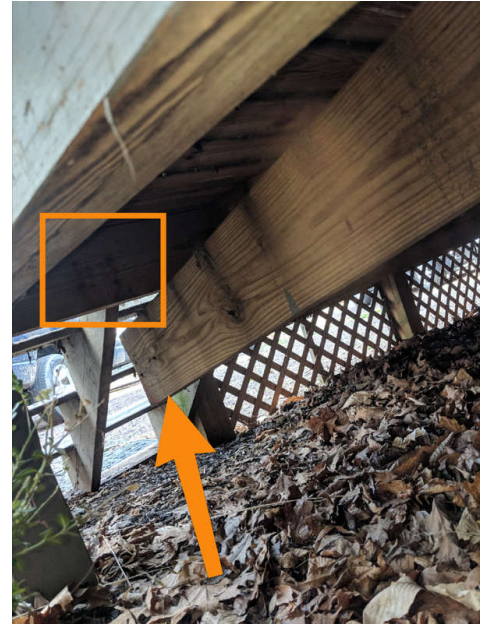
FASTENERS-SUPPORTS

Fasteners for the deck, porch or balcony *joist hangers / support post brackets / tie plates* were *missing / substandard*. Approved fasteners such as Teco nails should be installed in every nail hole in such hardware. Recommend that a qualified person install approved fasteners where necessary.

Recommendation
Contact a qualified professional.

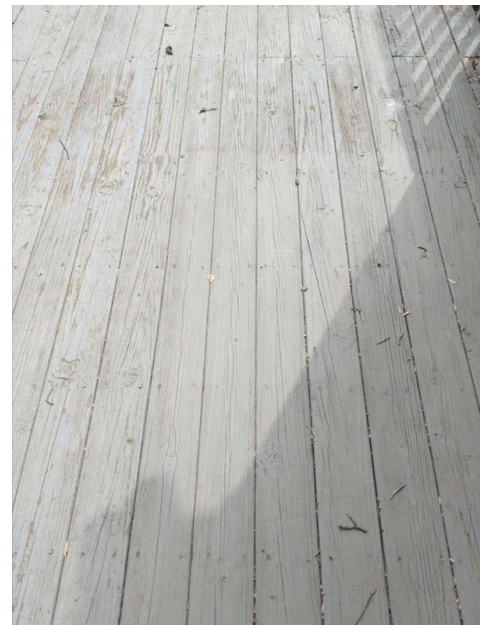
NO GAPS-DECK BOARDS

Decking boards were installed with little or no gap between them. Organic debris such as leaves or evergreen needles may accumulate in between the boards will likely cause rot or deterioration. This is a conducive condition for wood-destroying organisms. At a minimum, keep decking boards clean in the future. Ideally boards should be reinstalled with a 3/8 inch gap between them.

Contact a qualified professional.

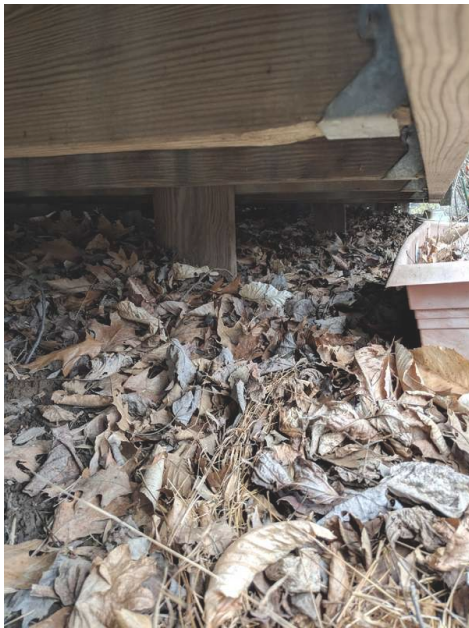
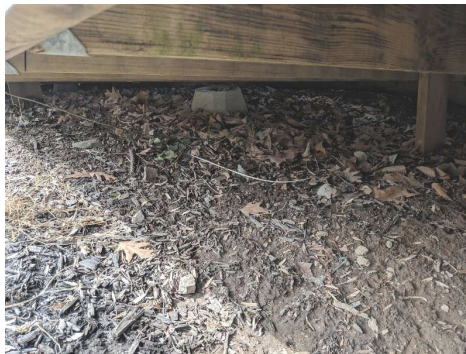
SUPPORTS INADEQUATE

The deck supports are not standard. There is a slight bow in the deck due to over spanning of the joist and inadequate supports. We recommend additional supports be installed

Contact a qualified deck contractor.

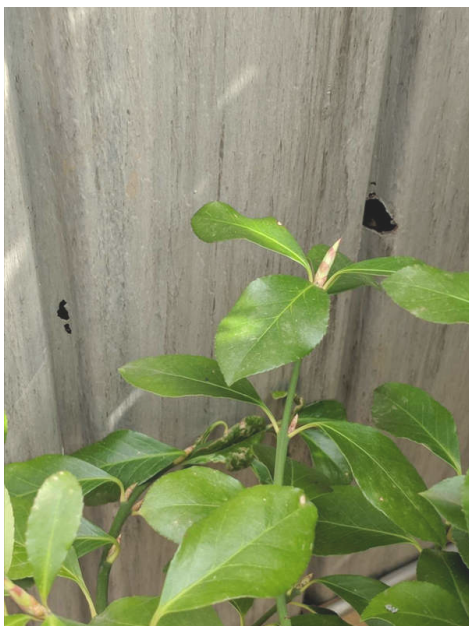
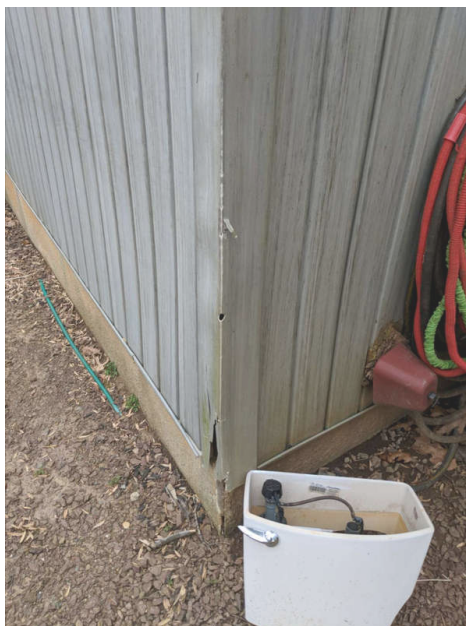
PUNCTURES

There were several puncture marks in the exterior siding. Repair is recommended

Contact a qualified professional.

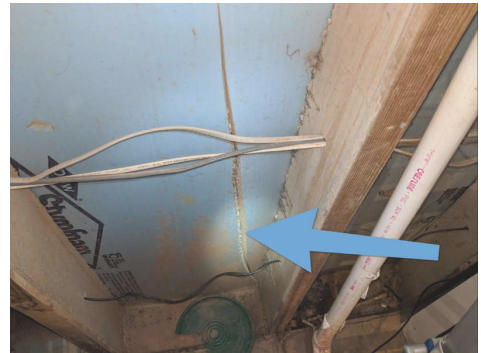
CONCRETE BULDGING

The concrete wall is bowed. This appears to have been a defect when assembled. The area should be monitored for water entry or future movement. If movement is noted, the wall should be repaired

Recommendation
Recommend monitoring.

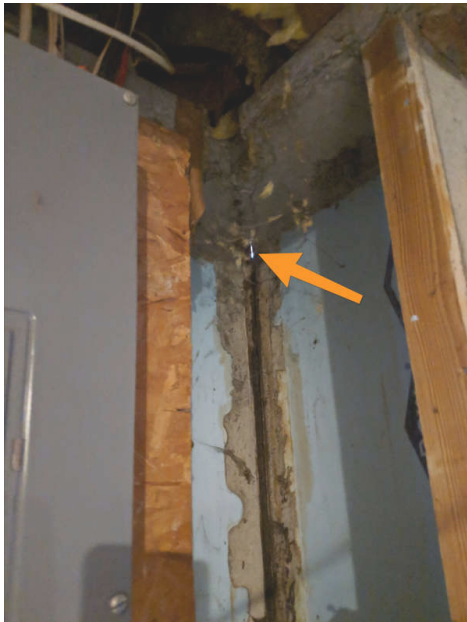
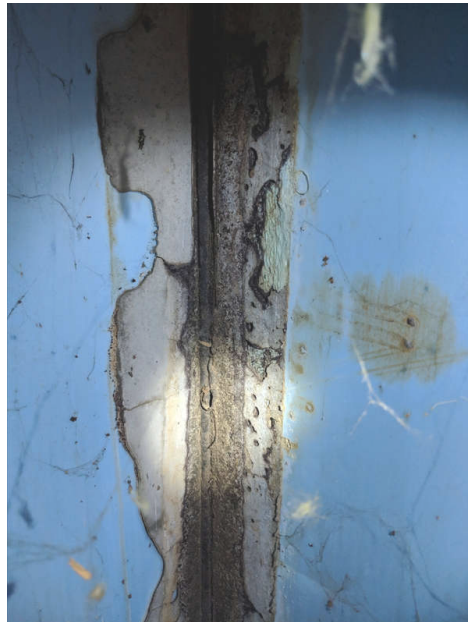
WATER ENTRY

Daylight was seen at the sill. Water stains and organic growth were seen at the corner by the electrical panel. This area should be sealed up from the exterior to prevent water entry. Organic growth should be treated and or removed

Recommendation
Contact a qualified professional.

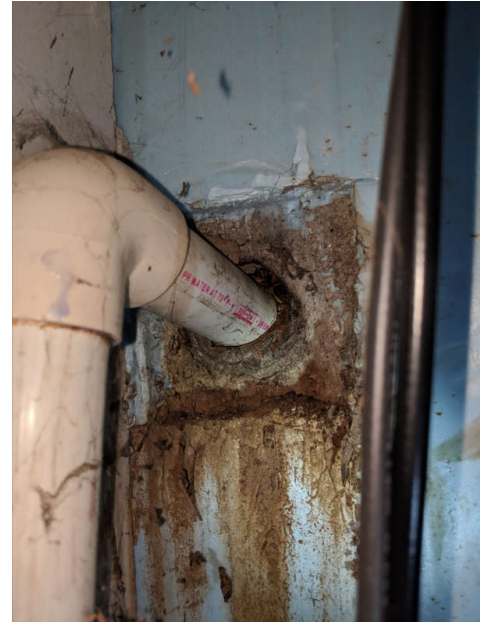
WATER ENTRY WALL PENETRATIONS

Water stains seen at foundation wall penetrations. We recommend sealing wall penetrations to prevent water entry

Recommendation
Contact a qualified professional.

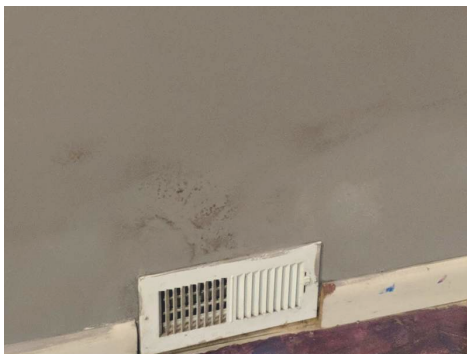
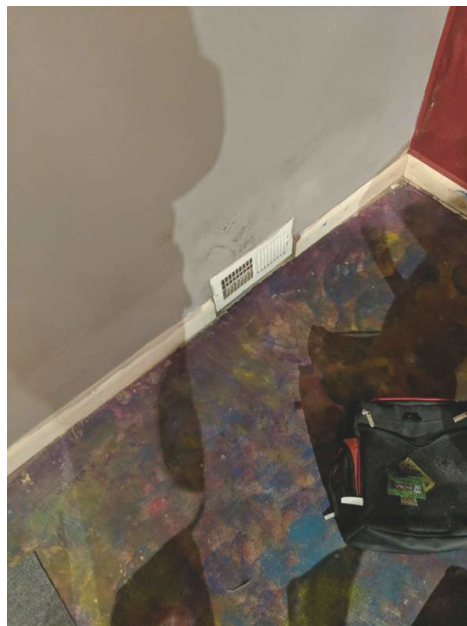
MOLD/MILDEW

Mold or mildew was noted in the basement. Mold testing is not part of a home inspection. Samples would need to be collected and sent to the lab for testing.

Contact a qualified mold inspection professional.

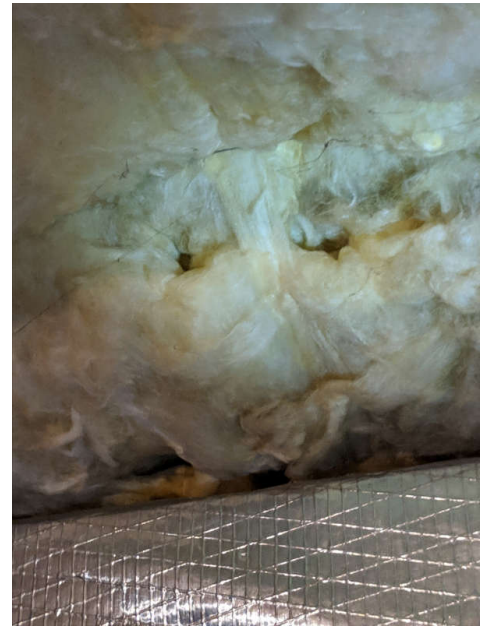
PEST EVIDENCE

Pest evidence such as burroughs were observed in the insulation in the basement. Rodents have been active in the past and can possibly still be present. We recommend traps be set

Contact a qualified professional.

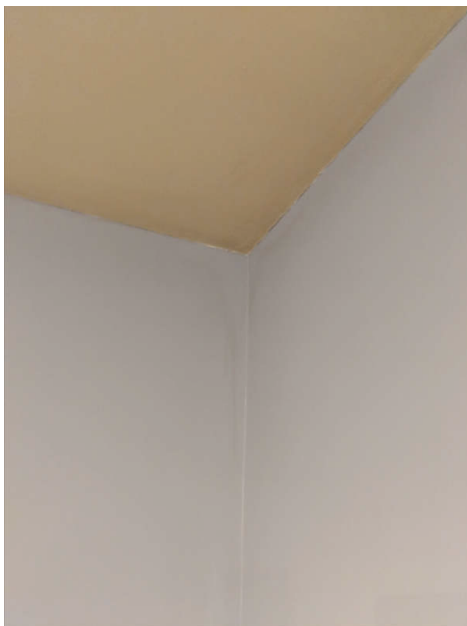
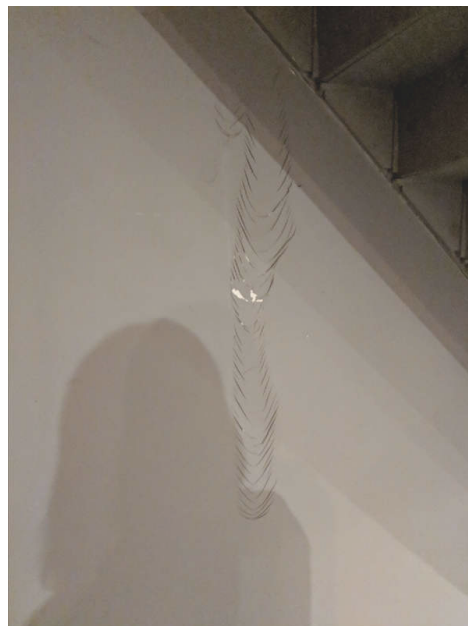
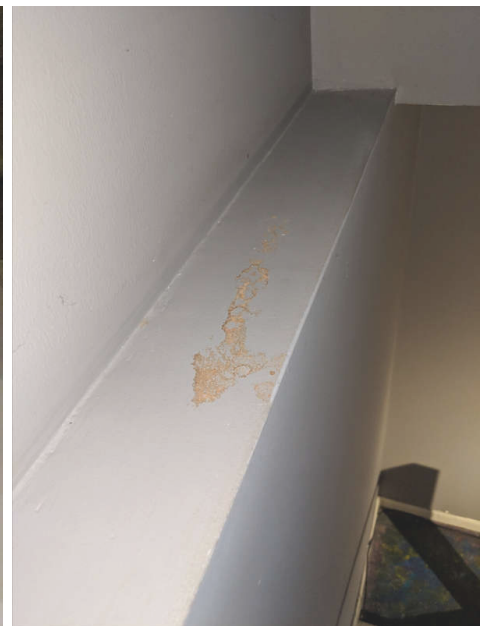
DRY STAINS

Stains were found in one or more ceiling areas. However, no elevated levels of moisture were found. If elevated moisture is found in the future, a qualified contractor should evaluate and repair as necessary.

Recommend monitoring.

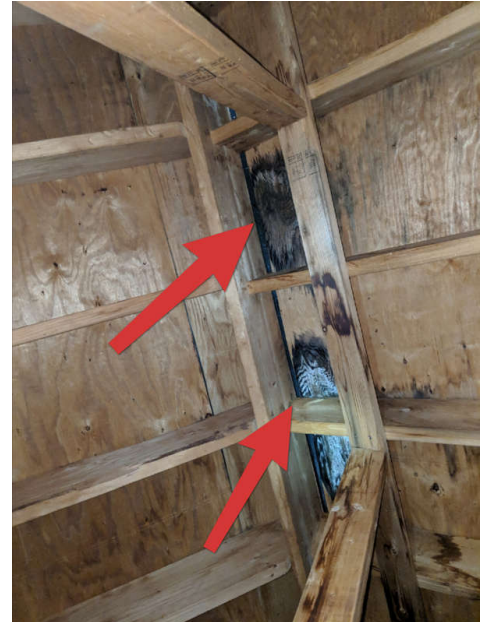
ACTIVE LEAK

One or more active roof leaks were found. Recommend further evaluate and repair any roof leaks. Recommend obtaining estimate(s) prior to closing.

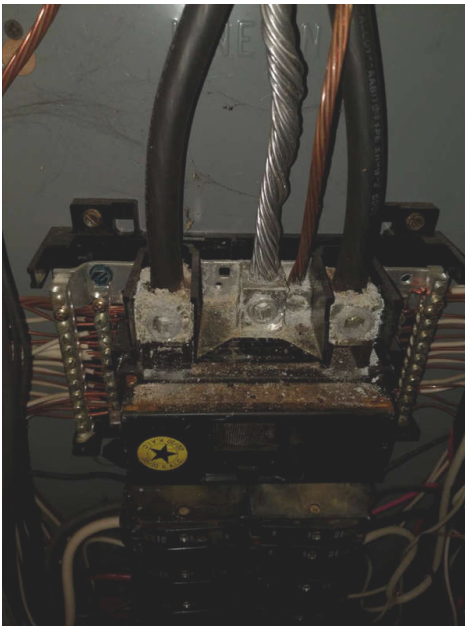
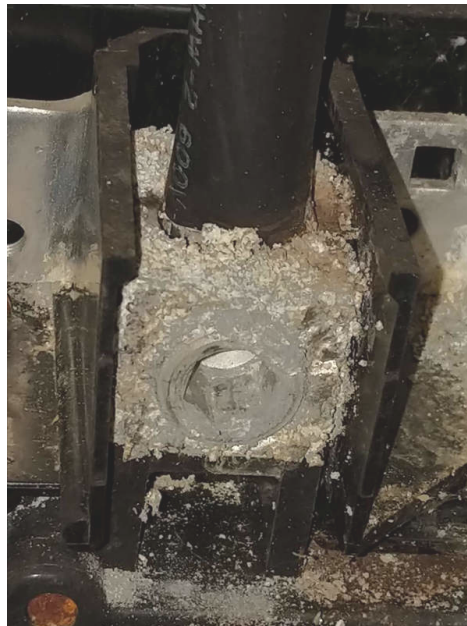
CORROSION

There is corrosion on one or more of the main breakers. We recommend the breaker be cleaned and secured to ensure a solid connection.

Contact a qualified electrical contractor.

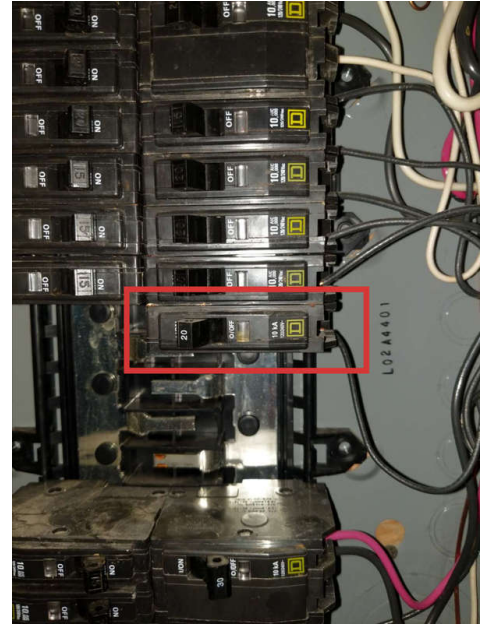
OVER FUSED

We found over-fusing in the main service panel, meaning the fuse or breaker is not rated for the connected wire. This is a potential fire hazard. We recommend the circuit be equipped with an properly rated overcurrent protection device.

Contact a qualified electrical contractor.

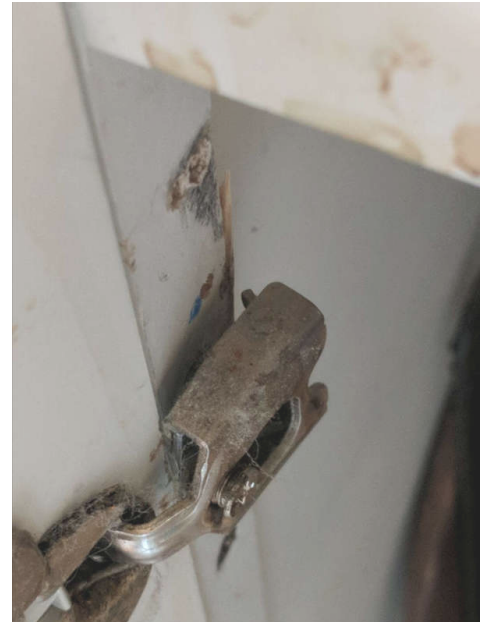
LOOSE HARDWARE

Hardware such as hinges, latches or pulls are loose and/or missing on one or more cabinets. Repairs should be made and/or hardware should be replaced as necessary, and by a qualified contractor if necessary.

Contact a qualified cabinet contractor.

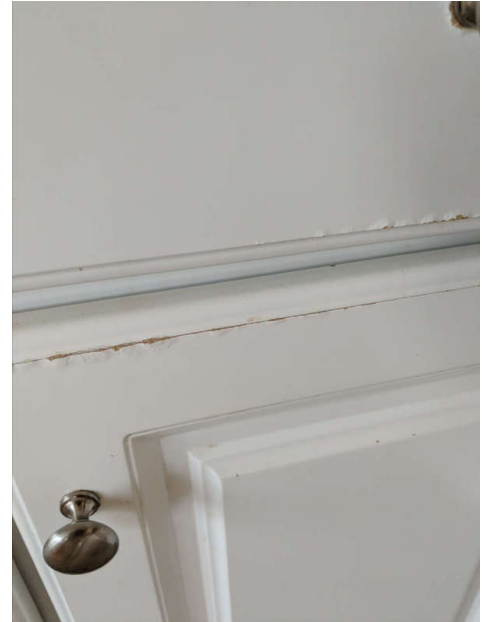
WATER DAMAGE MINOR

Water stains and/or minor water damage was found in the shelving or cabinet components below the sink. The client(s) should evaluate and consider having repairs made.

Contact a qualified cabinet contractor.

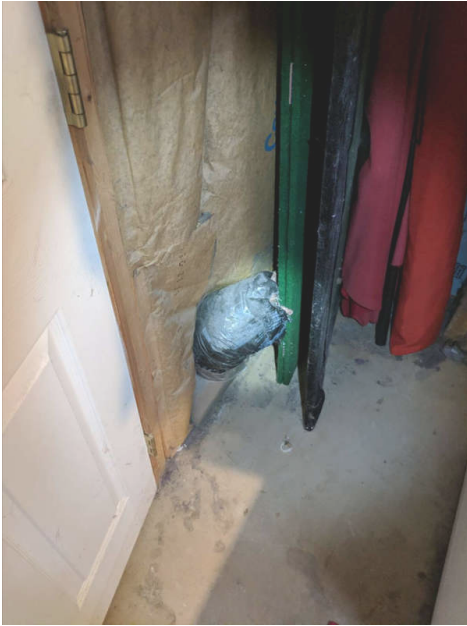
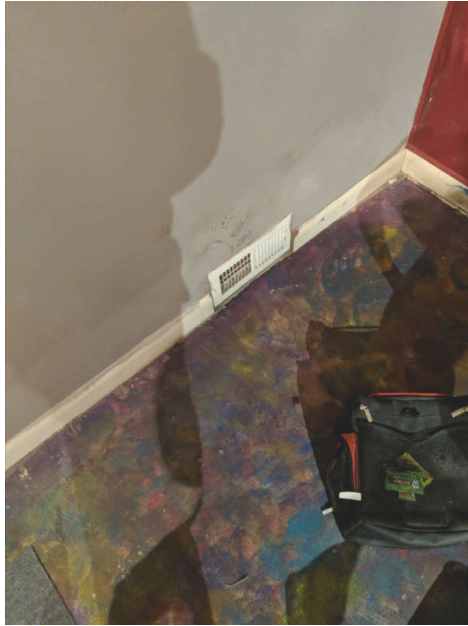
REGISTERS LOOSE / DAMAGED / MISSING

The ducting to the registers has been removed. We recommend following up with the home owner as to why it was removed and installing new duct work as needed

Contact a qualified HVAC professional.

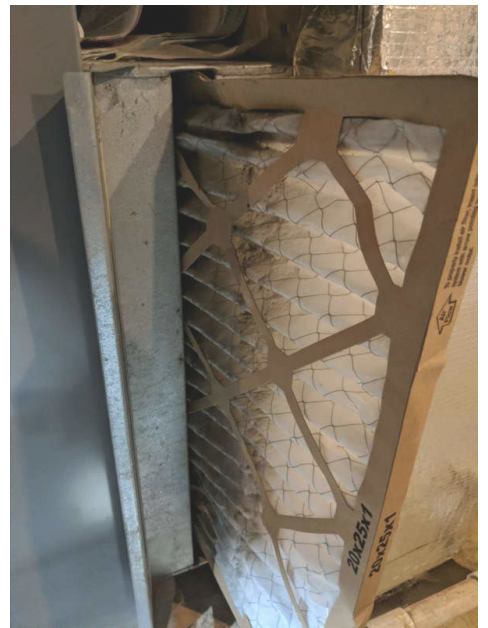
FILTER DIRTY

Air filters for the heating and/or cooling system were dirty at one or more locations. Indoor air quality will be reduced as a result. Recommend installing good quality filters at intended locations (e.g. in or at the air handler, behind return air grills). Filters should be sized correctly to minimize air gaps. Many types of filters are available. Recommend installing pleated filters or better rather than the cheapest disposable kind.

Recommended DIY Project

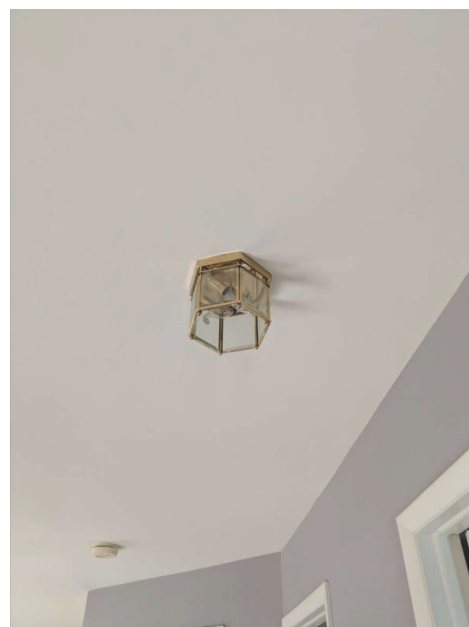
2nd Floor hallway

One or more light fixtures appear to be inoperable. Recommend further evaluation by replacing bulb(s) and/or consulting with the property owner(s). Repairs or replacement of the light fixture(s) by a qualified electrician may be necessary.

Contact a qualified electrical contractor.

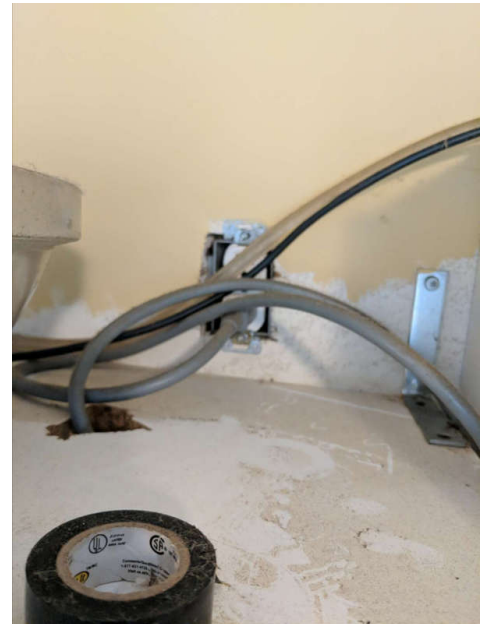
Microwave

One or more electric coverplates are broken, damaged or missing. This can be safety hazard due to the risk of shock depending on the severity of the issue. A qualified electrician should replace them as necessary.

Contact a qualified electrical contractor.

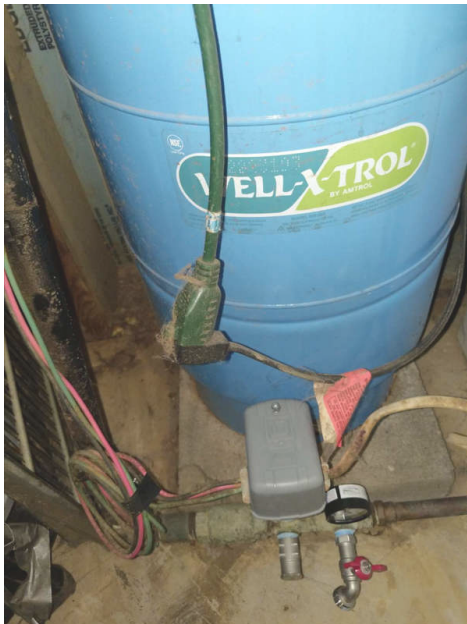
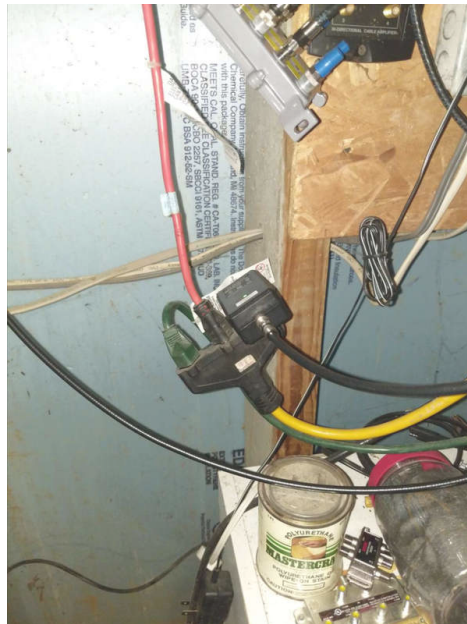
EXTENSION CORDS

Extension cords were being used as permanent wiring at one or more locations. They should only be used for portable equipment on a temporary basis. Using extension cords as permanent wiring is a potential fire and shock hazard, and indicates that wiring is inadequate and needs updating. Extension cords may be undersized. Connections may not be secure resulting in power fluctuations, damage to equipment, overheating and sparks that could start a fire. Recommend that a qualified electrician repair per standard building practices and eliminate extension cords for permanently installed equipment.

Contact a qualified electrical contractor.

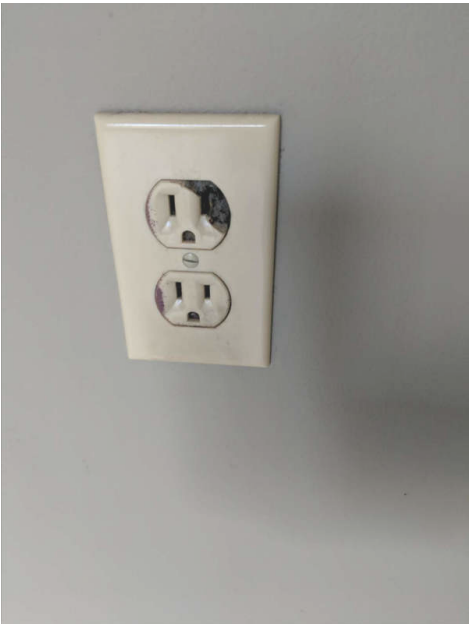
2nd Floor Bedroom

One or more receptacles were broken or damaged. This is a potential shock or fire hazard. Recommend that a qualified electrician replace such receptacles as necessary.

Recommendation
Contact a qualified electrical contractor.

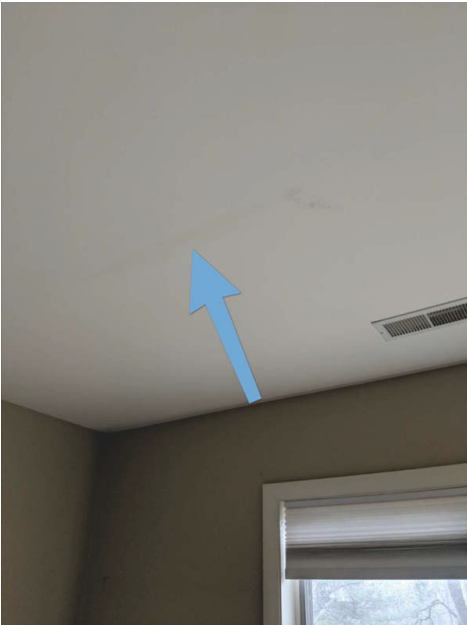
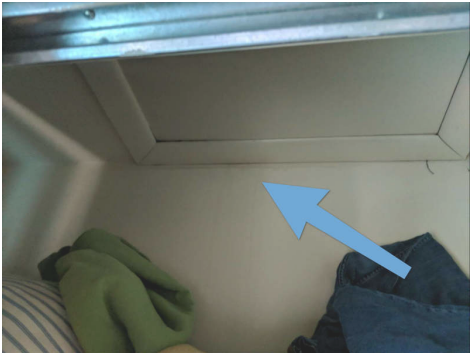
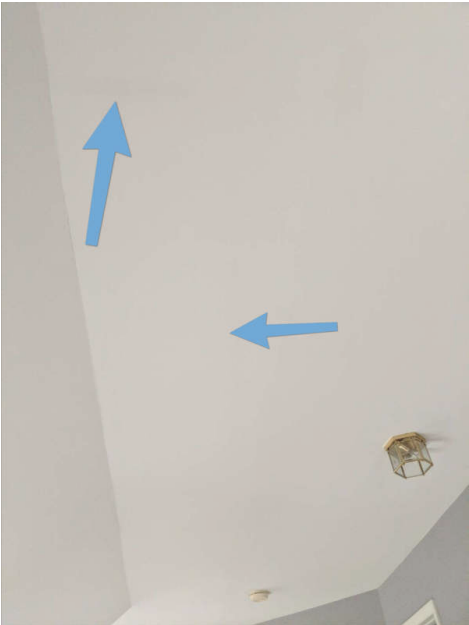
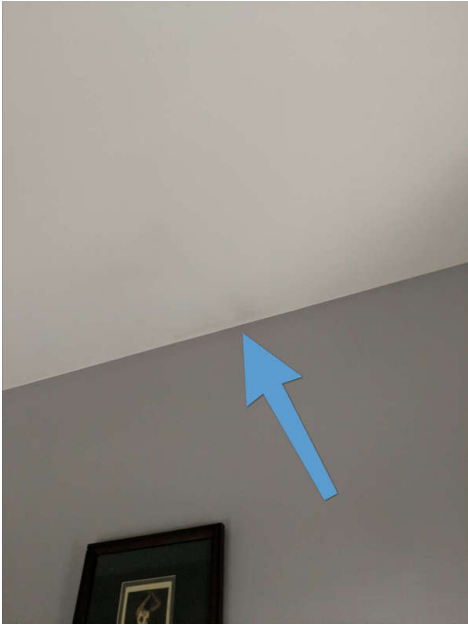
2nd Floor

Stains were found in one or more ceiling areas. However, no elevated levels of moisture were found. If elevated moisture is found in the future, a qualified contractor should evaluate and repair as necessary.

Recommendation
Recommend monitoring.

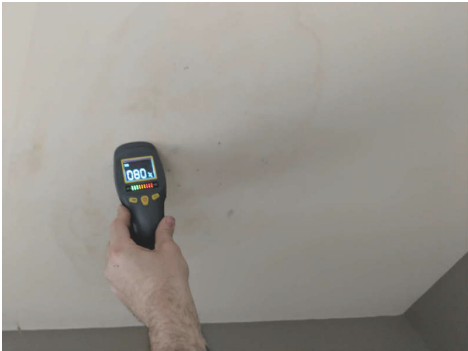
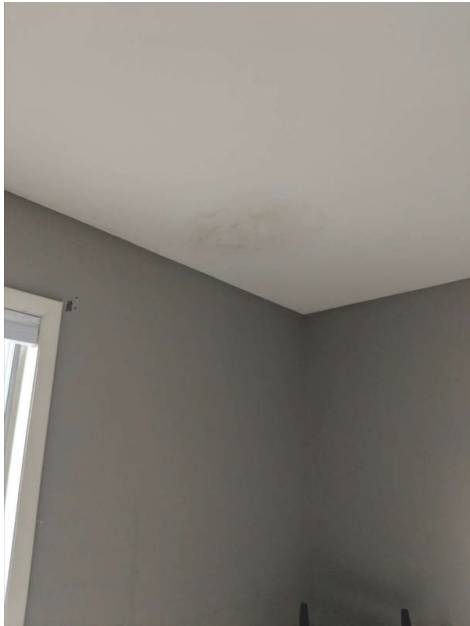
2nd Floor Bedroom

Stains and elevated levels of moisture were found in one or more ceiling areas. A qualified contractor should evaluate and repair as necessary.

Recommendation
Contact a qualified professional.

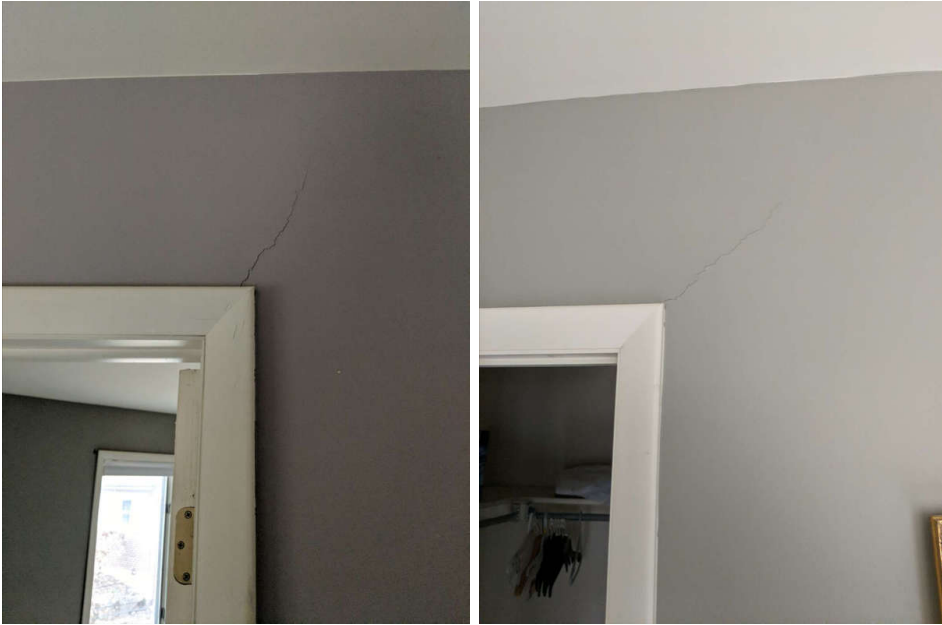
WALLS-MINOR CRACK

Minor cracks were found in walls in one or more areas. They do not appear to be a structural concern, but the client(s) may wish to repair these for aesthetic reasons.

Recommendation
Contact a qualified drywall contractor.

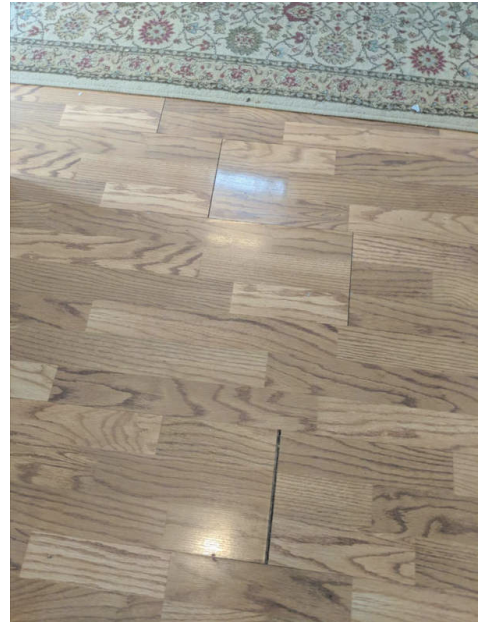
LAMINATE OPEN SEAMS

There were areas where the laminate flooring has separated at it's seams. We recommend the gaps be repaired

Contact a qualified professional.

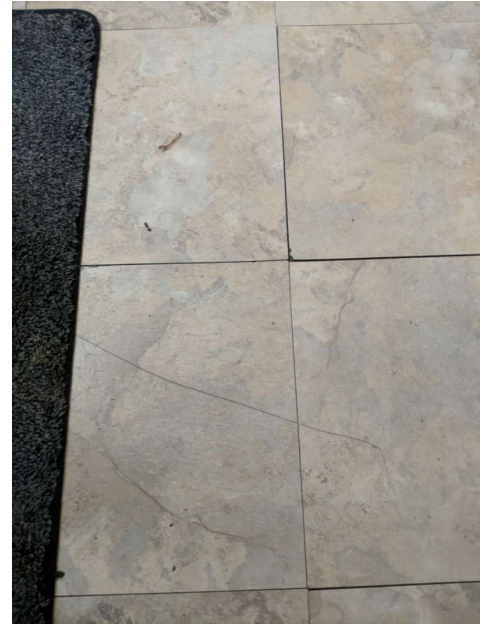
FLOORS-VINYL DETERIORATED

Vinyl flooring is damaged and/or lifting in one or more areas. A qualified contractor should replace or repair the damaged flooring.

Contact a qualified flooring contractor
