SUMMARY
1234 Main St. Lansdale Pennsylvania
19446
Buyer Name
05/08/2019 9:00AM

Donald Nagle
L&L Home Inspections, LLC
(484)-942-7344
ll.homeinspectionsllc@gmail.com

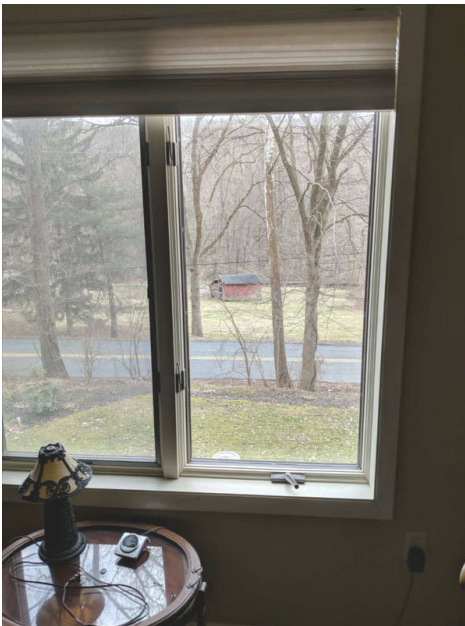
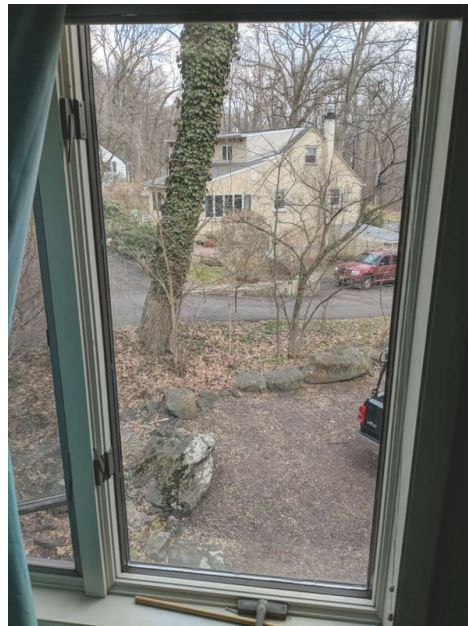
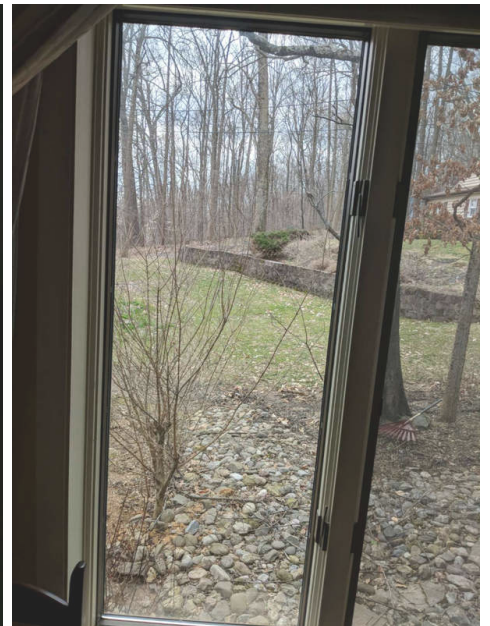
WINDOW-SCREENS MISSING

Screen(s) in one or more windows are missing. The client(s) should ask the property owner(s) about this. Screens are often removed for window cleaning and they may be stored somewhere. If not, then recommend installing screens where missing.

Contact a qualified window repair/installation contractor.

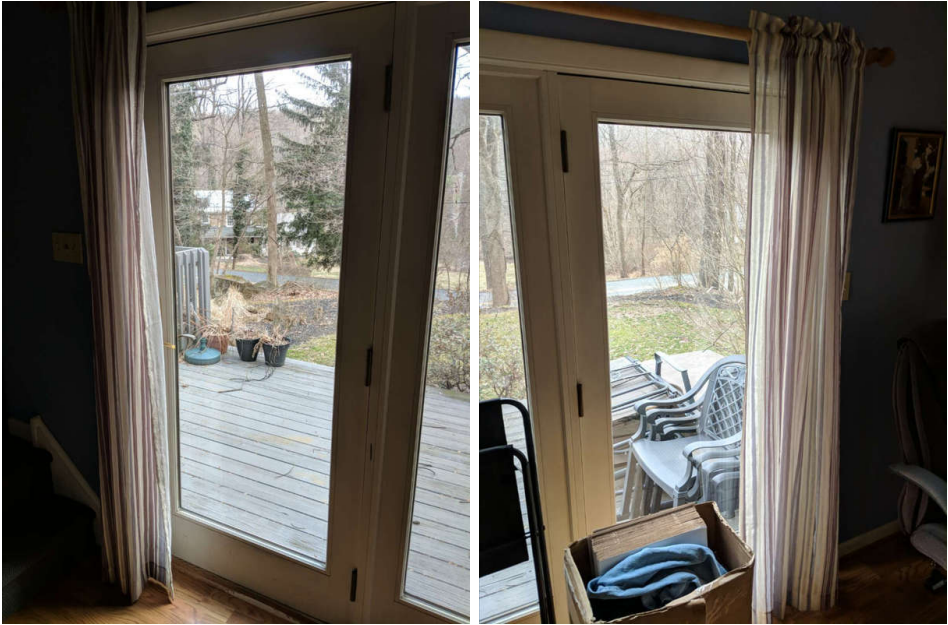
DOOR RUBS

One or more doors bind in their jamb, or are difficult to open and close. A qualified contractor should evaluate and repair as necessary. For example, adjusting jambs or trimming doors.

Contact a qualified door repair/installation contractor.

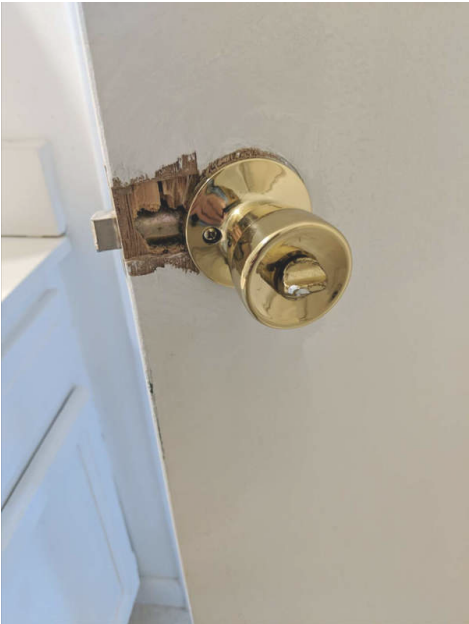
DOOR INTERIOR-DETERIORATED

One or more interior doors are damaged and/or deteriorated and should be repaired or replaced by a qualified contractor.

Contact a qualified door repair/installation contractor.

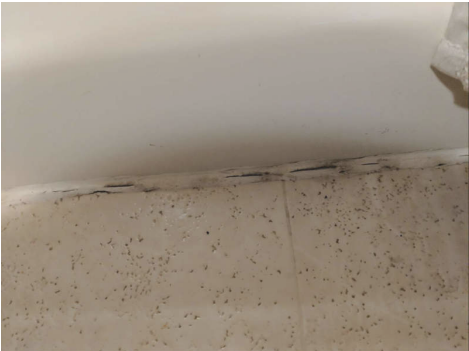
1st Floor

Caulk is missing or deteriorated along the base of one or more bathtubs, where flooring meets the tub. It should be replaced where deteriorated and/or applied where missing to prevent water intrusion and damage to the floor structure.

Recommended DIY Project

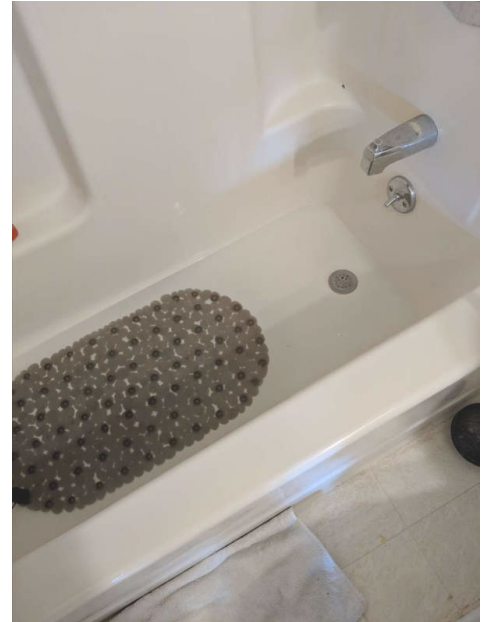
2nd Floor

One or more bathtub drains are clogged or drain slowly. Drain(s) should be cleared as necessary, and by a qualified plumber if necessary.

Contact a qualified plumbing contractor.

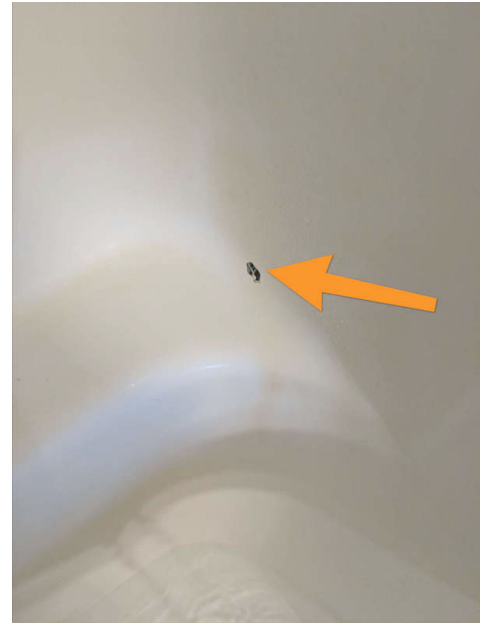
2nd Floor

There is a crack in the fiberglass insert for the shower pan. This may allow water to intrude below the shower Pan causing moisture issues. Recommend to have the shower Pan repaired to help prevent moisture intrusion in unseen areas.

Contact a qualified professional.

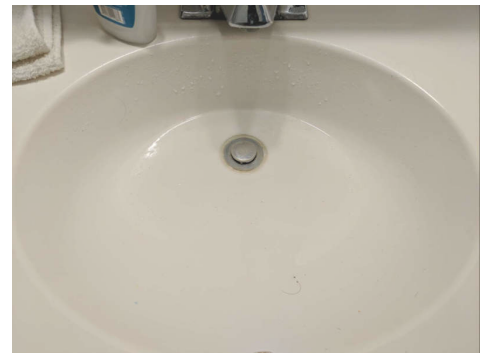
2nd Floor

One or more sinks are clogged or drain slowly. Drain(s) should be cleared as necessary, and by a qualified plumber if necessary.

Contact a qualified plumbing contractor.

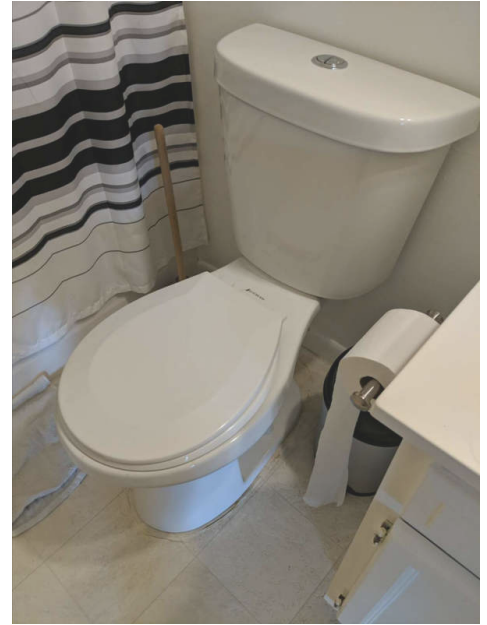
LOOSE

One or more toilets are loose. A qualified contractor should remove the toilet(s) for further evaluation and repairs if necessary. A new wax ring should be installed and toilet(s) should be securely anchored to the floor to prevent movement and leaking.

Contact a qualified plumbing contractor.
