## SUMMARY

1234 Main St. Margate Florida 33063

Matthew Miller  
Bless This Nest Inspections, LLC  
9545930601  
mattmiller1513@gmail.com

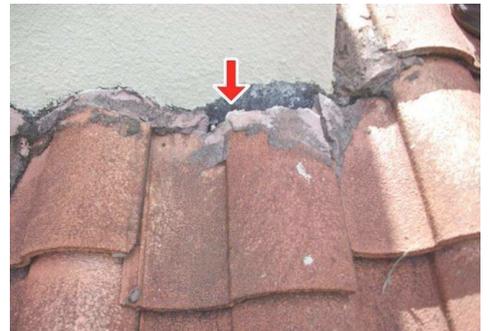
### 2.2.1 Tile

#### CRACKED/BROKEN TILES

There are broken/cracked Roofing tiles. This is usually cosmetic, but can lead to issues if not addressed timely. If underlayment is exposed to UV rays deterioration may occur. This can lead to leaks if the proper repairs are not made. A licensed roofing contractor should repair or replace any broken tiles.

Recommendation  
Contact a qualified roofing professional.

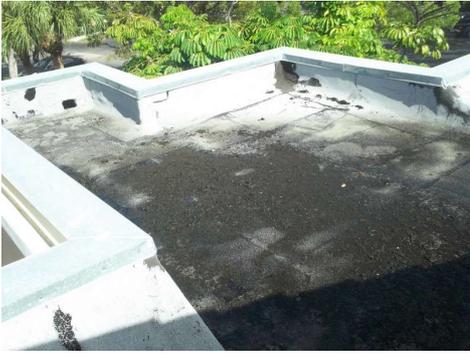
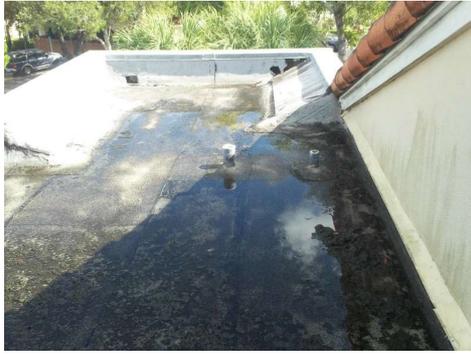
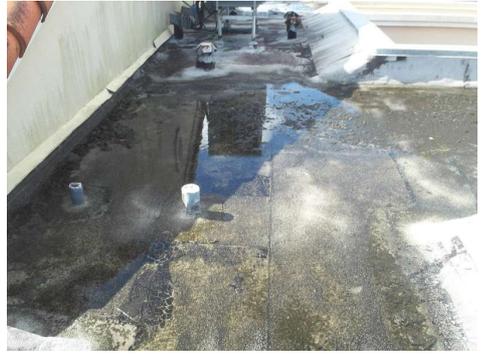
### 2.3.1 Flat

#### PONDING

Ponding (pools of standing water) was found at one or more locations on the flat or low-slope roof surface. Even on a flat roof, water should be removed by a drainage system so that any remaining water evaporates within 48 hours after it rains. According to the roof report, the ponding has led to active roof leaks and needs to be replaced.

Recommendation  
Contact a qualified roofing professional.

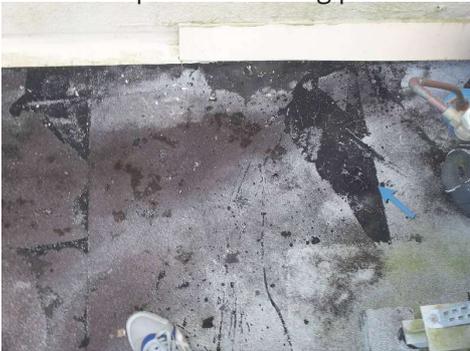
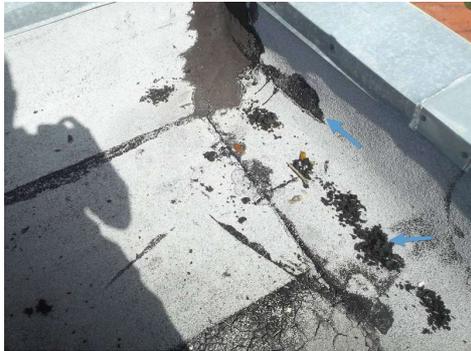
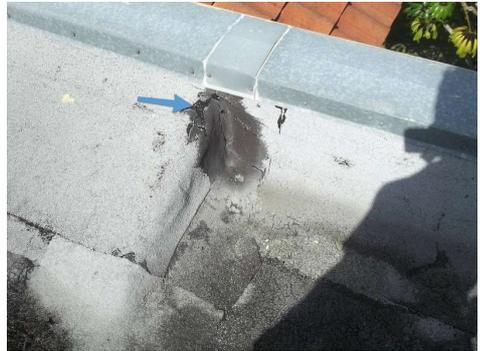
2.3.2 Flat  
**DAMAGE**

According to the roof report, there is damage to one or more areas of the flat roof. This can lead to moisture intrusion and leaks at interior living spaces. Any damaged roofing should be repaired or replaced as necessary.

Recommendation  
Contact a qualified roofing professional.

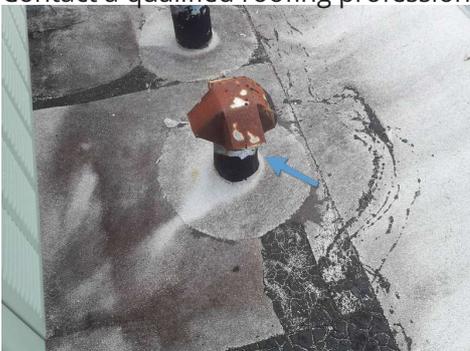
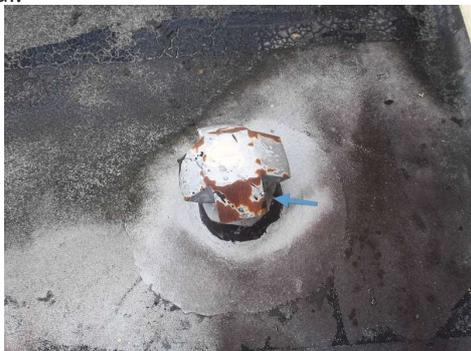
2.5.1 Flashing/Vents  
**VENT SEALING**

As noted in the roofing report, the area around one or more of the sewer vents should be properly sealed; as not to allow sunlight or weathering to enter into the underlayment area which will cause a deterioration and possible leakage in the future. These areas should be sealed.

Recommendation  
Contact a qualified roofing professional.

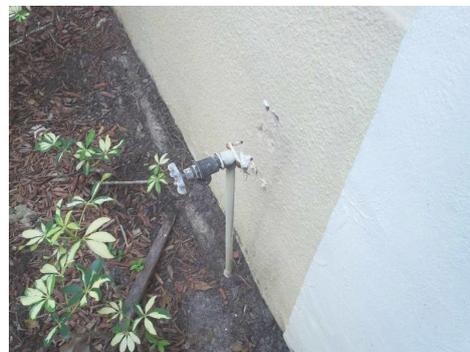
3.3.1 Exterior issues  
**LOOSE FAUCET**

The outside water faucet is loose by the front door and need to be secured to the wall at the front of home. Repairs are needed. A qualified licensed plumber should repair or correct as needed.

Contact a qualified plumbing contractor.

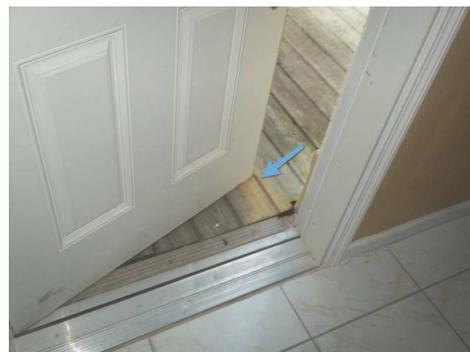
### 3.5.1 Windows and Door

#### DOOR - RUBS AT BOTTOM

The main entry door rubs at bottom when closing. This can cause some heat loss in winter and loss of cool air in summer if not corrected. This is considered unsafe and needs correcting. A qualified person should repair or replace as needed.

Contact a qualified professional.

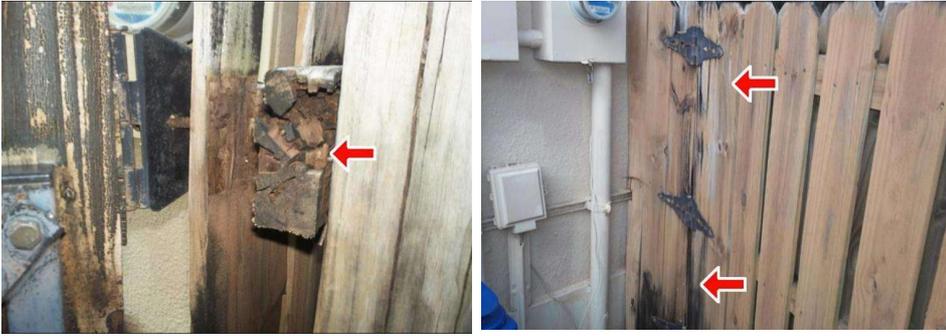
### 3.11.1 Fences and Gates

#### DAMAGED FENCE

Areas of the fencing are deteriorated and damaged. Fencing should be repaired as needed or replaced.

Contact a qualified fencing contractor

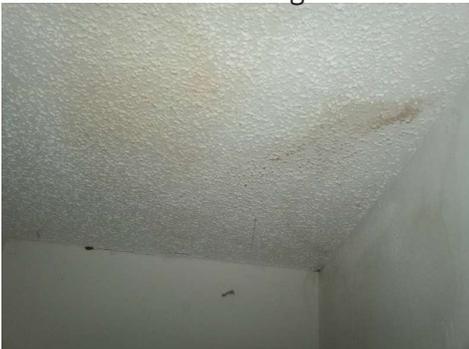
4.2.2 Floors, Walls, Ceilings

**CEILING-DRY STAINS**

Stains were found in one or more ceiling areas. However, no elevated levels of moisture were found. The stain(s) may be due to past roof and/or plumbing leaks. Recommend asking the property owner(s) about this, and monitoring the stained area(s) in the future, especially after heavy or prolonged rain. If elevated moisture is found in the future, a qualified contractor should evaluate and repair as necessary.

Recommendation  
Recommend monitoring.

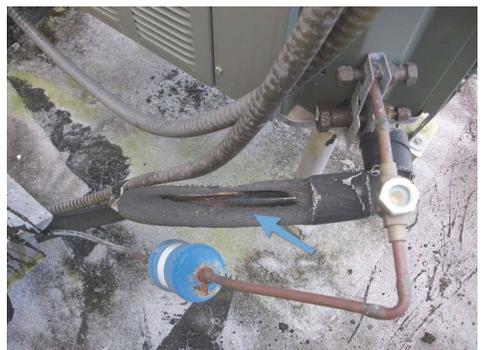
8.3.1 Condensing Unit

**LINE INSULATION**

Cosmetic, Maintenance, Monitor

Recommendation  
Contact a qualified HVAC professional.

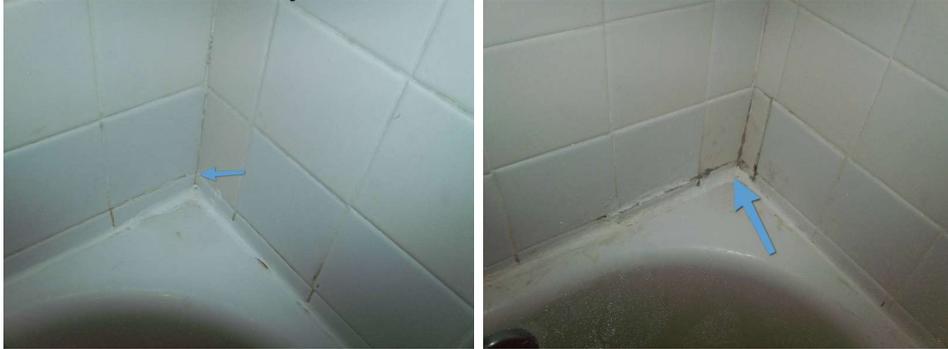
9.1.1 Bathub

**CAULKING AT SURROUND**

Caulk is missing or deteriorated above one or more bathtubs, where the tub surround meets the tub. It should be replaced where deteriorated and/or applied where missing to prevent water intrusion and damage to the wall structure.

Recommendation  
Recommended DIY Project

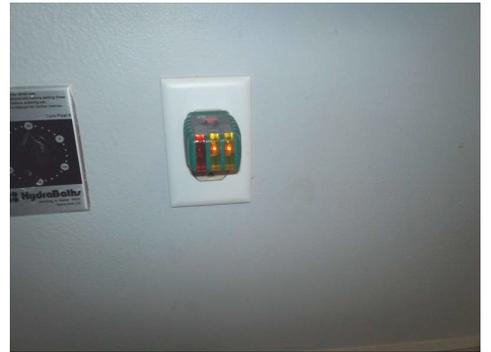
9.3.1 Electrical

**GFCI MISSING**

One or more electric receptacles at the bathroom(s) had no visible ground fault circuit interrupter (GFCI) protection, or the inspector was unable to determine if GFCI protection was present. If not GFCI-protected, receptacles in wet areas pose a shock hazard. Recommend that a qualified electrician evaluate and install GFCI protection if necessary and per standard building practices. General guidelines for GFCI-protected receptacles include the following locations:

Recommendation  
Contact a qualified electrical contractor.

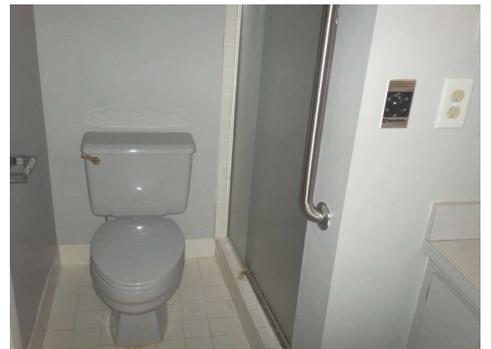
9.6.1 Shower

**SHOWER DOOR OBSTRUCTED**

Shower door was improperly installed and is obstructed by the toilet causing it to not fully open. This is considered unsafe and needs correcting. A qualified contractor should repair or replace as needed.

Recommendation  
Contact a qualified professional.

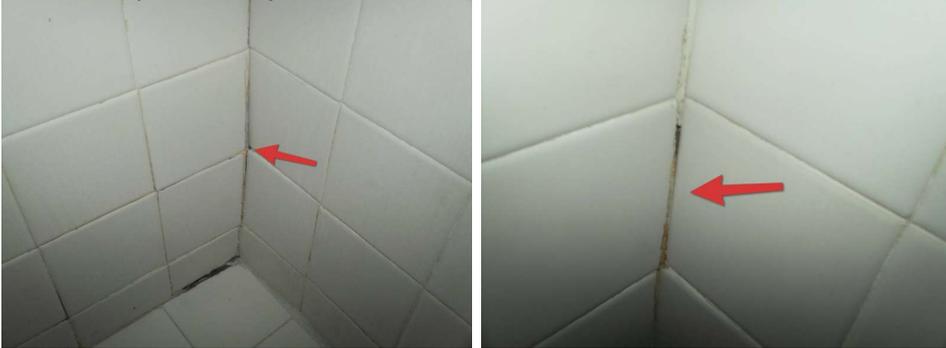
9.6.2 Shower

**WATER DAMAGE WALL**

The floor / wall by the shower was water-damaged. Framing in wall may need repair as well (not visible). Recommend that a qualified person repair/replace as necessary.

Recommendation  
Contact a qualified drywall contractor.

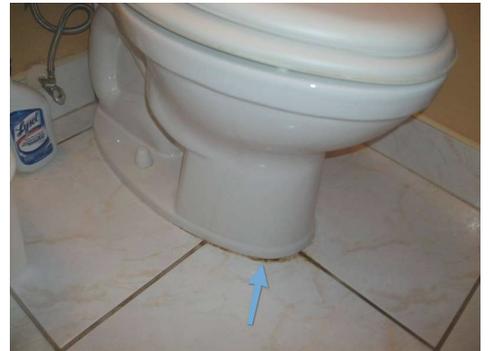
9.8.1 Toilets

**LOOSE**

One or more toilets are loose. A qualified contractor should remove the toilet(s) for further evaluation and repairs if necessary. A new wax ring should be installed and toilet(s) should be securely anchored to the floor to prevent movement and leaking.

Recommendation  
Contact a qualified plumbing contractor.

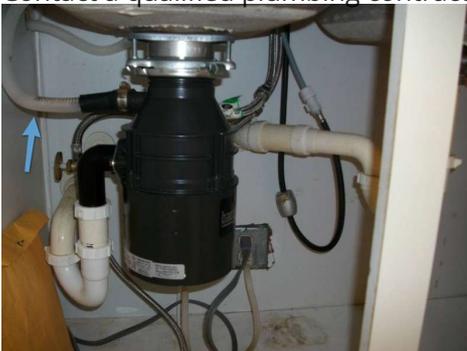
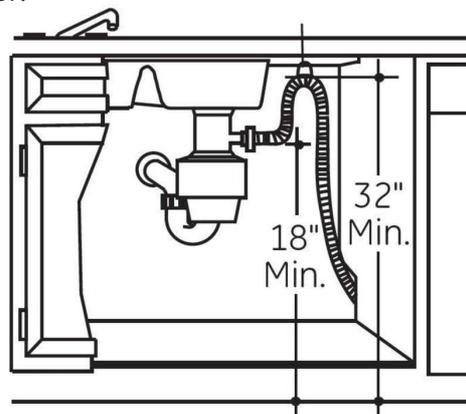
11.2.1 Dishwasher

**NO SECOND HIGH LOOP**

The dishwasher drain line is not configured with a second "high loop" to create a trap under the sink. It is meant to prevent water from siphoning out of the dishwasher, and to prevent water from the sink drain or food disposal from entering the dishwasher. Licensed plumber should correct improper installation.

Proper Connection

Recommendation  
Contact a qualified plumbing contractor.

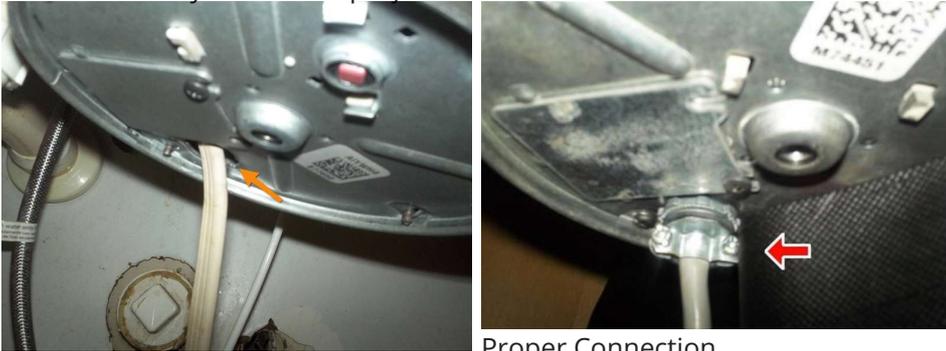
11.3.1 Garbage Disposal

**NO ANTI-STRAIN DEVICE**

The garbage disposal wiring is missing a romex connector (anti-strain device). Recommend repair as needed.

Proper Connection

Recommendation  
Contact a handyman or DIY project

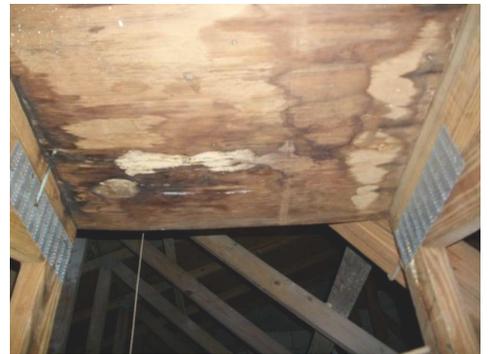
12.1.1 General

**DRY STAIN**

Stains were visible on the roof structure in one or more areas. These areas were dry at the time of the inspection. The stains may be caused by a past leak. Recommend asking the property owner(s) about past leaks. The client(s) should monitor these areas in the future, especially after heavy rains, to determine if active leaks exist. If leaks are found, a qualified roofing contractor should evaluate and repair as necessary.

Recommendation  
Contact a qualified roofing professional.

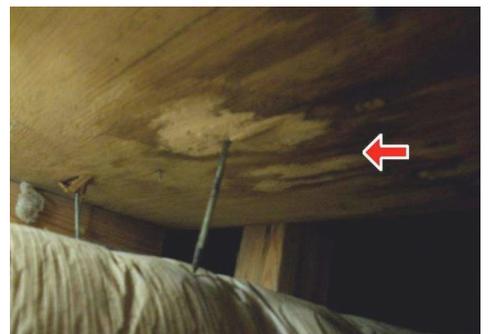
12.1.2 General

**WET STAIN**

One or more areas of the roof structure were wet or had elevated levels of moisture at the time of the inspection. There appears to be an active leak in the roof or structure exterior. A qualified contractor should evaluate and repair as necessary.

Recommendation  
Contact a qualified roofing professional.
