## SUMMARY

1234 Main St. Edmond OK 73012

Steve Bennett  
InterNACHI Certified, OK License...  
Redbud Property Inspections, LLC  
405-200-8957  
steve@redbudinspections.com

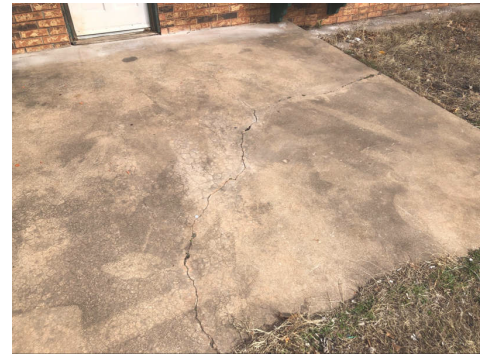
### 3.1.1 Patios

#### **PATIO CRACKING (MODERATE)**

REAR

The patio surface had moderate cracking visible at the time of the inspection. Cracks wider than 1/8" should be filled with an appropriate material to help prevent continued deterioration.

Contact a handyman or DIY project

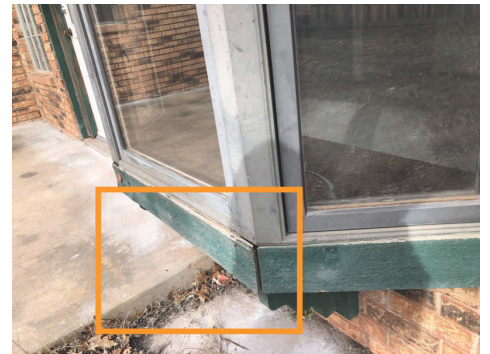
### 3.3.1 Siding, Flashing & Trim

#### **LOOSE BOARDS**

REAR

One or more siding boards were loose, which could result in moisture intrusion. Recommend a qualified siding contractor secure and fasten.

Contact a qualified siding specialist.

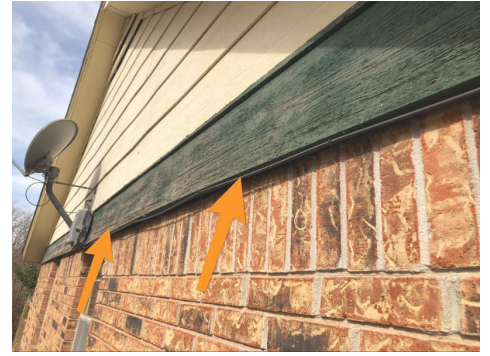
### 3.3.2 Siding, Flashing & Trim

#### **WARPING/BUCKLING**

REAR, WEST

Wood siding was warping or buckling in areas, potentially allowing for moisture intrusion. Recommend a qualified siding contractor evaluate and repair/replace.

Large gap

Contact a qualified siding specialist.

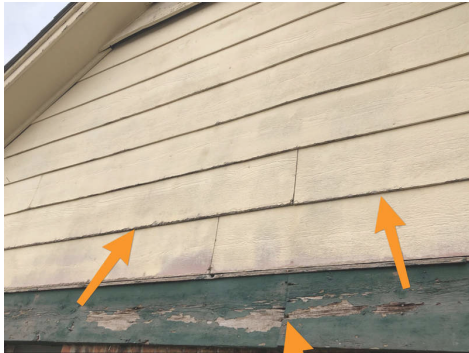
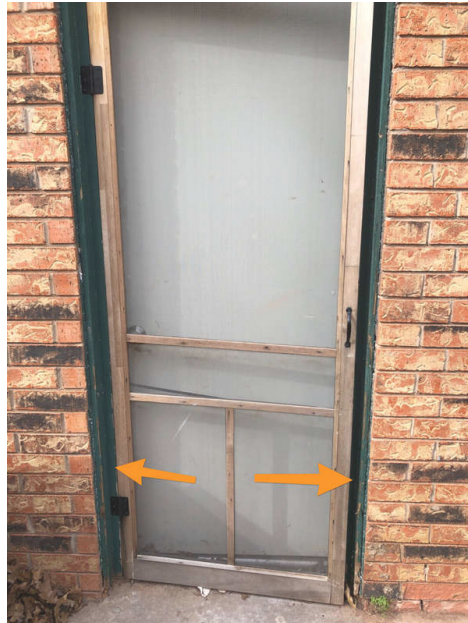
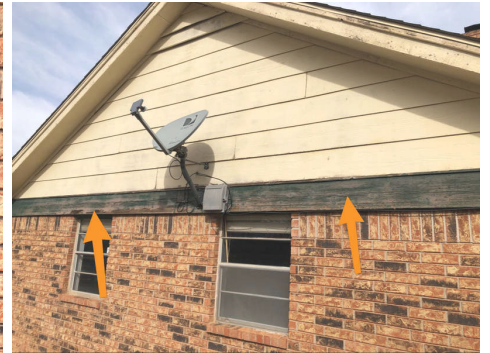
### 3.3.3 Siding, Flashing & Trim

#### **PAINT/FINISH FAILING**

VARIOUS

The paint or finish is failing. This can lead to deterioration and rot of the material. Recommend that the areas be properly prepared and painted / finished.

Contact a qualified painting contractor.

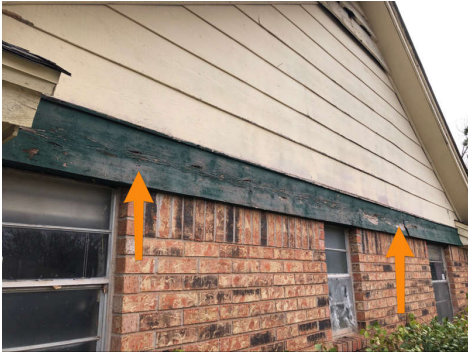
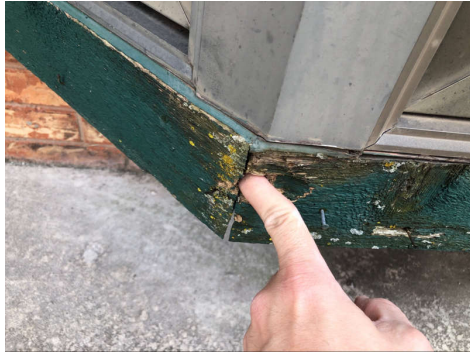
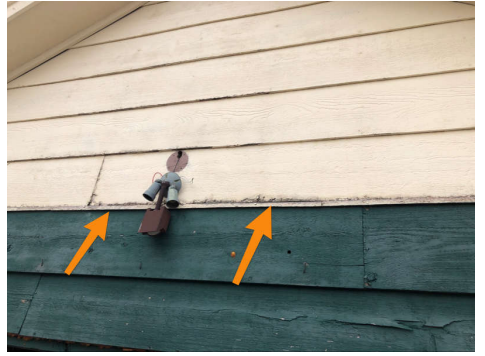
### 3.3.4 Siding, Flashing & Trim

#### **ROT-TYPE DAMAGE**

WEST, FRONT

An area of exterior siding/trim showed signs of wood rot. These areas should be repaired/replaced as necessary by a qualified siding contractor to prevent further deterioration.

Contact a qualified siding specialist.

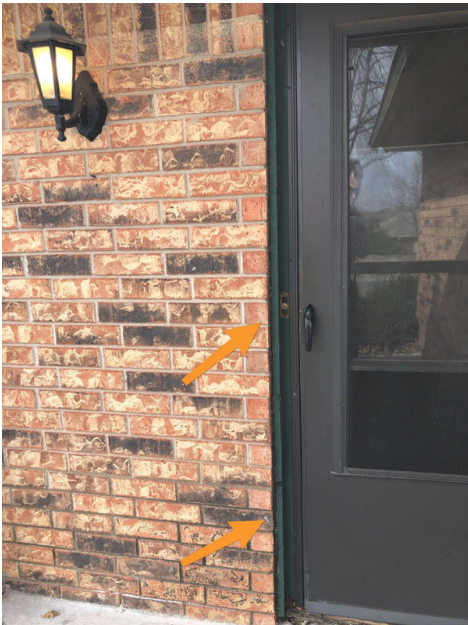
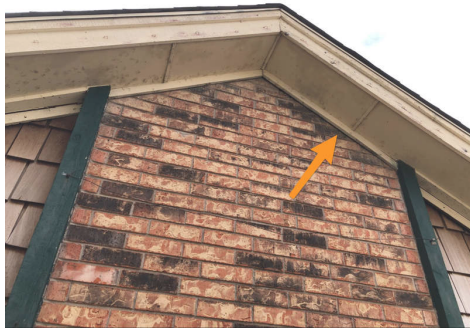
### 3.3.5 Siding, Flashing & Trim

## CAULKING/SEALANT RECOMMENDED

FRONT

Caulking/Sealant is recommended in one or more areas of the exterior to prevent moisture and/or pest intrusion.

Contact a handyman or DIY project

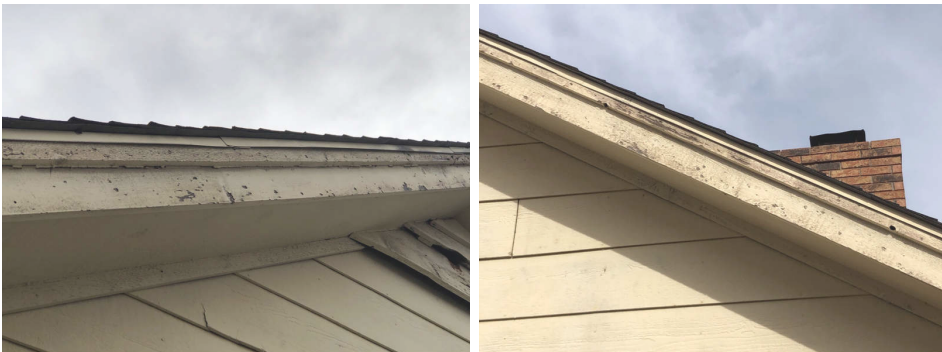
3.4.2 Eaves, Soffits & Fascia  
**PAINT/FINISH FAILING**

VARIOUS

The paint or finish is failing. This can lead to deterioration and rot of the material. Recommend that the areas be properly prepared and painted / finished.

Contact a qualified painting contractor.

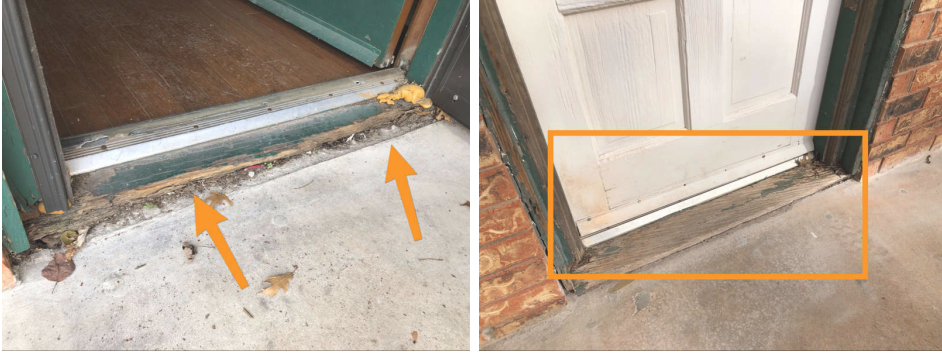
3.5.1 Exterior Doors  
**DOOR SILL/TRIM**  
 FRONT, REAR

Door sill and/or trim is loose, deteriorated or worn and repair or replacement should be considered.

Contact a qualified door repair/installation contractor.

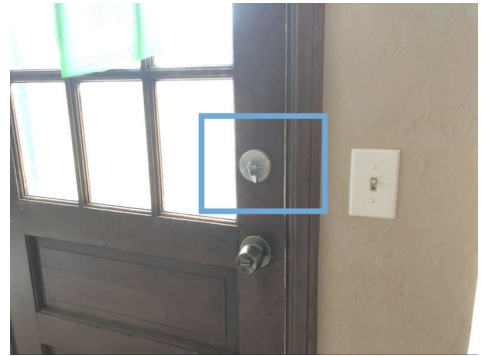
### 3.5.2 Exterior Doors

#### DEADBOLT STRIKEPLATE NEEDS ADJUSTMENT

REAR EXTERIOR

The strike plate for the deadbolt requires the doorknob to be pulled tightly in order to latch. Recommend adjusting the strike plate to allow for easier operation and less wear on the deadbolt mechanism.

Contact a handyman or DIY project

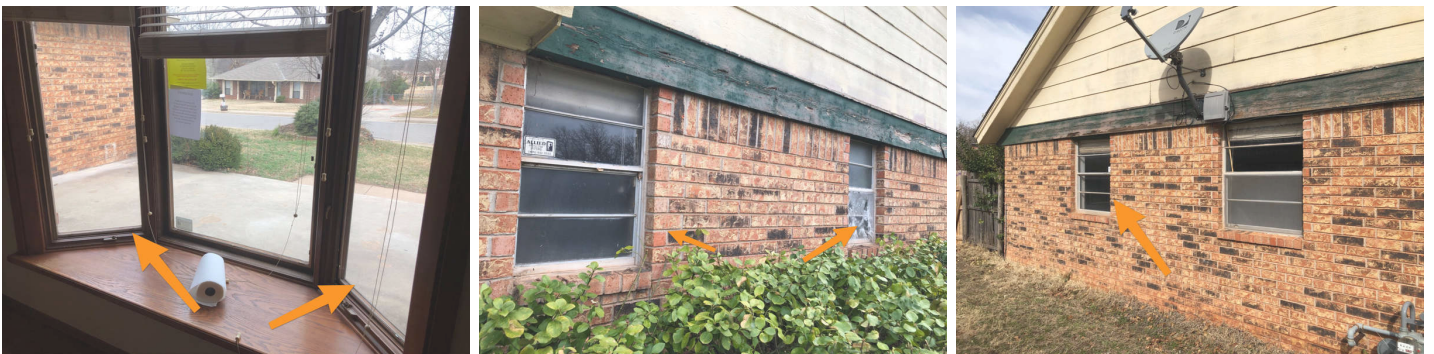
### 3.6.1 Window Exteriors

#### SCREEN DAMAGED/MISSING

LIVING ROOM, WEST, SOUTH

A window screen was damaged or missing altogether. Recommend repair/replacement by Handyman.

Contact a qualified professional.

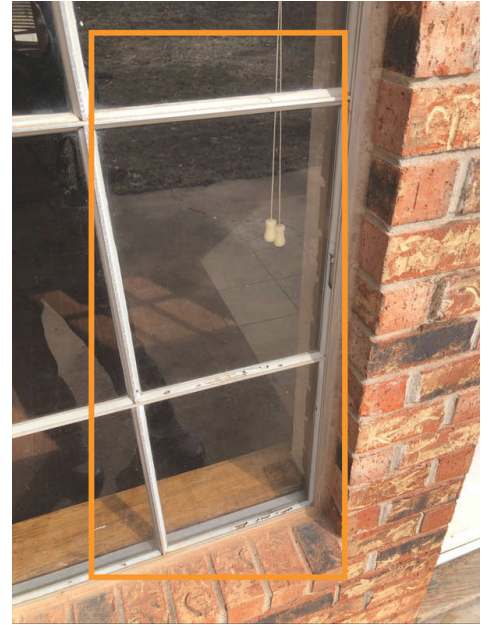
### 3.6.2 Window Exteriors

#### GLAZING STRIP DAMAGE

REAR

The plastic glazing strip around a window pane was damaged. This can lessen the integrity of the window and should be repaired/replaced as necessary.

Recommendation  
Contact a handyman or DIY project

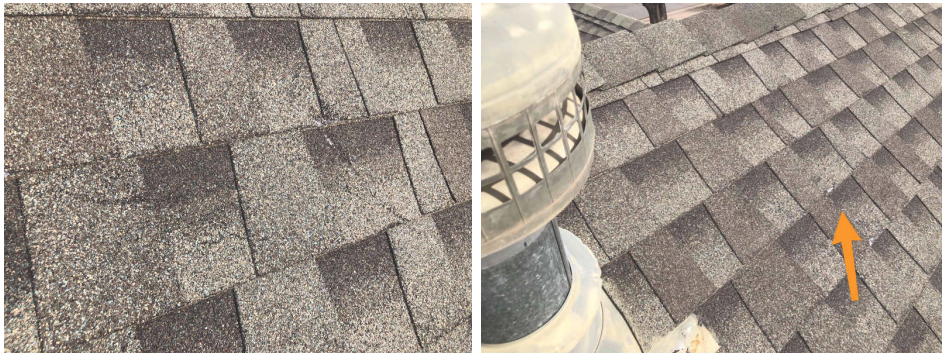
#### 4.2.1 Coverings

### DAMAGED OR MISSING SHINGLES

REAR

Damaged and/or missing asphalt composition shingles noted at the time of the inspection should be replaced to avoid damage to the underlying home structure from moisture intrusion.

\*Small number of shingles in an isolated area.

Recommendation  
Contact a qualified professional.

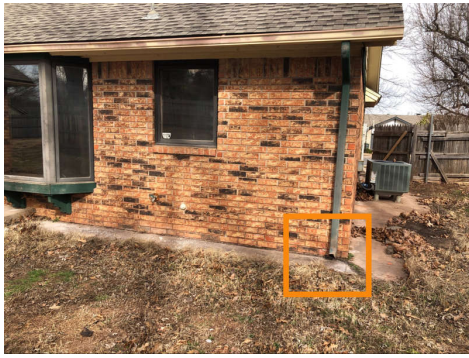
#### 4.4.1 Roof Drainage Systems

### DOWNSPOUTS DRAIN NEAR HOUSE

SOUTHEAST

One or more downspouts drain too close to the home's foundation. This can result in excessive moisture in the soil at the foundation, which can lead to foundation/structural movement. Recommend adjusting downspout extensions to drain at least 4-6 feet from the foundation.

Recommendation  
Contact a handyman or DIY project

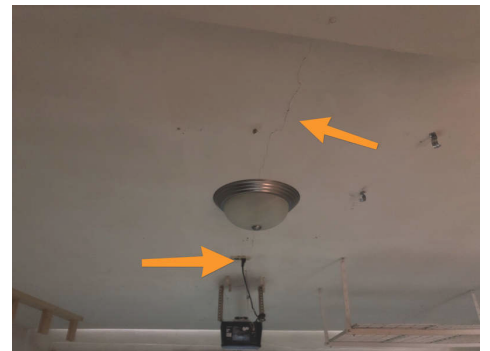
5.2.1 Ceiling

**DRYWALL (OPENER CRACKS)**

The ceiling had drywall cracks (cosmetic) in the garage. These are often created by vibrations from the garage door opener. While this damage is considered cosmetic, repair is recommended to prevent spreading of the cracks.

Recommendation  
Contact a qualified drywall contractor.

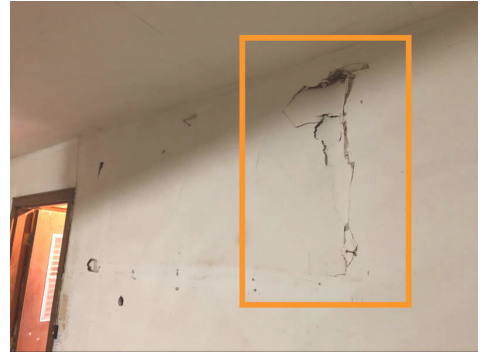
5.4.1 Walls/Firewalls

**FIREWALL (VIOLATIONS)**

The walls separating the garage from the home living space did not meet firewall requirements. The Inspector recommends correction by a qualified contractor.

Contact a qualified drywall contractor.

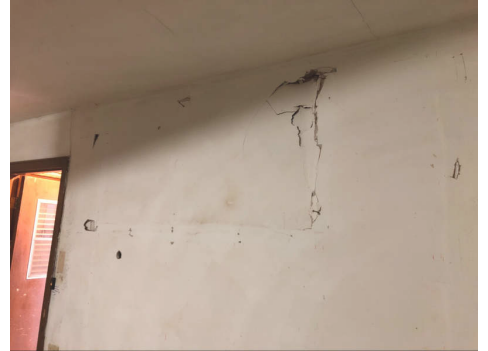
5.4.2 Walls/Firewalls

**WALLS (MODERATE DAMAGE)**

The garage walls had moderate damage visible at the time of the inspection. The Inspector recommends correction by a qualified contractor.

Contact a qualified drywall contractor.

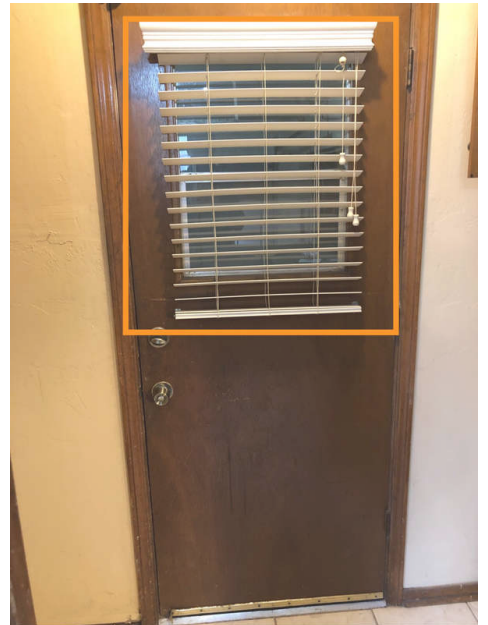
5.7.1 Occupant Door (From garage to inside of home)

**DOOR TO LIVING SPACE (NON-COMPLIANT)**

GARAGE

The door in the wall between the garage and the home living space did not meet generally-accepted current safety standards. Doors in firewalls must be a minimum of 1 3/8 inches thick, metal or a 20-minute fire-rated panel door. Note that a window or doggie-door, while common and convenient, is unlikely to provide sufficient firewall protection.

Contact a qualified door repair/installation contractor.

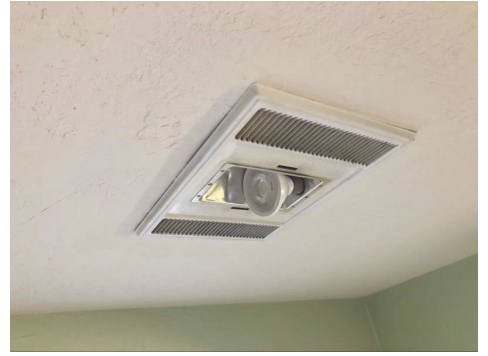
7.4.1 Exhaust Systems

**EXHAUST FAN INOPERATIVE**

WEST HALLWAY BATHROOM

And exhaust fan was not working by use of normal operating controls. Repair/replace as necessary.

Contact a qualified electrical contractor.

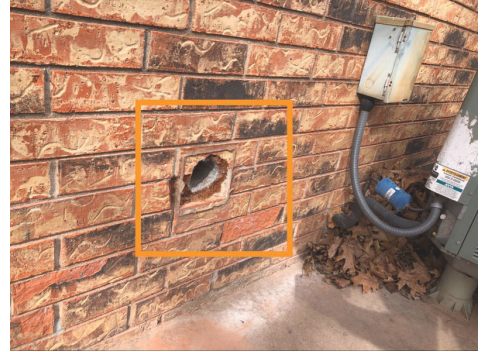
7.4.2 Exhaust Systems

**DRYER VENT LOUVER MISSING**

EAST EXTERIOR

The dryer vent louver is missing. This should be replaced so as to avoid access by wildlife and/or moisture.

Contact a handyman or DIY project

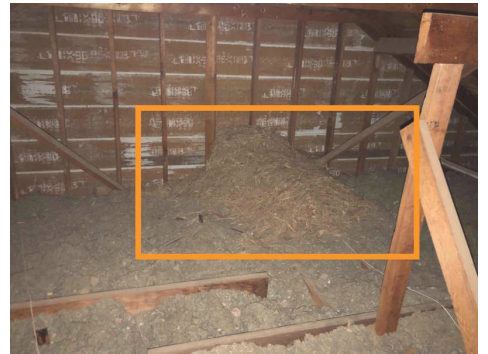
7.5.1 Attic (Structure)

**EVIDENCE OF WILDLIFE INTRUSION**

WEST ATTIC

Evidence was observed that indicates wildlife has been in the attic. Recommend removal and securing of access point.

Contact a qualified pest control specialist.

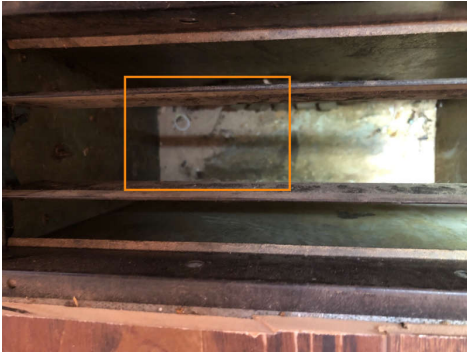
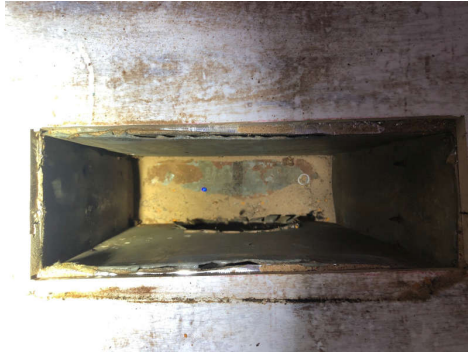
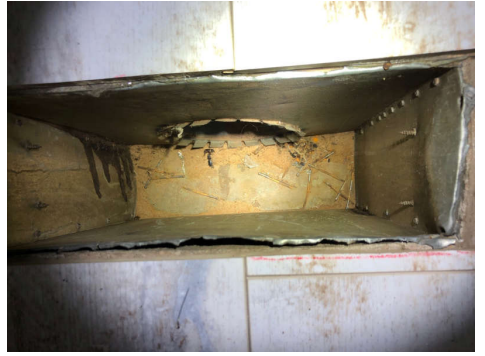
8.2.1 Distribution System

**SAND OBSERVED IN FLOOR REGISTER**

NORTHWEST BEDROOM, WEST BEDROOM, SOUTHWEST BEDROOM

Sand was observed in one or more floor registers. This may indicate damage to the in-slab ductwork. A scoping of the HVAC ducts is recommended to determine the extent of damage.

Contact a qualified HVAC professional.

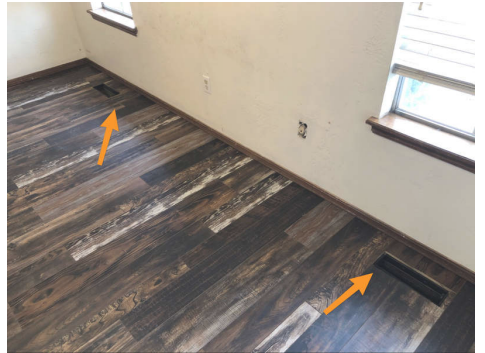
8.2.2 Distribution System

**FLOOR REGISTER MISSING**

NORTHWEST BEDROOM

A floor register was missing. In addition to not being able to direct air, the opening in the floor represents a safety hazard. Replace registers as necessary.

Contact a handyman or DIY project

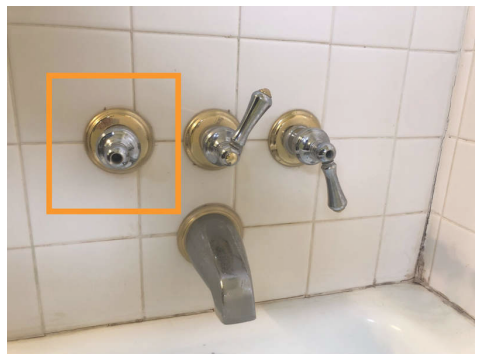
11.3.1 Water Supply, Distribution Systems & Fixtures

**FAUCET HANDLE MISSING**

WEST HALLWAY BATHROOM

A handle for a faucet was missing. Repair/replace as necessary.

Contact a handyman or DIY project

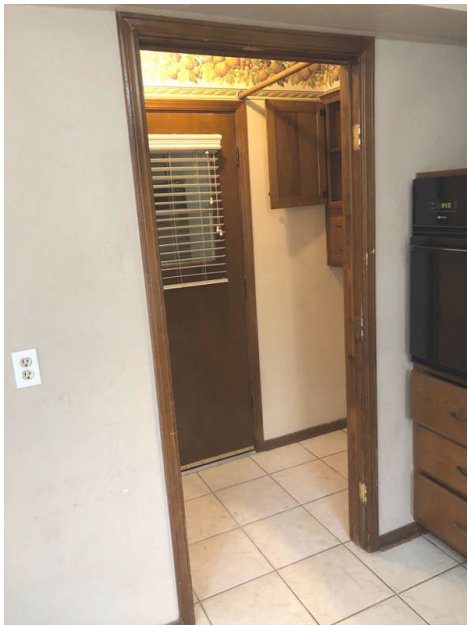
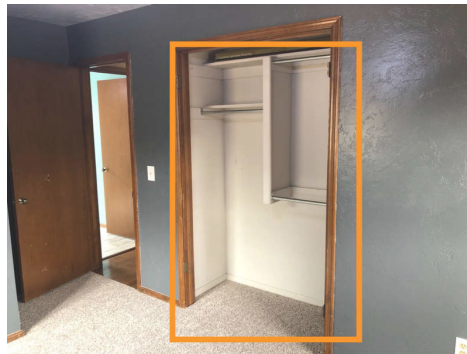
### 12.3.2 Doors

#### **DOOR(S) MISSING**

KITCHEN TO LAUNDRY, SOUTH BEDROOM CLOSET

One or more doors were not installed and were not located on the premises. It may be that the door was never installed or was removed out of convenience. Nonetheless, the door was missing.

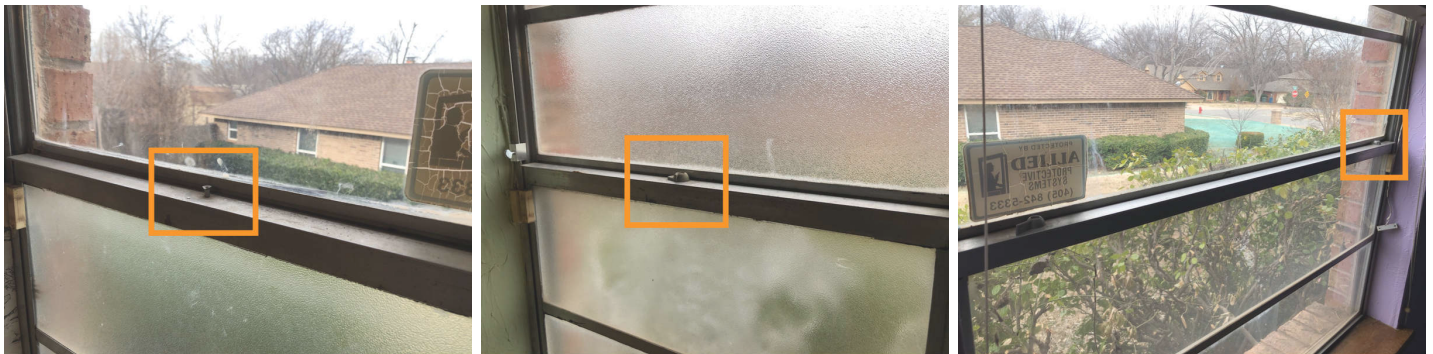
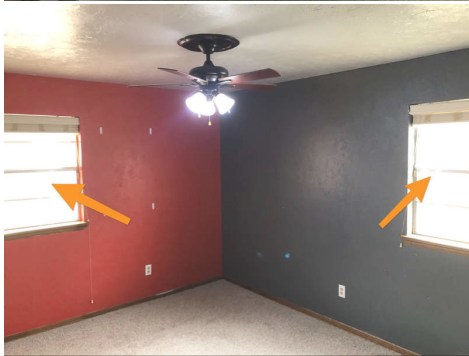
#### 12.4.2 Windows

### **BROKEN LOCK**

NORTHWEST BATHROOM, WEST HALLWAY BATHROOM, WEST BEDROOM, SOUTH BEDROOM

The locking mechanism was broken on one or more windows. Repair/replace as necessary.

Contact a handyman or DIY project

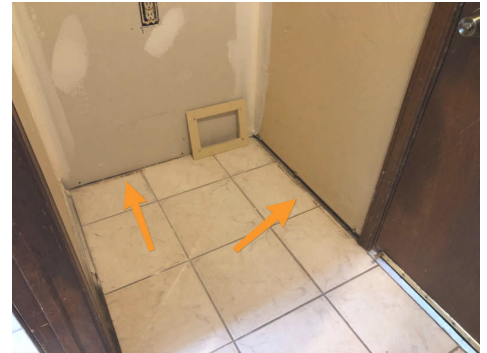
12.8.1 Trim

**INTERIOR TRIM PIECE MISSING**

LAUNDRY

Trim was missing. Repair/replace as necessary.

Contact a qualified carpenter.

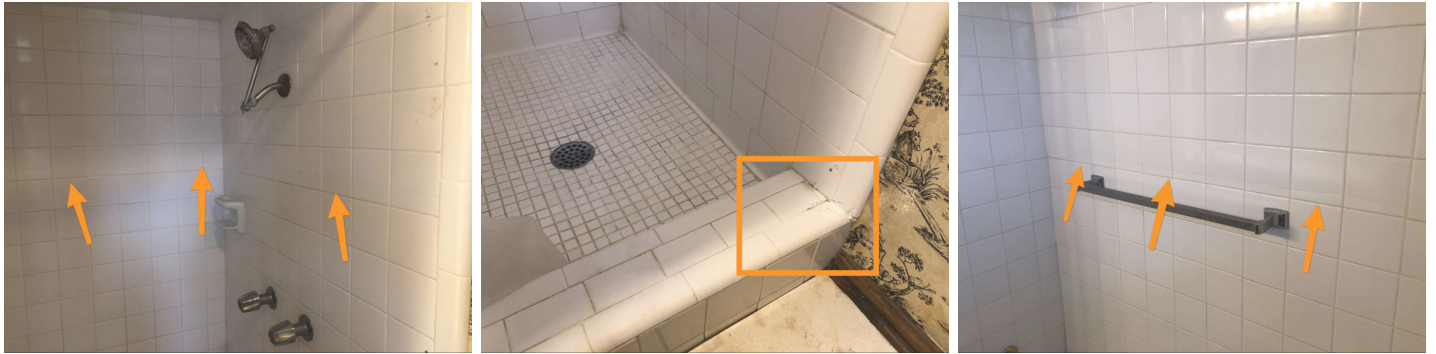
### SHOWER TILE DAMAGE

NORTHWEST BATHROOM, WEST HALLWAY BATHROOM

There is noticeable damage within the shower tile assembly. This can potentially allow moisture intrusion into the interior wall. Recommend a qualified professional repair as necessary.

Contact a qualified tile contractor

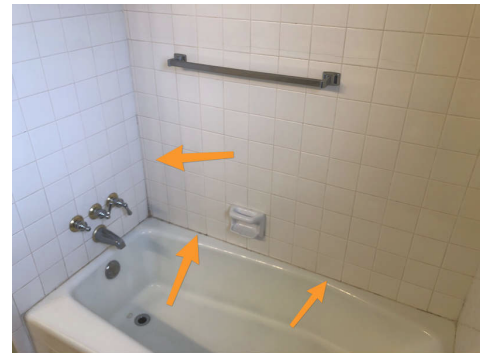
### GROUT DETERIORATING

WEST HALLWAY BATHROOM

Grout lines were cracked or deteriorated, potentially allowing for moisture intrusion. Recommend a qualified contractor repair or replace grout.

Contact a qualified countertop contractor.

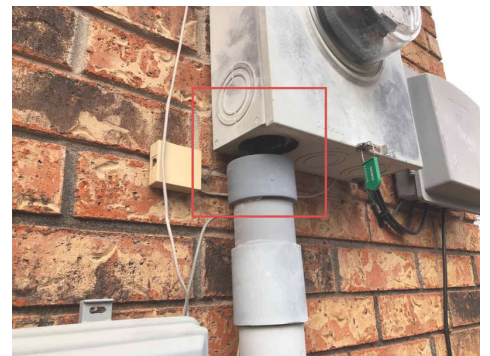
### RISER/RACEWAY DISCONNECTED

NORTHEAST EXTERIOR

The riser was disconnected at the meter box, exposing the service entrance cables to touch, impact and abrasion. This condition should be corrected to avoid shock/electrocution hazard or damage to the conductors. Work around service conductors should be performed by a qualified personnel only. Injury or death may result from attempts at correction by those without proper qualifications.

Contact a qualified electrical contractor.

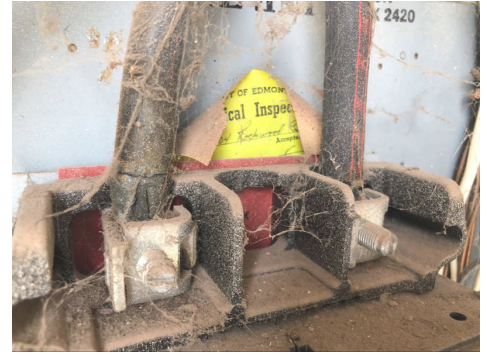
### CONTAMINATION IN PANEL

MAIN ELECTRICAL PANEL

Contamination was present in the electrical panel. Internal parts of electrical equipment, including busbars, wiring terminals, insulators, and other surfaces, should not be damaged or contaminated by foreign materials such as paint, plaster, cleaners, abrasives, or corrosive residues. This may cause undue stress to electrical components and systems and may void the manufacturers warranty. Consultation with a qualified electrical contractor is recommended.

Contact a qualified electrical contractor.

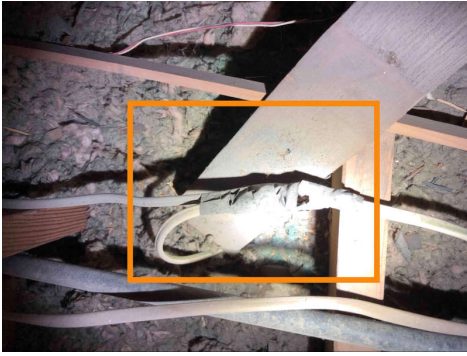
13.3.3 Branch Wiring, Circuits, Breakers & Fuses

### JUNCTION BOX MISSING

EAST ATTIC

Splices were noted without a proper junction box. Installation of a box is recommended to secure the connections.

Contact a qualified electrical contractor.

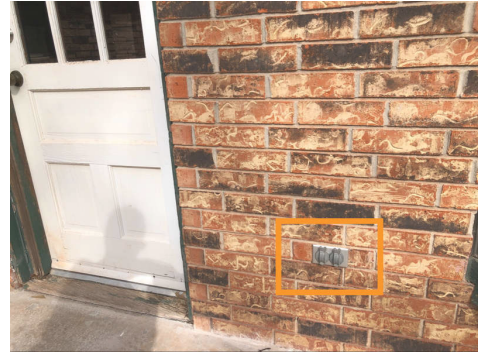
13.4.3 Lighting Fixtures, Switches & Receptacles

**INOPERABLE RECEPTACLE(S)**

REAR EXTERIOR

An electrical receptacle was inoperable at the time of the inspection. The Inspector recommends service by a qualified electrical contractor.

\*Possibly related to non-functional GFCI at main electrical panel.

Recommendation  
Contact a qualified electrical contractor.

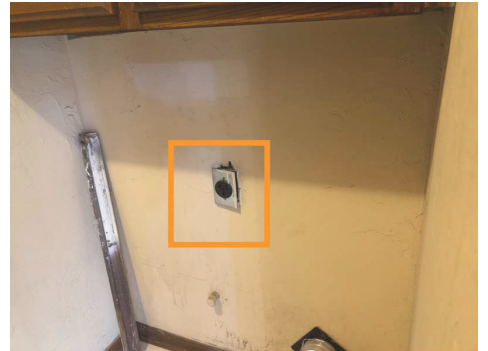
13.4.4 Lighting Fixtures, Switches & Receptacles

**LOOSE RECEPTACLE**

LAUNDRY

An electrical receptacle was improperly secured. Receptacles should be securely installed to prevent fire, shock and/or electrocution hazard. The Inspector recommends correction by a qualified electrical contractor.

Recommendation  
Contact a handyman or DIY project

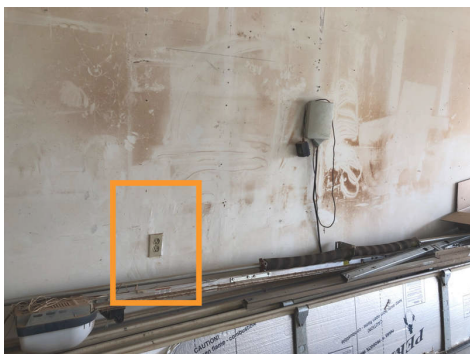
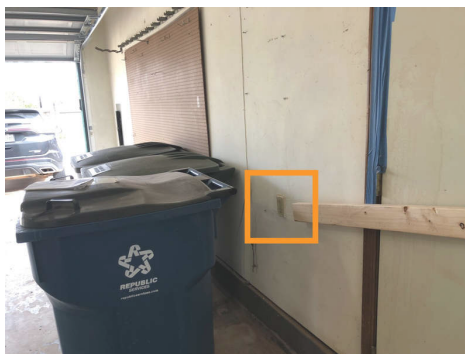
13.4.5 Lighting Fixtures, Switches & Receptacles

**UNGROUND RECEPTACLE, 3-PRONG**

GARAGE

Although the 3-prong electrical receptacles installed in this home typically indicate a home with grounded branch wiring, this home had no grounding system installed to protect devices such as switches, light fixtures and electrical receptacles. This condition is especially dangerous because it leads those using the electrical system to believe they are protected by a grounding system when they are not. Ungrounded electrical receptacles should be labeled as such. Although ungrounded electrical systems may have been commonly considered safe or acceptable at the time the home was originally constructed, as general knowledge of safe building practices has improved with the passage of time, building standards have changed to reflect current understanding. For safety reasons, the Inspector recommends that receptacles located in basements, crawlspaces, garages, the home exterior, and interior receptacles located within 6 feet of a plumbing fixture be provided with ground fault circuit interrupter (GFCI) protection in good working order to avoid potential electric shock or electrocution hazards. This can be achieved relatively inexpensively by: 1. Replacing an individual standard receptacle with a GFCI receptacle. 2. Replacing the electrical circuit receptacle located closest to the overcurrent protection device (usually a breaker) with a GFCI receptacle. 3. Replacing the breaker currently protecting the electrical circuit that contains the receptacles of concern with a GFCI breaker. Adding equipment grounding and a service grounding system will also increase home safety.

Recommendation  
Contact a qualified electrical contractor.

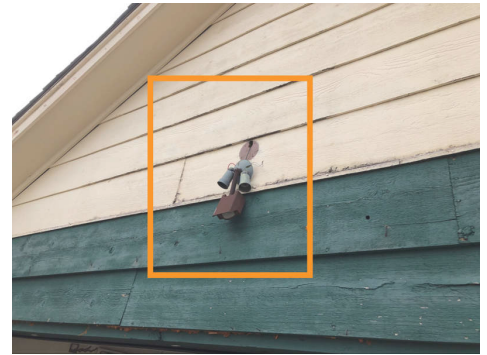
13.4.6 Lighting Fixtures, Switches & Receptacles

**DAMAGED LIGHT FIXTURE**

FRONT EXTERIOR

A light fixture showed visible damage. Recommend repair/replacement by qualified electrical contractor.

Contact a qualified electrical contractor.

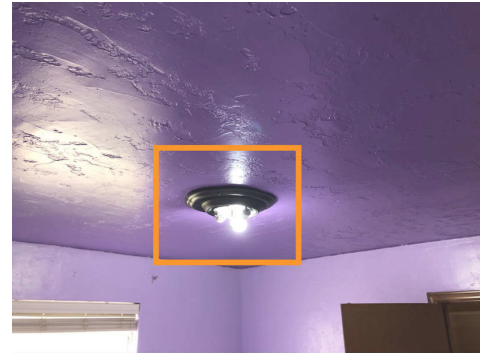
13.4.7 Lighting Fixtures, Switches & Receptacles

**LIGHT MISSING GLOBE/COVER**

WEST BEDROOM

A light fixture was missing its cover. Replacement is recommended.

Contact a handyman or DIY project

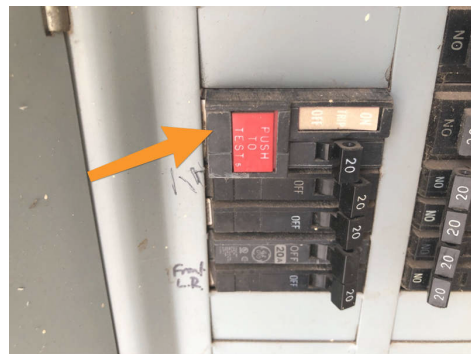
13.5.2 GFCI & AFCI

**GFCI FAILURE**

MAIN ELECTRICAL PANEL

A ground fault circuit interrupter (GFCI) electrical receptacle did not respond to testing, did not re-set, was slow to re-set or made a buzzing sound when re-set. The Inspector recommends replacement of the receptacle to ensure that it works correctly when required. All work should be performed by a qualified contractor.

Contact a qualified electrical contractor.

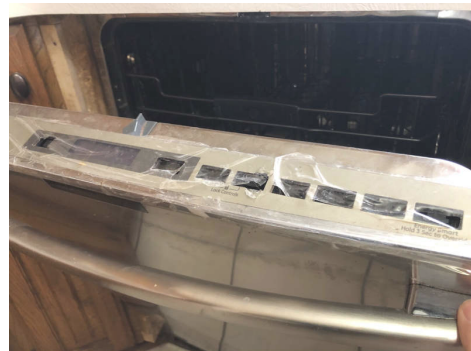
### 14.1.1 Dishwasher

#### **CONTROL PANEL DAMAGED**

KITCHEN

The dishwasher control panel was damaged. Operation could not be verified.

Contact a qualified appliance repair professional.

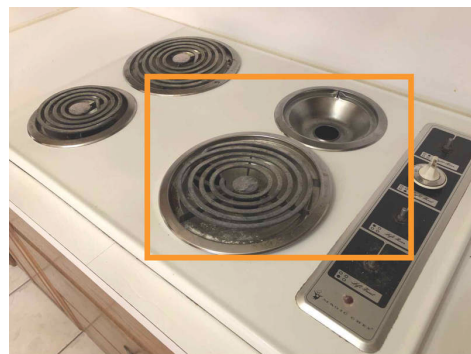
### 14.2.1 Cooktop/Exhaust Fan

#### **COOKTOP BURNER INOPERABLE**

KITCHEN

One or more heating elements did not heat up when turned on. Recommend qualified professional evaluate & repair.

Contact a qualified handyman.

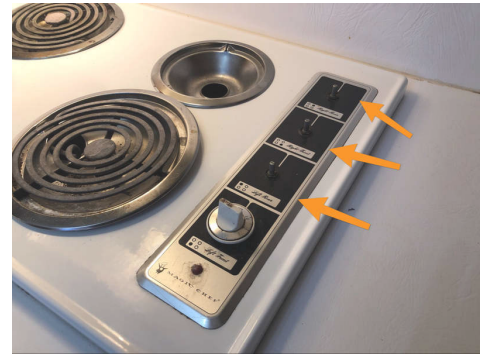
14.2.2 Cooktop/Exhaust Fan

### COOKTOP MISSING CONTROL KNOBS

KITCHEN

Cooktop was missing control knobs. Recommend contacting manufacturer for replacement parts.

Contact a qualified professional.

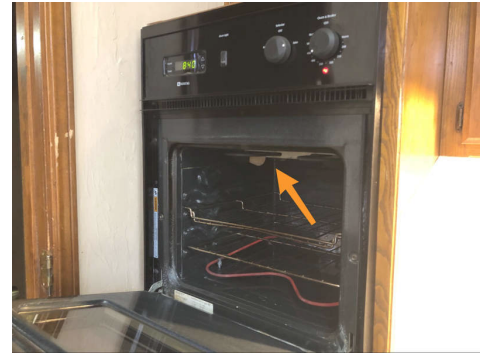
14.3.1 Oven

### OVEN LIGHT NOT OPERATIONAL

KITCHEN

Contact a handyman or DIY project

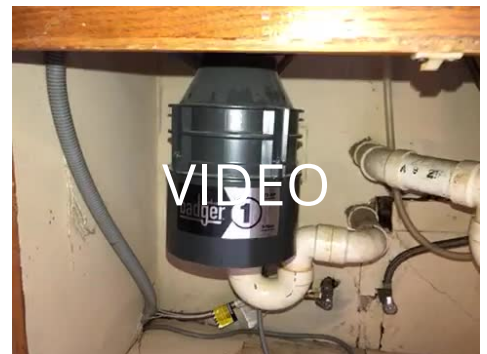
14.4.1 Garbage Disposal

### EXCESSIVE NOISE

KITCHEN

Garbage disposal was excessively noisy. There may be an unseen object in the disposal or it could be a problem with the motor itself.

Contact a qualified appliance repair professional.
